# SINCERE

## VEHICLE DAMAGE INSPECTION REPORT

Our Ref: 113/TP/2021

Reg No:	GBG5142E	Make &	Toyota
Reg date:	28/8/2017	Model	Hiace
Colour:	Blue	Engine No:	1KD2700401
Type:	Van	Chassis No:	JTFHT02P300220258
Type of Claims:	Third Party	Odometer No:	146084km
		Engine Cap:	2982cc

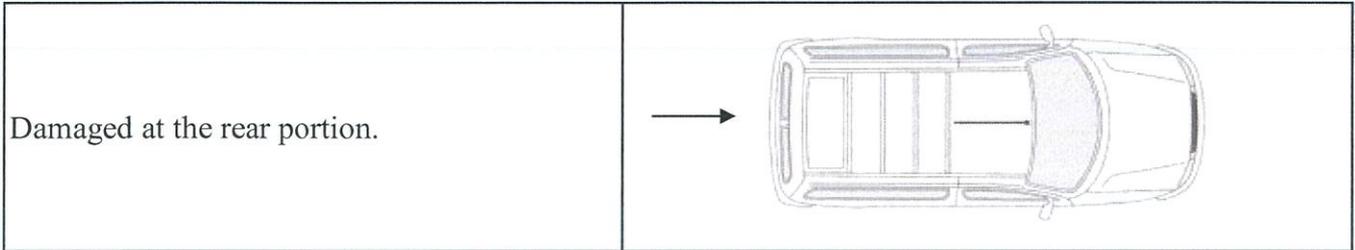
## POINT OF IMPACT

Our visual inspection of the vehicle revealed that the damages noted are at the rear portion.
