## VEHICLE DAMAGE INSPECTION REPORT

Our Ref: 113/TP/2021

Date of loss: 27/4/2021  
Claimant: Uka Leasing Pte Ltd

Reg No:	GBG5142E	Make &	Toyota
Reg date:	28/8/2017	Model	Hiace
Colour:	Blue	Engine No:	1KD2700401
Type:	Van	Chassis No:	JTFHT02P300220258
Type of Claims:	Third Party	Odometer No:	146084km
		Engine Cap:	2982cc

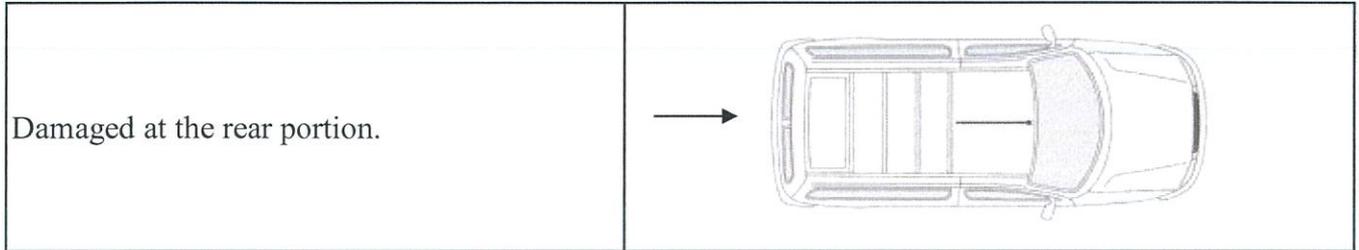
**POINT OF IMPACT**

Our visual inspection of the vehicle revealed that the damages noted are at the rear portion.
