Your Ref: BMW 330e
(chassis number WBA5X72090FJ20316)
Our Ref : CI/TP21008309/D

10 August 2021

**INSPECTION REPORT OF AN UNREGISTERED BMW 330e MOTOR CAR
WITH CHASSIS NUMBER WBA5X72090FJ20316**

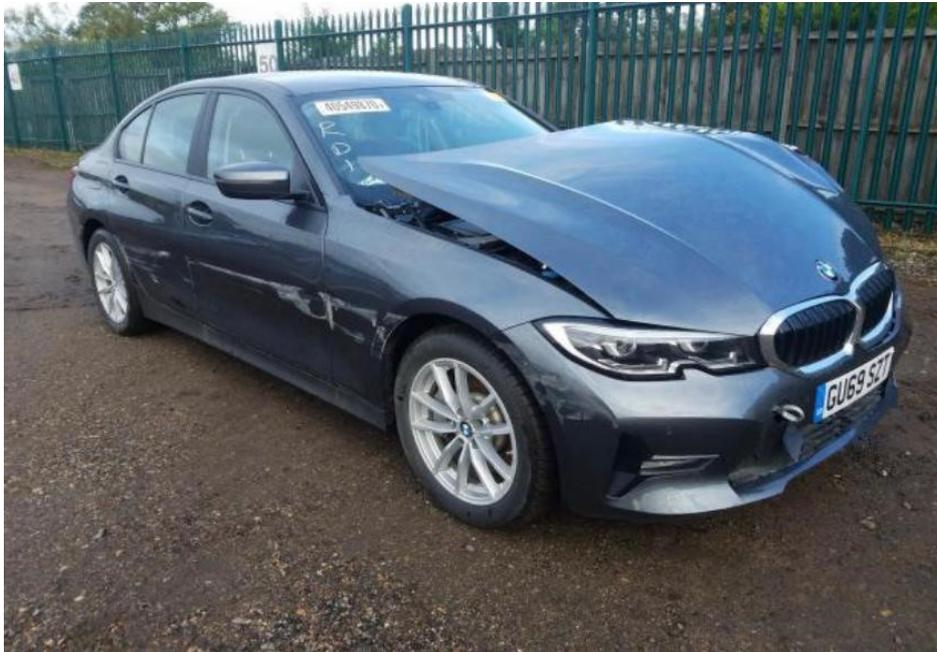
3. The photographs provided to me had showed damage along the entire right side and left side of the Motor Car. Body parts damaged along the right side include the front bumper, front right fender, front right door, rear right door, rear right fender and rear bumper amongst others. As for the left side, I had observed damage to the Motor Car's front bumper, front bonnet, front bonnet left hinge, front left headlamp, front left fender, charging socket cover, left wing mirror, left side outer "A" pillar, front left door, rear left door, rear left fender and rear bumper amongst others.

Photo 1 shows the front right body of the Motor Car (photograph provided to me). The Motor Car was observed to have sustained damages along its entire right side. The front bumper, front right fender, front right door and rear right door were amongst the body parts that were observed to have been damaged.

22. The body parts along the entire right side and left side of the Motor Car were visually examined and it was noted that the repair/restoration works carried out to the damaged area of the Motor Car (refer to photograph 1 – 4 above) were reasonably adequate and in order.

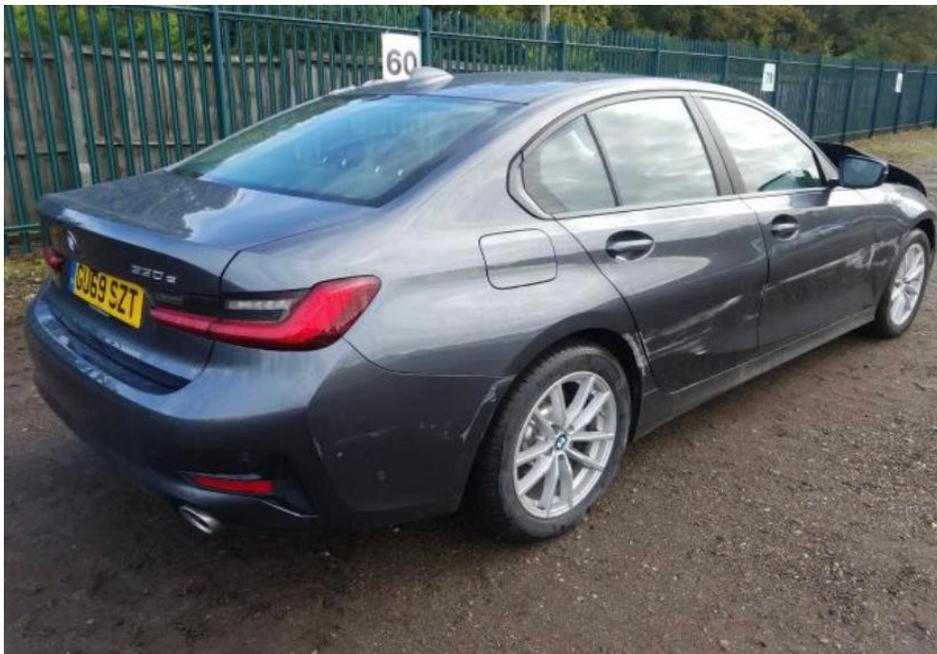
Photo 2 shows the rear right body of the Motor Car (photograph provided to me). The Motor Car was observed to have sustained damages along its entire right side. The rear bumper, rear right fender, rear right door and front right door were amongst the body parts that were observed to have been damaged. Overall, the damages along the entire right side were less severe as compared to the damages along the entire left side (refer to photograph 3 & 4 below).

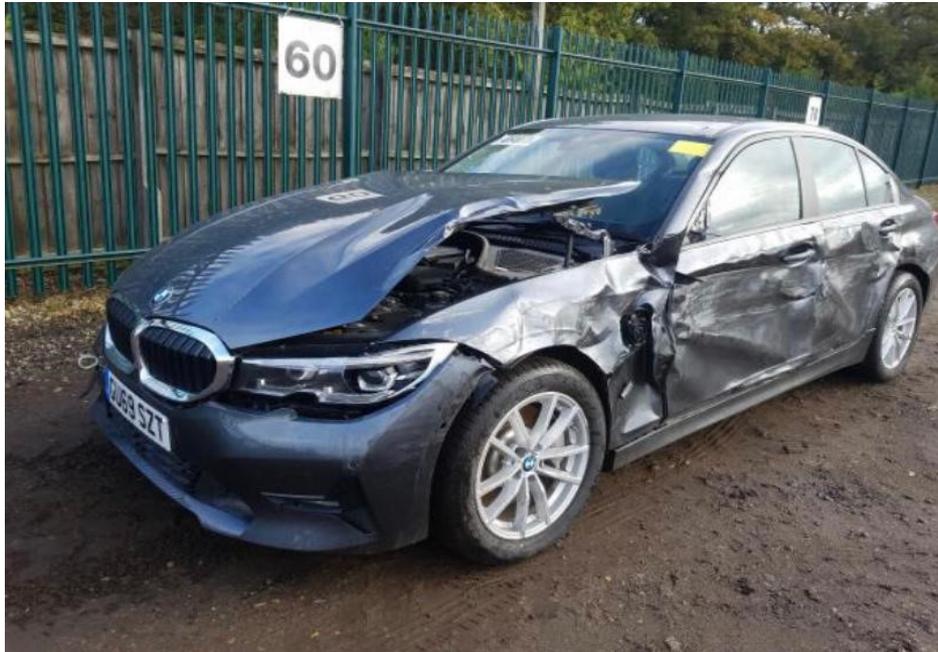
Photo 3 shows the front left body of the Motor Car (photograph provided to me). Apart for the right side, the Motor Car had also sustained damages along its entire left side. The front bumper, front bonnet, front left headlamp, front left fender, front left outer "A" pillar, left wing mirror, front left door and rear left door were amongst the body parts that were observed to have been damaged.

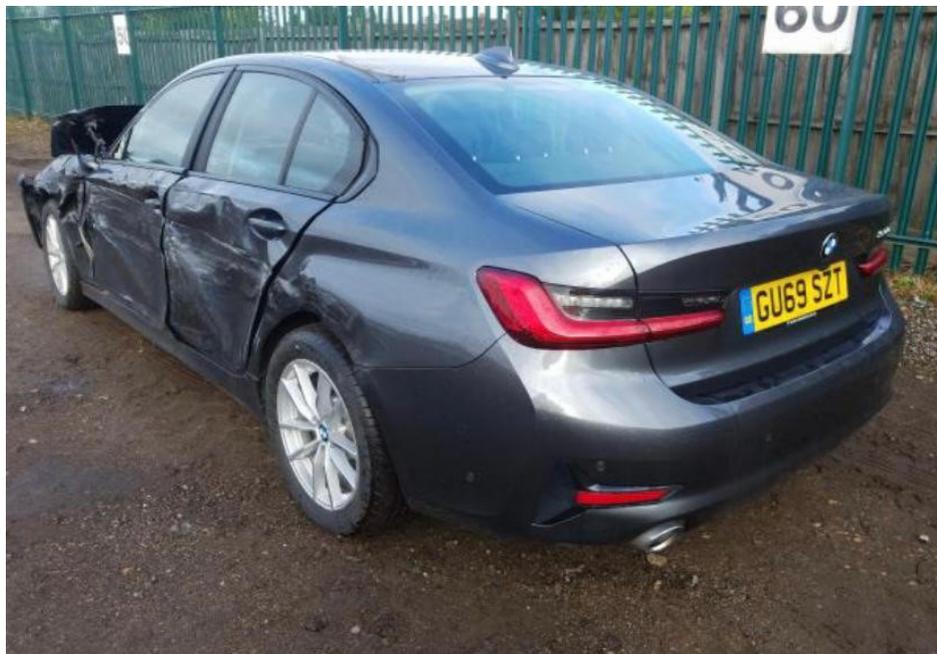
4. Overall, the damages along the entire left side of the Motor Car were more severe as compared to the damages along the entire right side. No physical damage was observed to other areas of the Motor Car. The airbags were not deployed, as seen from the photographs that were provided to me. See photo 1 – 4 below.

Photo 4 shows the rear left body of the Motor Car (photograph provided to me). Apart for the right side, the Motor Car had also sustained damages along its entire left side. The rear bumper, rear left fender, rear left door and front left door were amongst the body parts that were observed to have been damaged. Overall, the damages along the entire left side were more severe as compared to the damages along the entire right side (refer to photograph 1 & 2 above).

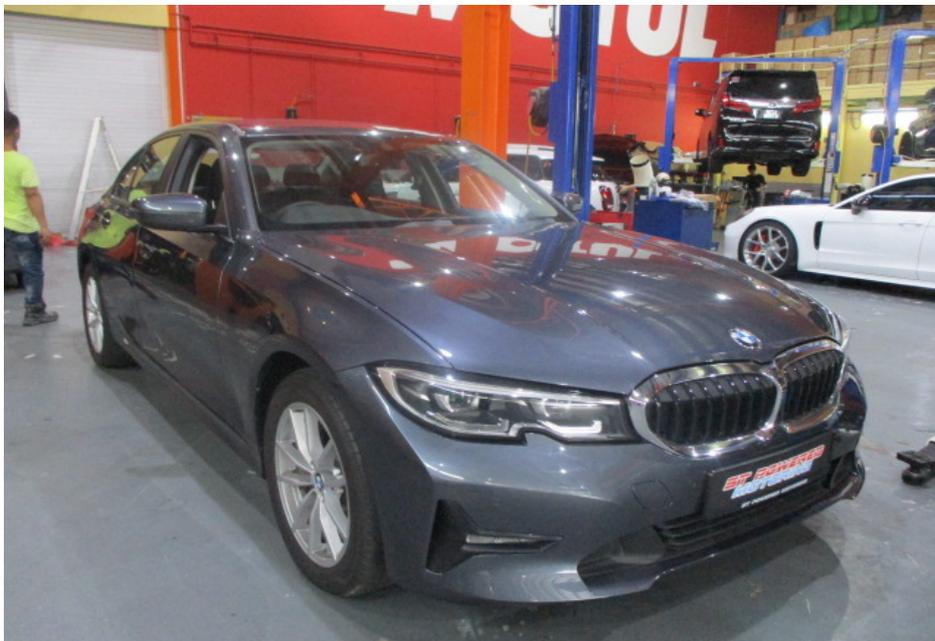
Photo 5 shows a general view of the front right body of the Motor Car at the time of my inspection. The Motor Car was observed to be in a relatively good general condition with no loose exterior fittings observed. The body parts along the entire right side of the Motor Car were visually examined and it was observed that the repair/restoration works carried out to the damaged area of the Motor Car (refer to photograph 1 & 2 above) were reasonably adequate and in order.

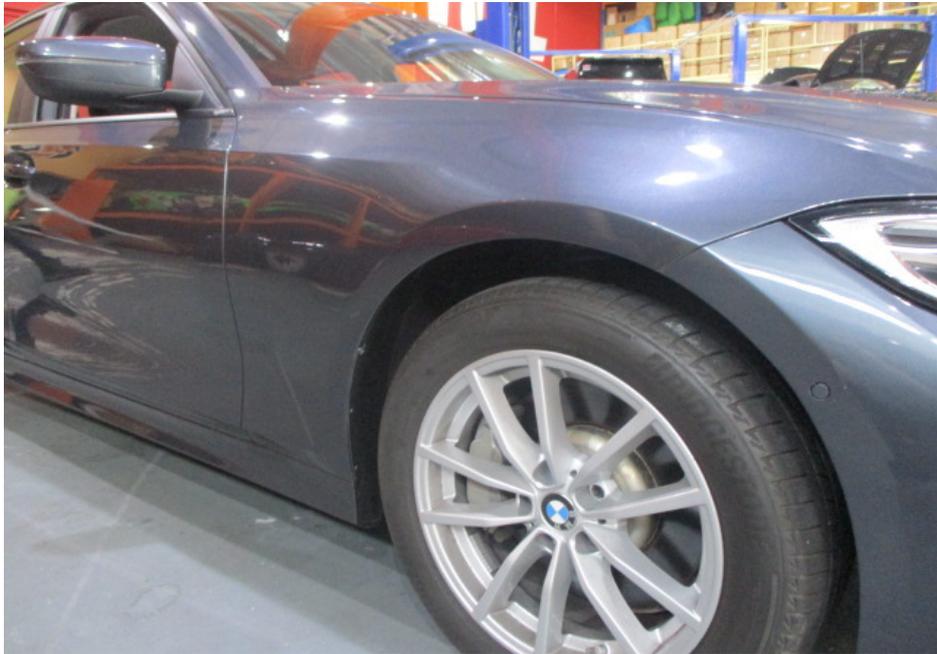
Photo 6 shows a closer view of the front bumper, front right fender and front right door of the Motor Car. The body parts along the entire right side of the Motor Car were visually examined and it was observed that the repair/restoration works carried out to the damaged area of the Motor Car (refer to photograph 1 & 2 above) were reasonably adequate and in order.

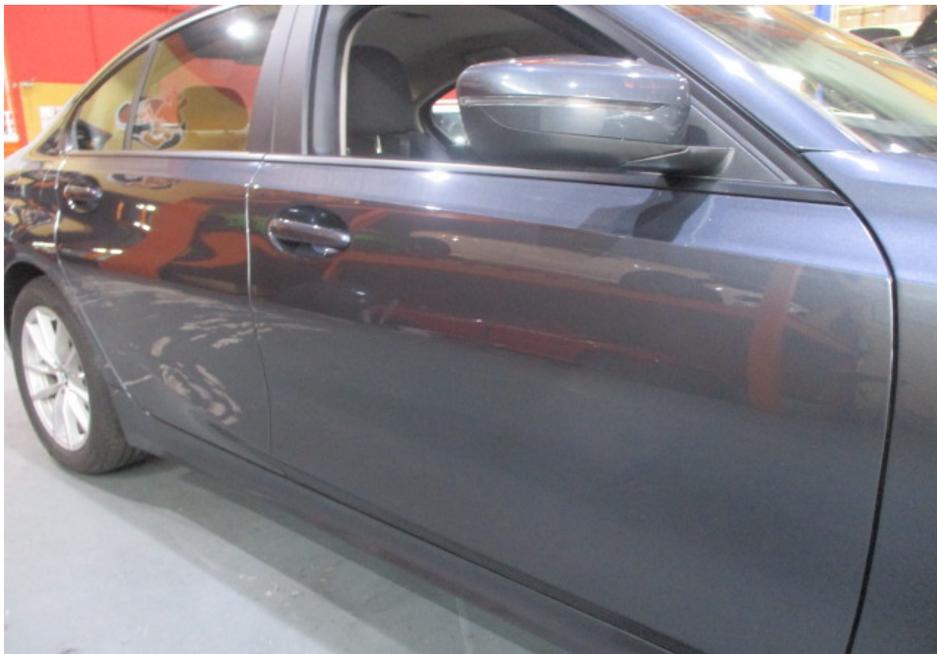
Photo 7 shows a closer view of the front right door and rear right door of the Motor Car. The body parts along the entire right side of the Motor Car were visually examined and it was observed that the repair/restoration works carried out to the damaged area of the Motor Car (refer to photograph 1 & 2 above) were reasonably adequate and in order.

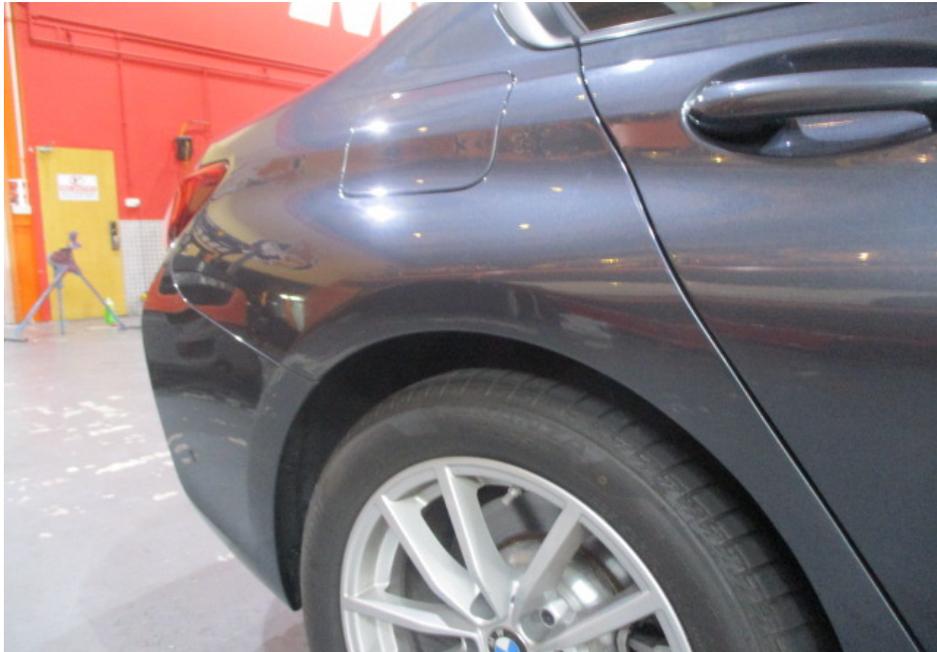
Photo 8 shows a closer view of the rear right door, rear right fender and rear bumper of the Motor Car. The body parts along the entire right side of the Motor Car were visually examined and it was observed that the repair/restoration works carried out to the damaged area of the Motor Car (refer to photograph 1 & 2 above) were reasonably adequate and in order.

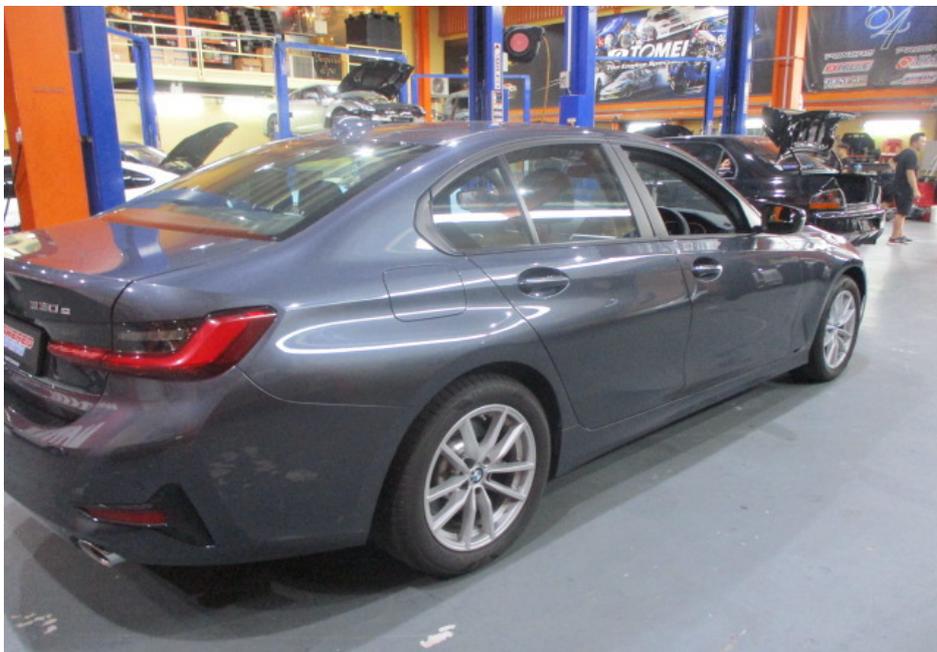
Photo 9 shows a general view of the rear right body of the Motor Car at the time of my inspection. The Motor Car was observed to be in a relatively good general condition with no loose exterior fittings observed. The body parts along the entire right side of the Motor Car were visually examined and it was observed that the repair/restoration works carried out to the damaged area of the Motor Car (refer to photograph 1 & 2 above) were reasonably adequate and in order.

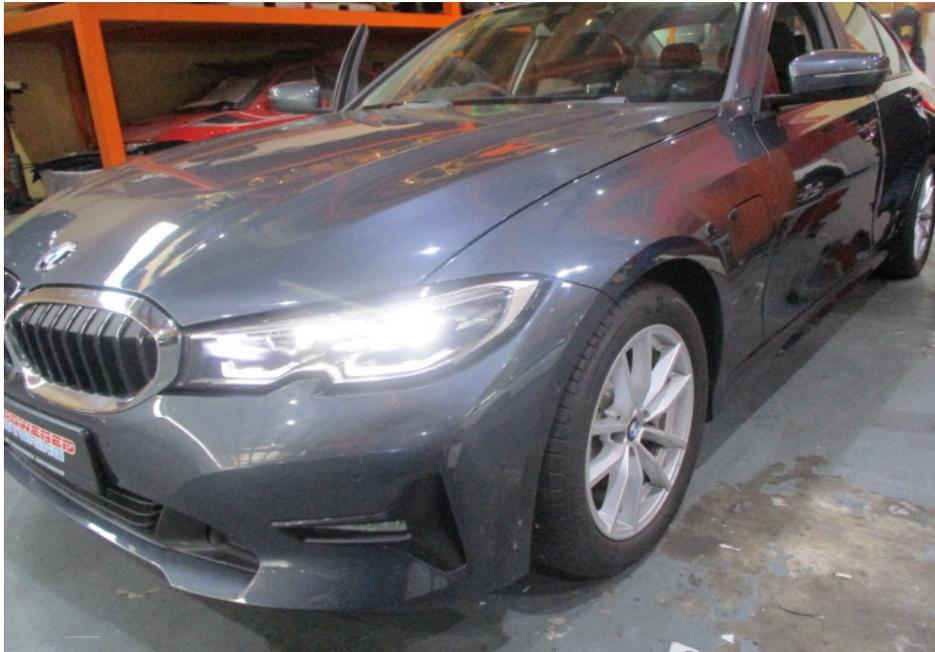
Photo 10 shows a general view of the front left body of the Motor Car at the time of my inspection. The Motor Car was observed to be in a relatively good general condition with no loose exterior fittings observed. The body parts along the entire left side of the Motor Car were visually examined and it was observed that the repair/restoration works carried out to the damaged area of the Motor Car (refer to photograph 3 & 4 above) were reasonably adequate and in order.

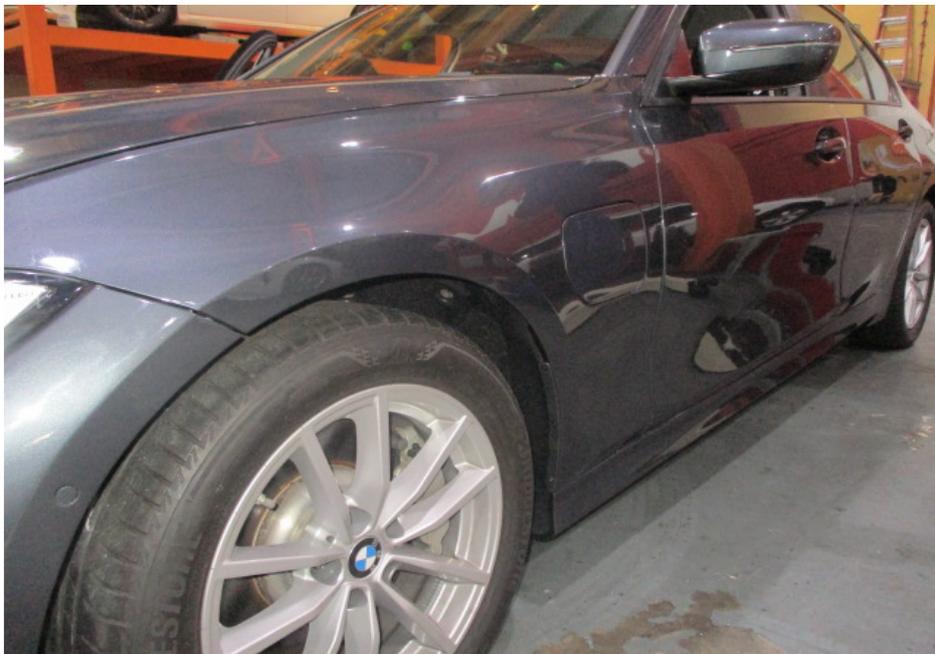
Photo 11 shows a closer view of the front bumper, front bonnet, front left fender and left wing mirror of the Motor Car. The body parts along the entire left side of the Motor Car were visually examined and it was observed that the repair/restoration works carried out to the damaged area of the Motor Car (refer to photograph 3 & 4 above) were reasonably adequate and in order.

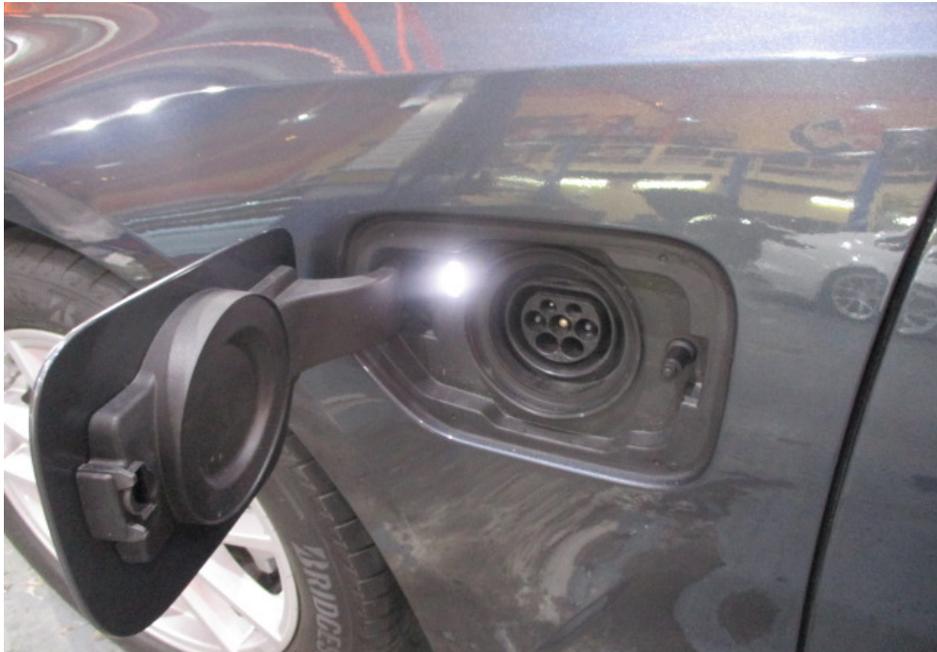
Photo 12 shows a closer view of the front left fender, charging socket and charging socket cover of the Motor Car. The body parts along the entire left side of the Motor Car were visually examined and it was observed that the repair/restoration works carried out to the damaged area of the Motor Car (refer to photograph 3 & 4 above) were reasonably adequate and in order.

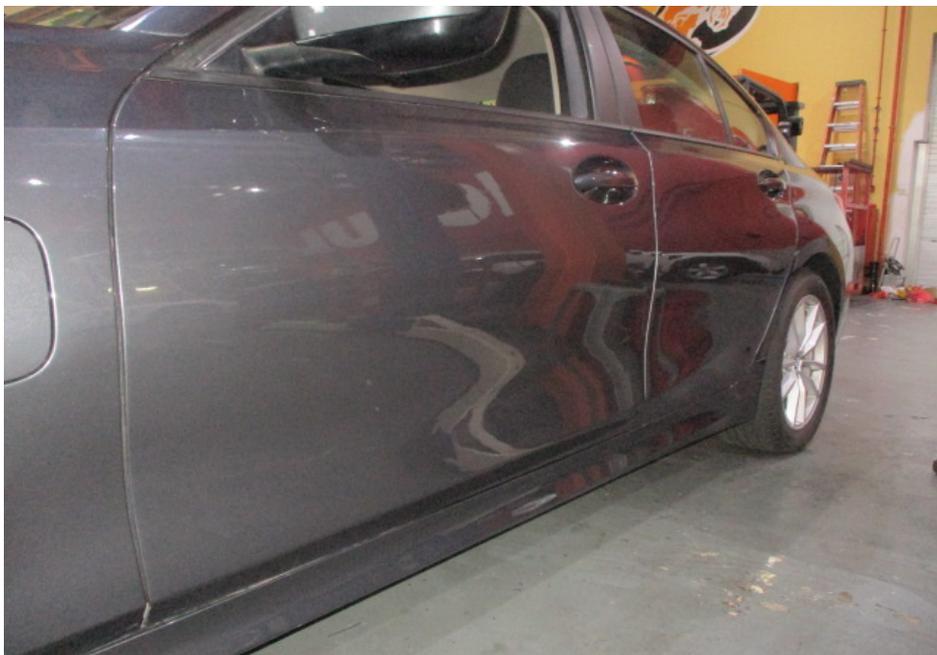
Photo 13 shows a closer view of the front left door and rear left door of the Motor Car. The body parts along the entire left side of the Motor Car were visually examined and it was observed that the repair/restoration works carried out to the damaged area of the Motor Car (refer to photograph 3 & 4 above) were reasonably adequate and in order.

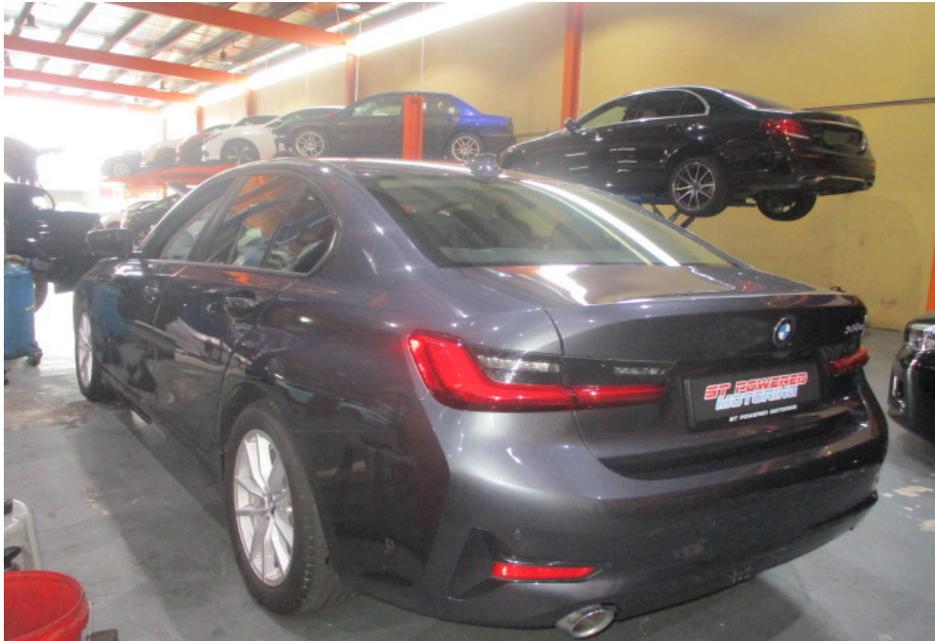
Photo 14 shows a general view of the rear left body of the Motor Car at the time of my inspection. The Motor Car was observed to be in a relatively good general condition with no loose exterior fittings observed. The body parts along the entire left side of the Motor Car were visually examined and it was observed that the repair/restoration works carried out to the damaged area of the Motor Car (refer to photograph 3 & 4 above) were reasonably adequate and in order.

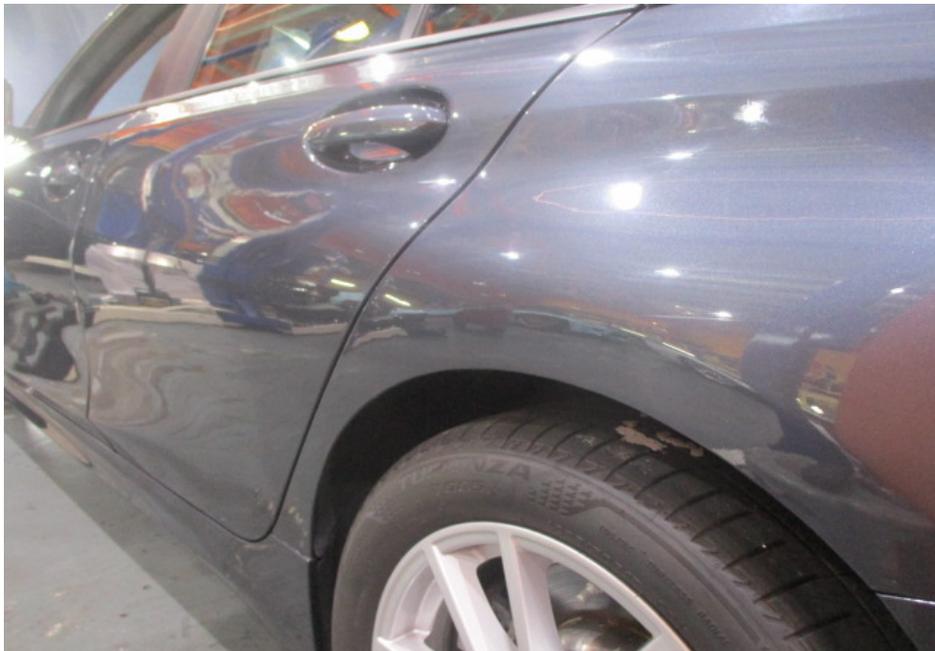
Photo 15 shows a closer view of the rear left door and rear left fender of the Motor Car. The body parts along the entire left side of the Motor Car were visually examined and it was observed that the repair/restoration works carried out to the damaged area of the Motor Car (refer to photograph 3 & 4 above) were reasonably adequate and in order.

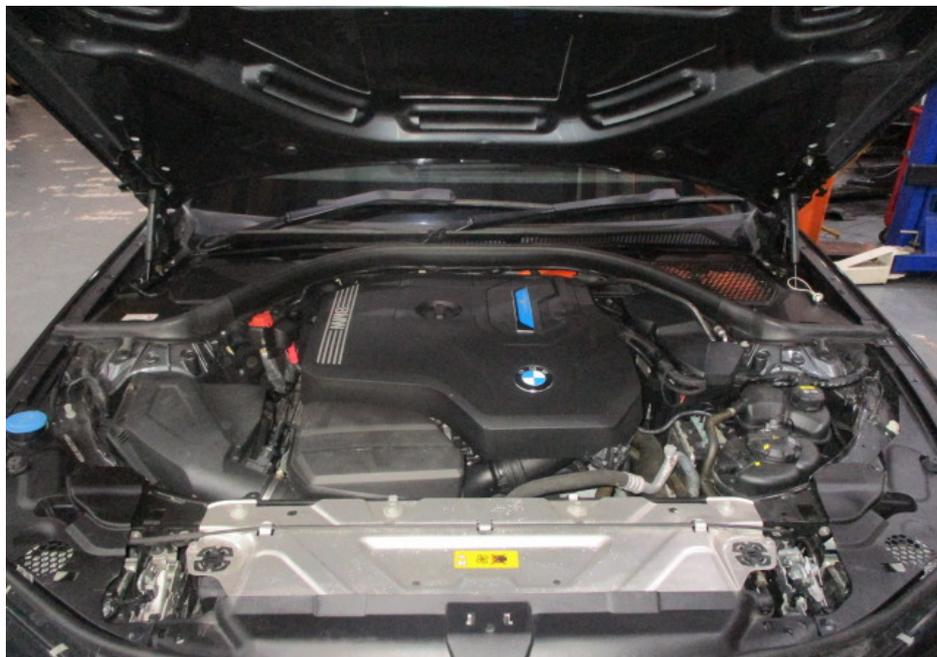
14. My examination of the engine compartment of the Motor Car revealed that the various parts and components inside the engine compartment were all intact and properly fitted. The engine oil, brake fluid and engine coolant were all found to be of sufficient level for operating purposes. Visually, there was also no contamination found to these fluids.

Photo 17 shows a general view of the engine compartment of the Motor Car at the time of my inspection. The various parts and components inside the engine compartment were all observed to be intact and properly fitted. There was also no sign(s) or indication(s) of fluid leak and/or fluid stain found inside the engine compartment.

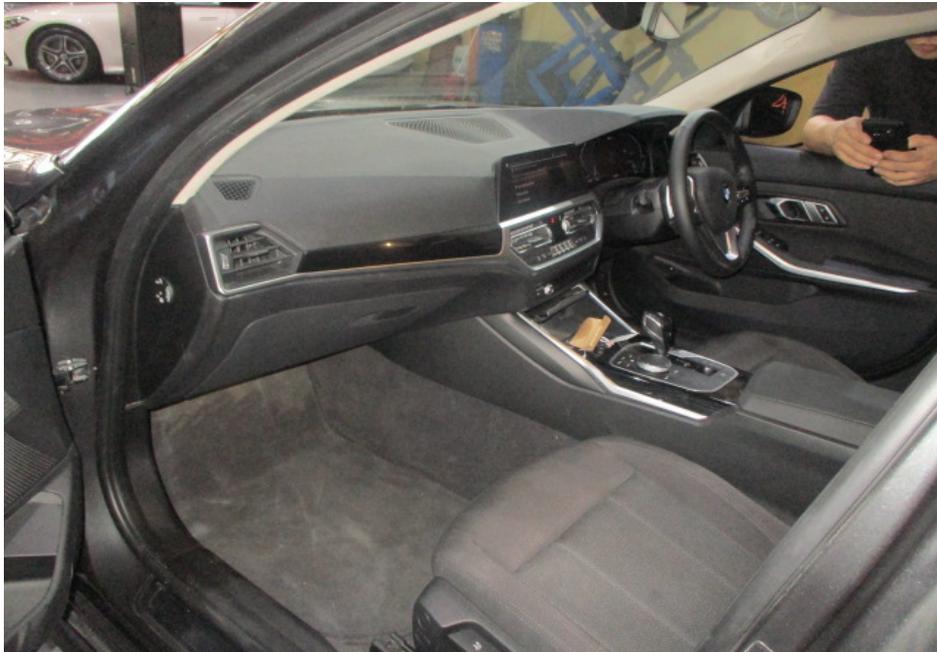
Photo 18 shows the interior compartment of the Motor Car at the time of my inspection. The various parts and components, trims, carpet and upholstery inside the interior compartment were all observed to be intact and properly fitted.

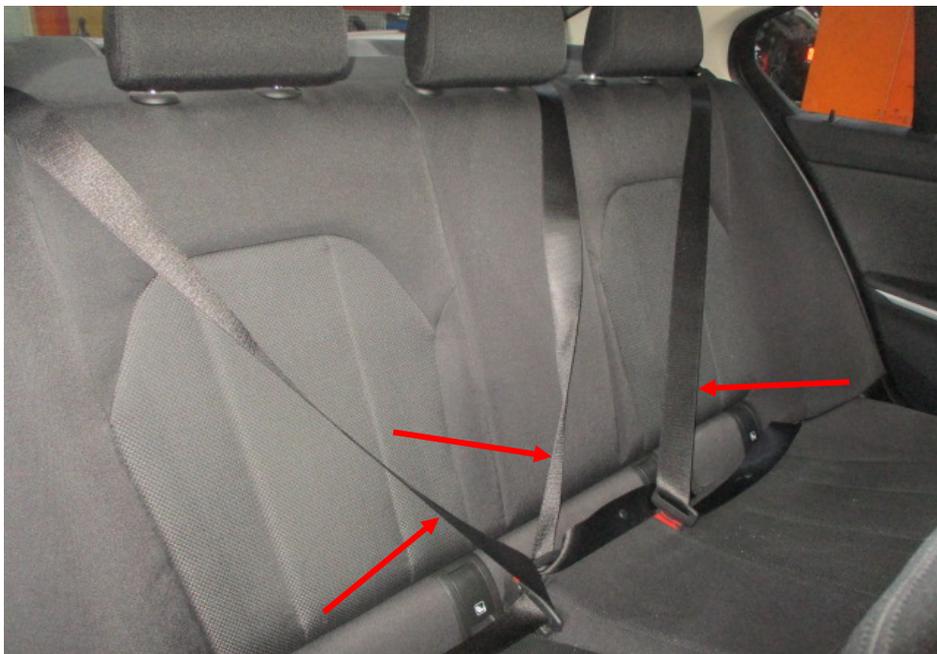
12. The seats of the Motor Car were found to be secured to the floorboard of the Motor Car via seat rails bolted onto the floorboard. Retractable seat belt reels and pre-tensioners were fitted on all seats of the Motor Car. The seat belts were tested and were able to be fastened securely into the respective pre-tensioners that were fixed to the side of all the seats.

Photo 19 shows the rear seats of the Motor Car. All the seats of the Motor Car were secured via seat rails to the floorboard. They were also fitted with a retractable seat belt reel and a pre-tensioner. The seat belts (arrowed) were tested and were able to be fastened into the respective pre-tensions that were fitted on the side of each individual seat.

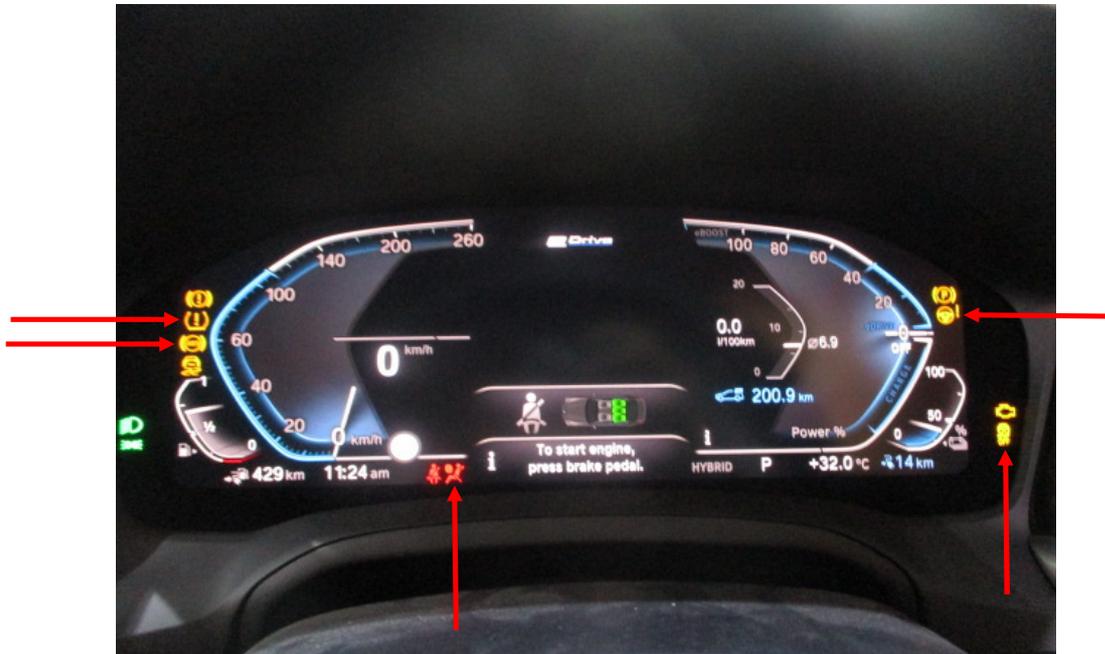
Photo 20 shows the warning lights for the various electronic safety features appearing on the instrument panel of the Motor Car during its self-test when the engine is cranked, in particular the ABS, SRS, IAS, TPM and DSC lights (arrowed).

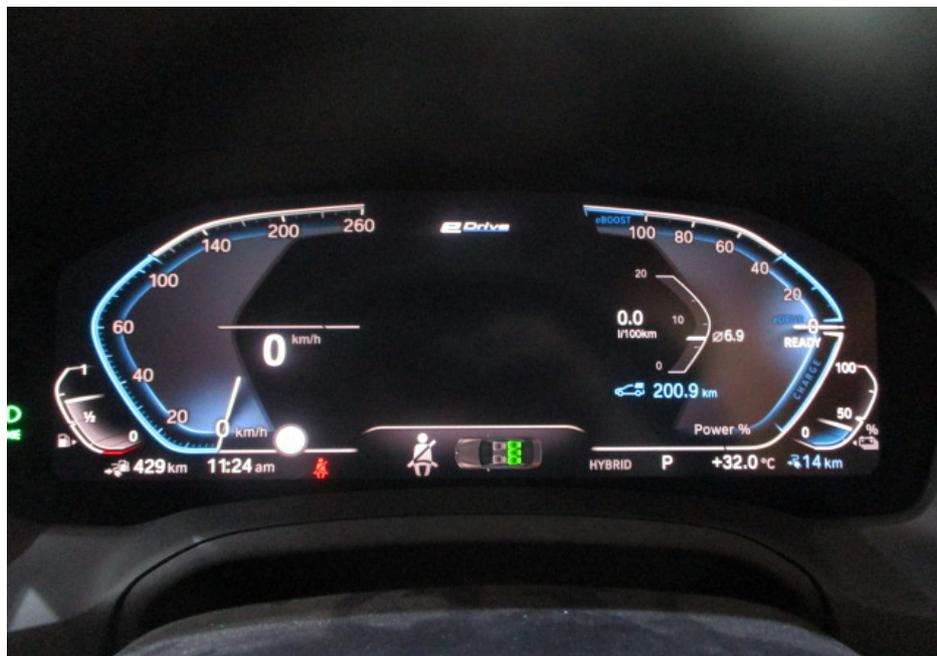
13. The Motor Car's automatic self-test of the functionality of its various electronic safety features like the Anti-Lock Brake System (ABS), Supplemental Restraint System (SRS), Integral Active Steering (IAS), Tyre Pressure Monitor (TPM) and Dynamic Stability Control (DSC) during cranking of the engine had indicated that these electronic systems were in working condition. This was determined from the respective warning lights disappearing from the instrument panel after the self-test.

Photo 21 shows the respective warning lights no longer illuminated, indicating that there is no fault detected to the ABS, SRS, IAS, TPM and DSC systems of the Motor Car during the self-test. These electronic systems were hence in working condition at the time of my inspection.

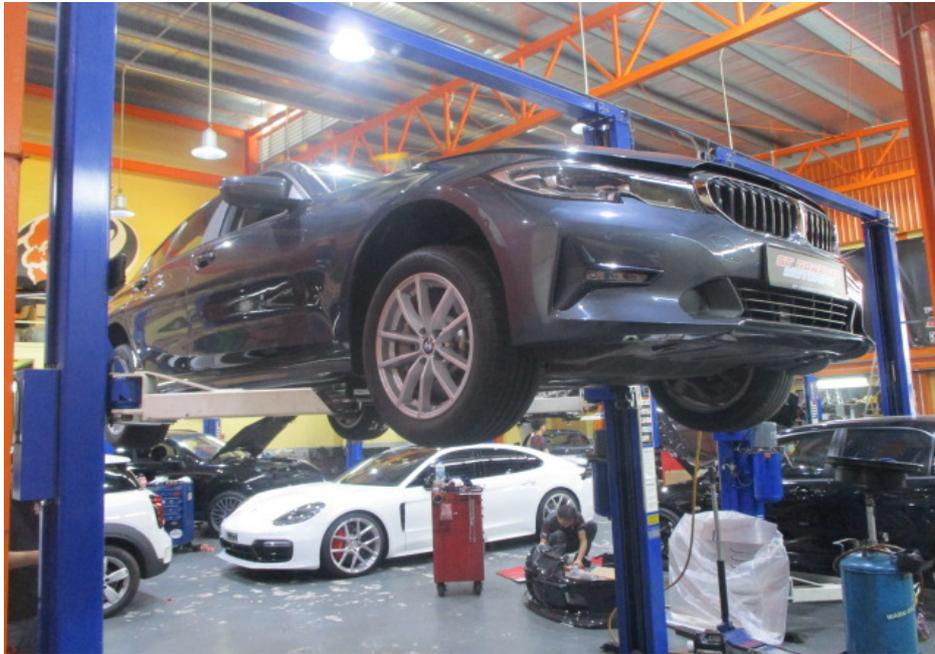
15. My checks on the underside of the Motor Car revealed no sign(s) or indication(s) of fluid leakage and/or fluid stain(s). The engine block and automatic transmission assembly were both secured properly. All undercarriage components of the Motor Car were also observed to be intact and secured in an appropriate manner.

Photo 22 shows the Motor Car hoisted up for checks on its undercarriage. There was no sign(s) or indication(s) of fluid leakage and/or fluid stain(s) on the underside of the Motor Car. The undercarriage components of the Motor Car were also all observed to be intact and secured in an appropriate manner.

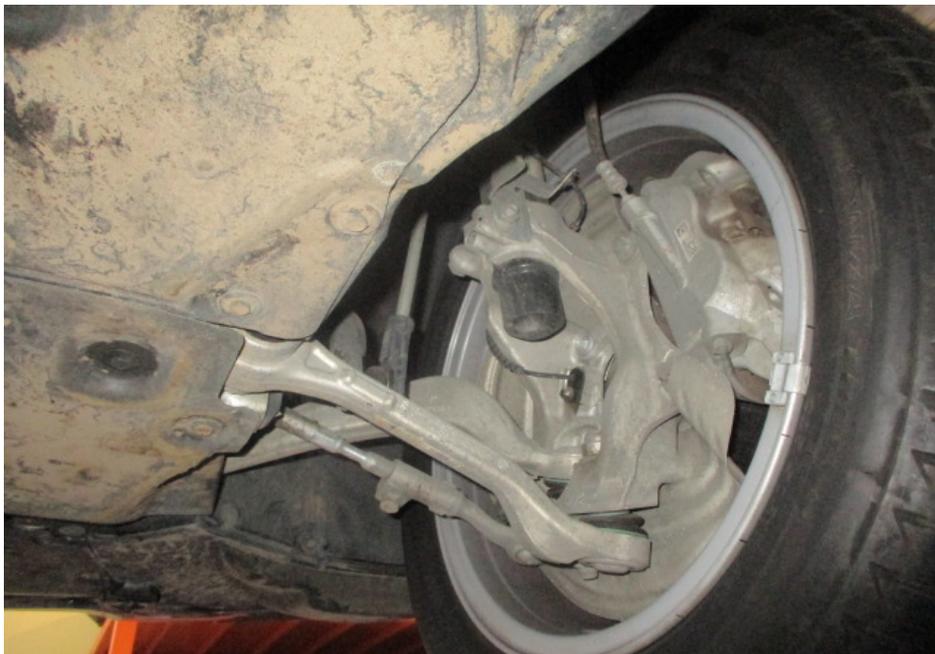
Photo 23 shows the various undercarriage components at the front right wheel of the Motor Car. The mechanical components, control arms and linkages were all found to be intact and secured in an appropriate manner. I also did not observe any fluid leak and/or fluid stain on the underside of the Motor Car.

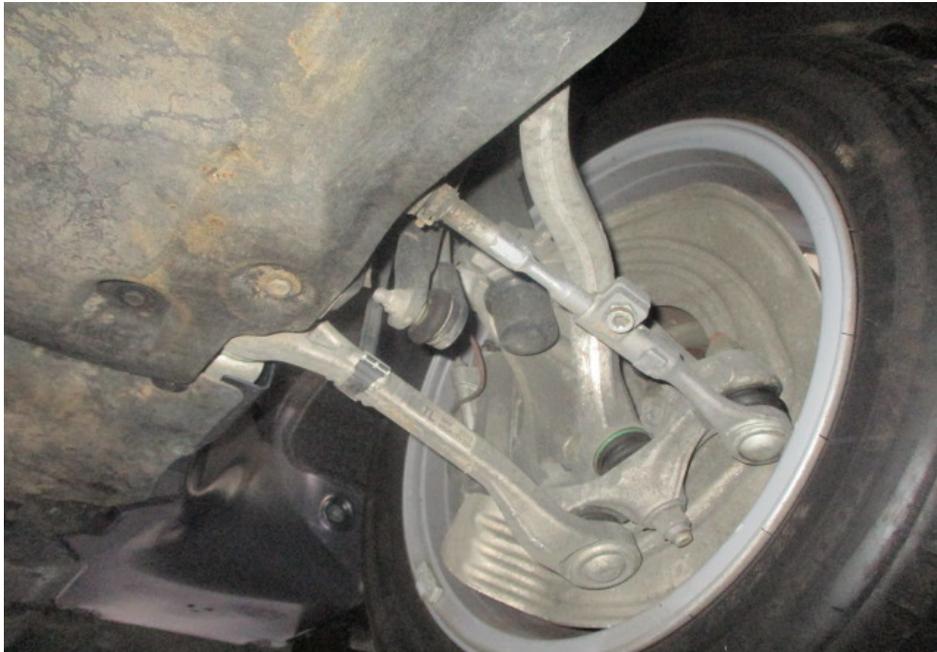
Photo 24 shows the various undercarriage components at the front left wheel of the Motor Car. The mechanical components, control arms and linkages were all found to be intact and secured in an appropriate manner.

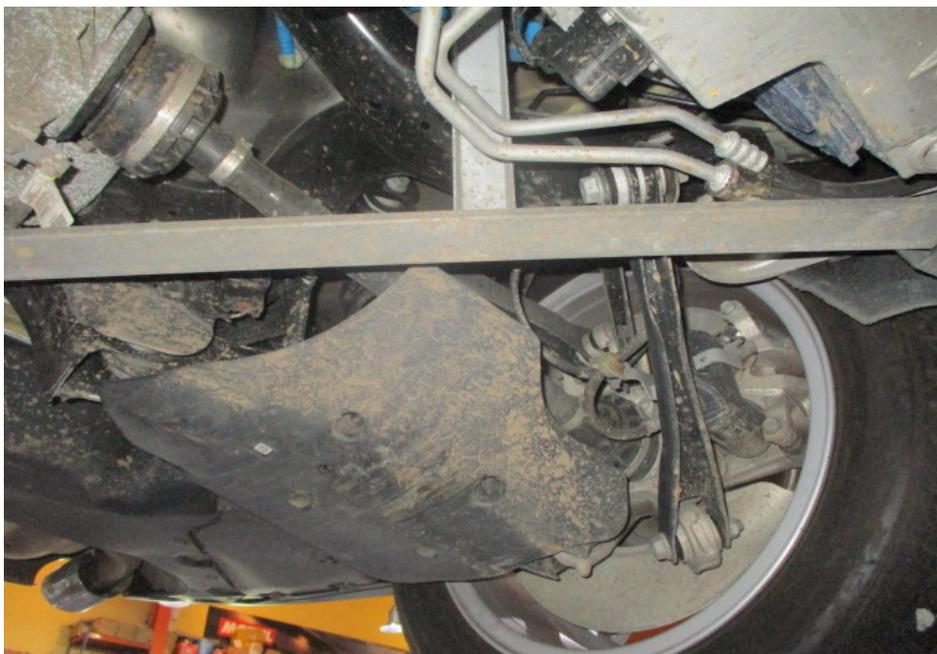
Photo 25 shows the various undercarriage components at the rear left wheel of the Motor Car. The mechanical components, control arms and linkages were all found to be intact and secured in an appropriate manner.

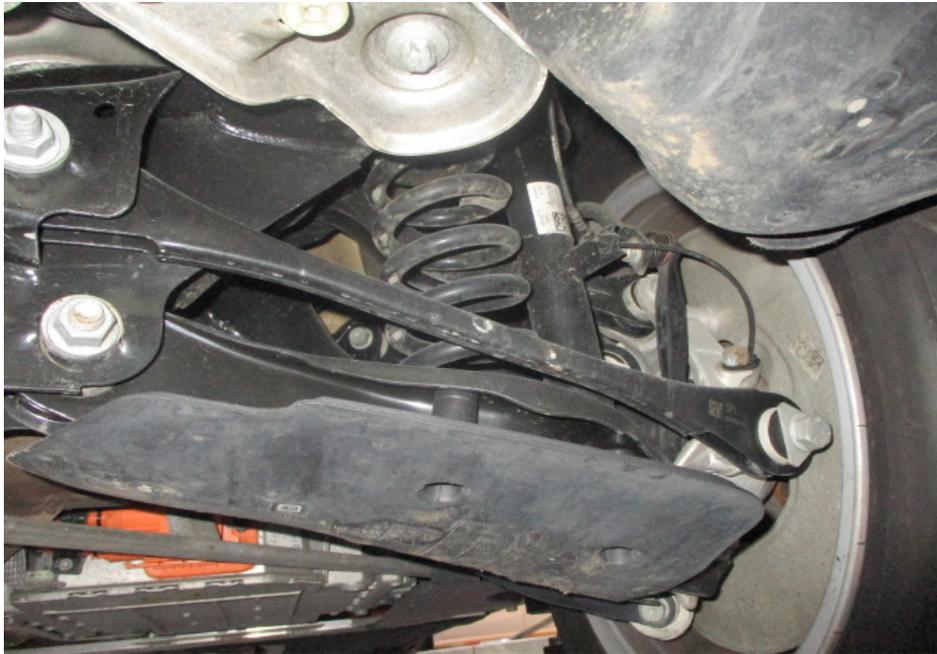
Photo 26 shows a general view of the control arms and linkages at the rear right wheel of the Motor Car. I did not observe any fluid leak and/or fluid stain on the underside of the Motor Car. All of the Motor Car's undercarriage components were observed to be intact and secured in an appropriate manner.

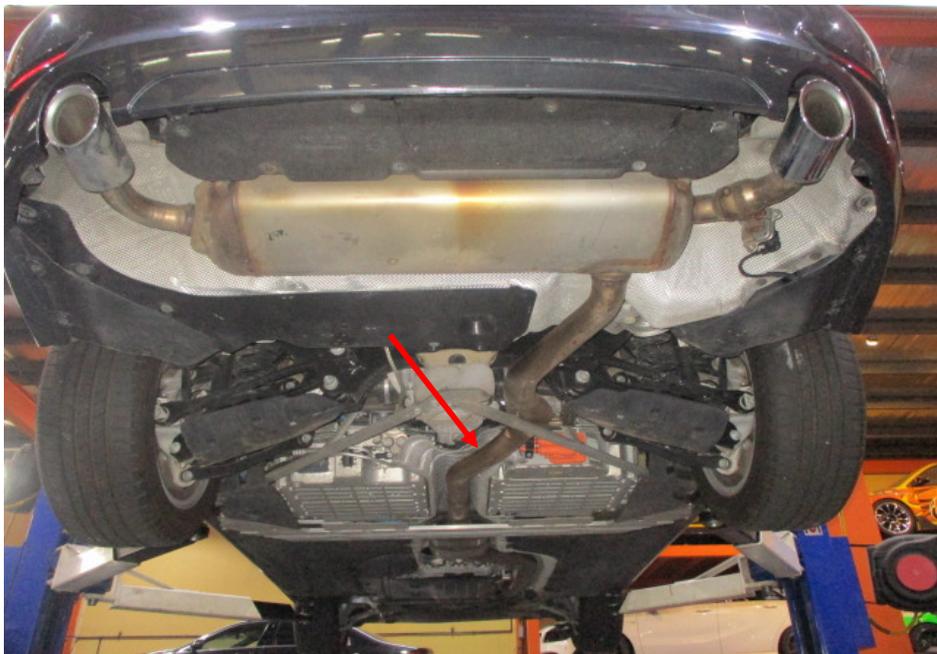
Photo 27 shows a general view of the Motor Car's exhaust system (rear section). My examination of the Motor Car's exhaust system revealed no sign(s) or indication(s) of any cut or weld marks along its exhaust pipes (arrowed), on its centre resonator box, on its catalytic converter and on its rear muffler.

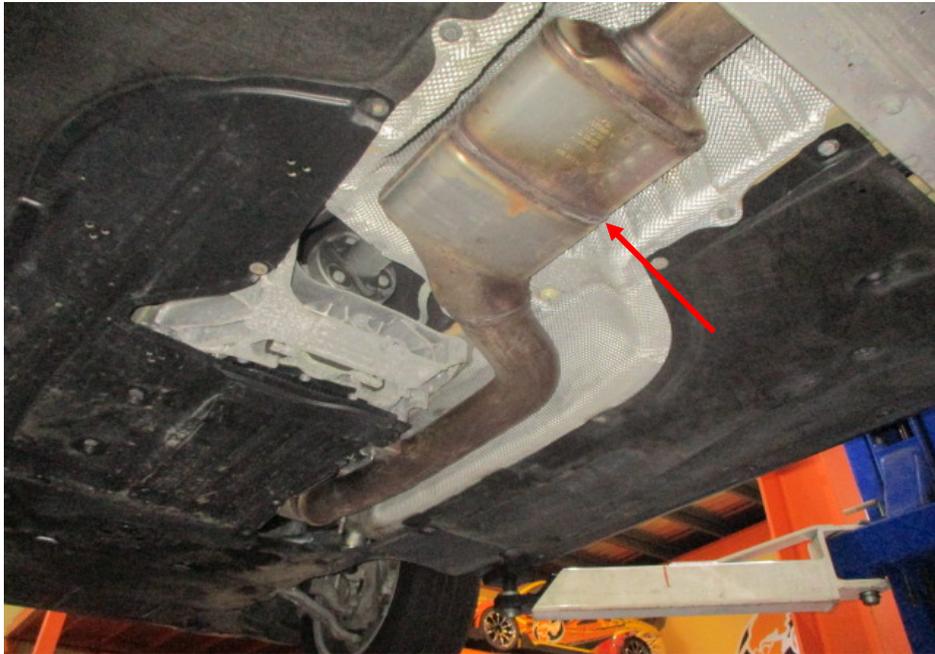
Photo 28 shows a general view of the Motor Car's exhaust system (front section). My examination of the Motor Car's exhaust system revealed no sign(s) or indication(s) of any cut or weld marks along its exhaust pipes, on its centre resonator box (arrowed), on its catalytic converter and on its rear muffler.

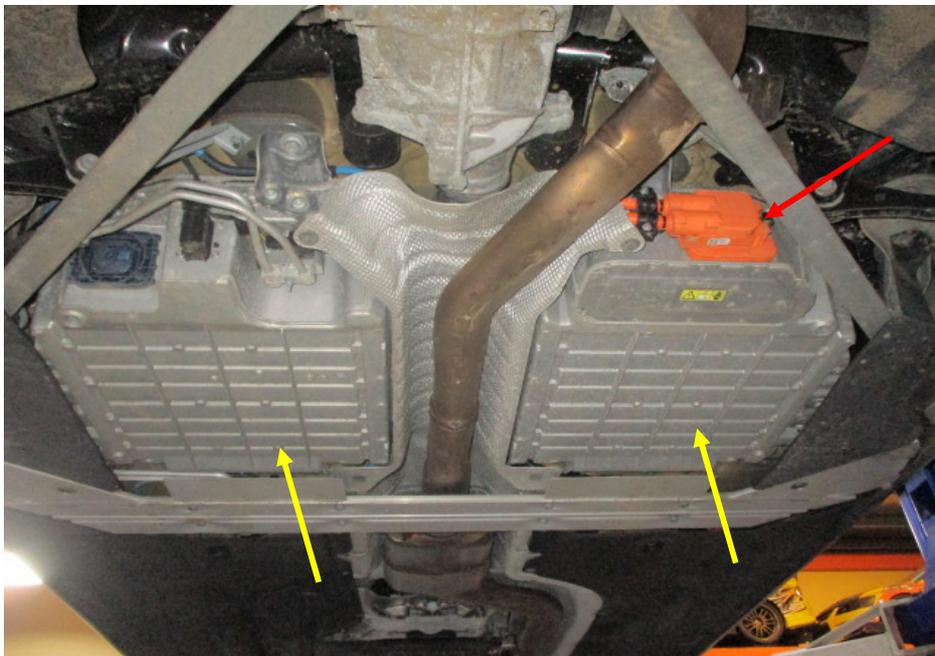
Photo 29 shows the Motor Car's electric battery (yellow arrow) that was fitted at the underside centre of the Motor Car. The cable connections (red arrow) were checked and found to be securely fitted into the respective connectors. The electric battery was also observed to be fitted securely. The electric cables connecting the electric motor within the engine compartment to the electric battery were securely fitted into the respective connectors and protected by dust covers.

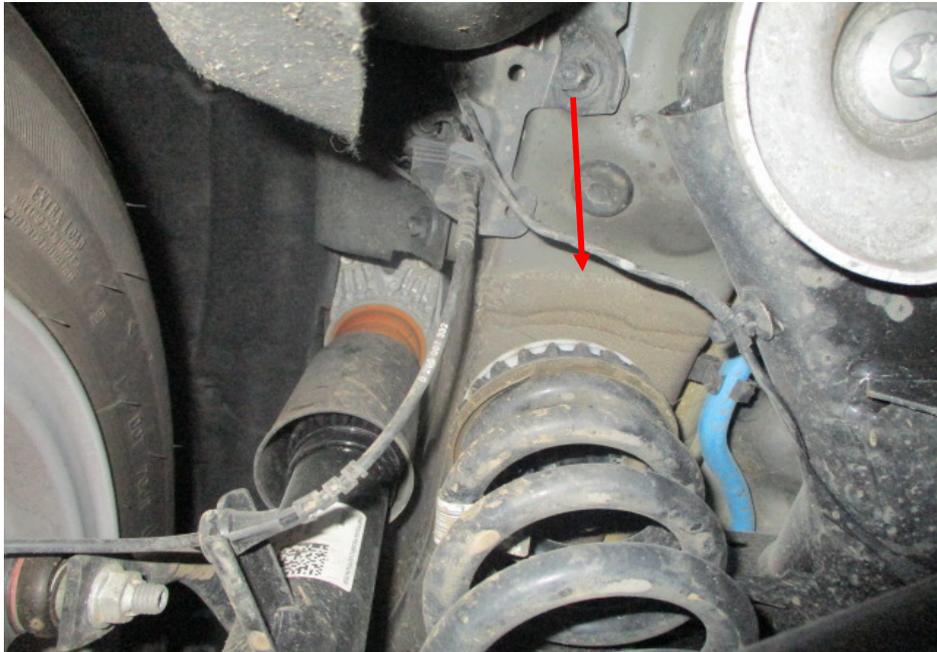
11. Visually, I did not find any weld marks, other than the original spot weld marks, on the chassis/structural body of the Motor Car. The original factory sealant at the joints along the chassis/structural body was also untouched, again indicating that no replacement of the chassis/structural body was carried out; and that the chassis/structural body was originally fitted.

Photo 30 shows the chassis/structural body at the underside rear left of the Motor Car. I did not find any weld marks other than original spot weld marks on the chassis/structural body of the Motor Car. The original factory sealant (arrowed) at the joints along the chassis/structural body was also untouched, indicating no work was done on the chassis/structural body of the Motor Car and that the chassis/structural body was originally fitted.

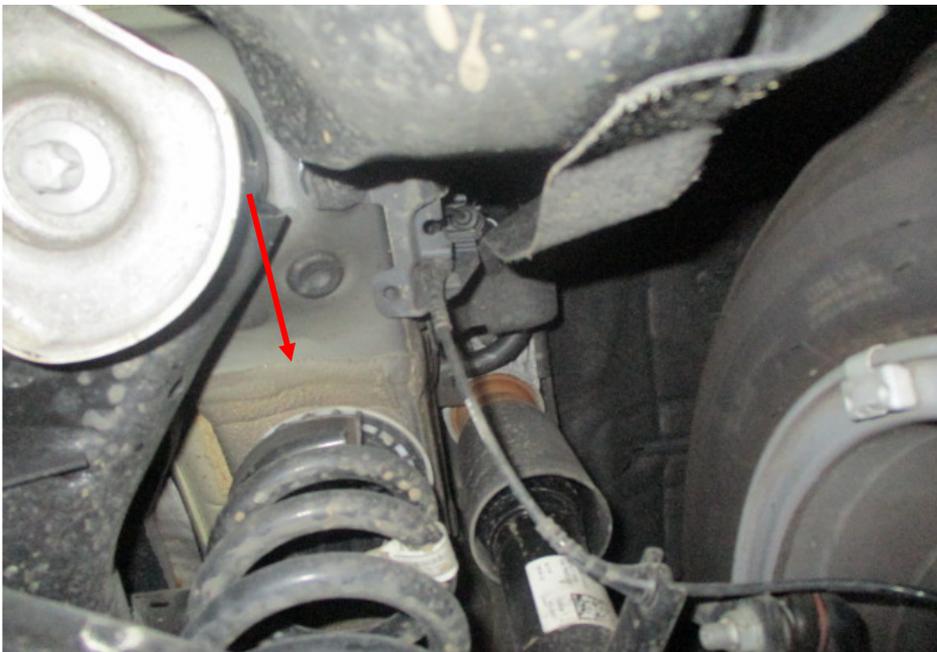
Photo 31 shows the chassis/structural body at the underside rear right of the Motor Car. The original factory sealant (arrowed) at the joints along the chassis/structural body was observed to be untouched. In general, I had found no work was carried out on the chassis/structural body of the Motor Car. The chassis/structural body of the Motor Ca was originally fitted.
