Your Ref: BMW 330e
(chassis number WBA5X72090FJ20316)
Our Ref : CI/TP21008309/D

10 August 2021

**INSPECTION REPORT OF AN UNREGISTERED BMW 330e MOTOR CAR
WITH CHASSIS NUMBER WBA5X72090FJ20316**

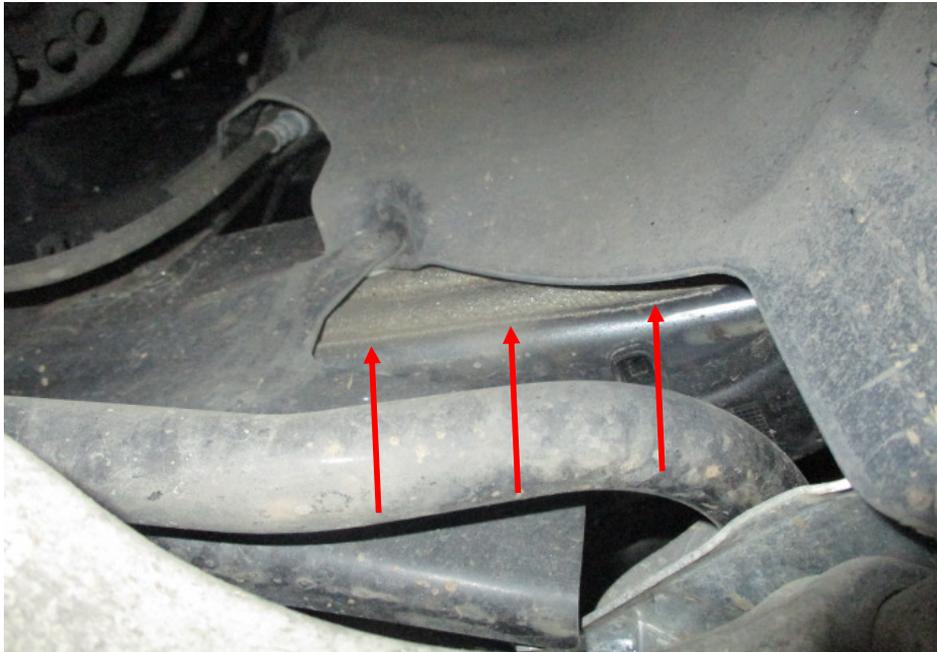
Photo 32 shows the chassis/structural body at the underside front right of the Motor Car. The original factory sealant (arrowed) at the joints along the chassis/structural body was observed to be untouched. In general, I had found no work was carried out on the chassis/structural body of the Motor Car. The chassis/structural body of the Motor Ca was originally fitted.

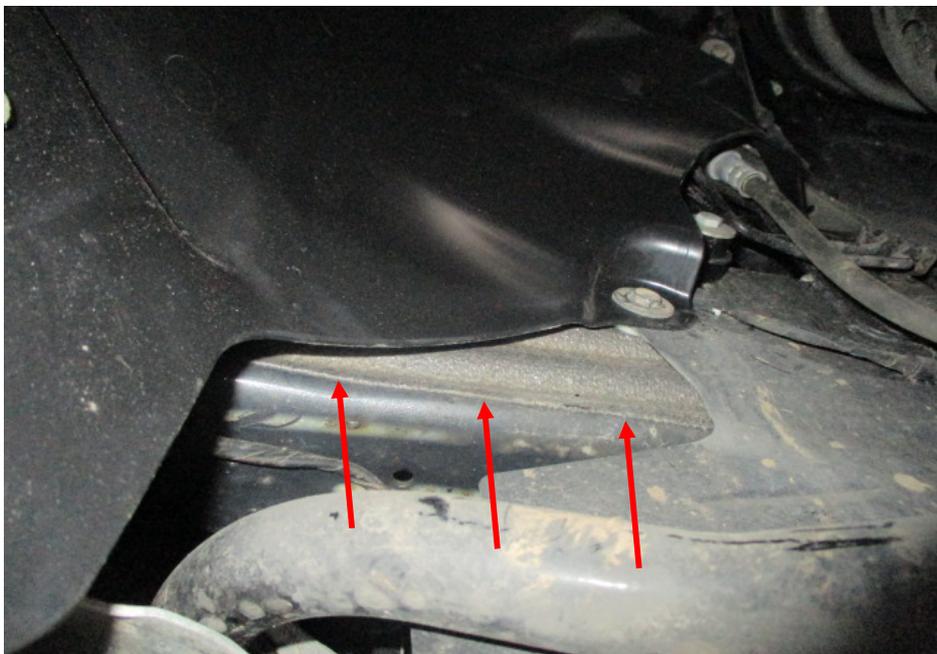
Photo 33 shows the chassis/structural body at the underside front left of the Motor Car. I did not find any weld marks other than original spot weld marks on the chassis/structural body of the Motor Car. The original factory sealant (arrowed) at the joints along the chassis/structural body was also untouched, indicating no work was done on the chassis/structural body of the Motor Car and that the chassis/structural body was originally fitted.

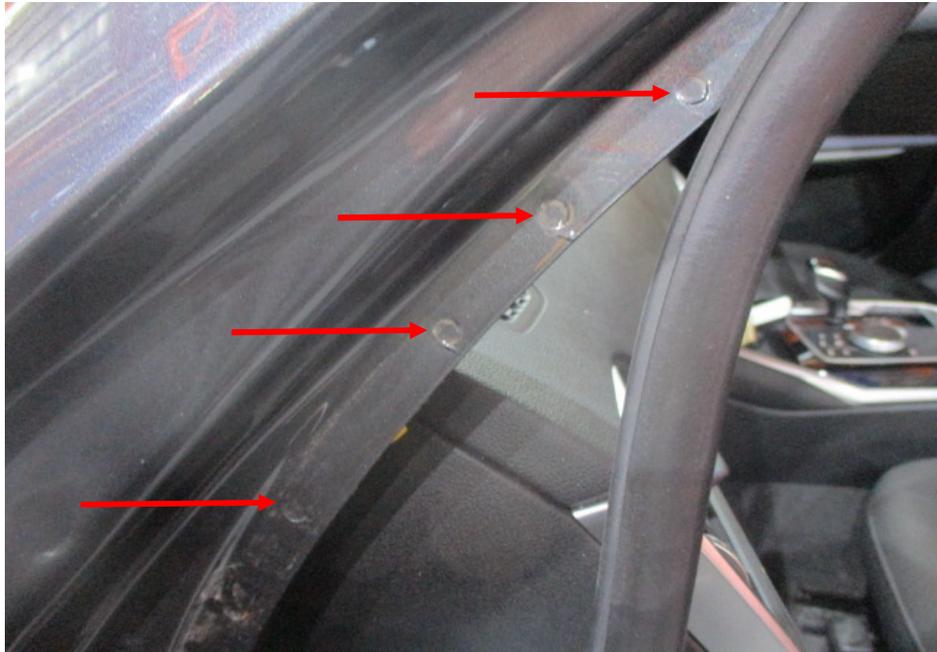
10. Checks on the non-detachable body panels like the rear fenders, floorboard, roof panel, pillars and rocker panels amongst others, revealed that these body panels were spot welded onto the chassis/structural body of the Motor Car. The original factory sealant at the joints of the non-detachable body panels was all untouched indicating no replacement of the non-detachable body panels was carried out; and that these body panels were all originally fitted.

Photo 34 shows the left side "A" pillar of the Motor Car. I did not find any weld marks other than original spot weld marks (arrowed) on the left side "A" pillar of the Motor Car which, indicates that there was no re-welding works carried out. In general, I had found all the non-detachable body panels of the Motor Car to be originally fitted at the time of my inspection.

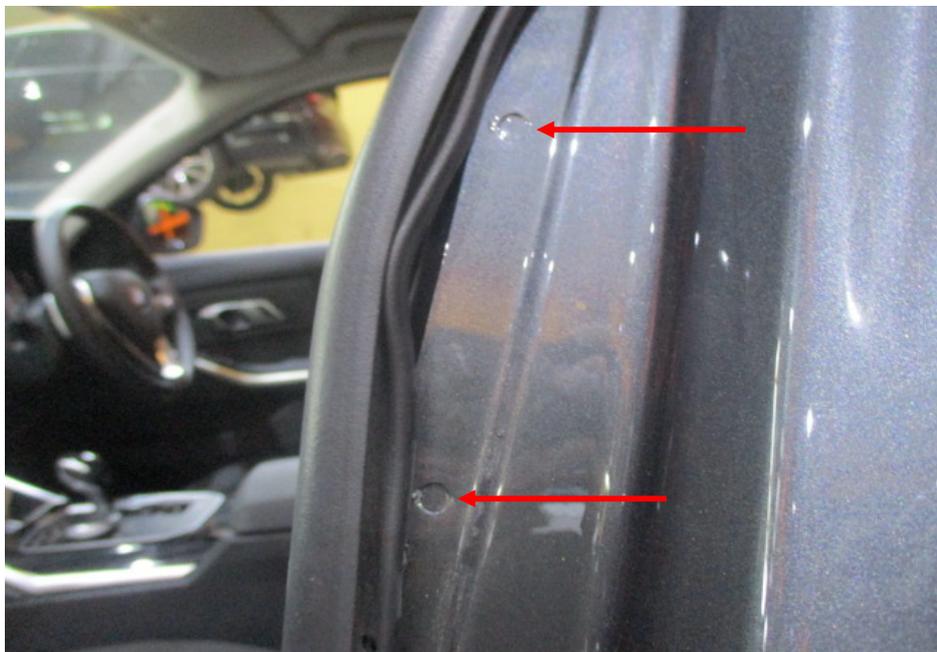
Photo 35 shows the left side "B" pillar of the Motor Car. I did not find any weld marks other than original spot weld marks (arrowed) on the left side "B" pillar of the Motor Car which, indicates that there was no re-welding works carried out. In general, I had found all the non-detachable body panels of the Motor Car to be originally fitted at the time of my inspection.

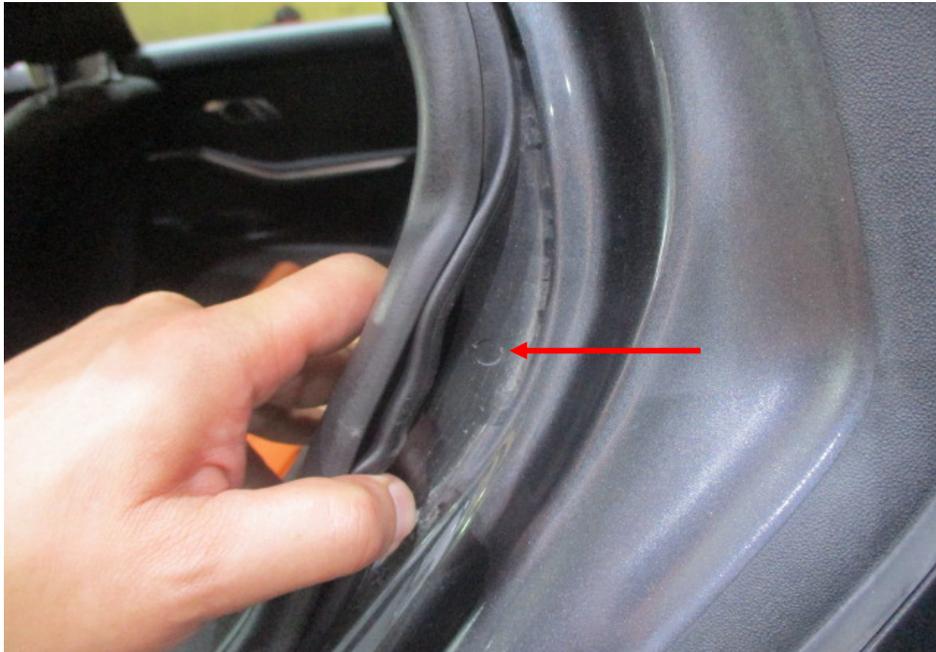
Photo 36 shows the left side "C" pillar of the Motor Car. I did not find any weld marks other than original spot weld marks (arrowed) on the left side "C" pillar of the Motor Car which, indicates that there was no re-welding works carried out. In general, I had found all the non-detachable body panels of the Motor Car to be originally fitted at the time of my inspection.
