Your Ref: BMW M5
(chassis number WBSJF02010GA04867)
Our Ref : CI/TP21008310/D

12 August 2021

INSPECTION REPORT OF AN UNREGISTERED BMW M5 MOTOR CAR WITH CHASSIS NUMBER WBSJF02010GA04867

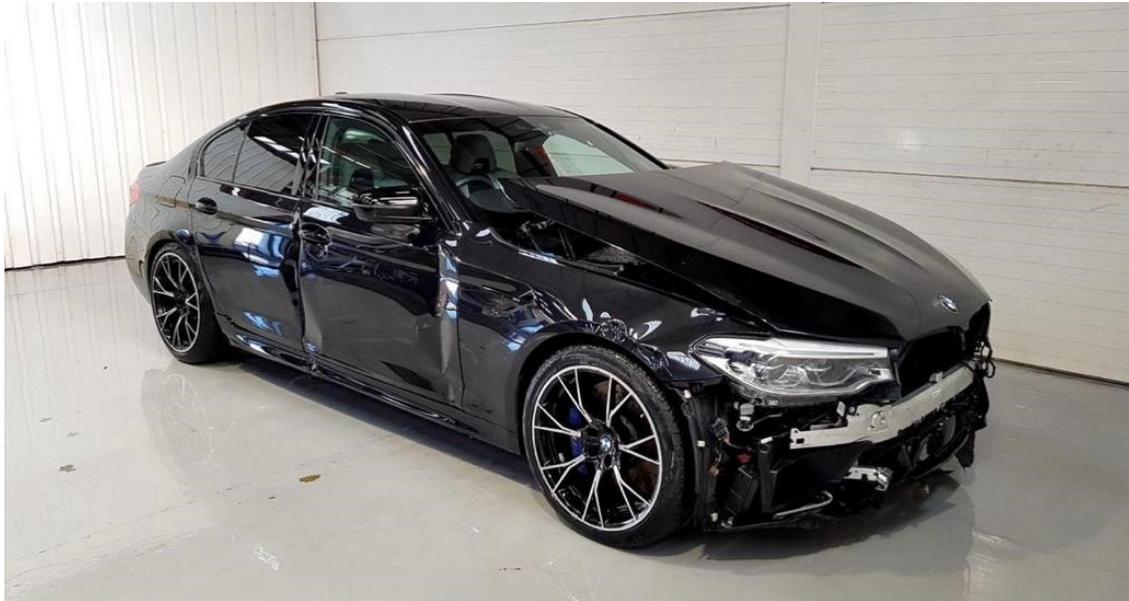
Photo 1 shows a general view of the front right body of the Motor Car (photograph provided to me). The Motor Car was observed to have sustained damage at its right side body. The front bonnet, front right fender, front right door, rear right door and right side rocker panel garnish amongst others were observed to be damaged. The front bumper and all its related parts and attachments were also observed to be dislodged/missing/damaged. This includes the front bumper lower grille, front bumper left lower grille, front bumper right lower grille, front bumper tow hook cover, radiator grilles and radar unit amongst others.

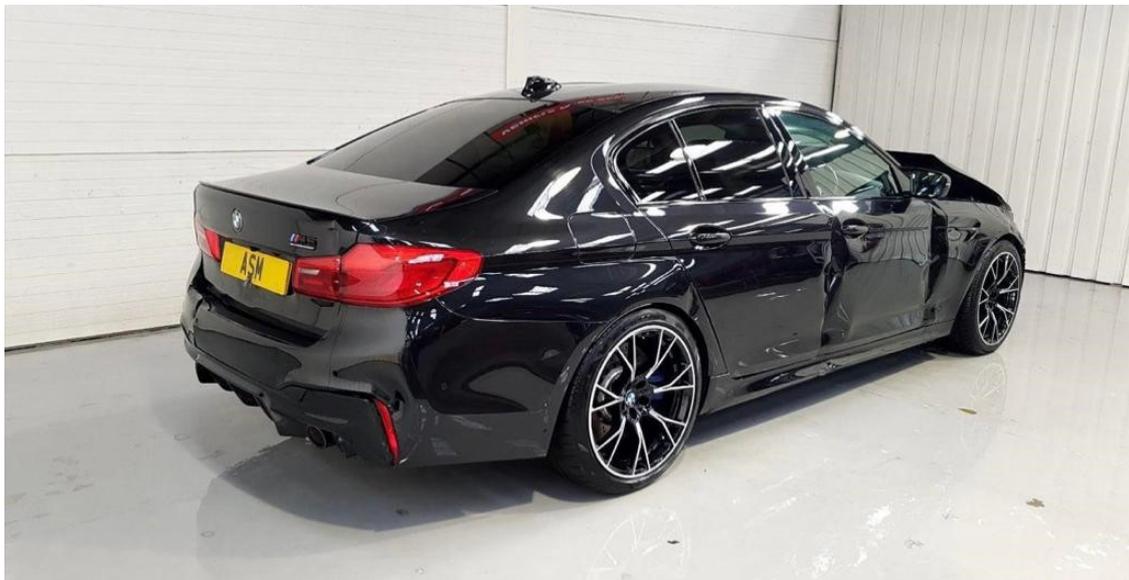
Photo 2 shows a general view of the rear right body of the Motor Car (photograph provided to me). The Motor Car was observed to have sustained damage at its right side body. The front bonnet, front right fender, front right door, rear right door and right side rocker panel garnish amongst others were observed to be damaged. The front bumper and all its related parts and attachments were also observed to be dislodged/missing/damaged. The airbags of the Motor Car were not deployed as seen from the photographs that were provided to me.

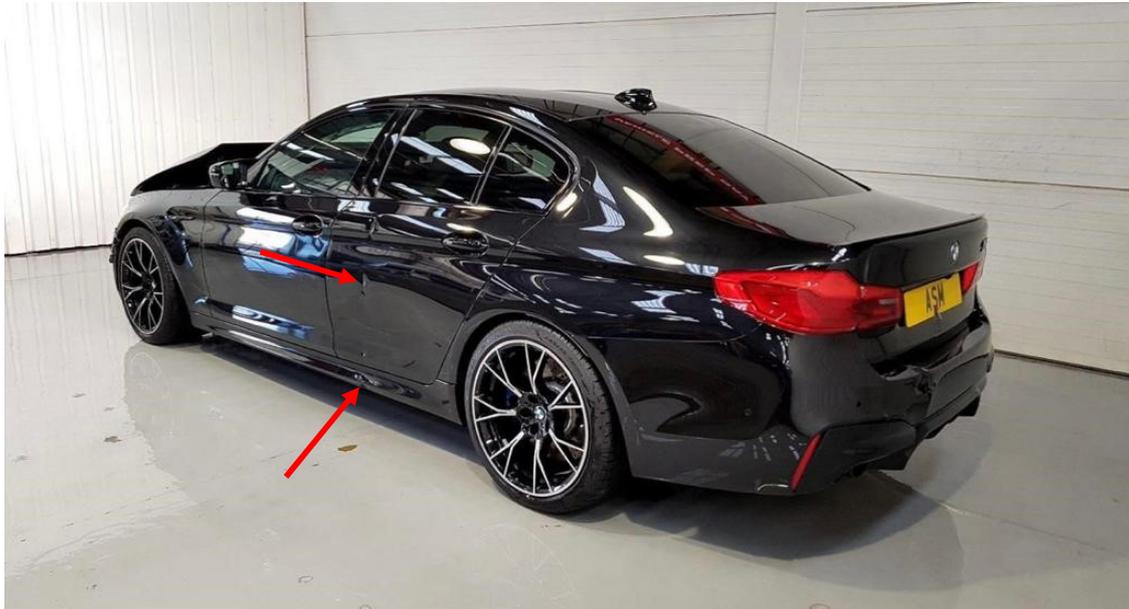
Photo 3 shows a general view of the rear left body of the Motor Car (photograph provided to me). Relatively minor damage (arrowed) was observed on the Motor Car's rear left door and left side rocker panel garnish. The airbags of the Motor Car were not deployed as seen from the photographs that were provided to me.

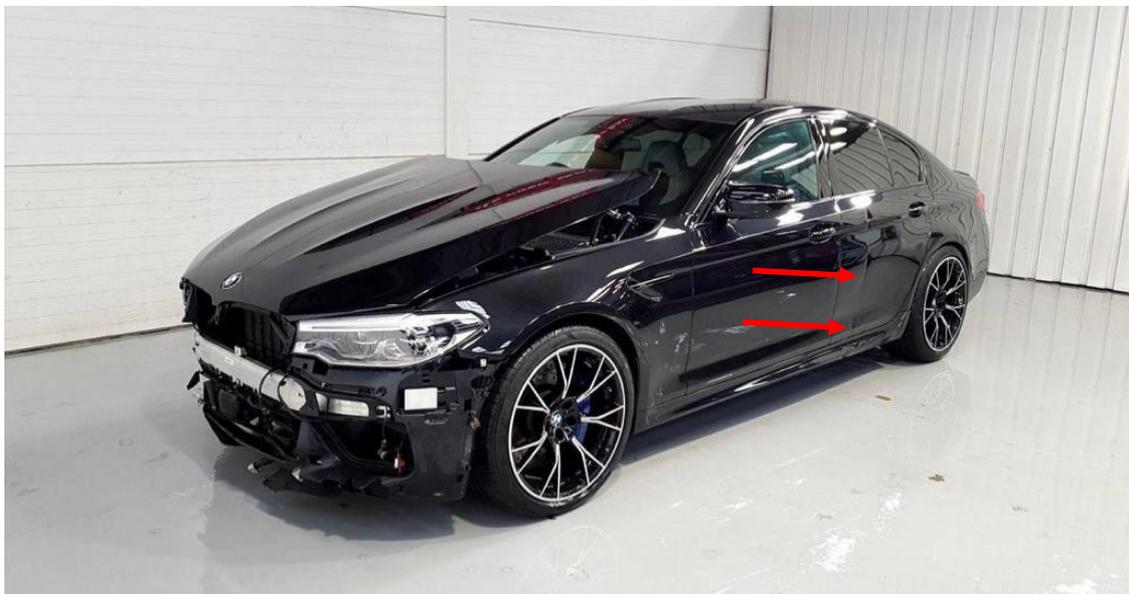
Photo 4 shows a general view of the front left body of the Motor Car (photograph provided to me). The front bumper and all its related parts and attachments were observed to be dislodged/missing/damaged. This includes the front bumper lower grille, front bumper left lower grille, front bumper right lower grille, front bumper tow hook cover, radiator grilles and radar unit amongst others. Relatively minor damage (arrowed) was also observed on the Motor Car's rear left door and left side rocker panel garnish. The airbags of the Motor Car were not deployed as seen from the photographs that were provided to me.

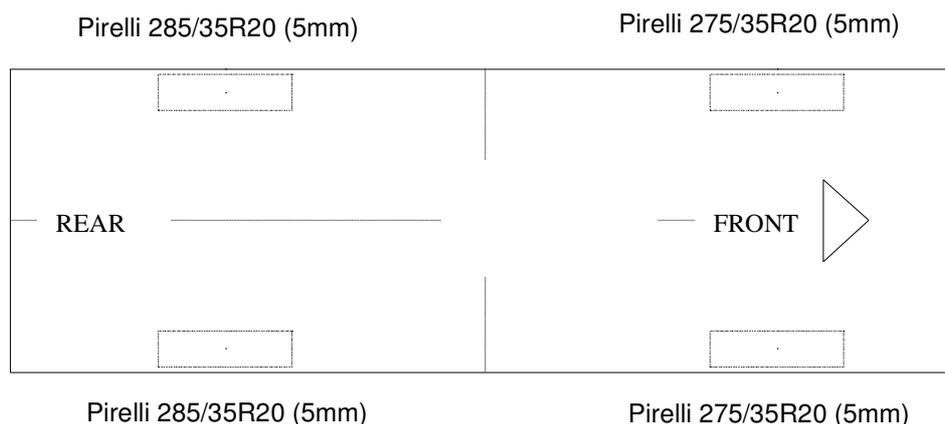
9. It was fitted with 20inch sport wheel rims that were wrapped with tyres that were observed to be of serviceable condition. The tyres were also sufficiently inflated for vehicular operation. The tyre brand, tyre size and approximate remaining tread depth of the 4 tyres of the Motor Car were recorded as follows: -

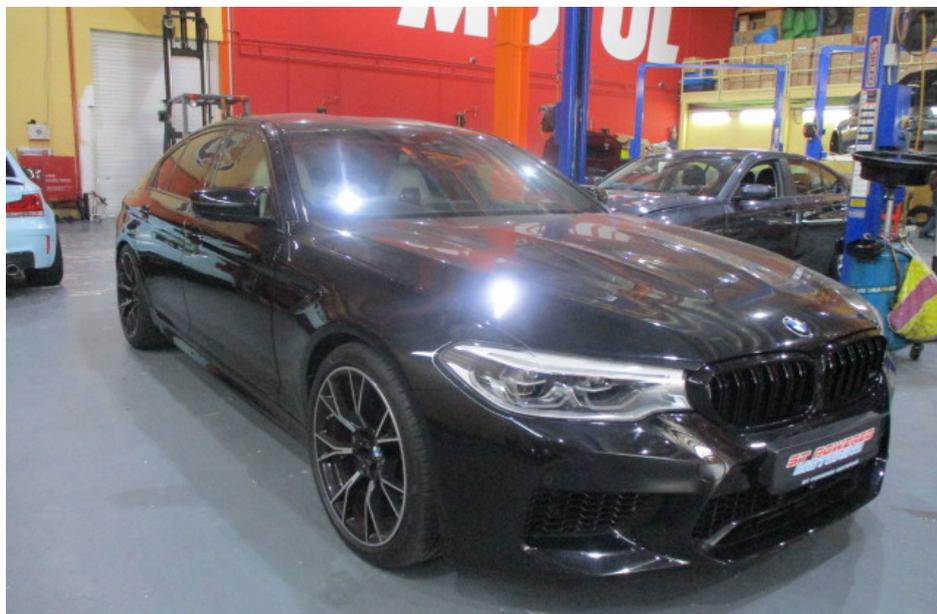
Photo 5 shows a general view of the front right body of the Motor Car at the time of my inspection. The Motor Car was observed to be in a relatively good general condition with no loose exterior fittings observed. The body parts at the frontal body and right side body of the Motor Car were visually examined and it was observed that the repair/restoration works carried out to the damaged area of the Motor Car (refer to photograph 1 & 2 above) were reasonably adequate and in order.

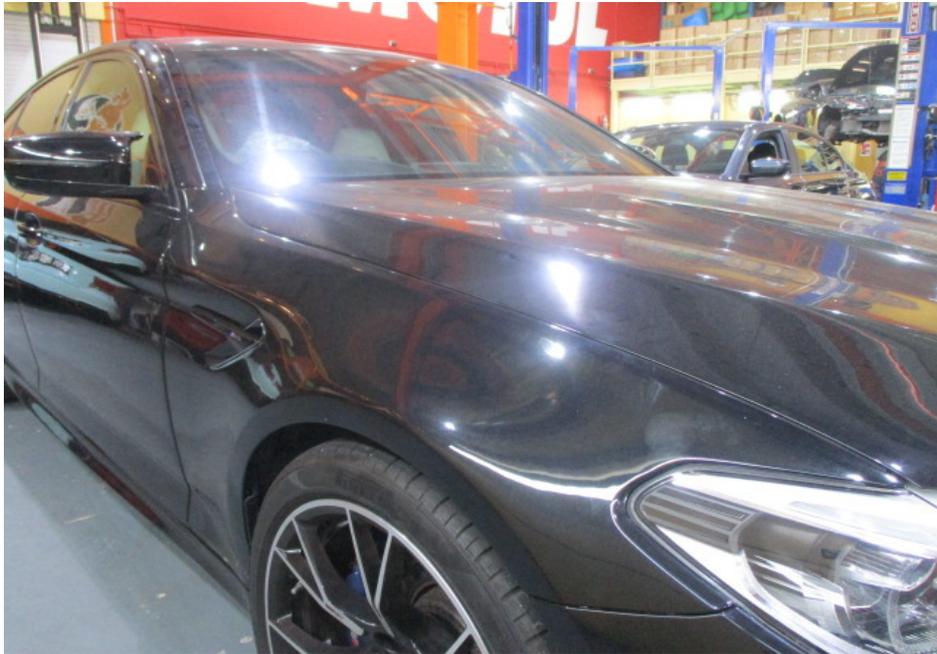
Photo 6 shows a closer view of the Motor Car's front right fender and front bonnet at the time of my inspection. The body parts at the right side body of the Motor Car were visually examined and it was observed that the repair/restoration works carried out to the damaged area of the Motor Car (refer to photograph 1 & 2 above) were reasonably adequate and in order.

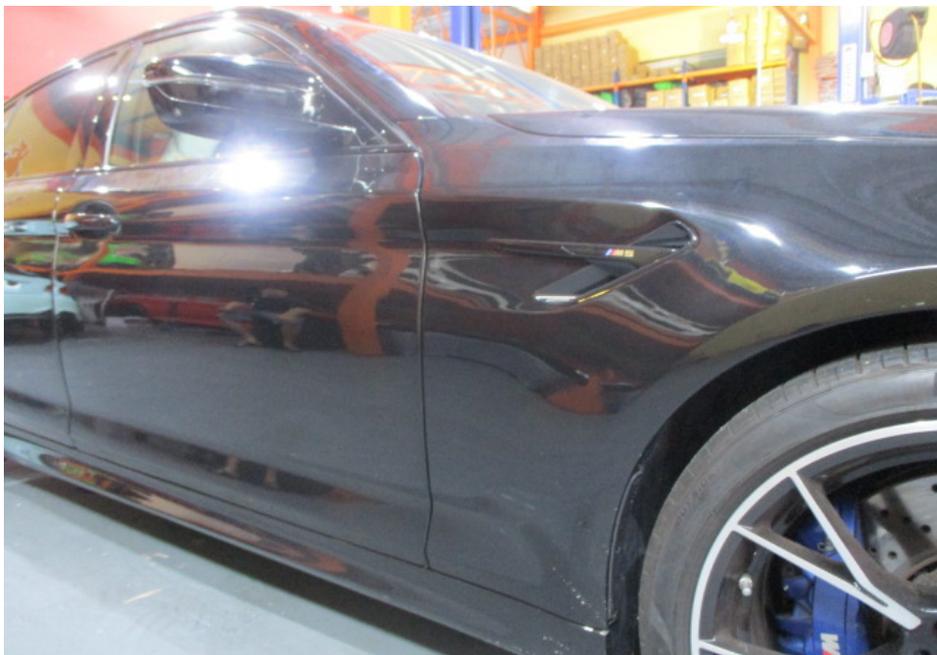
Photo 7 shows a closer view of the Motor Car's front right fender and front right door at the time of my inspection. The body parts at the right side body of the Motor Car were visually examined and it was observed that the repair/restoration works carried out to the damaged area of the Motor Car (refer to photograph 1 & 2 above) were reasonably adequate and in order.

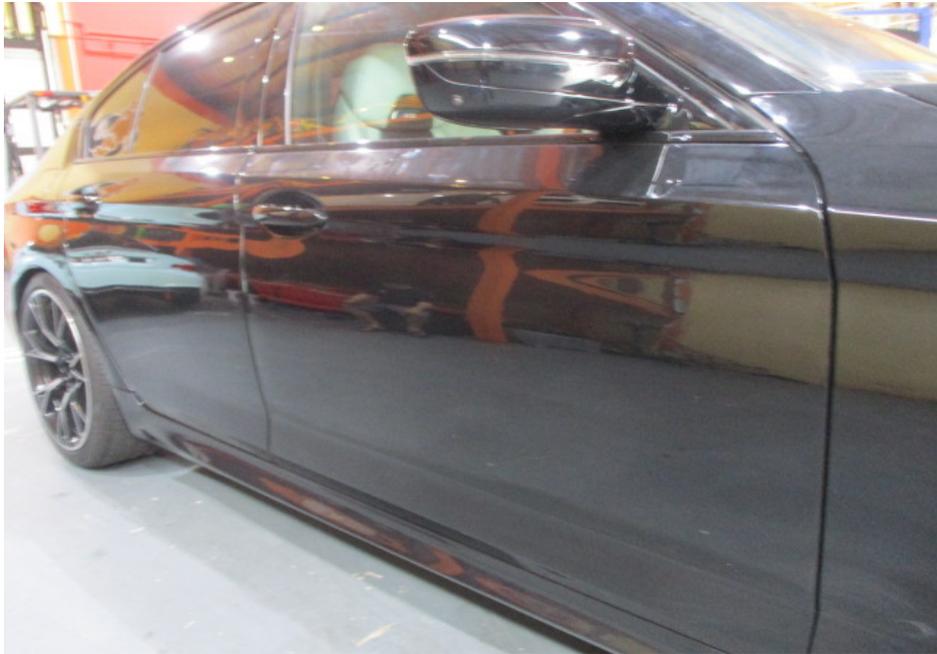
Photo 8 shows a closer view of the Motor Car's front right door and rear right door at the time of my inspection. The body parts at the right side body of the Motor Car were visually examined and it was observed that the repair/restoration works carried out to the damaged area of the Motor Car (refer to photograph 1 & 2 above) were reasonably adequate and in order.

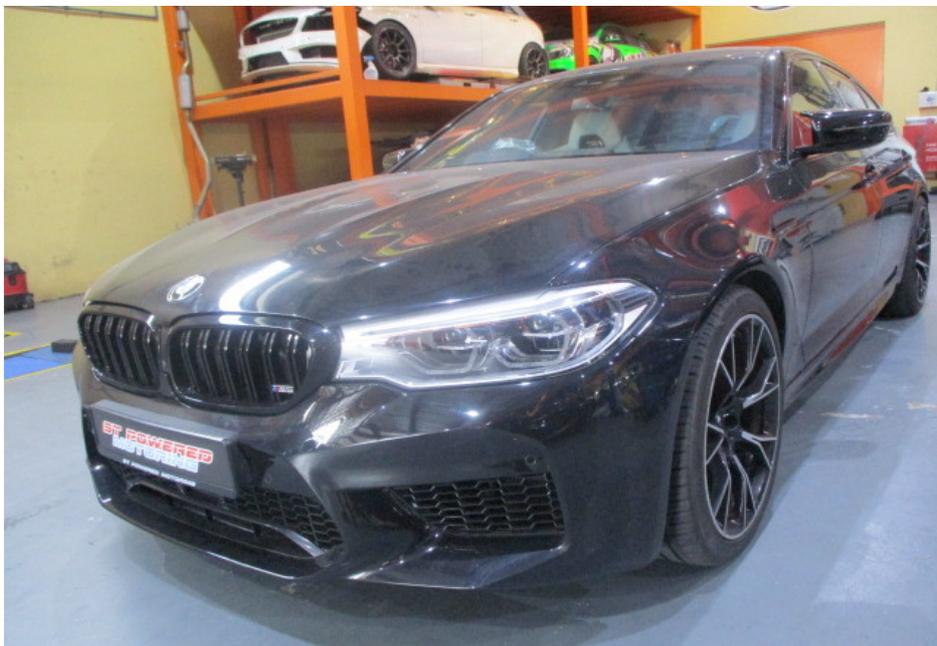
Photo 9 shows a general view of the front left body of the Motor Car at the time of my inspection. The Motor Car was observed to be in a relatively good general condition with no loose exterior fittings observed. The body parts at the frontal body of the Motor Car were visually examined and it was observed that the repair/restoration works carried out to the damaged area of the Motor Car (refer to photograph 1 & 4 above) were reasonably adequate and in order.

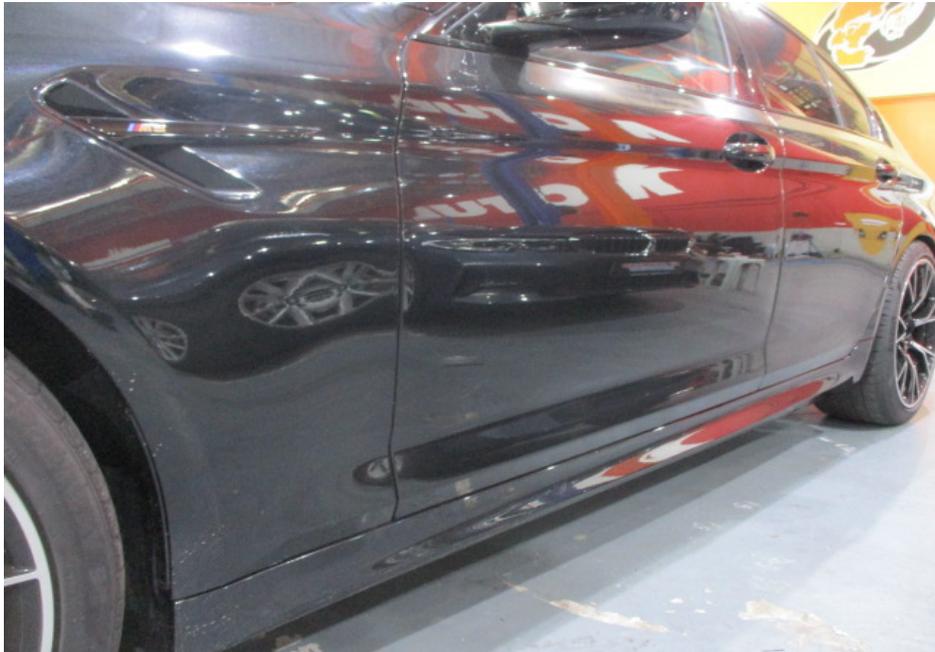
Photo 10 shows a closer view of Motor Car's rear left door and left side rocker panel garnish at the time of my inspection. The body parts at the left side body of the Motor Car were visually examined and it was observed that the repair/restoration works carried out to the damaged area of the Motor Car (refer to photograph 3 & 4 above) were reasonably adequate and in order.

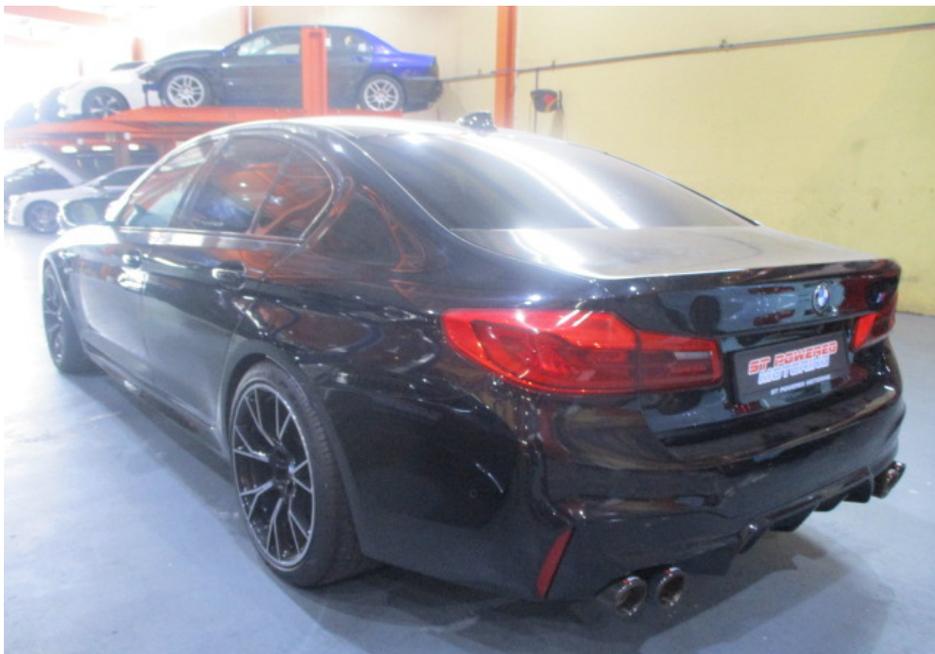
Photo 11 shows a general view of the rear left body of the Motor Car at the time of my inspection. The Motor Car was observed to be in a relatively good general condition with no loose exterior fittings observed. The mileage of the Motor Car recorded at the time of my inspection was 7,080km.

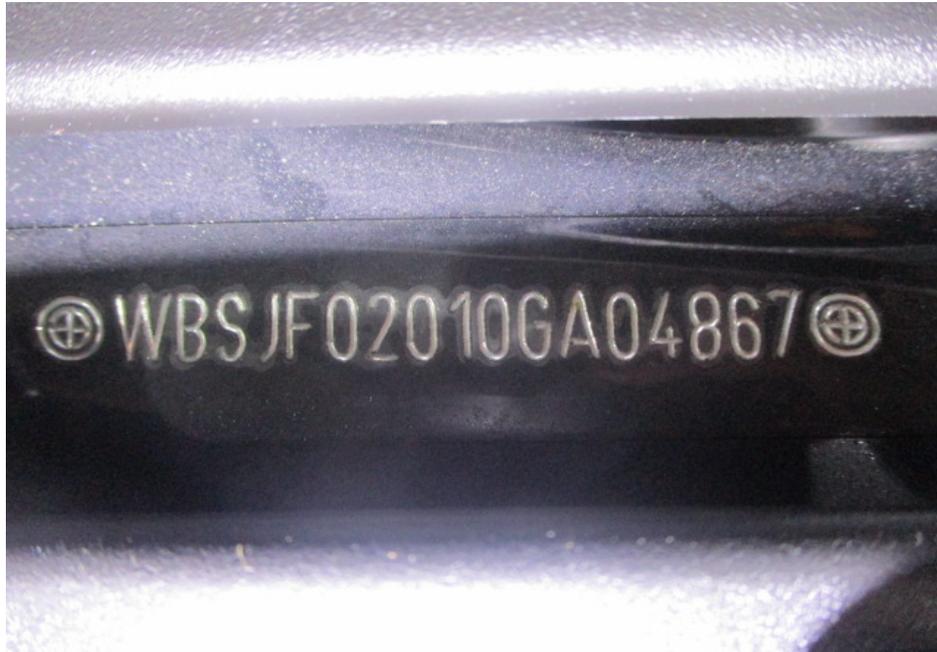
Photo 12 shows the chassis number of the Motor Car. The chassis number recorded was WBSJF02010GA04867.

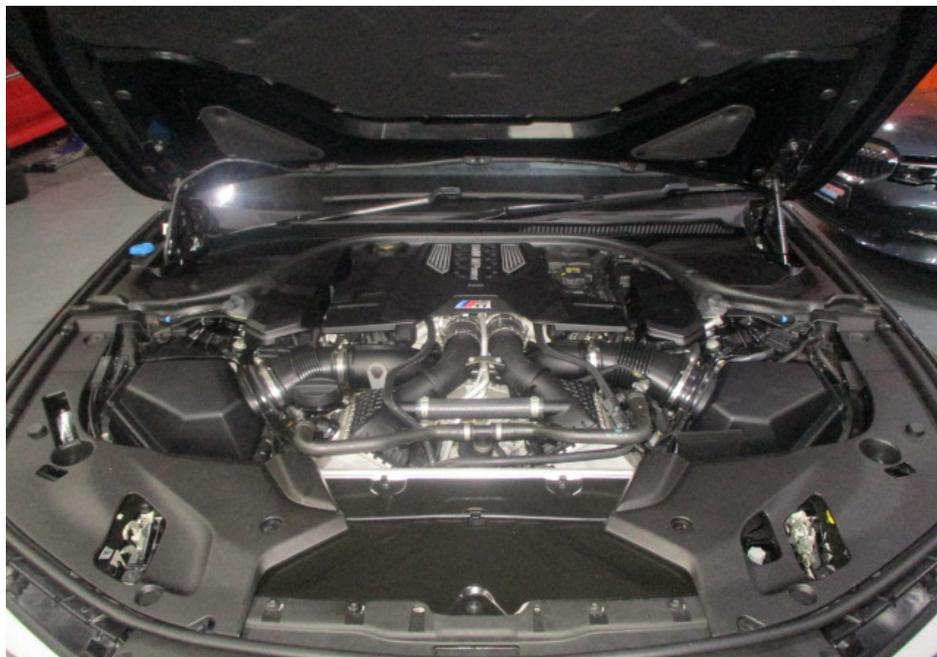
Photo 13 shows a general view of the engine compartment of the Motor Car at the time of my inspection. The various parts and components inside the engine compartment were all observed to be intact and properly fitted. There was also no sign(s) or indication(s) of fluid leak and/or fluid stain found inside the engine compartment.

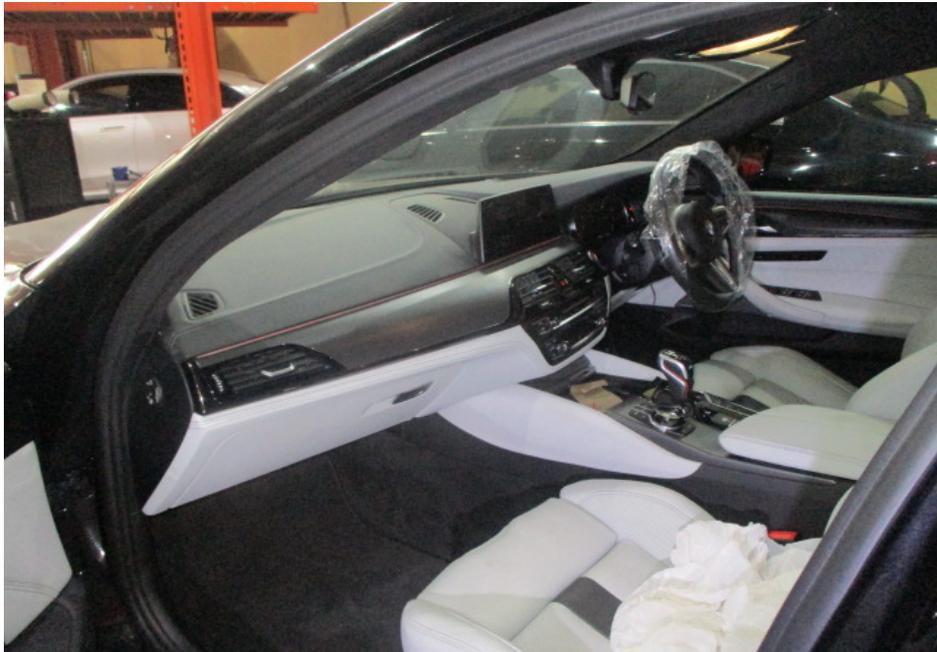
Photo 14 shows the interior compartment of the Motor Car at the time of my inspection. The various parts and components, trims, carpet and upholstery inside the interior compartment were all observed to be intact and properly fitted.

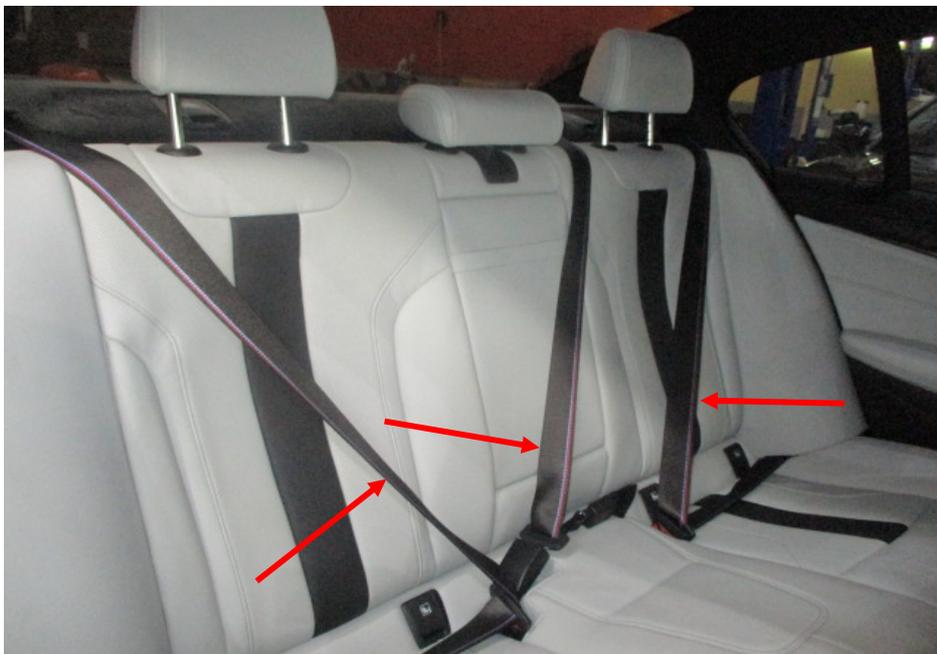
Photo 15 shows the rear seats of the Motor Car. All the seats of the Motor Car were secured via seat rails to the floorboard. They were also fitted with a retractable seat belt reel and a pre-tensioner. The seat belts (arrowed) were tested and were able to be fastened into the respective pre-tensions that were fitted on the side of each individual seat.

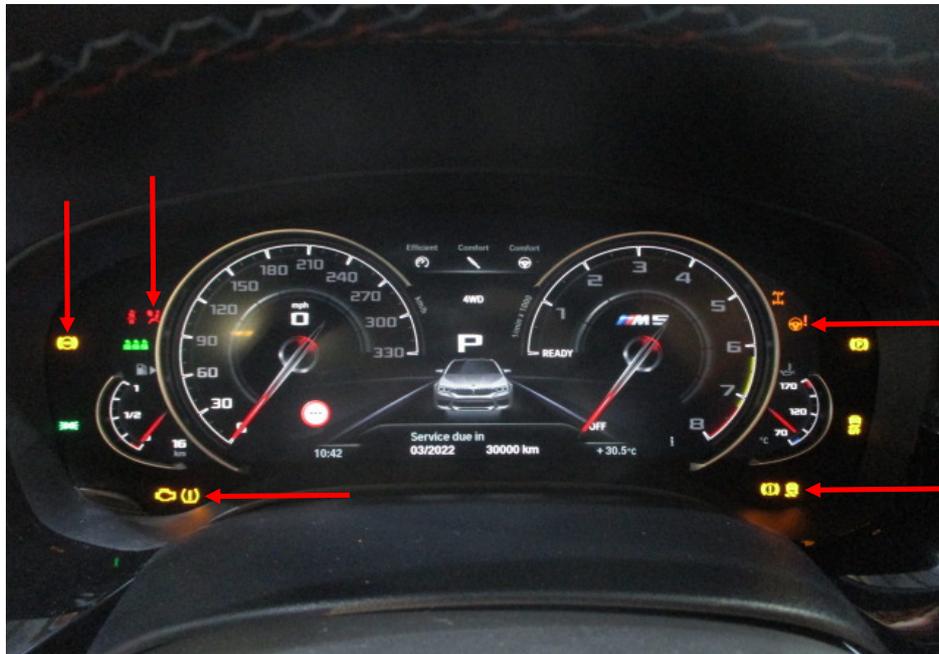
Photo 16 shows the warning lights for the various electronic safety features appearing on the instrument panel of the Motor Car during its self-test when the engine is cranked, in particular the ABS, SRS, IAS, TPM and DSC lights (arrowed).

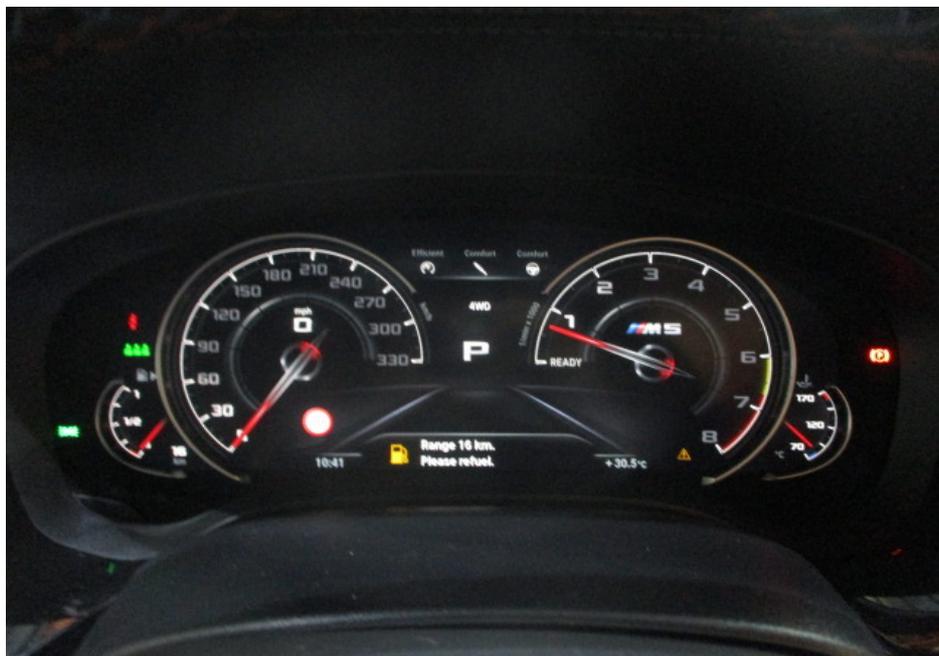
Photo 17 shows the respective warning lights no longer illuminated, indicating that there is no fault detected to the ABS, SRS, IAS, TPM and DSC systems of the Motor Car during the self-test. These electronic systems were hence in working condition at the time of my inspection.

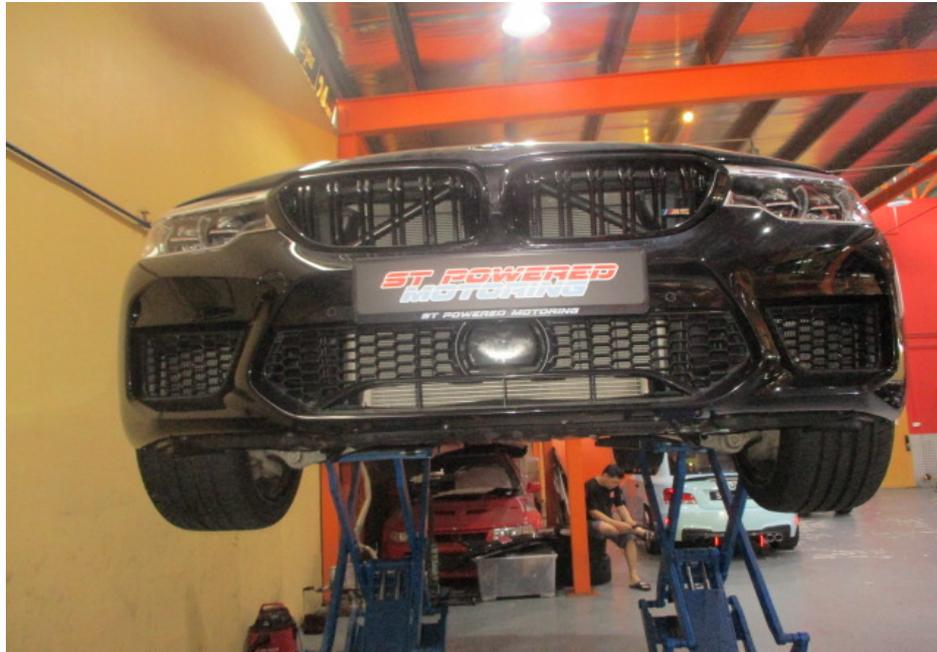
Photo 18 shows the Motor Car hoisted up for checks on its undercarriage. There was no sign(s) or indication(s) of fluid leakage and/or fluid stain(s) on the underside of the Motor Car. The undercarriage components of the Motor Car were also all observed to be intact and secured in an appropriate manner.

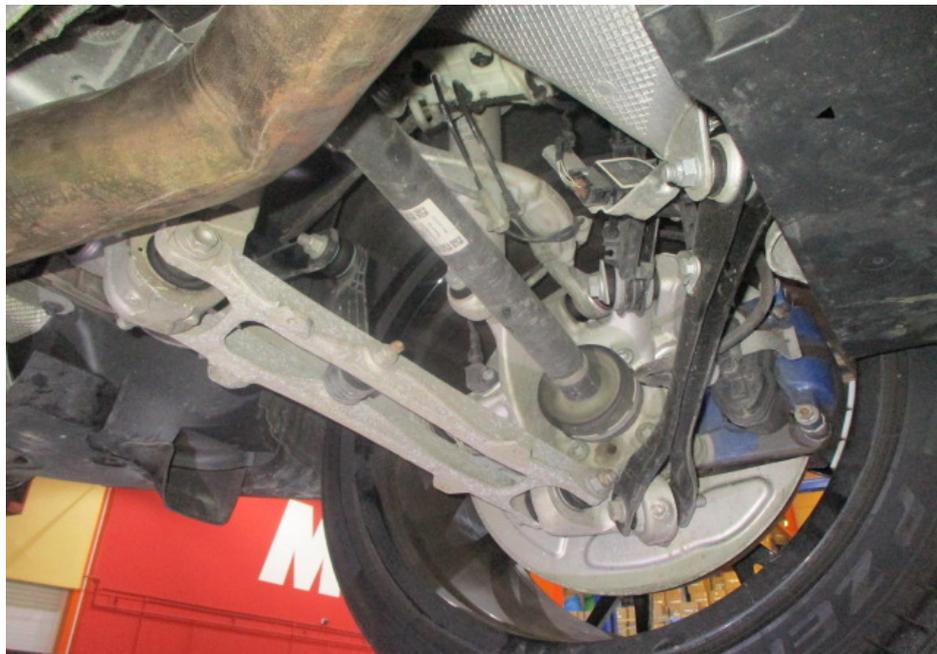
Photo 19 shows a general view of the control arms and linkages at the rear left wheel of the Motor Car. I did not observe any fluid leak and/or fluid stain on the underside of the Motor Car. All of the Motor Car's undercarriage components were observed to be intact and secured in an appropriate manner.

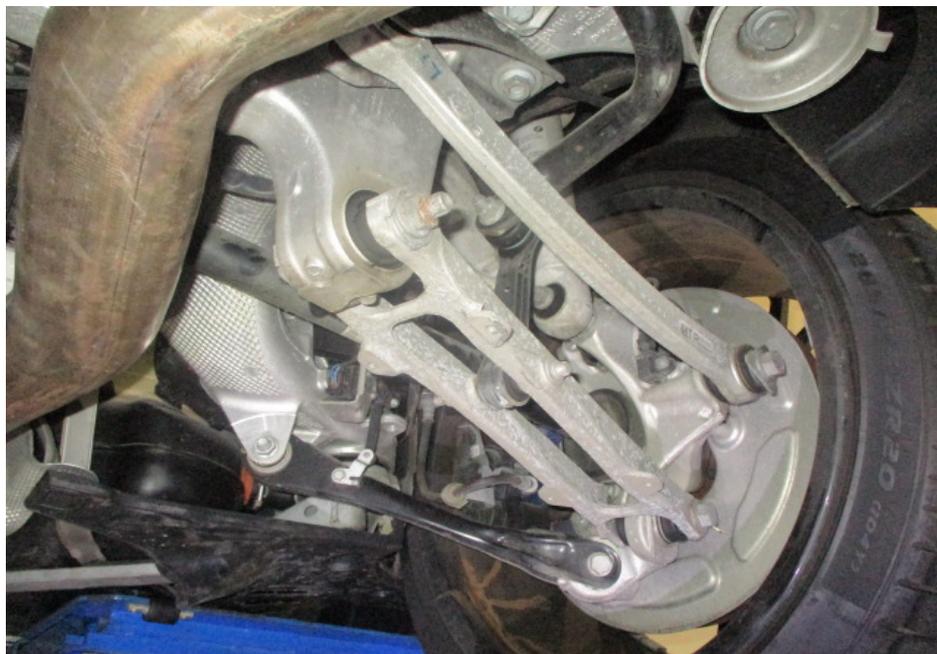
Photo 20 shows a general view of the control arms and linkages at the rear right wheel of the Motor Car. I did not observe any fluid leak and/or fluid stain on the underside of the Motor Car. All of the Motor Car's undercarriage components were observed to be intact and secured in an appropriate manner.

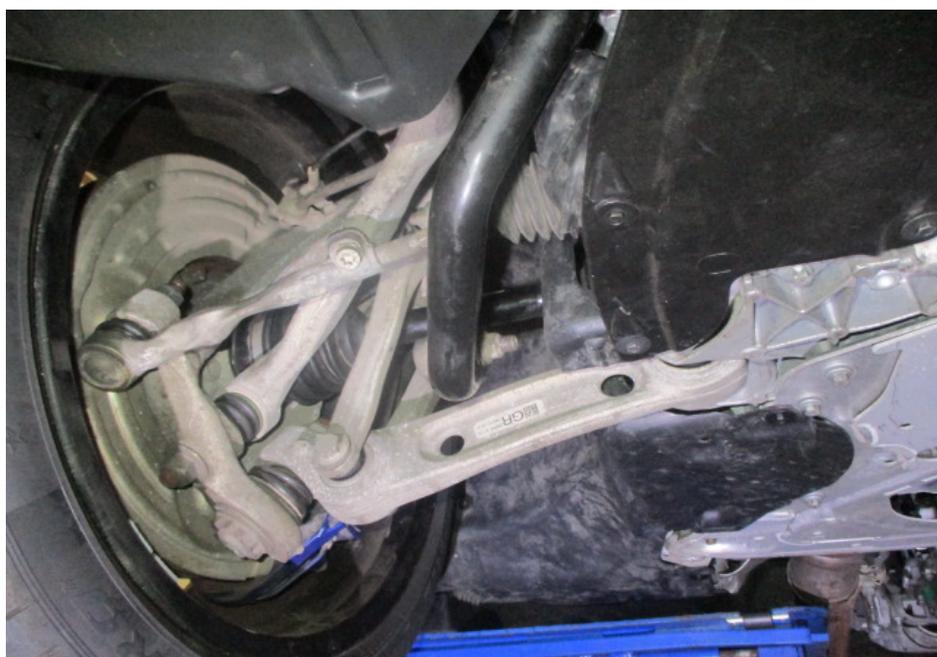
Photo 21 shows the various undercarriage components at the front right wheel of the Motor Car. The mechanical components, control arms and linkages were all found to be intact and secured in an appropriate manner.

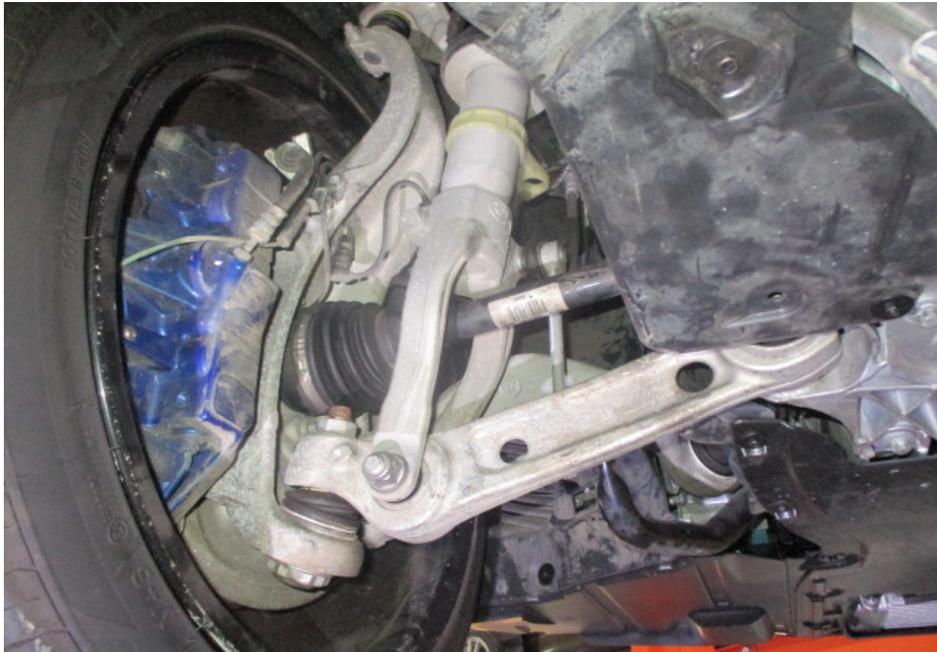
Photo 22 shows the various undercarriage components at the front left wheel of the Motor Car. The mechanical components, control arms and linkages were all found to be intact and secured in an appropriate manner. I also did not observe any fluid leak and/or fluid stain on the underside of the Motor Car.

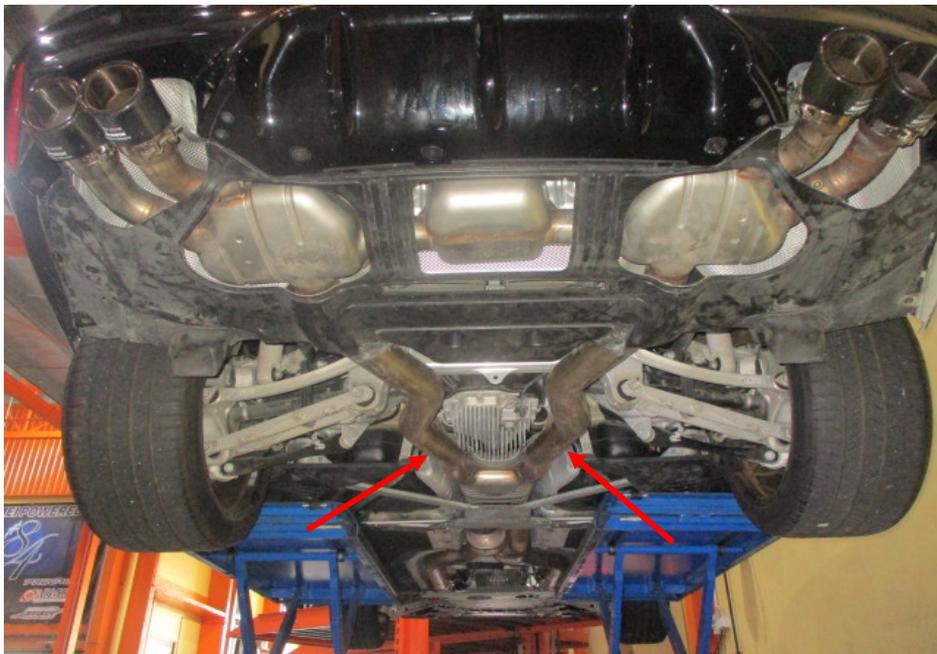
Photo 23 shows the rear section of the Motor Car's exhaust system. My examination of the Motor Car's exhaust system revealed no sign(s) or indication(s) of any cut or weld marks along its exhaust pipes (arrowed), centre resonator boxes, rear mufflers and on its catalytic converters.

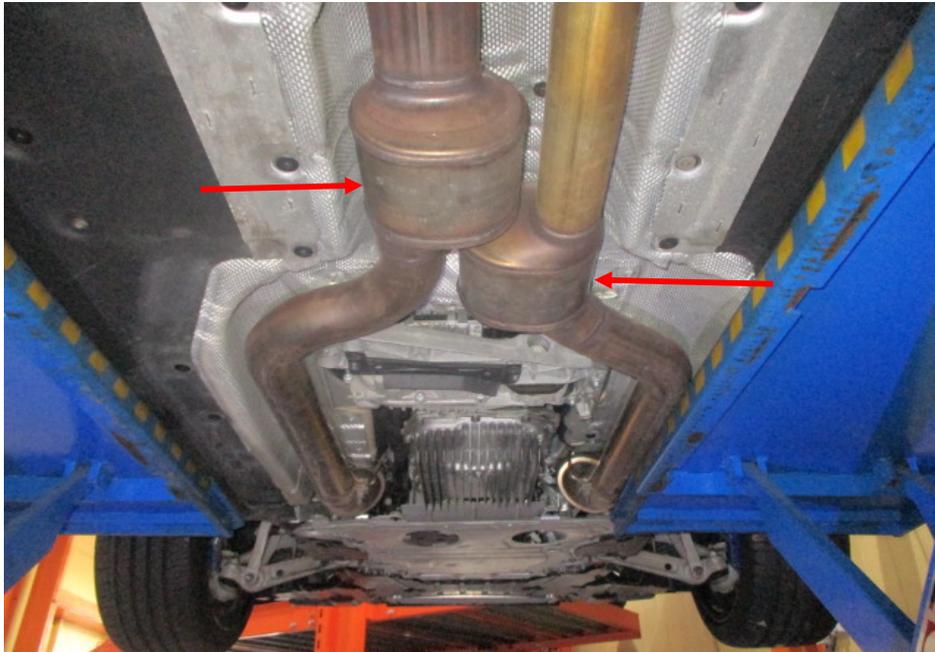
Photo 24 shows the front section of the Motor Car's exhaust system. My examination of the Motor Car's exhaust system revealed no sign(s) or indication(s) of any cut or weld marks along its exhaust pipes, centre resonator boxes (arrowed), rear mufflers and on its catalytic converters.

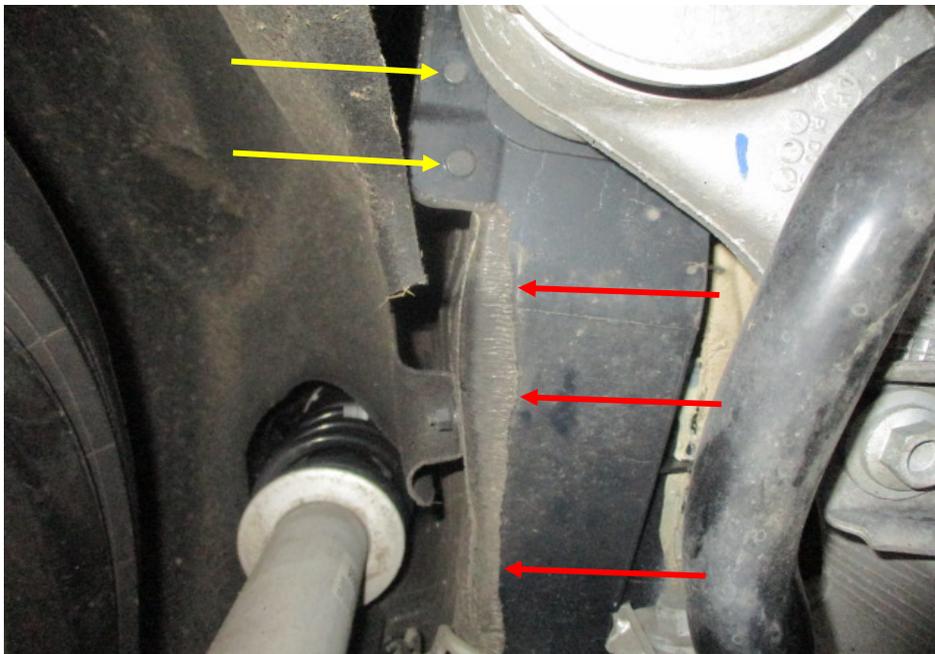
Photo 25 shows the chassis/structural body at the underside rear left of the Motor Car. I did not find any weld marks other than original spot weld marks (yellow arrow) on the chassis/structural body of the Motor Car. The original factory sealant (red arrow) at the joints along the chassis/structural body was also untouched, indicating no work was done on the chassis/structural body of the Motor Car and that the chassis/structural body was originally fitted.

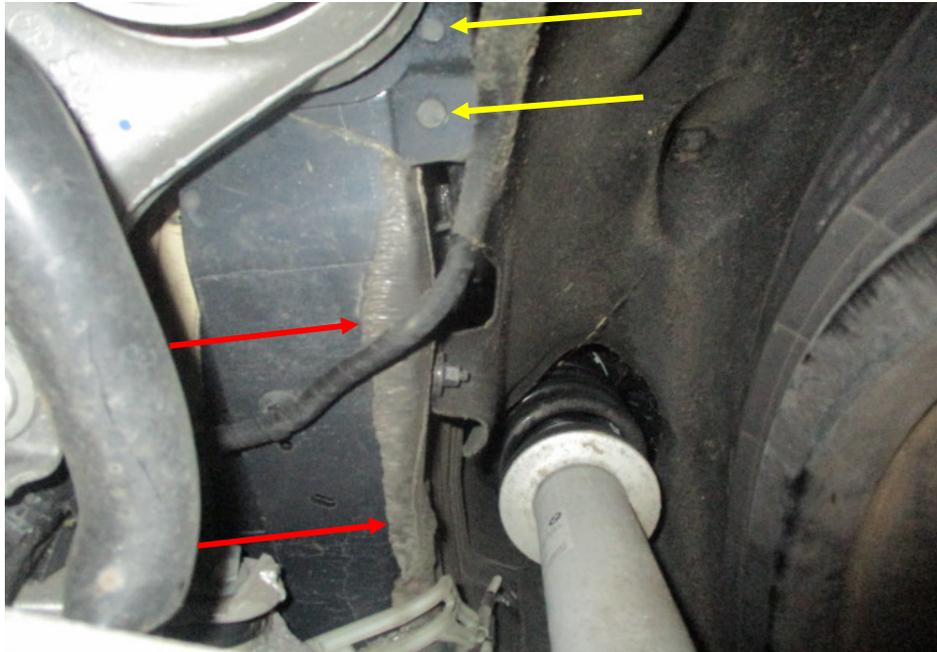
Photo 26 shows the chassis/structural body at the underside rear right of the Motor Car. I did not find any weld marks other than original spot weld marks (yellow arrow) on the chassis/structural body of the Motor Car. The original factory sealant (red arrow) at the joints along the chassis/structural body was also untouched, indicating no work was done on the chassis/structural body of the Motor Car and that the chassis/structural body was originally fitted.

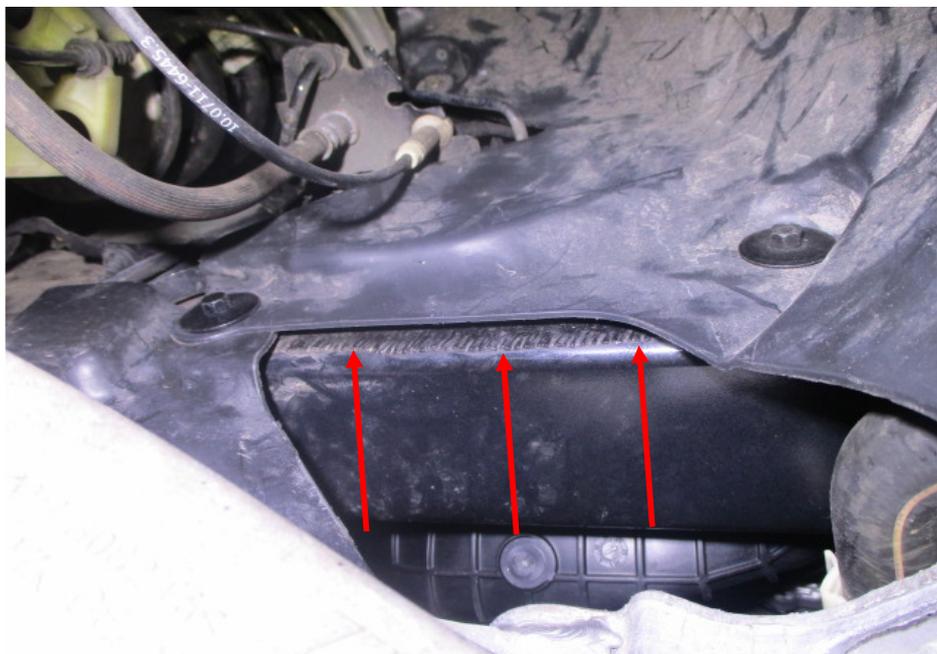
Photo 27 shows the chassis/structural body at the underside front right of the Motor Car. The original factory sealant (arrowed) at the joints along the chassis/structural body was observed to be untouched. In general, I had found no work was carried out on the chassis/structural body of the Motor Car. The chassis/structural body of the Motor Car was originally fitted.

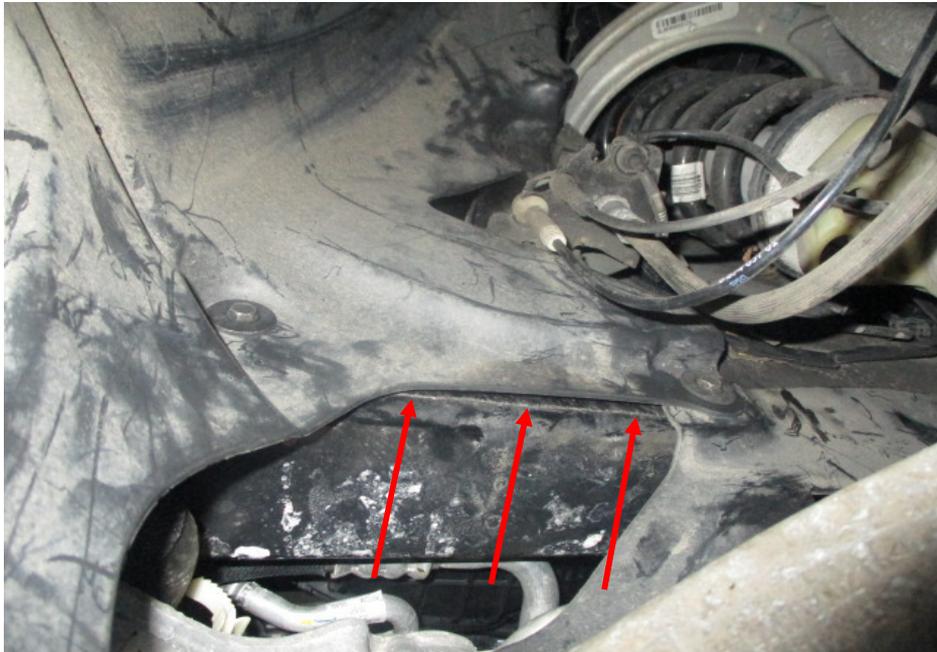
Photo 28 shows the chassis/structural body at the underside front left of the Motor Car. The original factory sealant (arrowed) at the joints along the chassis/structural body was observed to be untouched. In general, I had found no work was carried out on the chassis/structural body of the Motor Car. The chassis/structural body of the Motor Car was originally fitted.

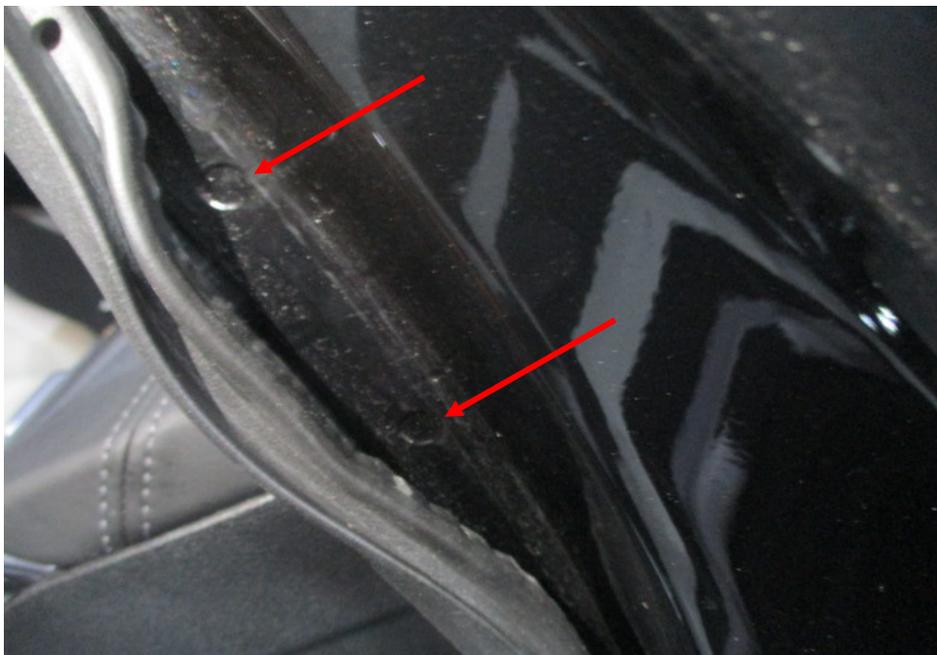
Photo 29 shows the right side "A" pillar of the Motor Car. I did not find any weld marks other than original spot weld marks (arrowed) on the right side "A" pillar of the Motor Car which, indicates that there was no re-welding works carried out. In general, I had found all the non-detachable body panels of the Motor Car to be originally fitted at the time of my inspection.

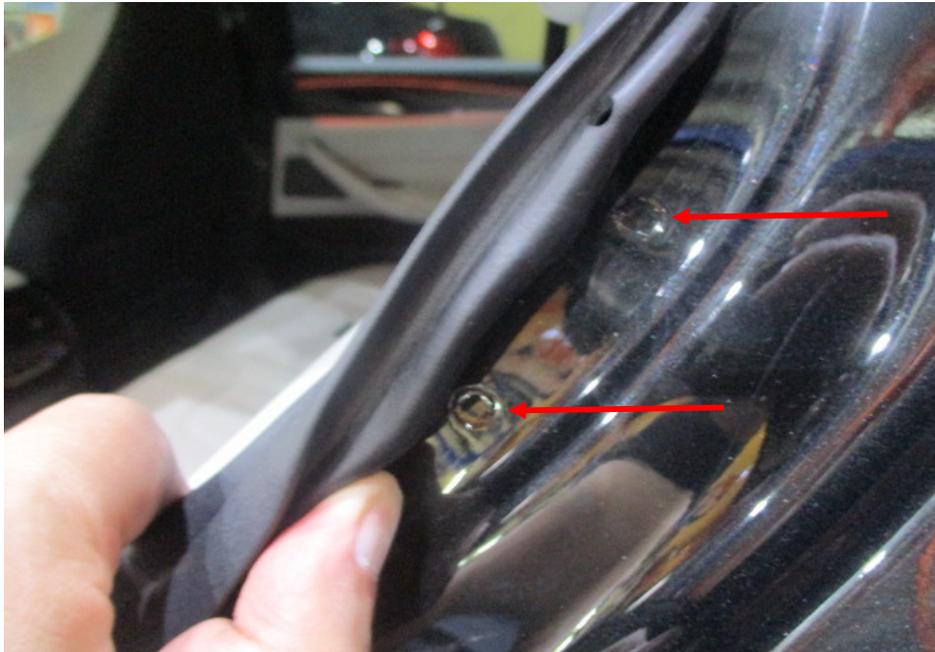
Photo 30 shows the left side "C" pillar of the Motor Car. I did not find any weld marks other than original spot weld marks (arrowed) on the left side "C" pillar of the Motor Car which, indicates that there was no re-welding works carried out. In general, I had found all the non-detachable body panels of the Motor Car to be originally fitted at the time of my inspection.
