Your Ref: Mercedes Benz E220d
(chassis number W1K2130042A810666)

Our Ref : CI/TP21008311/D

**INSPECTION REPORT OF AN UNREGISTERD MERCEDES BENZ E220d
COUPE MOTOR CAR WITH CHASSIS NUMBER W1K2130042A810666**

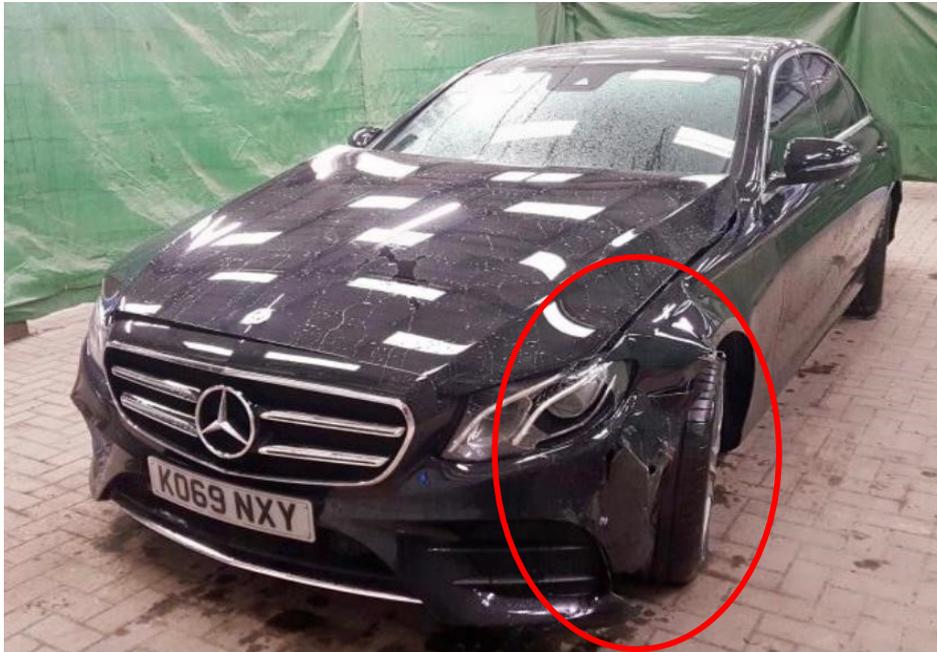
Photo 1 shows the front left body of the Motor Car (photograph provided to me). The Motor Car was observed to have sustained damage at its front left portion (circled). The front bumper, front bonnet, front left headlamp and front left fender were amongst the body parts that were observed to have been damaged.

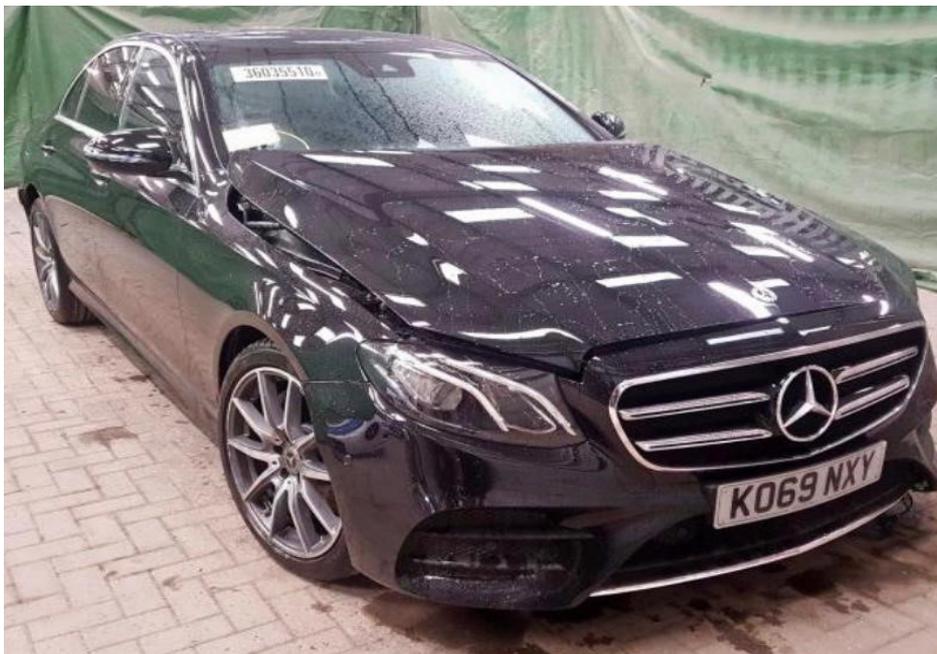
Photo 2 shows the front right body of the Motor Car (photograph provided to me). No physical damage was seen to the front right portion of the Motor Car. The photographs provided had also seem to show that the airbags were not deployed.

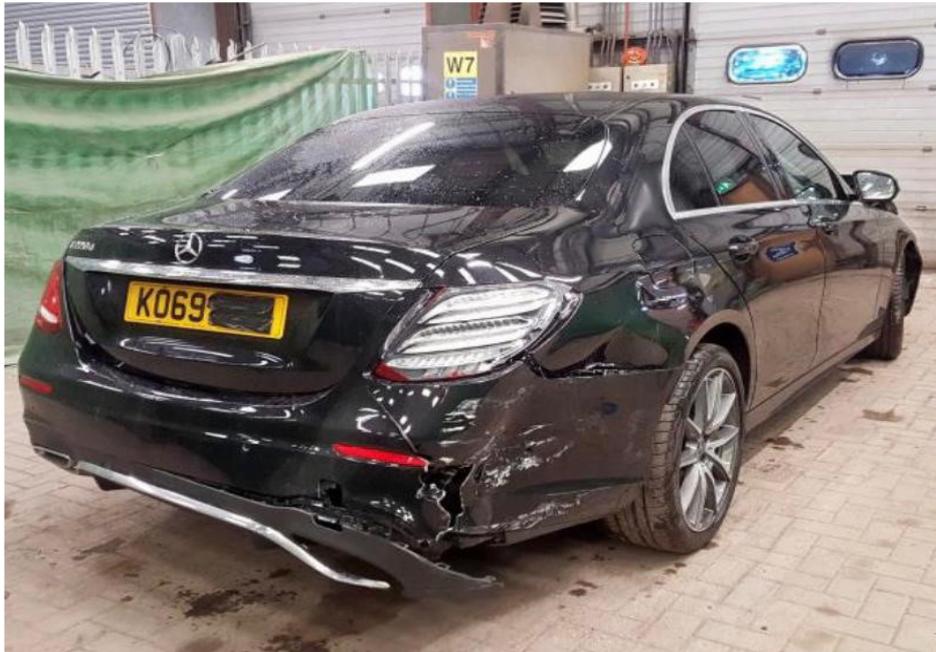
Photo 3 shows the rear right body of the Motor Car (photograph provided to me). Apart for the front left portion, the photographs provided had also showed damaged to the rear right portion of the Motor Car. The rear bumper, rear bumper lower cover, rear bumper lower chrome moulding, rear bumper right reflector, rear right exhaust chrome garnish, rear right taillamp and rear right fender were amongst the body parts that were observed to have been damaged.

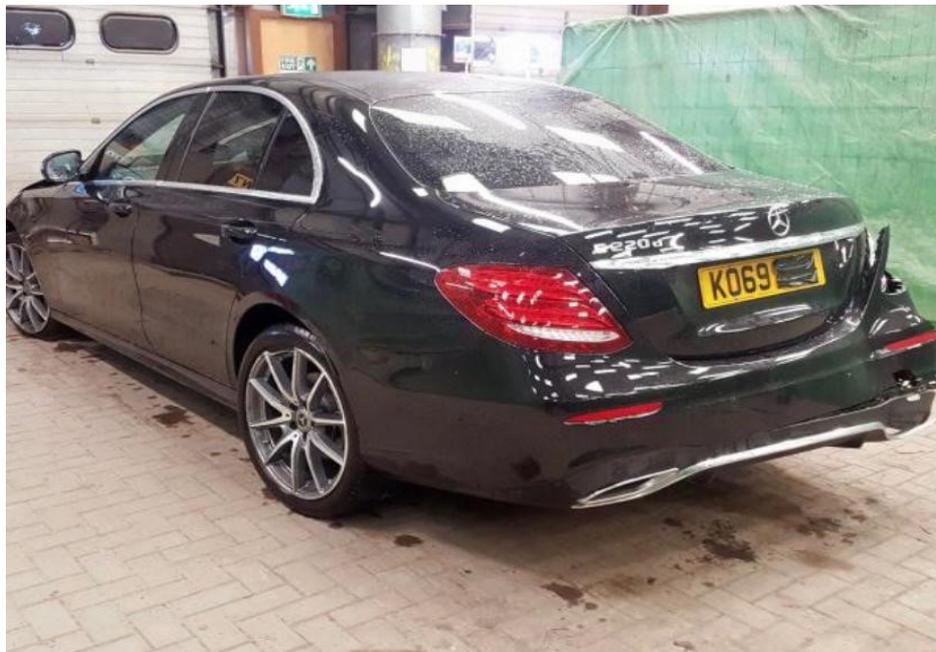
Photo 4 shows the rear left body of the Motor Car (photograph provided to me). No physical damage was seen to the rear left portion of the Motor Car. The photographs provided had also seem to show that the airbags were not deployed.

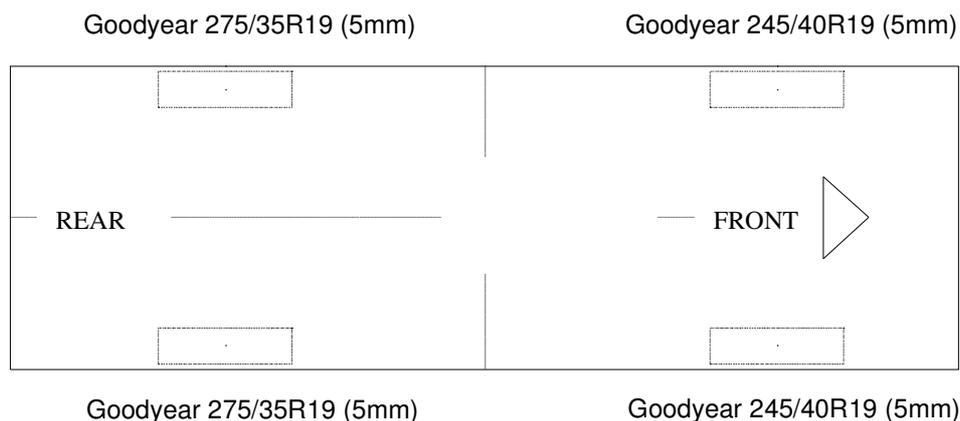
- It was fitted with 19inch sport wheel rims that were wrapped with tyres that were observed to be of serviceable condition. The tyres were also sufficiently inflated for vehicular operation. The tyre brand, tyre size and approximate remaining tread depth of the 4 tyres of the Motor Car were recorded as follows: -

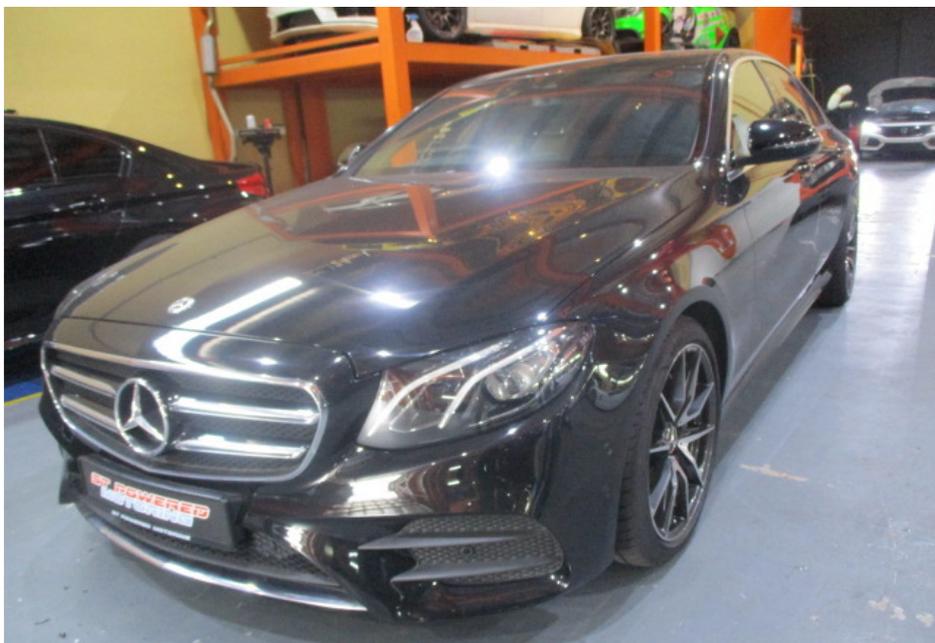
Photo 5 shows a general view of the front left body of the Motor Car at the time of my inspection. The Motor Car was observed to be in a relatively good general condition with no loose exterior fittings observed. The body parts at the front left portion of the Motor Car were visually examined and it was observed that the repair/restoration works carried out to the damaged area of the Motor Car (refer to photograph 1 above) were reasonably adequate and in order.

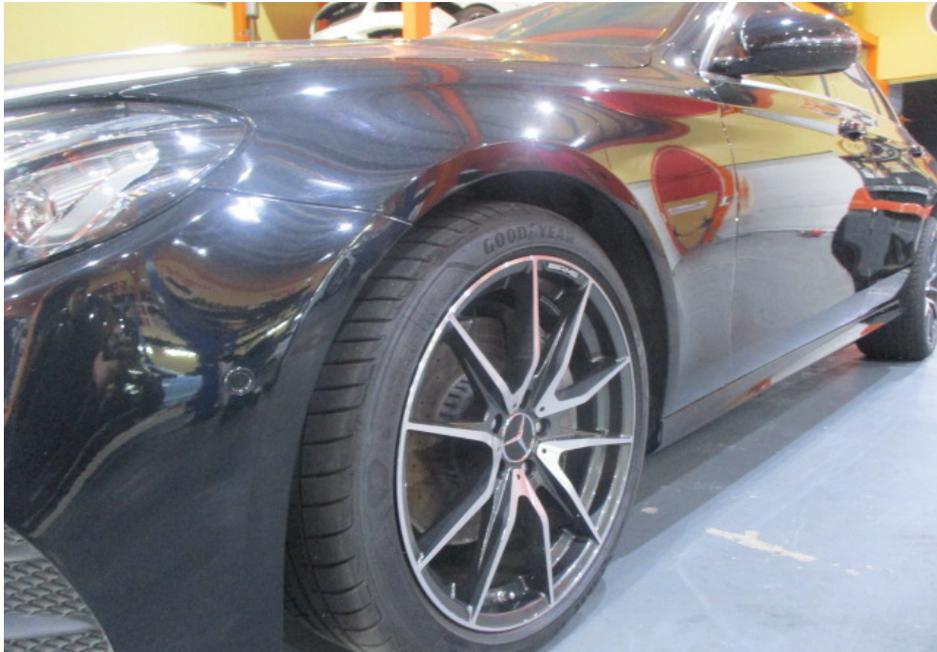
Photo 6 shows a closer view of the Motor Car's front bumper, front left headlamp and front left fender at the time of my inspection. The body parts at the front left portion of the Motor Car were visually examined and it was observed that the repair/restoration works carried out to the damaged area of the Motor Car (refer to photograph 1 above) were reasonably adequate and in order.

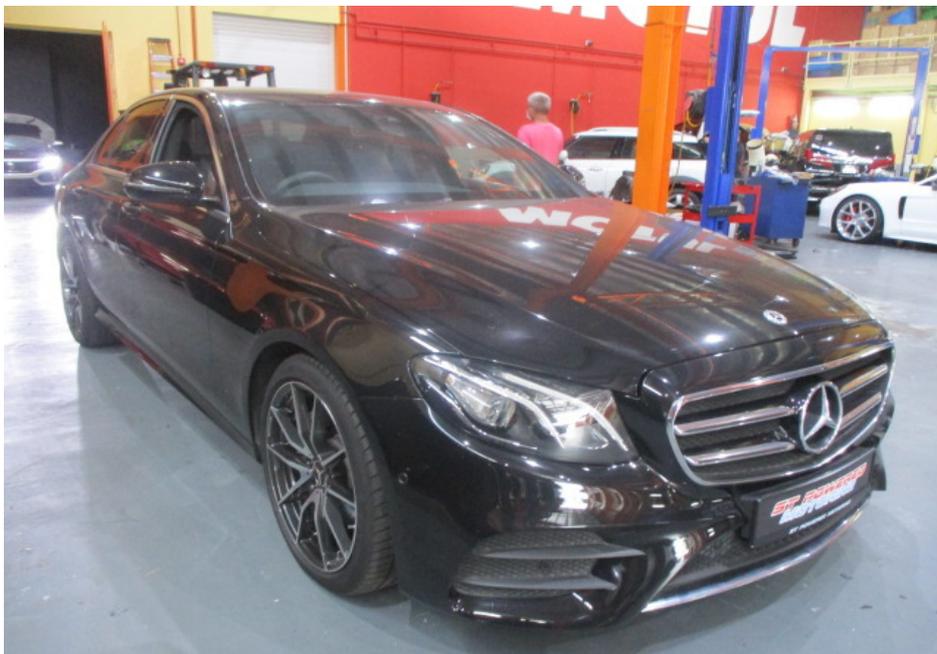
Photo 7 shows a general view of the front right body of the Motor Car at the time of my inspection. The Motor Car was observed to be in a relatively good general condition with no loose exterior fittings observed. The mileage of the Motor Car recorded at the time of my inspection was 6,234km.

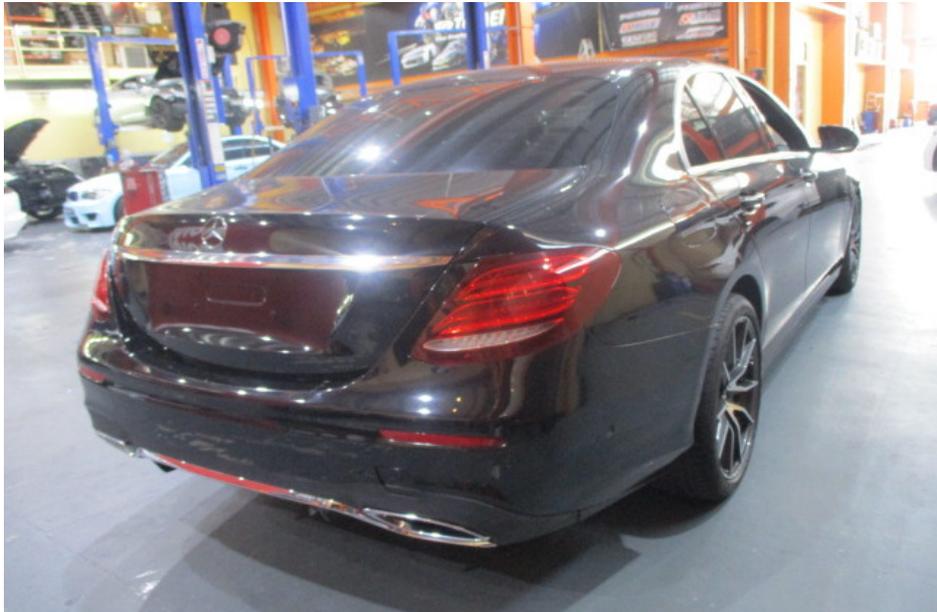
Photo 8 shows a general view of the rear right body of the Motor Car at the time of my inspection. The Motor Car was observed to be in a relatively good general condition with no loose exterior fittings observed. The body parts at the rear right portion of the Motor Car were visually examined and it was observed that the repair/restoration works carried out to the damaged area of the Motor Car (refer to photograph 3 above) were reasonably adequate and in order.

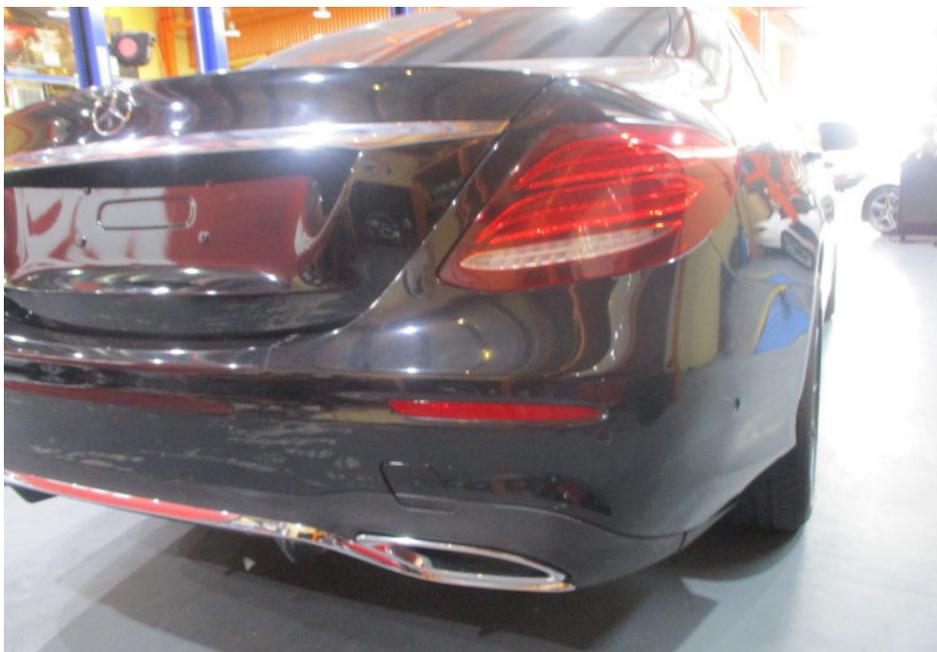
Photo 9 shows a closer view of the Motor Car's rear bumper, rear bumper lower cover, rear bumper lower chrome moulding, rear bumper right reflector and rear right exhaust chrome garnish at the time of my inspection. The body parts at the rear right portion of the Motor Car were visually examined and it was observed that the repair/restoration works carried out to the damaged area of the Motor Car (refer to photograph 3 above) were reasonably adequate and in order.

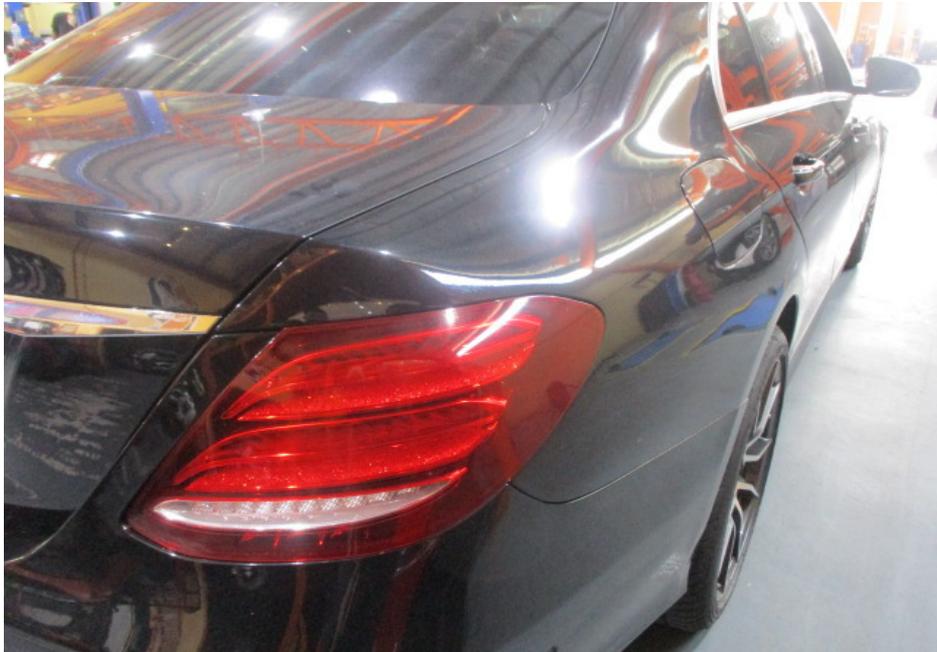
Photo 10 shows a closer view of the Motor Car's rear right taillamp and rear right fender at the time of my inspection. The body parts at the rear right portion of the Motor Car were visually examined and it was observed that the repair/restoration works carried out to the damaged area of the Motor Car (refer to photograph 3 above) were reasonably adequate and in order.

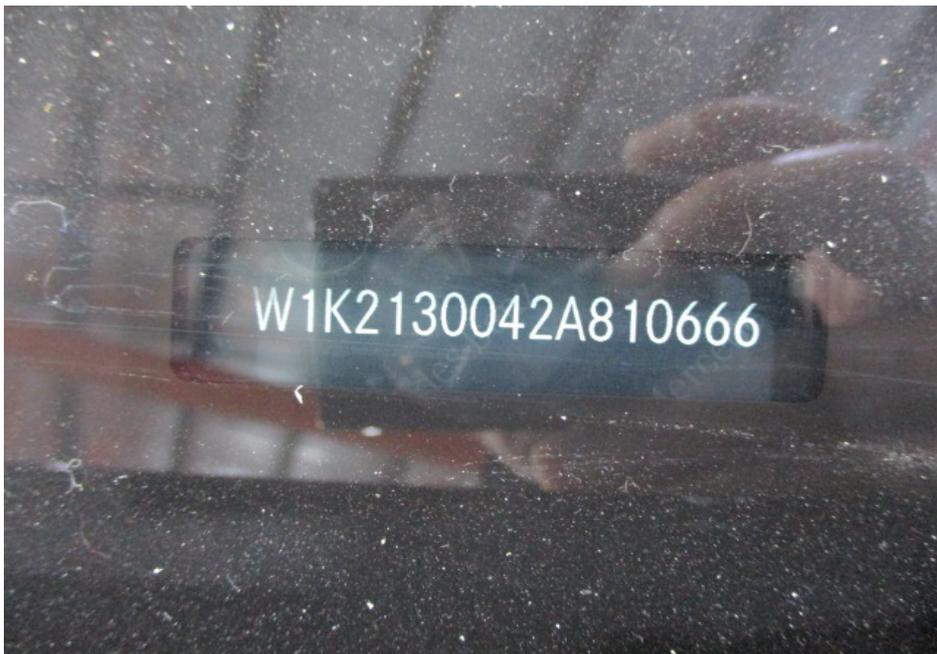
Photo 11 shows the chassis number of the Motor Car. The chassis number recorded was W1K2130042A810666.

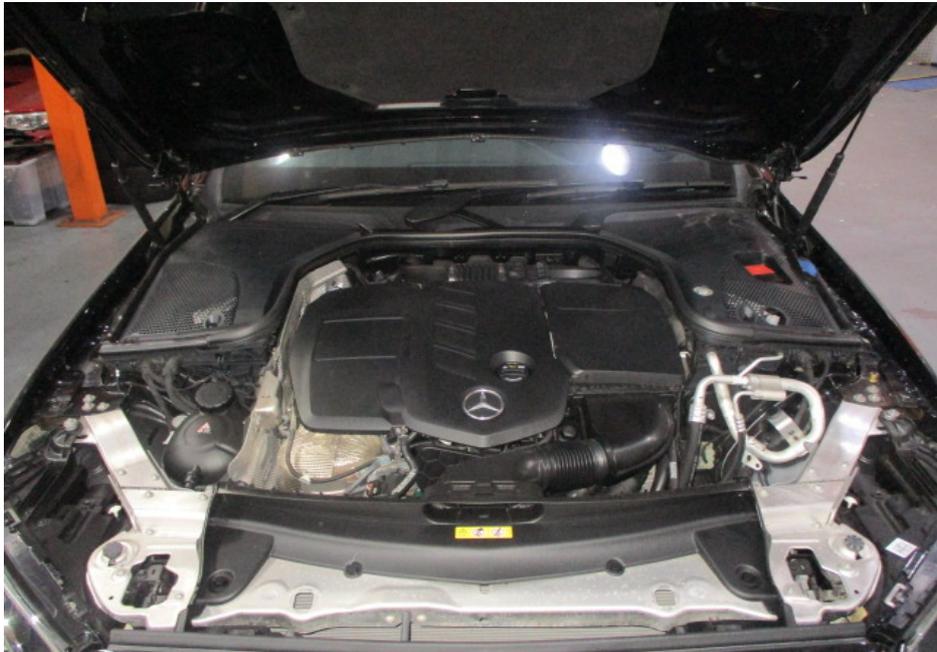
Photo 12 shows a general view of the engine compartment of the Motor Car at the time of my inspection. The various parts and components inside the engine compartment were all observed to be intact and properly fitted. There was also no sign(s) or indication(s) of fluid leak and/or fluid stain found inside the engine compartment.

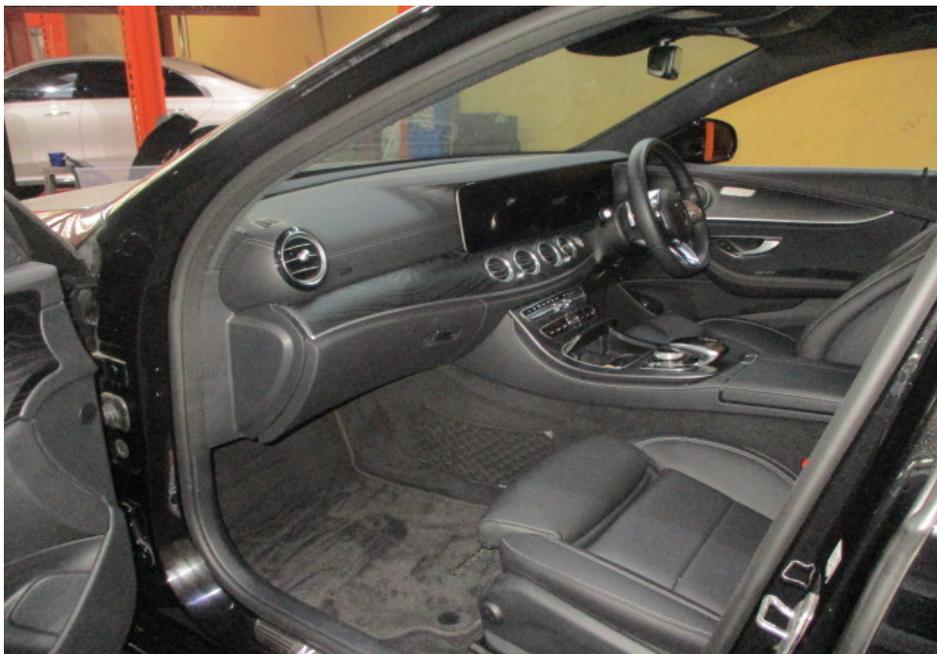
Photo 13 shows the interior compartment of the Motor Car at the time of my inspection. The various parts and components, trims, carpet and upholstery inside the interior compartment were all observed to be intact and properly fitted.

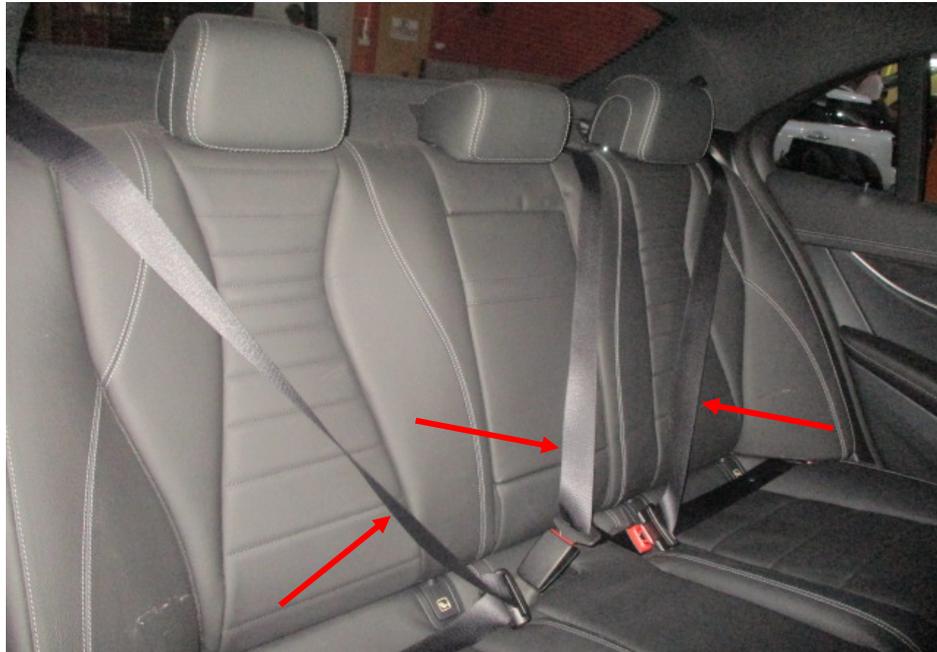
Photo 14 shows the rear seats of the Motor Car. All the seats of the Motor Car were secured via seat rails to the floorboard. They were also fitted with a retractable seat belt reel and a pre-tensioner. The seat belts (arrowed) were tested and were able to be fastened into the respective pre-tensions that were fitted on the side of each individual seat.

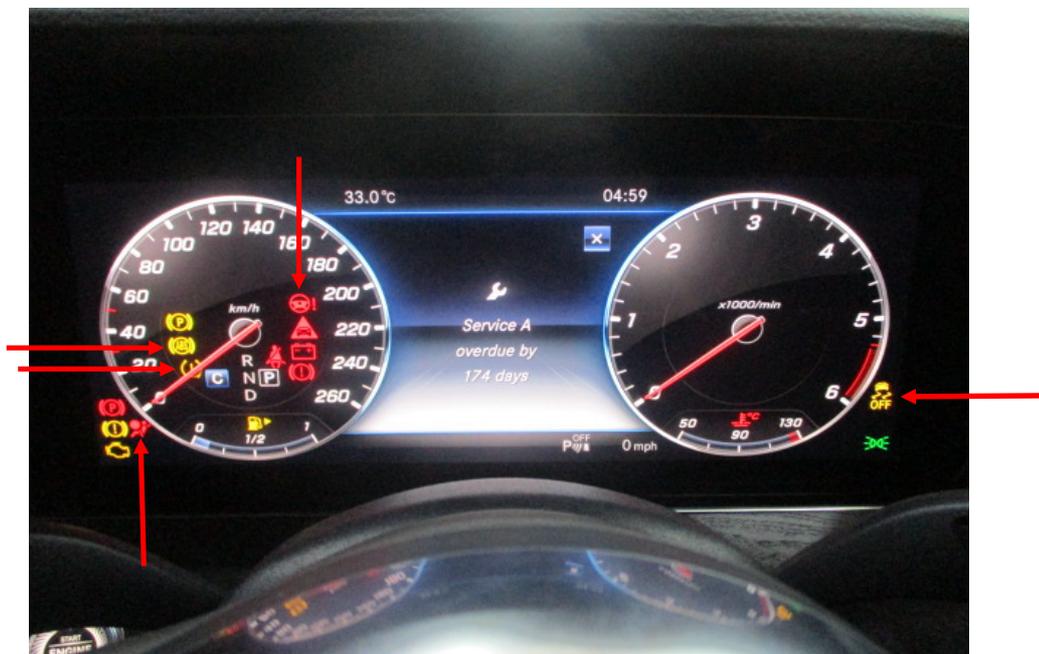
Photo 15 shows the warning lights for the various electronic safety features appearing on the instrument panel of the Motor Car during its self-test when the engine is cranked, in particular the ABS, SRS, EPS, TPM and TCS lights (arrowed).

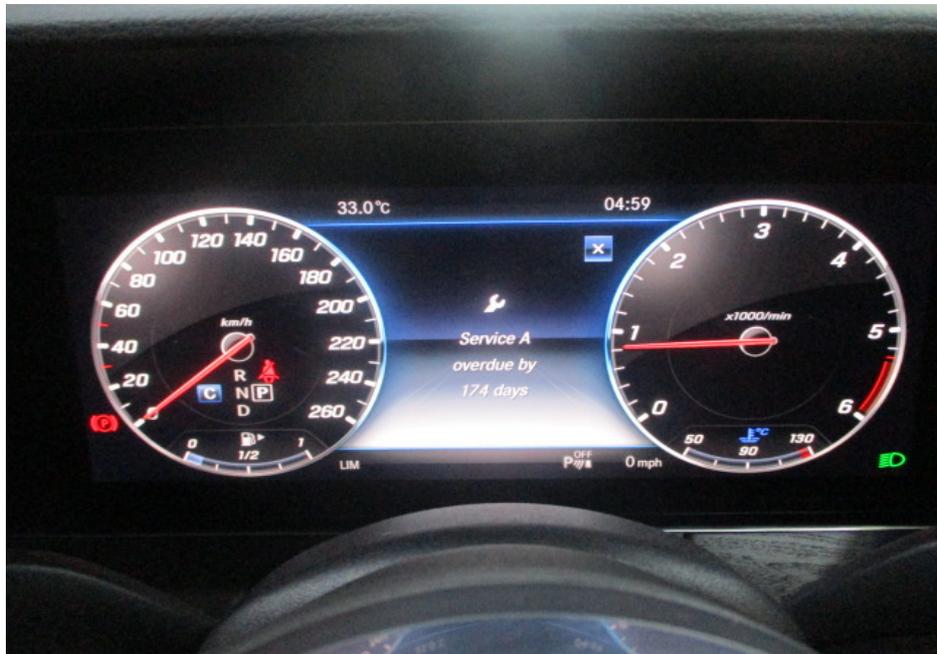
Photo 16 shows the respective warning lights no longer illuminated, indicating that there is no fault detected to the ABS, SRS, EPS, TPM and TCS systems of the Motor Car during the self-test. These electronic systems were hence in working condition at the time of my inspection.

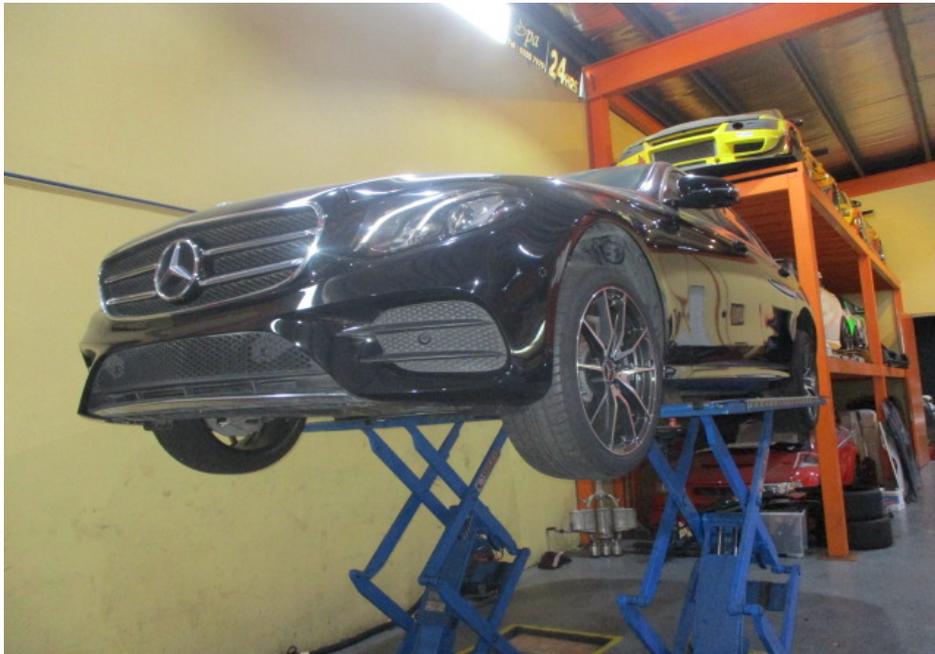
Photo 17 shows the Motor Car hoisted up for checks on its undercarriage. There was no sign(s) or indication(s) of fluid leakage and/or fluid stain(s) on the underside of the Motor Car. The undercarriage components of the Motor Car were also all observed to be intact and secured in an appropriate manner.

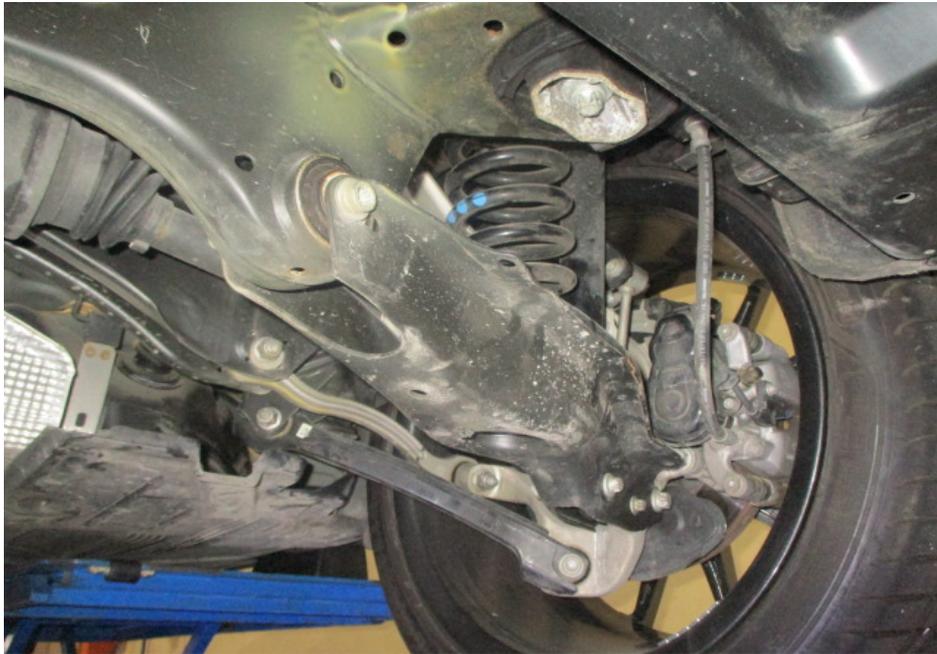
Photo 18 shows a general view of the control arms and linkages at the rear right wheel of the Motor Car. I did not observe any fluid leak and/or fluid stain on the underside of the Motor Car. All of the Motor Car's undercarriage components were observed to be intact and secured in an appropriate manner

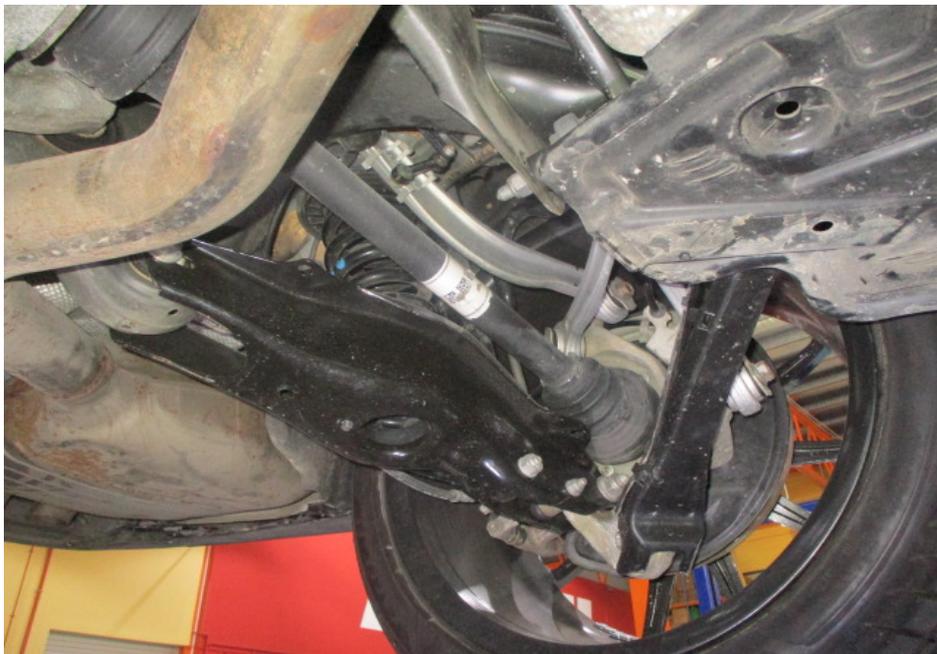
Photo 19 shows a general view of the control arms and linkages at the rear left wheel of the Motor Car. I did not observe any fluid leak and/or fluid stain on the underside of the Motor Car. All of the Motor Car's undercarriage components were observed to be intact and secured in an appropriate manner.

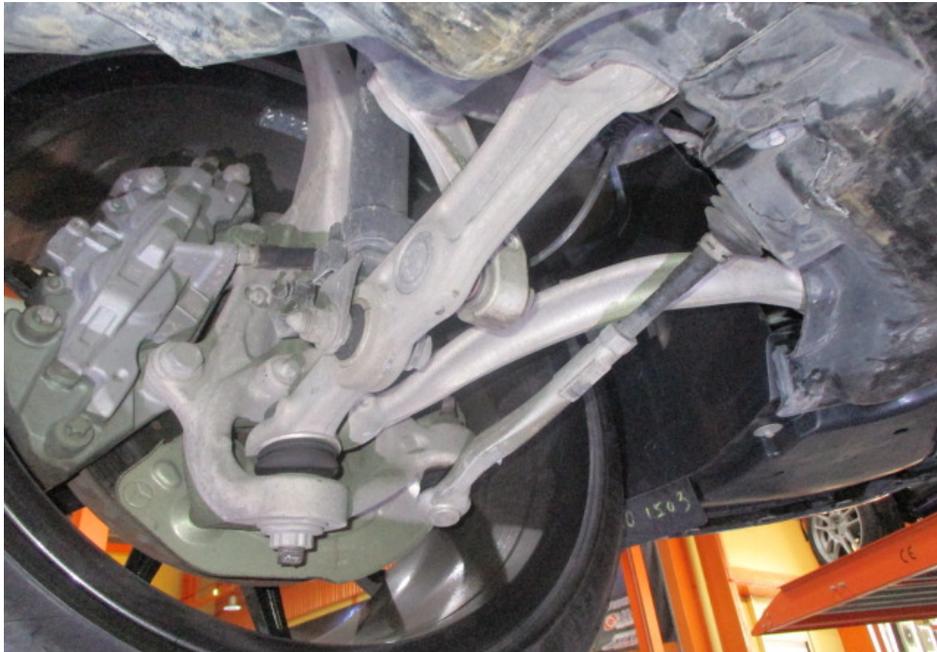
Photo 20 shows the various undercarriage components at the front left wheel of the Motor Car. The mechanical components, control arms and linkages were all found to be intact and secured in an appropriate manner.

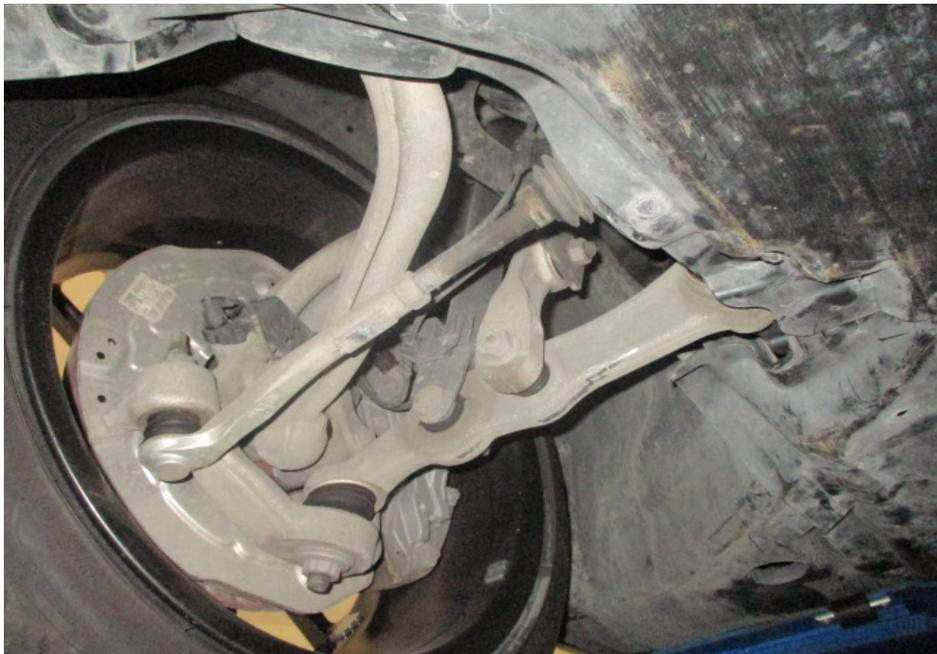
Photo 21 shows the various undercarriage components at the front right wheel of the Motor Car. The mechanical components, control arms and linkages were all found to be intact and secured in an appropriate manner. I also did not observe any fluid leak and/or fluid stain on the underside of the Motor Car.

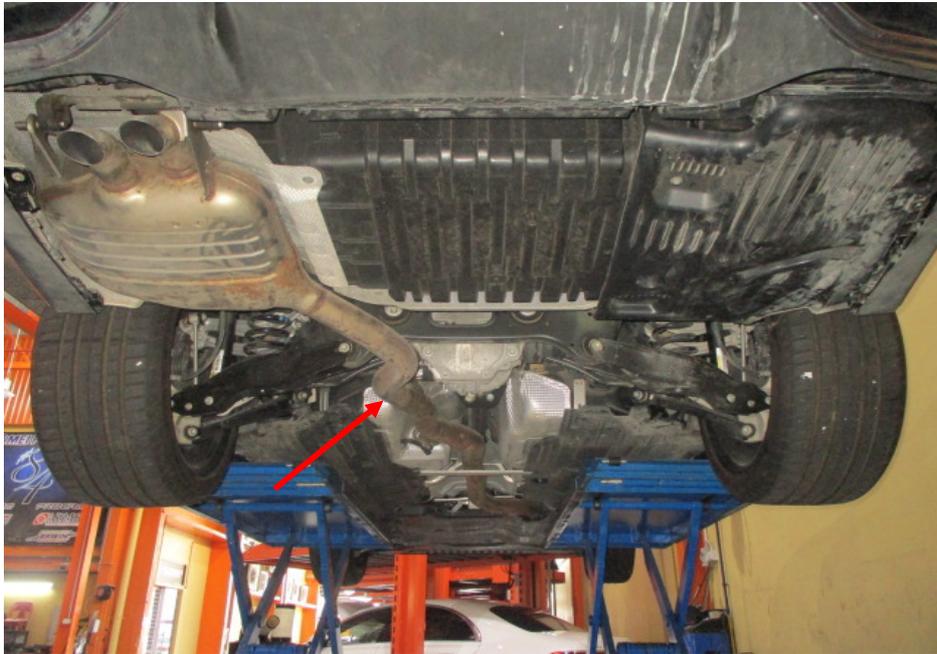
Photo 22 shows a general view of the Motor Car's exhaust system (rear section). My examination of the Motor Car's exhaust system revealed no sign(s) or indication(s) of any cut or weld marks along its exhaust pipes (arrowed), on its catalytic converter and on its rear muffler.

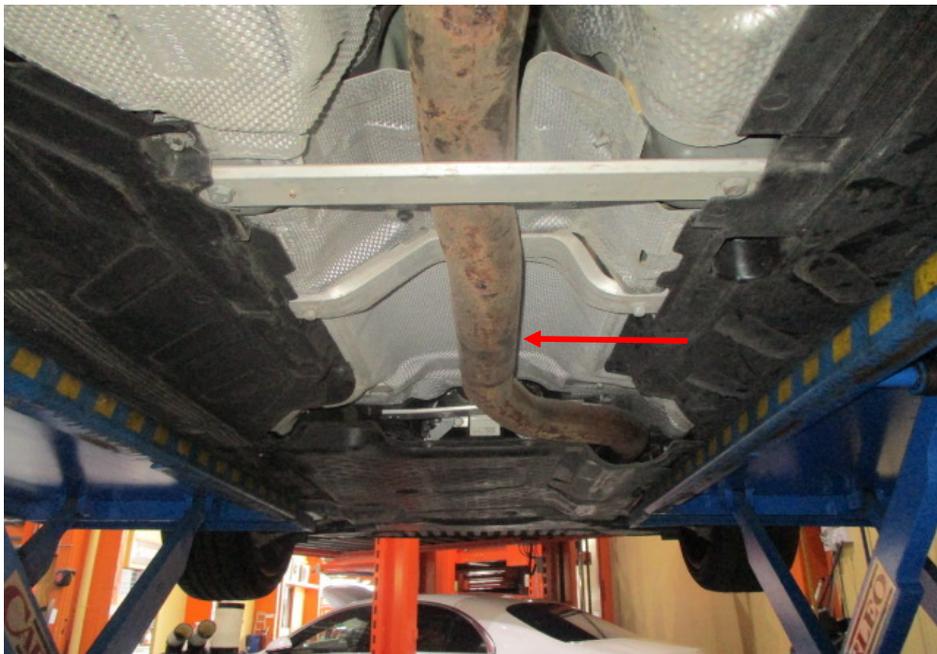
Photo 23 shows a general view of the Motor Car's exhaust system (front section). My examination of the Motor Car's exhaust system revealed no sign(s) or indication(s) of any cut or weld marks along its exhaust pipes, catalytic converter and on its rear muffler.

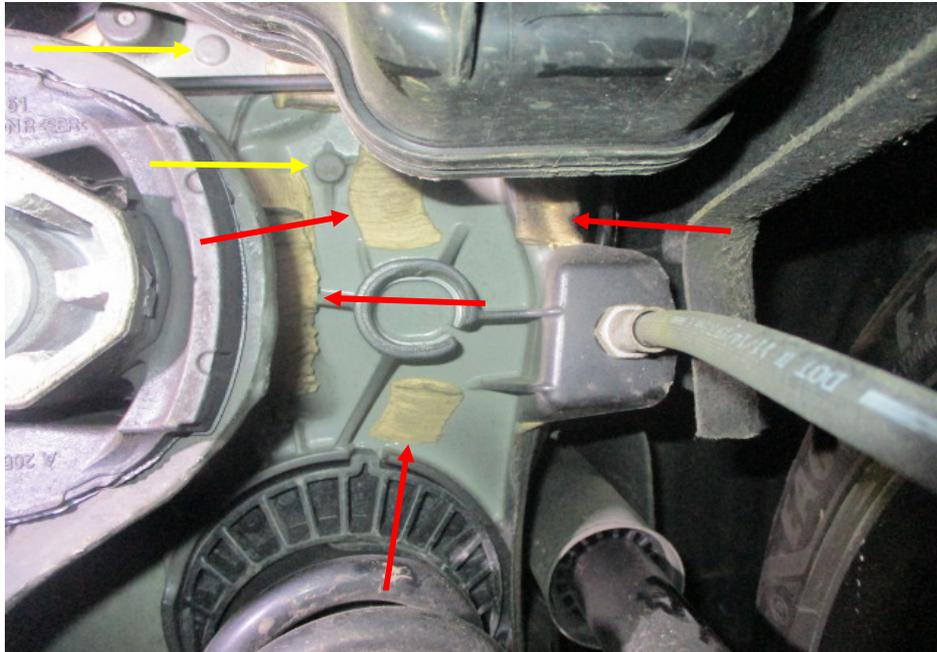
Photo 24 shows the chassis/structural body at the underside rear right of the Motor Car. I did not find any weld marks other than original spot weld marks (yellow arrow) on the chassis/structural body of the Motor Car. The original factory sealant (red arrow) at the joints along the chassis/structural body was untouched, indicating no work was done on the chassis/structural body of the Motor Car and that the chassis/structural body was originally fitted.

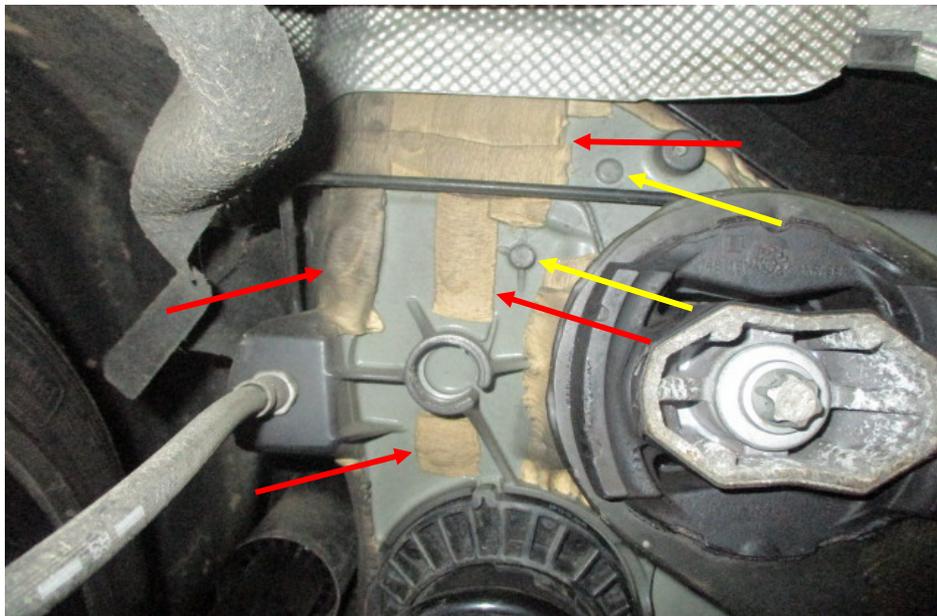
Photo 25 shows the chassis/structural body at the underside rear left of the Motor Car. I did not find any weld marks other than original spot weld marks (yellow arrow) on the chassis/structural body of the Motor Car. The original factory sealant (red arrow) at the joints along the chassis/structural body was untouched, indicating no work was done on the chassis/structural body of the Motor Car and that the chassis/structural body was originally fitted.

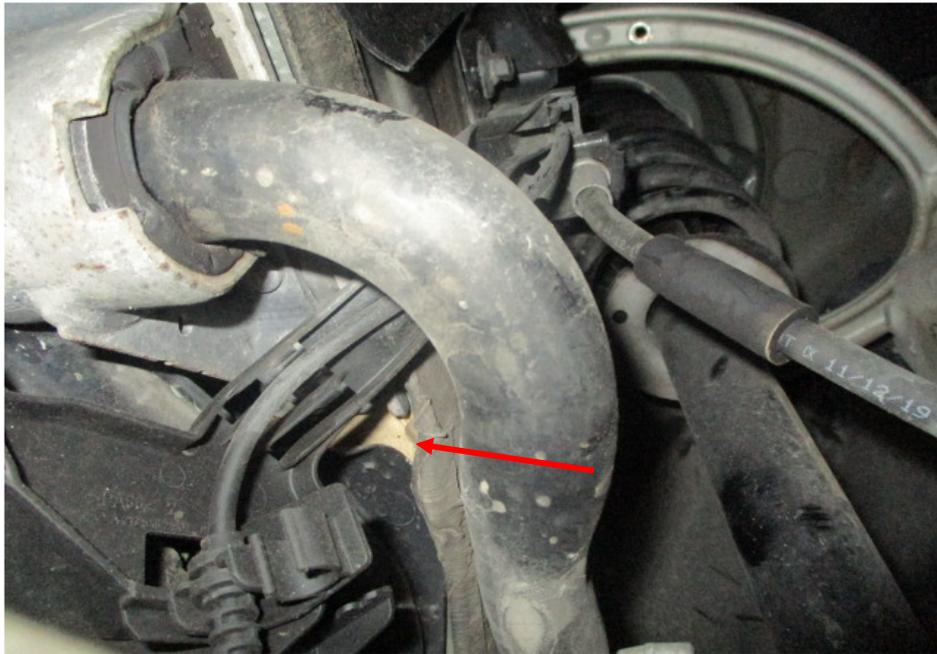
Photo 26 shows the chassis/structural body at the underside front left of the Motor Car. The original factory sealant (arrowed) at the joints along the chassis/structural body was observed to be untouched. In general, I had found no work was carried out on the chassis/structural body of the Motor Car. The chassis/structural body of the Motor Car was originally fitted.

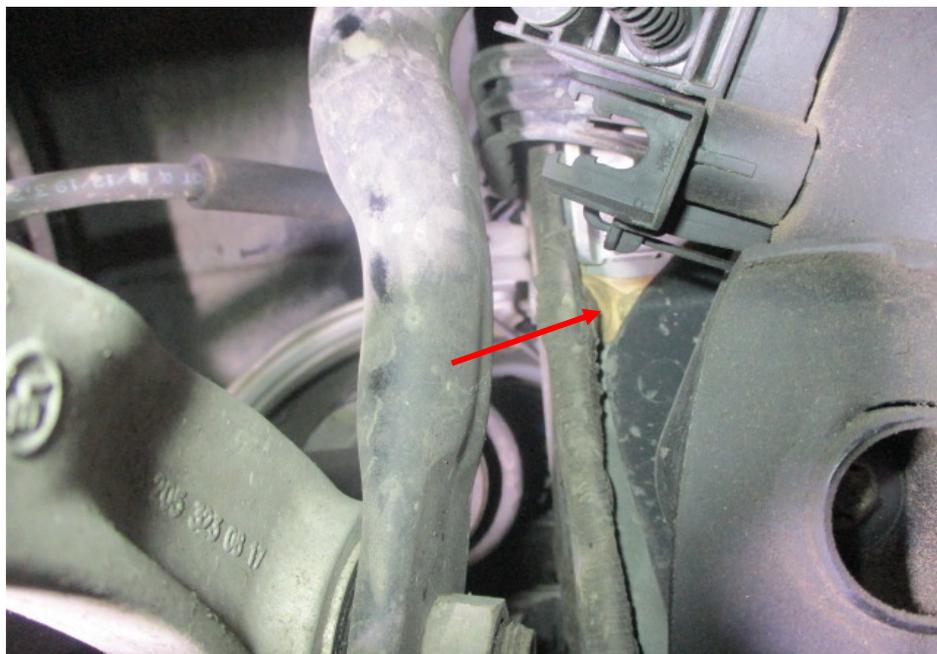
Photo 27 shows the chassis/structural body at the underside front right of the Motor Car. The original factory sealant (arrowed) at the joints along the chassis/structural body was observed to be untouched. In general, I had found no work was carried out on the chassis/structural body of the Motor Car. The chassis/structural body of the Motor Car was originally fitted.

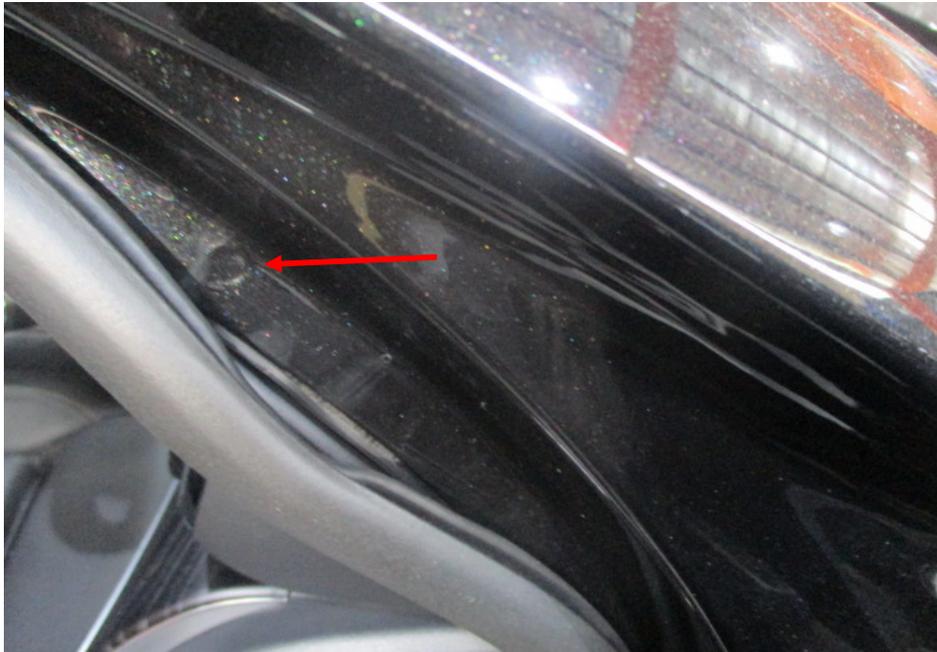
Photo 28 shows the right side "A" pillar of the Motor Car. I did not find any weld marks other than original spot weld marks (arrowed) on the right side "A" pillar of the Motor Car, which indicates that there was no re-welding works carried out. In general, I had found all the non-detachable body panels of the Motor Car to be originally fitted at the time of my inspection.

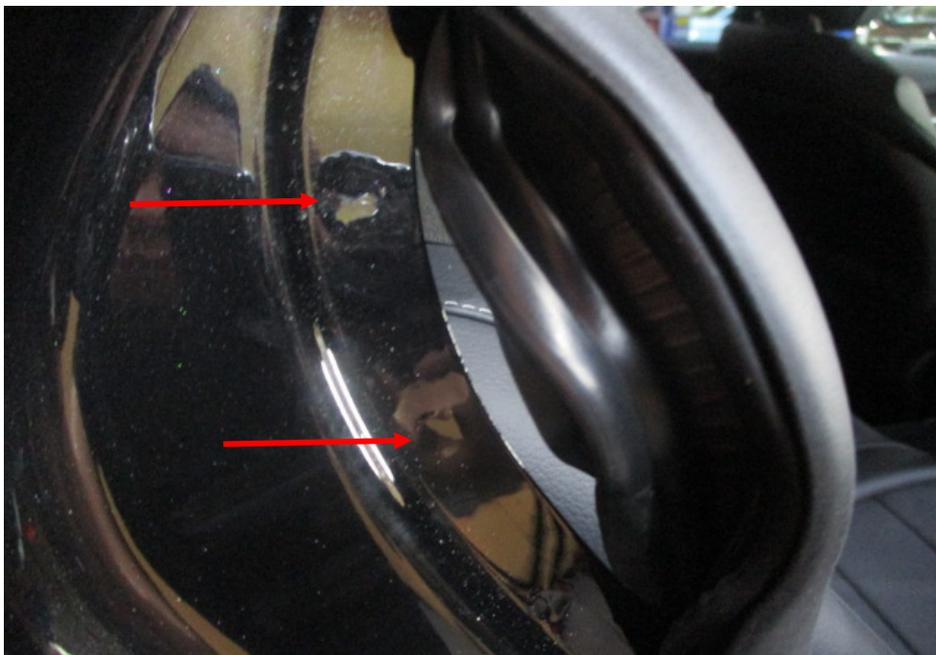
Photo 29 shows the right side "C" pillar of the Motor Car. I did not find any weld marks other than original spot weld marks (arrowed) on the right side "C" pillar of the Motor Car, which indicates that there was no re-welding works carried out. In general, I had found all the non-detachable body panels of the Motor Car to be originally fitted at the time of my inspection.

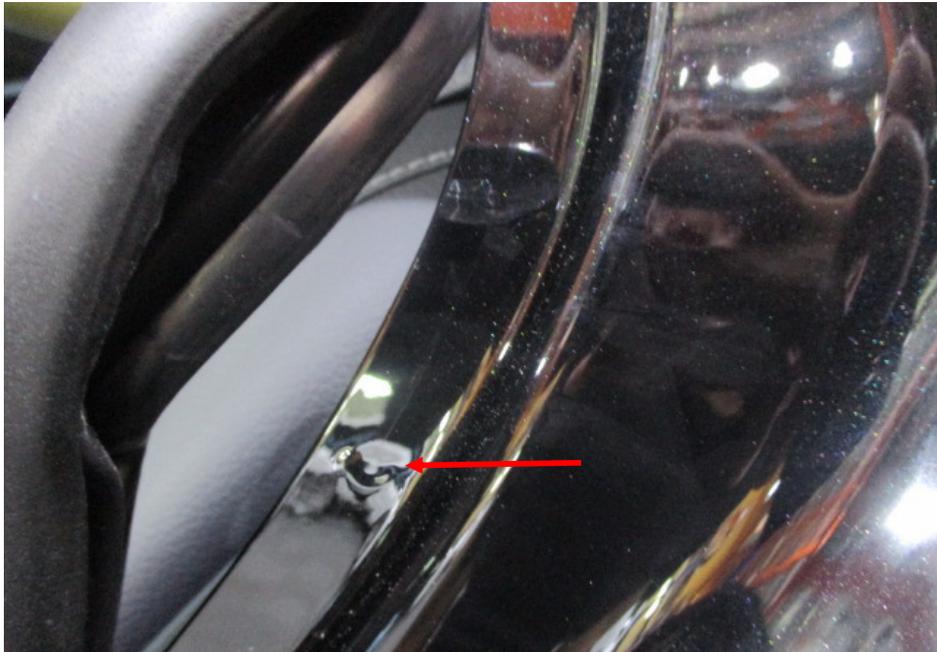
Photo 30 shows the left side "C" pillar of the Motor Car. I did not find any weld marks other than original spot weld marks (arrowed) on the left side "C" pillar of the Motor Car, which indicates that there was no re-welding works carried out. In general, I had found all the non-detachable body panels of the Motor Car to be originally fitted at the time of my inspection.
