## LKK Auto Consultants Pte Ltd

Affiliated to Federation Internationale Des Experts En Automobile				
MS FIRST CAPITAL INSURANCE LTD 36 ROBINSON ROAD #16-01 CITY HOUSESINGAPORE 068877			Ref: CC4/FCI21008317/R1pa3q2	
			Date: 17/09/2021	
			Code: FCI2	
<b>1. Policy Particulars :- THIRD PARTY CLAIM</b>				
Insured Veh.	SLG 6408P	Veh. Inspected	SLL 316J	
Policy No.	D-21096970MFZH	Coverage (\$)	0.00	
Claim No.	D21002258MFZH/1	Excess (\$)	0.00	
Assign From		Assign Date	06/08/2021	
<b>2. Vehicle Particulars &amp; Condition</b>				
Make & Model	MAZDA 6 4-DOOR SEDAN 2.0L	c.c	1998	
Engine No.	HIDDEN	Year of Reg.	2017	
Chassis No.	JM6GL1071H0106083	Colour	RED	
Odometer	137484 KM	Steering	IN ORDER	
Brakes	IN ORDER	Modification	SPORTS RIM	
General	FAIR			
<b>3. Conditions of Tyres</b>				
	Size	Make	Balance	
R/H Front Tyre	225/55 R17	YOKOHAMA	6 mm	
L/H Front Tyre	225/55 R17	YOKOHAMA	6 mm	
R/H Rear Tyre	225/55 R17	YOKOHAMA	6 mm	
L/H Rear Tyre	225/55 R17	YOKOHAMA	6 mm

## ADJUSTMENT ON REPAIR COST FOR VEHICLE NO. SLL 316J

### PHOTOGRAPHS FOR VEHICLE NO. SLL 316J

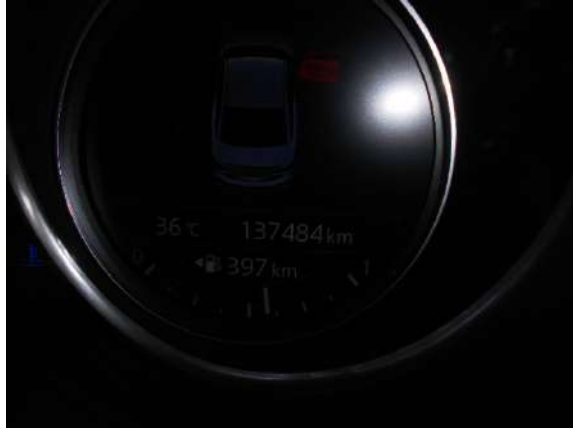
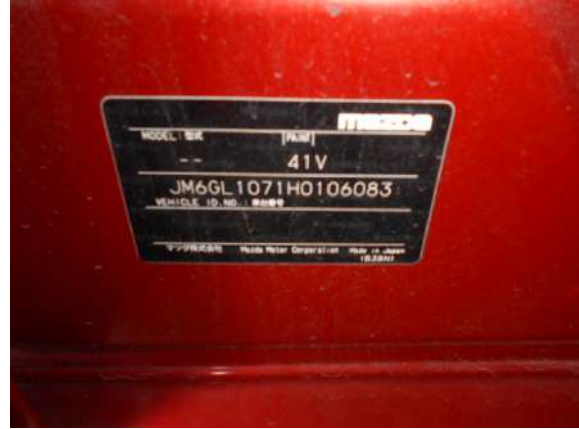
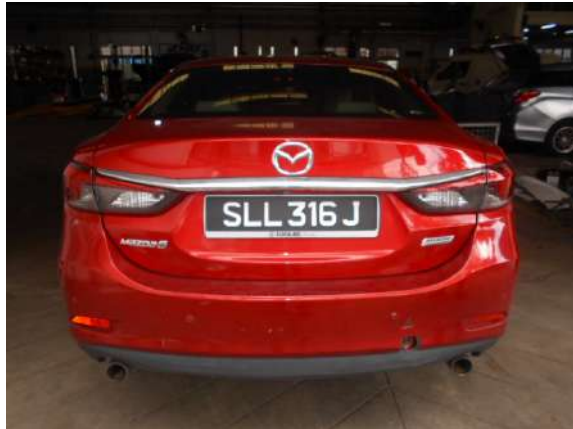
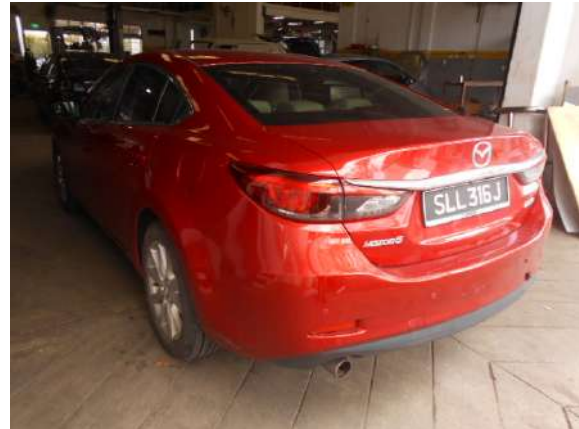
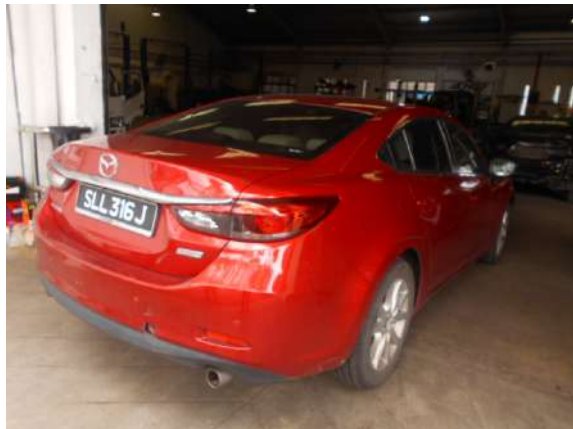
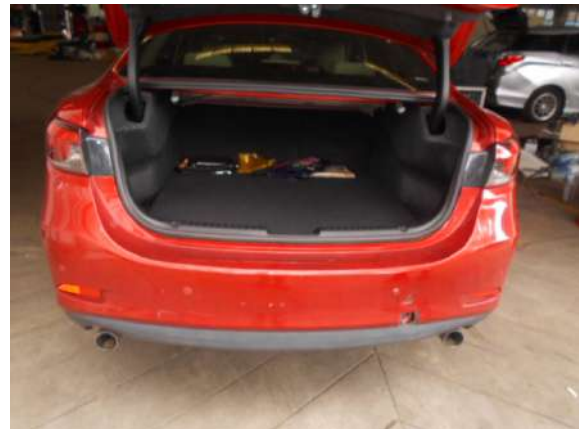
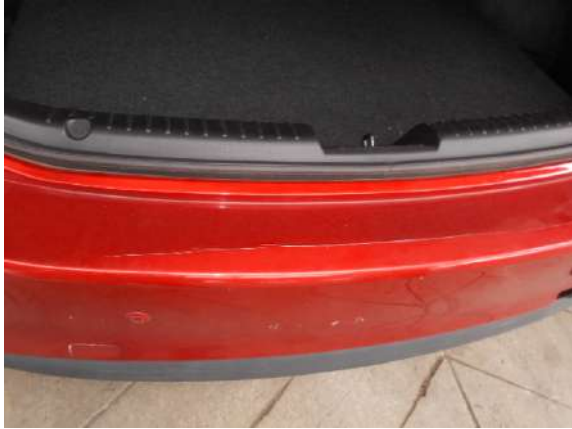
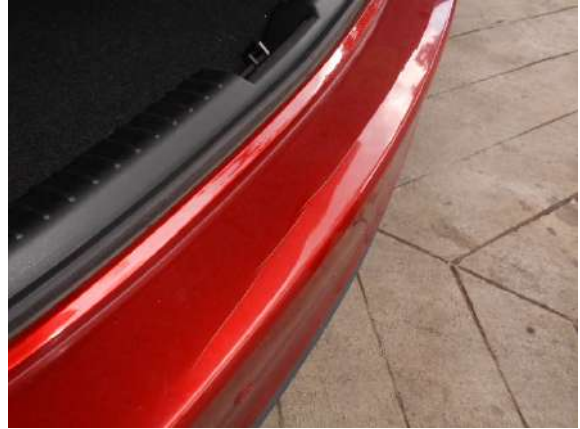
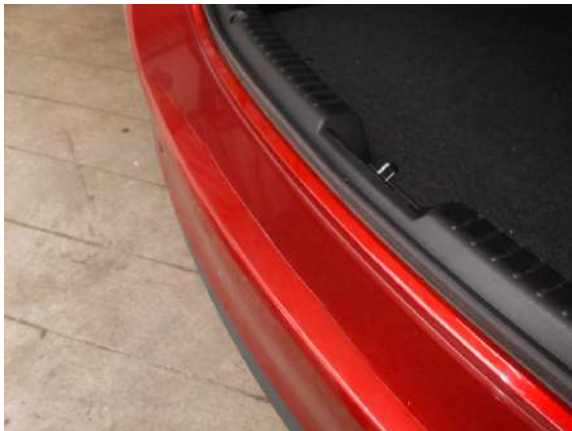
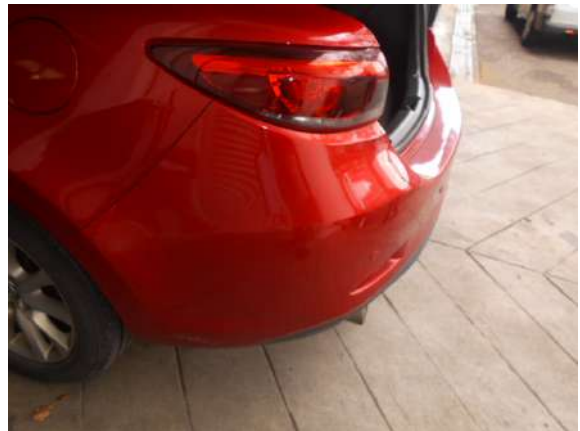
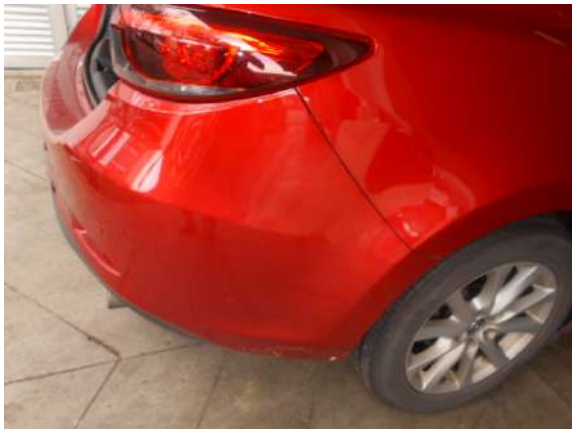
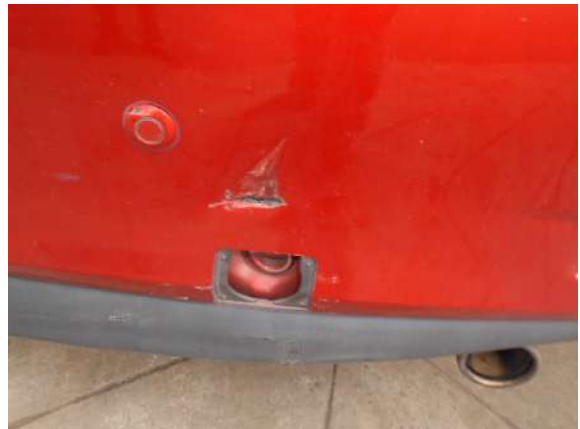
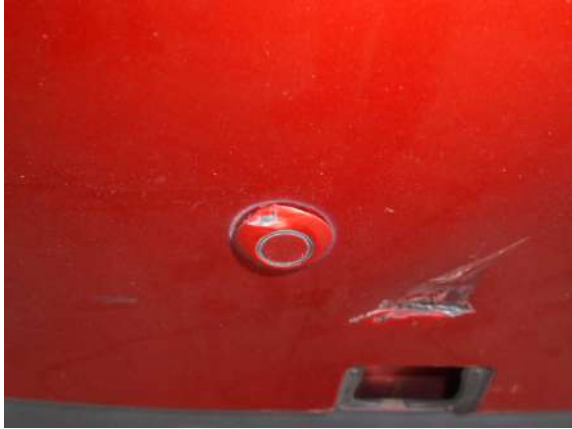
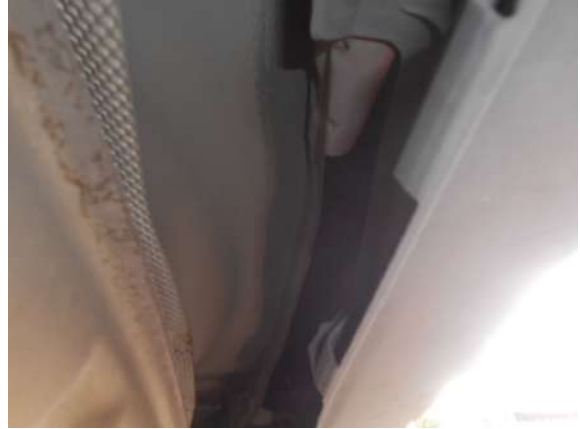
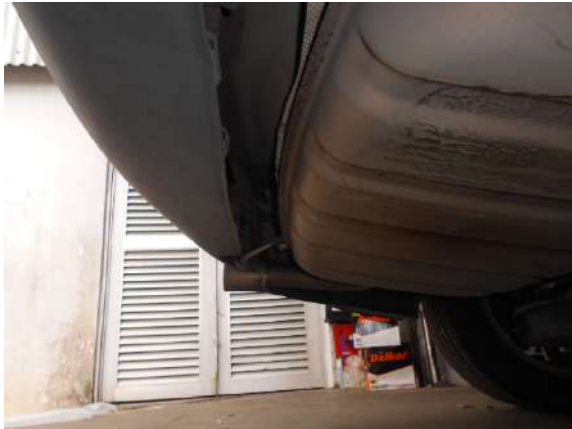
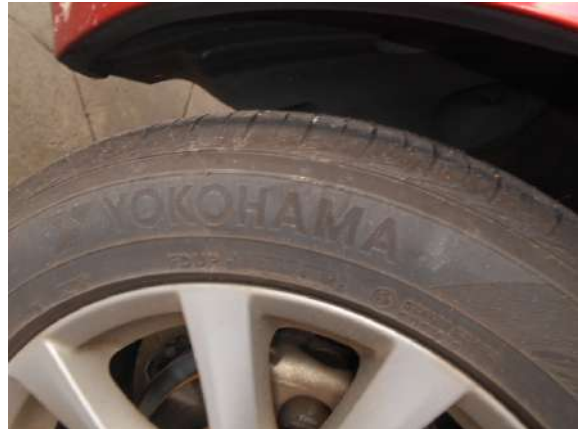
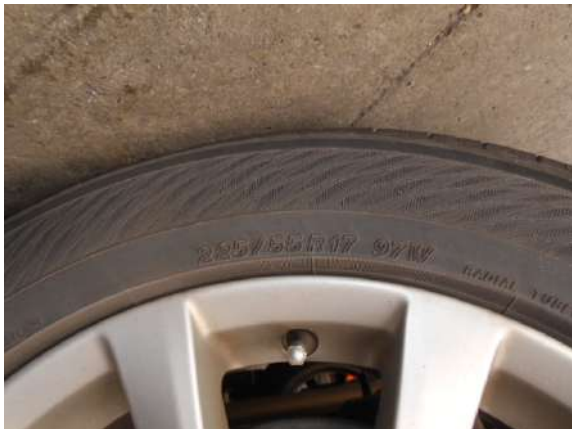
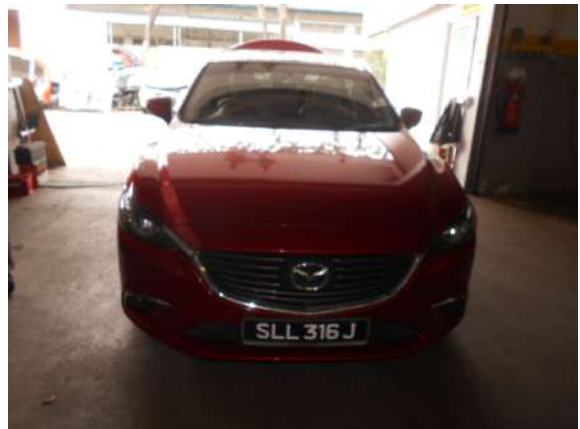
### INSPECTION

<b>4. Description of Damages</b>				
THE VEHICLE SUSTAINED DAMAGES AT THE REAR PORTION. DAMAGES SEE DETAILS.				
<b>5. General Information</b>				
Accident Date	05/08/2021	Inspection Date	11/08/2021	
Survey held at	15 FAN YONG ROAD			
Repairer	MOVA AUTOMOTIVE PTE LTD			
<b>5a. Remarks</b>				
A)THE INSPECTION WAS CONDUCTED ON A"WITHOUT PREJUDICE" BASIS. B)IN ACCORDANCE TO YOUR INSTRUCTIONS, WE HAVE NOT AUTHORISED REPAIRS.				
<b>5b. Estimate Days of Repair</b>				
ESTIMATED NORMAL PERIOD FOR REPAIR:			<b>3 Working Days</b>
