Your Ref: SHD 1615D
Our Ref : CI/TP21008325/D

INSPECTION REPORT OF A MOTOR TAXI SHD 1615D

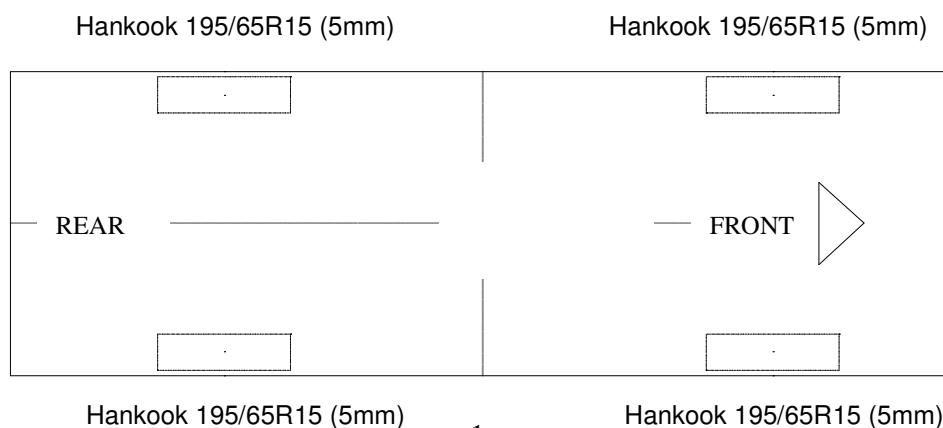
4. It was fitted with 15inch wheel rims that were wrapped with tyres that were observed to be of serviceable condition. The tyres were also sufficiently inflated for vehicular operation. The tyre brand, tyre size and approximate remaining tread depth of the 4 tyres of the motor taxi were recorded as follows: -
