Your Ref: S1M03EQ6
Our Ref : CS4/ASM21008377/N

16 August 2021

**TECHNICAL INVESTIGATION REPORT OF FIRE INCIDENT INVOLVING THE
INSURED VEHICLE SMV 91S ON 24 JULY 2021**

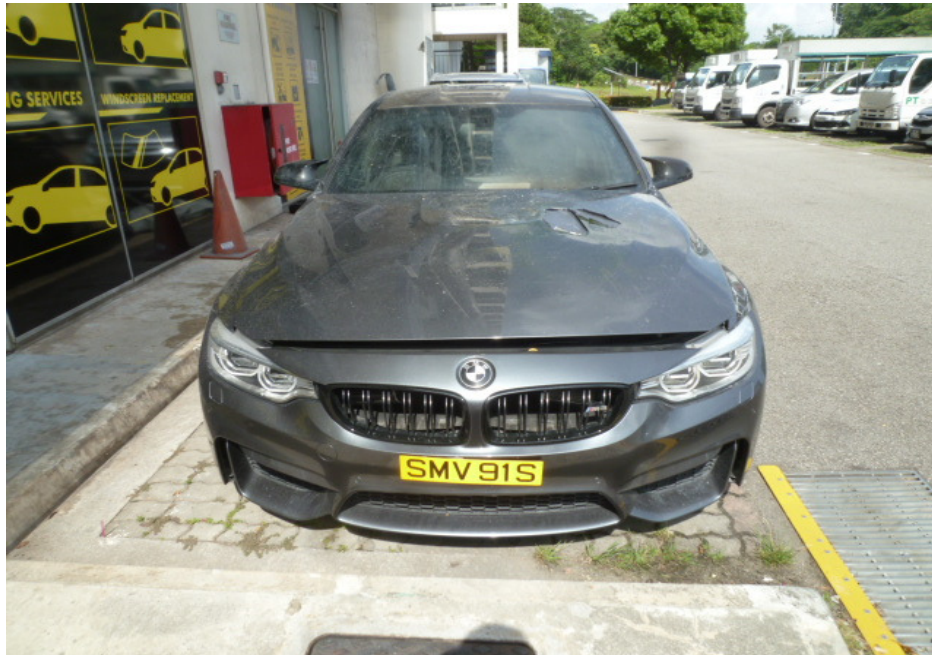
Photo 1 shows the general view of the frontal portion of the Insured Vehicle at the time of our inspection. The exterior body of the Insured Vehicle had sustained visible fire damage. This included its front windscreen and front bonnet.

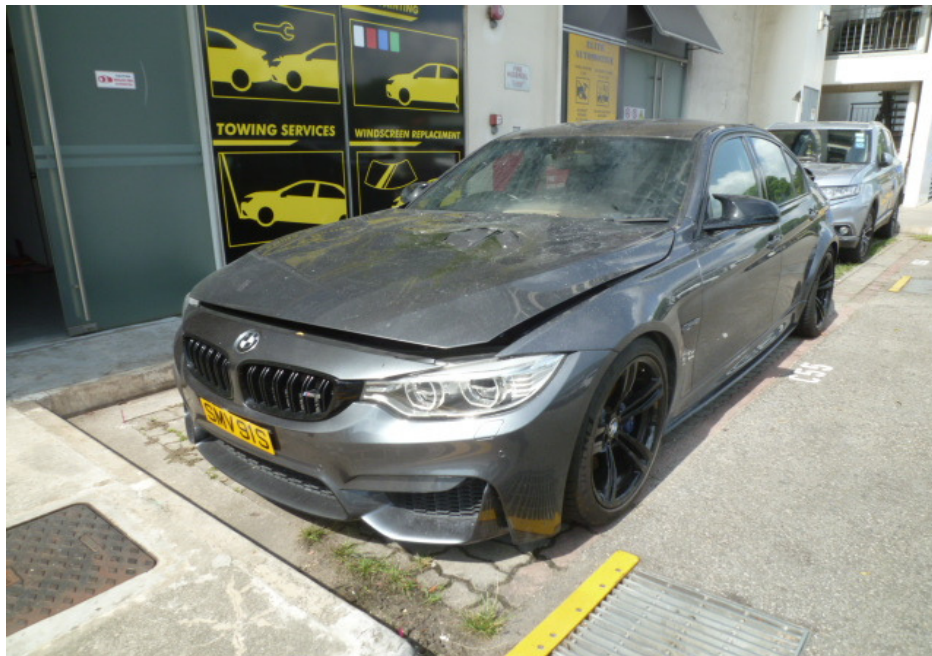
Photo 2 shows the general view of the left frontal portion of the Insured Vehicle at the time of our inspection. The exterior body of the Insured Vehicle had sustained visible fire damage. This included its front windscreen and front bonnet.

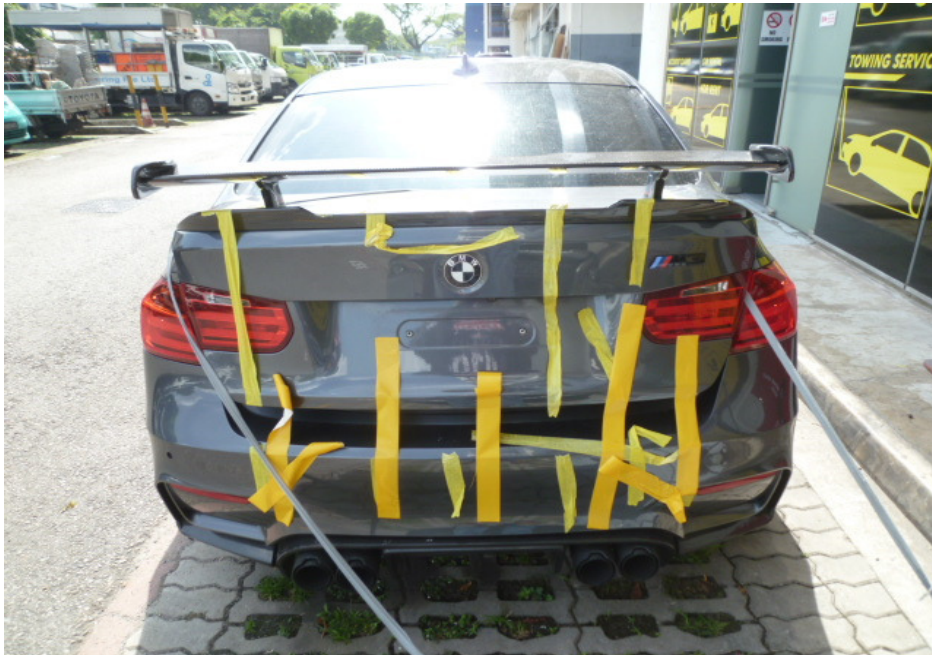
Photo 3 shows the general view of the rear portion of the Insured Vehicle at the time of our inspection. The fire damage was confined to its engine compartment. The rear portion of the Insured Vehicle was observed to be relatively unaffected by the fire.

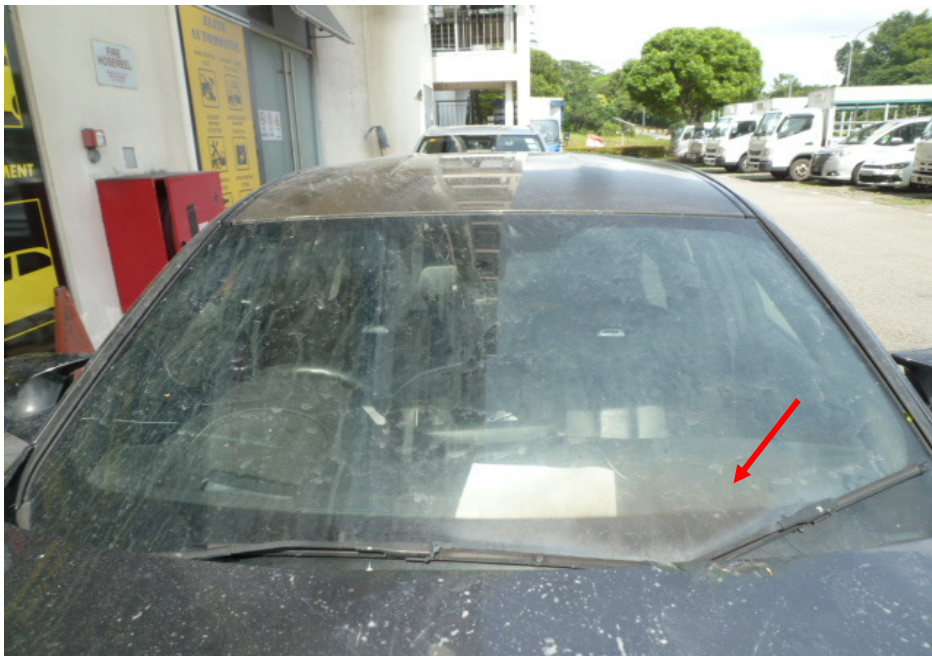
Photo 4 shows a closer view of the front windscreen of the Insured Vehicle at the time of our inspection. The front windscreen had sustained minor fire damage at the lower left portion (arrowed).

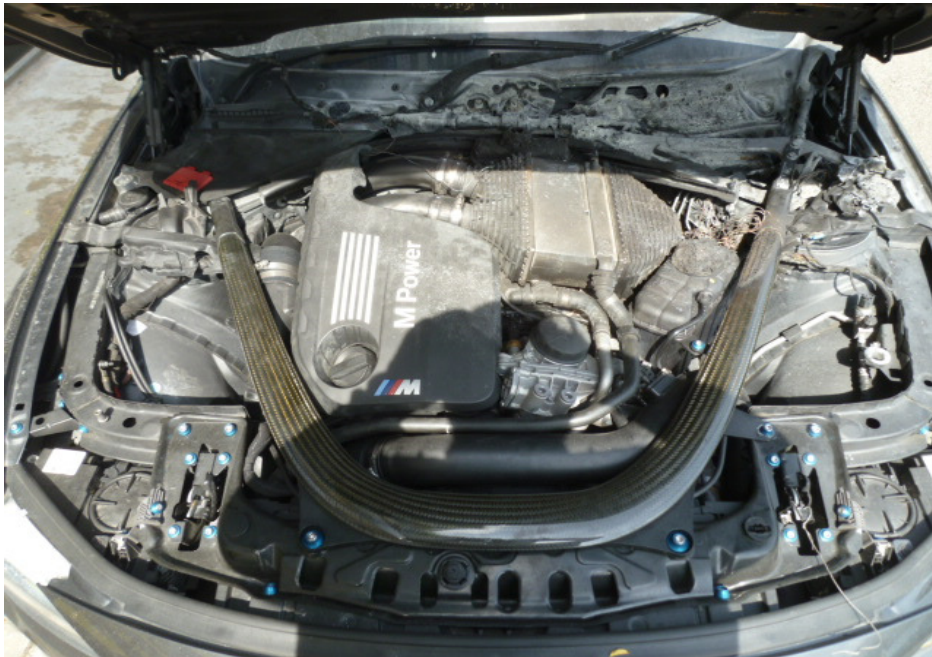
Photo 5 shows a general view of the engine compartment of the Insured Vehicle at the time of our inspection. Some of the components inside the engine compartment were found to be severely burnt and/or melted as a result of the fire.

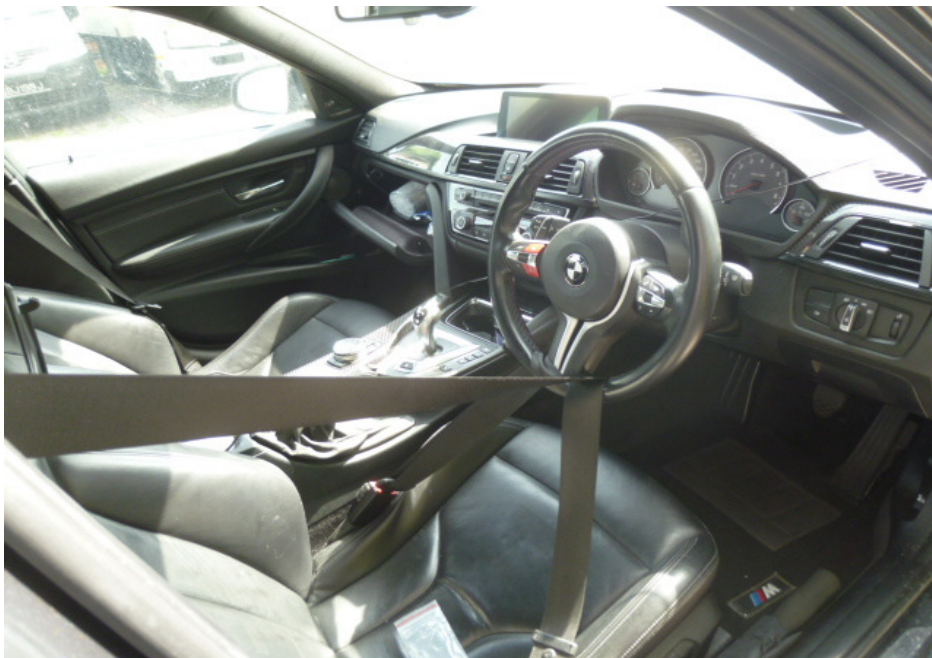
Photo 6 shows the interior compartment of the Insured Vehicle, which was observed to be relatively unaffected by the fire.

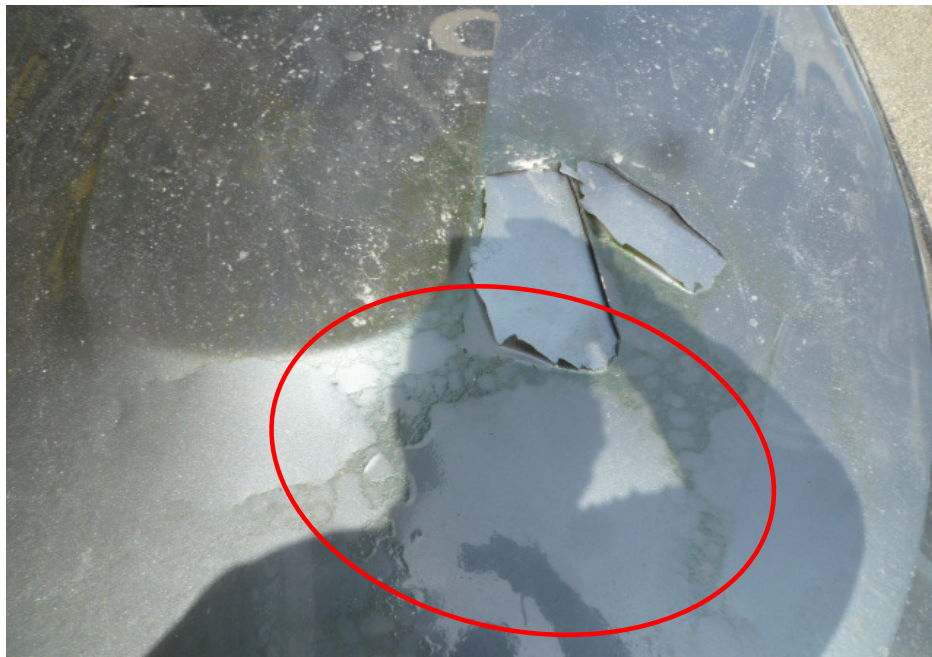
8. For this particular case, the fire appears to have originated within the engine compartment of the Insured Vehicle, somewhere around the rear left portion of the engine compartment. A closer examination revealed faint whitish burn marks on the bottom left portion on the underside of the bonnet due to prolonged exposure to high heat intensity. We also observed paint bubbles on the rear left portion of the front bonnet. In general the location of the fires' origin was determined given that the damage of fire nature was confined to these particular areas on the Insured Vehicle.

9. The whitish burn marks are a result of exposure to prolonged heat intensity. Rust would normally start to develop around these areas soon after a fire as prolonged exposure to high heat intensity usually causes steel/metal material body parts to be exposed to natural environmental condition. The rust that had developed on the underside of the front bonnet, around the rear left area, is an indication that the rear left portion of the engine compartment had sustained exposure to prolonged high heat intensity. See photos 7 & 8 below.

Photo 7 shows paint bubbles on the rear left portion of the front bonnet (circled).

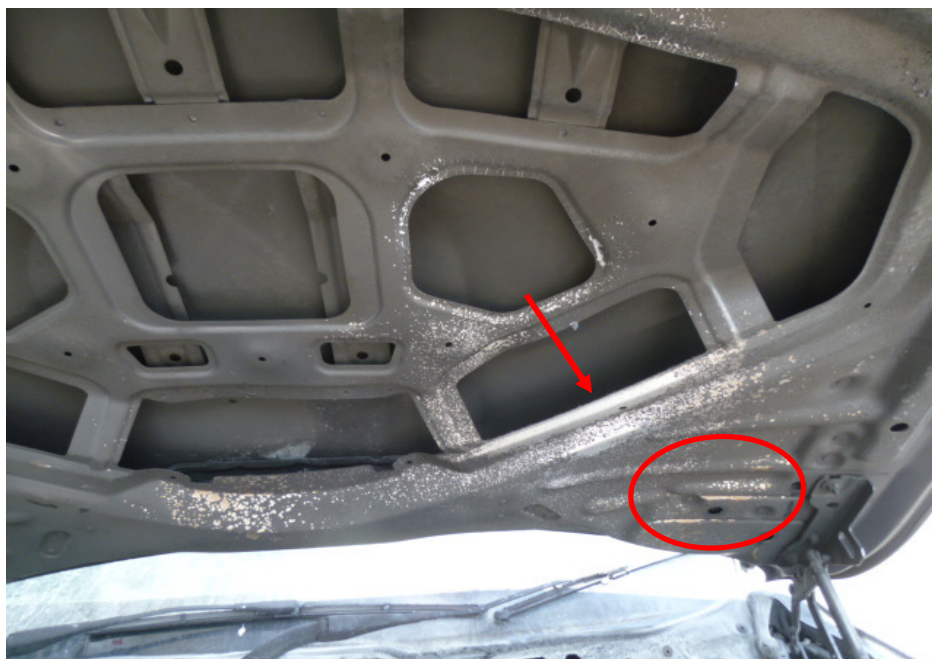
Photo 8 shows the faint whitish burn marks on the bottom left portion on the underside of the bonnet (arrowed) and the rust (circled) that had developed on the underside of the front bonnet, around the bottom left area. The development of rust is an indication that this area was exposed to prolonged exposure to high heat intensity, which had caused the steel/metal material of the front bonnet to be exposed to natural environmental condition. Hence the fire to the Insured Vehicle can be determined to have originated towards the rear left portion of the engine compartment.

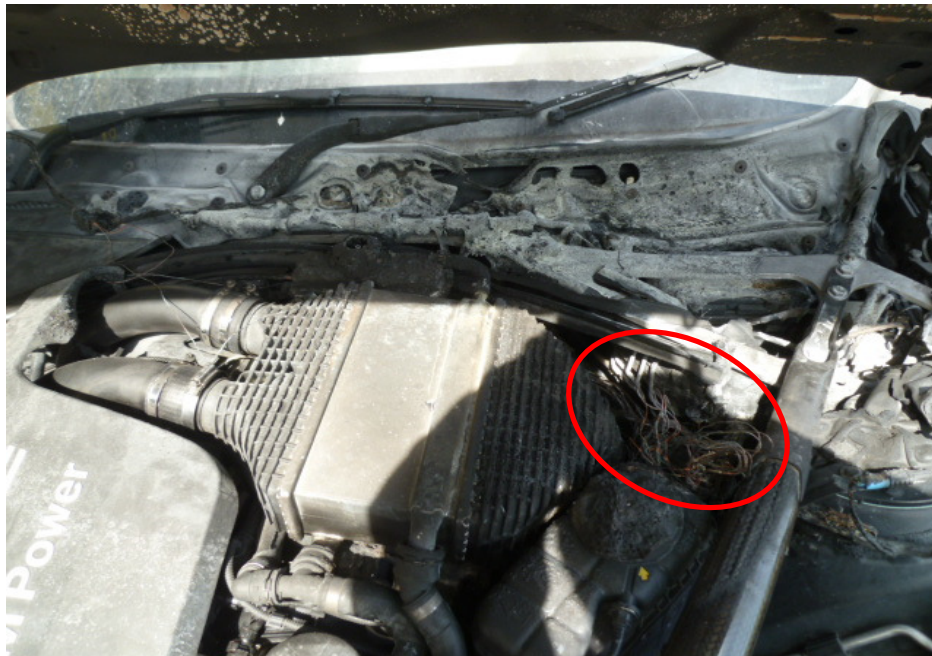
10. Upon closer examination of the rear left portion of the engine compartment, which was where the fire to the Insured Vehicle had likely started, we had found traces of greenish residue on several stretches of burnt wirings. The presence of greenish residue indicates internal heating of copper wires, a sign of an electrical short circuit occurring. The greenish residue is normally left behind from oxidation as a result of chemical reaction involving the copper wires. This physical evidence would then appear to suggest that the cause of fire to the Insured Vehicle could have possibly been due to electrical in nature. See photos 9 - 13 below.

Photo 9 shows the burnt wirings around the rear left portion of the engine compartment (circled), which is in the immediate vicinity where the fire to the Insured Vehicle had likely started.

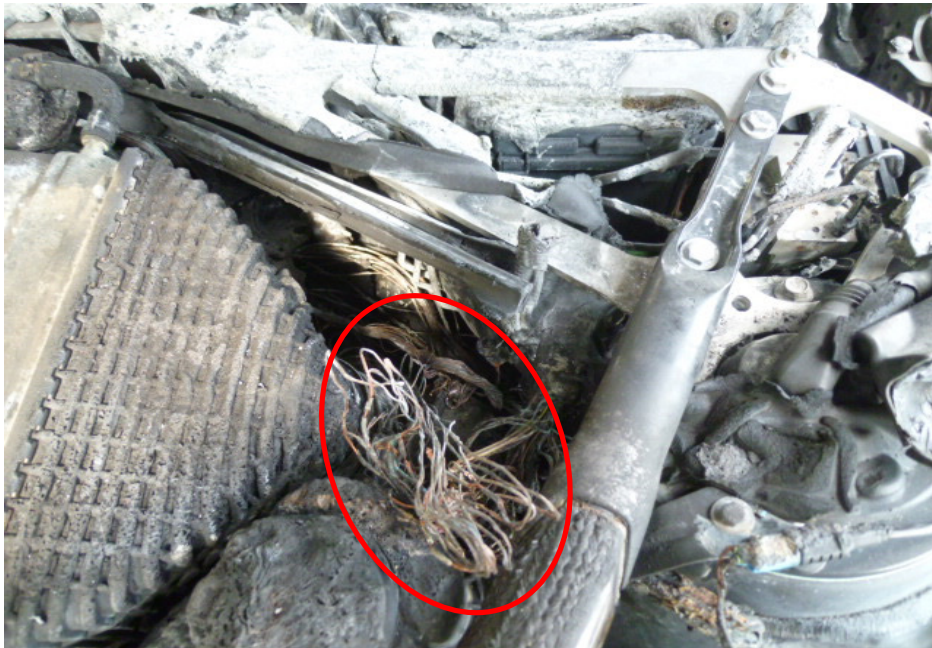
Photo 10 shows a closer view of the burnt wirings around the rear left portion of the engine compartment, which is in the immediate vicinity where the fire to the Insured Vehicle had likely started. We noticed greenish residue on several stretches of burnt wirings (circled). The presence of greenish residue indicates internal heating of copper wires, a sign of an electrical short circuit occurring. The greenish residue is normally left behind from oxidation as a result of chemical reaction involving the copper wires.

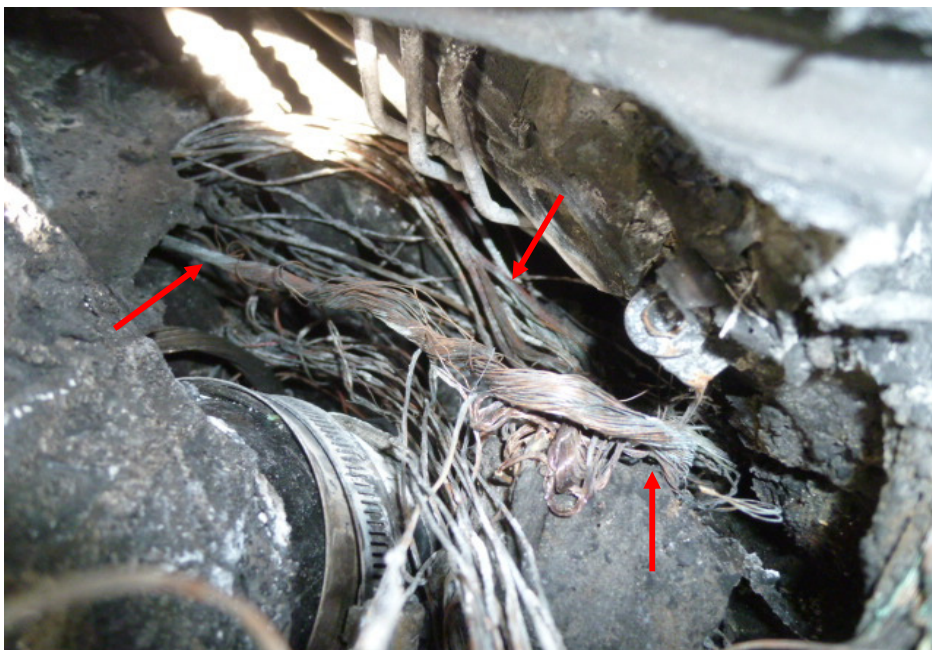
Photo 11 shows a close up view of the greenish residue found on several stretches of burnt wirings (red arrows). The presence of such greenish residue suggests occurrence of an electrical short circuit.

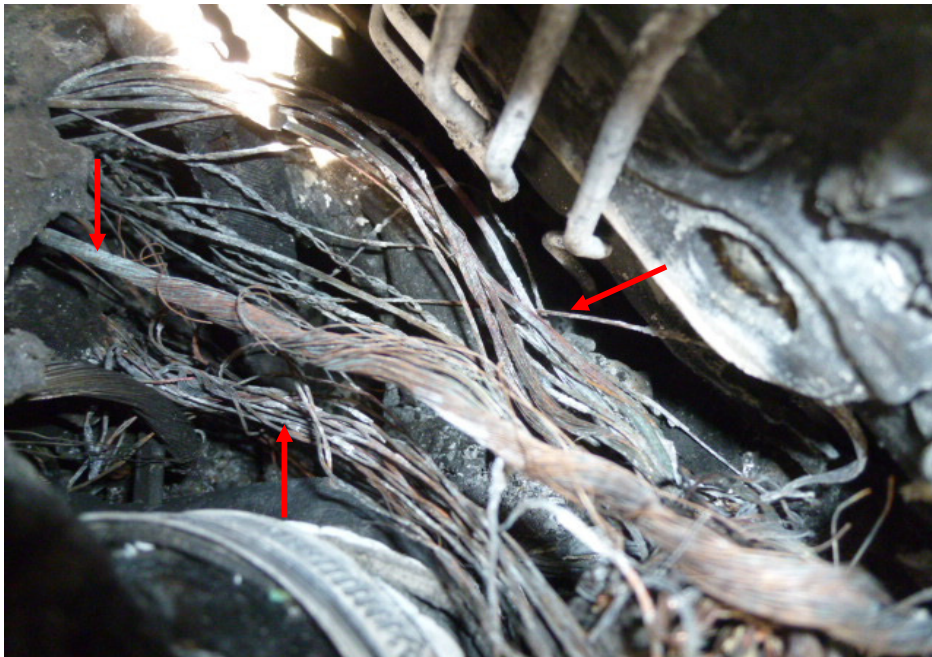
Photo 12 shows a close up view of the greenish residue found on several stretches of burnt wirings (red arrows). The presence of such greenish residue suggests occurrence of an electrical short circuit.

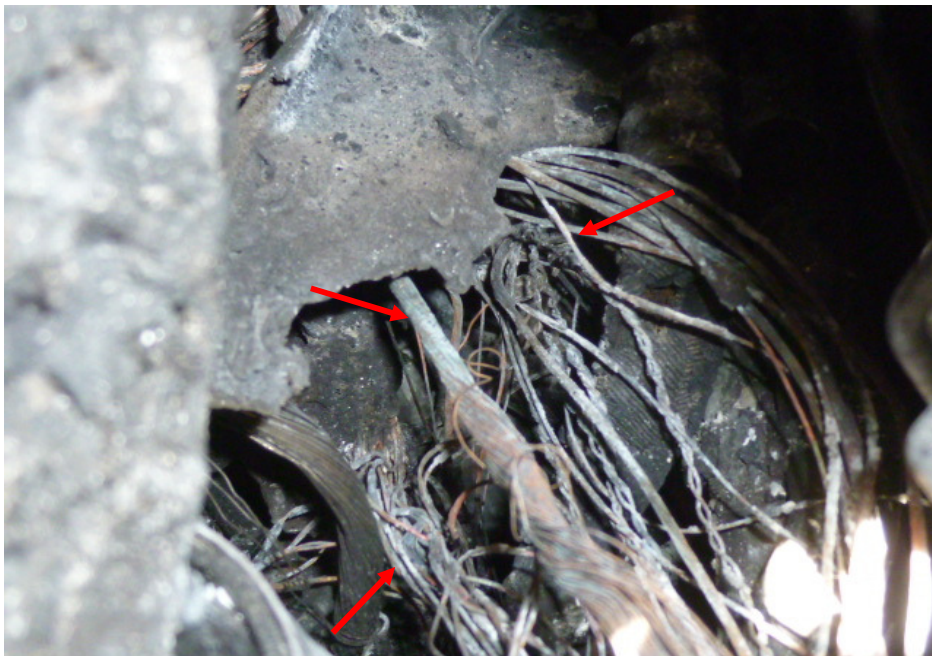
Photo 13 shows a close up view of the greenish residue found on several stretches of burnt wirings (red arrows). The presence of such greenish residue suggests occurrence of an electrical short circuit.
