Your Ref: TP/IP/36045/2021
Our Ref : CI/TPD21008396/P

11th August 2021

Fatal Accident Investigation Team

MECHANICAL INSPECTION REPORT OF MOTOR LORRY YQ 9063Z

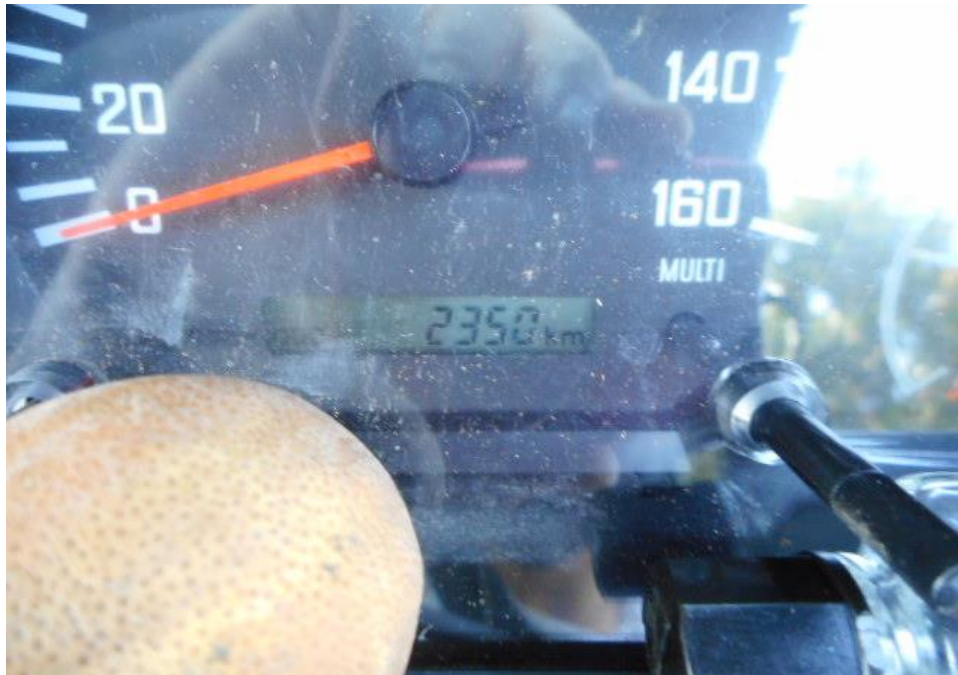
Photo 1 shows a general view of the instrument cluster of the Motor Lorry at the time of my inspection. The mileage of the Motor Lorry was 2,350 km

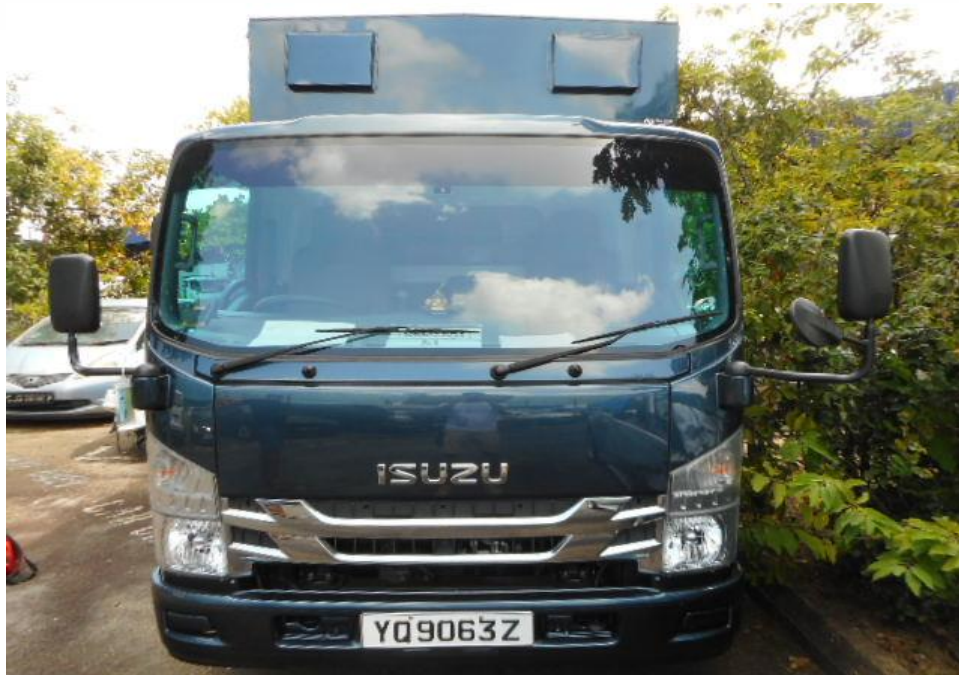
Photo 2 shows a general view of the Motor Lorry's frontal portion at the time of my inspection. The Motor Lorry was observed to be intact and unaffected by the accident.

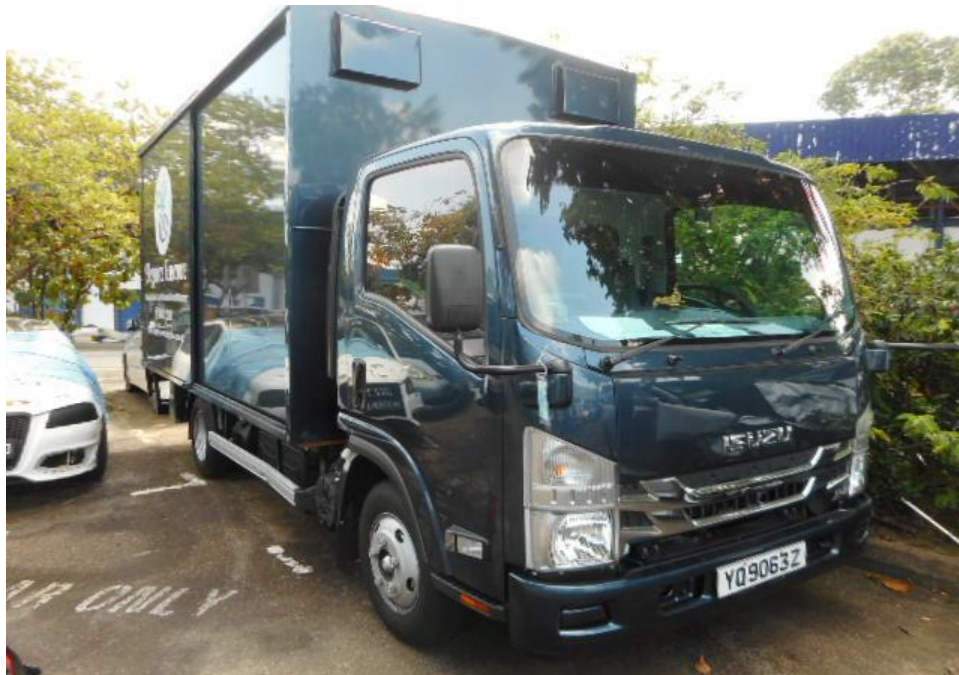
4. The mileage of the Motor Lorry at the time of my inspection was 2,350km.
5. The Motor Lorry was observed to sustained damage at its right portion. Its right body panel and right guard rail were damage at the time of my inspection as a result of the accident.

Photo 3 shows a general view of the Motor Lorry's right portion at the time of my inspection. It appeared to have sustained damage at its right portion. Its right body panel and right guard rail were damaged at the time of my inspection as a result of the accident.

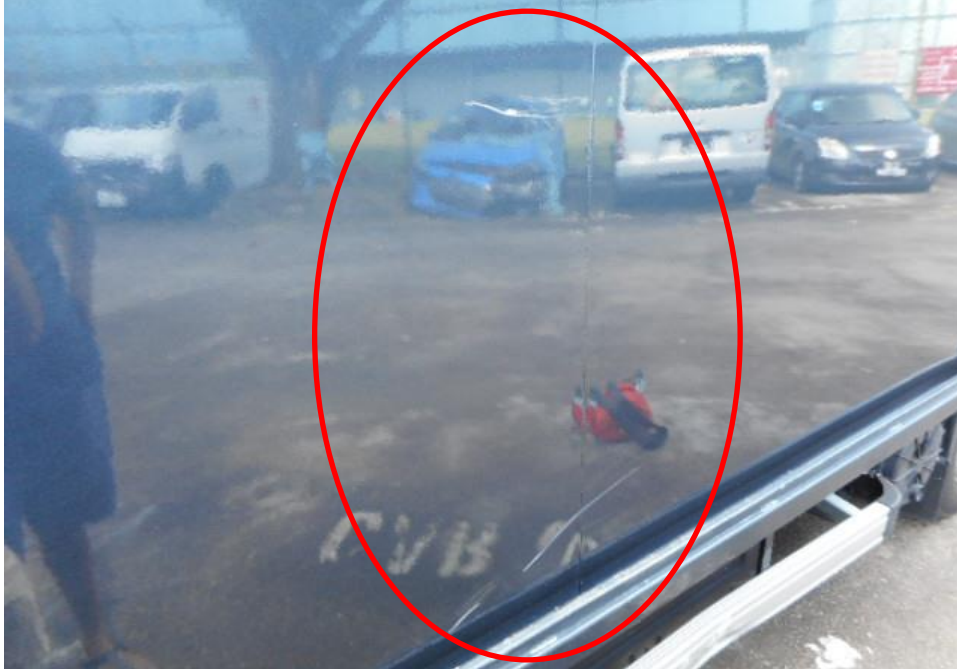
Photo 4 shows a close up view of the Motor Lorry's right portion at the time of my inspection. It appeared to have sustained damage at its right portion. Its right body panel (circled) were damage at the time of my inspection as a result of the accident.

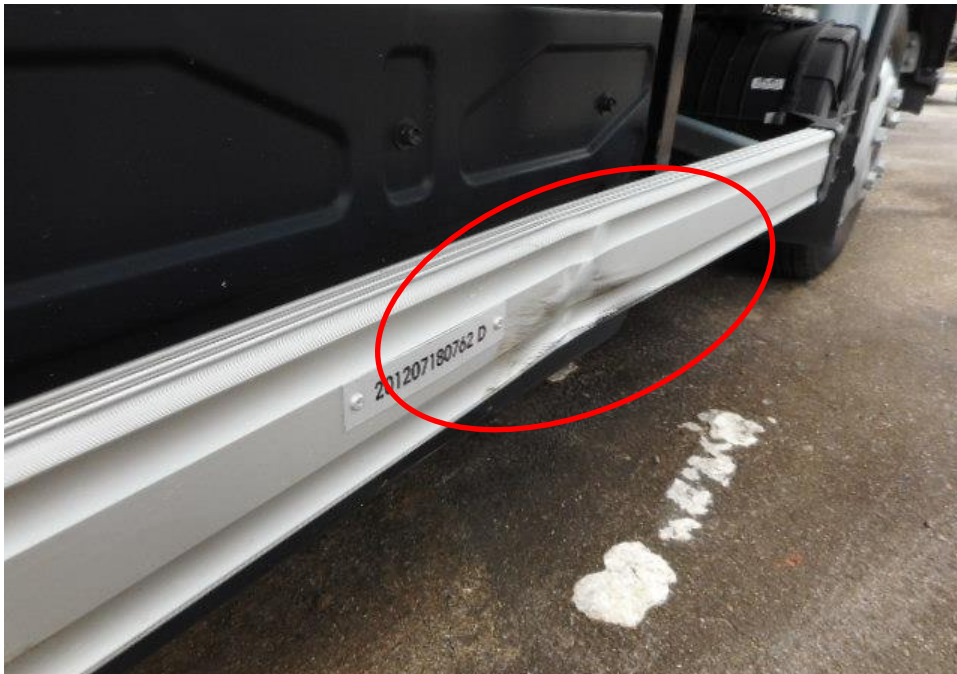
Photo 5 shows a close up view of the Motor Lorry's right portion at the time of my inspection. It appeared to have sustained damage at its right portion. Its right guard rail (circled) were damage at the time of my inspection as a result of the accident.

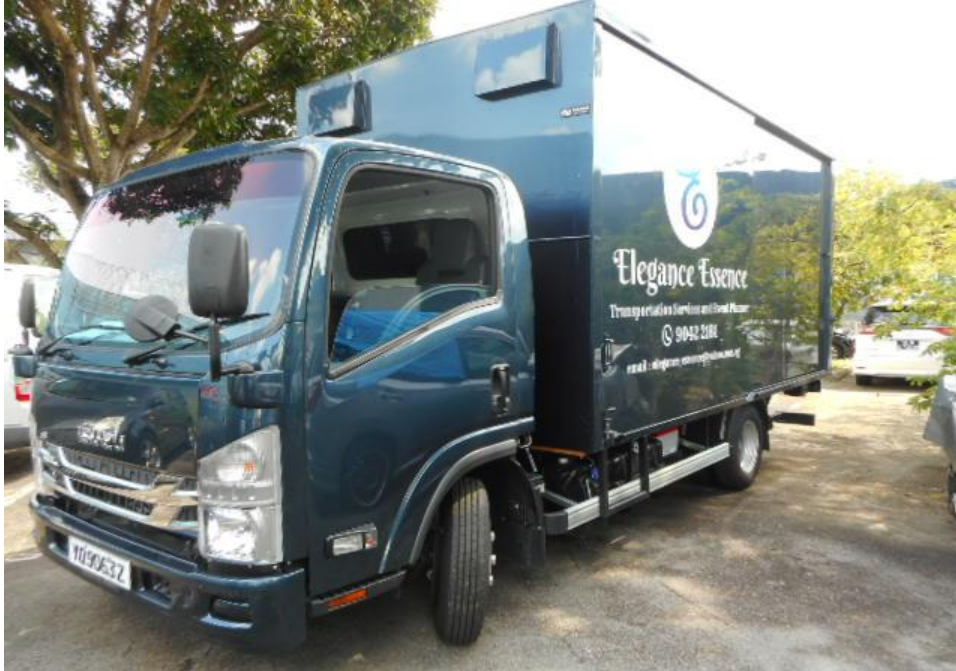
Photo 6 shows a general view of the left body of the Motor Lorry at the time of my inspection. The Motor Lorry was observed to be intact and unaffected by the accident.

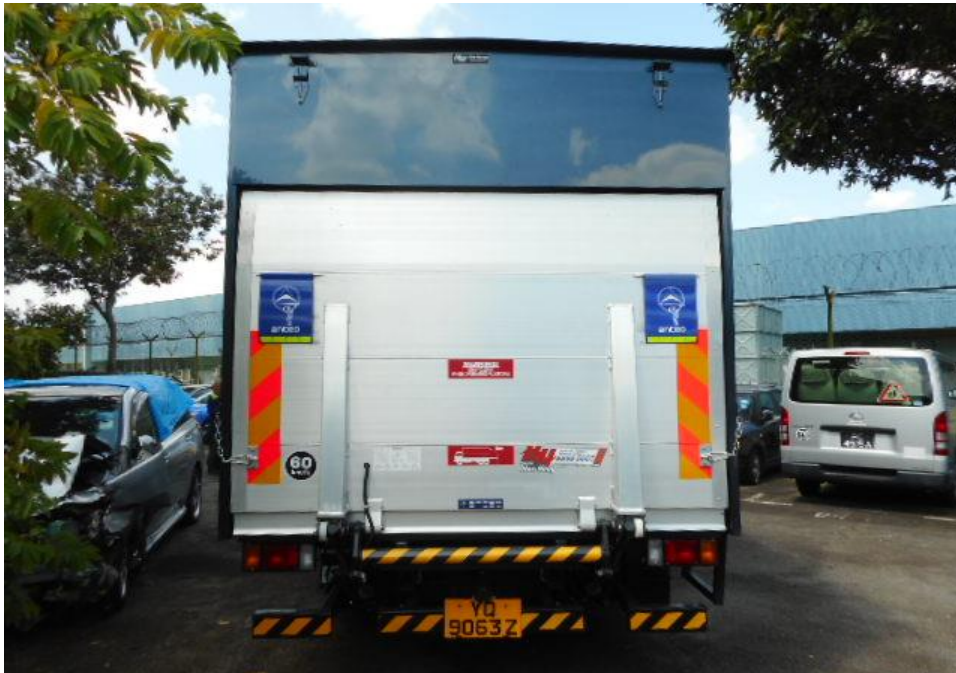
Photo 7 shows a general view of the rear body of the Motor Lorry at the time of my inspection. The Motor Lorry was observed to be intact and unaffected by the accident.

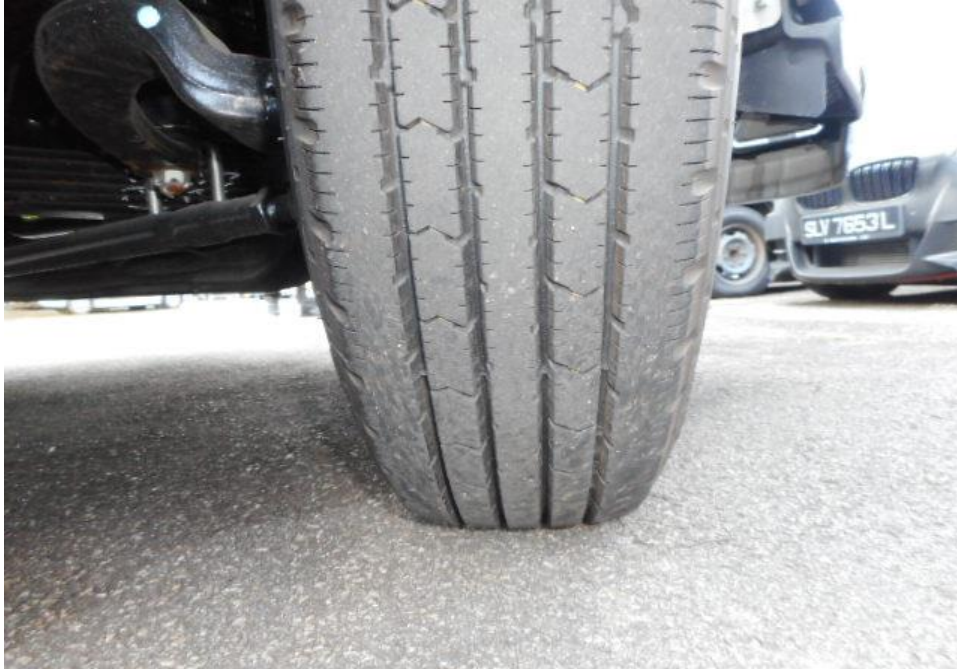
Photo 8 shows the condition of the front right tyre of the Motor Lorry, which was observed to be in serviceable condition with remaining tread depth of approximately 6.6mm. The tyre, which was wrapped around standard steel wheel rim, was also observed to be sufficiently inflated for vehicular operation. There was no tear, cut or burst mark(s) on the outer and the inner sidewalls as well as across the tread of the 6 tyres that were fitted on the Motor Lorry.

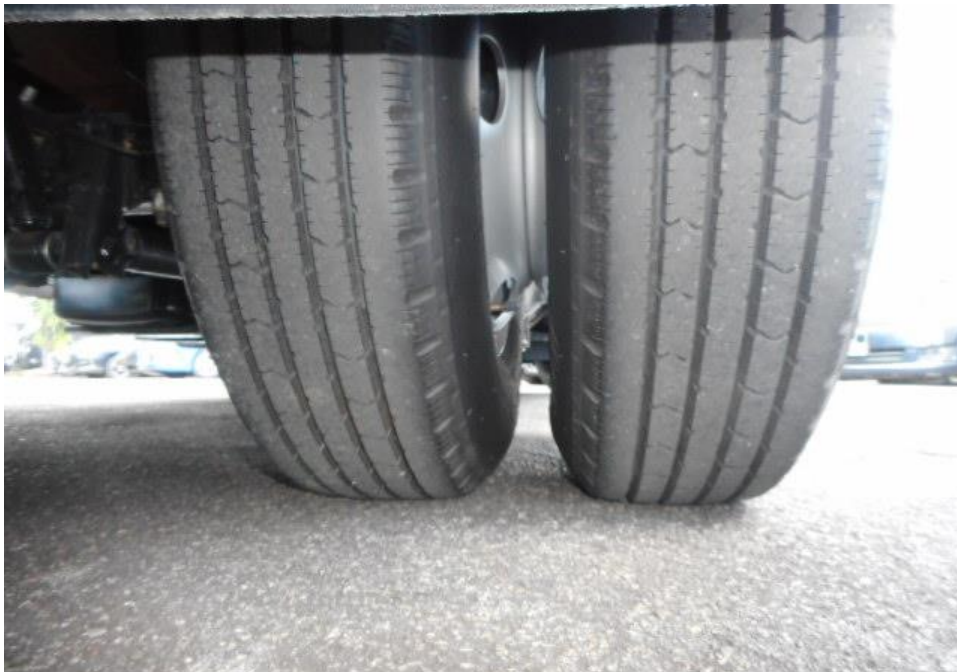
Photo 9 shows the condition of the rear right tyre of the Motor Lorry, which was observed to be in serviceable condition with remaining tread depth of approximately 7.3mm. The tyre, which was wrapped around standard steel wheel rim, it was observed to be sufficiently inflated for vehicular operation.

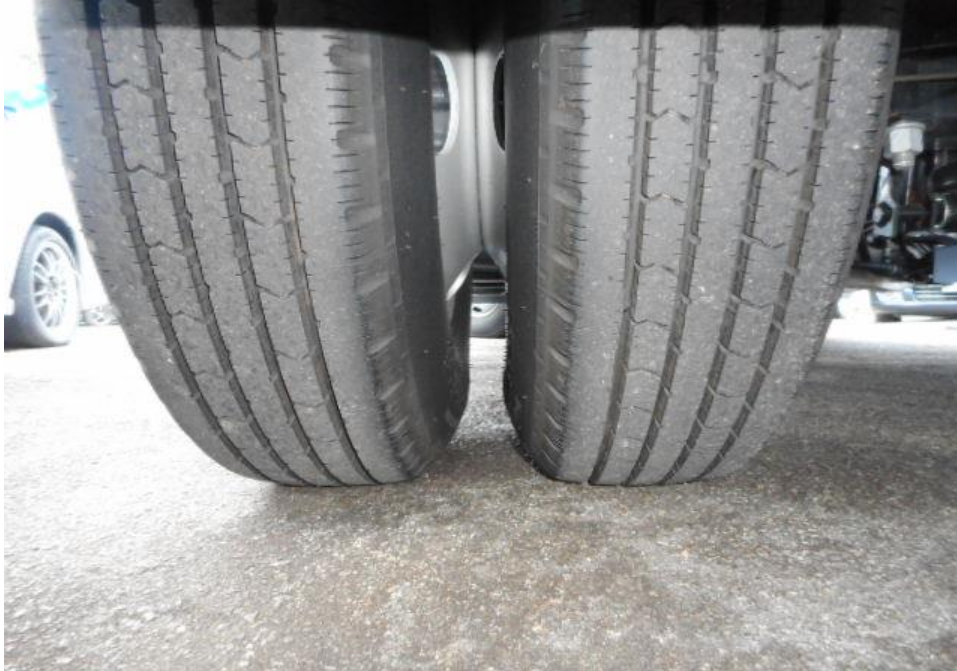
Photo 10 shows the condition of the rear left tyres of the Motor Lorry, which was observed to be in serviceable condition with remaining tread depth of approximately 7.8mm. The tyres, which were wrapped around standard steel wheel rim, were also observed to be sufficiently inflated for vehicular operation. There was also no damage found on all 6 steel wheel rims of the Motor Lorry.

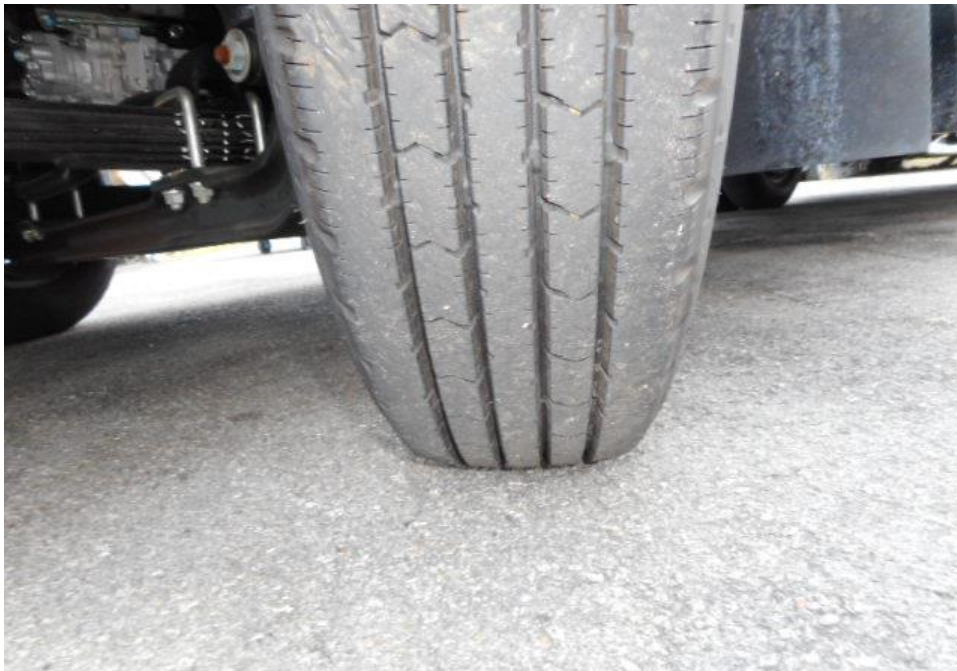
Photo 11 shows the condition of the rear right tyres of the Motor Lorry, which were observed to be in serviceable condition with remaining tread depth of approximately 6.7mm. There was also no tear, cut or burst mark(s) on the outer and the inner sidewalls as well as across the tread of the 6 tyres that were fitted on the Motor Lorry.

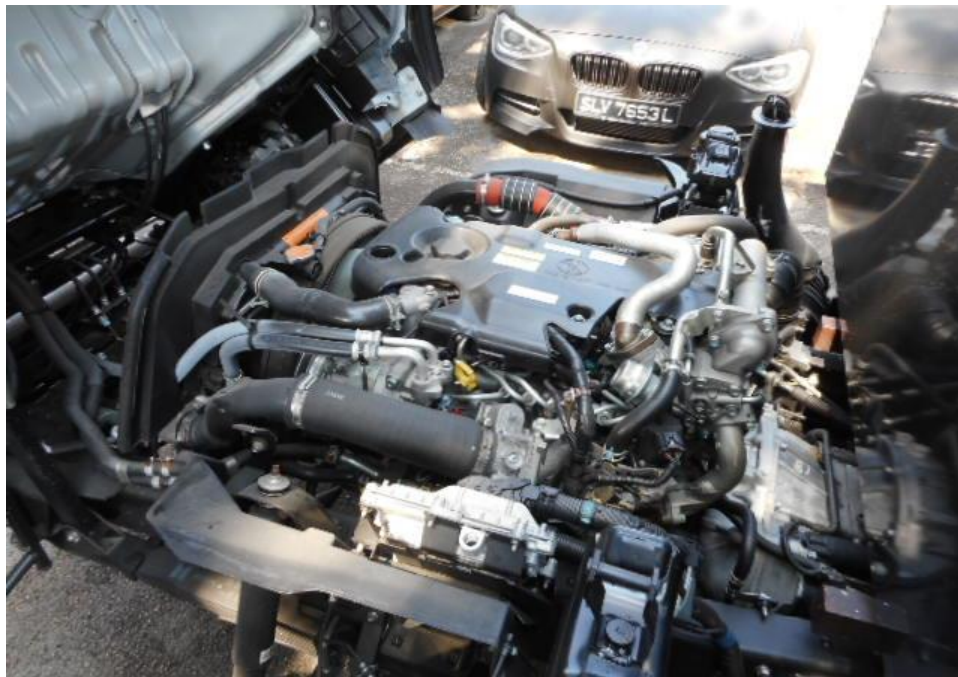
Photo 12 shows a general view of the Motor Lorry's engine compartment, which was accessed by lifting the front cabin of the Motor Lorry. The various parts and components inside the engine compartment were unaffected by the accident. There was also no sign(s) or indication(s) of fresh fluid leakage and/or fluid stain within the engine compartment

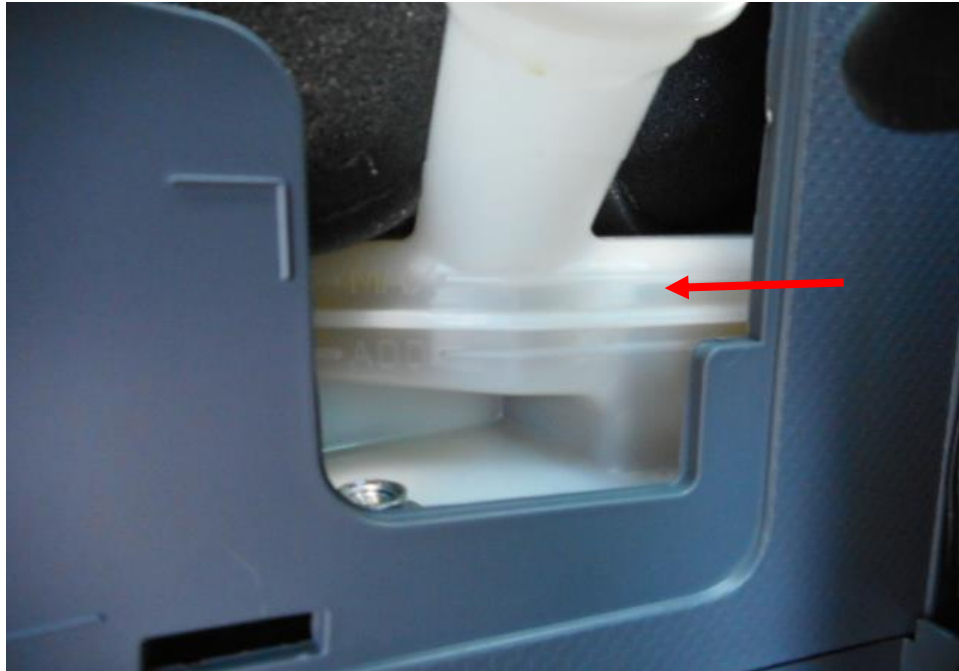
Photo 13 shows the brake fluid reservoir of the Motor Lorry at the time of my inspection. The brake fluid was observed to be of sufficient level (arrowed) and without any visible contamination.

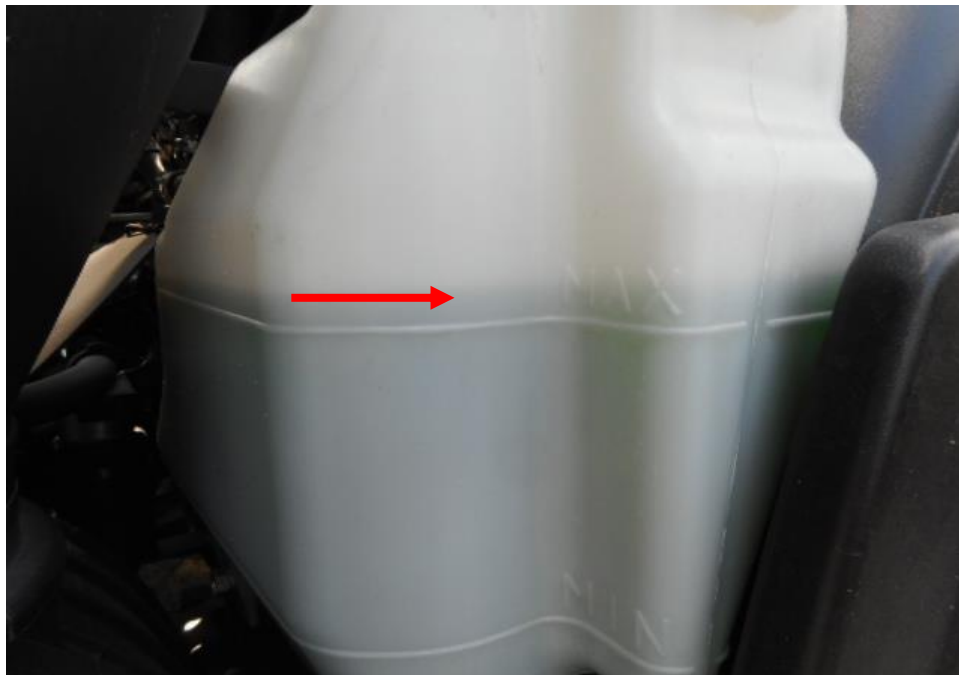
Photo 14 shows the engine coolant reservoir of the Motor Lorry at the time of my inspection. The engine coolant was observed to be of sufficient level (arrowed) and without any visible contamination.

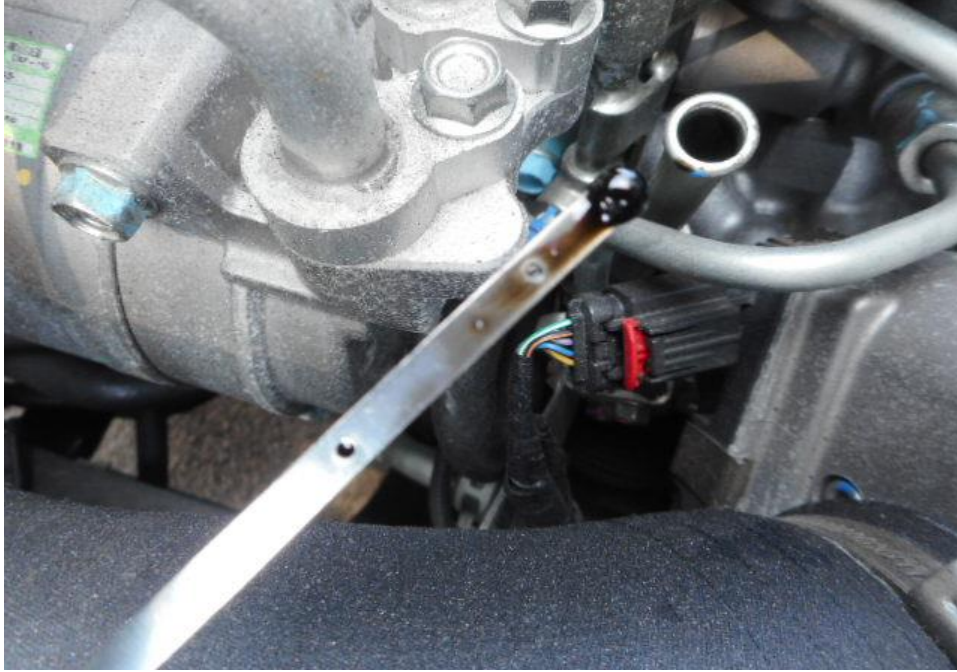
Photo 15 shows the engine oil dip stick of the Motor Lorry at the time of my inspection. The engine oil was observed to be of sufficient level and without any visible contamination.

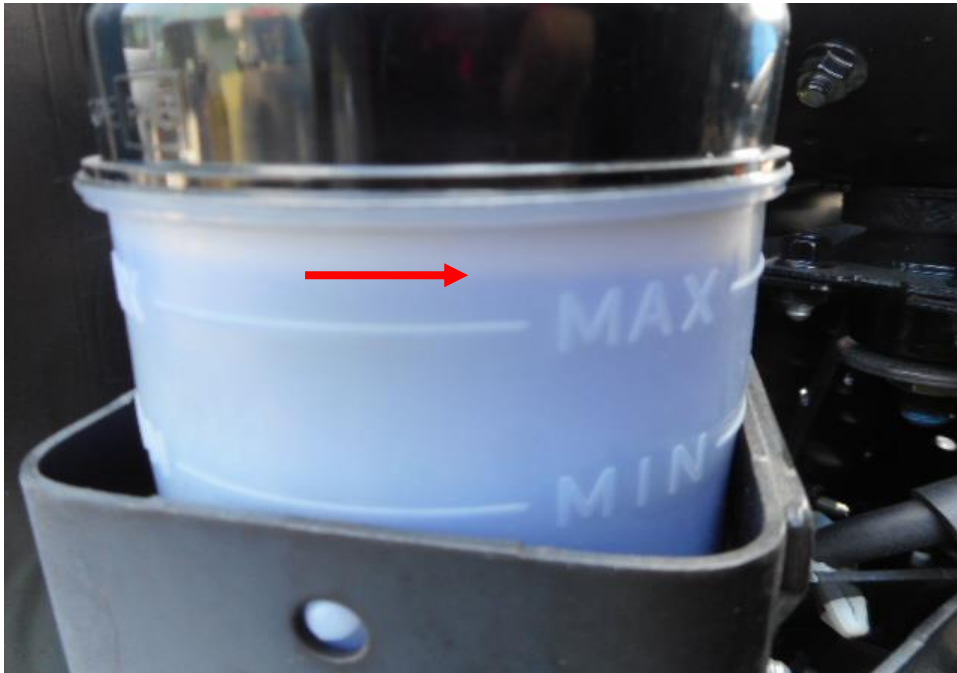
Photo 16 shows the power steering fluid reservoir of the Motor Lorry at the time of my inspection. The power steering fluid was observed to be of sufficient level (arrowed) and without any visible contamination.

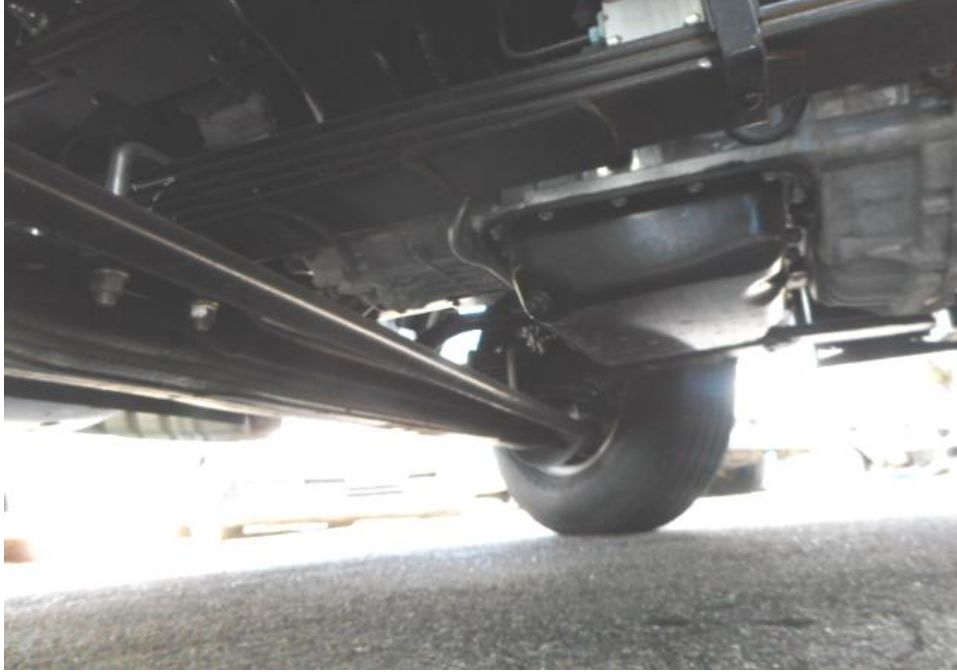
Photo 17 shows the undercarriage of the Motor Lorry, at the area where the engine housing and transmission housing are located. I did not find any sign(s) or indication(s) of fluid leak and/or fluid stain(s) on the underside of the Motor Lorry.

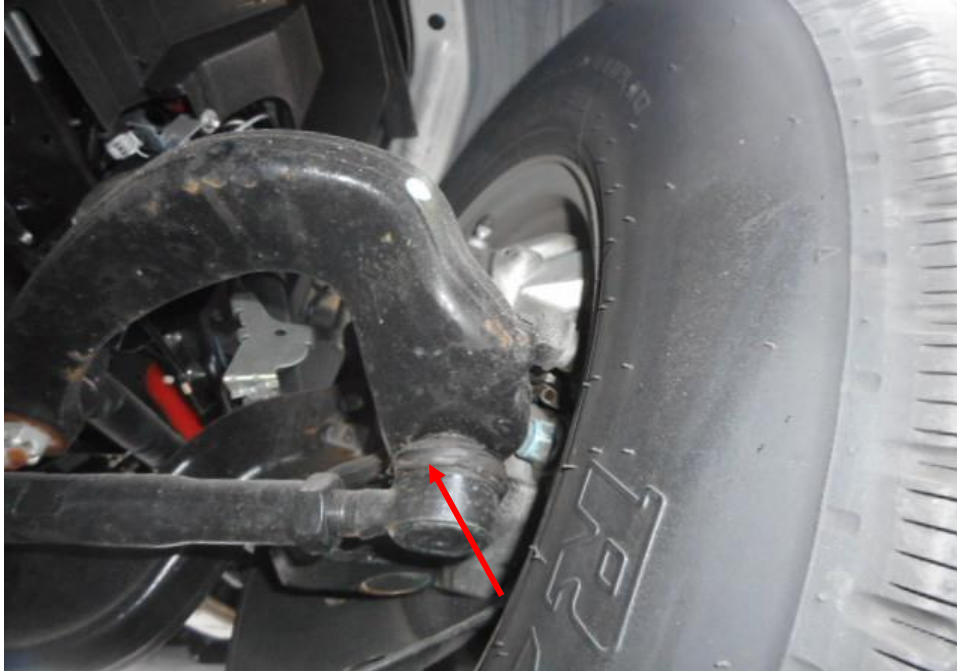
Photo 18 shows the various undercarriage components at the front right wheel of the Motor Lorry, in particular the steering tie rod end (arrowed). The various steering components were all found to be intact, suggesting that the steering system of the Motor Lorry was likely to be in serviceable condition at the material time of accident. There was also no sign of fluid stain(s) observed on the various undercarriage components.

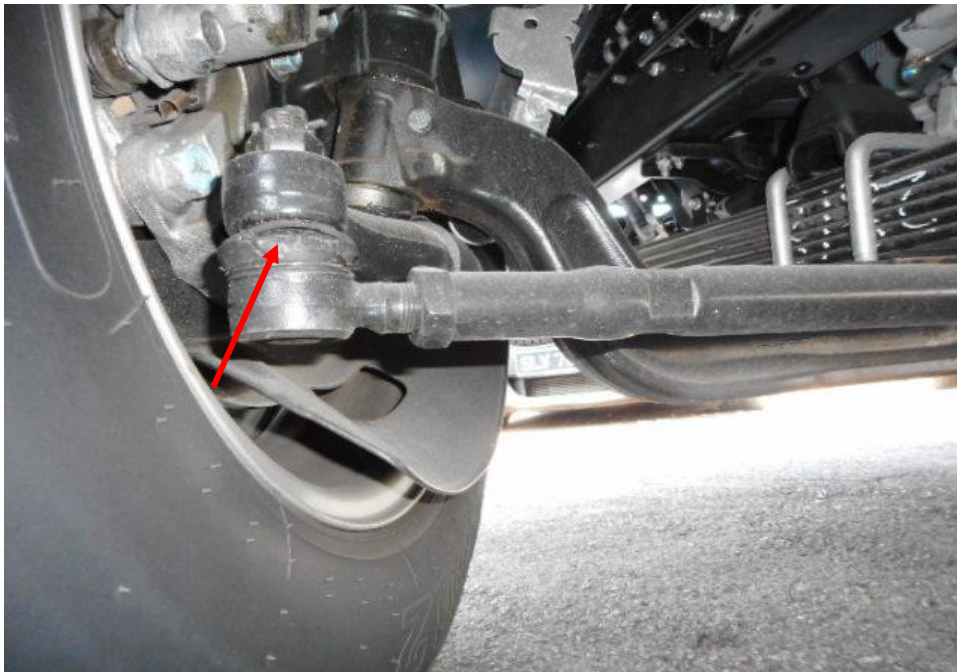
Photo 19 shows the various undercarriage components at the front left wheel of the Motor Lorry, in particular the steering tie rod end (arrowed). The various undercarriage components of the Motor Lorry were all found to be intact without any visible damage. There was also no sign of fluid stain(s) observed on the various undercarriage components.

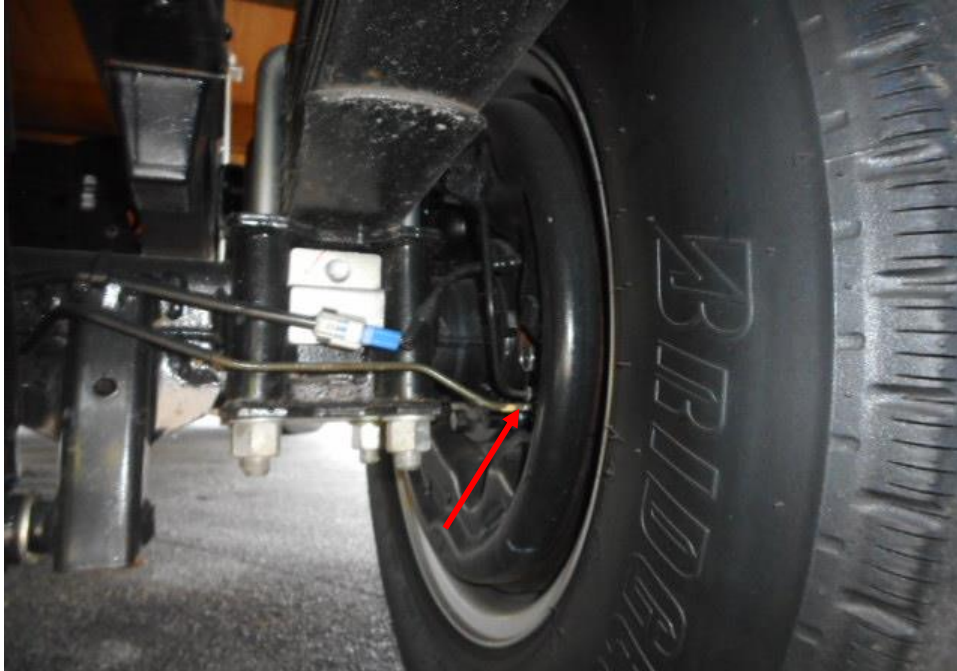
Photo 20 shows the brake pipe (arrowed) at the rear right wheel of the Motor Lorry. I did not observe any leakage of brake fluid at the time of my inspection of the Motor Lorry. My static tests of the Motor Lorry's braking system, along with my visual examination of the various mechanical components in the braking system, had indicated that there was no internal leakage of pressure/vacuum. Hence the braking system of the Motor Lorry was likely to be in serviceable condition at the material time of accident.

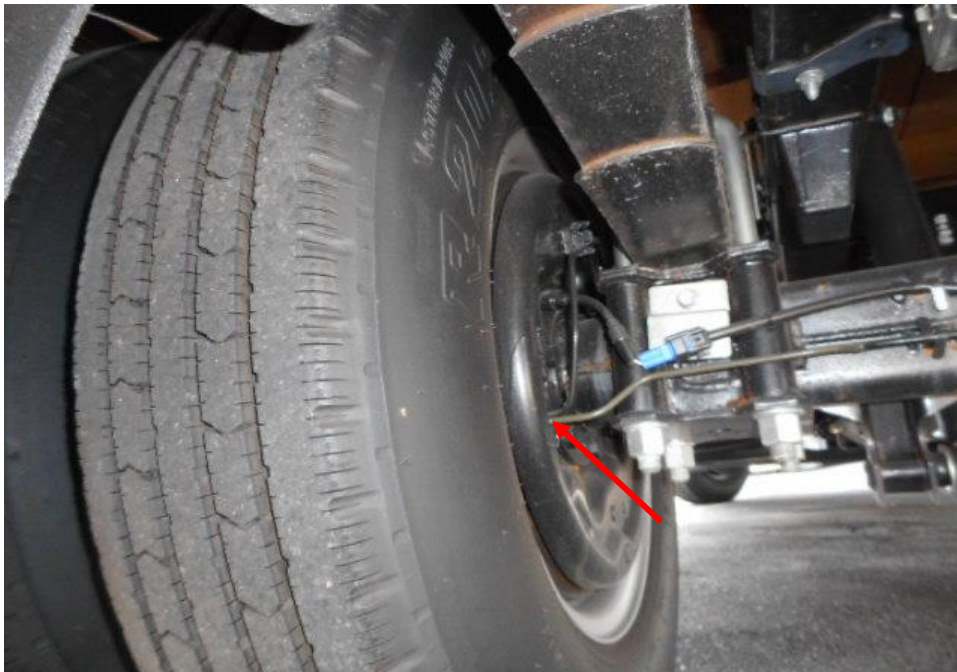
Photo 21 shows the brake pipe (arrowed) at the rear left wheel of the Motor Lorry. I did not observe any leakage of brake fluid at the time of my inspection of the Motor Lorry. My static tests of the Motor Lorry's braking system, along with my visual examination of the various mechanical components in the braking system had indicated that there was no internal leakage of pressure/vacuum. Hence the braking system of the Motor Lorry was likely to be in serviceable condition at the material time of accident.

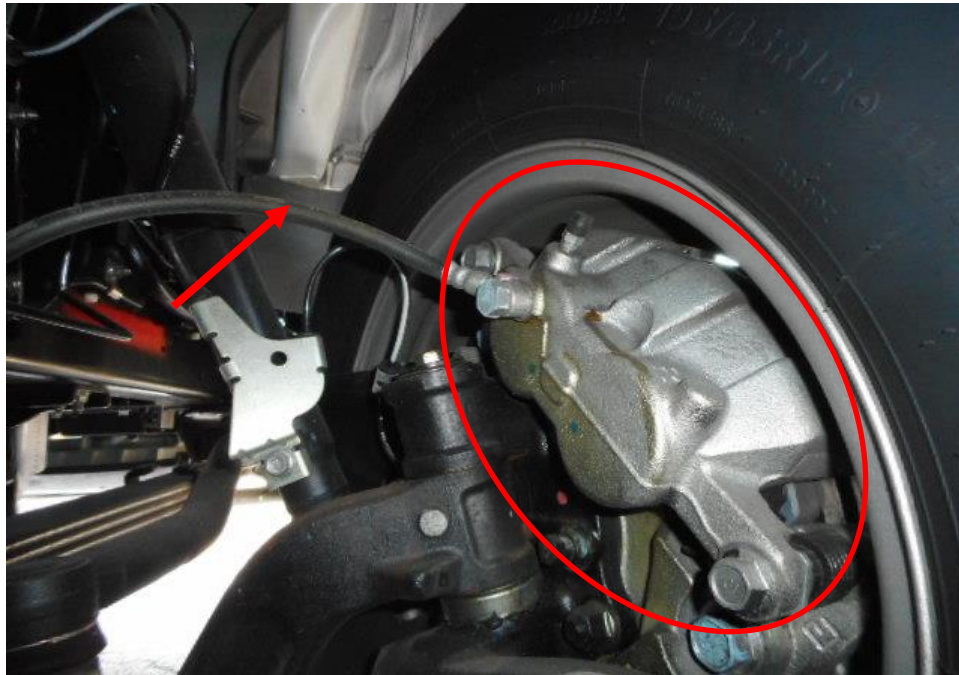
Photo 22 shows the brake hose/pipe (arrowed) at the front right wheel of the Motor Lorry. No leakage of brake fluid was observed. Visual examination of the various components of the braking system like the brake caliper (circled), brake booster, brake pedal etc had revealed all to be intact and without visible damage at the time of accident. There was also no sign of fluid stain(s) observed on the various undercarriage components.

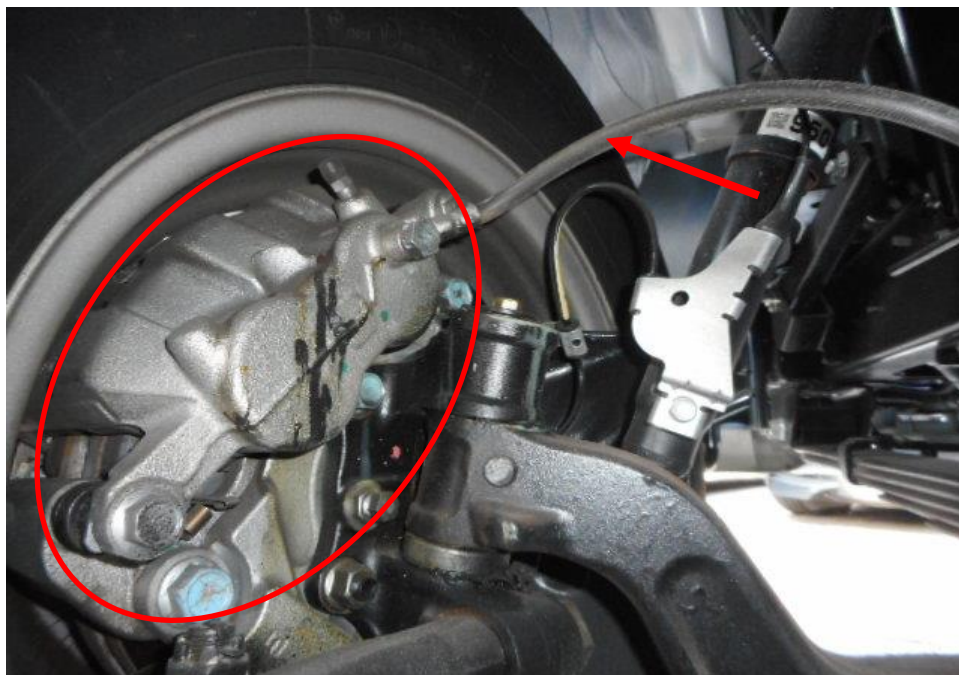
Photo 23 shows the brake hose/pipe (arrowed) at the front left wheel of the Motor Lorry. No leakage of brake fluid was observed. Visual examination of the various components of the braking system like the brake caliper (circled), brake booster, brake pedal etc had revealed all to be intact and without visible damage at the time of accident. There was also no sign of fluid stain(s) observed on the various undercarriage components.

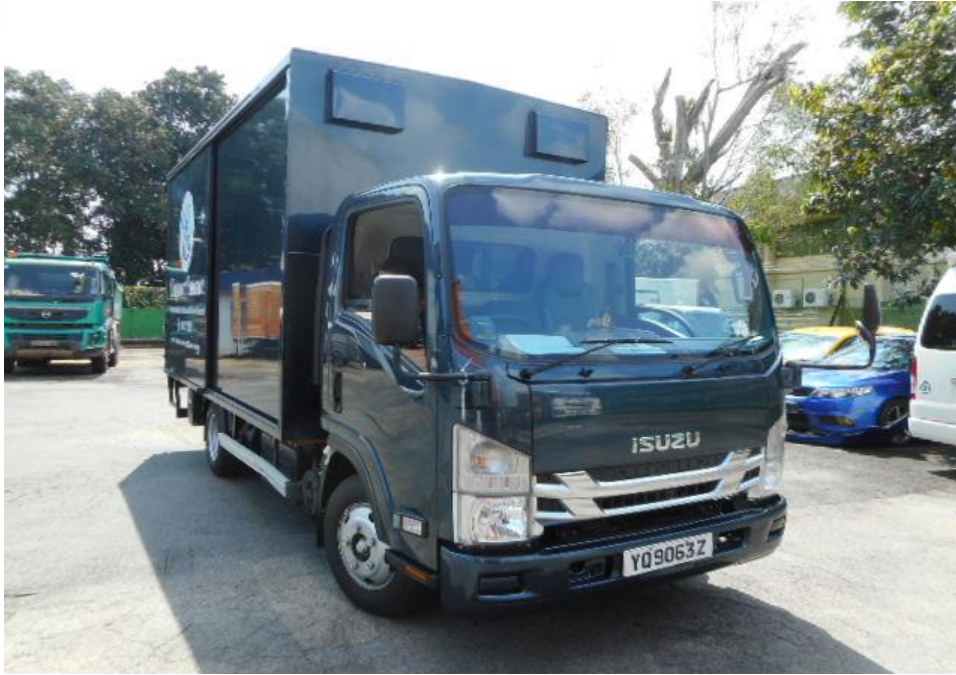
Photo 24 shows the front right wheel of the Motor Lorry turned to its full left. During my steering system test, I did not experience any abnormal free play and/or resistance when I had turned the steering wheel towards full left and full right. This would suggest that the steering system of the Motor Lorry was likely to be in serviceable condition at the material time of accident.

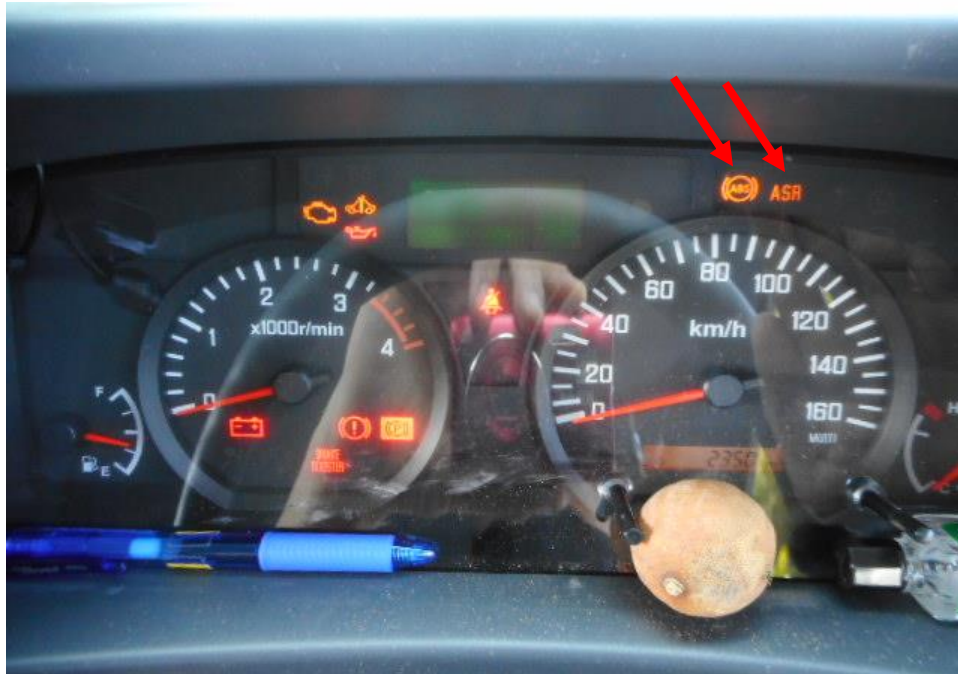
Photo 25 shows the warning light for Anti-Lock Brake System (ABS) and Traction Control System (TC) (arrowed) appearing on the instrument panel of the Motor Van during the self-test of its various electronic operating systems when its engine was cranked.

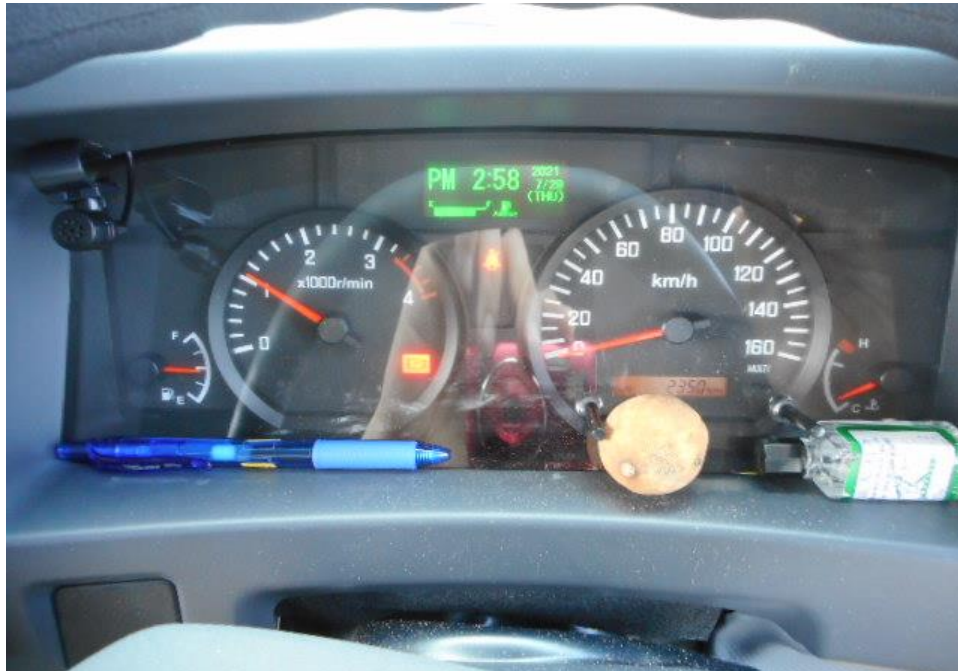
Photo 26 shows no warning lights illuminated on the instrument panel of the Motor Van after the engine was cranked. This would suggest that there was no abnormality to the electronic operating system of the Motor Van, like the ABS and TC etc.
