Your Ref : SMC 5193Z
Our Ref : CC4/AIG21008450/P

**AUTOMOBILE TECHNICAL INVESTIGATION REPORT OF ACCIDENT
INVOLVING SMC 5193Z AND SMG 2733P ON 28 July 2021**

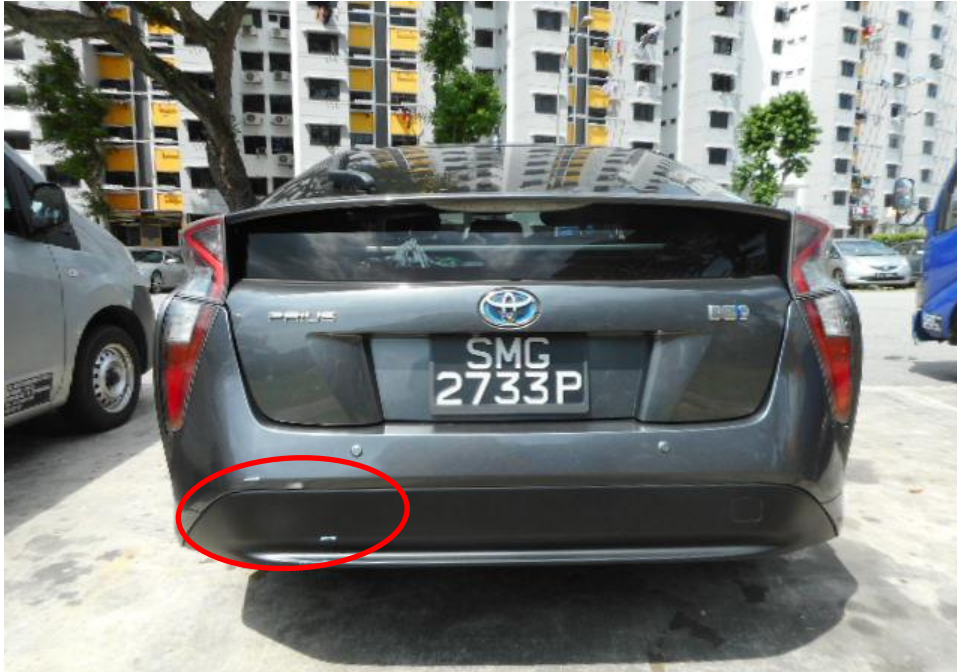
Photo 1 shows the general view of the rear portion of Toyota at the time of inspection. The rear bumper (circled) had been damaged.

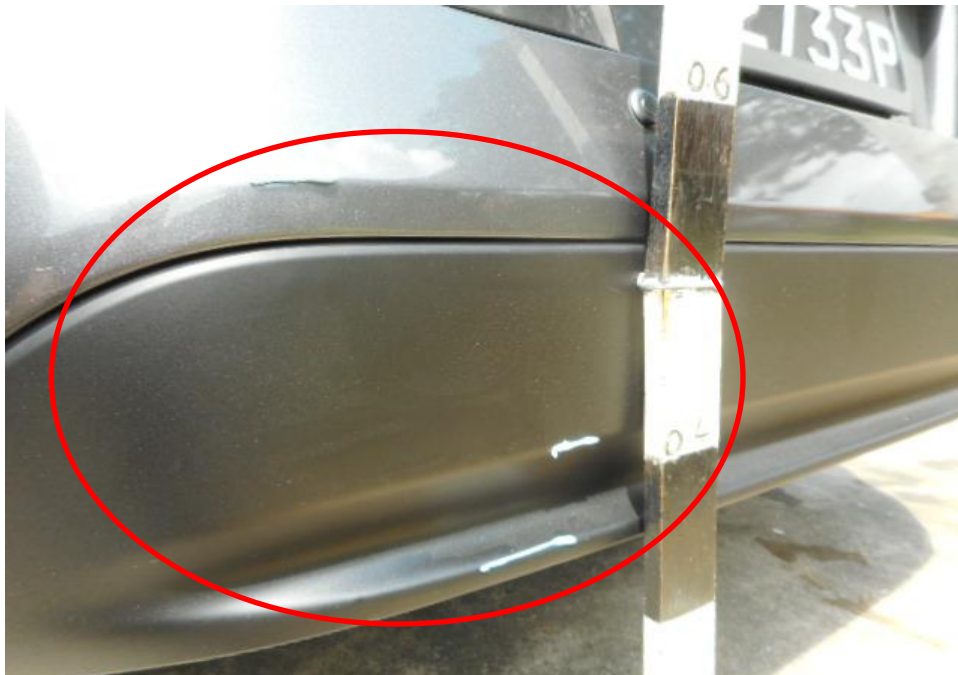
Photo 2 shows the close up view of the rear left portion of Toyota at the time of inspection. The rear bumper (circled) had been damaged.

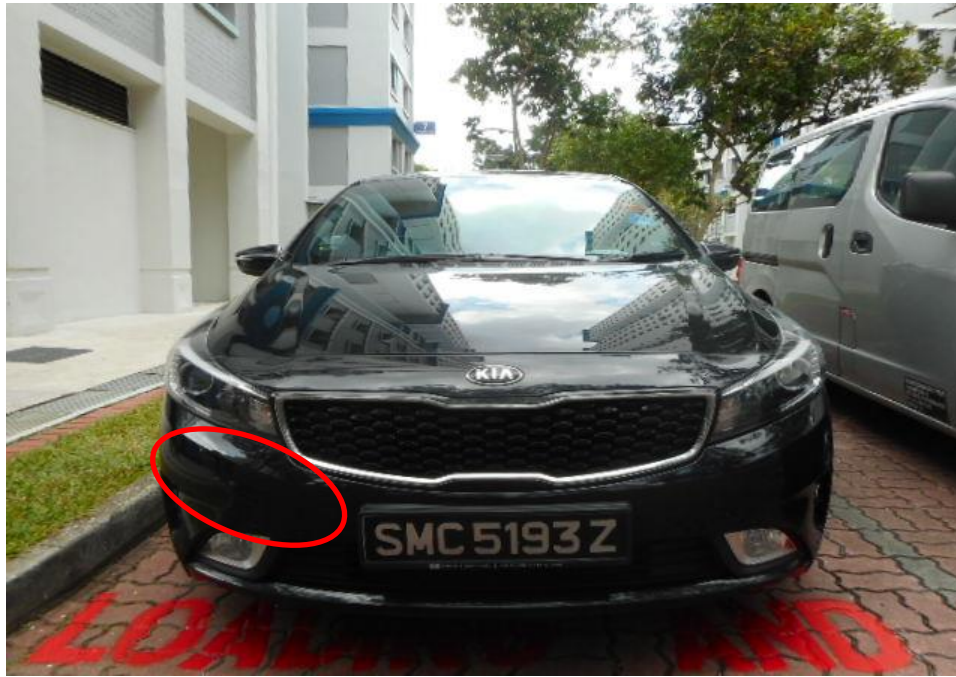
Photo 3 shows the general view of the front portion of Kia at the time of inspection. The front bumper right portion (circled) had paint scratch marks.

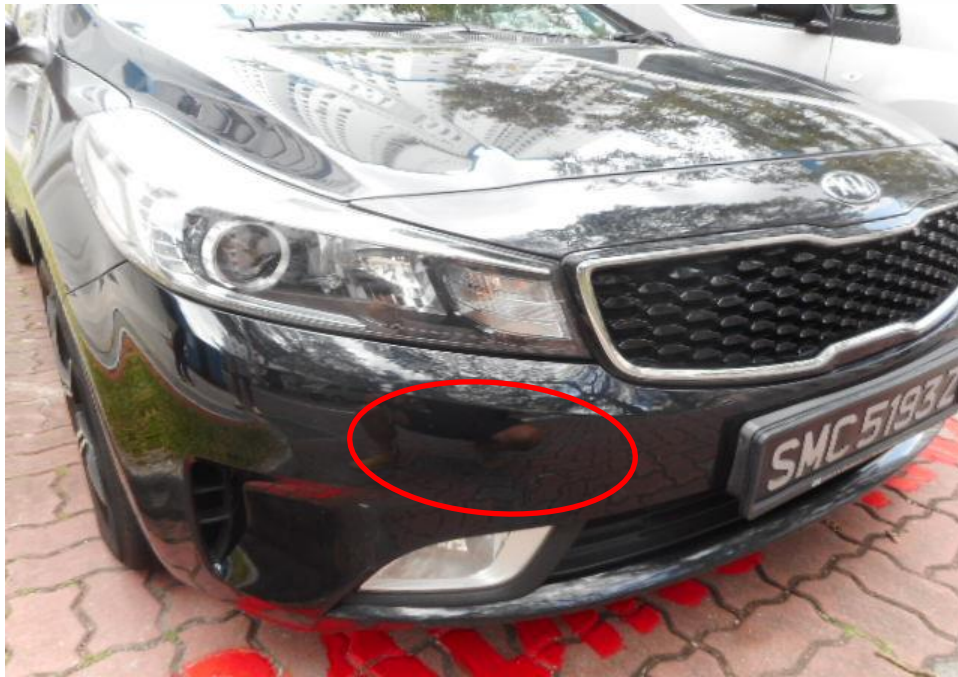
Photo 4 shows the close up view of the front right portion of Kia at the time of inspection. The front bumper right portion (circled) had paint scratch marks.

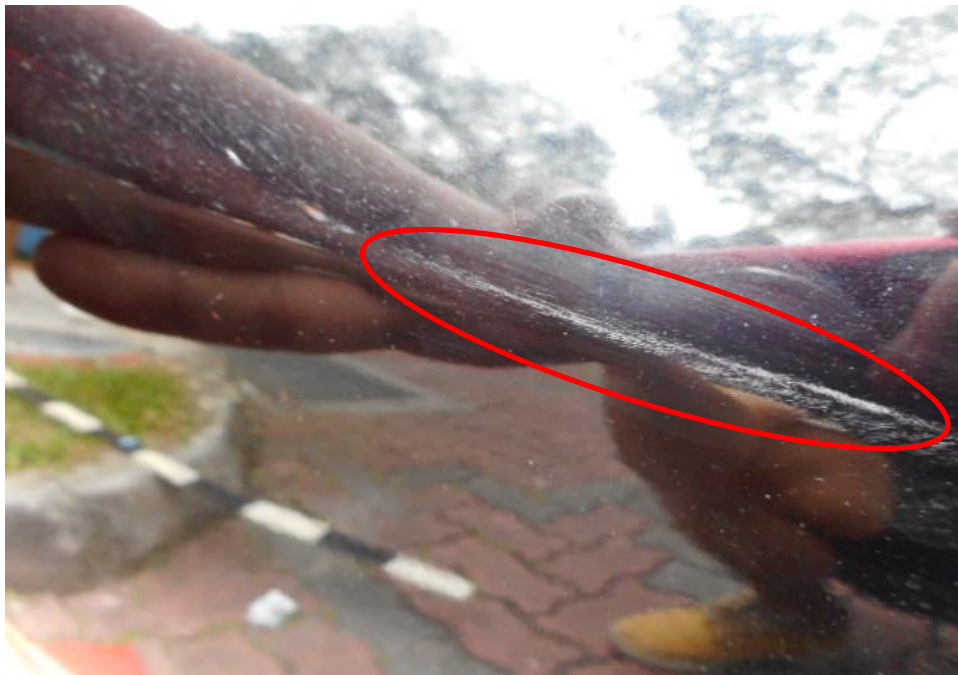
Photo 5 shows the close up view of the front right portion of Kia at the time of inspection. The front bumper right portion (circled) had paint scratch marks.

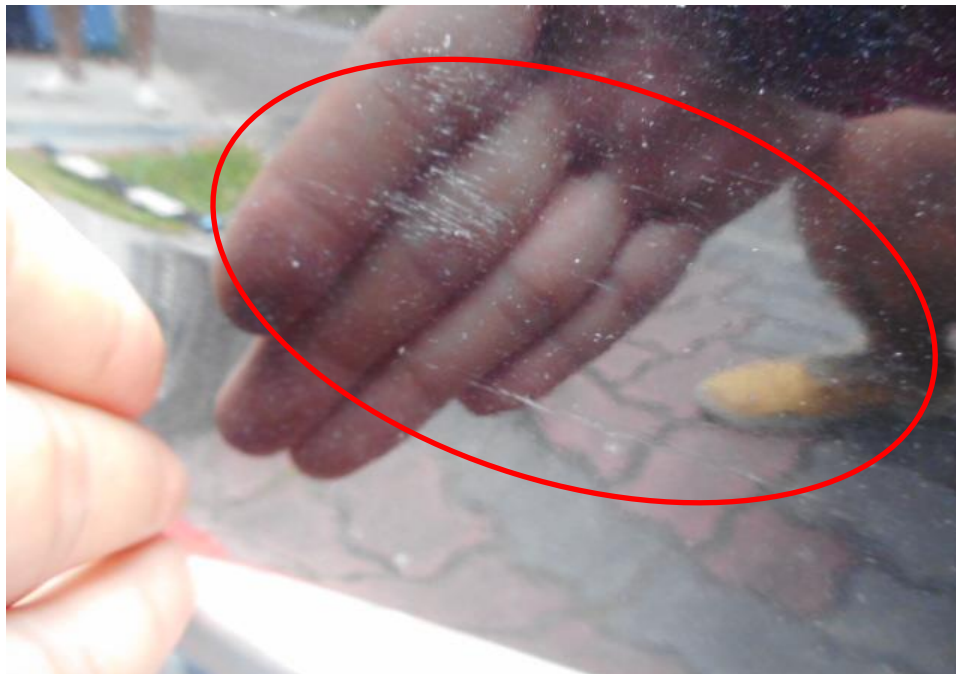
Photo 6 shows the close up view of the front right portion of Kia at the time of inspection. The front bumper right portion (circled) had paint scratch marks.

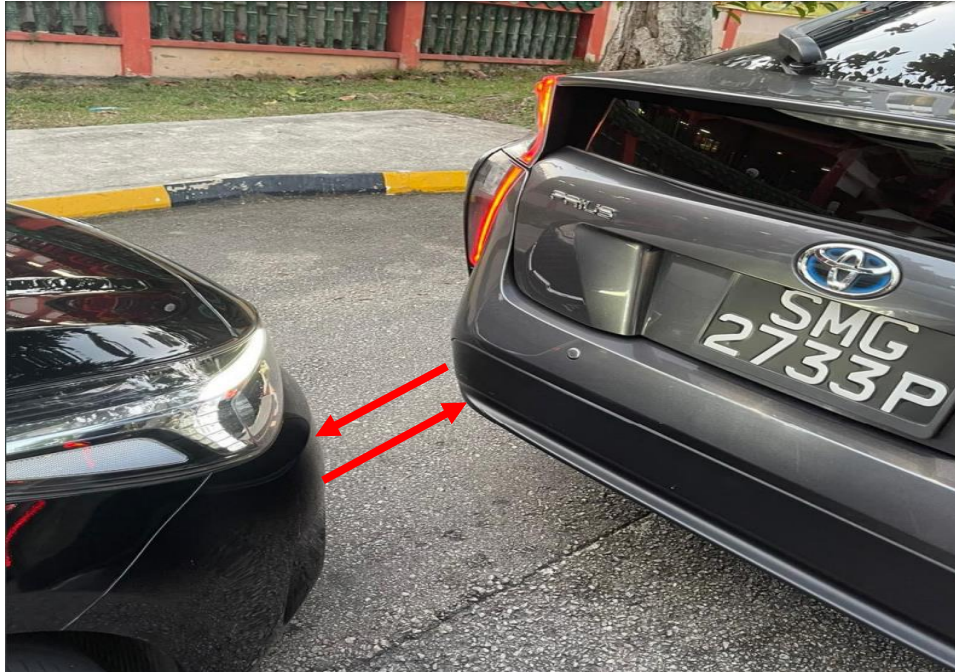
Photo 7 shows a general view of the Kia behind the Toyota. The Kia's front bumper right portion is directly behind the Toyota's rear bumper left portion. These is likely the area where the damages might have been at on the Toyota and the Kia (arrowed).

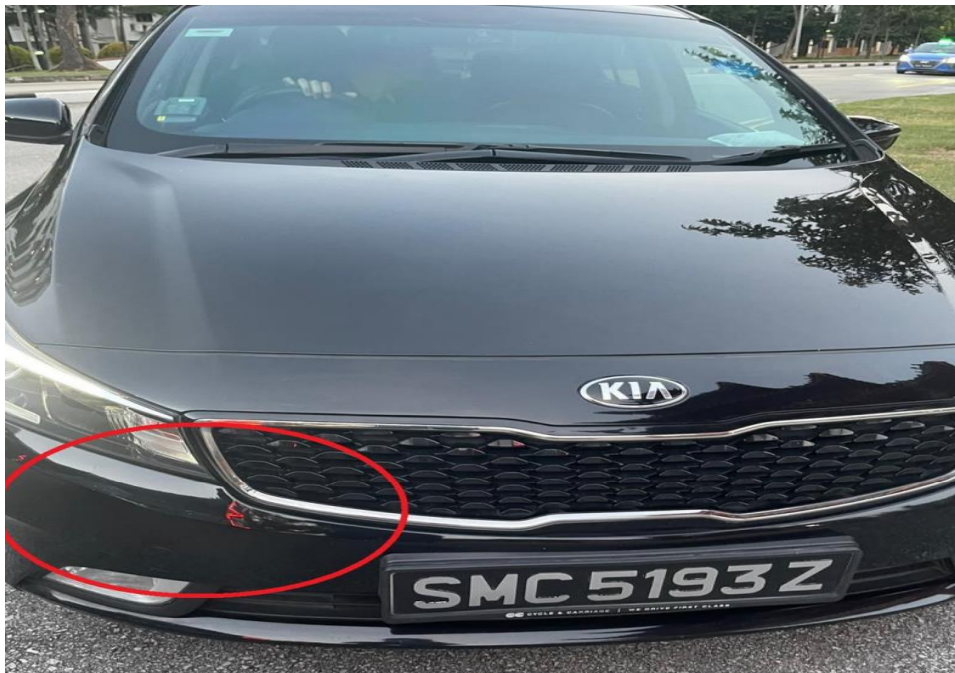
Photo 8 shows the general view of the front portion of the Kia, the front portion, front right bumper portion (circled) of the Kia. This is where the likely damages might have been at on the Kia.

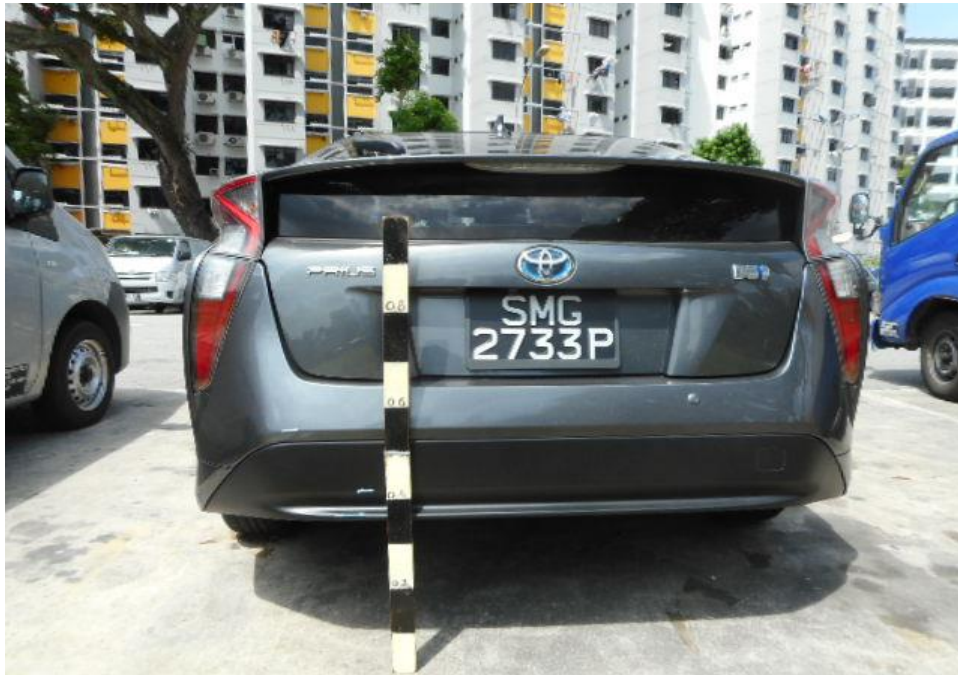
Photo 9 shows the general view of the height measurement being conducted on the rear portion of Toyota. The height above ground level of where the scratches of the rear bumper left portion, was at, 38cm, 42cm and 54cm respectively.

- a) the height above ground level of the range of damages (which included the damage of the rear bumper left portion of the Toyota) was measured to be between 38cm, 42cm and 54cm above ground level respectively.
- b) the height measurements above ground level of front bumper right portion of the Kia was measured to be at 42cm, 45cm and 52cm above ground level respectively;
- c) The height measurements appear to support the findings of possible contact between the rear left portion of Toyota and the front right portion of Kia.

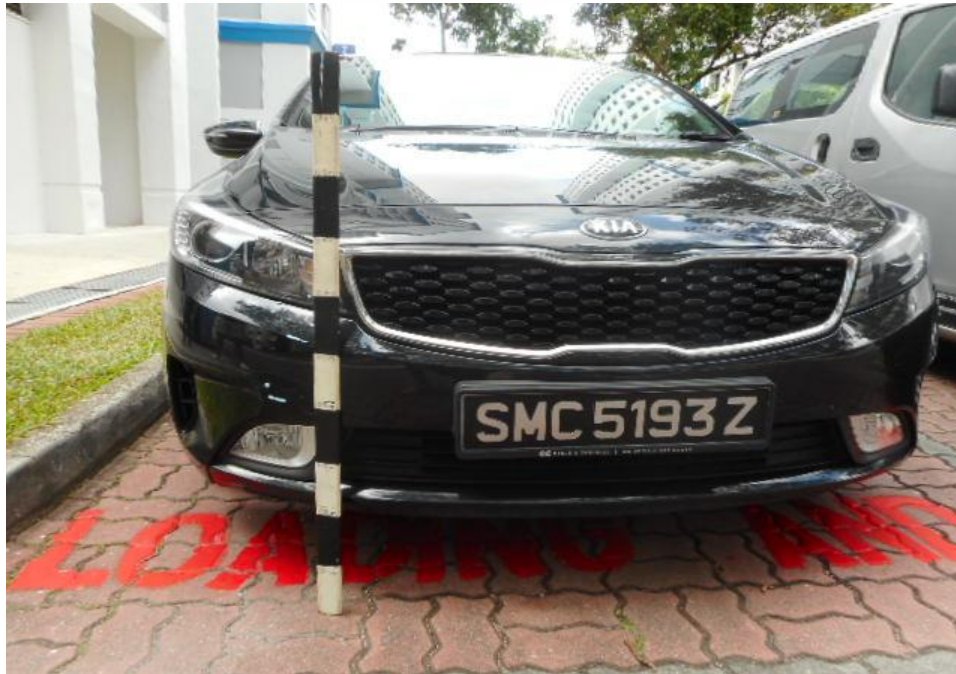
Photo 10 shows a general view of the height measurement being conducted on the front portion of Kia. The front bumper right portion where is the, was measured to be at 42cm, 45cm and 52cm above ground level.

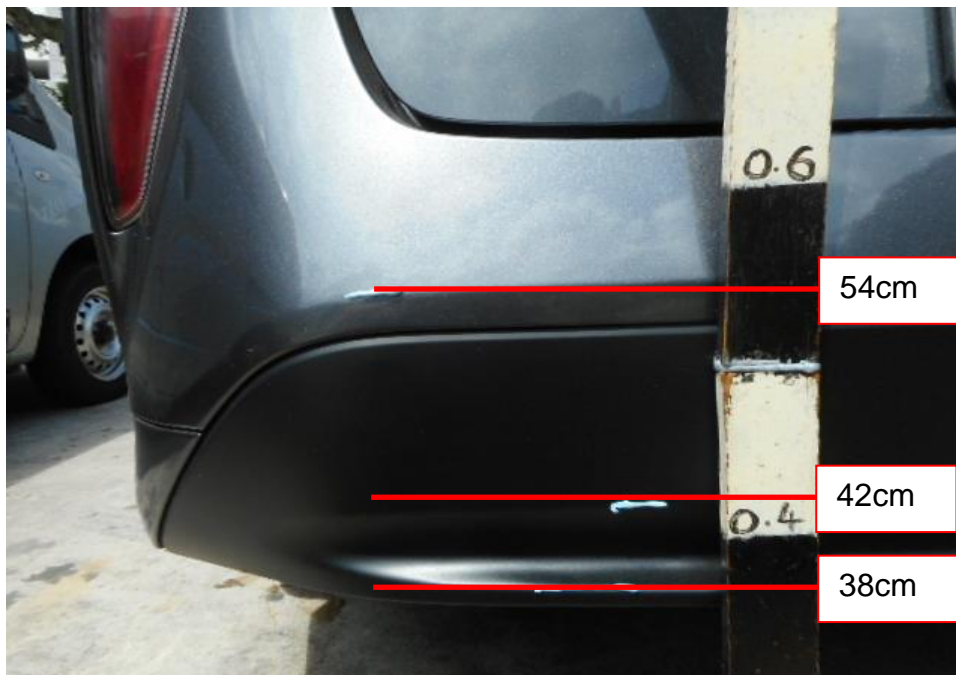
Photo 11 shows the close up view of the height measurement being conducted on the rear portion of Toyota. The height above ground level of where the damage were found on the rear bumper left portion of the Toyota was between 38cm, 42cm and 54cm.

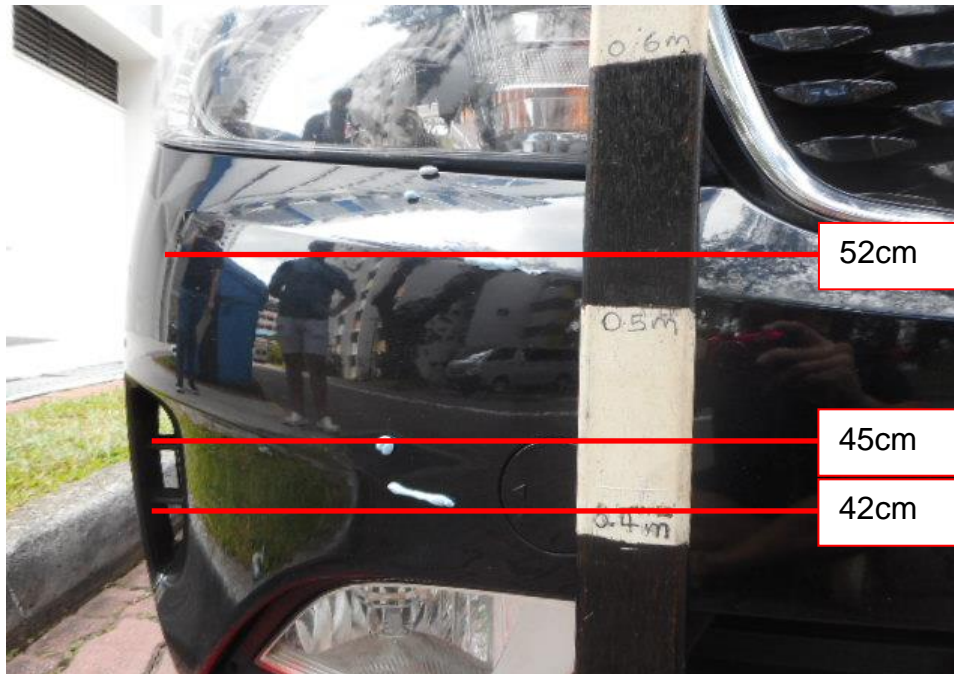
Photo 12 shows the close up view of the height measurement being conducted on the front bumper right portion of the Kia. The scratched marks found on the front bumper left portion was measured to be between 42cm, 45cm and 52cm above ground level.
