Your Ref: Porsche 718 Cayman GT 4
(chassis number WP0ZZZ98ZLK284443)

12 August 2021

Our Ref : CI/TP21008478/D

INSPECTION REPORT OF AN UNREGISTERED PORSCHE 718 CAYMAN GT 4 MOTOR CAR WITH CHASSIS NUMBER WP0ZZZ98ZLK284443

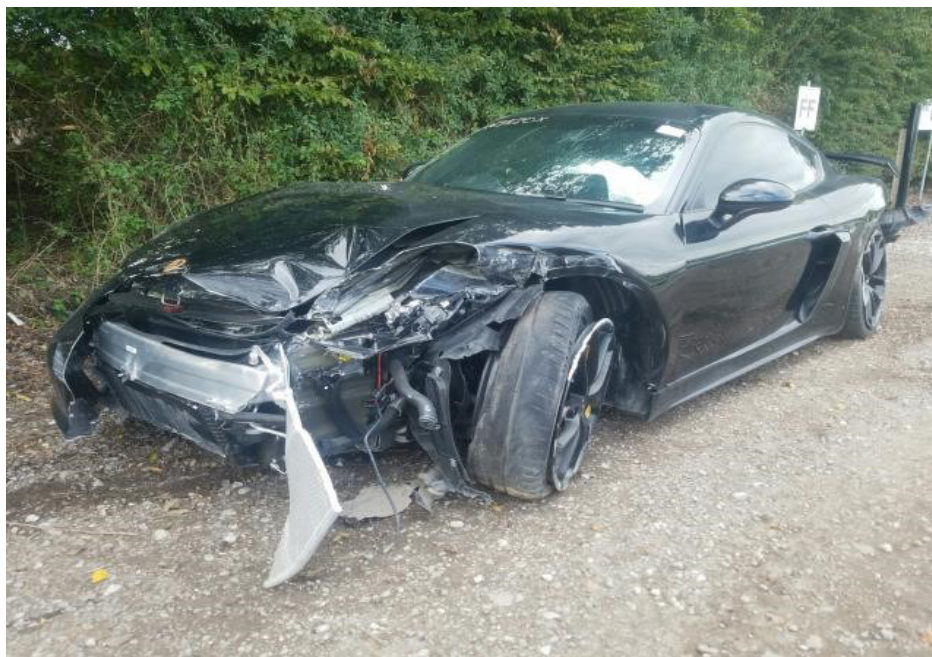
3. The photographs provided to me had showed damage to the front left portion and rear left portion of the Motor Car. Body parts damaged at the front left portion include the Motor Car's front bumper, front bumper lower lip, front bumper reinforcement, front bumper left lower grille, front bumper left corner garnish, front left day running light, front bonnet, front bonnet lock, front bonnet compartment garnishes, front left aircon condenser, front left headlamp, front left signal lamp, front left fender, front left fender inner shield, front left wheel rim and front left tyre amongst others.

Photo 1 shows the front left body of the Motor Car (photograph provided to me). The Motor Car was observed to have sustained damage at its front left portion. The front bumper, front bumper lower lip, front bumper reinforcement, front bumper left lower grille, front bumper left corner garnish, front left day running light, front bonnet, front left aircon condenser, front left headlamp, front left signal lamp, front left fender, front left fender inner shield, front left wheel rim and front left tyre were amongst the body parts that were observed to have been damaged.

23. The body parts at the front left portion and rear left portion of the Motor Car were visually examined and it was noted that the repair/restoration works carried out to the damaged area of the Motor Car (refer to photograph 1 & 3 above) were reasonably adequate and in order.

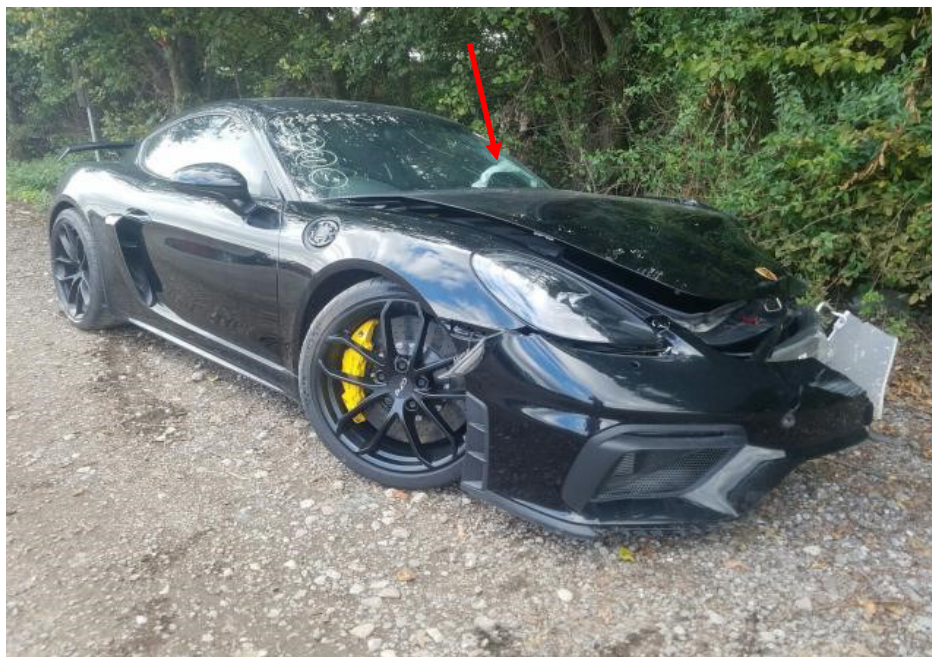
5. The Motor Car's front left passenger airbag was deployed as seen from the photographs that were provided to me. See photo 1 – 4 below.

Photo 2 shows the front right body of the Motor Car (photograph provided to me). There appears to be no physical damage along the right side body of the Motor Car. The front left passenger airbag was deployed (arrowed).

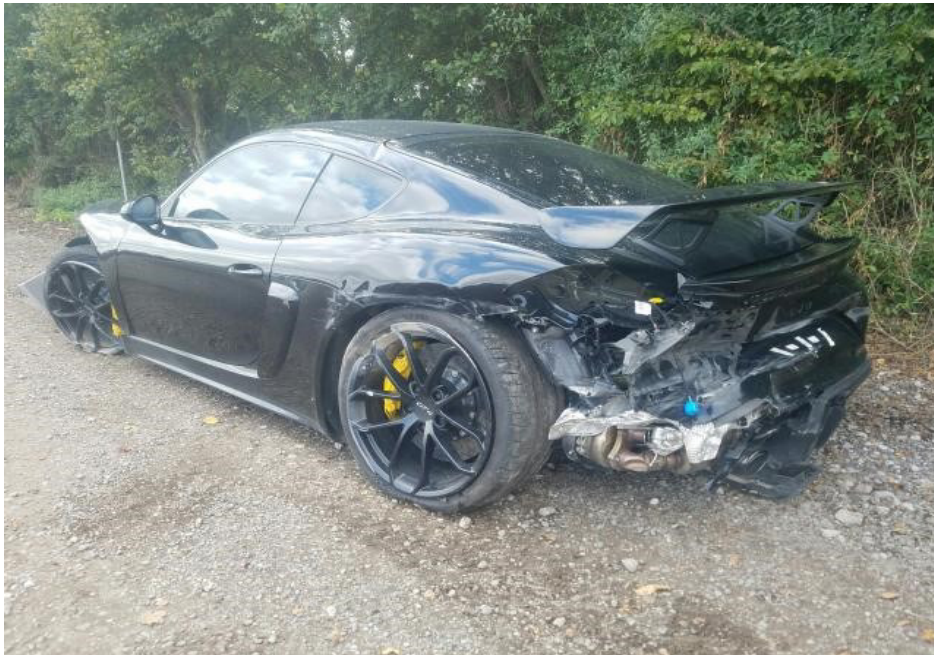
4. With regard to the rear left portion, I had observed damage to the Motor Car's rear bumper, rear bumper lower diffuser, rear bumper reinforcement, rear bumper left reflector, rear bumper top centre garnish, rear bumper top lip, rear left exhaust, rear left exhaust heat shield, rear left body panel, rear left body panel inner shield, rear left taillamp and rear left wheel rim amongst others.

Photo 3 shows the rear left body of the Motor Car (photograph provided to me). Apart for the front left portion, the Motor Car had also sustained damage at its rear left portion. The rear bumper, rear bumper lower diffuser, rear bumper reinforcement, rear bumper left reflector, rear bumper top centre garnish, rear bumper top lip, rear left exhaust, rear left exhaust heat shield, rear left taillamp, rear left body panel, rear left body panel inner shield and rear left wheel rim were amongst the body parts that were observed to have been damaged.

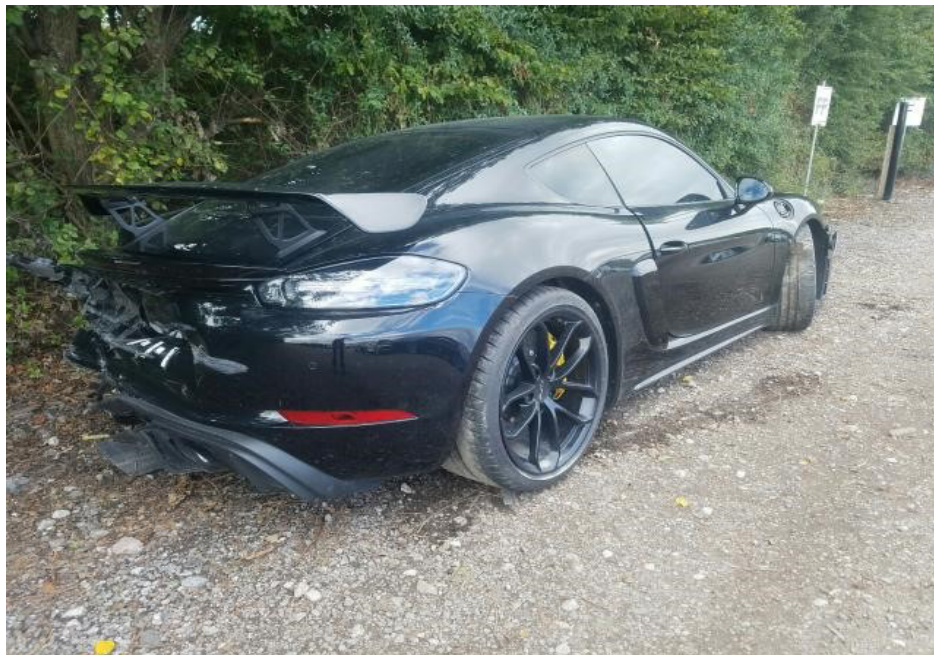
Photo 4 shows the rear right body of the Motor Car (photograph provided to me). There appears to be no physical damage along the right side body of the Motor Car.

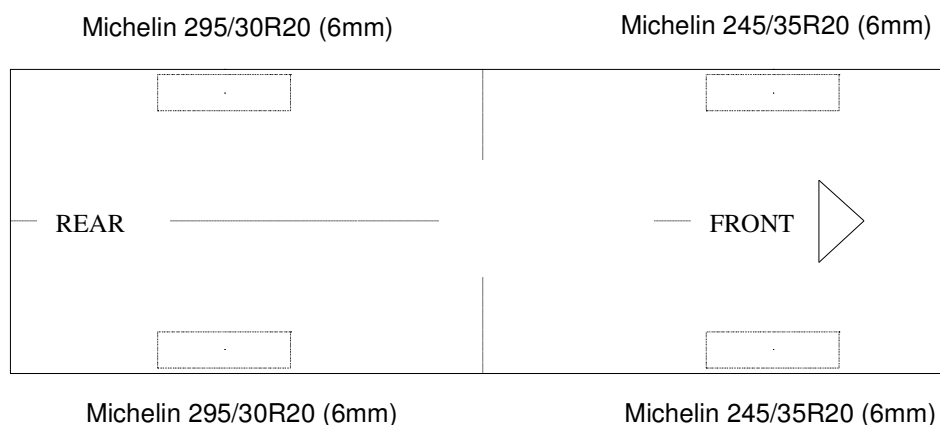
9. It was fitted with 20inch sport wheel rims that were wrapped with tyres that were observed to be of serviceable condition. The tyres were also sufficiently inflated for vehicular operation. The tyre brand, tyre size and approximate remaining tread depth of the 4 tyres of the Motor Car were recorded as follows: -

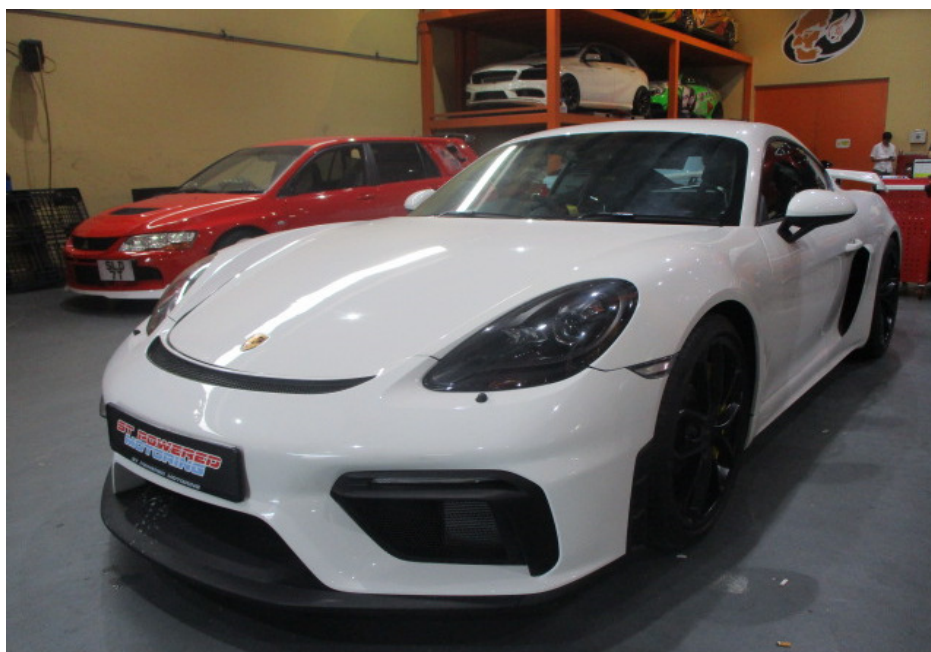
Photo 5 shows a general view of the Motor Car's front left body at the time of my inspection. The Motor Car was observed to be in a relatively good general condition with no loose exterior fittings observed. The body parts at the front left portion of the Motor Car were visually examined and it was observed that the repair/restoration works carried out to the damaged area of the Motor Car (refer to photograph 1 above) were reasonably adequate and in order.

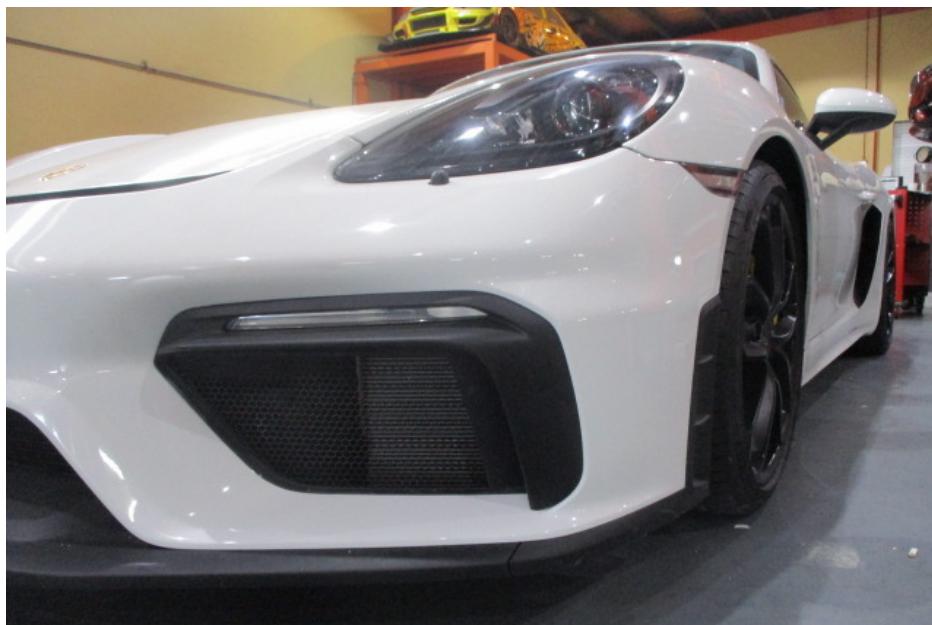
Photo 6 shows a closer view of the Motor Car's front bumper, front bumper lower lip, front bumper left lower grille and front left day running light at the time of my inspection. The body parts at the front left portion of the Motor Car were visually examined and it was observed that the repair/restoration works carried out to the damaged area of the Motor Car (refer to photograph 1 above) were reasonably adequate and in order.

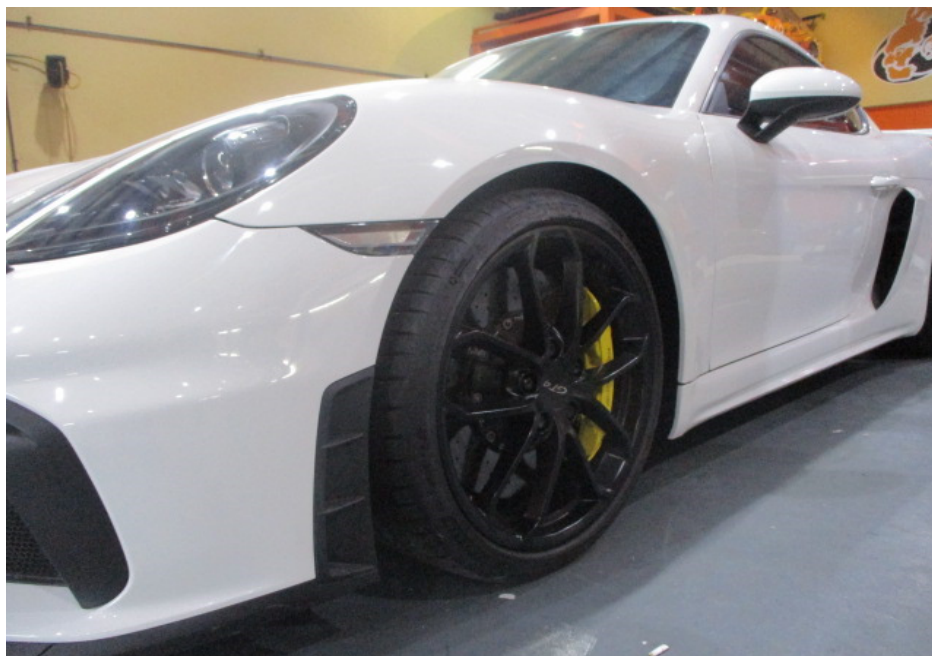
Photo 7 shows a closer view of the Motor Car's front bumper, front bumper left corner garnish, front left signal lamp, front left fender and front left wheel at the time of my inspection. The body parts at the front left portion of the Motor Car were visually examined and it was observed that the repair/restoration works carried out to the damaged area of the Motor Car (refer to photograph 1 above) were reasonably adequate and in order.

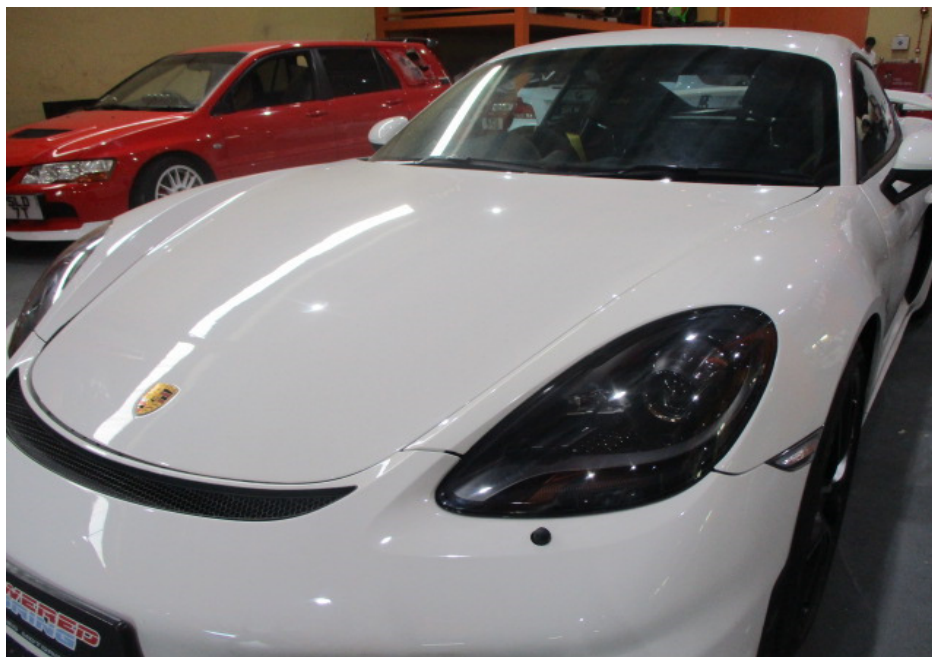
Photo 8 shows a closer view of the Motor Car's front bumper, front left headlamp and front bonnet at the time of my inspection. The body parts at the front left portion of the Motor Car were visually examined and it was observed that the repair/restoration works carried out to the damaged area of the Motor Car (refer to photograph 1 above) were reasonably adequate and in order.

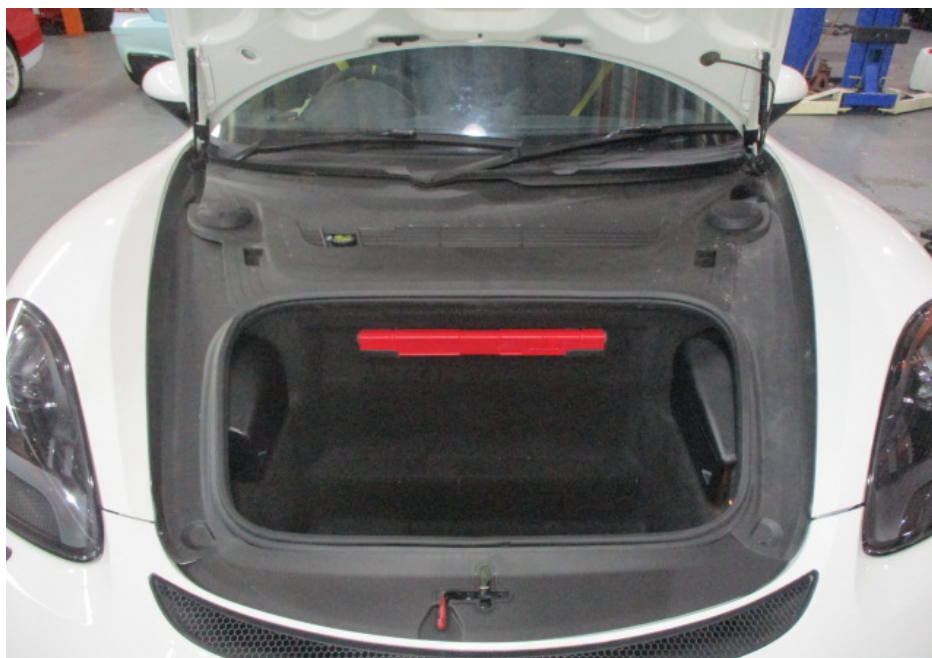
Photo 9 shows a general of the Motor Car's front bonnet compartment at the time of my inspection. All inner trims, garnishes and upholstery etc were observed to be properly fitted. The body parts at the front left portion of the Motor Car were visually examined and the repair/restoration works carried out to the damaged area of the Motor Car (refer to photograph 1 above) were found to be reasonably adequate and in order.

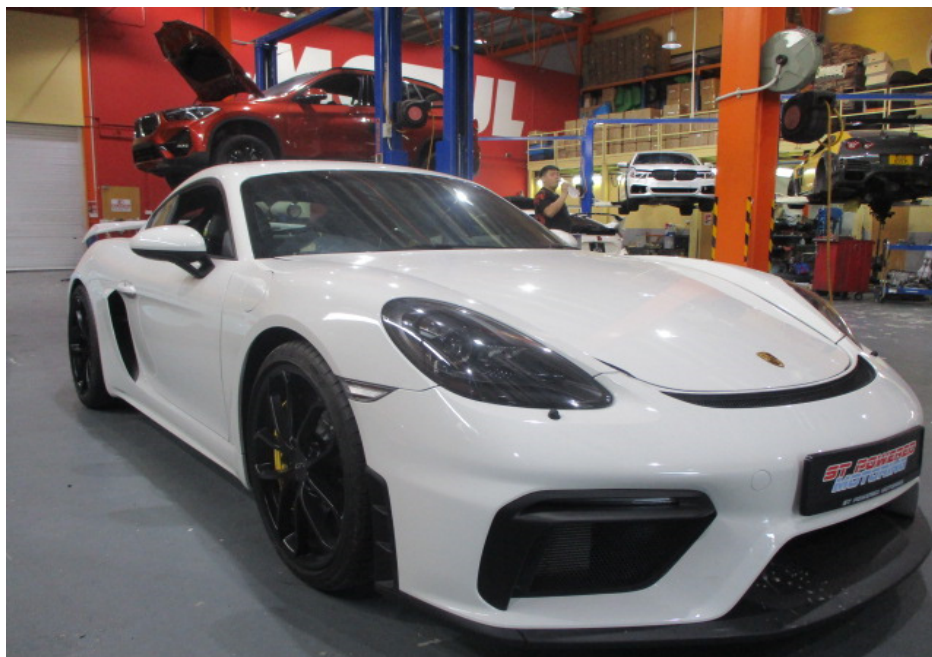
Photo 10 shows a general view of the front right body of the Motor Car at the time of my inspection. The Motor Car was observed to be in a relatively good general condition with no loose exterior fittings observed. The mileage of the Motor Car recorded at the time of my inspection was 906km.

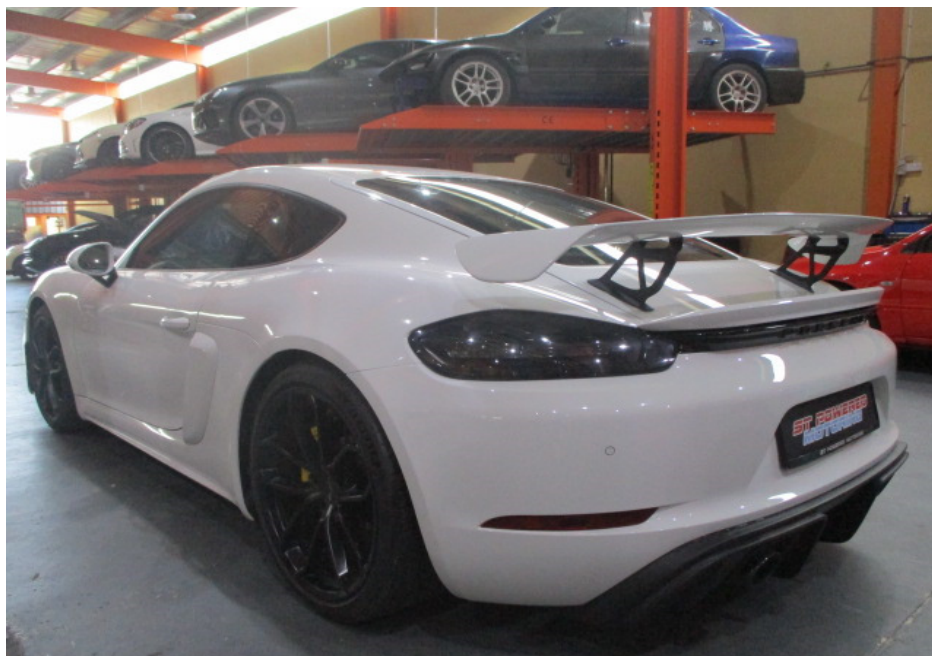
Photo 11 shows a general view of the Motor Car's rear left body at the time of my inspection. The Motor Car was observed to be in a relatively good general condition with no loose exterior fittings observed. The body parts at the rear left portion of the Motor Car were visually examined and it was observed that the repair/restoration works carried out to the damaged area of the Motor Car (refer to photograph 3 above) were reasonably adequate and in order.

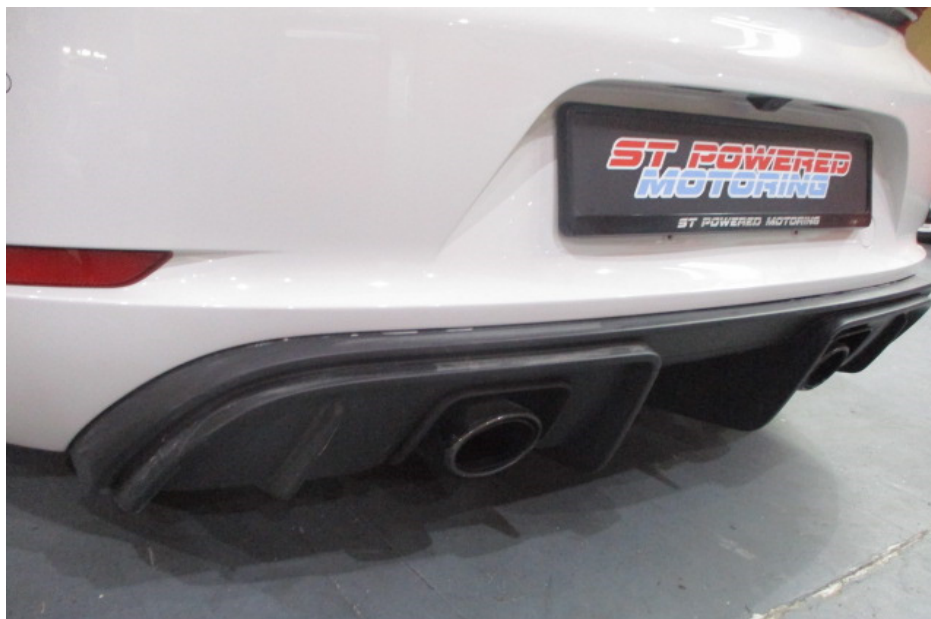
Photo 12 shows a closer view of the Motor Car's rear bumper, rear bumper left reflector, rear bumper lower diffuser and rear left exhaust at the time of my inspection. The body parts at the rear left portion of the Motor Car were visually examined and it was observed that the repair/restoration works carried out to the damaged area of the Motor Car (refer to photograph 3 above) were reasonably adequate and in order.

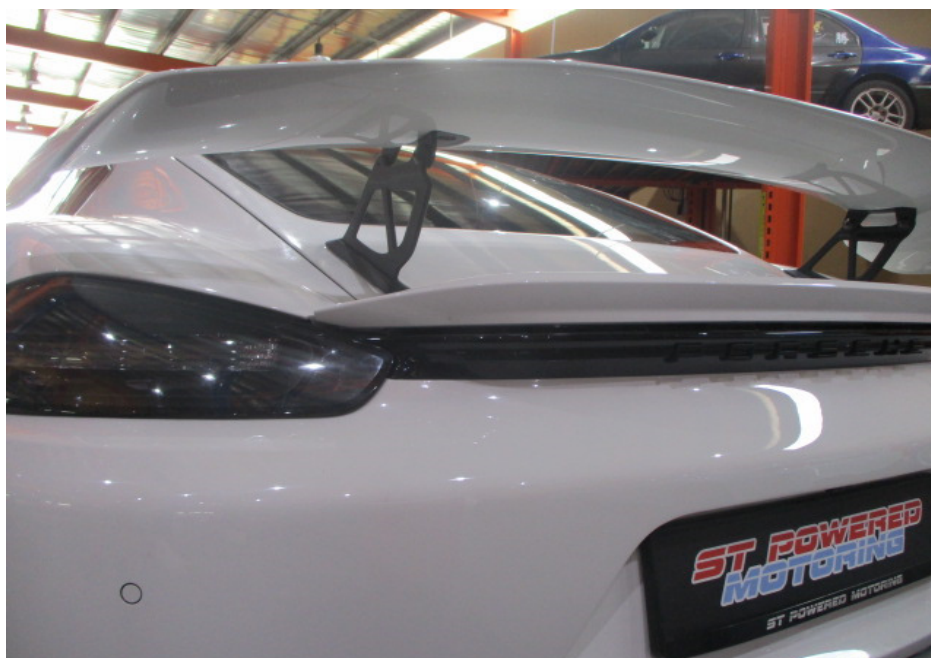
Photo 13 shows a closer view of the Motor Car's rear bumper, rear bumper top centre garnish, rear bumper top lip and rear left taillamp at the time of my inspection. The body parts at the rear left portion of the Motor Car were visually examined and it was observed that the repair/restoration works carried out to the damaged area of the Motor Car (refer to photograph 3 above) were reasonably adequate and in order.

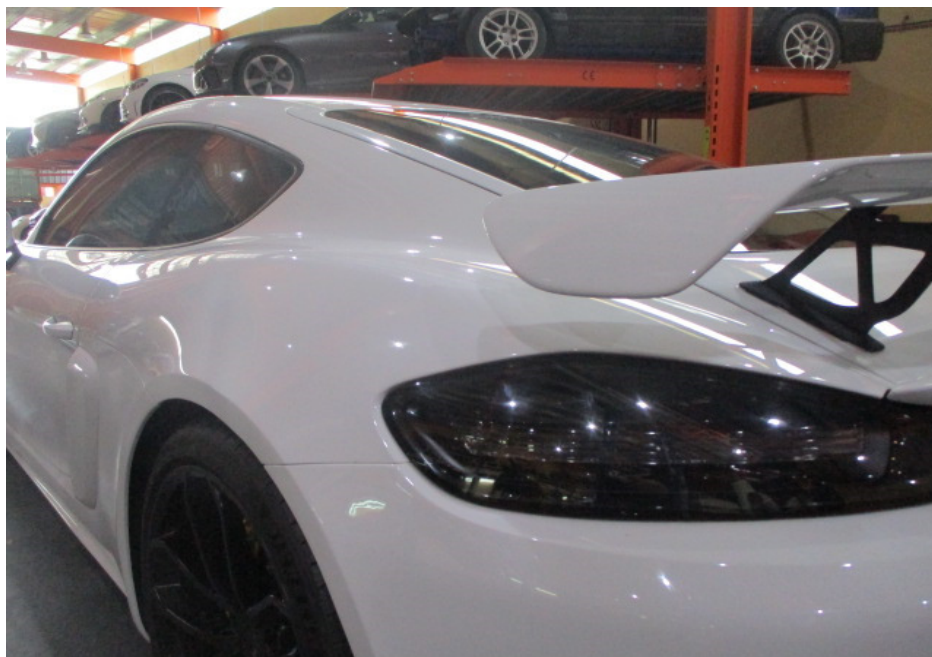
Photo 14 shows a closer view of the Motor Car's rear left taillamp and rear left body panel at the time of my inspection. The body parts at the rear left portion of the Motor Car were visually examined and it was observed that the repair/restoration works carried out to the damaged area of the Motor Car (refer to photograph 3 above) were reasonably adequate and in order.

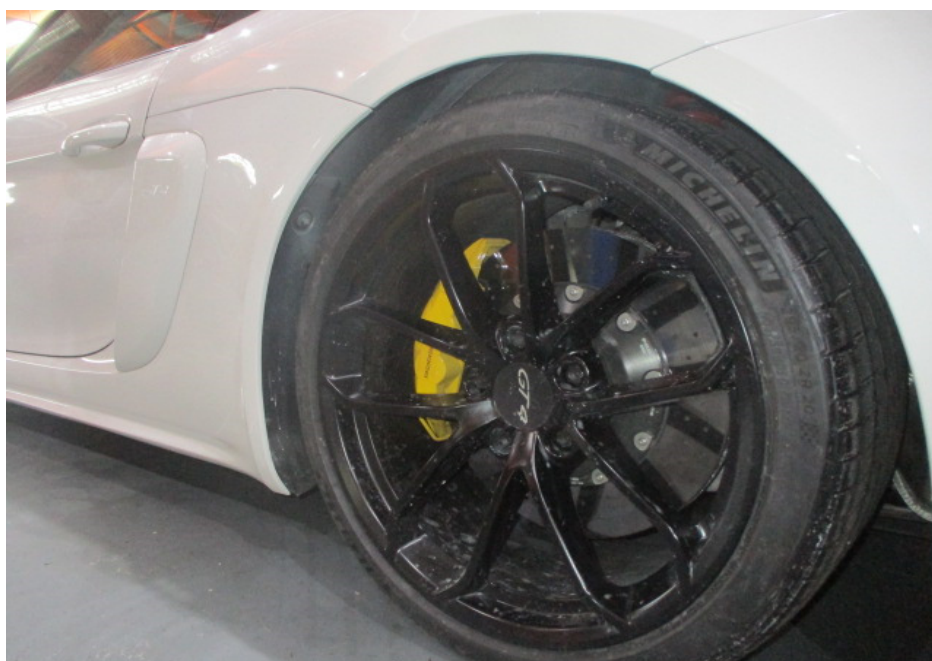
Photo 15 shows a closer view of the Motor Car's rear left wheel rim and rear left body panel at the time of my inspection. The body parts at the rear left portion of the Motor Car were visually examined and it was observed that the repair/restoration works carried out to the damaged area of the Motor Car (refer to photograph 3 above) were reasonably adequate and in order.

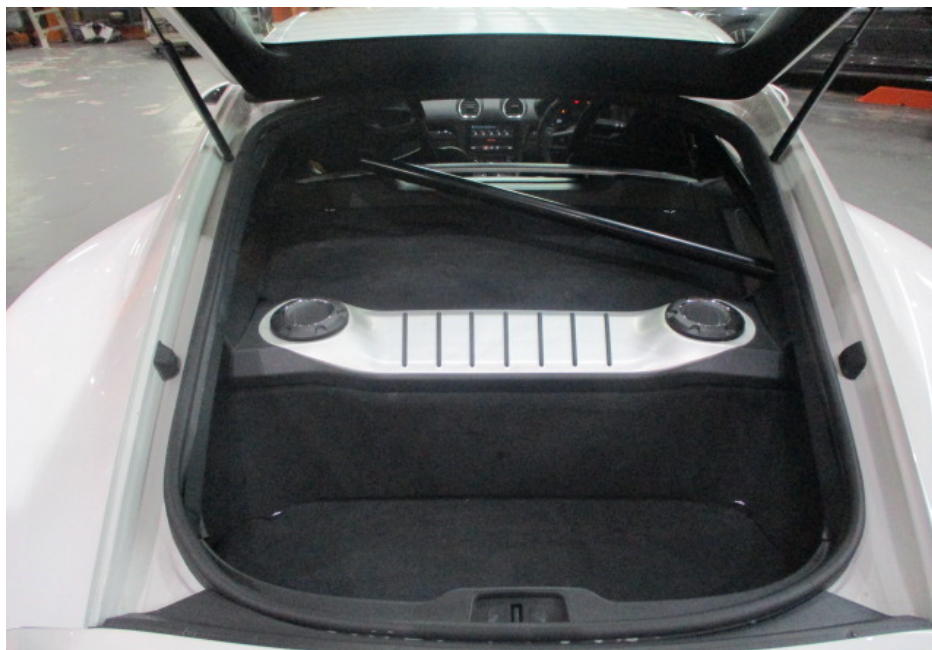
Photo 16 shows a general of the Motor Car's rear boot compartment at the time of my inspection. All inner trims, garnishes and upholstery etc were observed to be properly fitted. The body parts at the rear left portion of the Motor Car were visually examined and the repair/restoration works carried out to the damaged area of the Motor Car (refer to photograph 3 above) were found to be reasonably adequate and in order.

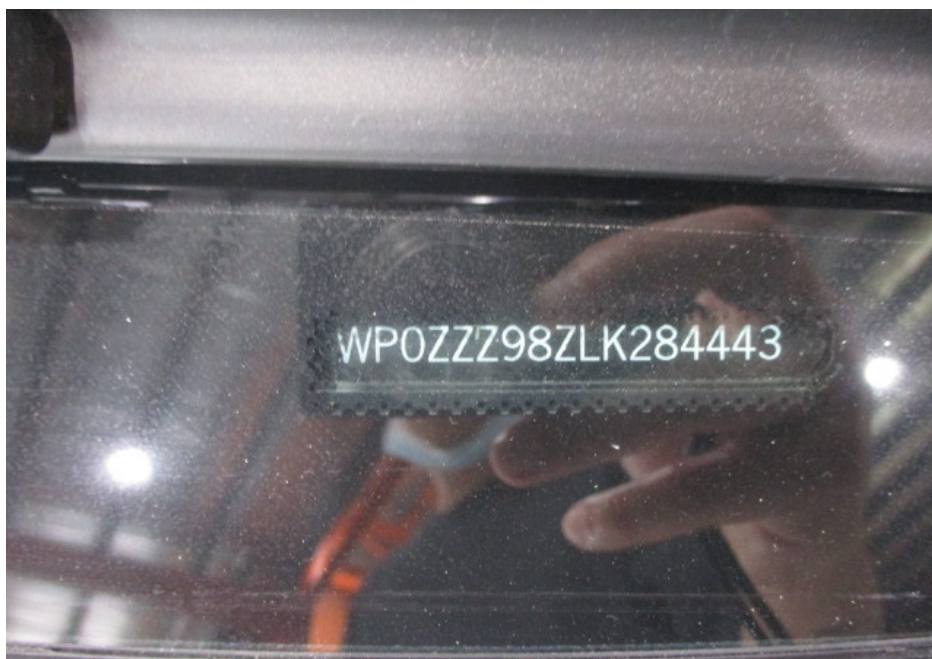
Photo 17 shows the chassis number of the Motor Car. The chassis number recorded WP0ZZZ98ZLK284443.

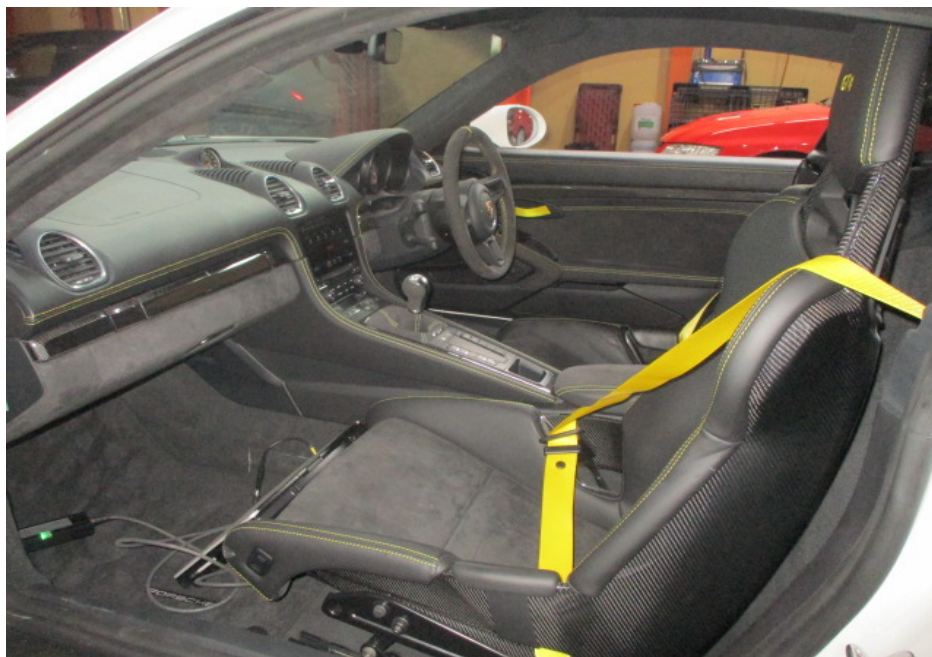
Photo 18 shows the interior compartment of the Motor Car at the time of my inspection. The various parts and components, trims, carpet and upholstery inside the interior compartment were all observed to be intact and properly fitted

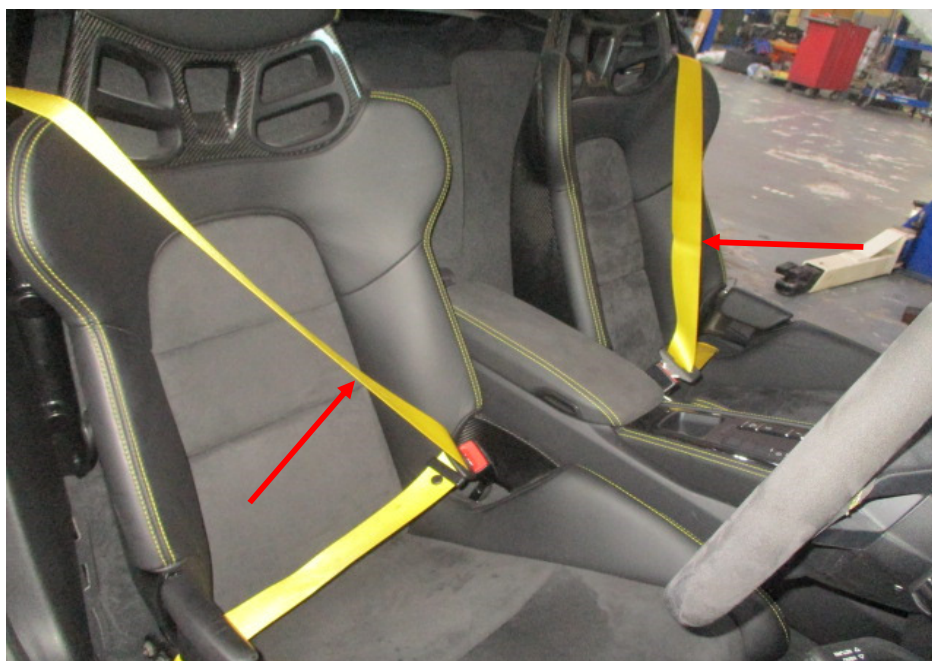
13. The seats of the Motor Car were found to be secured to the floorboard of the Motor Car via seat rails bolted onto the floorboard. Retractable seat belt reels and pre-tensioners were fitted on all seats of the Motor Car. The seat belt reels were tested and were able to be fastened securely into the respective pre-tensioners that were fixed to the side of all the seats.

Photo 19 shows the seats of the Motor Car. All the seats of the Motor Car were secured via seat rails to the floorboard. They were also fitted with a retractable seat belt reel and a pre-tensioner. The seat belts (arrowed) were tested and were able to be fastened into the respective pre-tensions that were fitted on the side of each individual seat.

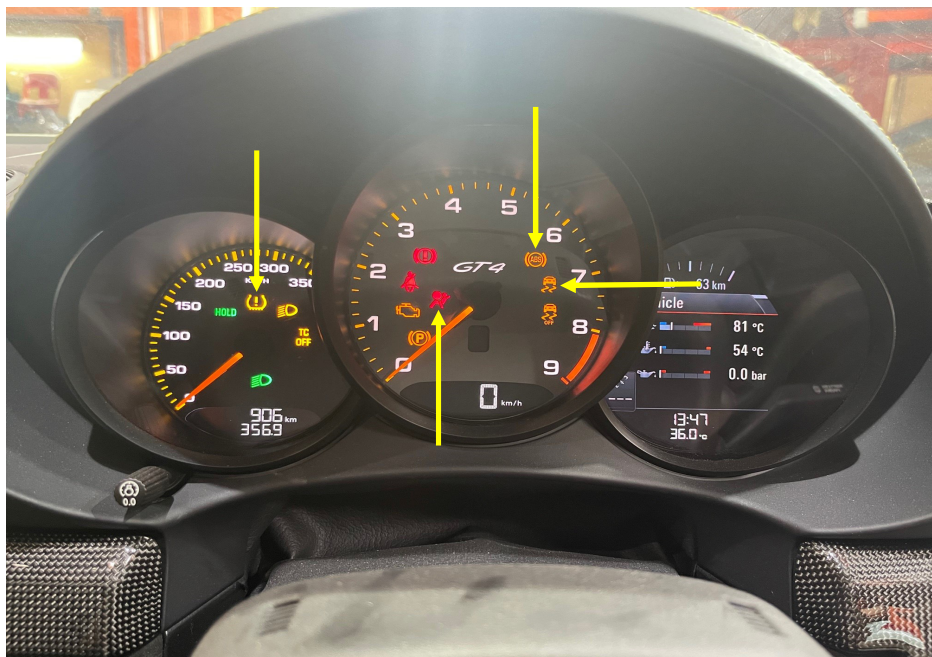
Photo 20 shows the warning lights for the various electronic safety features appearing on the instrument panel of the Motor Car during its self-test when the engine is cranked, in particular the ABS, SRS, TPM and TCS lights (arrowed).

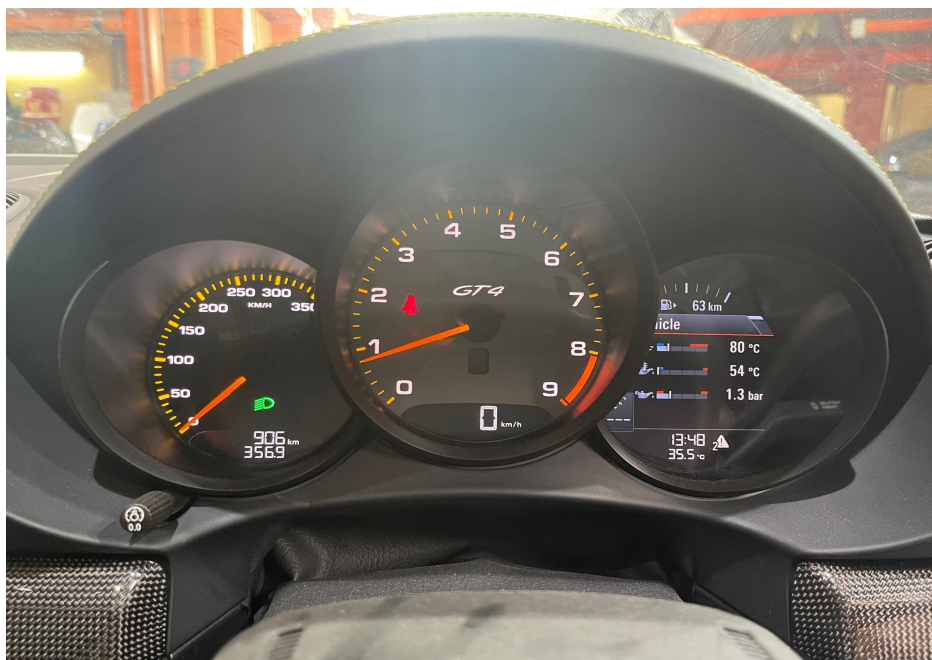
14. The Motor Car's automatic self-test of the functionality of its various electronic safety features like the Anti-Lock Brake System (ABS), Supplemental Restraint System (SRS), Tyre Pressure Monitor (TPM) and Traction Control System (TCS) during cranking of the engine had indicated that these electronic systems were in working condition. This was determined from the respective warning lights disappearing from the instrument panel after the self-test.

Photo 21 shows the respective warning lights no longer illuminated, indicating that there is no fault detected to the ABS, SRS, TPM and TCS systems of the Motor Car during the self-test. These electronic systems were hence in working condition at the time of my inspection.

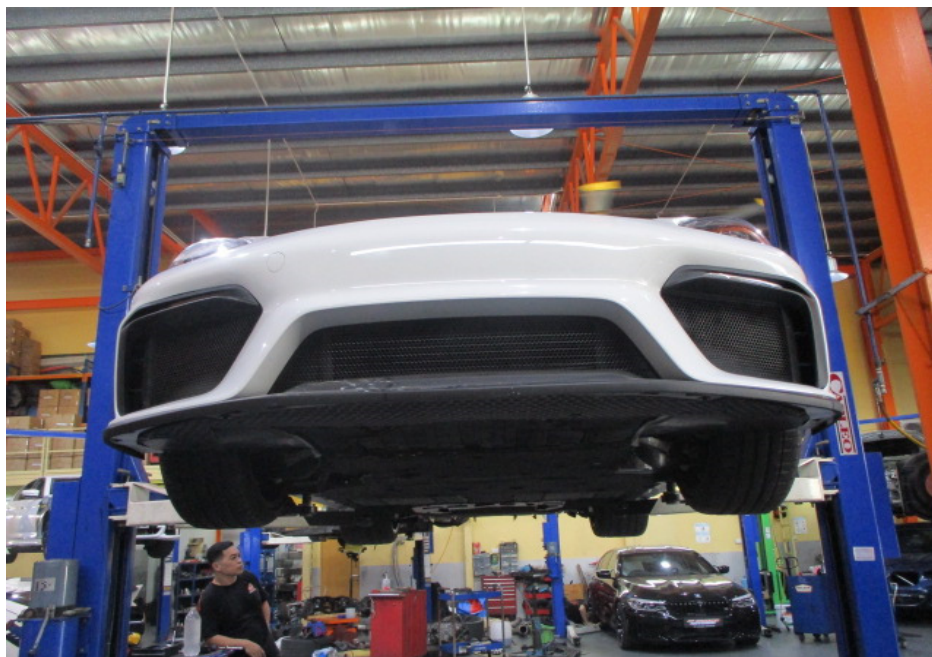
16. My checks on the underside of the Motor Car revealed no sign(s) or indication(s) of fluid leakage and/or fluid stain(s). The engine block and manual transmission assembly were both secured properly. All undercarriage components of the Motor Car were also observed to be intact and secured in an appropriate manner.

Photo 22 shows the Motor Car hoisted up for checks on its undercarriage. There was no sign(s) or indication(s) of fluid leakage and/or fluid stain(s) on the underside of the Motor Car. The undercarriage components of the Motor Car were also all observed to be intact and secured in an appropriate manner.

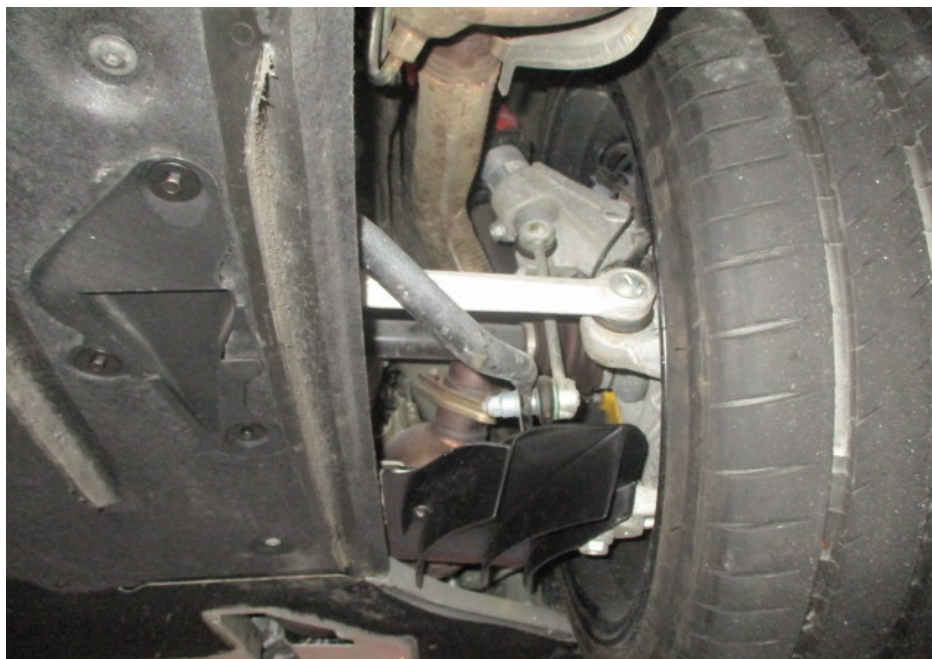
Photo 23 shows a general view of the control arms and linkages at the rear right wheel of the Motor Car. I did not observe any fluid leak and/or fluid stain on the underside of the Motor Car. All of the Motor Car's undercarriage components were observed to be intact and secured in an appropriate manner.

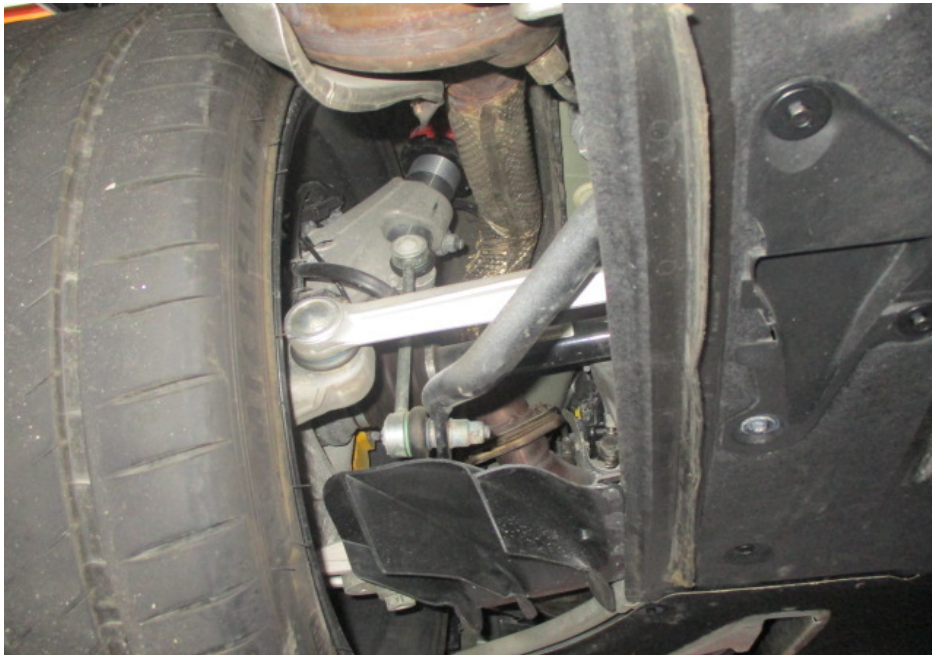
Photo 24 shows a general view of the control arms and linkages at the rear left wheel of the Motor Car. I did not observe any fluid leak and/or fluid stain on the underside of the Motor Car. All of the Motor Car's undercarriage components were observed to be intact and secured in an appropriate manner.

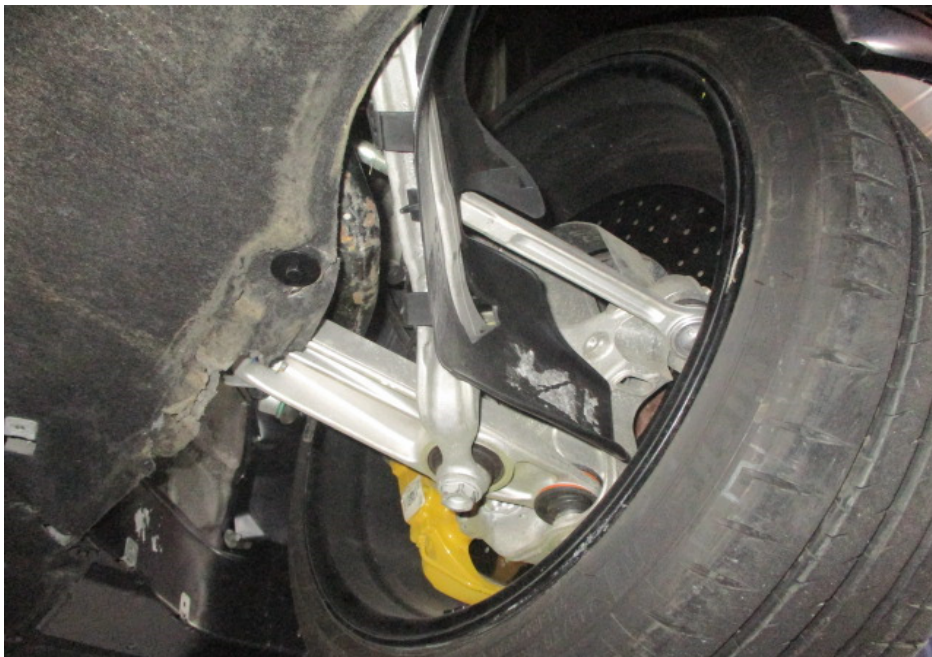
Photo 25 shows the various undercarriage components at the front left wheel of the Motor Car. The mechanical components, control arms and linkages were all found to be intact and secured in an appropriate manner.

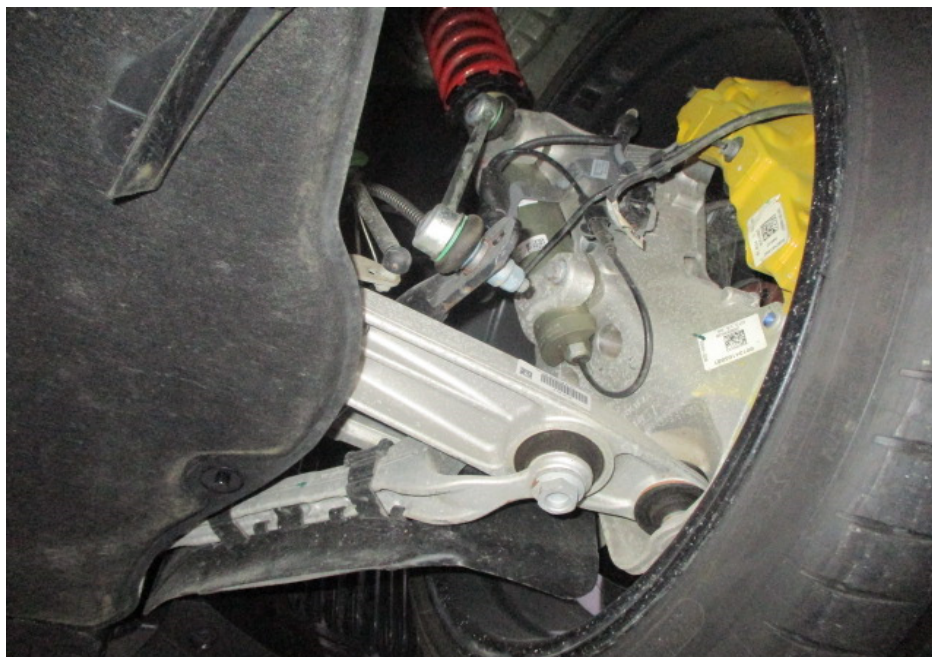
Photo 26 shows the various undercarriage components at the front right wheel of the Motor Car. The mechanical components, control arms and linkages were all found to be intact and secured in an appropriate manner. I also did not observe any fluid leak and/or fluid stain on the underside of the Motor Car.

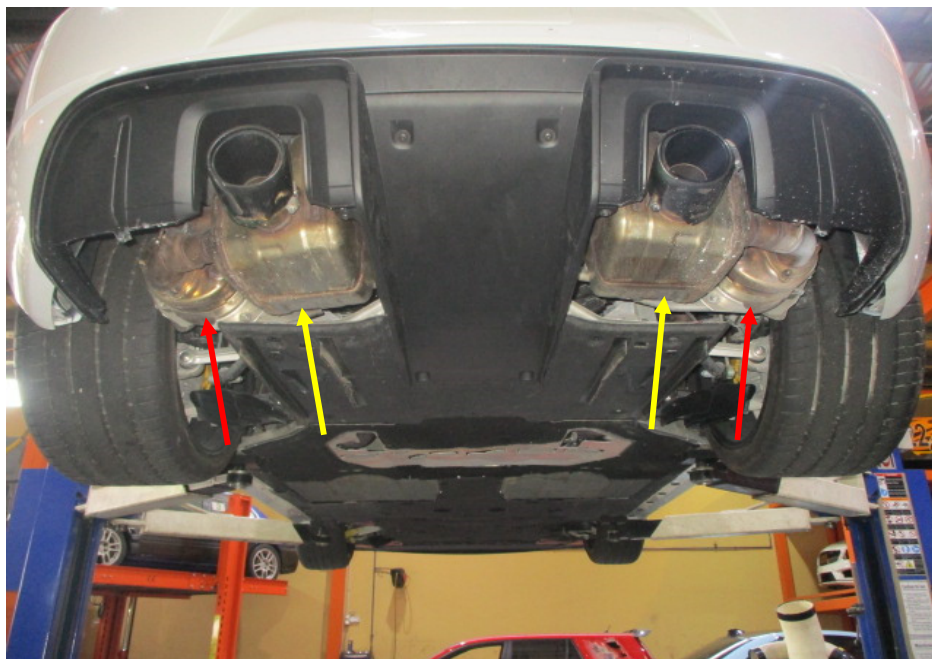
Photo 27 shows a general view of the Motor Car's exhaust system. My examination of the Motor Car's exhaust system revealed no sign(s) or indication(s) of any cut or weld marks along its exhaust pipes, on its rear mufflers (yellow arrow) and on its catalytic converters (red arrow).

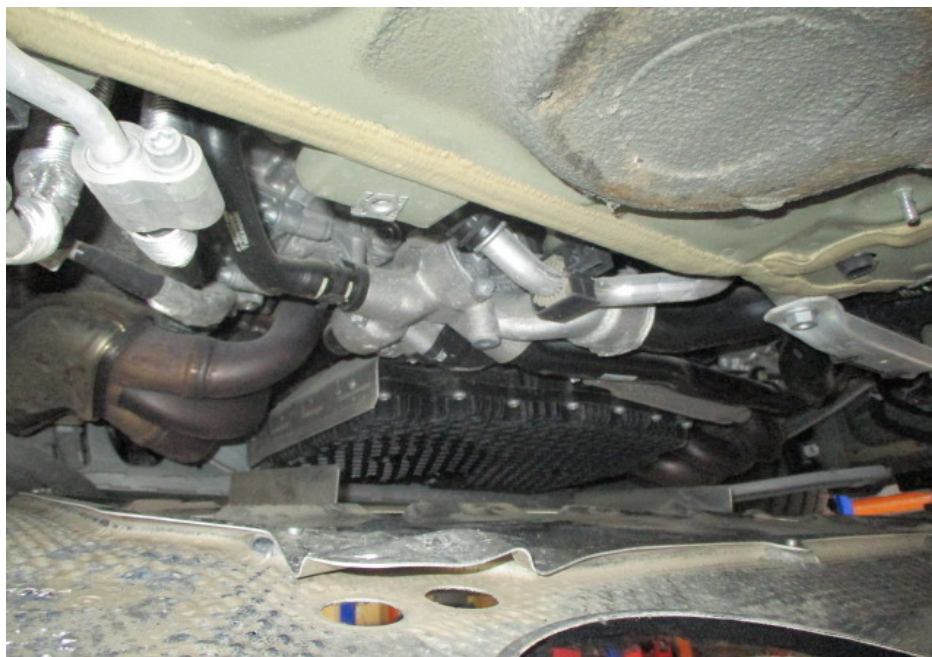
15. My examination of the engine compartment of the Motor Car revealed that the various parts and components inside the engine compartment were all intact and properly fitted. The engine oil, brake fluid and engine coolant were all found to be of sufficient level for operating purposes. Visually, there was also no contamination found to these fluids.

Photo 28 shows a general view of the engine compartment of the Motor Car at the time of my inspection. The engine compartment was at the rear underside of the Motor Car. The various parts and components inside the engine compartment were all observed to be intact and properly fitted. There was also no sign(s) or indication(s) of fluid leak and/or fluid stain found inside the engine compartment.

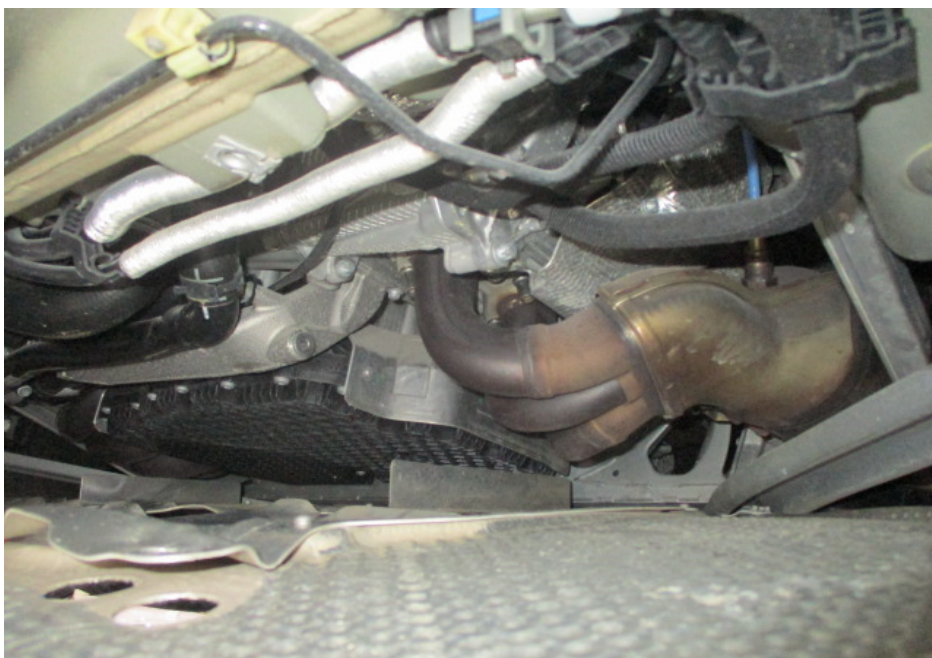
Photo 29 shows another view of the engine compartment of the Motor Car at the time of my inspection. The engine compartment was at the rear underside of the Motor Car. The various parts and components inside the engine compartment were all observed to be intact and properly fitted. There was also no sign(s) or indication(s) of fluid leak and/or fluid stain found inside the engine compartment.

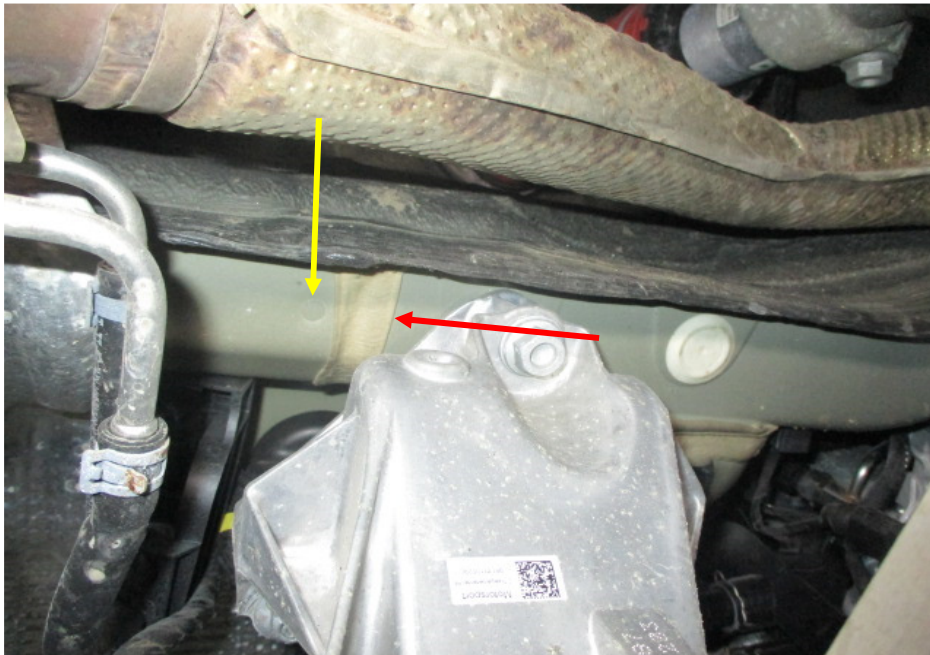
12. Visually, I did not find any weld marks, other than the original spot weld marks, on the chassis/structural body of the Motor Car. The original factory sealant at the joints along the chassis/structural body was also untouched, again indicating that no replacement of the chassis/structural body was carried out; and that the chassis/structural body was originally fitted.

Photo 30 shows the chassis/structural body at the underside rear right of the Motor Car. I did not find any weld marks other than original spot weld marks (yellow arrow) on the chassis/structural body of the Motor Car. The original factory sealant (red arrow) at the joints along the chassis/structural body was untouched, indicating no work was done on the chassis/structural body of the Motor Car and that the chassis/structural body was originally fitted.
