Your Ref: Porsche 718 Cayman GT 4
(chassis number WP0ZZZ98ZLK284443)

12 August 2021

Our Ref : CI/TP21008478/D

INSPECTION REPORT OF AN UNREGISTERED PORSCHE 718 CAYMAN GT 4 MOTOR CAR WITH CHASSIS NUMBER WP0ZZZ98ZLK284443

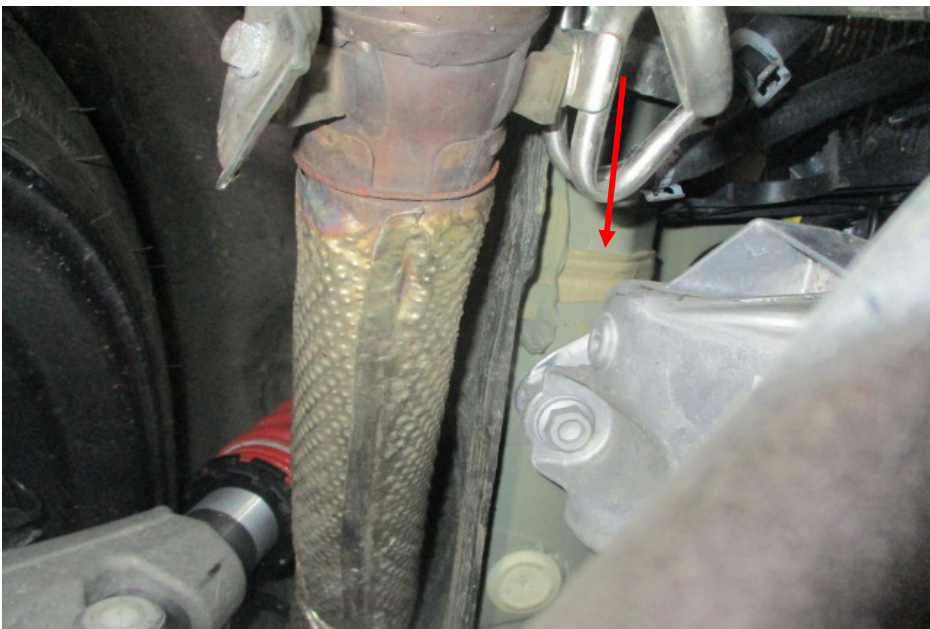
Photo 31 shows the chassis/structural body at the underside rear left of the Motor Car. I did not find any weld marks other than original spot weld marks on the chassis/structural body of the Motor Car. The original factory sealant (arrowed) at the joints along the chassis/structural body was untouched, indicating no work was done on the chassis/structural body of the Motor Car and that the chassis/structural body was originally fitted.

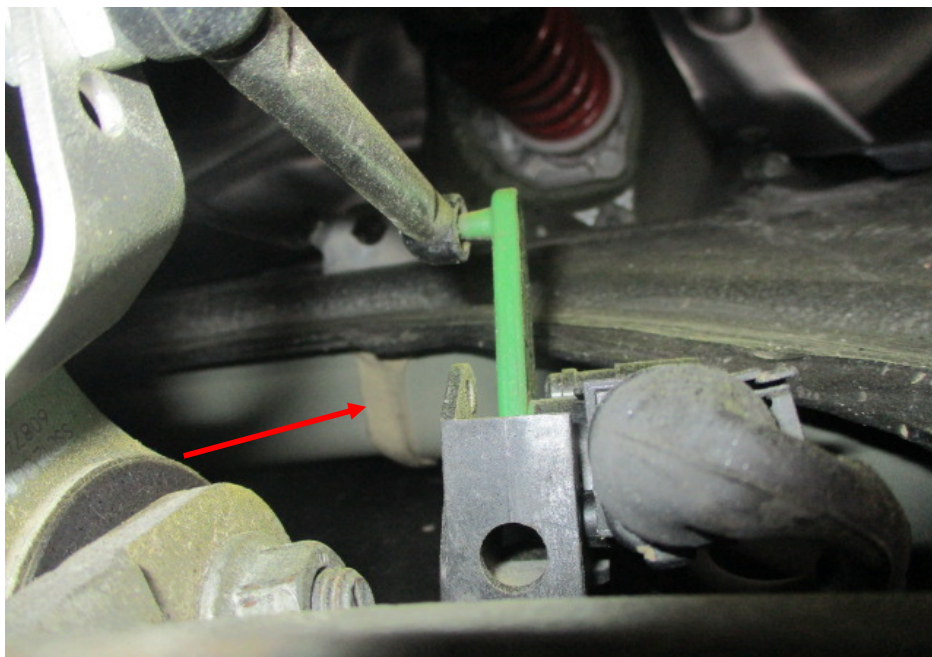
Photo 32 shows the chassis/structural body at the underside front left of the Motor Car. The original factory sealant (arrowed) at the joints along the chassis/structural body was observed to be untouched. In general, I had found no work was carried out on the chassis/structural body of the Motor Car. The chassis/structural body of the Motor Car was originally fitted.

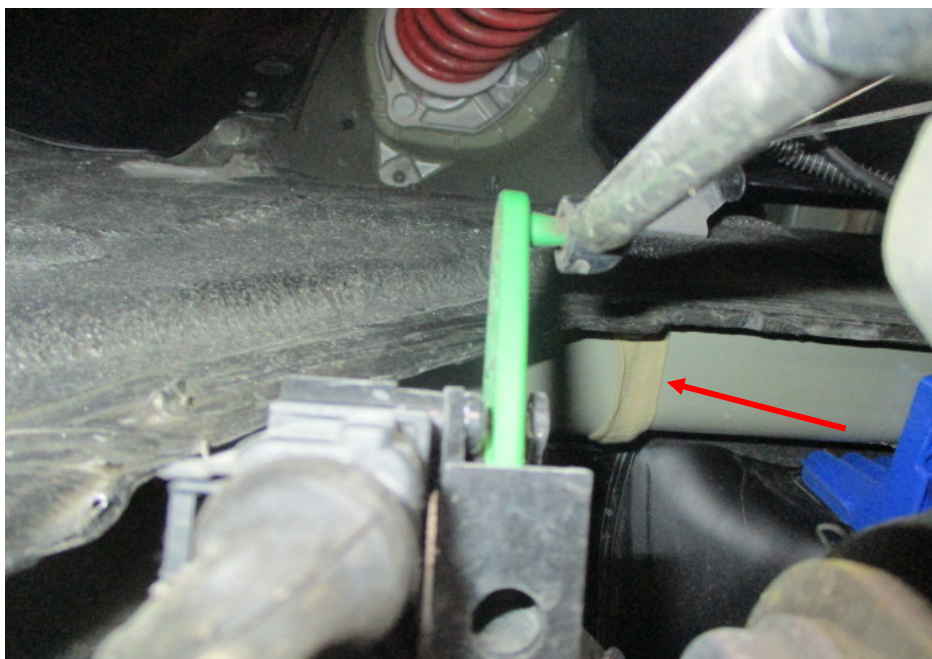
Photo 33 shows the chassis/structural body at the underside front right of the Motor Car. The original factory sealant (arrowed) at the joints along the chassis/structural body was observed to be untouched. In general, I had found no work was carried out on the chassis/structural body of the Motor Car. The chassis/structural body of the Motor Car was originally fitted.

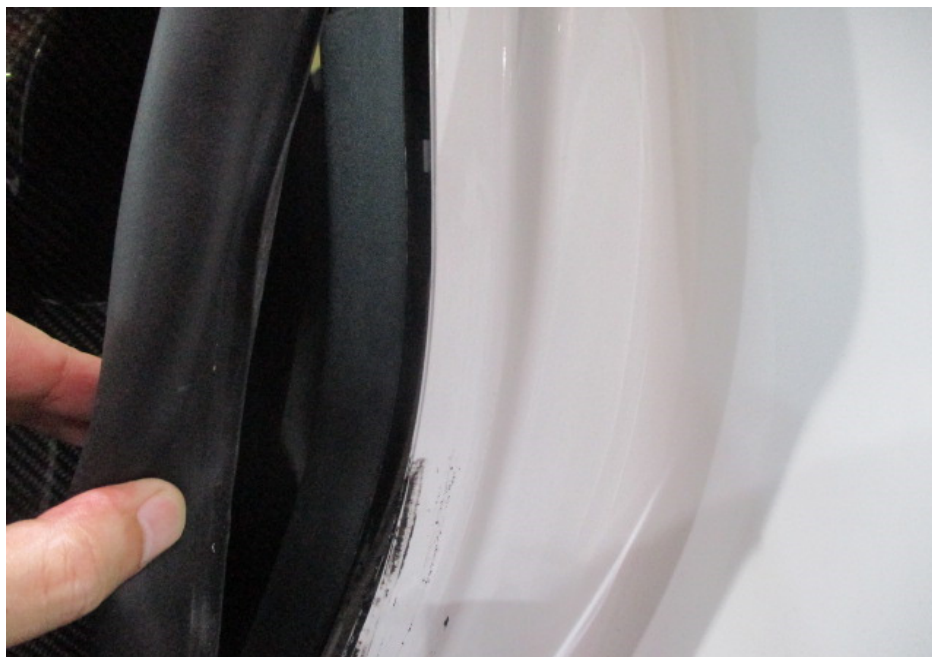
11. Checks on the non-detachable body panels like the rear body panels, floorboard, roof panel, pillars and rocker panels amongst others, revealed that these body panels were spot welded onto the chassis/structural body of the Motor Car. The original factory sealant at the joints of the non-detachable body panels was all untouched indicating no replacement of the non-detachable body panels was carried out; and that these body panels were all originally fitted except for the rear left body panel of the Motor Car, which was found to be replaced (refer to photograph 34 below).

Photo 34 shows the rear left body panel of the Motor Car. I did not find any original weld marks at the rear left body panel of the Motor Car, indicating that the rear left body panel of the Motor Car was replaced. The lack of original weld marks seen was due to replacement work when the replaced rear left body panel was re-welded onto the Motor Car and smoothen for re-spraying work.

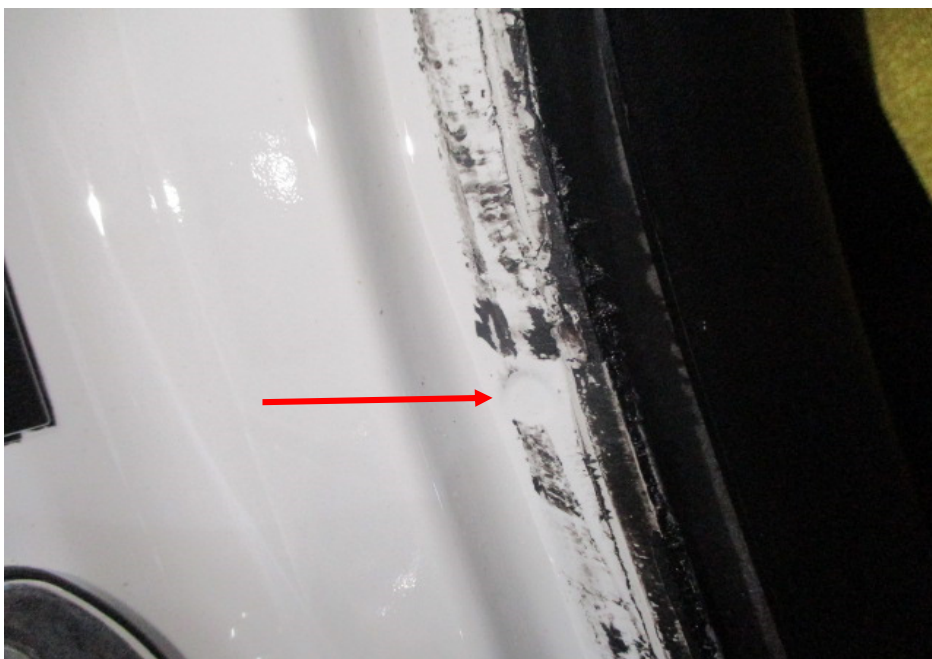
Photo 35 shows the rear right body panel of the Motor Car. I did not find any weld marks other than original spot weld marks (arrowed) on the rear right body panel of the Motor Car, which indicates that there was no re-welding works carried out. In general, I had found all the non-detachable body panels of the Motor Car to be originally fitted at the time of my inspection.

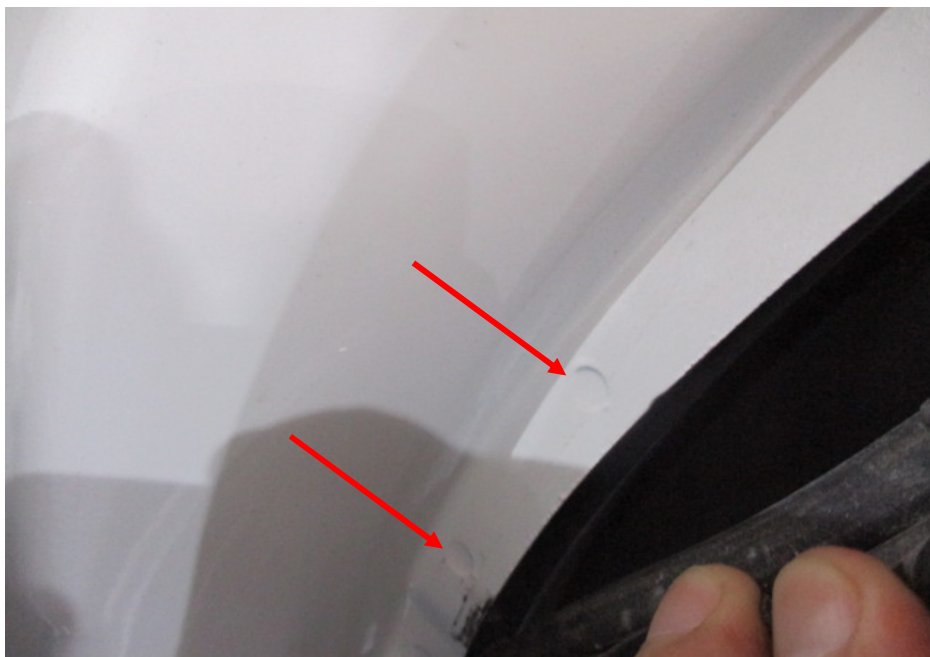
Photo 36 shows the left side "A" pillar of the Motor Car. I did not find any weld marks other than original spot weld marks (arrowed) on the left side "A" pillar of the Motor Car, which indicates that there was no re-welding works carried out. In general, I had found all the non-detachable body panels of the Motor Car to be originally fitted at the time of my inspection.
