Your Ref: Porsche 718 Boxster
(chassis number WP0ZZZ98ZKS200220)
Our Ref : CI/TP21008599/D

21 August 2021

**INSPECTION REPORT OF AN UNREGISTERD PORSCHE 718 BOXSTER
MOTOR CAR WITH CHASSIS NUMBER WP0ZZZ98ZKS200220**

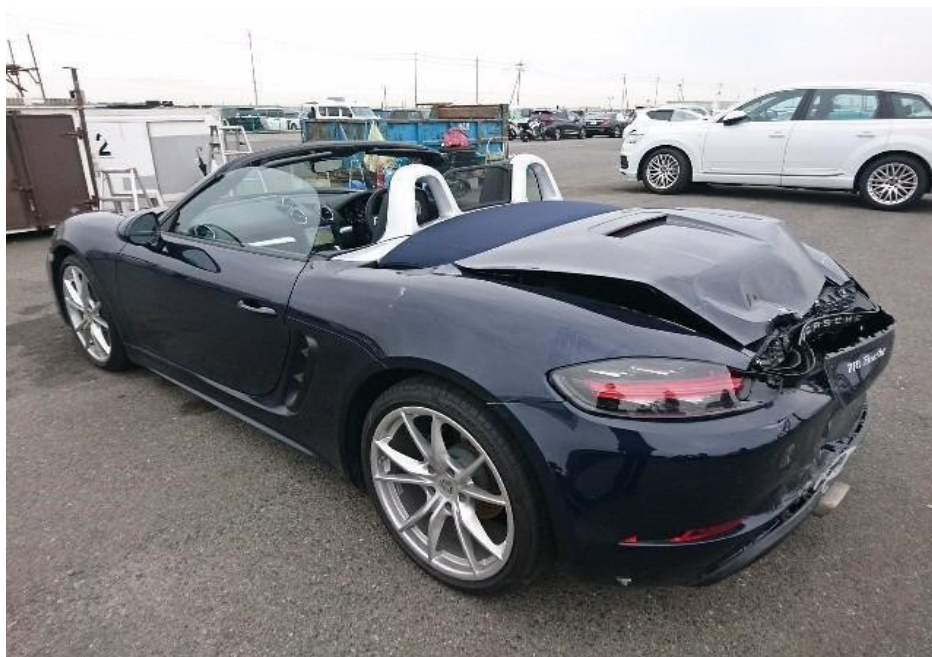
Photo 1 shows the rear left body of the Motor Car (photograph provided to me). The Motor Car was observed to have sustained damage at its rear portion. The rear bumper, rear bumper left reflector, rear bumper top centre garnish, rear bumper top lip, rear exhaust tip, rear left taillamp and rear bootlid were amongst the body parts that were observed to have been damaged.

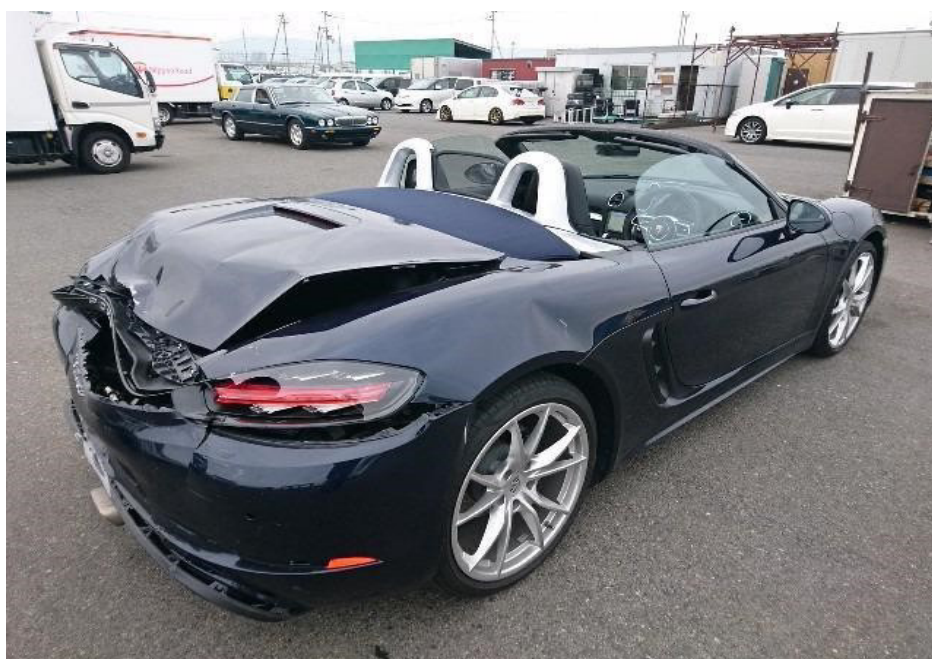
Photo 2 shows the rear right body of the Motor Car (photograph provided to me). The Motor Car was observed to have sustained damage at its rear portion. The rear bumper, rear bumper right reflector, rear bumper lower cover, rear right taillamp, rear bootlid and rear right body panel were amongst the body parts that were observed to have been damaged. As seen from the photographs, the airbags of the Motor Car were not deployed.

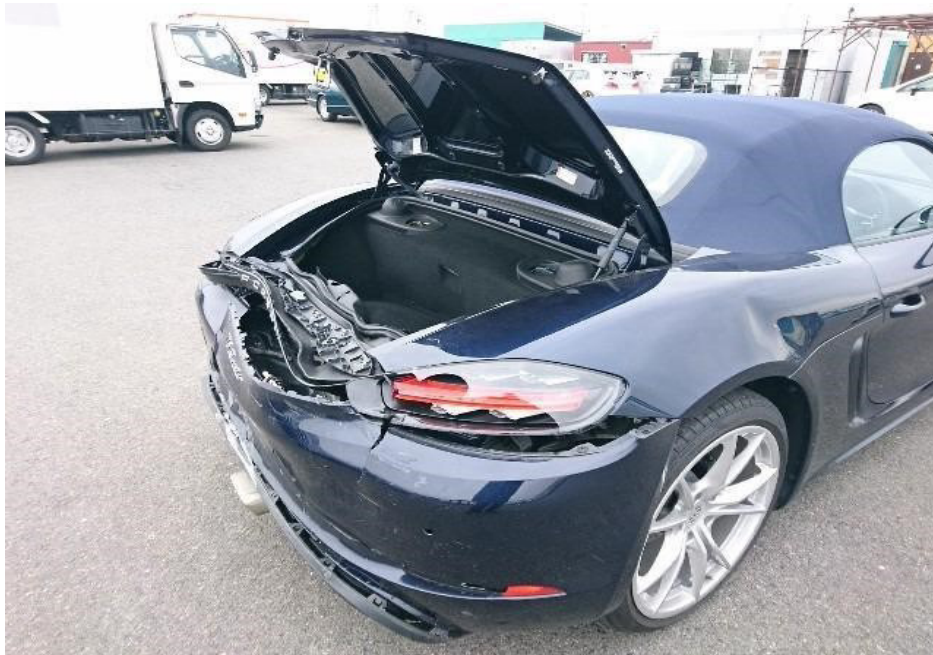
Photo 3 shows another view of the Motor Car's rear right body (photograph provided to me). The Motor Car was observed to have sustained damage at its rear portion. The rear bumper top centre garnish, rear bumper top lip, rear end panel, rear end panel inner garnish, rear bootlid, rear bootlid lock, rear bootlid weatherstrip, rear right taillamp and rear right body panel were amongst the body parts that were observed to have been damaged.

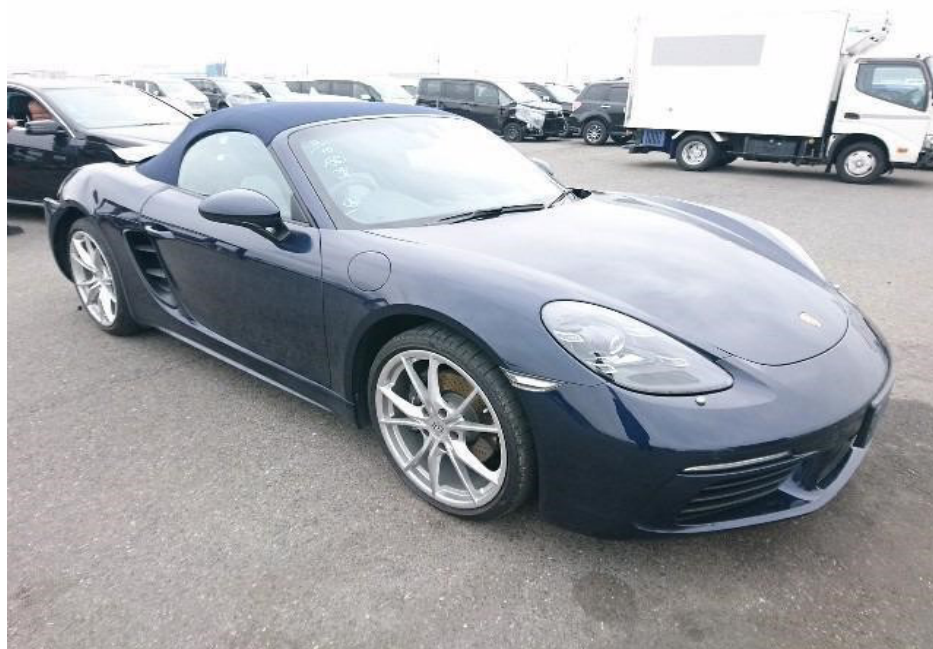
Photo 4 shows the front right body of the Motor Car (photograph provided to me). Apart for the rear portion, there was no physical damage seen to other areas of the Motor Car. The airbags were also not deployed.

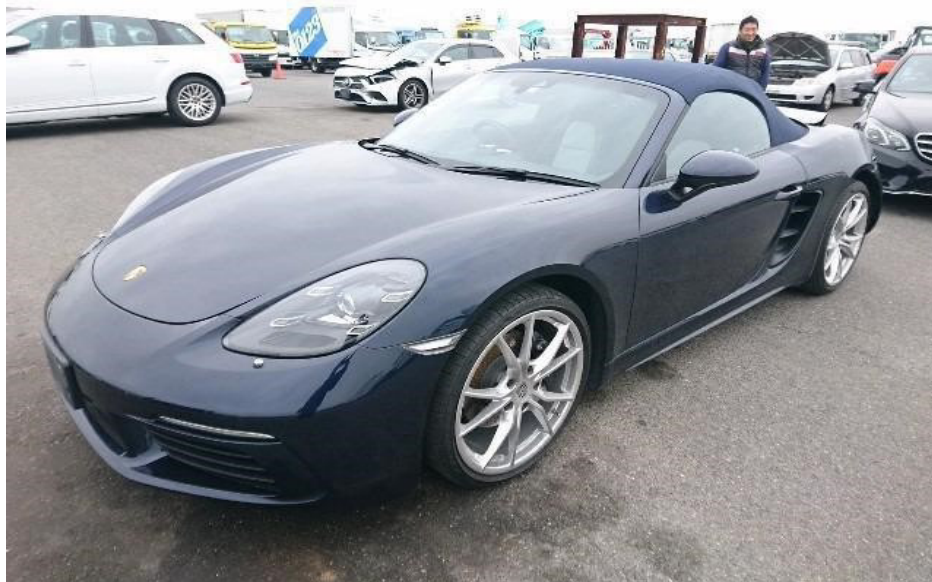
Photo 5 shows the front left body of the Motor Car (photograph provided to me). Apart for the rear portion, there was no physical damage seen to other areas of the Motor Car. The airbags were also not deployed.

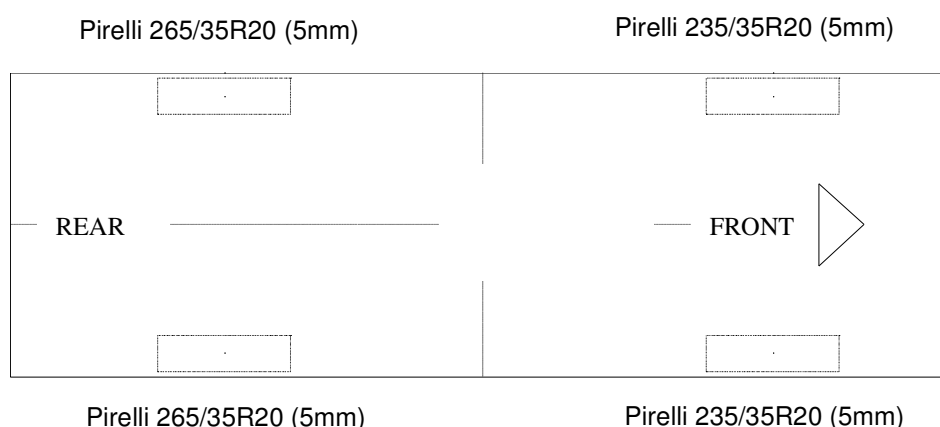
9. It was fitted with 20inch sport wheel rims that were wrapped with tyres that were observed to be of serviceable condition. The tyres were also sufficiently inflated for vehicular operation. The tyre brand, tyre size and approximate remaining tread depth of the 4 tyres of the Motor Car were recorded as follows: -

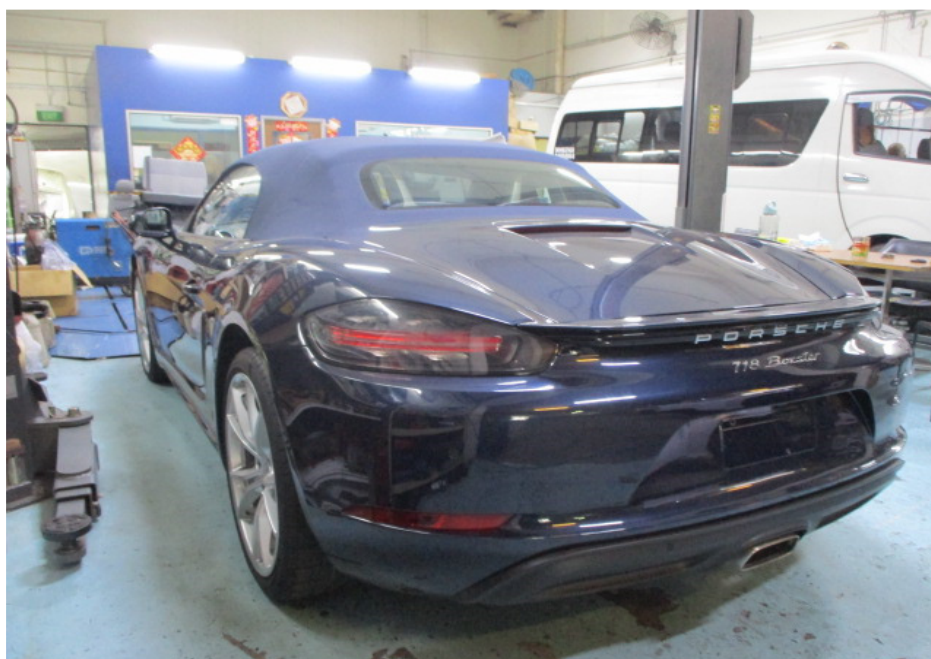
Photo 6 shows a general view of the rear left body of the Motor Car at the time of my inspection. The Motor Car was observed to be in a relatively good general condition with no loose exterior fittings observed. The body parts at the rear portion of the Motor Car were visually examined and it was observed that the repair/restoration works carried out to the damaged area of the Motor Car (refer to photograph 1 – 3 above) were reasonably adequate and in order.

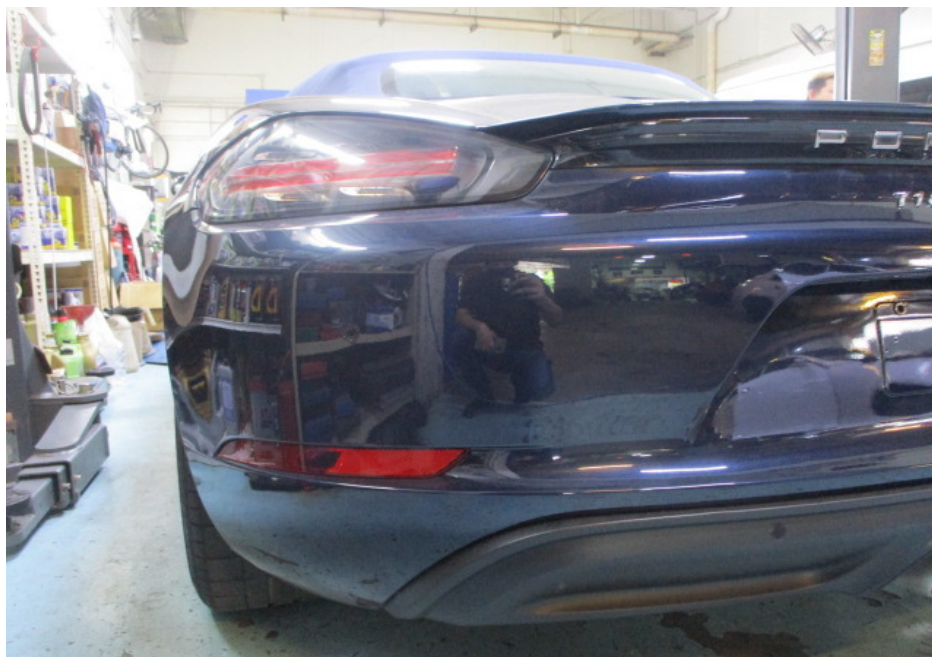
Photo 7 shows a closer view of the Motor Car's rear bumper, rear bumper left reflector, rear bumper lower cover and rear left taillamp. The body parts at the rear portion of the Motor Car were visually examined and it was observed that the repair/restoration works carried out to the damaged area of the Motor Car (refer to photograph 1 – 3 above) were reasonably adequate and in order.

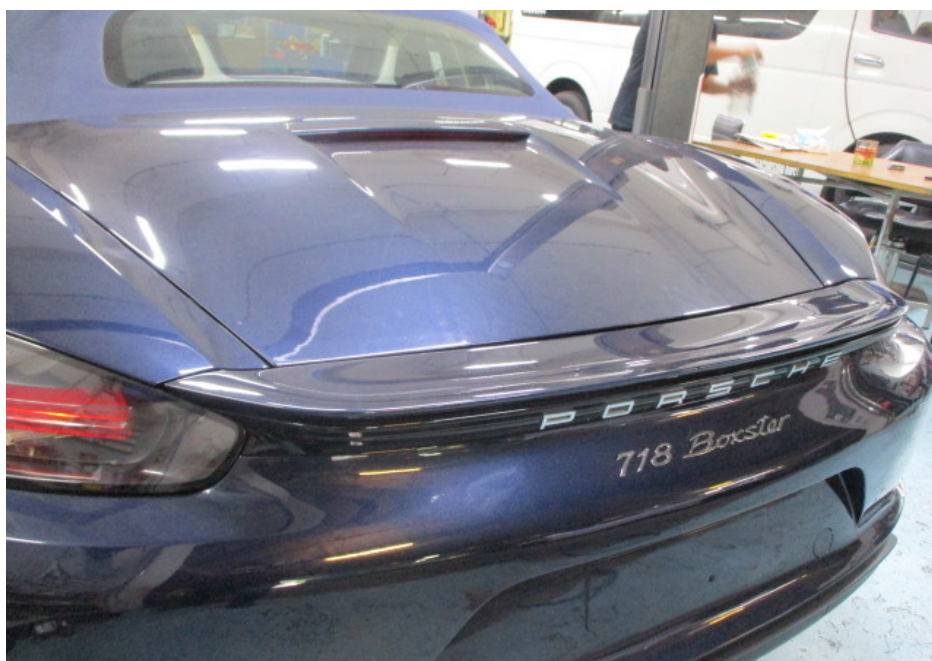
Photo 8 shows a closer view of the Motor Car's rear bumper top centre garnish, rear bumper top lip and rear bootlid. The body parts at the rear portion of the Motor Car were visually examined and it was observed that the repair/restoration works carried out to the damaged area of the Motor Car (refer to photograph 1 – 3 above) were reasonably adequate and in order.

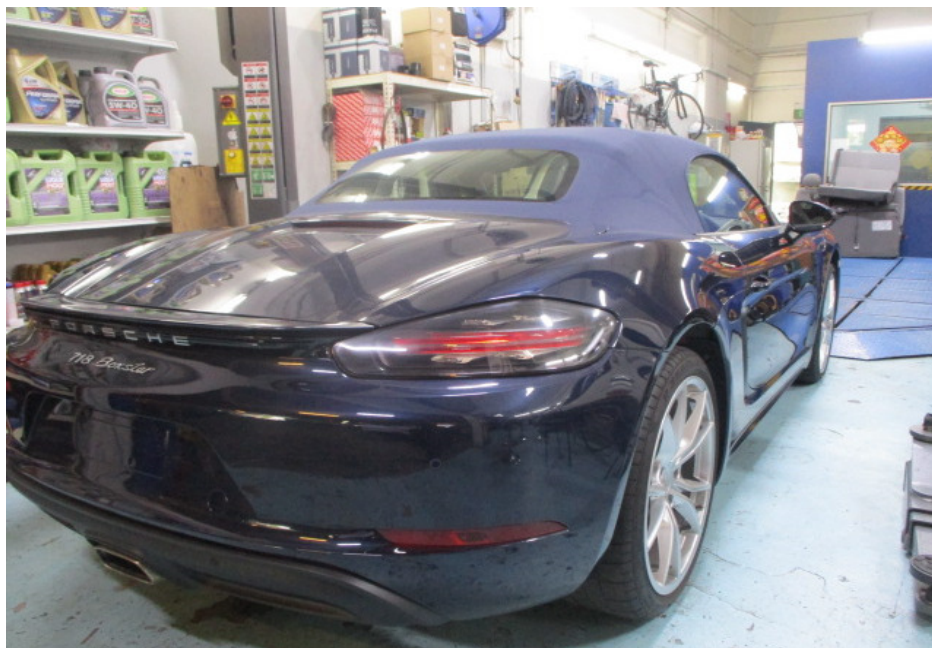
Photo 9 shows a general view of the rear right body of the Motor Car at the time of my inspection. The Motor Car was observed to be in a relatively good general condition with no loose exterior fittings observed. The body parts at the rear portion of the Motor Car were visually examined and it was observed that the repair/restoration works carried out to the damaged area of the Motor Car (refer to photograph 1 – 3 above) were reasonably adequate and in order.

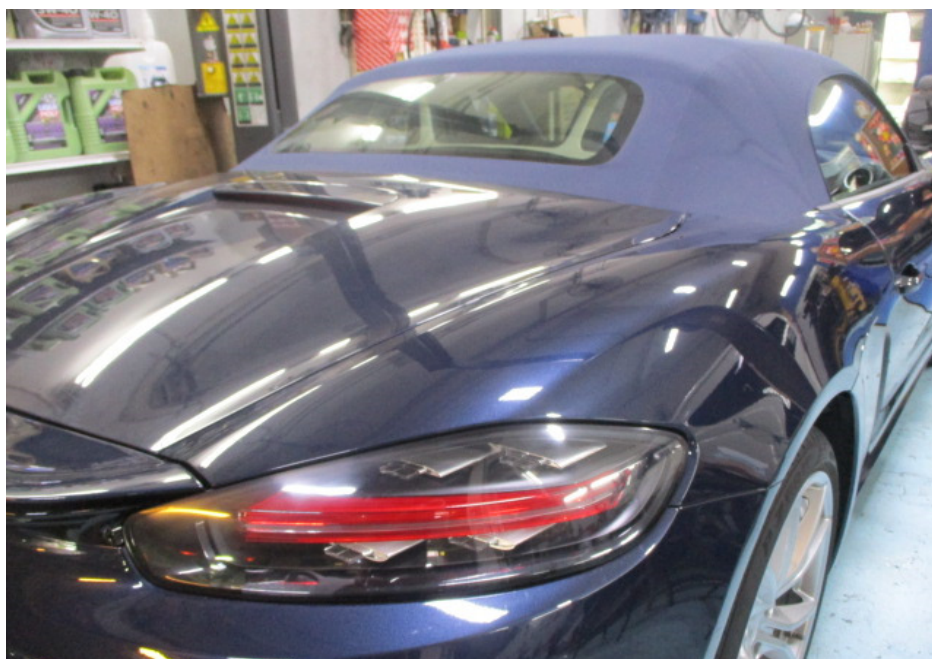
Photo 10 shows a closer view of the Motor Car's rear right body panel, rear right taillamp and rear bootlid. The body parts at the rear portion of the Motor Car were visually examined and it was observed that the repair/restoration works carried out to the damaged area of the Motor Car (refer to photograph 1 – 3 above) were reasonably adequate and in order.

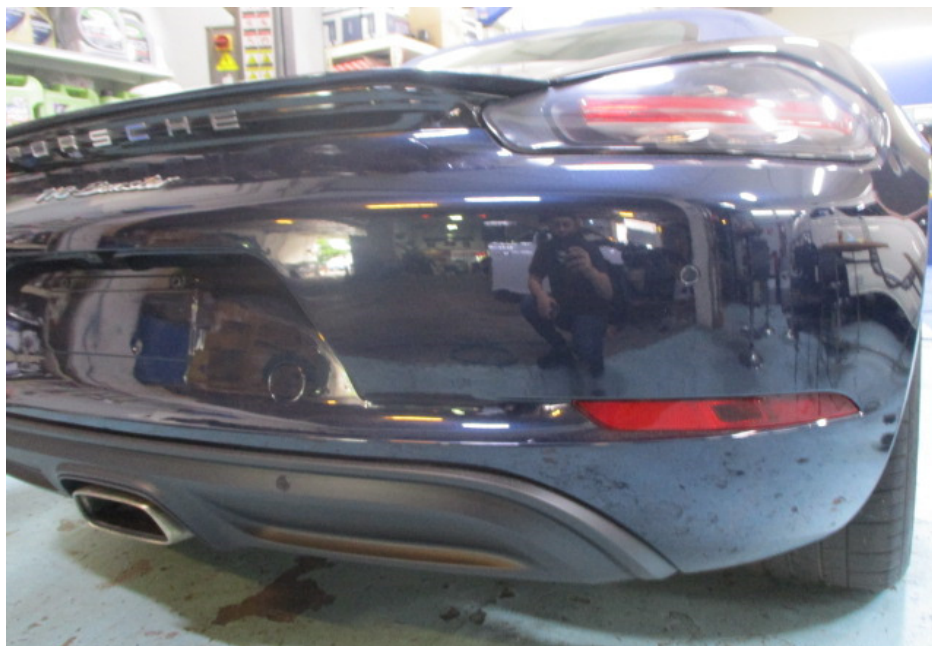
Photo 11 shows a closer view of the Motor Car's rear bumper, rear bumper right reflector, rear bumper lower cover and rear exhaust tip. The body parts at the rear portion of the Motor Car were visually examined and it was observed that the repair/restoration works carried out to the damaged area of the Motor Car (refer to photograph 1 – 3 above) were reasonably adequate and in order.

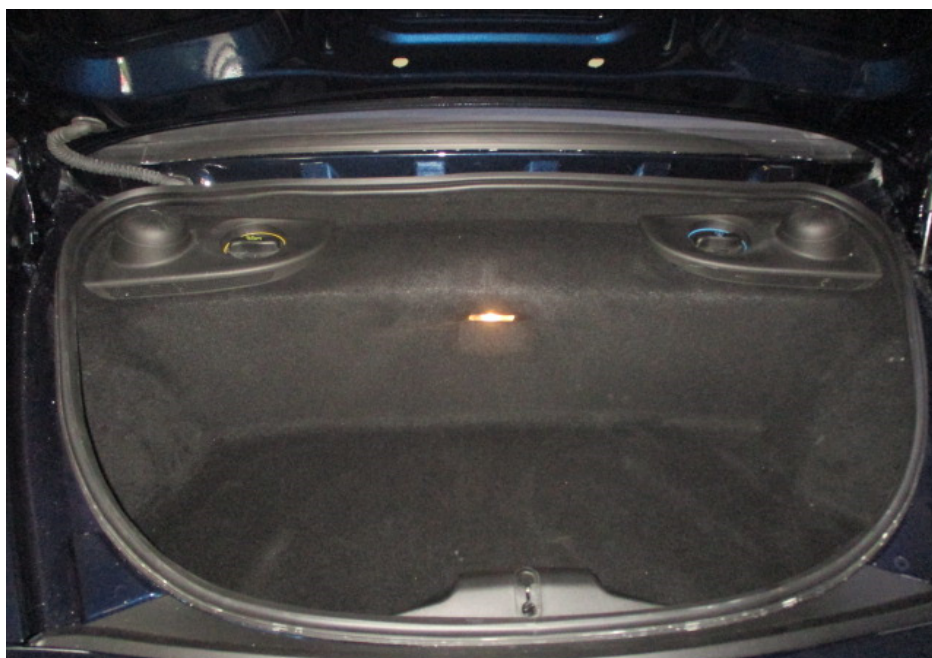
Photo 12 shows a general of the Motor Car's rear boot compartment at the time of my inspection. All inner trims, garnishes and upholstery etc were observed to be properly fitted. The body parts at the rear portion of the Motor Car were visually examined and the repair/restoration works carried out to the damaged area of the Motor Car (refer to photograph 1 - 3 above) were found to be reasonably adequate and in order.

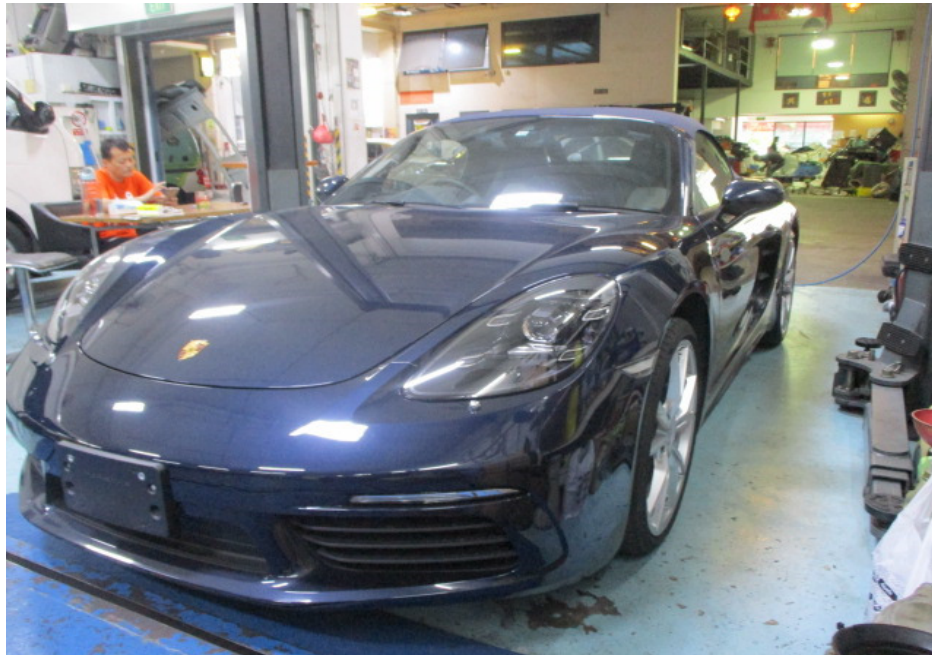
Photo 13 shows a general view of the front left body of the Motor Car at the time of my inspection. The Motor Car was observed to be in a relatively good general condition with no loose exterior fittings observed. The mileage of the Motor Car recorded at the time of my inspection was 10,673km.

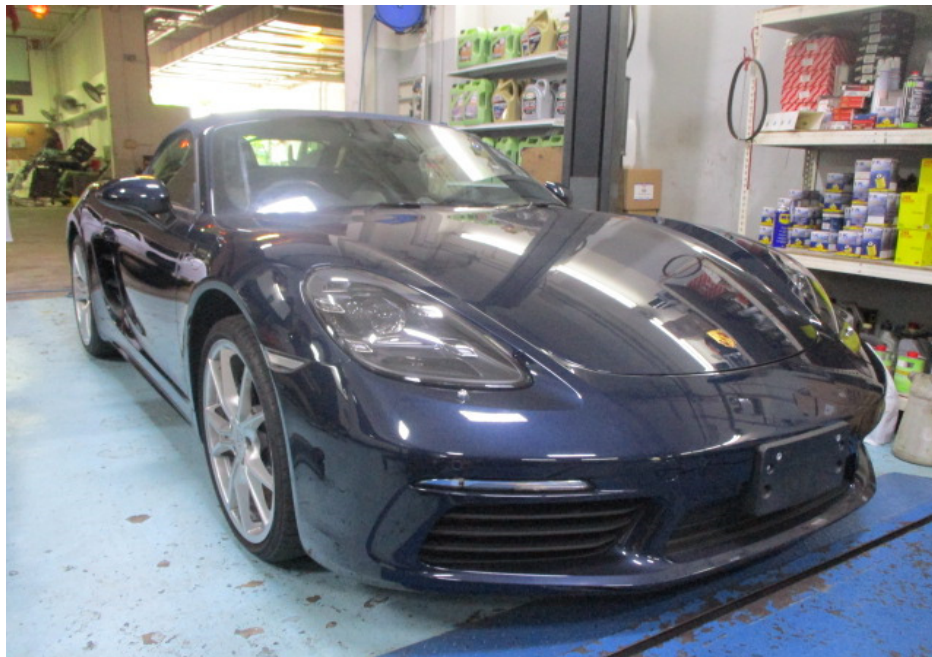
Photo 14 shows a general view of the front right body of the Motor Car at the time of my inspection. The Motor Car was observed to be in a relatively good general condition with no loose exterior fittings observed. The mileage of the Motor Car recorded at the time of my inspection was 10,673km.

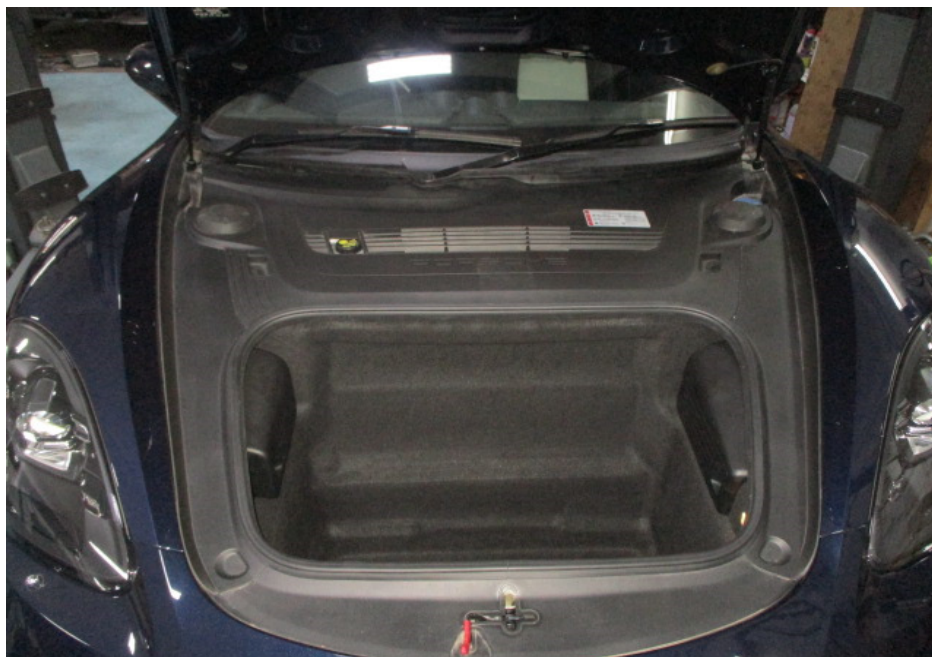
Photo 15 shows a general of the Motor Car's front bonnet compartment at the time of my inspection. All inner trims, garnishes and upholstery etc were observed to be properly fitted.

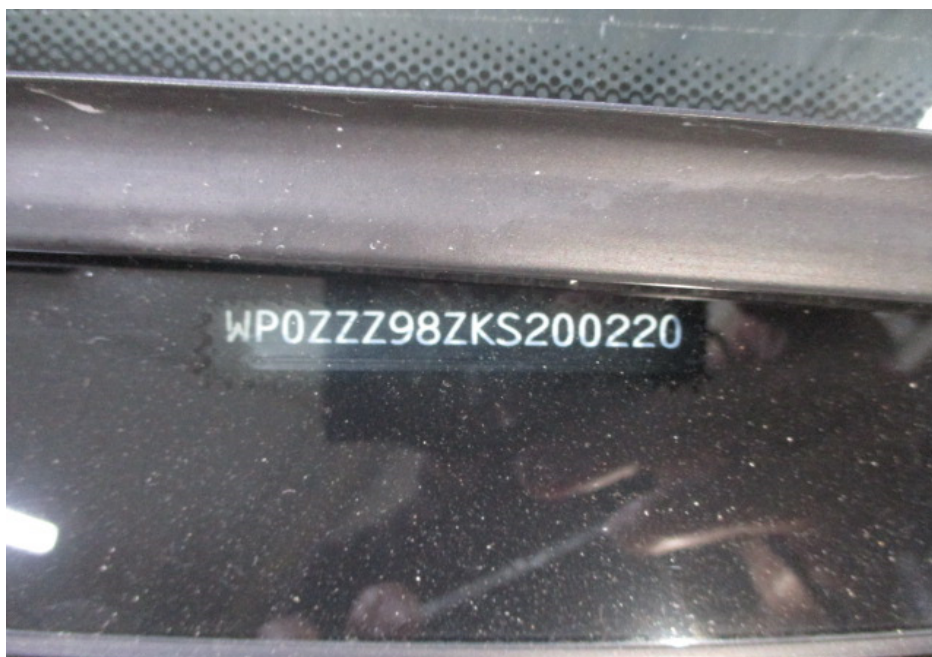
Photo 16 shows the chassis number of the Motor Car. The chassis number recorded WP0ZZZ98ZKS200220.

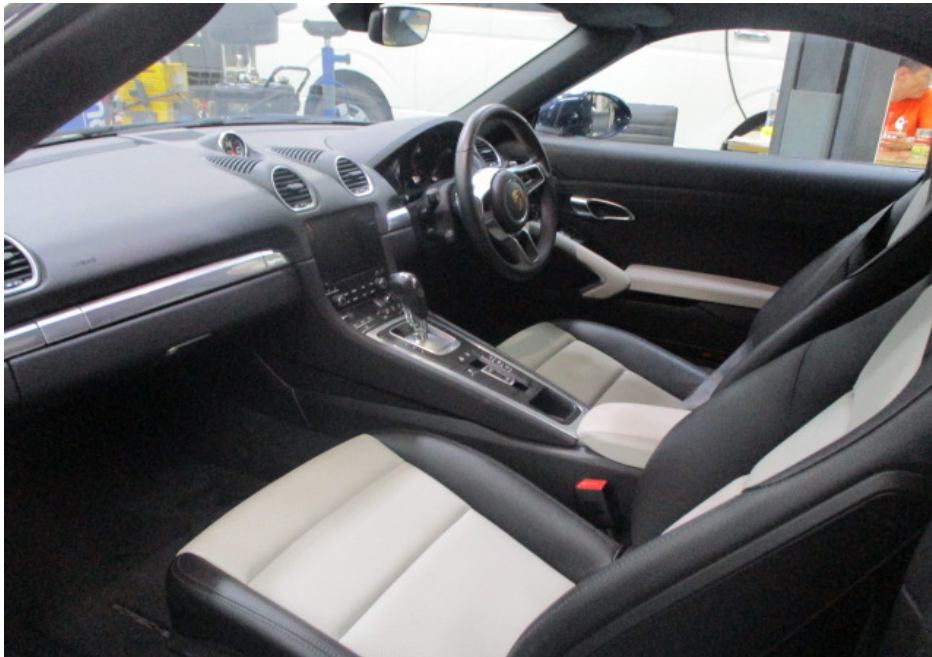
Photo 17 shows the interior compartment of the Motor Car at the time of my inspection. The various parts and components, trims, carpet and upholstery inside the interior compartment were all observed to be intact and properly fitted

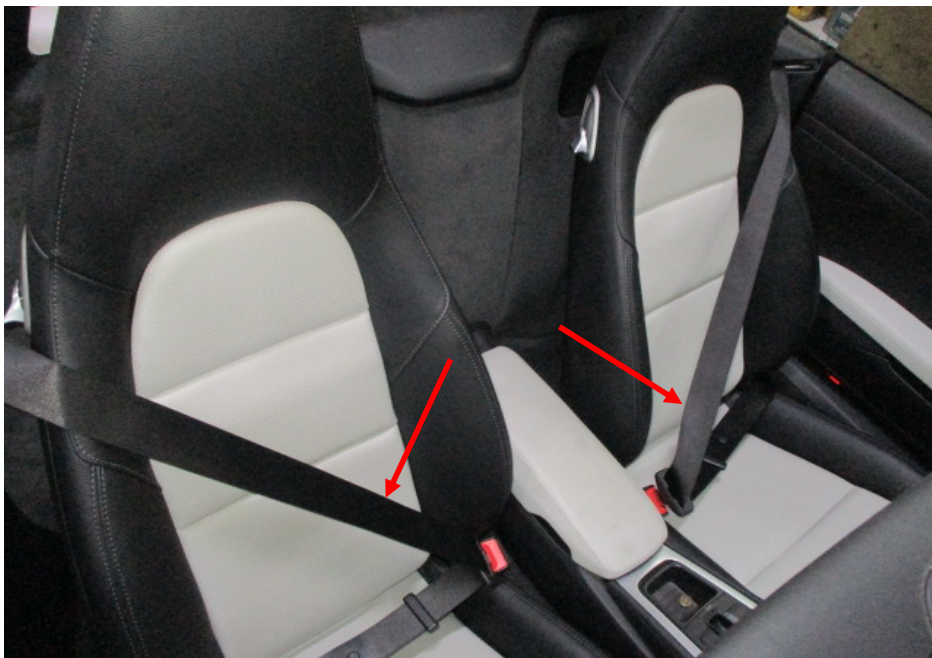
Photo 18 shows the seats of the Motor Car. All the seats of the Motor Car were secured via seat rails to the floorboard. They were also fitted with a retractable seat belt reel and a pre-tensioner. The seat belts (arrowed) were tested and were able to be fastened into the respective pre-tensions that were fitted on the side of each individual seat.

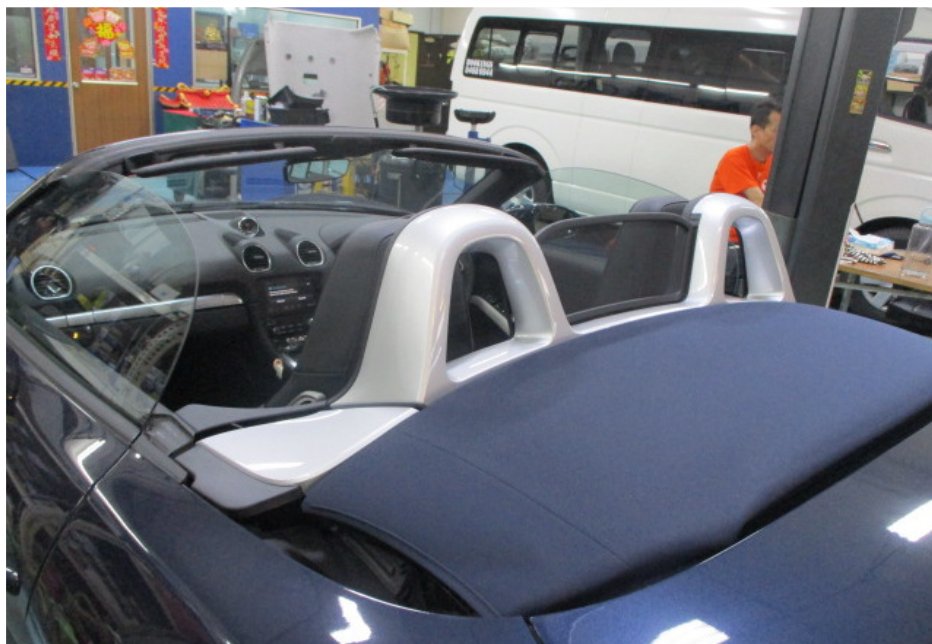
Photo 19 shows the Motor Car with its soft top roof in an open position. It was observed that as a safety feature, the soft top roof could only open and close when the Motor Car was in a stationary position. When in an open position, the soft top roof is completely folded into its rear compartment with no parts protruding out of the Motor Car's body. The soft top roof was also found adequately secured to the "A" pillar after closing.

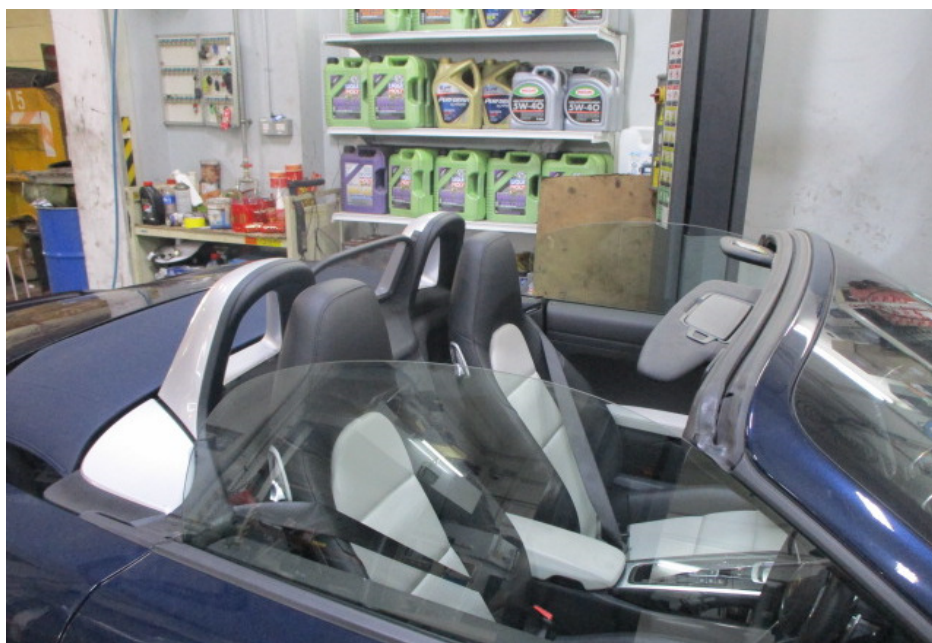
Photo 20 shows another view of the Motor Car with its soft top roof in an open position. It was observed that as a safety feature, the soft top roof could only open and close when the Motor Car was in a stationary position. When in an open position, the soft top roof is completely folded into its rear compartment with no parts protruding out of the Motor Car's body. The soft top roof was also found adequately secured to the "A" pillar after closing.

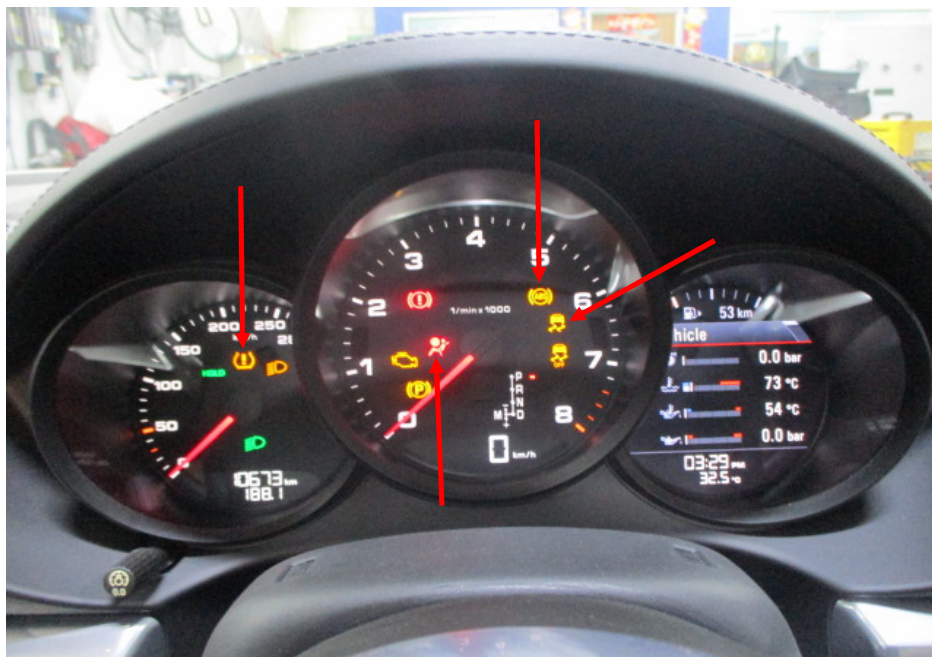
Photo 21 shows the warning lights for the various electronic safety features appearing on the instrument panel of the Motor Car during its self-test when the engine is cranked, in particular the ABS, SRS, TPM and TCS lights (arrowed).

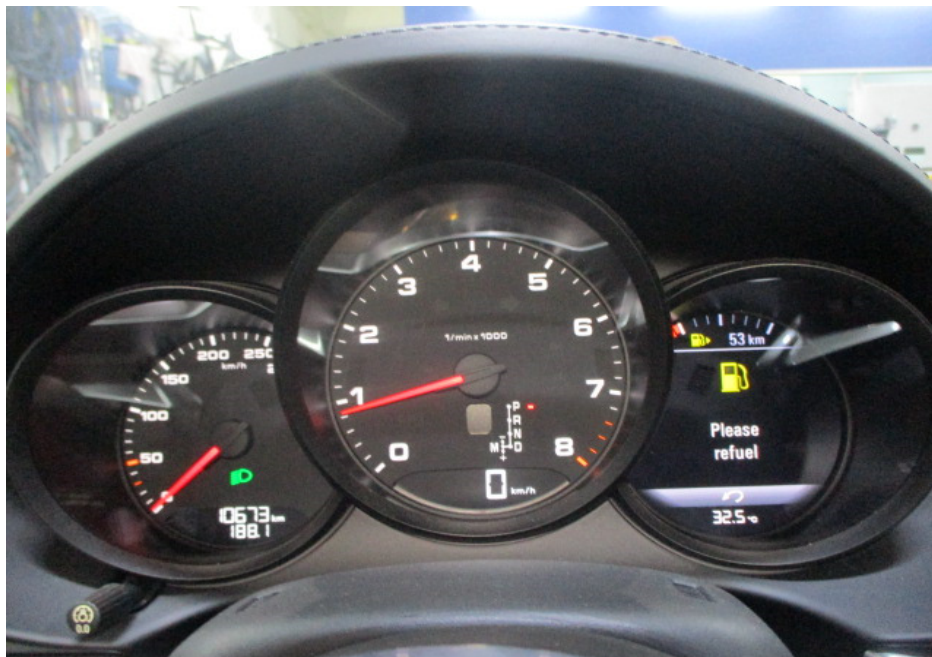
Photo 22 shows the respective warning lights no longer illuminated, indicating that there is no fault detected to the ABS, SRS, TPM and TCS systems of the Motor Car during the self-test. These electronic systems were hence in working condition at the time of my inspection.

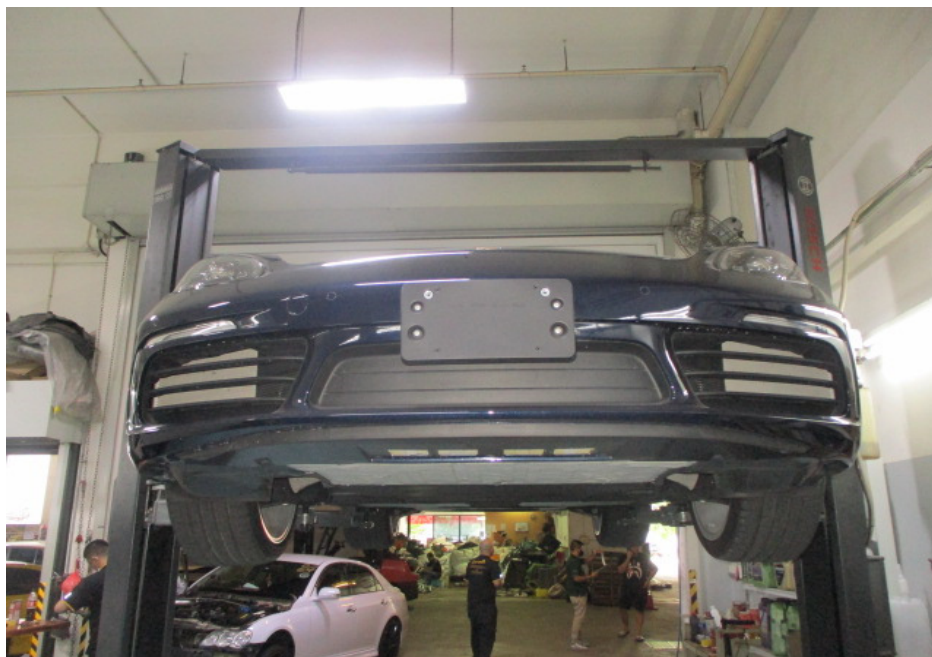
Photo 23 shows the Motor Car hoisted up for checks on its undercarriage. There was no sign(s) or indication(s) of fluid leakage and/or fluid stain(s) on the underside of the Motor Car. The undercarriage components of the Motor Car were also all observed to be intact and secured in an appropriate manner.

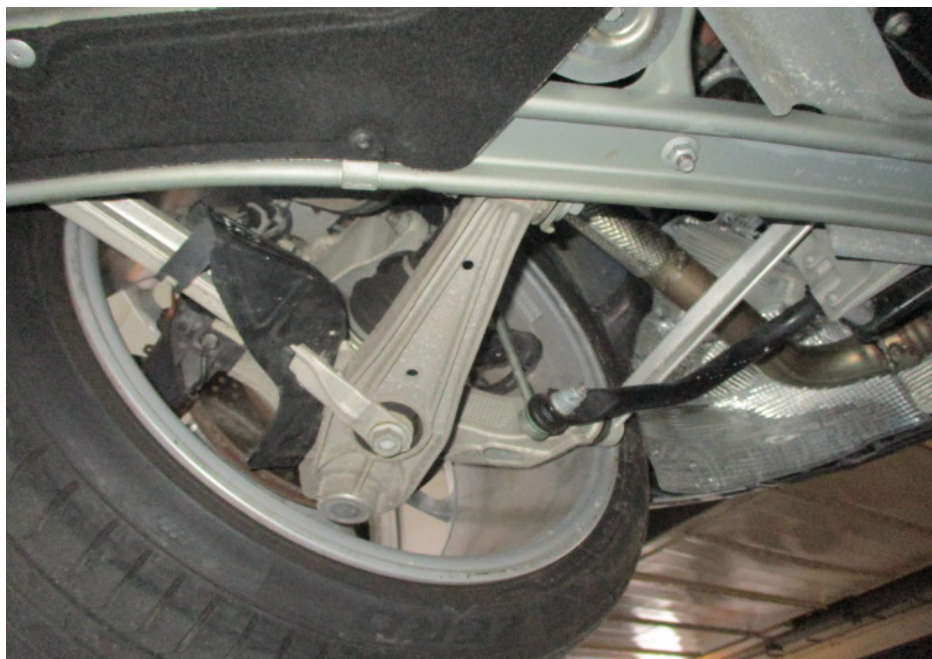
Photo 24 shows a general view of the control arms and linkages at the rear right wheel of the Motor Car. I did not observe any fluid leak and/or fluid stain on the underside of the Motor Car. All of the Motor Car's undercarriage components were observed to be intact and secured in an appropriate manner.

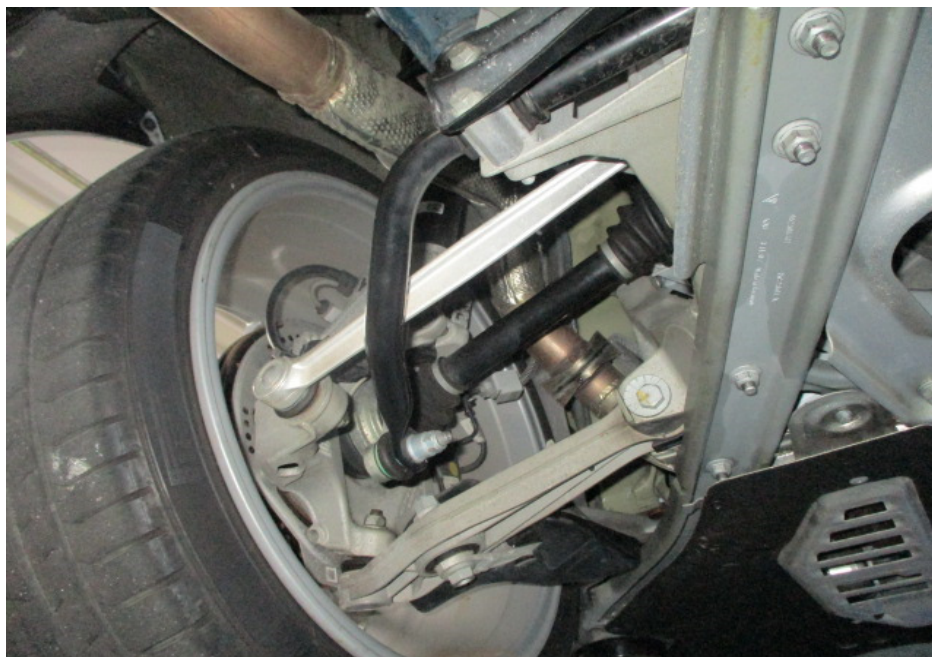
Photo 25 shows a general view of the control arms and linkages at the rear left wheel of the Motor Car. I did not observe any fluid leak and/or fluid stain on the underside of the Motor Car. All of the Motor Car's undercarriage components were observed to be intact and secured in an appropriate manner.

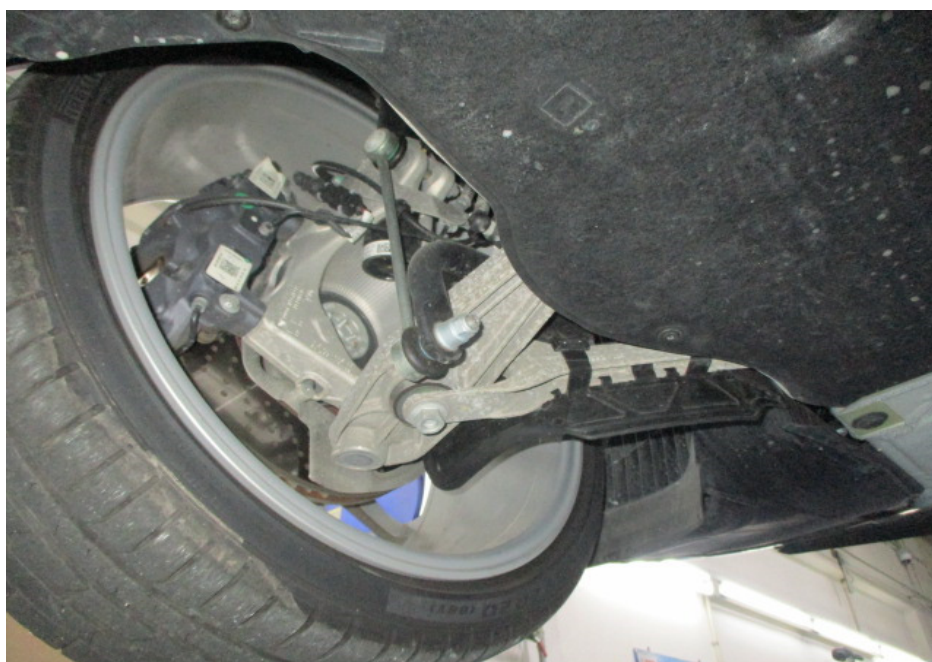
Photo 26 shows the various undercarriage components at the front left wheel of the Motor Car. The mechanical components, control arms and linkages were all found to be intact and secured in an appropriate manner.

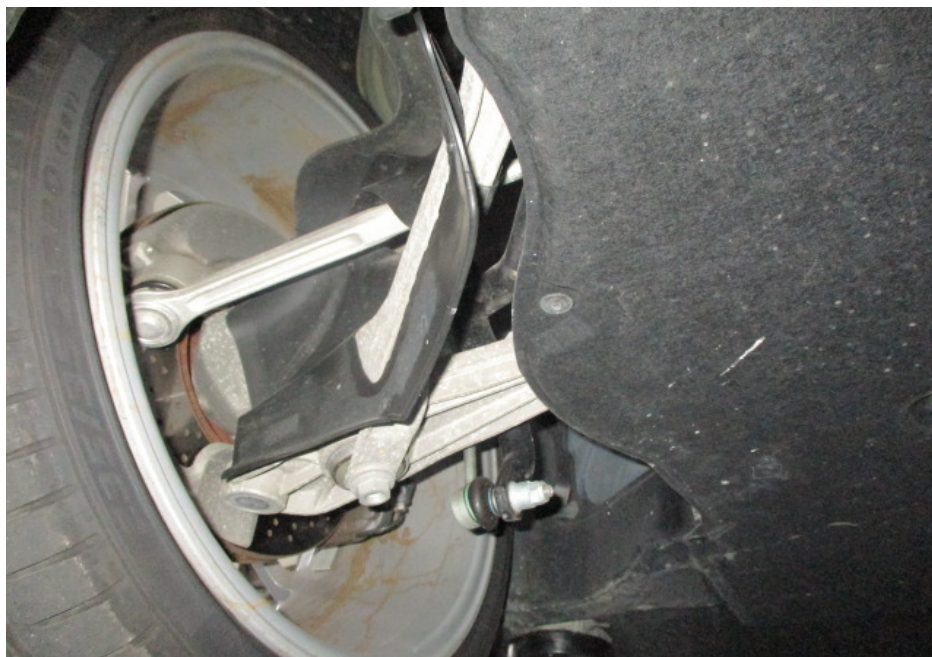
Photo 27 shows the various undercarriage components at the front right wheel of the Motor Car. The mechanical components, control arms and linkages were all found to be intact and secured in an appropriate manner. I also did not observe any fluid leak and/or fluid stain on the underside of the Motor Car.

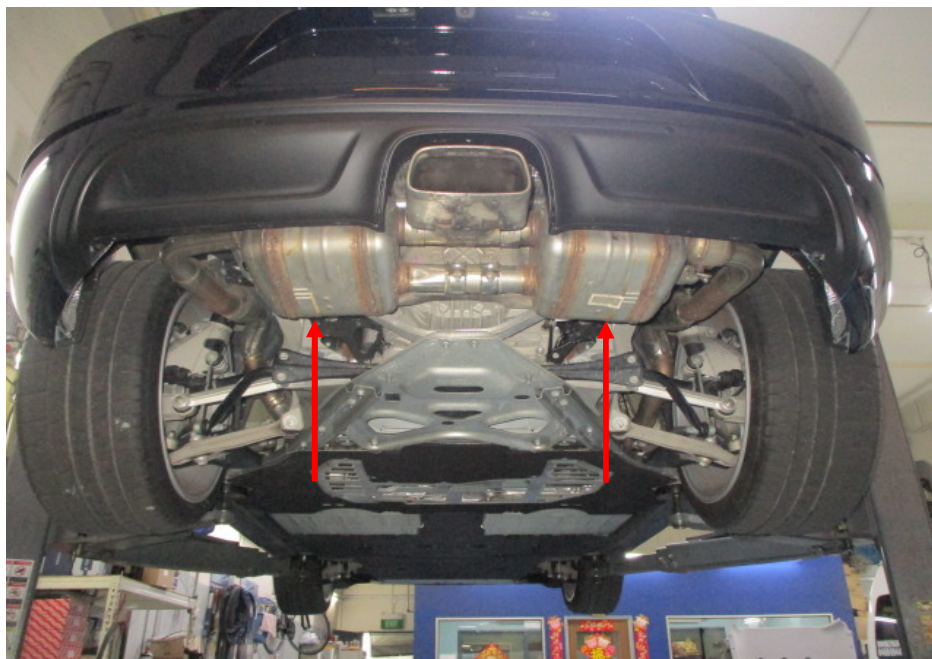
Photo 28 shows the Motor Car's rear mufflers (arrowed). My examination of the Motor Car's exhaust system revealed no sign(s) or indication(s) of any cut or weld marks along its exhaust pipes, on its catalytic converters and on its rear mufflers.

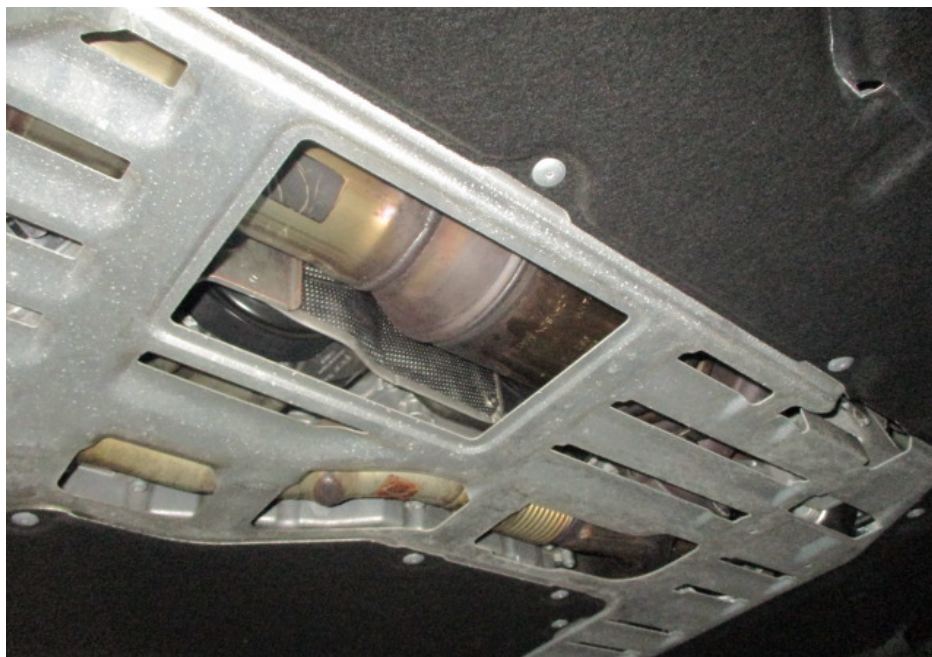
Photo 29 shows the Motor Car's catalytic converters. My examination of the Motor Car's exhaust system revealed no sign(s) or indication(s) of any cut or weld marks along its exhaust pipes, on its catalytic converters and on its rear mufflers.

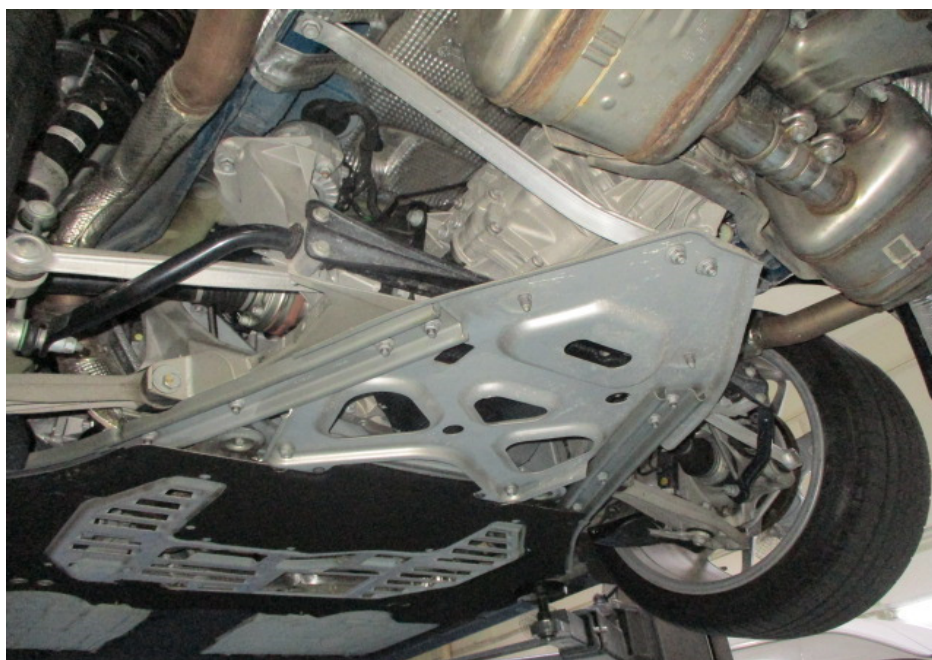
Photo 30 shows a general view of the Motor Car's engine compartment. The engine compartment was at the rear underside of the Motor Car. The various parts and components inside the engine compartment were all observed to be intact and properly fitted. There was also no sign(s) or indication(s) of fluid leak and/or fluid stain found inside the engine compartment.

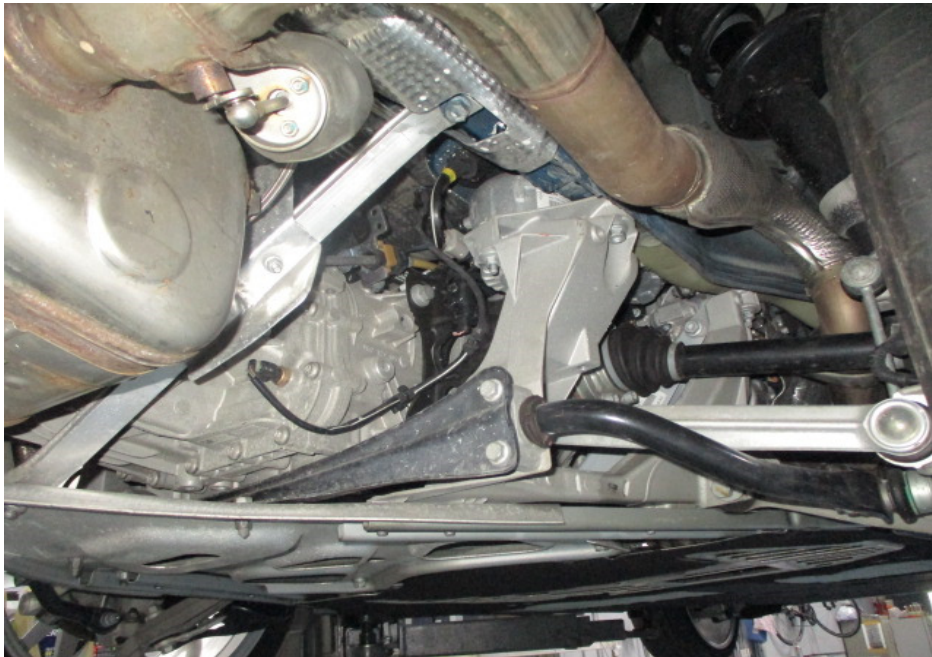
Photo 31 shows another view of the Motor Car's engine compartment. The engine compartment was at the rear underside of the Motor Car. The various parts and components inside the engine compartment were all observed to be intact and properly fitted. There was also no sign(s) or indication(s) of fluid leak and/or fluid stain found inside the engine compartment.

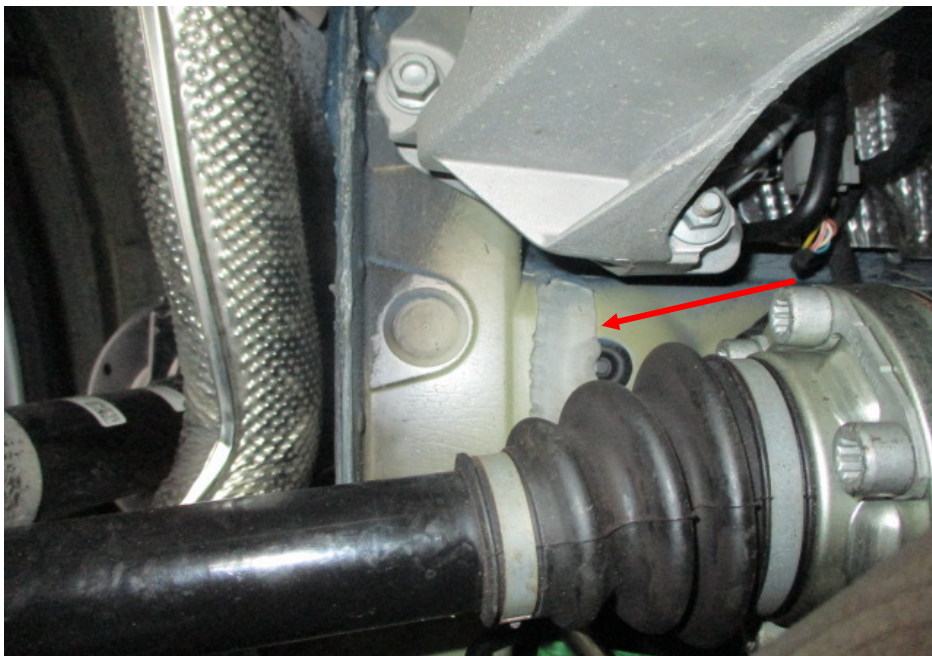
Photo 32 shows the chassis/structural body at the underside rear left of the Motor Car. I did not find any weld marks other than original spot weld marks on the chassis/structural body of the Motor Car. The original factory sealant (arrowed) at the joints along the chassis/structural body was untouched, indicating no work was done on the chassis/structural body of the Motor Car and that the chassis/structural body was originally fitted.
