Your Ref: Porsche 718 Boxster
(chassis number WP0ZZZ98ZKS200220)
Our Ref : CI/TP21008599/D

21 August 2021

**INSPECTION REPORT OF AN UNREGISTERD PORSCHE 718 BOXSTER
MOTOR CAR WITH CHASSIS NUMBER WP0ZZZ98ZKS200220**

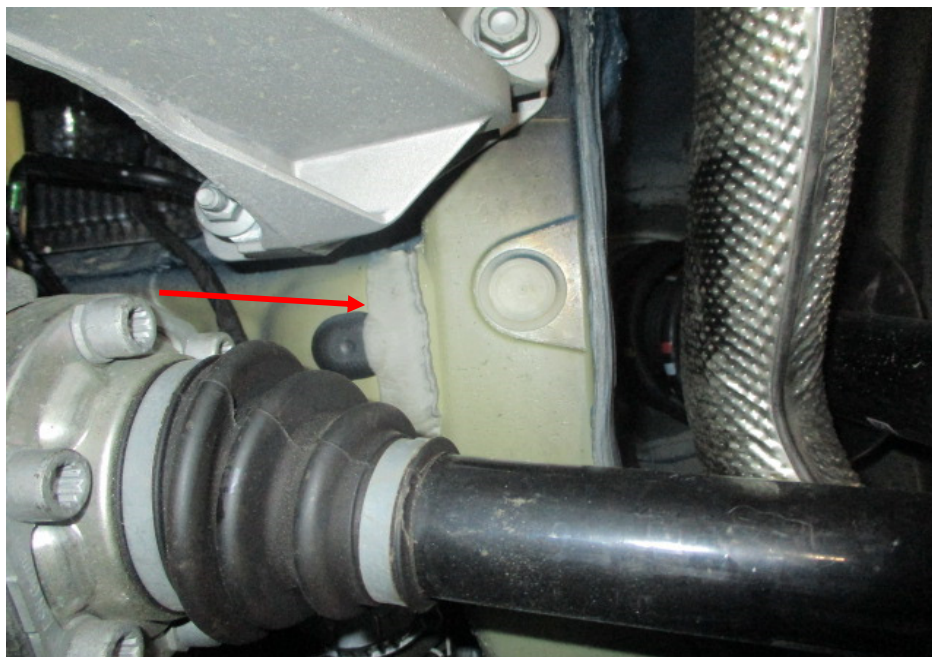
Photo 33 shows the chassis/structural body at the underside rear right of the Motor Car. I did not find any weld marks other than original spot weld marks on the chassis/structural body of the Motor Car. The original factory sealant (arrowed) at the joints along the chassis/structural body was untouched, indicating no work was done on the chassis/structural body of the Motor Car and that the chassis/structural body was originally fitted.

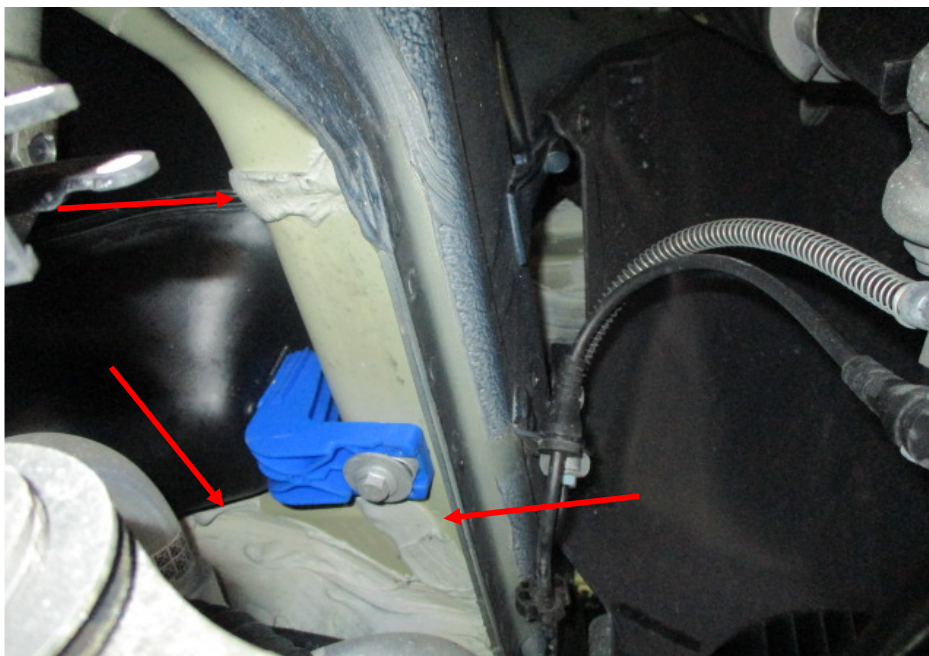
Photo 34 shows the chassis/structural body at the underside front right of the Motor Car. The original factory sealant (arrowed) at the joints along the chassis/structural body was observed to be untouched. In general, I had found no work was carried out on the chassis/structural body of the Motor Car. The chassis/structural body of the Motor Car was originally fitted.

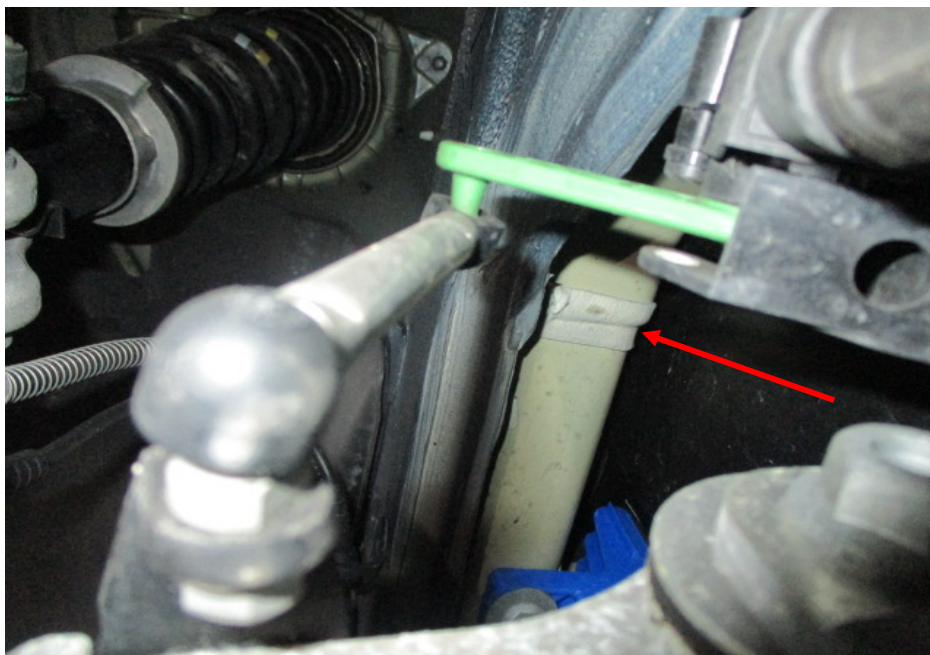
Photo 35 shows the chassis/structural body at the underside front left of the Motor Car. The original factory sealant (arrowed) at the joints along the chassis/structural body was observed to be untouched. In general, I had found no work was carried out on the chassis/structural body of the Motor Car. The chassis/structural body of the Motor Car was originally fitted.

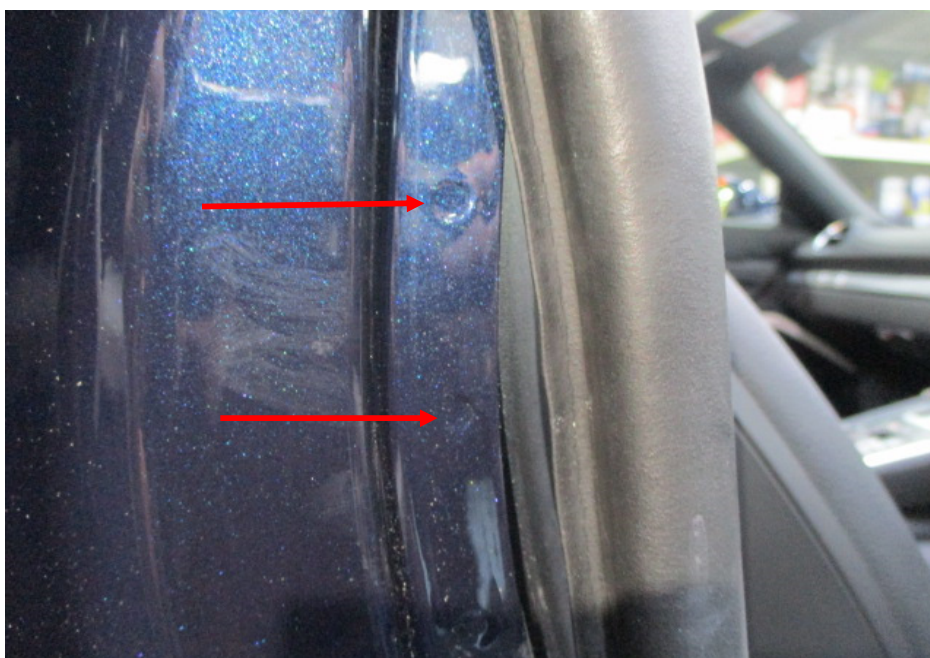
Photo 36 shows the rear right body panel of the Motor Car. I did not find any weld marks other than original spot weld marks (arrowed) on the rear right body panel of the Motor Car, which indicates that there was no re-welding works carried out. In general, I had found all the non-detachable body panels of the Motor Car to be originally fitted at the time of my inspection.

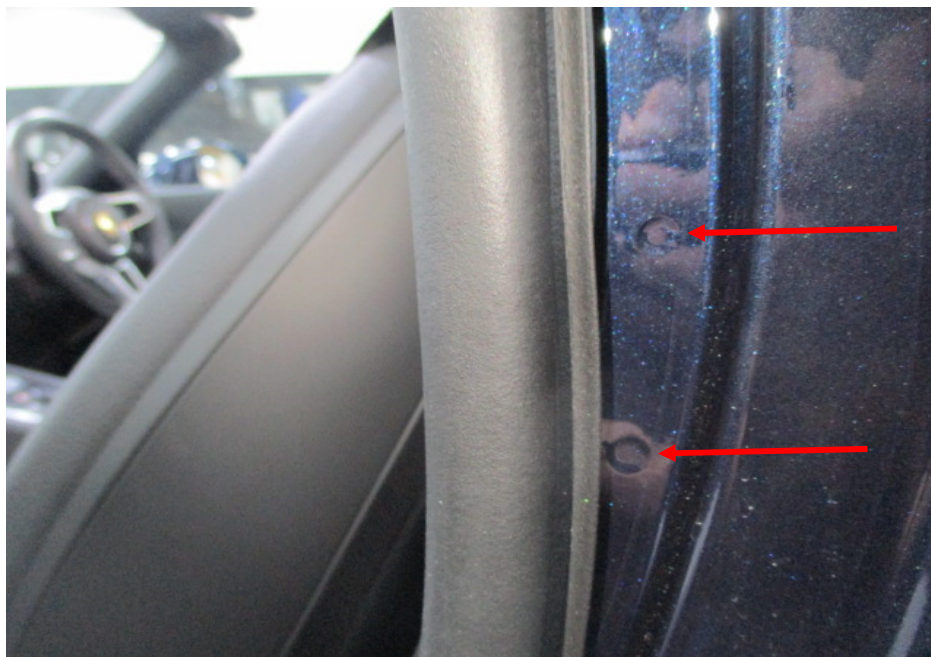
Photo 37 shows the rear left body panel of the Motor Car. I did not find any weld marks other than original spot weld marks (arrowed) on the rear left body panel of the Motor Car, which indicates that there was no re-welding works carried out. In general, I had found all the non-detachable body panels of the Motor Car to be originally fitted at the time of my inspection.
