Your Ref: BMW 530i  
(chassis number WBAJR32090WD97553)  
Our Ref : CI/TP21008602/D

**INSPECTION REPORT OF AN UNREGISTERED BMW 530i MOTOR CAR  
WITH CHASSIS NUMBER WBAJR32090WD97553**

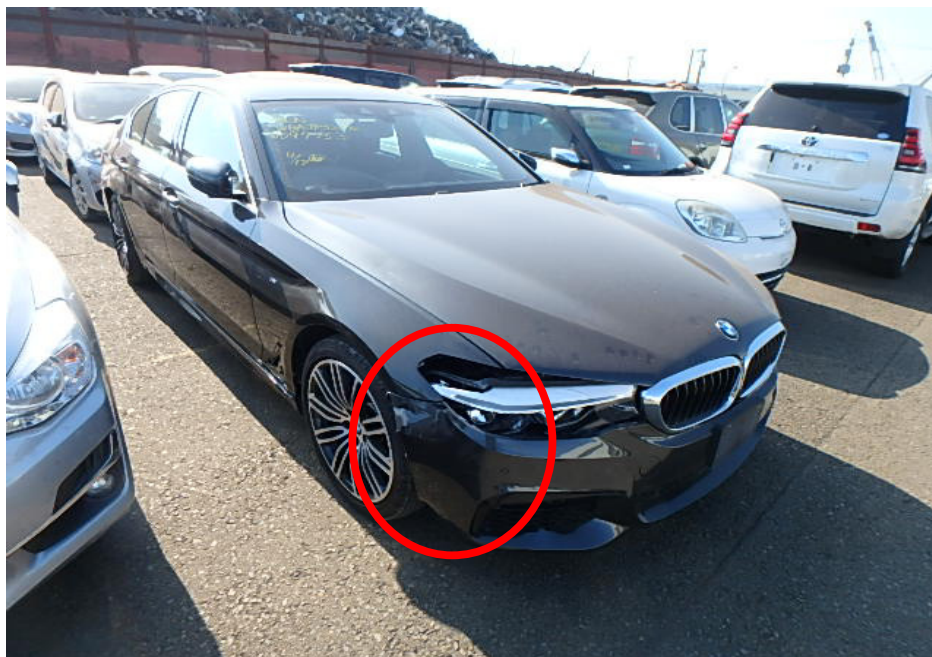
**Photo 1** shows a general view of the front right body of the Motor Car (photograph provided to me). The Motor Car was observed to have sustained damage at its front right body (circled). The front bumper, front right headlamp and front right fender were observed to be damaged.

22. The body parts at the front right body and rear right body of the Motor Car were visually examined, and it was noted that the repair/restoration works carried out to the damaged area of the Motor Car (refer to photograph 1 - 4 above) were reasonably adequate and in order.

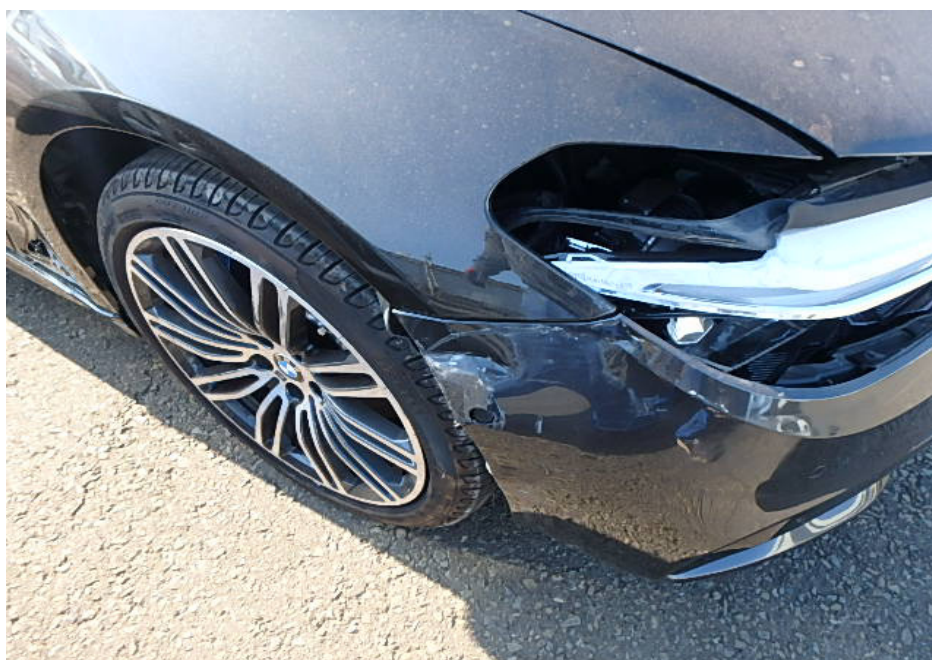
**Photo 2** shows a closer view of the damage at the front right body of the Motor Car (photograph provided to me). The front bumper, front right headlamp and front right fender were observed to be damaged.

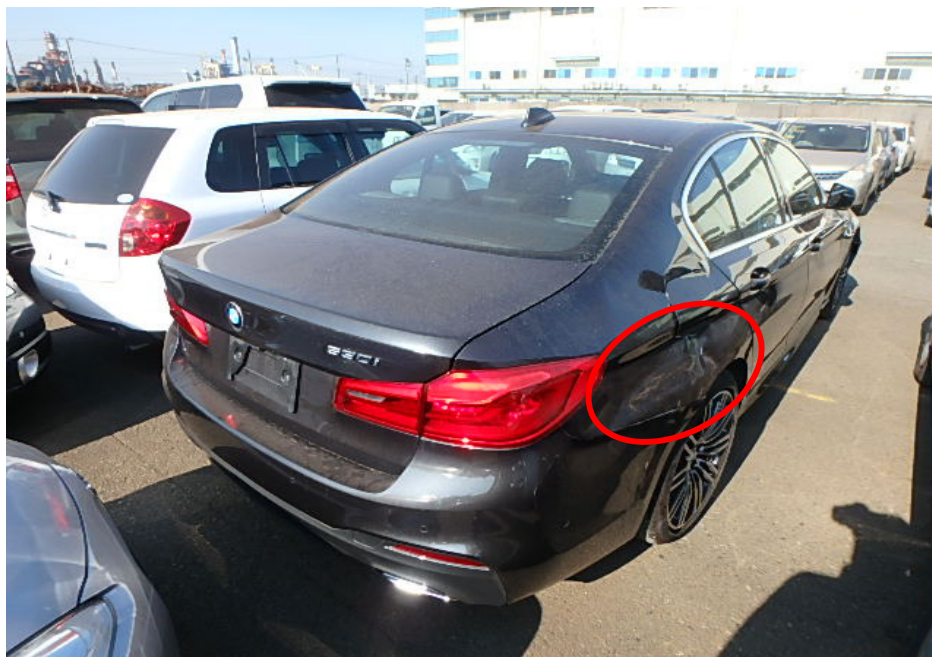
**Photo 3** shows a general view of the rear right body of the Motor Car (photograph provided to me). Apart for the front right body, I had also observed damage to the Motor Car's rear right fender (circled).

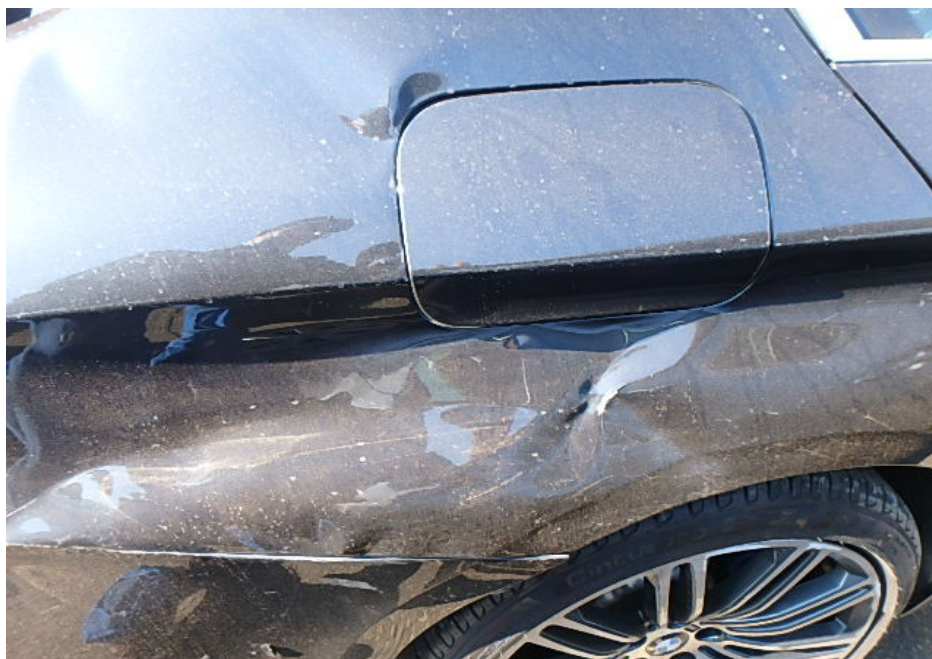
**Photo 4** shows a closer view of the damage to the rear right fender of the Motor Car (photograph provided to me).

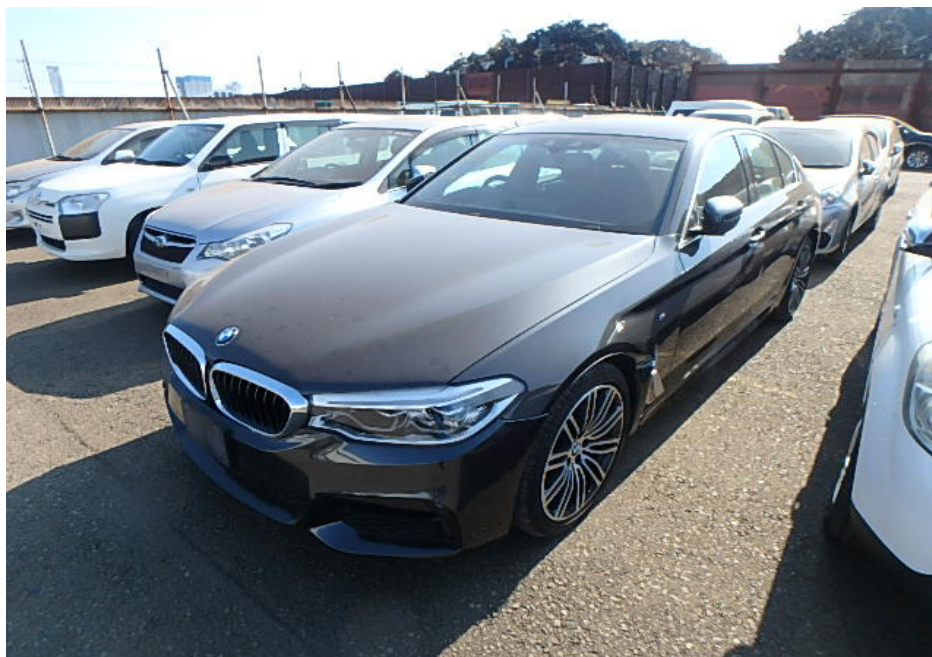
**Photo 5** shows the front left body of the Motor Car (photograph provided to me). Apart for the front right body and rear right body, there was no physical damage observed to other areas of the Motor Car. The airbags were not deployed as seen from the photographs that were provided to me.

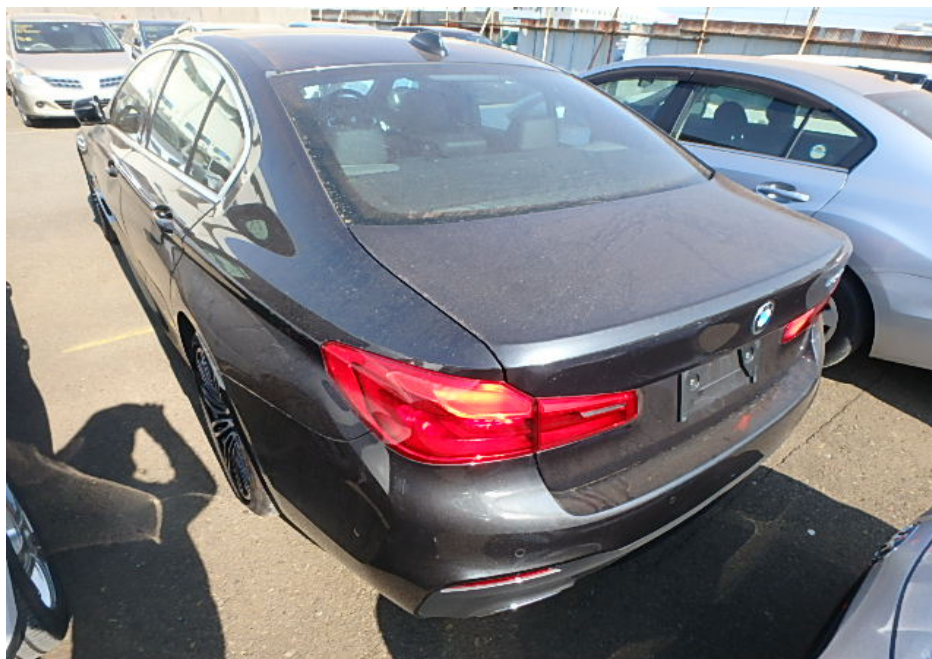
**Photo 6** shows the rear left body of the Motor Car (photograph provided to me). Apart for the front right body and rear right body, there was no physical damage observed to other areas of the Motor Car. The airbags were not deployed as seen from the photographs that were provided to me.

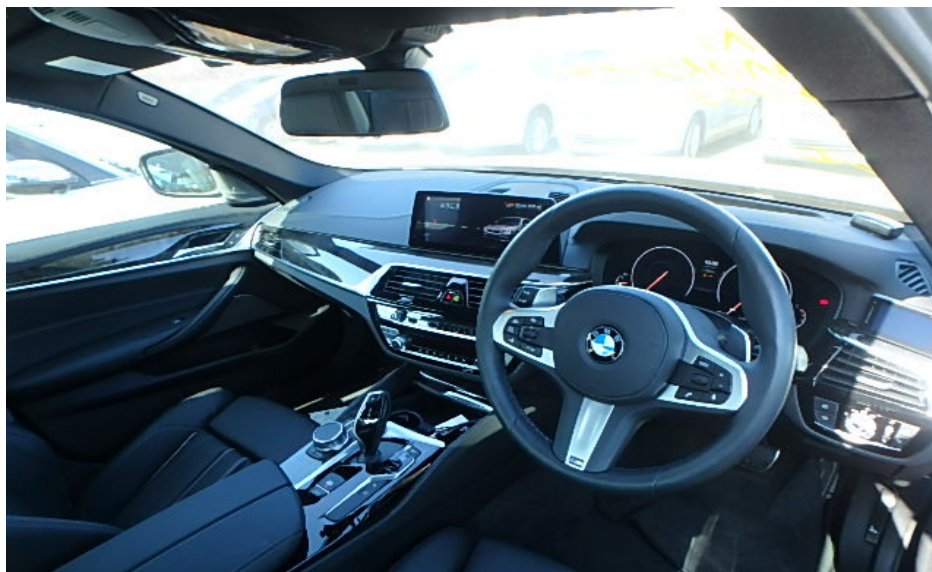
**Photo 7** shows the interior compartment of the Motor Car (photograph provided to me). Parts and components within the interior compartment were observed to be unaffected. The airbags of the Motor Car were also not deployed as seen from the photographs that were provided to me.

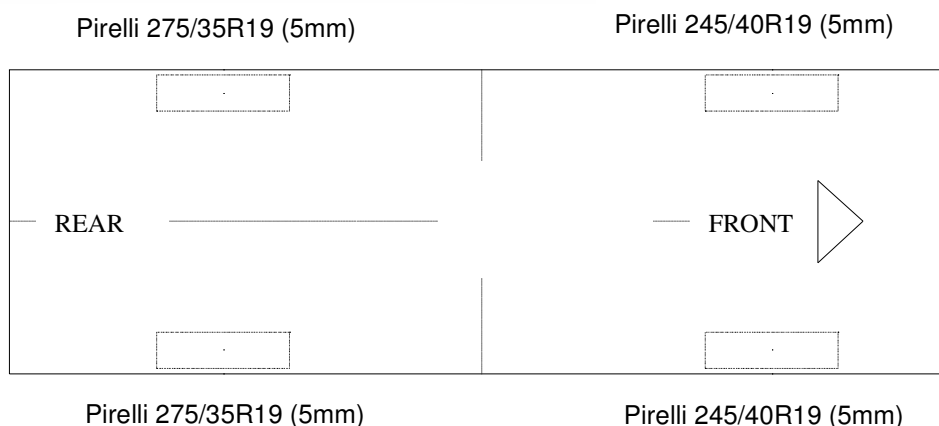
8. It was fitted with 19inch sport wheel rims that were wrapped with tyres that were observed to be of serviceable condition. The tyres were also sufficiently inflated for vehicular operation. The tyre brand, tyre size and approximate remaining tread depth of the 4 tyres of the Motor Car were recorded as follows: -

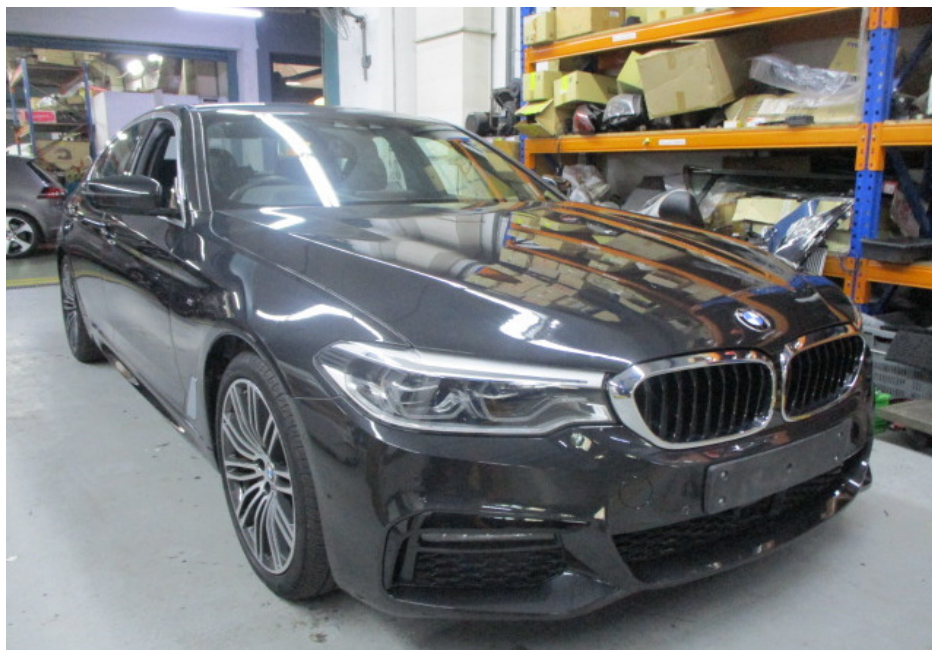
**Photo 8** shows a general view of the front right body of the Motor Car at the time of my inspection. The Motor Car was observed to be in a relatively good general condition with no loose exterior fittings observed. The body parts at the front right body of the Motor Car were visually examined and it was observed that the repair/restoration works carried out to the damaged area of the Motor Car (refer to photograph 1 & 2 above) were reasonably adequate and in order.

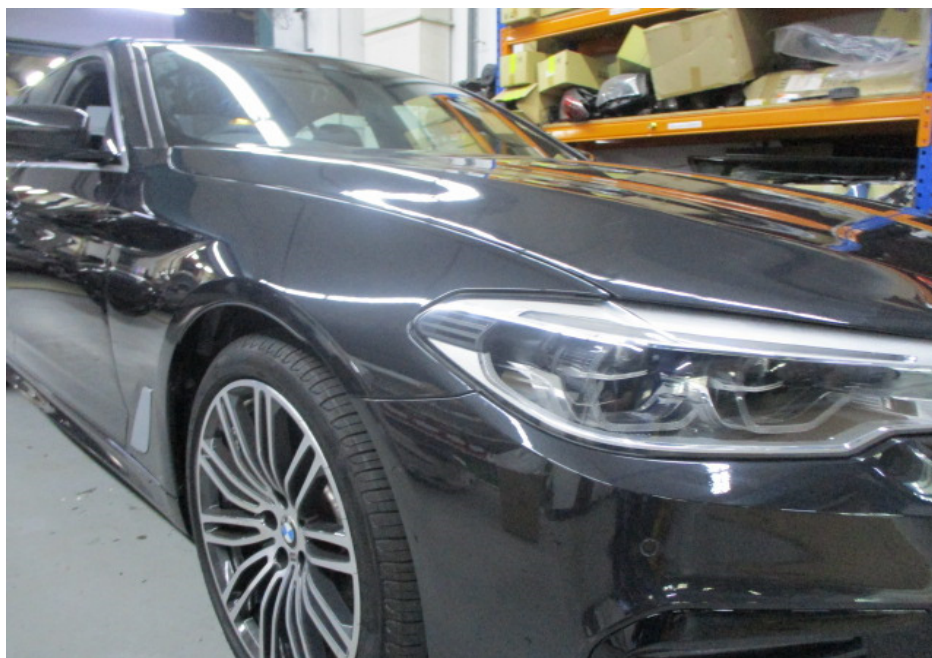
**Photo 9** shows a closer view of the front bumper, front right headlamp and front right fender of the Motor Car at the time of my inspection. The body parts at the front right body of the Motor Car were visually examined and it was observed that the repair/restoration works carried out to the damaged area of the Motor Car (refer to photograph 1 & 2 above) were reasonably adequate and in order.

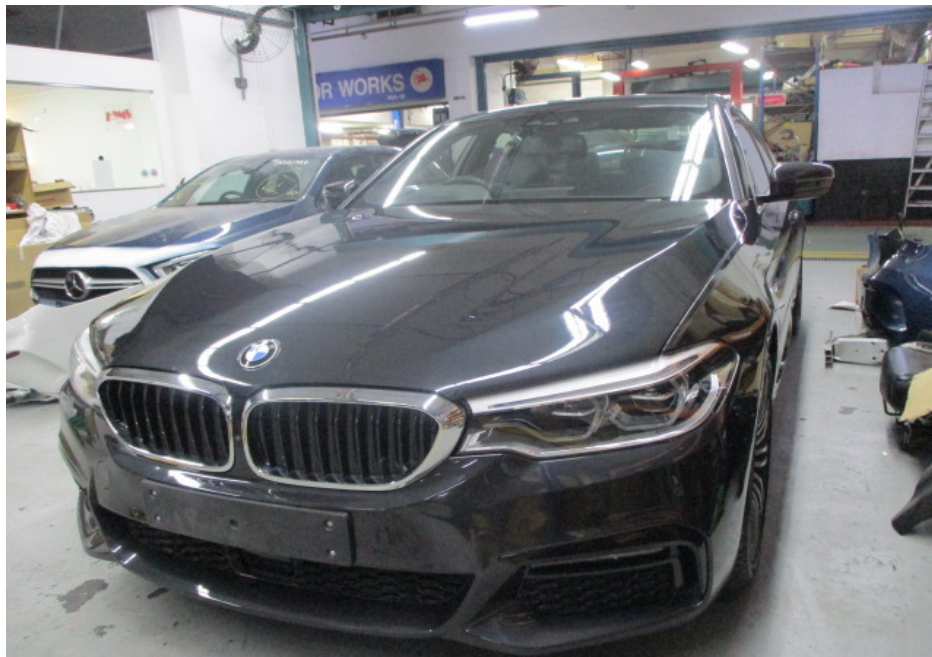
**Photo 10** shows a general view of the front left body of the Motor Car at the time of my inspection. The Motor Car was observed to be in a relatively good general condition with no loose exterior fittings observed. The mileage of the Motor Car recorded at the time of my inspection was 9,797km.

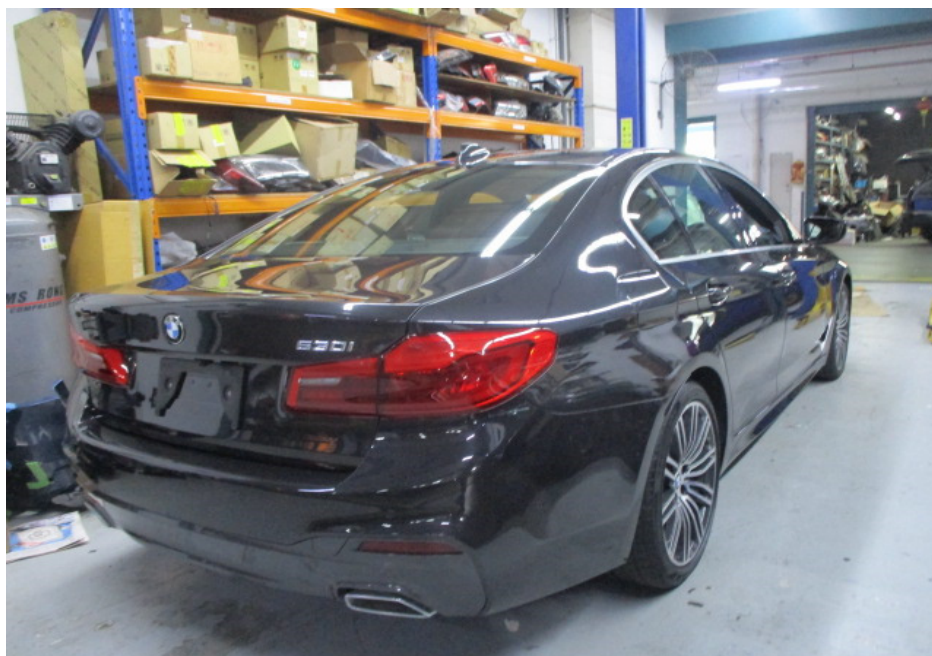
**Photo 11** shows a general view of the rear right body of the Motor Car at the time of my inspection. The body parts at the rear right body of the Motor Car, in particular the rear right fender, were visually examined and it was observed that the repair/restoration works carried out to the damaged area of the Motor Car (refer to photograph 3 & 4 above) were reasonably adequate and in order.

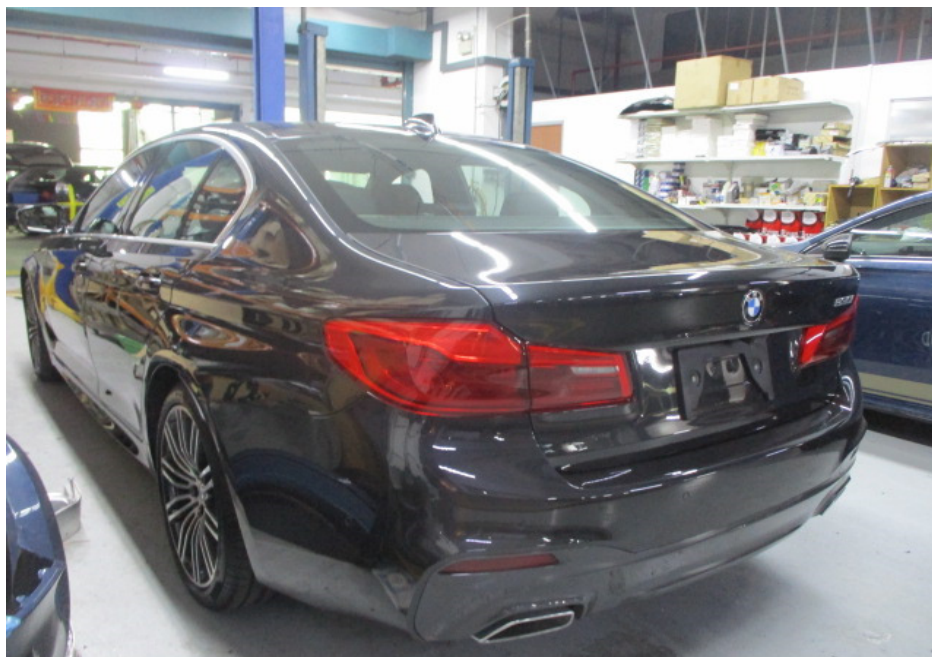
**Photo 12** shows a general view of the rear left body of the Motor Car at the time of my inspection. The Motor Car was observed to be in a relatively good general condition with no loose exterior fittings observed. The mileage of the Motor Car recorded at the time of my inspection was 9,797km.

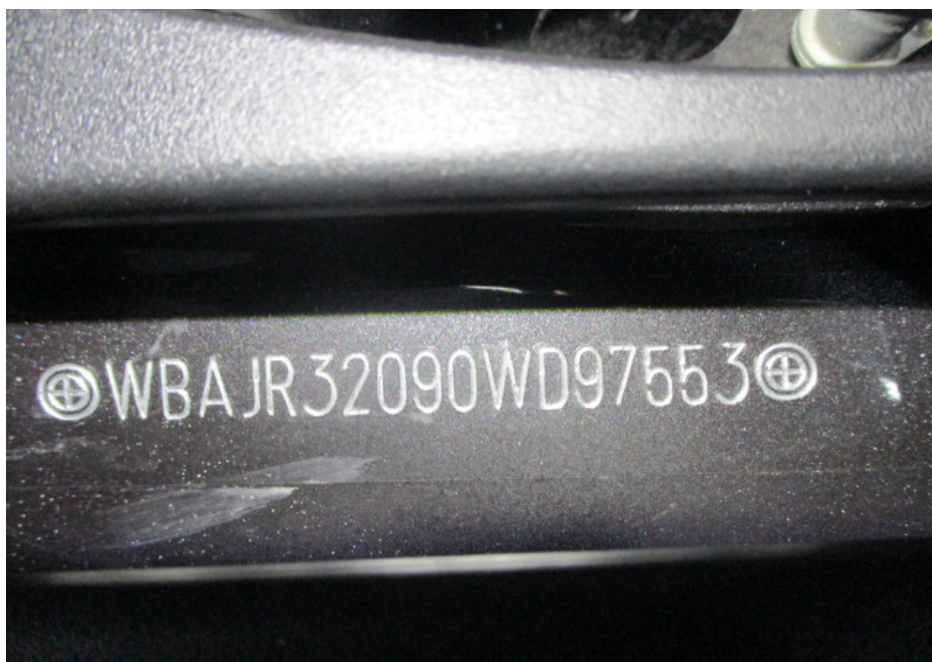
**Photo 13** shows the chassis number of the Motor Car. The chassis number recorded was WBAJR32090WD97553.

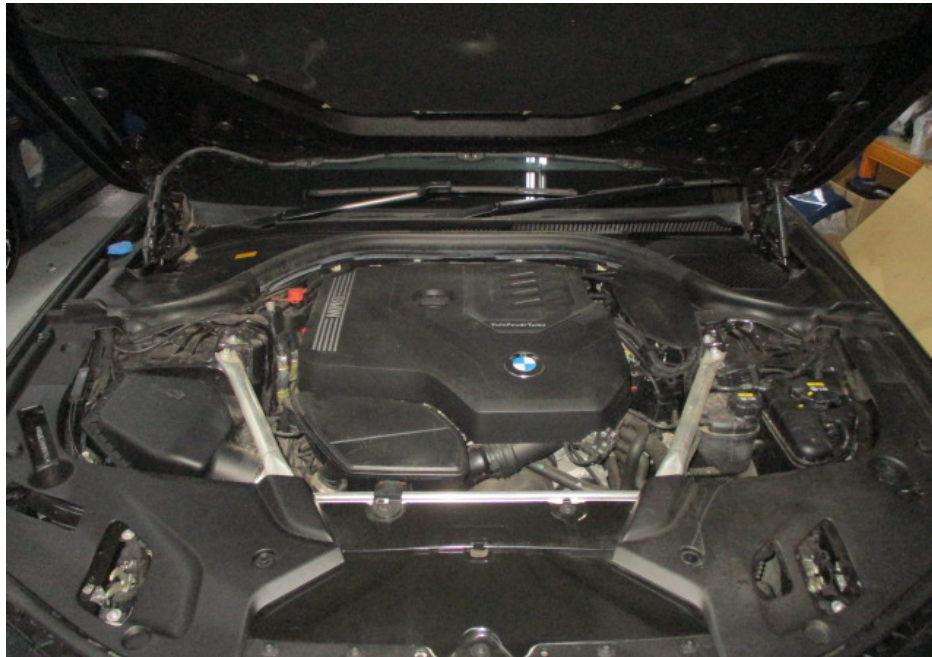
**Photo 14** shows a general view of the engine compartment of the Motor Car at the time of my inspection. The various parts and components inside the engine compartment were all observed to be intact and properly fitted. There was also no sign(s) or indication(s) of fluid leak and/or fluid stain found inside the engine compartment.

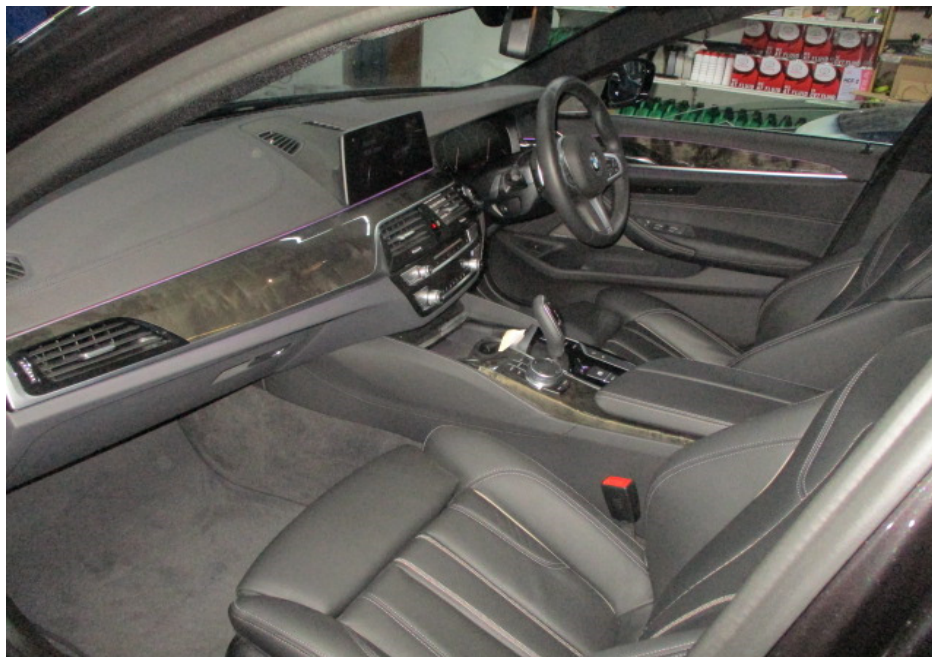
**Photo 15** shows the interior compartment of the Motor Car at the time of my inspection. The various parts and components, trims, carpet and upholstery inside the interior compartment were all observed to be intact and properly fitted.

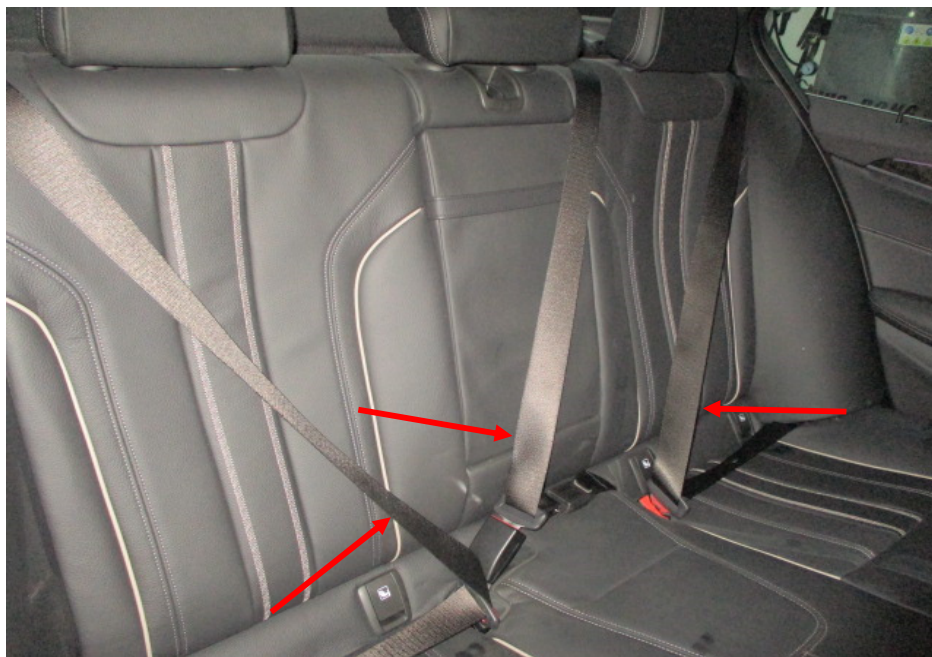
**Photo 16** shows the rear seats of the Motor Car. All the seats of the Motor Car were secured via seat rails to the floorboard. They were also fitted with a retractable seat belt reel and a pre-tensioner. The seat belts (arrowed) were tested and were able to be fastened into the respective pre-tensions that were fitted on the side of each individual seat.

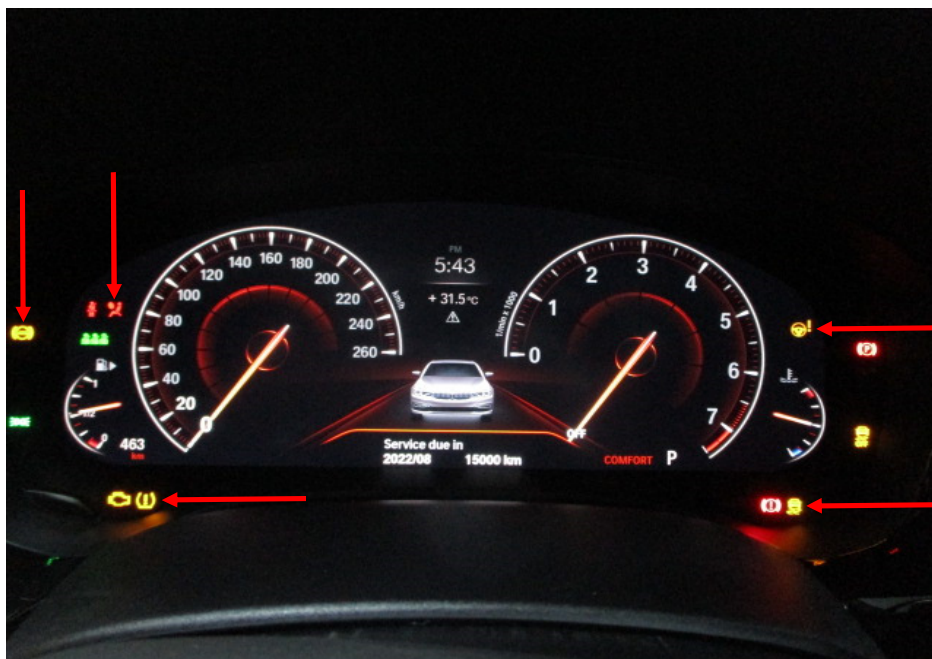
**Photo 17** shows the warning lights for the various electronic safety features appearing on the instrument panel of the Motor Car during its self-test when the engine is cranked, in particular the ABS, SRS, IAS, TPM and DSC lights (arrowed).

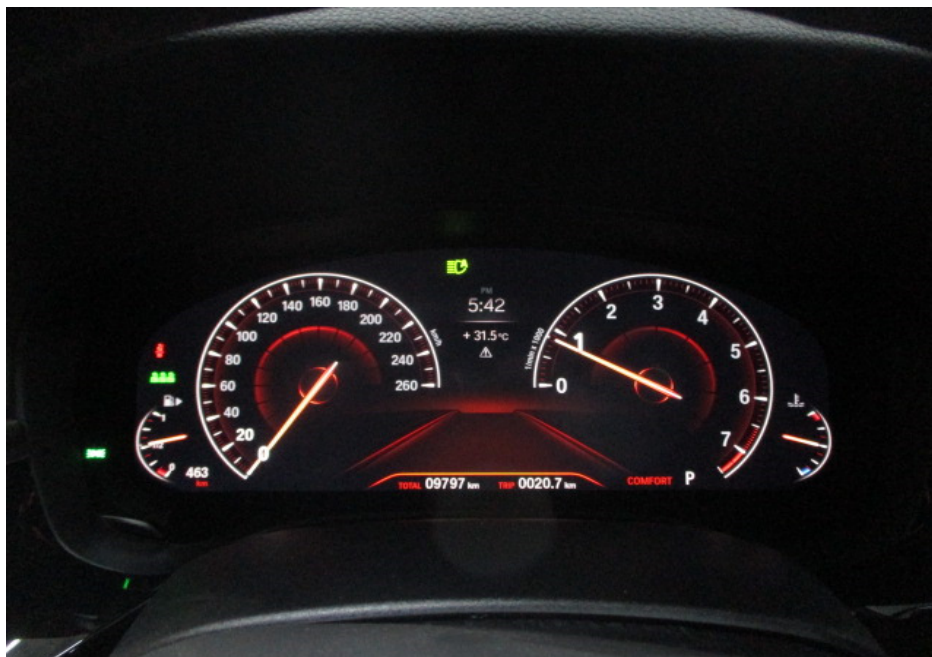
**Photo 18** shows the respective warning lights no longer illuminated, indicating that there is no fault detected to the ABS, SRS, IAS, TPM and DSC systems of the Motor Car during the self-test. These electronic systems were hence in working condition at the time of my inspection.

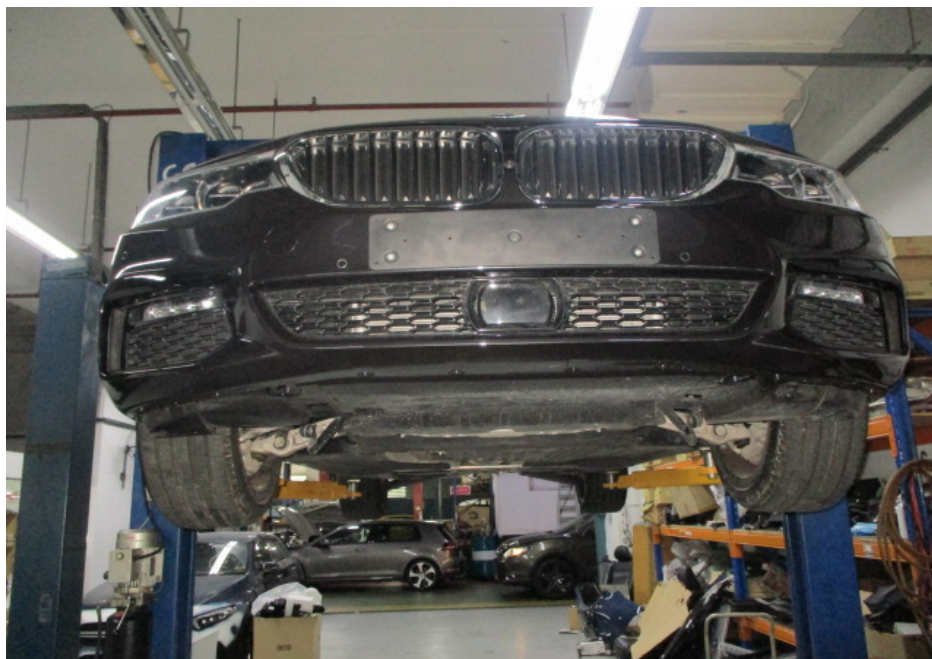
**Photo 19** shows the Motor Car hoisted up for checks on its undercarriage. There was no sign(s) or indication(s) of fluid leakage and/or fluid stain(s) on the underside of the Motor Car. The undercarriage components of the Motor Car were also all observed to be intact and secured in an appropriate manner.

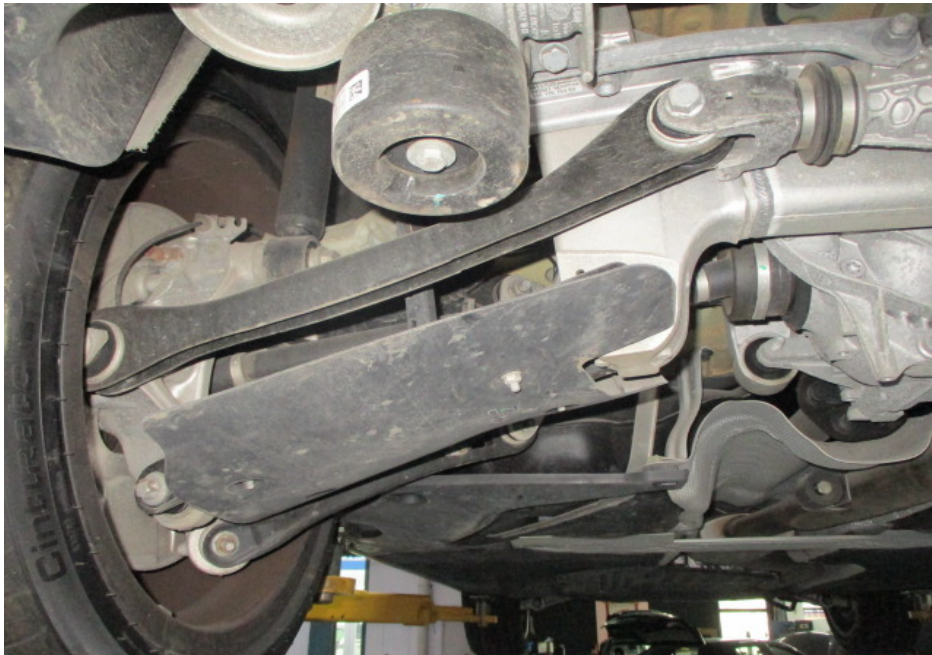
**Photo 20** shows a general view of the control arms and linkages at the rear left wheel of the Motor Car. I did not observe any fluid leak and/or fluid stain on the underside of the Motor Car. All of the Motor Car's undercarriage components were observed to be intact and secured in an appropriate manner.

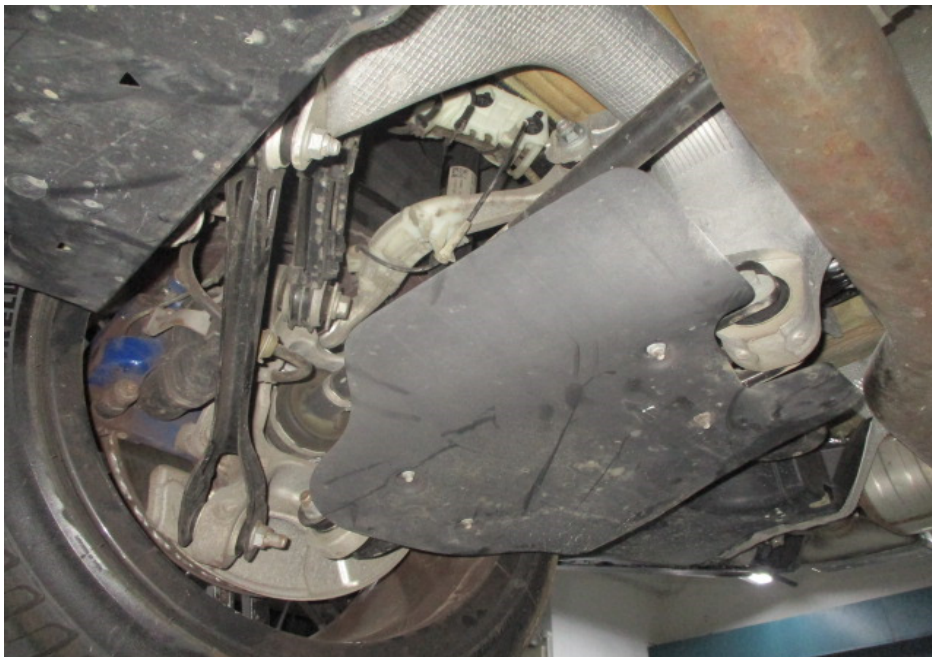
**Photo 21** shows a general view of the control arms and linkages at the rear right wheel of the Motor Car. I did not observe any fluid leak and/or fluid stain on the underside of the Motor Car. All of the Motor Car's undercarriage components were observed to be intact and secured in an appropriate manner.

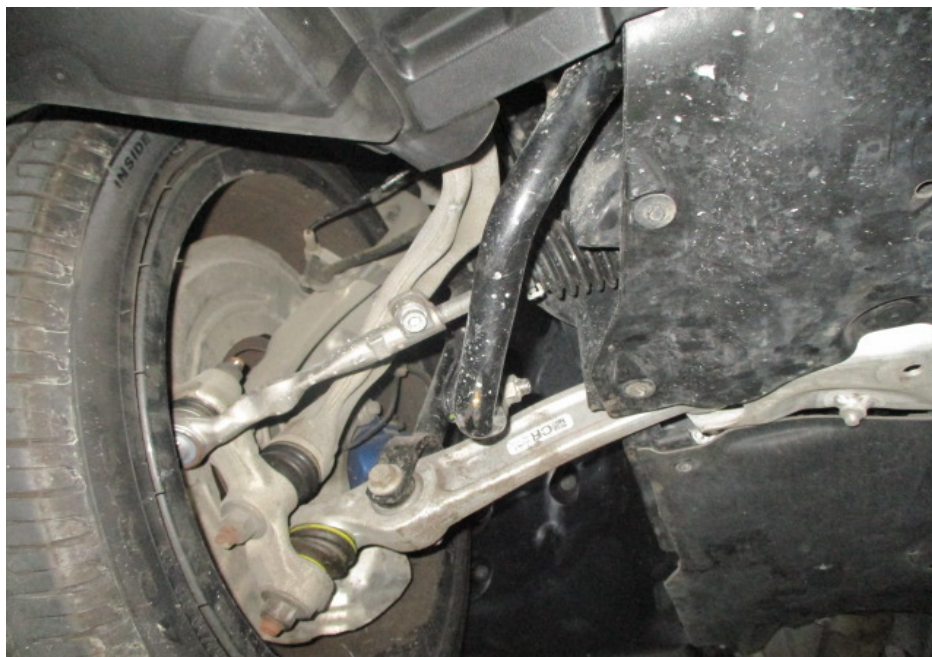
**Photo 22** shows the various undercarriage components at the front right wheel of the Motor Car. The mechanical components, control arms and linkages were all found to be intact and secured in an appropriate manner.

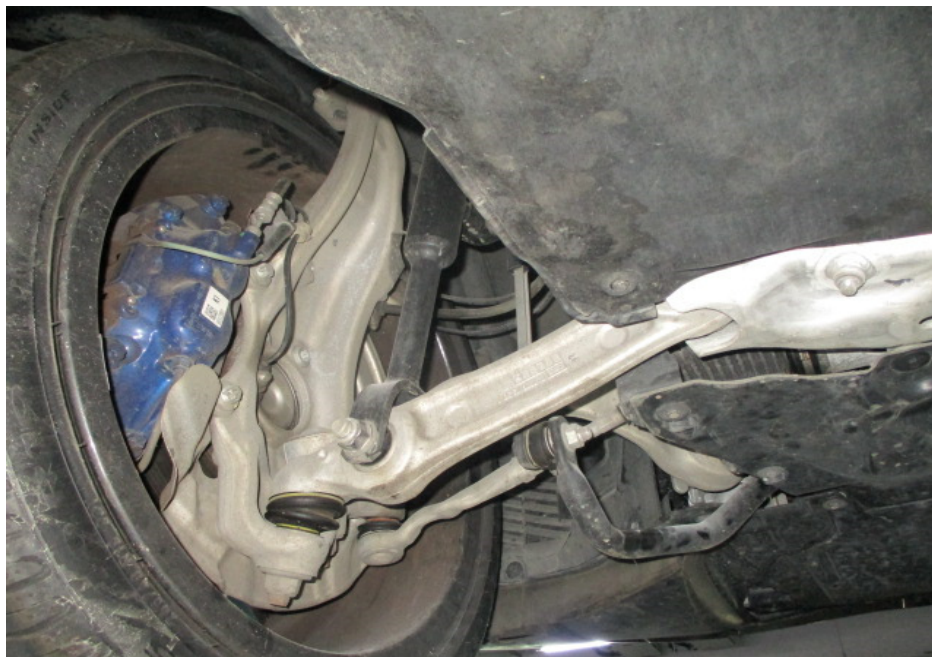
**Photo 23** shows the various undercarriage components at the front left wheel of the Motor Car. The mechanical components, control arms and linkages were all found to be intact and secured in an appropriate manner. I also did not observe any fluid leak and/or fluid stain on the underside of the Motor Car.

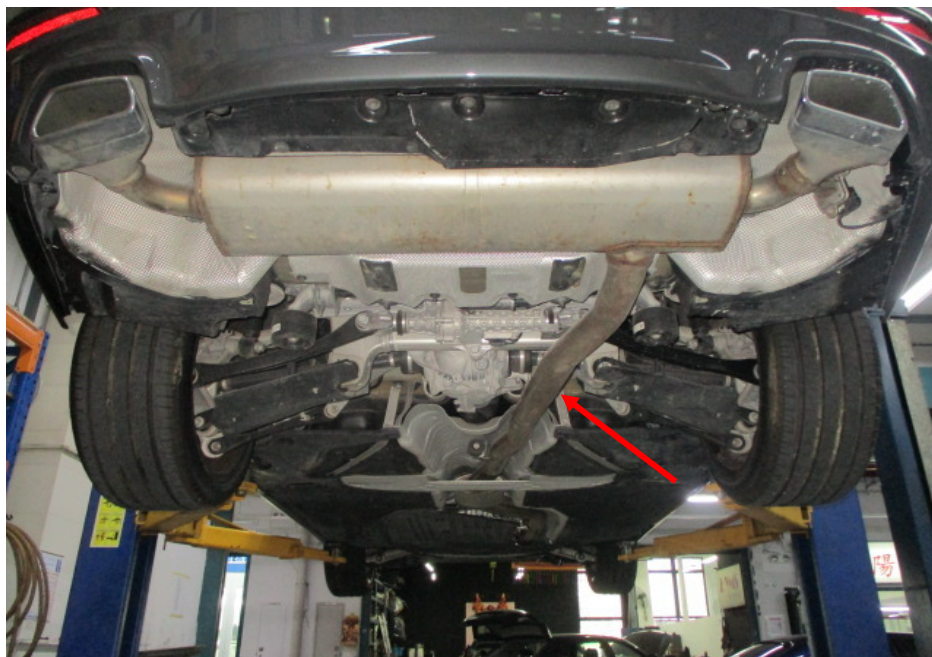
**Photo 24** shows the rear section of the Motor Car's exhaust system. My examination of the Motor Car's exhaust system revealed no sign(s) or indication(s) of any cut or weld marks along its exhaust pipes (arrowed), on its centre resonator box, on its rear muffler and on its catalytic converter.

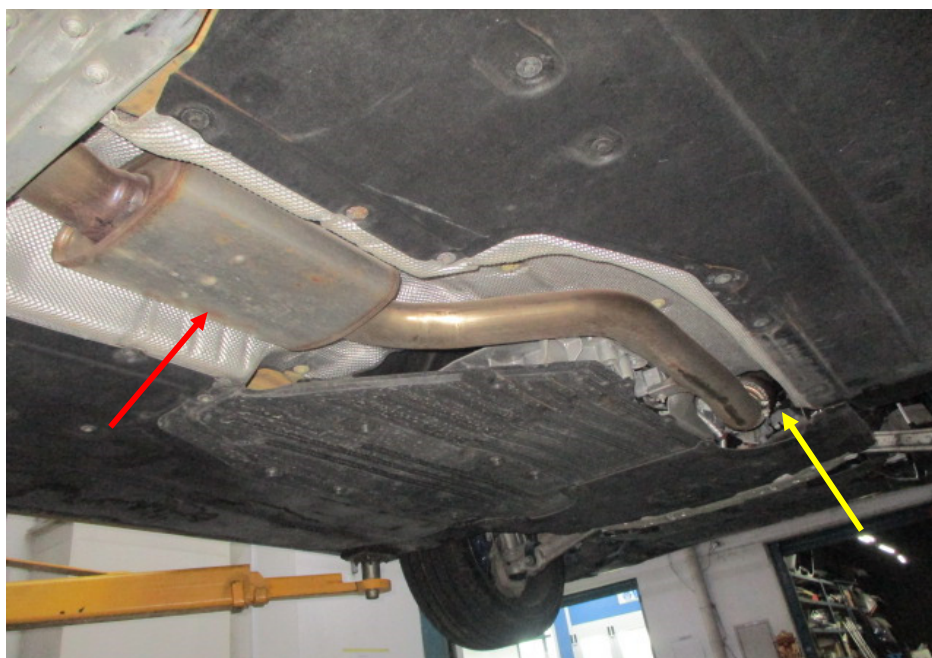
**Photo 25** shows the front section of the Motor Car's exhaust system. My examination of the Motor Car's exhaust system revealed no sign(s) or indication(s) of any cut or weld marks along its exhaust pipes, on its centre resonator box (red arrow), on its rear muffler and on its catalytic converter (yellow arrow).

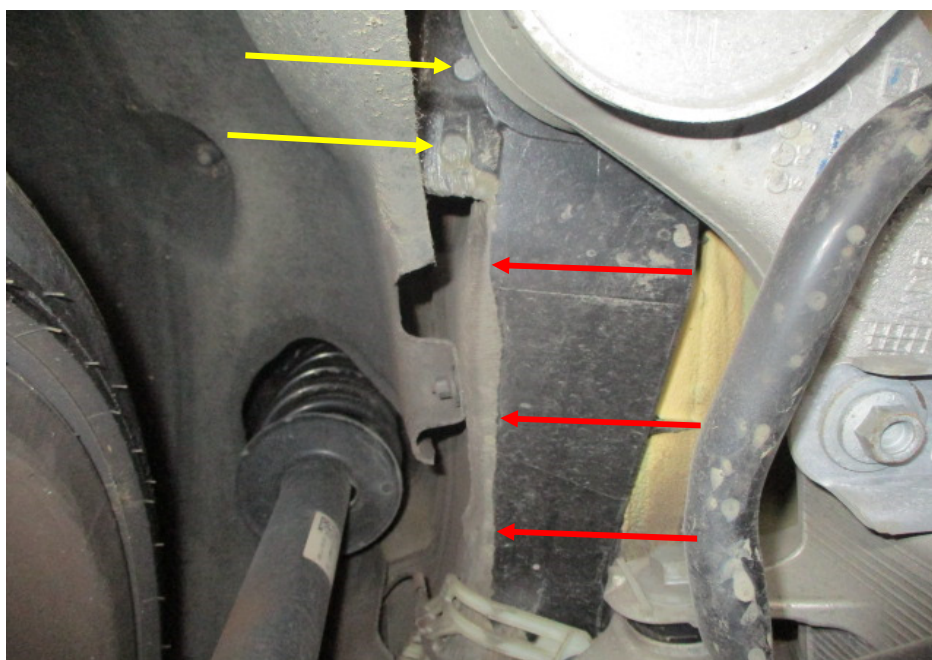
**Photo 26** shows the chassis/structural body at the underside rear left of the Motor Car. I did not find any weld marks other than original spot weld marks (yellow arrow) on the chassis/structural body of the Motor Car. The original factory sealant (red arrow) at the joints along the chassis/structural body was also untouched, indicating no work was done on the chassis/structural body of the Motor Car and that the chassis/structural body was originally fitted.

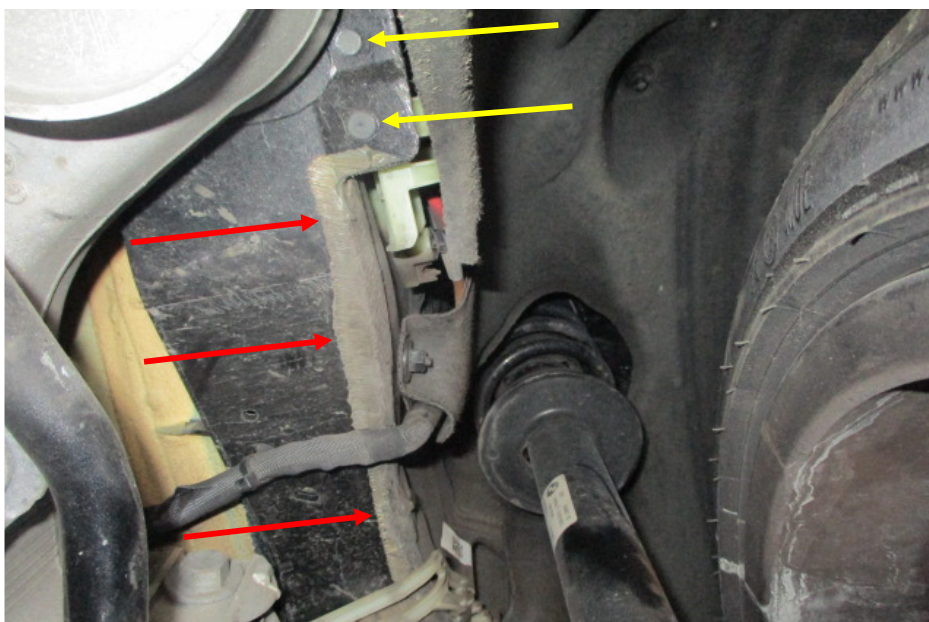
**Photo 27** shows the chassis/structural body at the underside rear right of the Motor Car. I did not find any weld marks other than original spot weld marks (yellow arrow) on the chassis/structural body of the Motor Car. The original factory sealant (red arrow) at the joints along the chassis/structural body was also untouched, indicating no work was done on the chassis/structural body of the Motor Car and that the chassis/structural body was originally fitted.

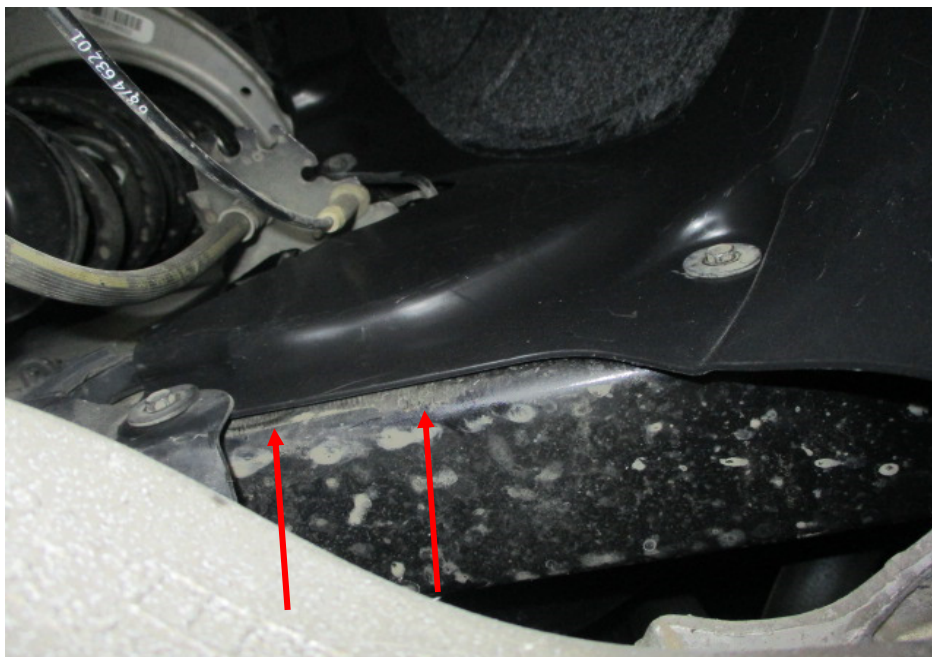
**Photo 28** shows the chassis/structural body at the underside front right of the Motor Car. The original factory sealant (arrowed) at the joints along the chassis/structural body was observed to be untouched. In general, I had found no work was carried out on the chassis/structural body of the Motor Car. The chassis/structural body of the Motor Car was originally fitted.

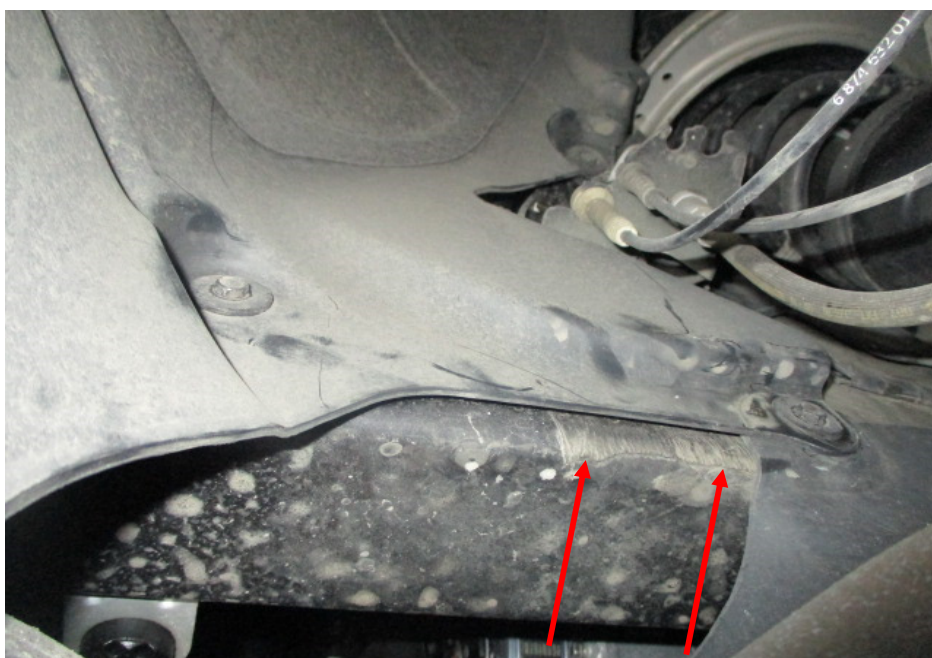
**Photo 29** shows the chassis/structural body at the underside front left of the Motor Car. The original factory sealant (arrowed) at the joints along the chassis/structural body was observed to be untouched. In general, I had found no work was carried out on the chassis/structural body of the Motor Car. The chassis/structural body of the Motor Car was originally fitted.

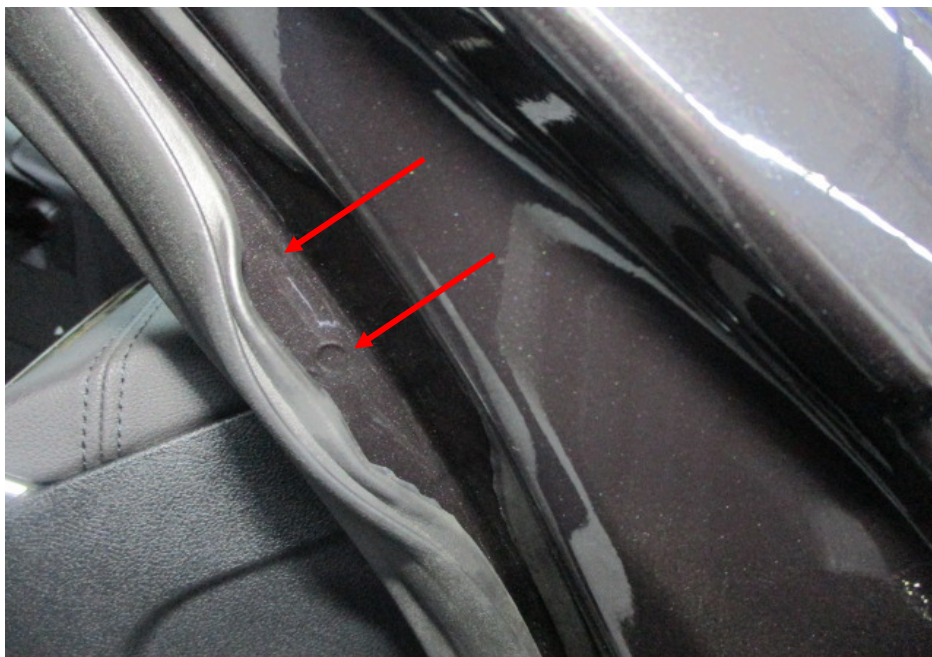
**Photo 30** shows the right side "A" pillar of the Motor Car. I did not find any weld marks other than original spot weld marks (arrowed) on the right side "A" pillar of the Motor Car which, indicates that there was no re-welding works carried out. In general, I had found all the non-detachable body panels of the Motor Car to be originally fitted at the time of my inspection.

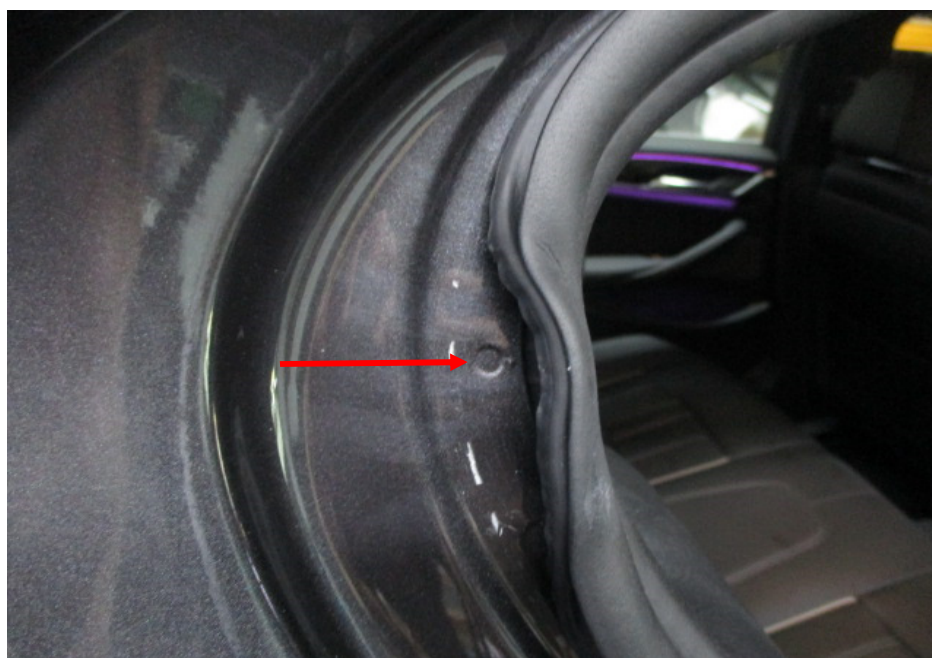
**Photo 31** shows the right side "C" pillar of the Motor Car. I did not find any weld marks other than original spot weld marks (arrowed) on the right side "C" pillar of the Motor Car which, indicates that there was no re-welding works carried out. In general, I had found all the non-detachable body panels of the Motor Car to be originally fitted at the time of my inspection.

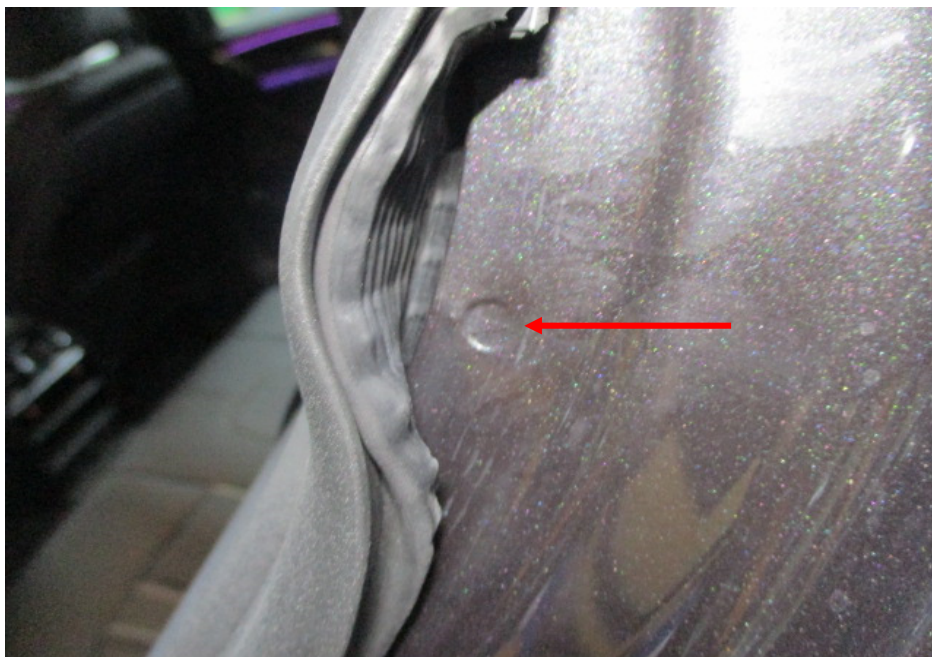
**Photo 32** shows the left side "C" pillar of the Motor Car. I did not find any weld marks other than original spot weld marks (arrowed) on the left side "C" pillar of the Motor Car which, indicates that there was no re-welding works carried out. In general, I had found all the non-detachable body panels of the Motor Car to be originally fitted at the time of my inspection.
