Your Ref: TP/IP/32313/2021
Our Ref : CI/TPD21008633/N

9 August 2021

INSPECTION REPORT OF MOTORCYCLE FBB 4895Z

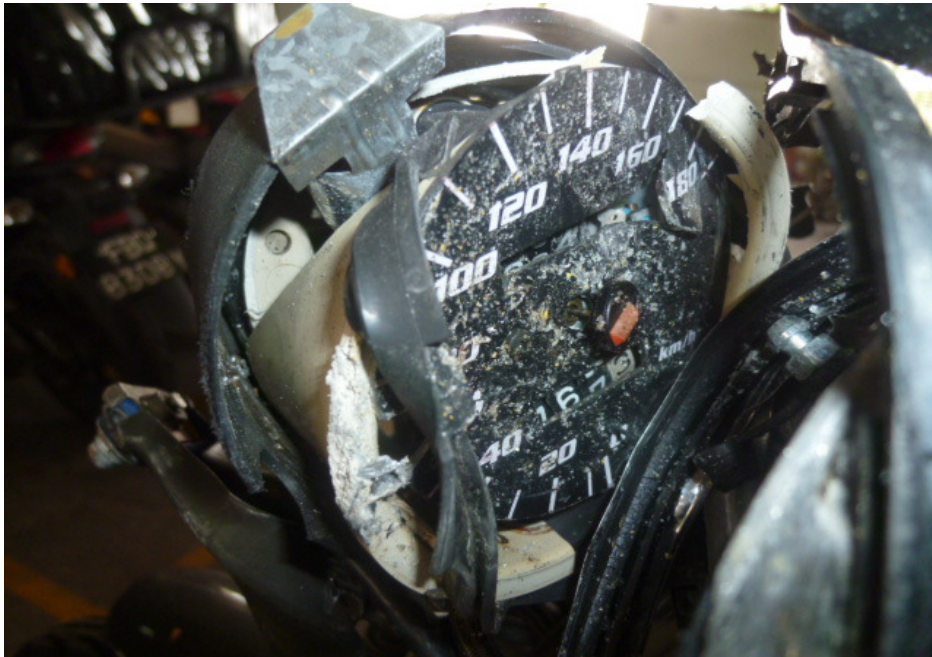
4. The mileage of the Motorcycle could not be recorded at the time of our inspection due to damages sustained to the speedometer gauge.
5. The Motorcycle was observed to have sustained damages all around. The body parts that were found to have been damaged include its speedometer gauge, headlight assembly, front mudguard, side mirrors, front brake lever, clutch lever, handlebars, handlebar ends, petrol tank, left front footrest bracket, seat, left rear side cover and tail light assembly, amongst others.

Photo 1 shows the speedometer gauge of the Motorcycle. The mileage of the Motorcycle could not be recorded at the time of our inspection due to damages sustained to the speedometer gauge as a result of the accident.

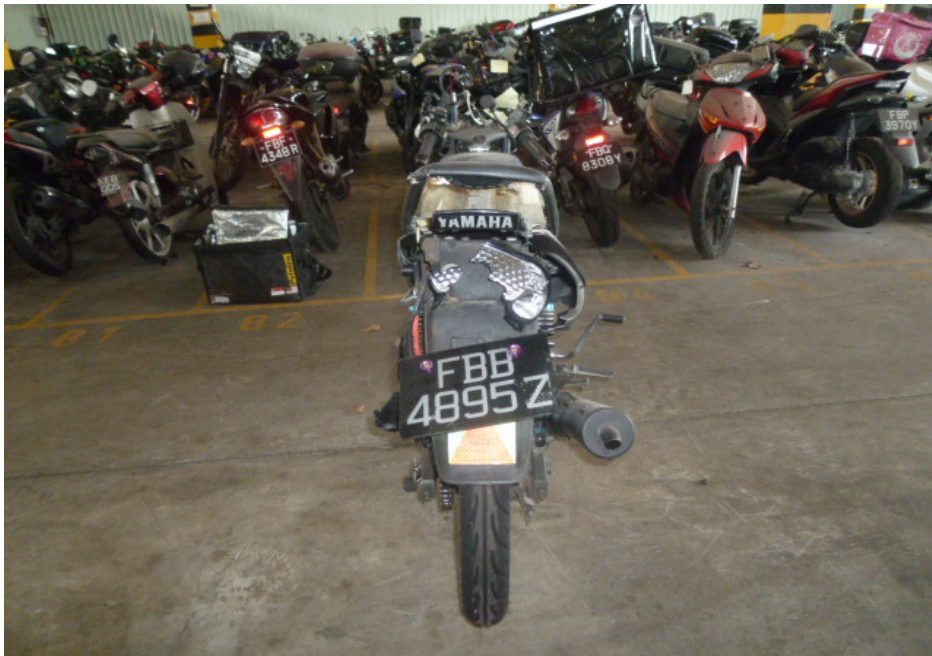
Photo 2 shows a general view of the rear portion of the Motorcycle at the time of our inspection. The Motorcycle was observed to have sustained damages all around.

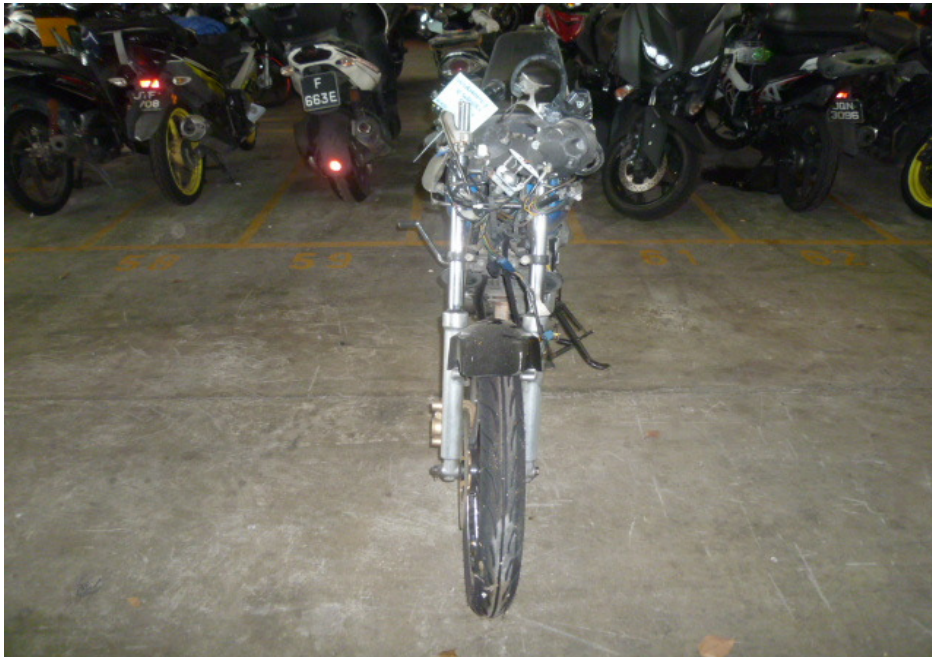
Photo 3 shows a general view of the frontal portion of the Motorcycle at the time of our inspection. The Motorcycle was observed to have sustained damages all around. The body parts that were found to have been damaged include its speedometer gauge, headlight assembly, front mudguard, side mirrors, front brake lever, clutch lever, handlebars, handlebar ends, petrol tank, left front footrest bracket, seat, left rear side cover and tail light assembly, amongst others.

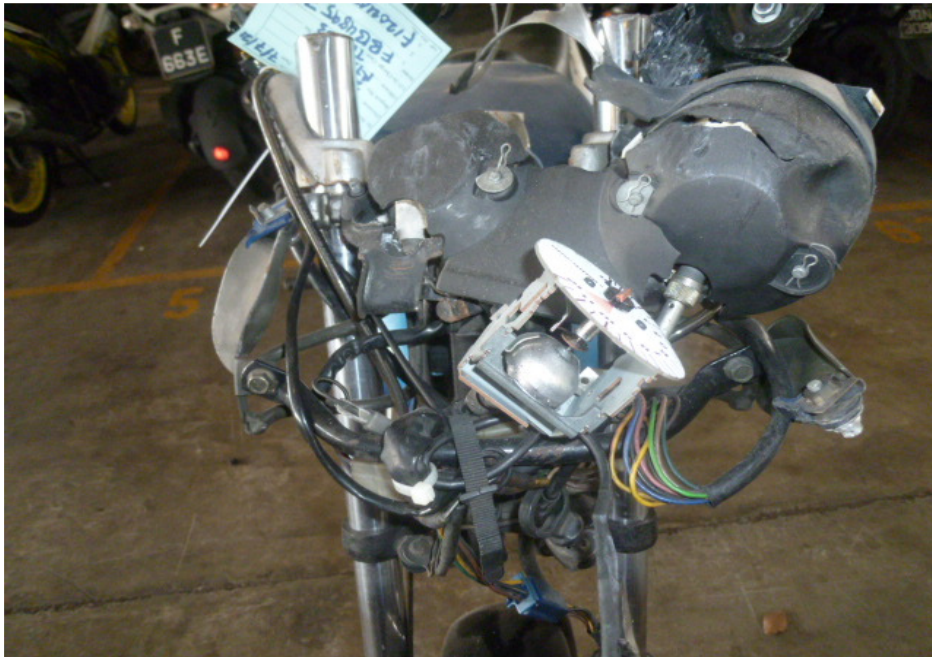
Photo 4 shows a closer view of the headlight assembly which was amongst the body parts at the front body of the Motorcycle that had sustained damage as a result of the accident.

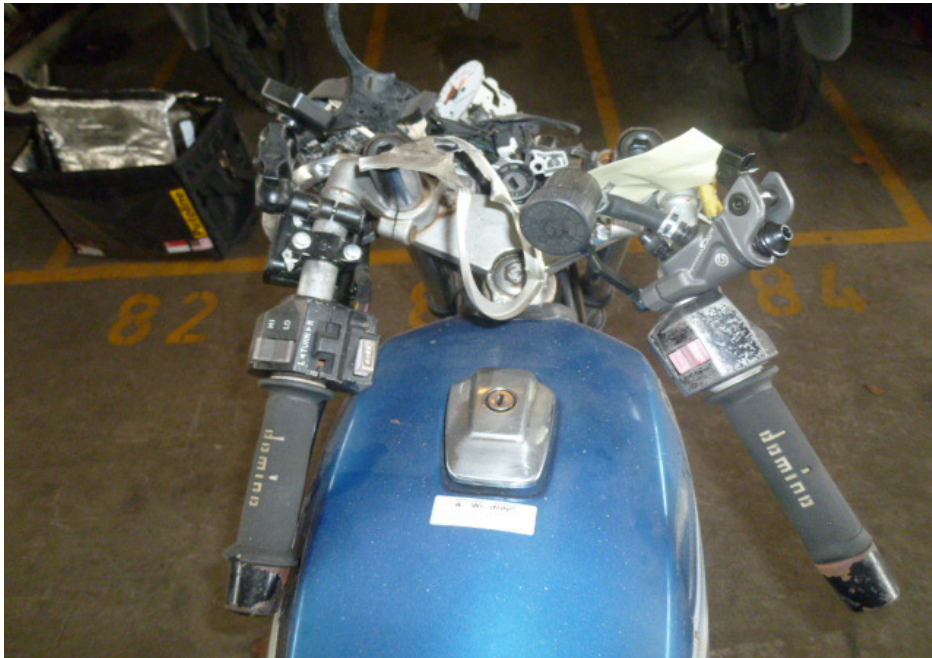
Photo 5 shows a close up view of the handlebars, side mirrors, front brake lever, clutch lever and handlebar ends of the Motorcycle. These parts were amongst the body parts of the Motorcycle which were damaged as a result of the accident.

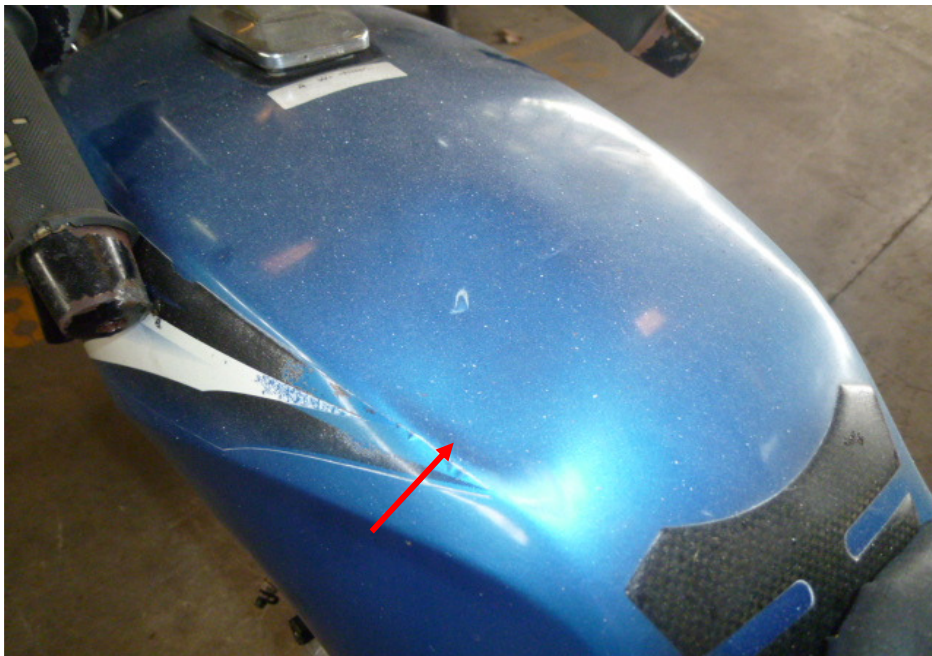
Photo 6 shows a closer view of the petrol tank, which was amongst the body parts of the Motorcycle that had sustained damage as a result of the accident (arrowed).

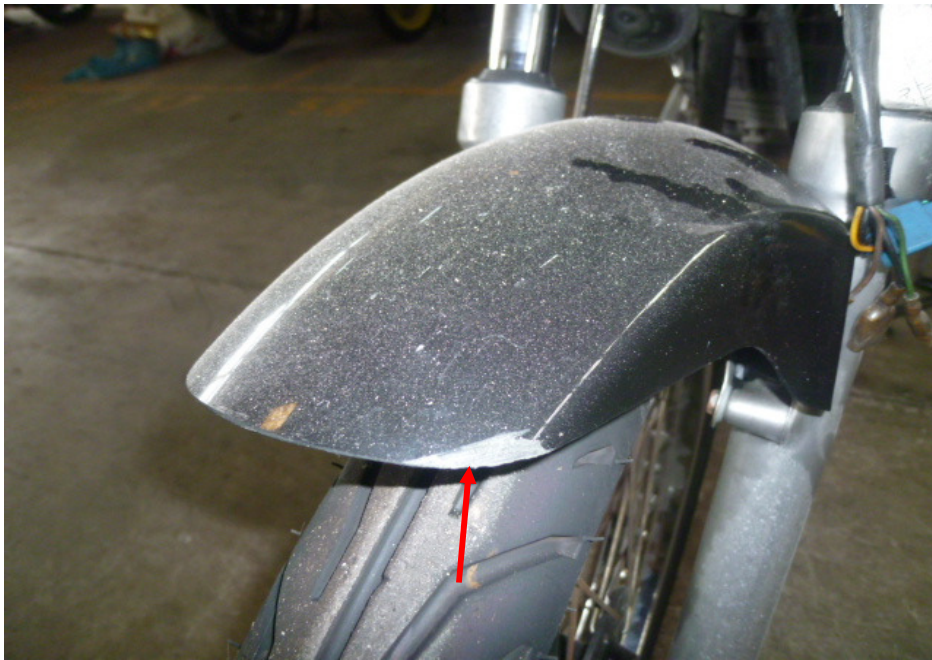
Photo 7 shows a closer view of the front mudguard (arrowed) which was amongst the body parts of the Motorcycle that had sustained damage as a result of the accident.

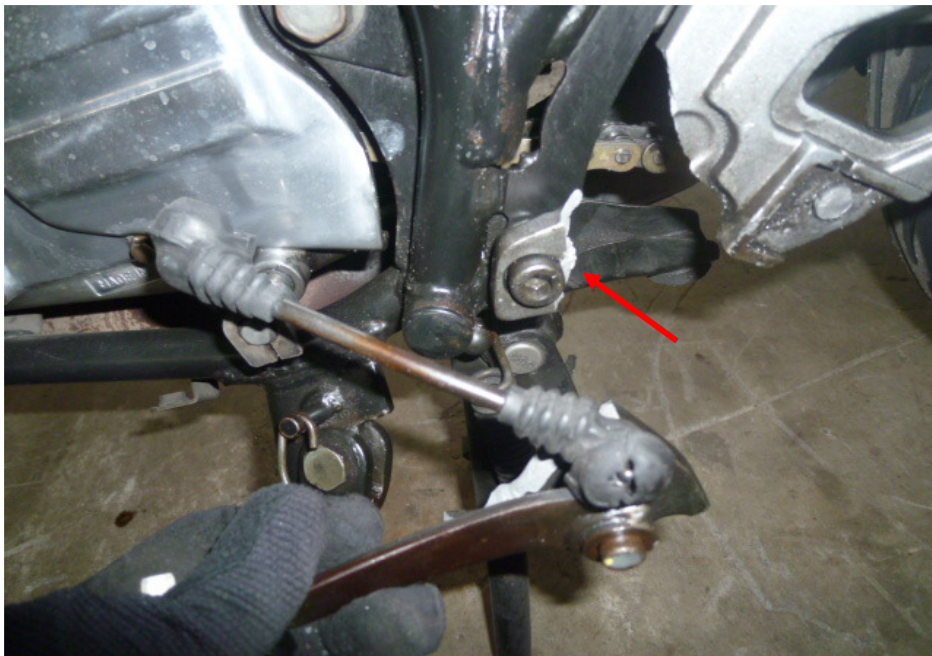
Photo 8 shows the broken left front footrest bracket (arrowed) of the Motorcycle as a result of the accident.

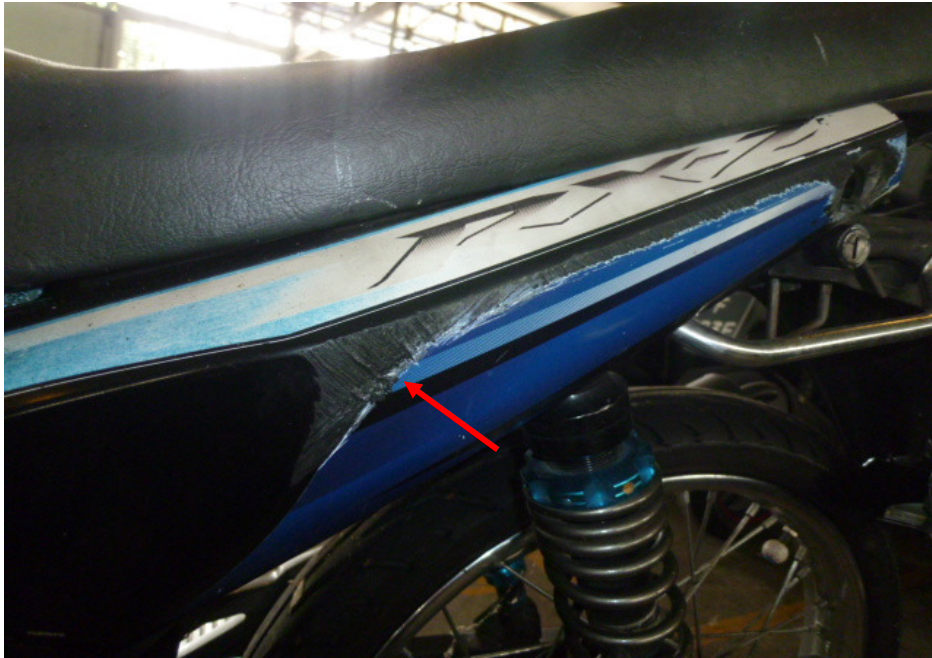
Photo 9 shows the grazed left rear side cover (arrowed) of the Motorcycle as a result of the accident.

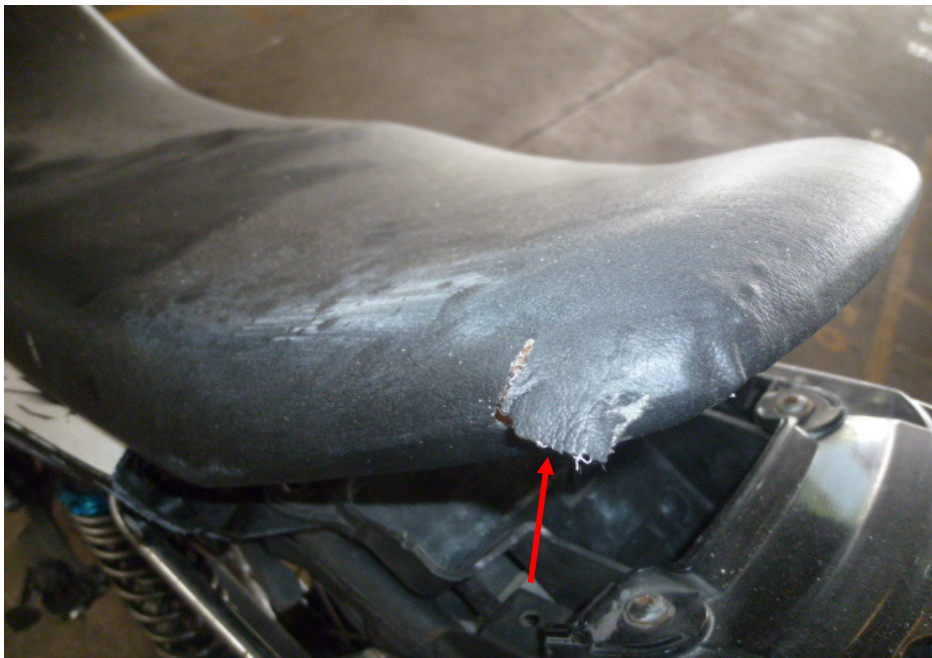
Photo 10 shows the deformed seat of the Motorcycle as a result of the accident (arrowed).

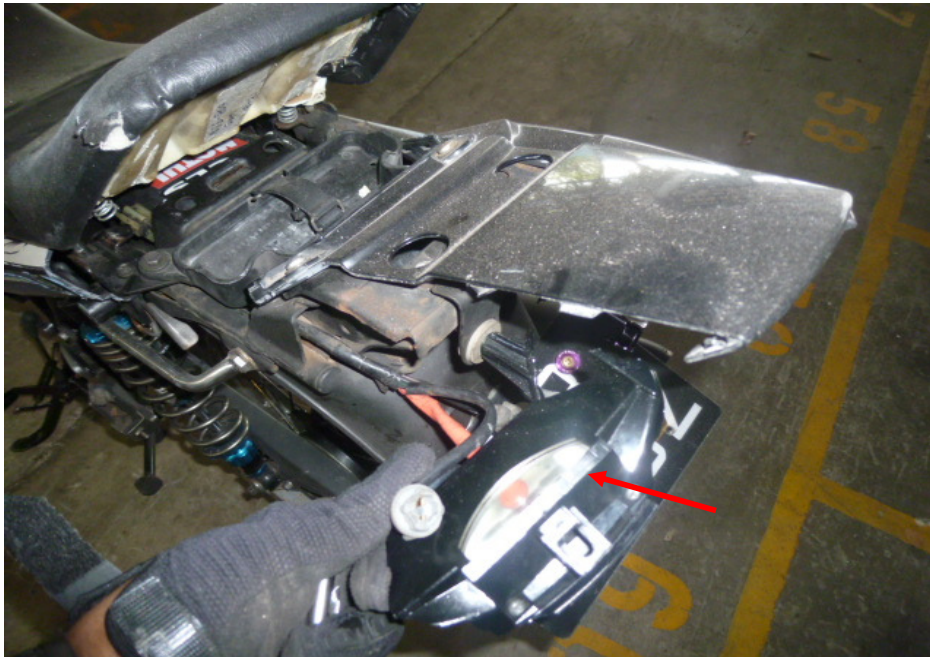
Photo 11 shows the broken tail light assembly of the Motorcycle as a result of the accident (arrowed).

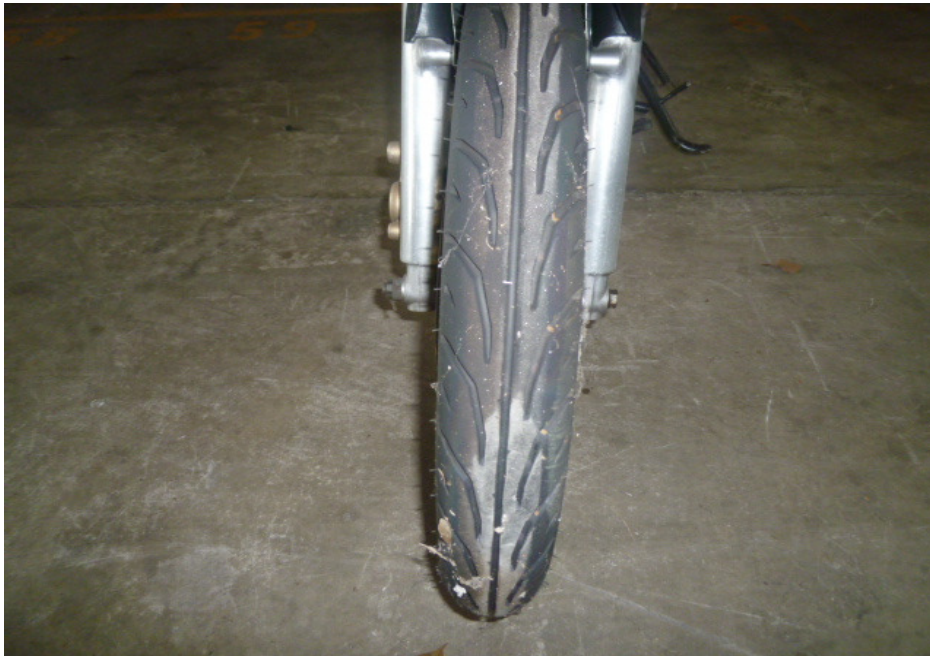
Photo 12 shows the front tyre of the Motorcycle at the time of our inspection. The front tyre was observed to be in serviceable condition with remaining tread depth of approximately 7mm. The tyre was also observed to be sufficiently inflated for vehicular operation. We did not observe any tear, burst mark(s) and/or punctured hole(s) on the sidewalls as well as across the tread of the front tyre.

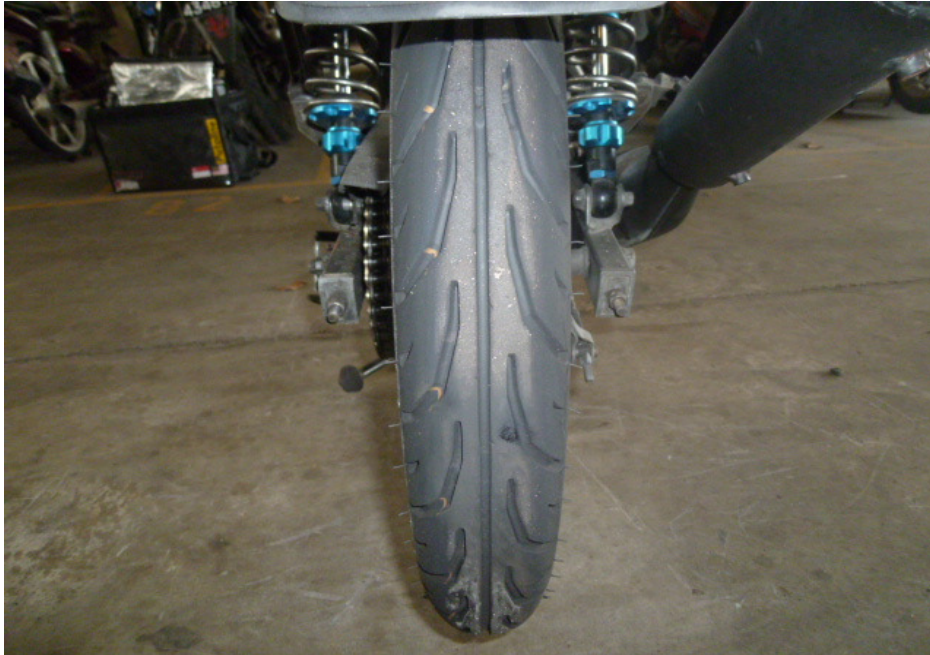
Photo 13 shows the condition of the Motorcycle's rear tyre. The rear tyre was observed to be in serviceable condition with remaining tread depth of approximately 5mm. The tyre was also observed to be sufficiently inflated for vehicular operation. We did not observe any tear, burst mark(s) and/or punctured hole(s) on the sidewalls as well as across the tread of the rear tyre.

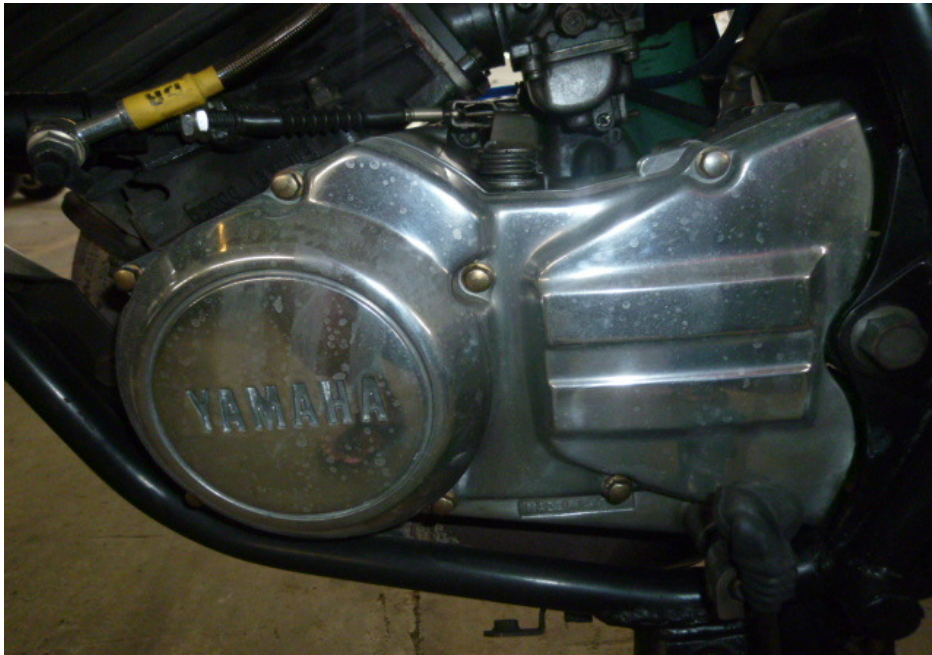
Photo 14 shows the left side of the engine of the Motorcycle at the time of our inspection. The various engine related parts and components were found to be intact with no visible damage. There was also no sign(s) or indication(s) of fluid leak observed around the left engine area of the Motorcycle.

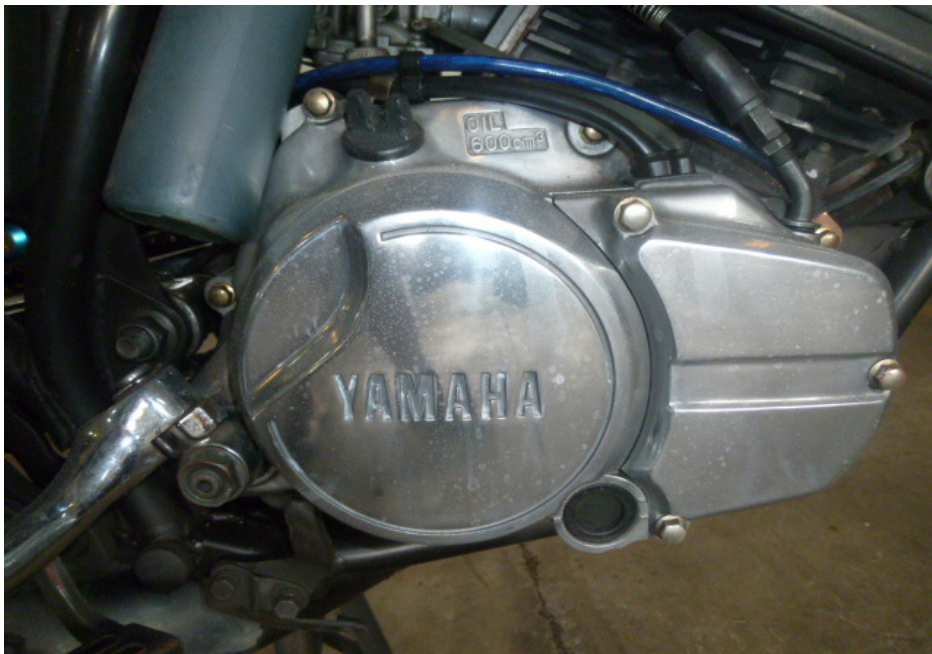
Photo 15 shows the right side of the engine of the Motorcycle at the time of our inspection. The various engine related parts and components were found to be intact with no visible damage. There was also no sign(s) or indication(s) of fluid leak observed around the right engine area of the Motorcycle.

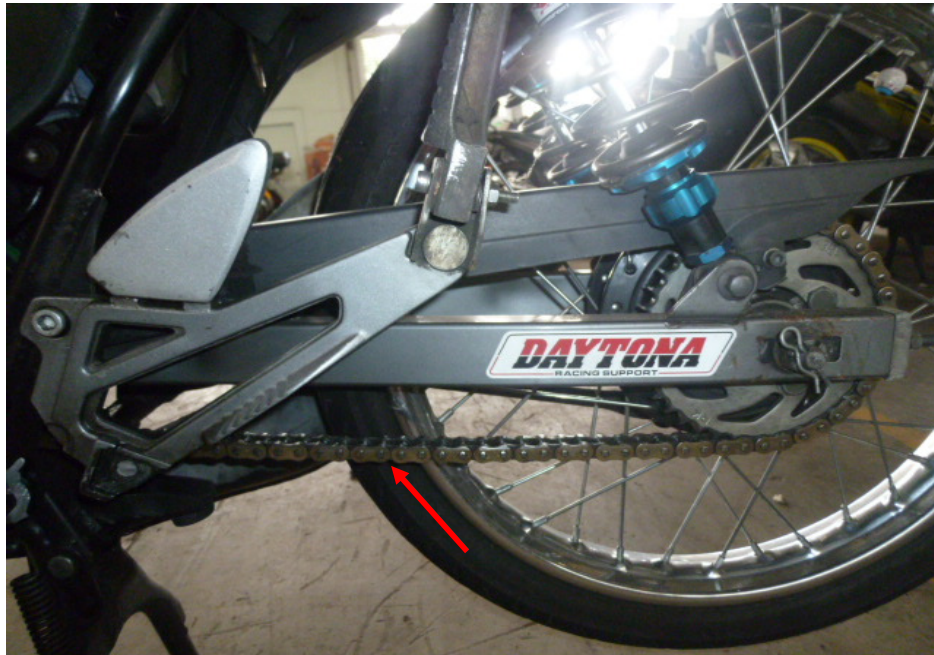
Photo 16 shows the general view of the gear train (arrowed) of the Motorcycle, which was observed to be intact with no misalignment. It was also adequately lubricated for operating purposes.

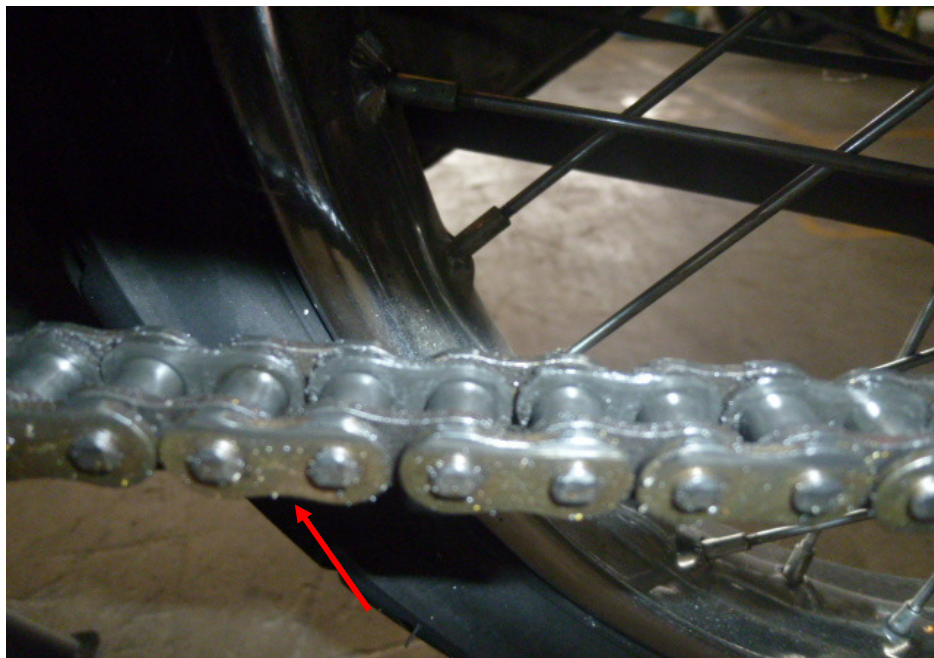
Photo 17 shows a closer view of the gear train (arrowed) of the Motorcycle, which was observed to be intact with no misalignment. It was also adequately lubricated for operating purposes.

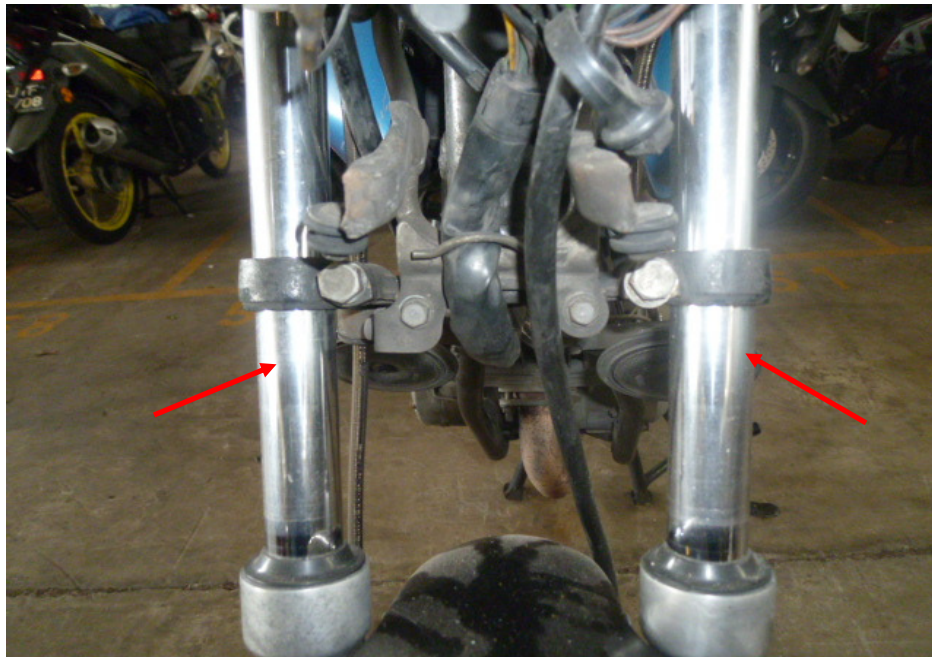
11. For this case, we were not able to conduct any test(s) on the steering system of the Motorcycle due to the damage of its front fork assembly. The front forks were found to be bent inwards as a result of the accident.

16. For this case, we were not able to carry out any operational tests to the steering system and braking system of the Motorcycle due to the damage of its front fork assembly, which had rendered the Motorcycle immobile for the operational tests. We were not able to push the Motorcycle manually forward and backward, simulating movement of the Motorcycle, for the operational tests. See photos 18 – 25 below.

Photo 18 shows the front fork assembly of the Motorcycle. The front forks were observed to be bent inwards as a result of the accident (arrowed). We were hence not able to conduct any tests on the steering system of the Motorcycle.

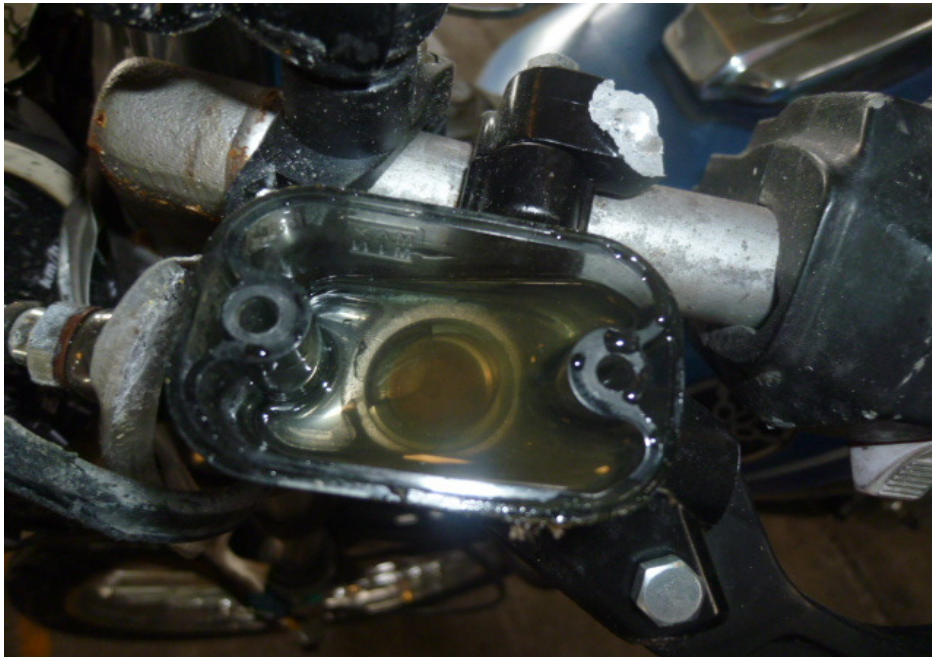
13. Our visual examination of the various components in the Motorcycle's hydraulic clutch system like the clutch lever and clutch hose revealed all to be intact and without damage. There was also no leakage of clutch fluid observed along the clutch hose. This was from the respective clutch fluid reservoir at the left handlebar of the Motorcycle. The clutch fluid was found to be of sufficient level for operating purposes and without any contamination.

Photo 19 shows the hydraulic clutch fluid reservoir for the hydraulic clutch system of the Motorcycle. The hydraulic clutch fluid was observed to be of sufficient level for operational purposes and without any contamination.

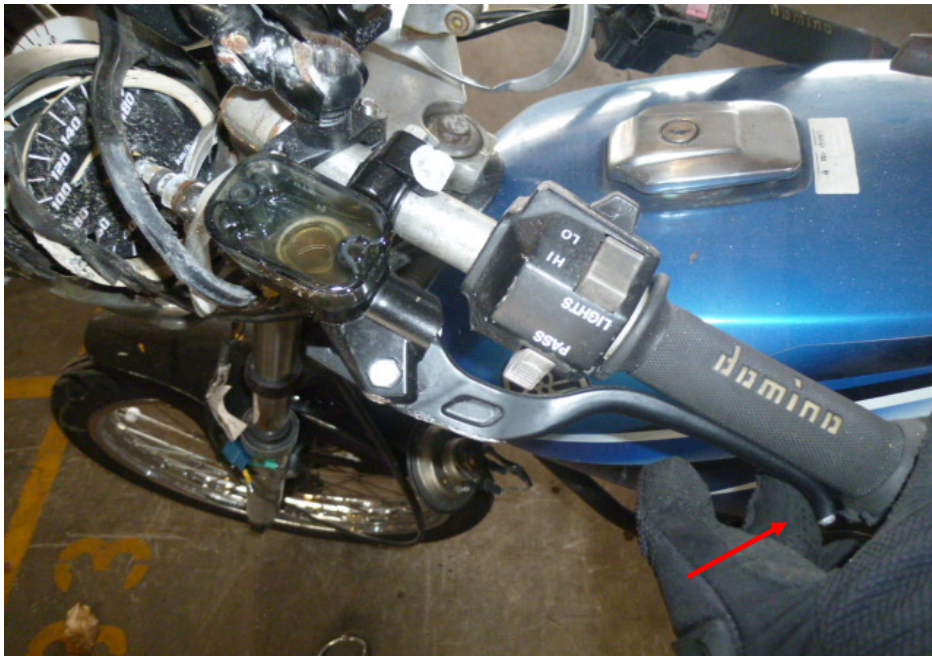
Photo 20 shows the clutch lever being depressed. There was some resistance felt (spongy like feel) upon pressing the clutch lever (arrowed). This would indicate that there is no leakage of pressure/vacuum in the hydraulic clutch system.

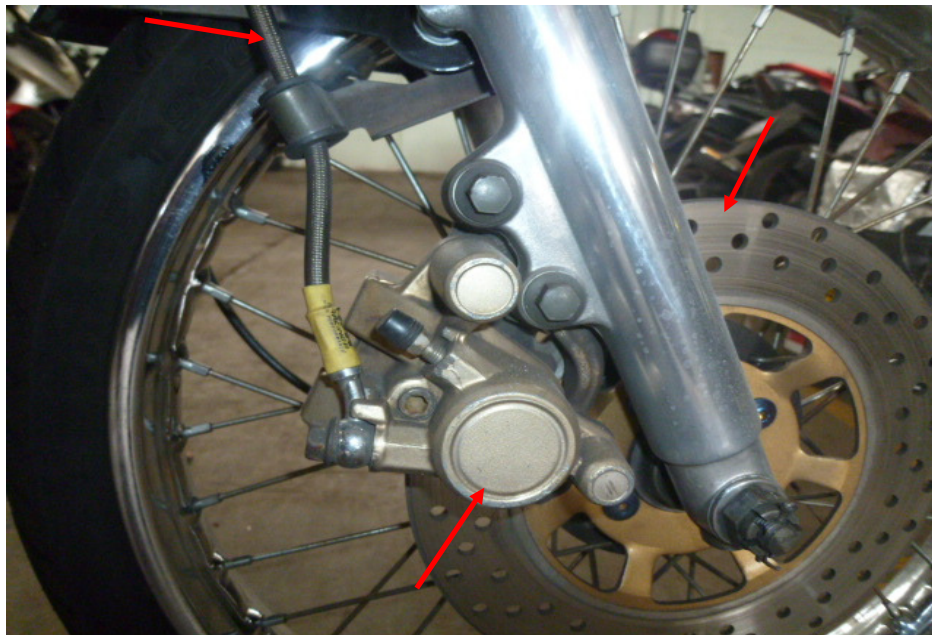
14. The brake system of the Motorcycle was of a semi-hydraulic type, where hydraulic (brake fluid) pressure controls the brake for the front wheel while the brake for the rear wheel is controlled by mechanical means (cables and springs). Our visual examination of the various components in the brake system, like the brake disc, brake caliper, drum and brake foot pedal, revealed all to be intact and without damage. The brake fluid for the front brake was found to be of sufficient level for operating purposes and without any contamination. There was also no visible tear or cut observed on the connecting hoses and cables. However we found that part of the front brake lever had broken off as a result of the accident. We also observed a leakage of brake fluid along the front brake hose. This was from the respective front brake fluid reservoir to the front brake caliper of the Motorcycle. Upon closer examination, we found that the front brake hose was cut as a result of the accident.

Photo 21 shows a close up view of the front brake caliper, front brake disc and front brake hose (arrowed) of the Motorcycle, which are all part of the components in the hydraulic front brake system of the Motorcycle. Our visual checks of the front brake caliper and front brake disc had revealed all to be intact with no visible damage. However we observed a leakage of brake fluid along the front brake hose.

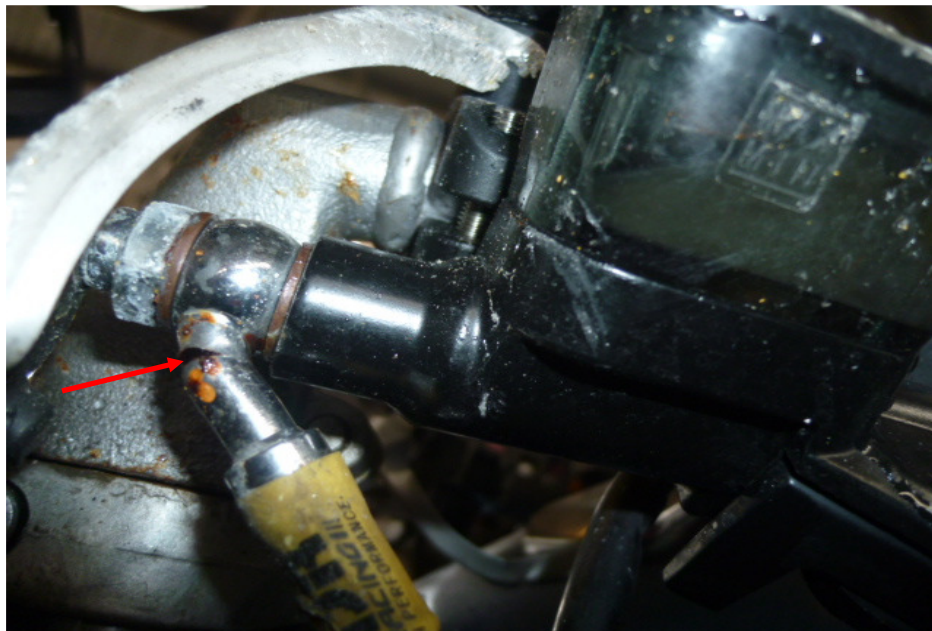
Photo 22 shows the front brake reservoir of the Motorcycle. We observed a leakage of brake fluid along the front brake hose. This was from the respective front brake fluid reservoir to the front brake caliper of the Motorcycle. Upon closer examination, we found that the front brake hose was cut as a result of the accident (arrowed).

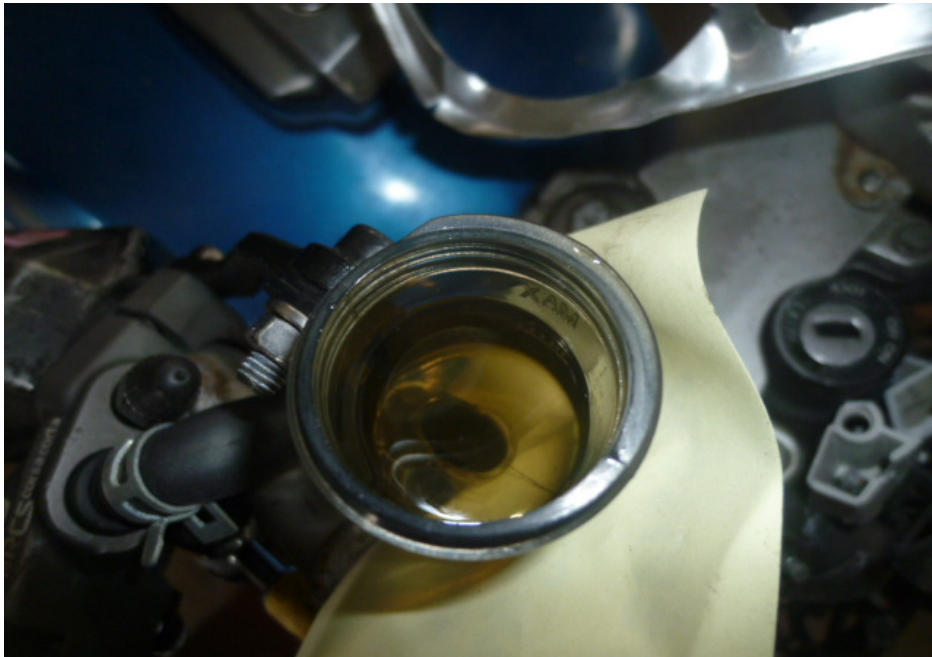
Photo 23 shows the brake fluid reservoir for the front brake of the Motorcycle. The brake fluid was found to be of sufficient level for operating purposes and without any contamination.

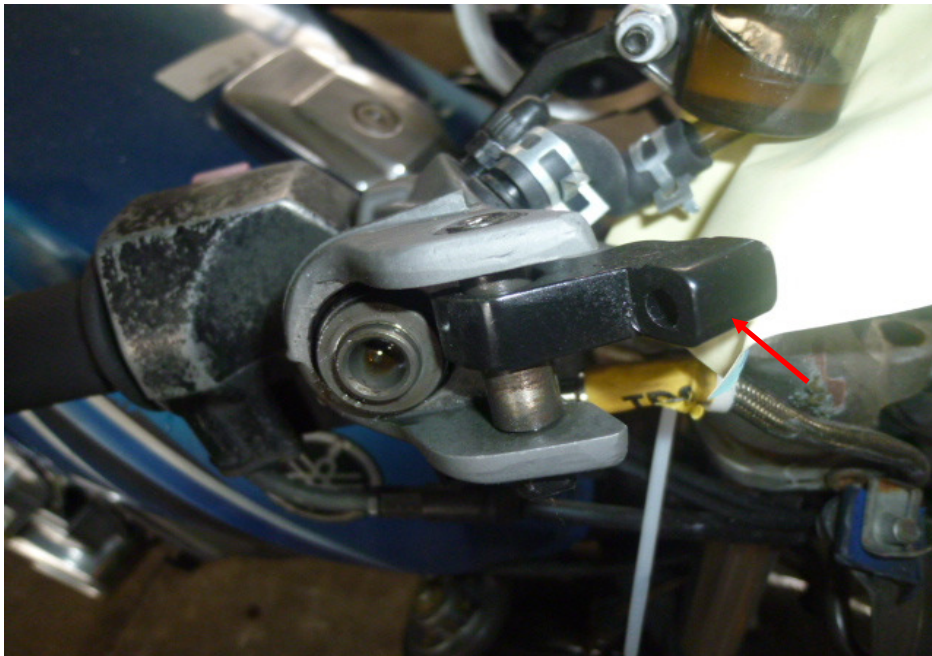
15. For this case, static as well as operational brake tests could not be conducted on the Motorcycle's front braking system due to the broken front brake lever and cut front brake hose. We were unable to determine if there was any leakage of pressure/vacuum in the front brake system.

Photo 24 shows the front brake reservoir. We were unable to depress the front brake lever as part of it had broken off as a result of the accident (arrowed). Hence we were unable to determine if there was any leakage of pressure/vacuum in the front brake system.

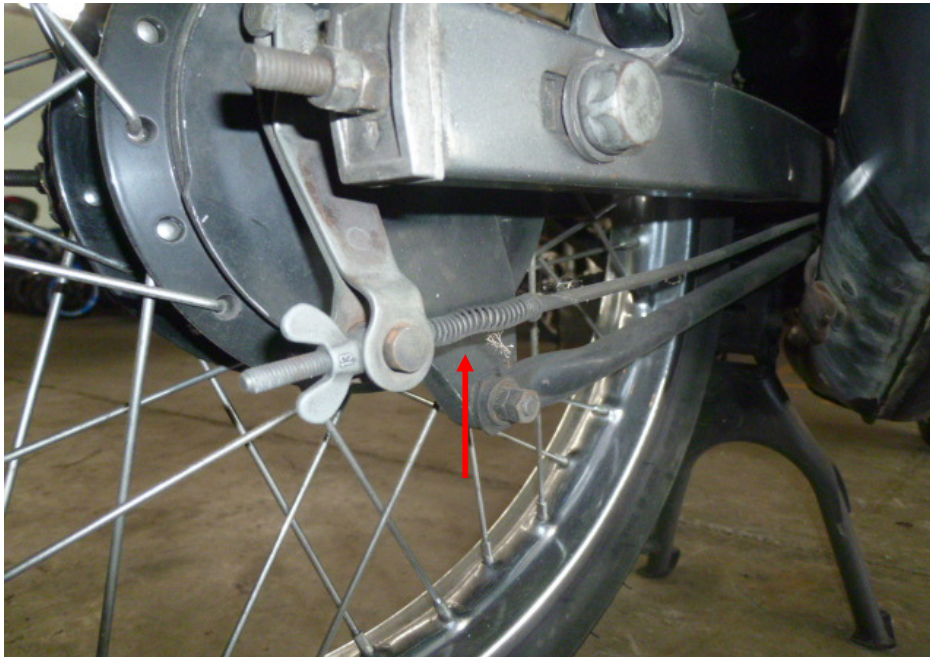
Photo 25 shows the rear wheel of the Motorcycle. The type of brake system for the rear wheel was of a mechanical type, controlled by the brake foot pedal of the Motorcycle. Our checks of the cable (arrowed), spring and drum which are all part of the components in the rear brake system of the Motorcycle reveal all to be intact and without damage.
