Your Ref: TP/IP/34241/2021
Our Ref : CI/TPD21008634/N

Fatal Accident Investigation Team

INSPECTION REPORT OF MOTORCYCLE FBQ 340E

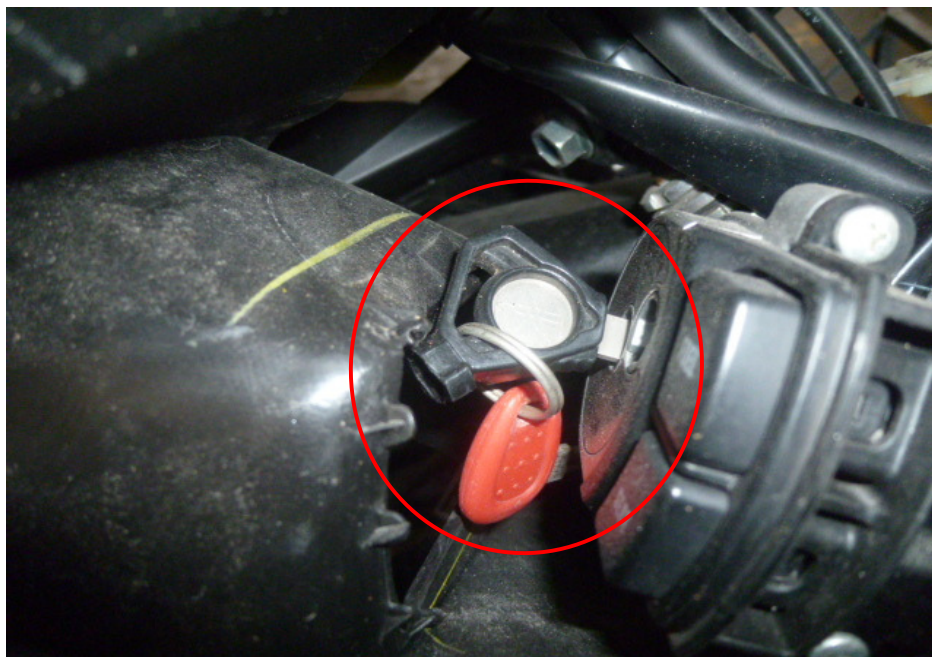
4. The mileage of the Motorcycle could not be recorded at the time of our inspection due to a jammed key in the ignition.
5. The Motorcycle was observed to have sustained minor damages all around. The body parts that were found to have been damaged include its windshield, front cowling, front mudguard, front fork assembly, front wheel rim, right hand brake lever, right side mirror, side cowlings, right lower side cover, left pillion foot peg and top box rack, amongst others as a result of the accident. See photos 1 – 14 below.

Photo 1 shows the jammed key in the ignition of the Motorcycle as a result of the accident (circled).

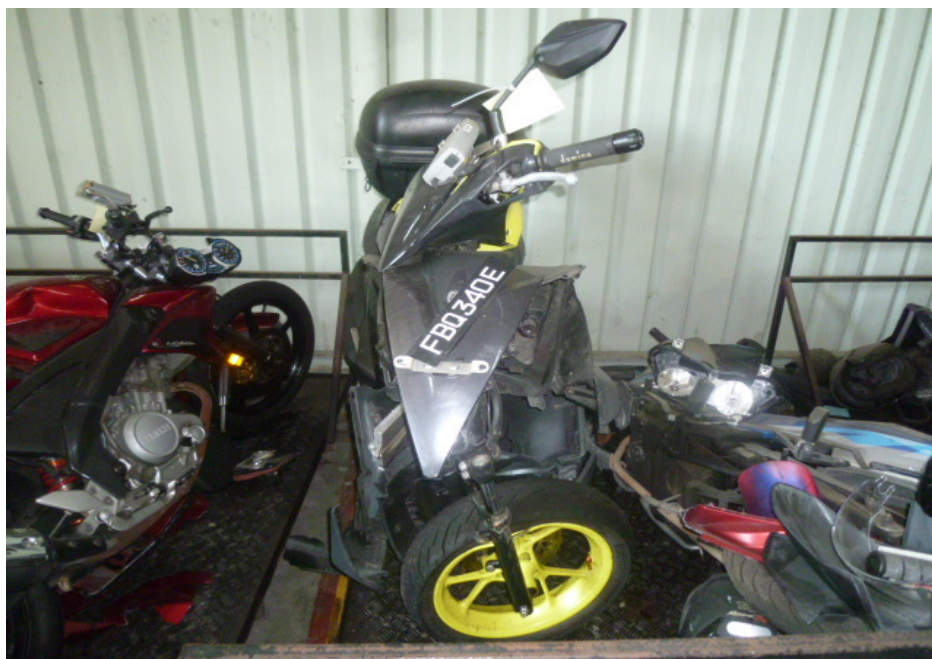
Photo 2 shows a general view of the frontal portion of the Motorcycle at the time of our inspection. The Motorcycle was observed to have sustained damages all around.

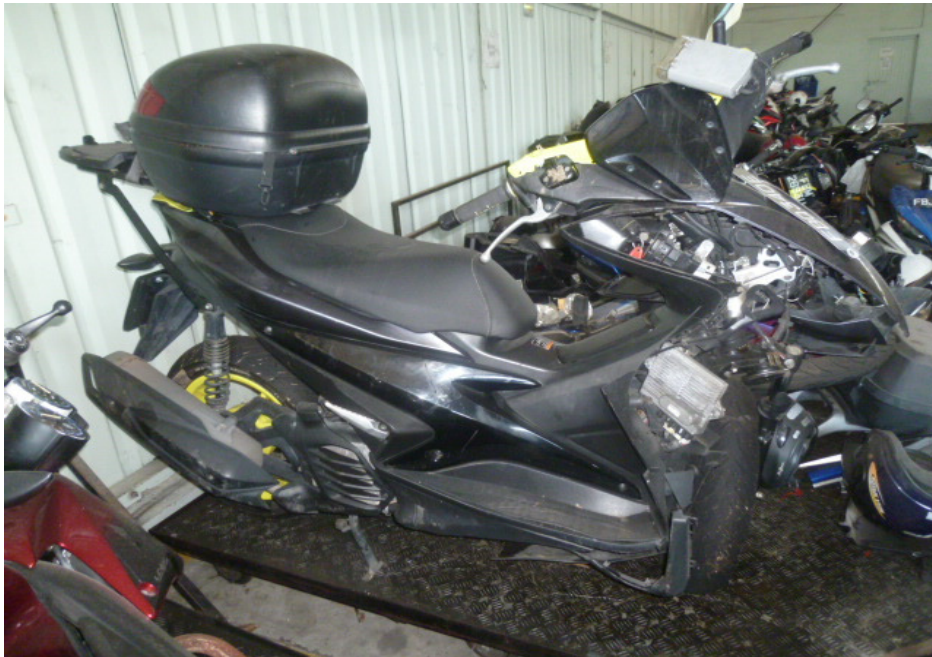
Photo 3 shows a general view of the right body of the Motorcycle at the time of our inspection. The Motorcycle was observed to have sustained damages all around.

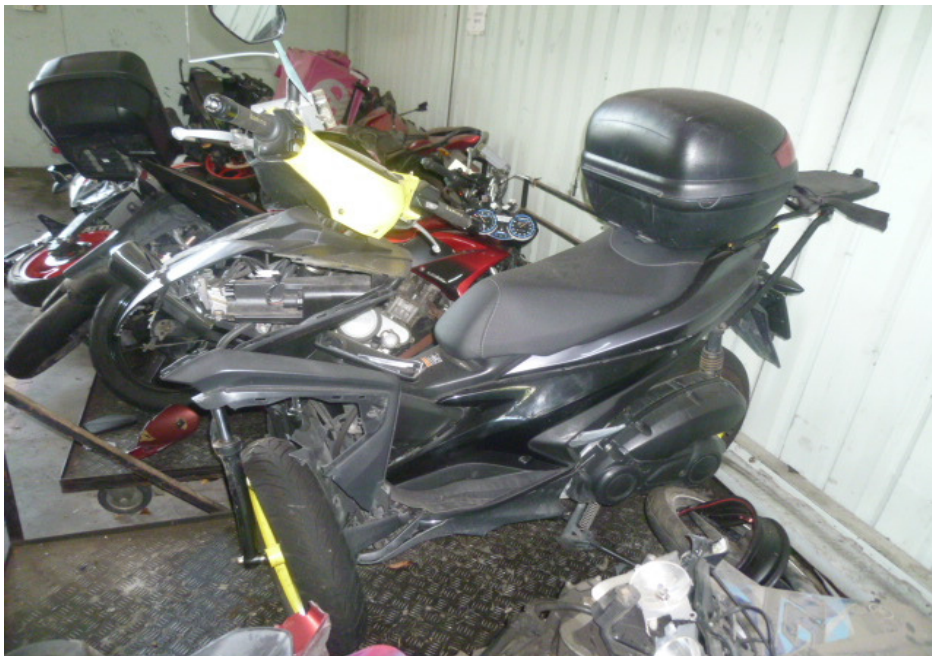
Photo 4 shows a general view of the left portion of the Motorcycle at the time of our inspection. The Motorcycle was observed to have sustained damages all around.

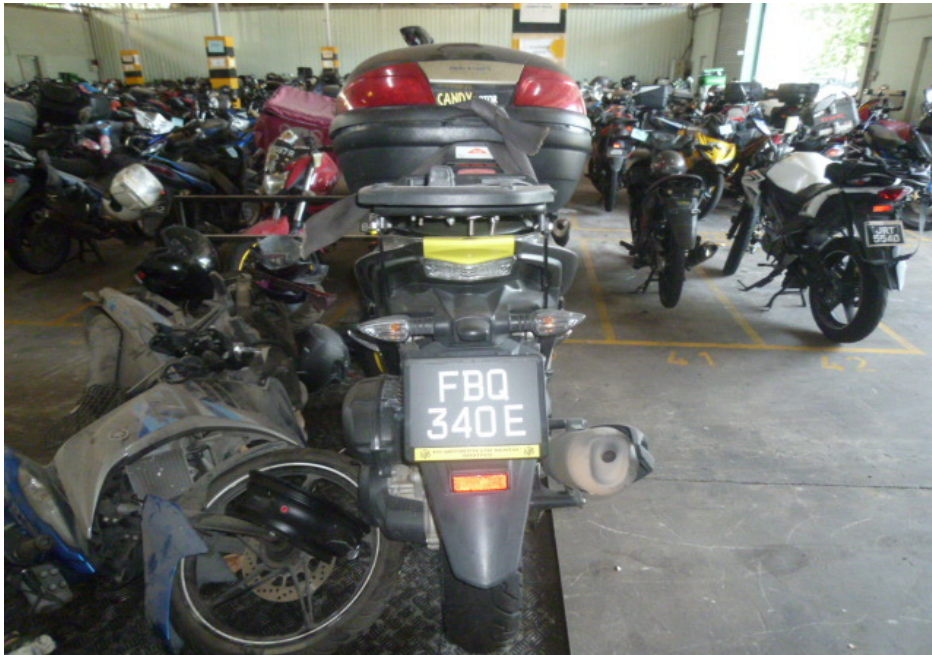
Photo 5 shows a general view of the rear portion of the Motorcycle at the time of our inspection. The Motorcycle was observed to have sustained damages all around. The body parts that were found to have been damaged include its windshield, front cowling, front mudguard, front fork assembly, front wheel rim, right hand brake lever, right side mirror, side cowlings, right lower side cover, left pillion foot peg and top box rack, amongst others as a result of the accident.

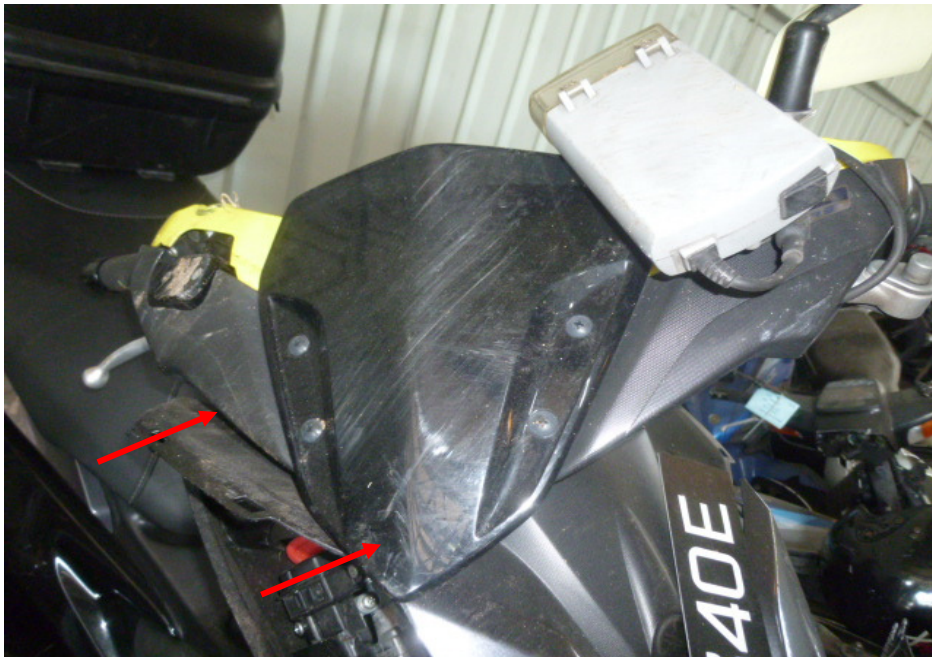
Photo 6 shows a closer view of the grazed windshield and front cowling of the Motorcycle at the time of our inspection (arrowed).

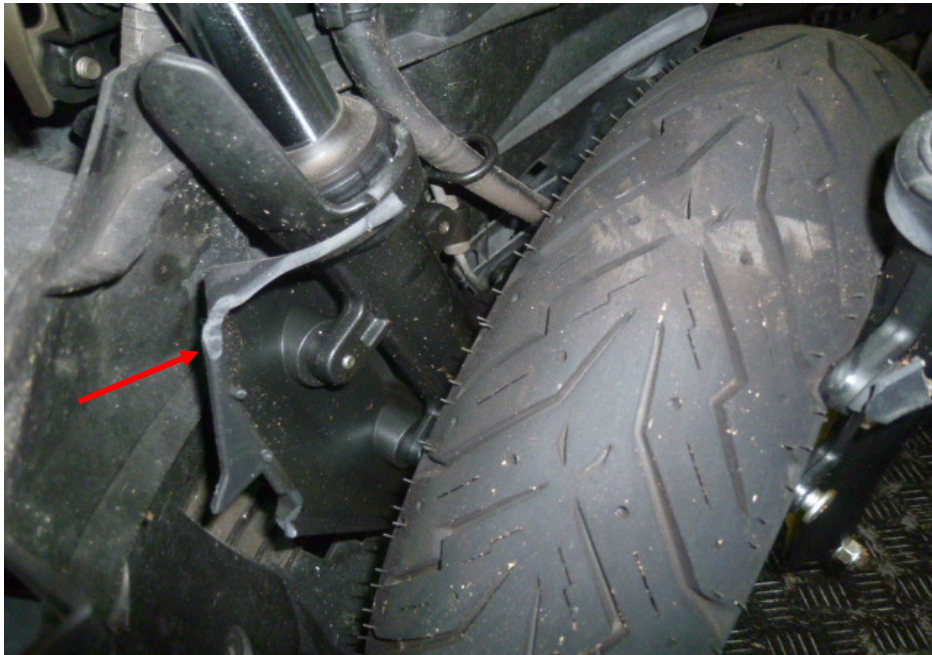
Photo 7 shows a closer view of the cracked front mudguard which was amongst the body parts at the front body of the Motorcycle that had sustained damage as a result of the accident (arrowed).

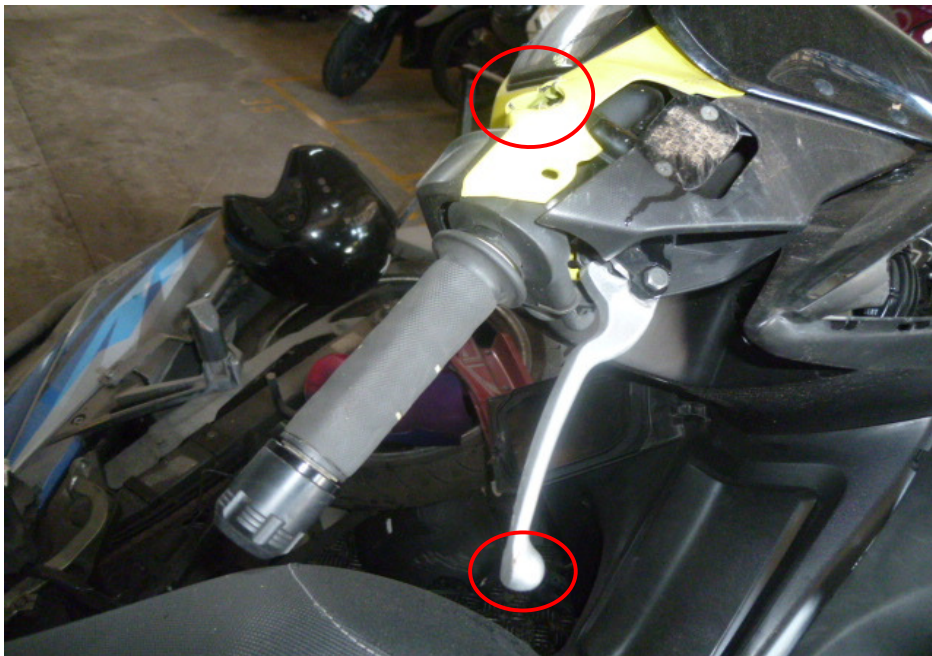
Photo 8 shows a closer view of the missing right side mirror and front brake lever of the Motorcycle which were observed to be damaged due to the accident (circled).

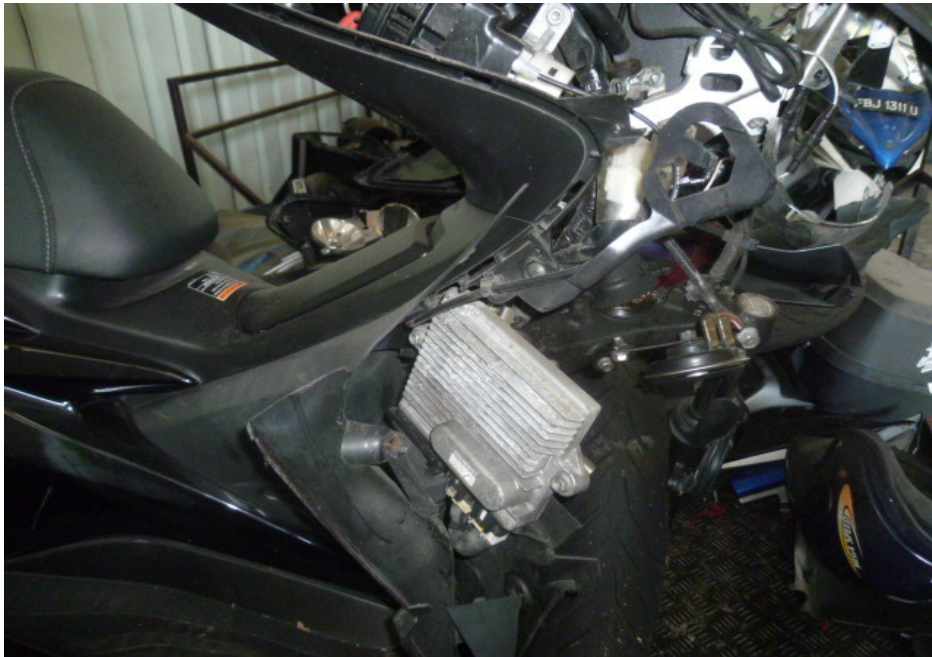
Photo 9 shows the missing right side cowling of the Motorcycle as a result of the accident.

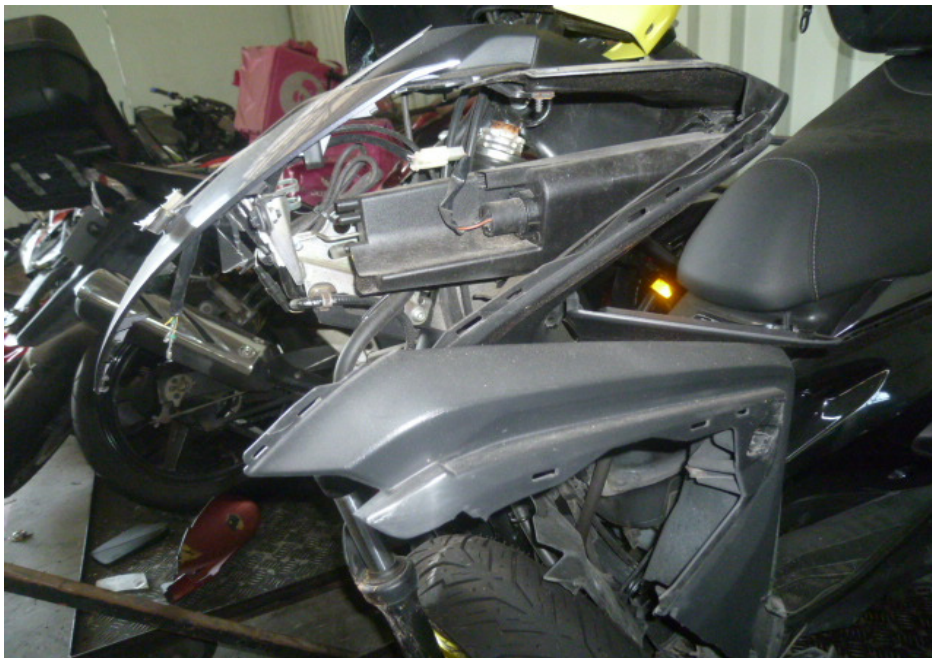
Photo 10 shows the broken left side cowling of the Motorcycle as a result of the accident.

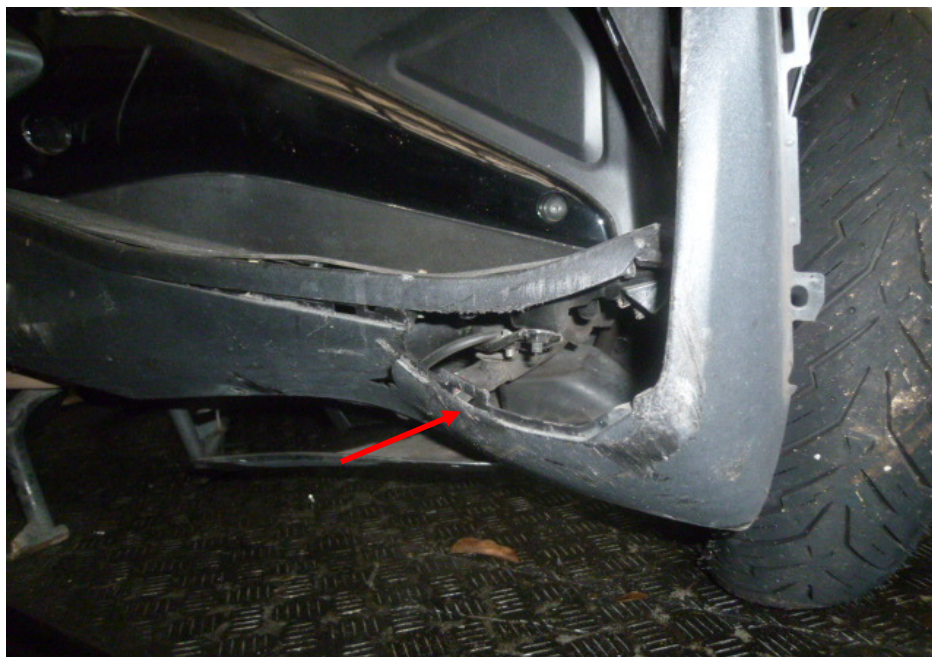
Photo 11 shows a closer view of the cracked right lower side cover of the Motorcycle as a result of the accident (arrowed).

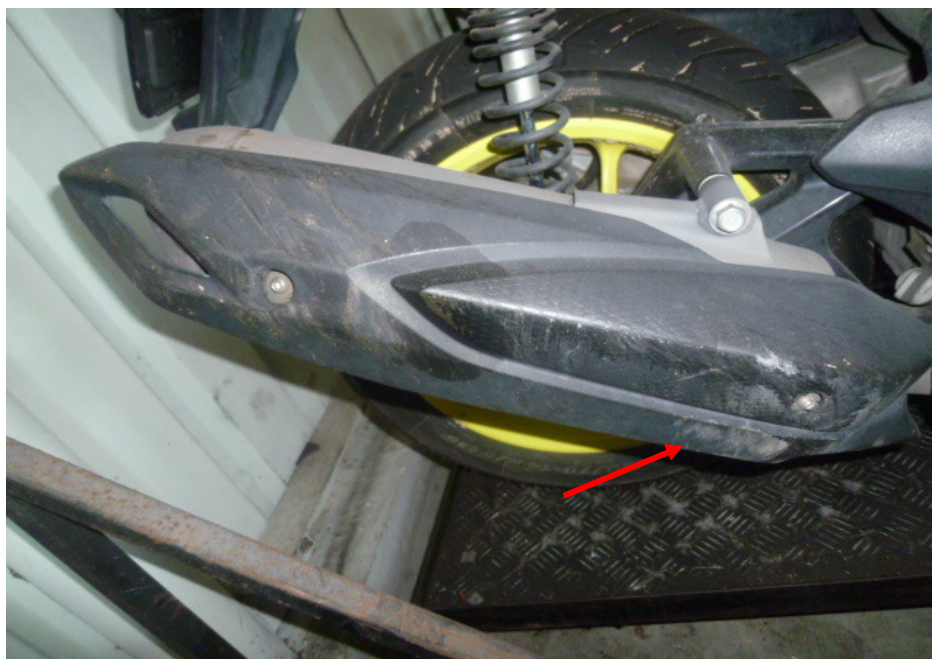
Photo 12 shows a closer view of the grazed exhaust muffler heat shield of the Motorcycle at the time of our inspection (arrowed).

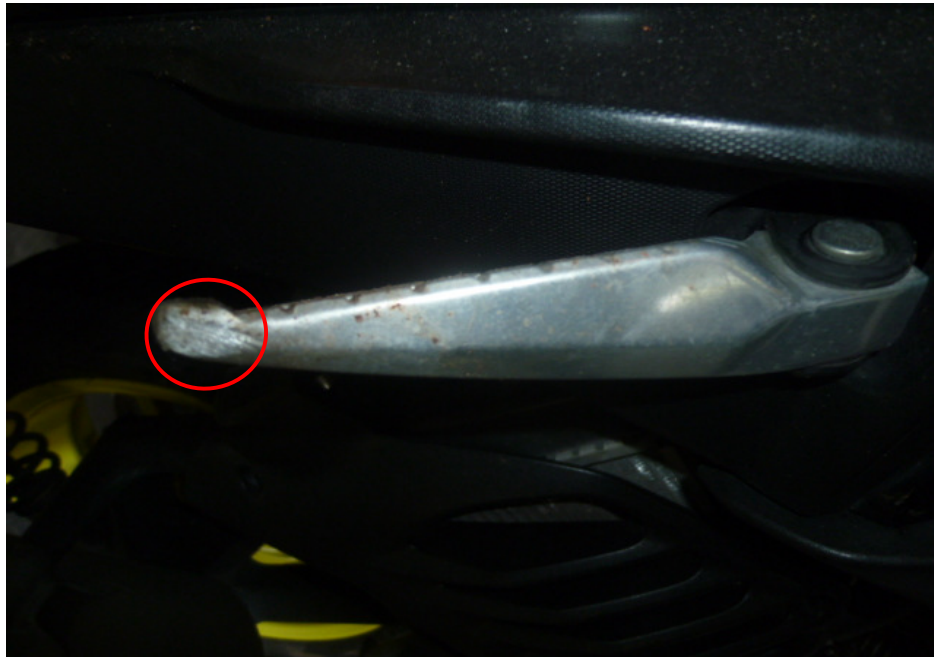
Photo 13 shows a closer view of the grazed left pillion foot peg of the Motorcycle at the time of our inspection (circled).

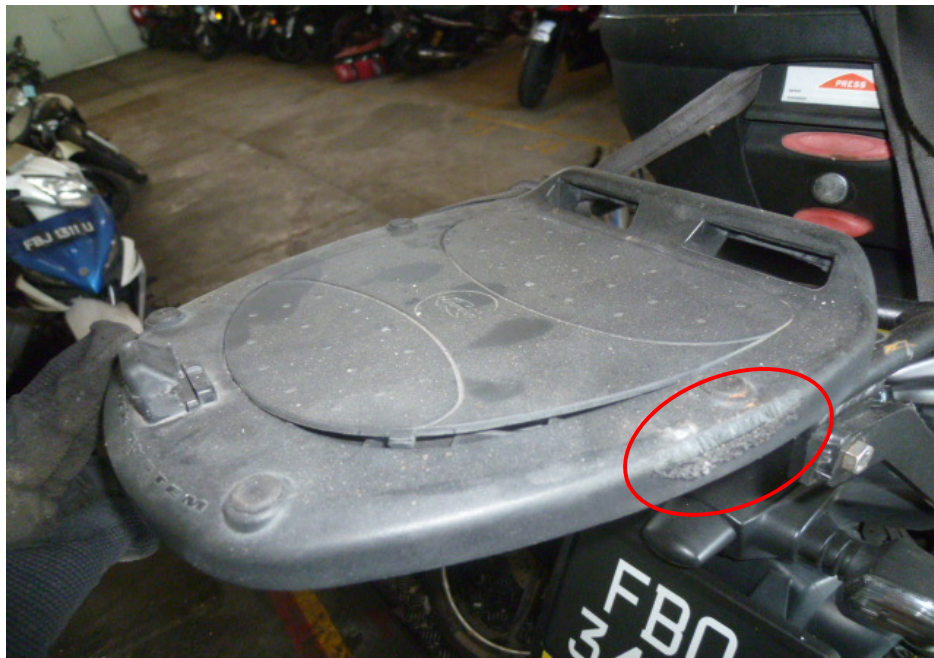
Photo 14 shows a closer view of the top box rack of the Motorcycle which had sustained damages of grazing nature due to the accident (circled).

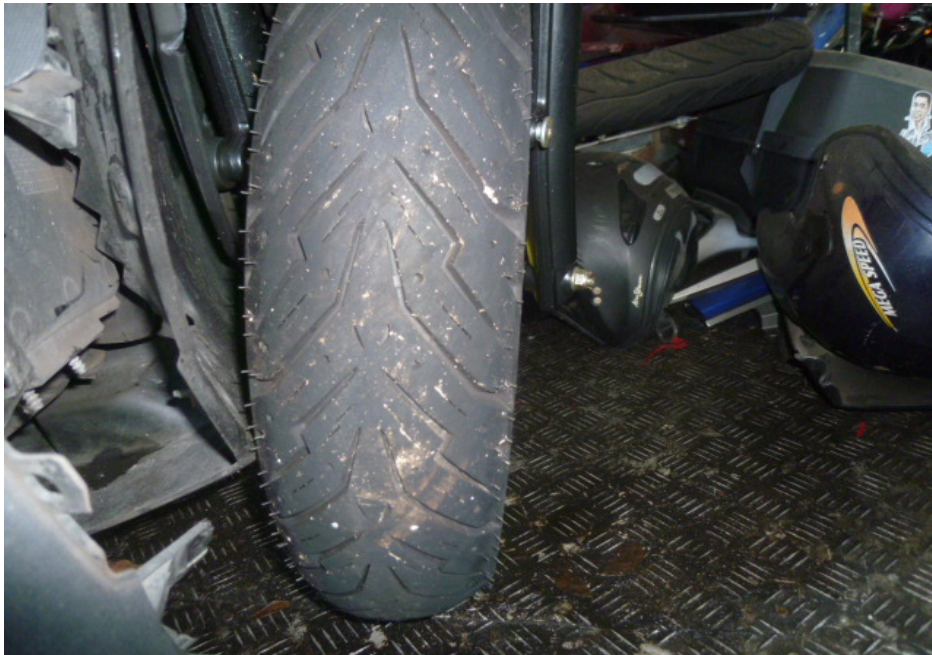
Photo 15 shows the condition of the Motorcycle's front tyre. The front tyre was observed to be in serviceable condition with remaining tread depth of approximately 8mm. There was no tear, burst mark(s) and/or punctured hole(s) on the sidewalls as well as across the tread of the front tyre. However the front tyre was observed to be deflated.

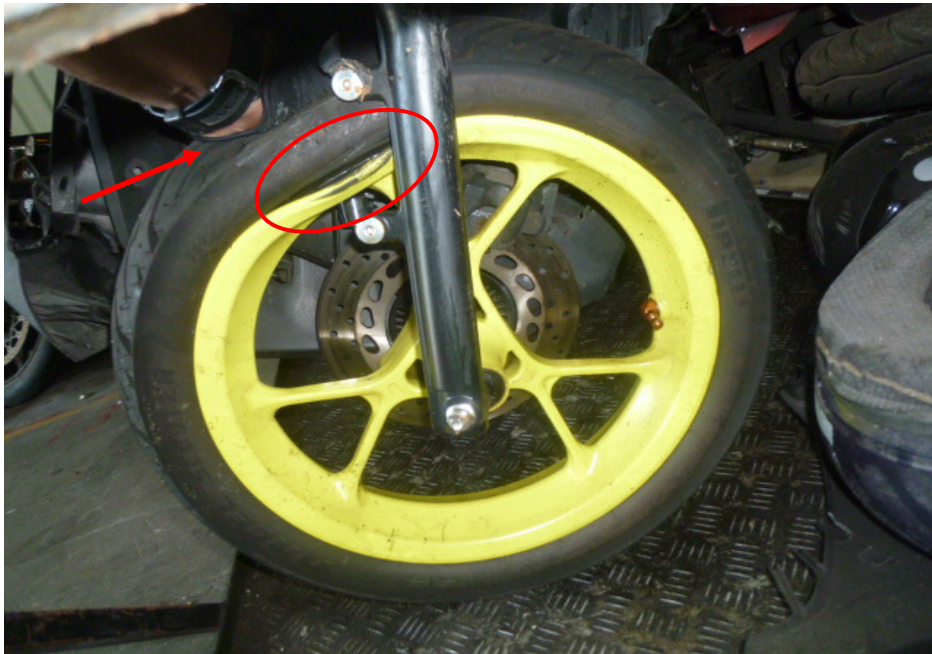
7. The 2 tyres were wrapped around alloy wheel rims. At the time of our inspection, we did not observe any visible damage on the rear wheel rim of the Motorcycle. However we did observe that the front wheel rim was bent. See photos 15 - 17 below.

Photo 16 shows the bent front wheel rim (circled) and deflated front tyre (arrowed) of the Motorcycle at the time of our inspection.

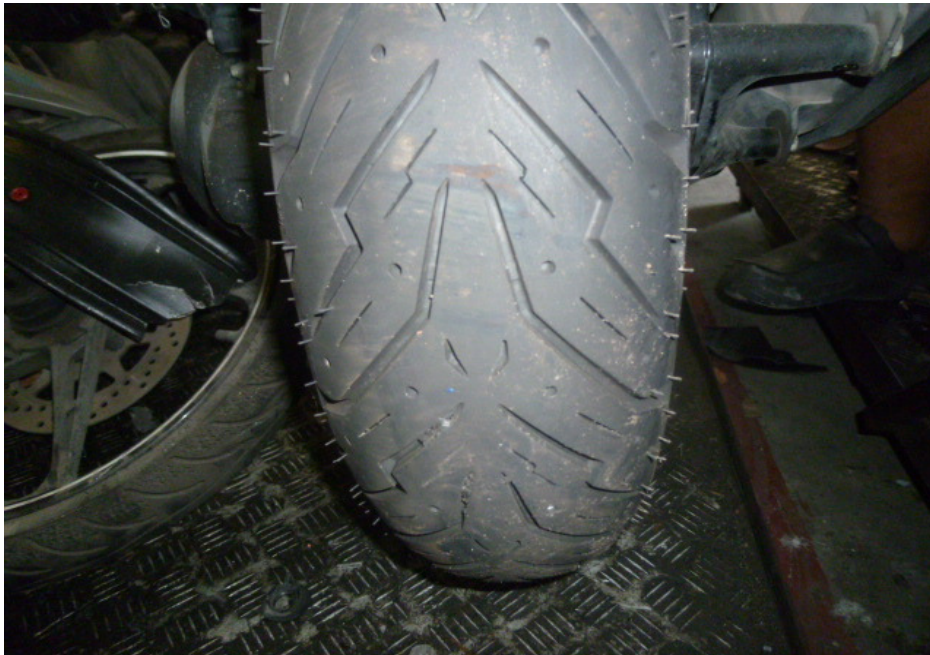
Photo 17 shows the condition of the Motorcycle's rear tyre. The rear tyre was observed to be in serviceable condition with remaining tread depth of approximately 6mm. The tyre was also observed to be sufficiently inflated for vehicular operation. We did not observe any tear, burst mark(s) and/or punctured hole(s) on the sidewalls as well as across the tread of the rear tyre.

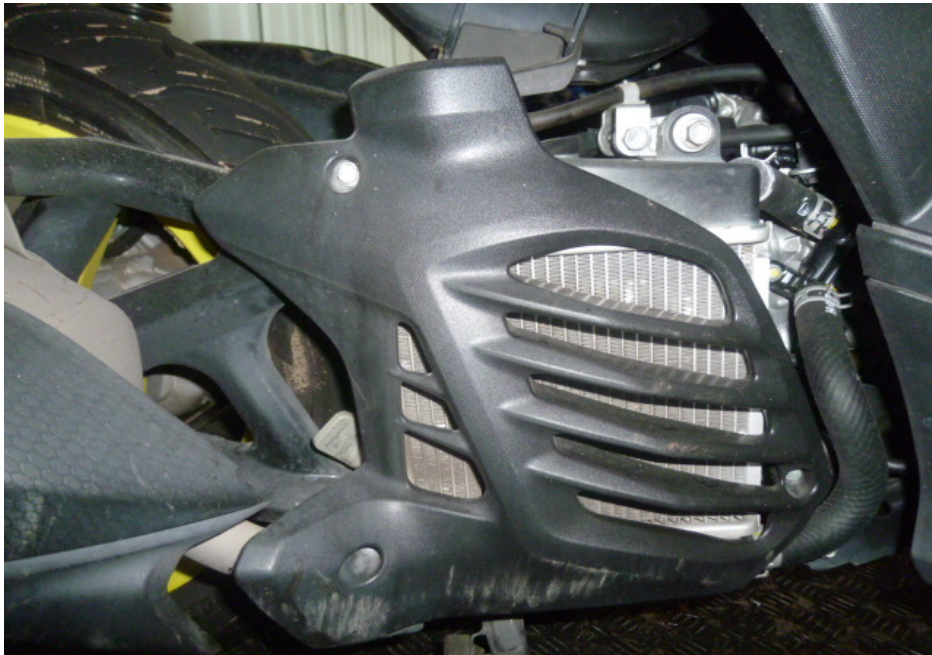
Photo 18 shows the radiator of the Motorcycle at the time of our inspection. The radiator was found to be intact with no visible damage. There was also no sign(s) or indication(s) of fluid leak observed around the radiator of the Motorcycle.

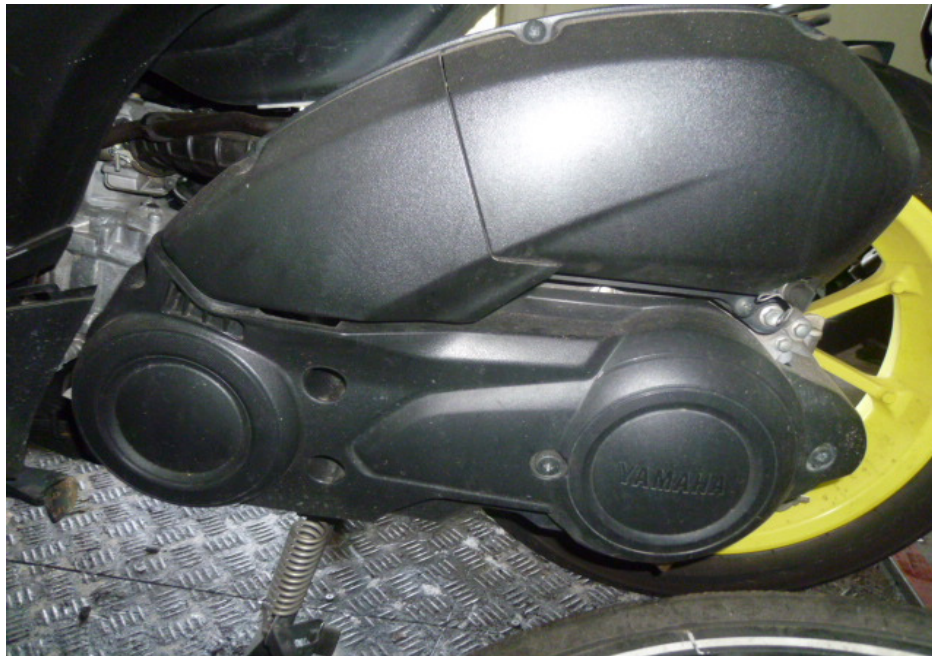
Photo 19 shows the drive train cover of the Motorcycle which was found to be intact without any misalignment.

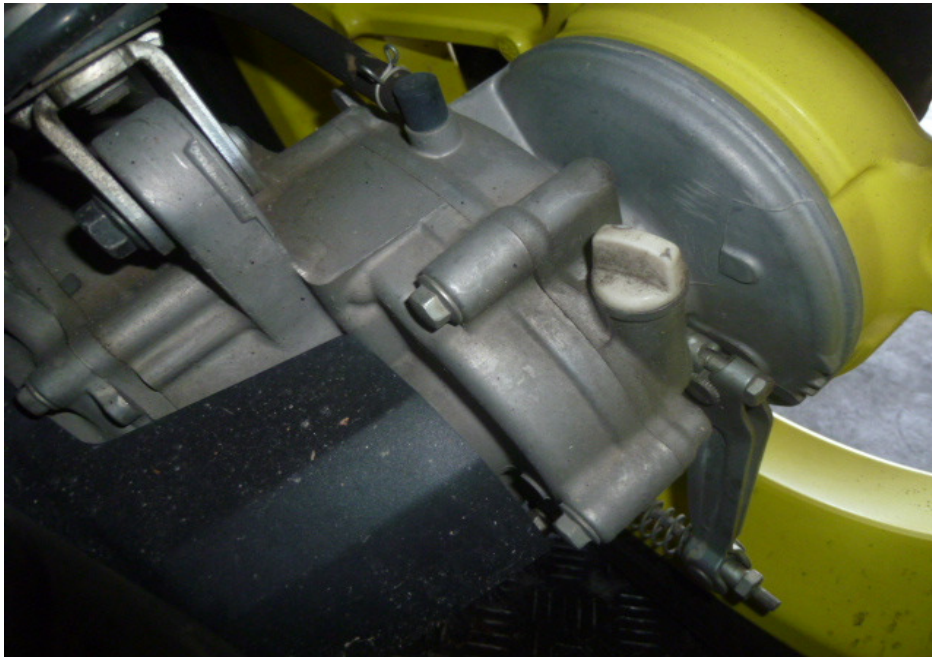
Photo 20 shows the drive train of the Motorcycle which was found to be intact without any misalignment.

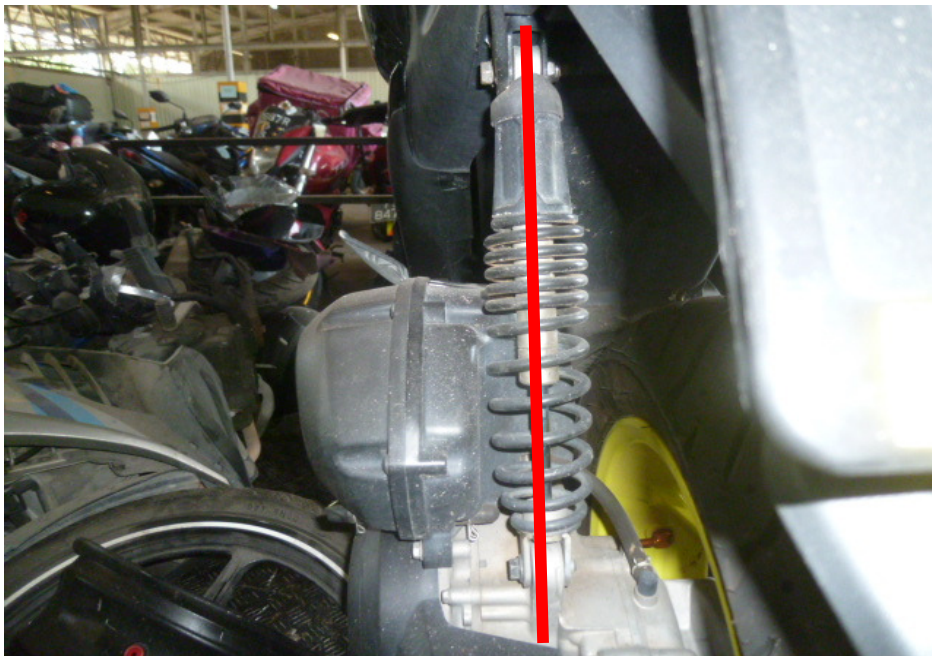
Photo 21 shows the left shock absorber of the Motorcycle which was found to be intact without any misalignment.

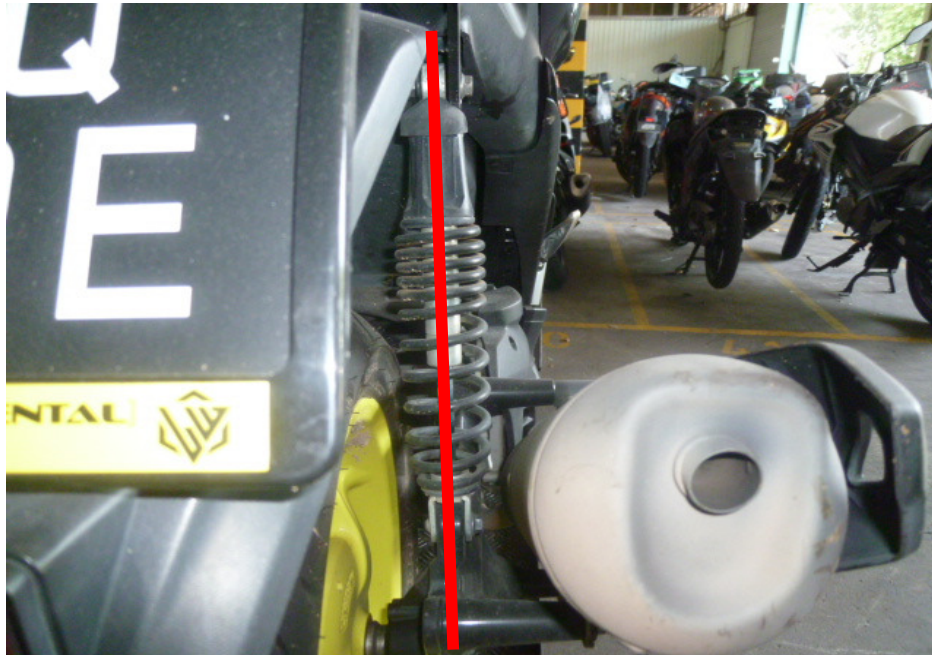
Photo 22 shows the right shock absorber of the Motorcycle which was found to be intact without any misalignment.

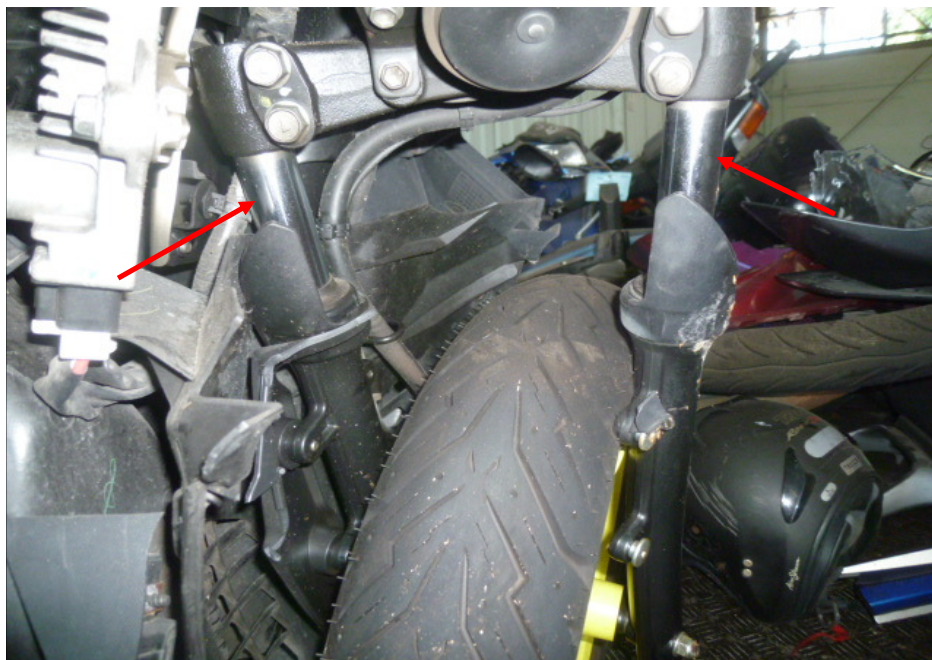
10. For this case, we were not able to conduct any test(s) on the steering system of the Motorcycle due to the damage of its front fork assembly. The front forks and steering stem were found to be bent as a result of the accident.

Photo 23 shows the front fork assembly of the Motorcycle. The front forks were observed to be bent (arrowed) as a result of the accident. We were hence not able to conduct any tests on the steering system of the Motorcycle.

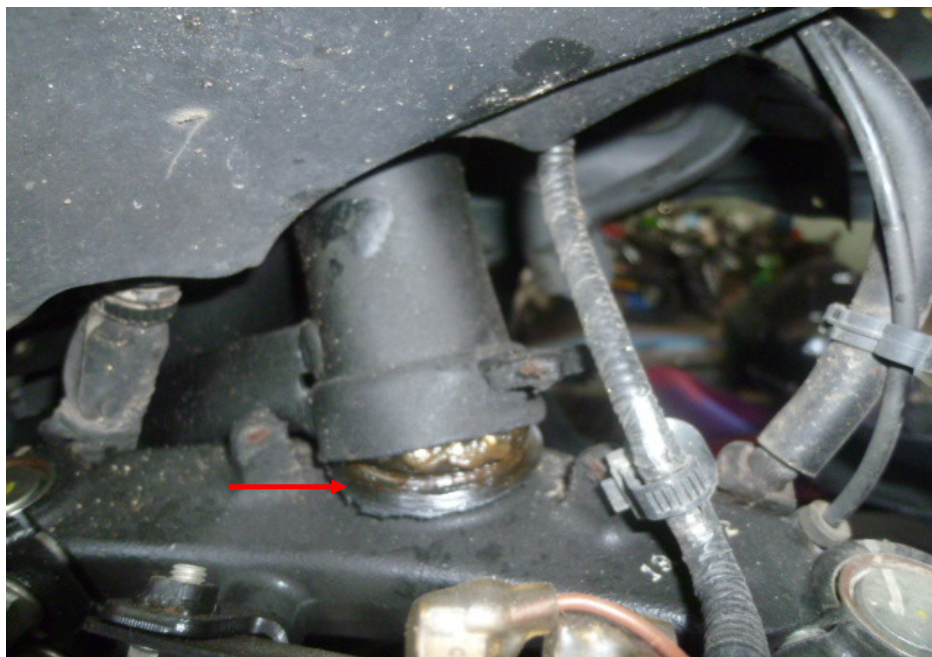
Photo 24 shows the steering stem of the Motorcycle. The steering stem observed to be bent (arrowed) as a result of the accident. We were hence not able to conduct any tests on the steering system of the Motorcycle.

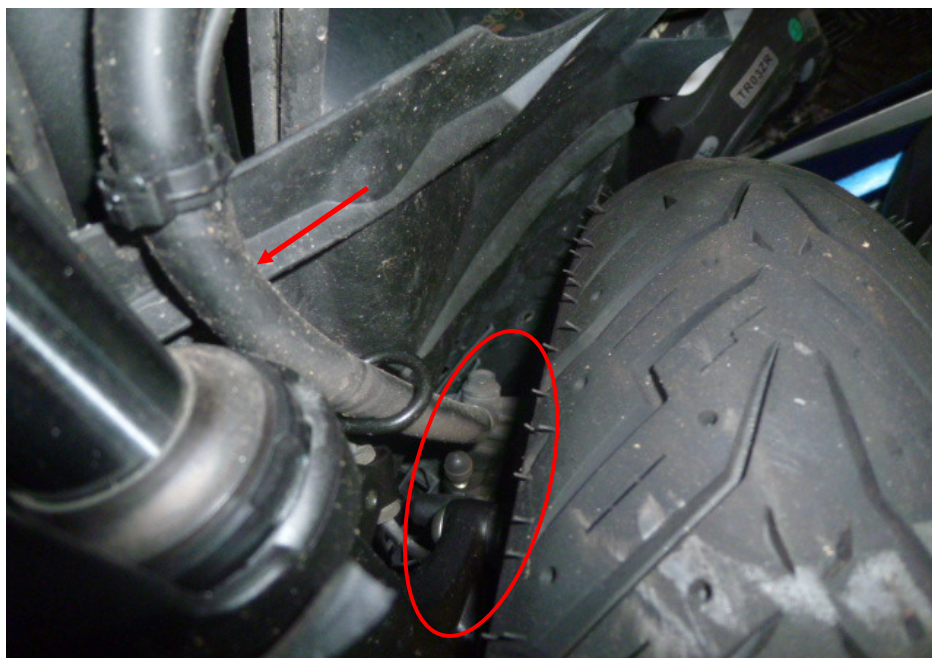
12. However due to the damage sustained to the steering system as a result of the accident, we were unable to turn the handlebar to conduct a visual examination of the front brake disc and front brake caliper of the Motorcycle.

Photo 25 shows due to the damage sustained to the steering system as a result of the accident, we were unable to turn the handlebar to conduct a visual examination of the front brake disc and front brake caliper of the Motorcycle (circled). Our visual checks of the front brake hose had revealed it to be intact with no visible damage (arrowed). No leakage of brake fluid was also observed.

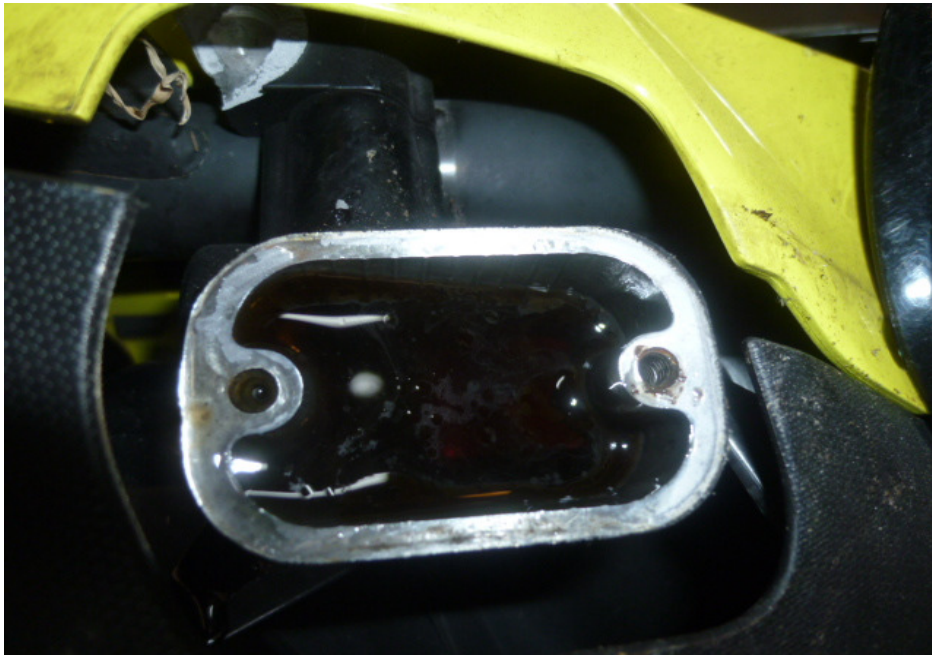
Photo 26 shows the brake fluid reservoir for the front brake of the Motorcycle. The brake fluid was observed to be of sufficient level and without contamination for operational purposes.

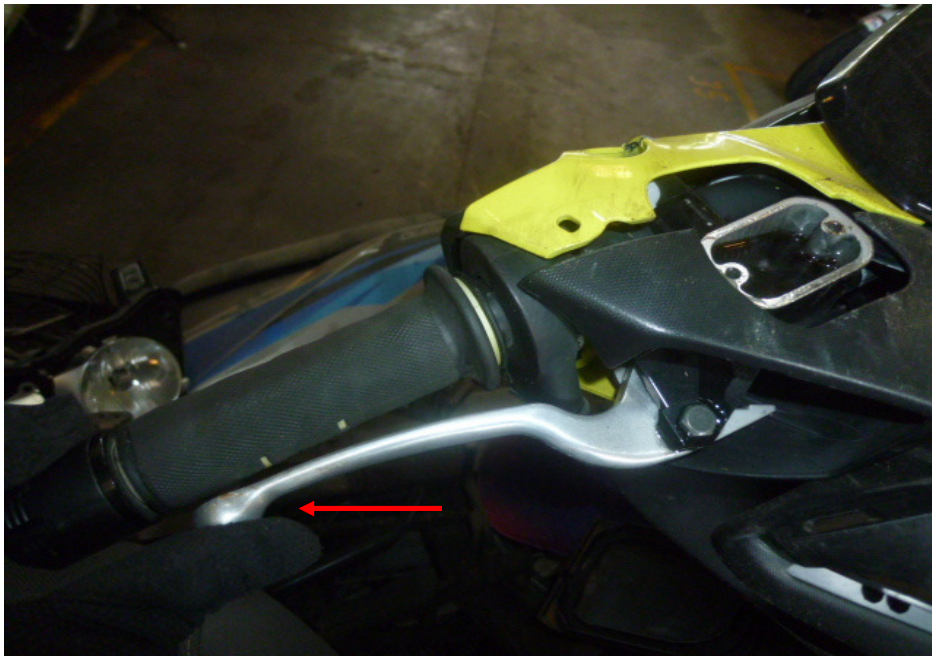
13. Static brake tests conducted on the Motorcycle had appeared to indicate that the front brake system of the Motorcycle was not in serviceable condition. There was no resistance felt (spongy like feel) upon pressing the right hand brake lever. This would indicate that there may be a leakage of pressure/vacuum in the front brake system.

Photo 27 shows the front brake lever being depressed. There was no resistance felt (spongy like feel) upon pressing the front brake lever (arrowed). This would indicate that there may be a leakage of pressure/vacuum in the front brake system.

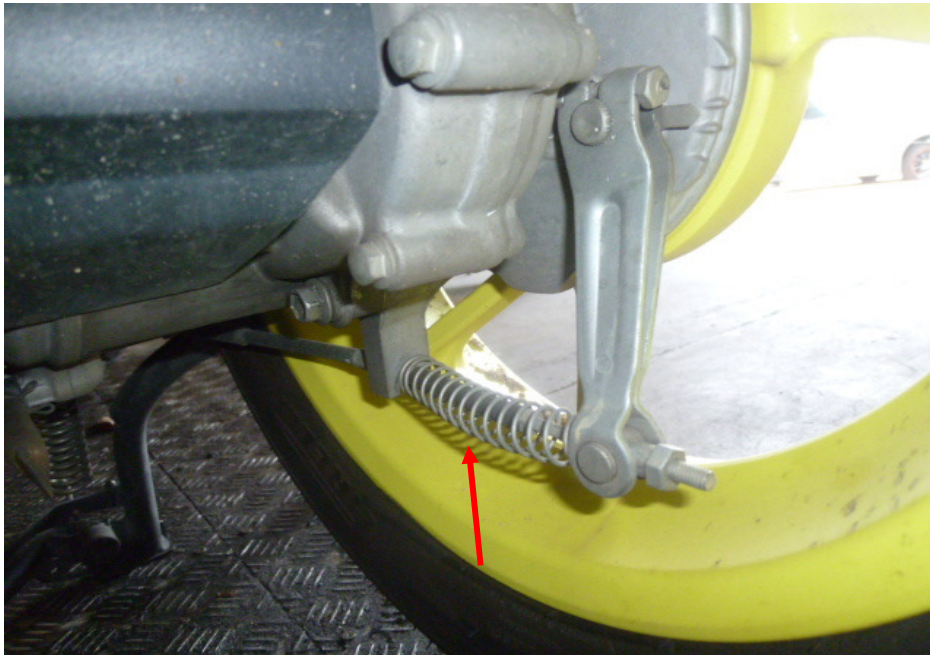
Photo 28 shows the rear wheel of the Motorcycle. The type of brake system for the rear wheel was of a mechanical type, controlled by the brake foot pedal of the Motorcycle. Our checks of the cable (arrowed), spring and drum which are all part of the components in the rear brake system of the Motorcycle reveal all to be intact and without damage.
