Your Ref: TP/IP/14569/2021  
Our Ref : CI/TPD21008636/N

**Fatal Accident Investigation Team**

**INSPECTION REPORT OF MOTORCYCLE FY 6115K**

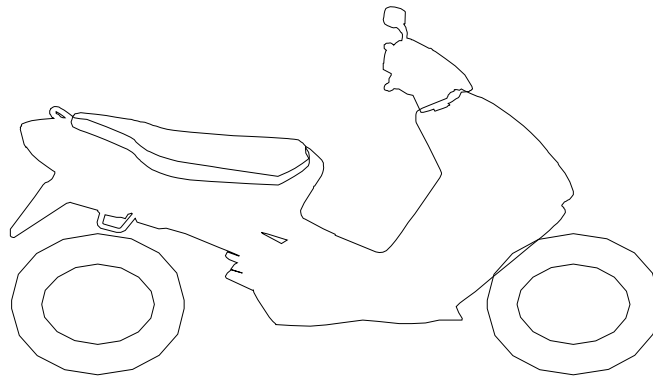
Swallow 160/60 - 17 (4mm)

Bridgestone 120/60 - 17 (4mm)

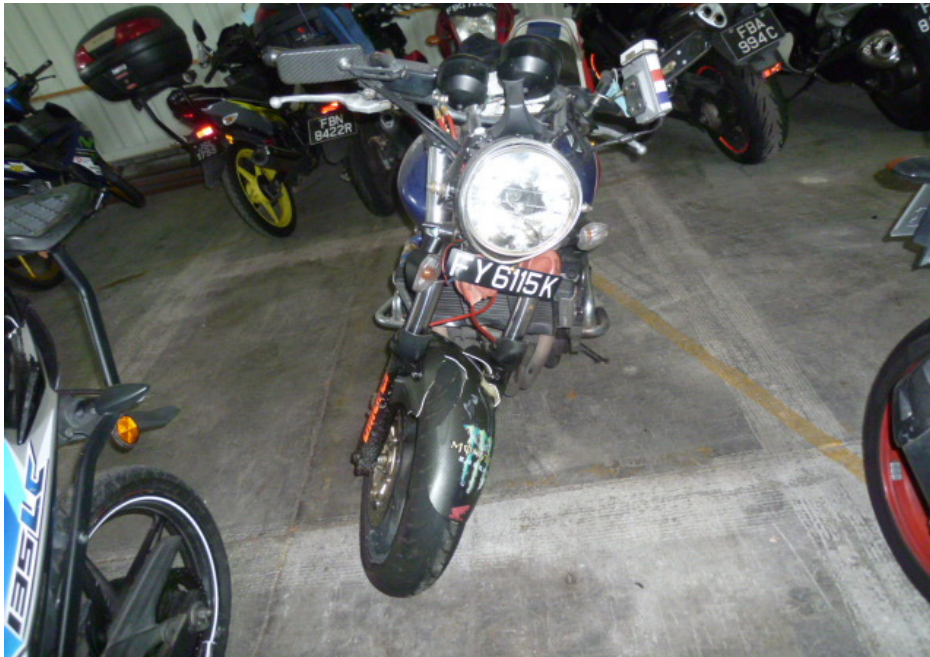
**Photo 1** shows a general view of the frontal portion of the Motorcycle at the time of our inspection. The Motorcycle was observed to have sustained damages all around.

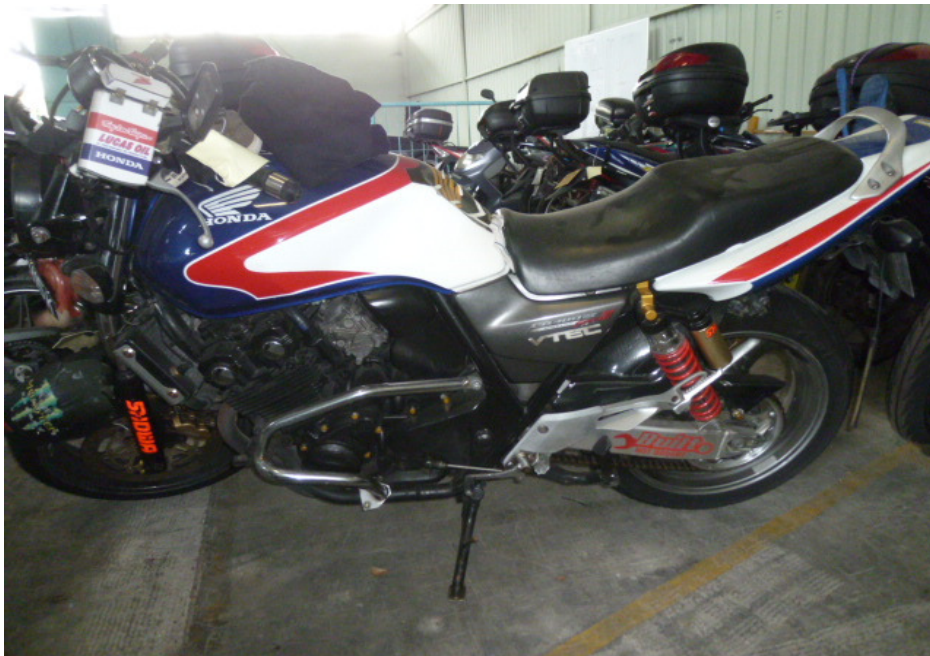
**Photo 2** shows a general view of the left body of the Motorcycle at the time of our inspection. The Motorcycle was observed to have sustained damages all around.

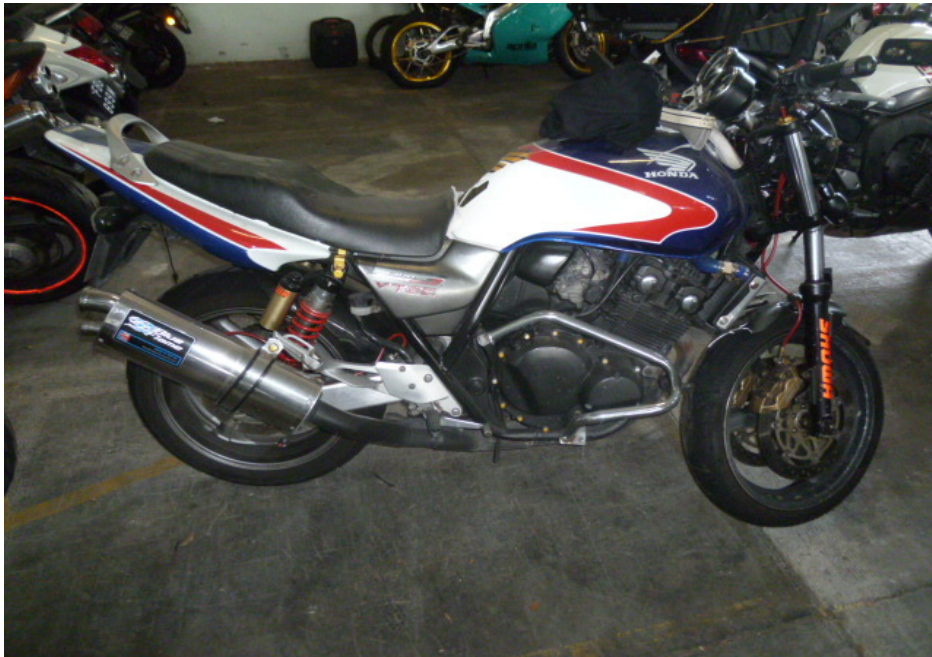
**Photo 3** shows a general view of the right body of the Motorcycle at the time of our inspection. The Motorcycle was observed to have sustained damages all around. The body parts that were found to have been damaged include its speedometer gauge, headlight cover, headlight, front forks, front mudguard, radiator, right handlebar end, right side mirror, front brake lever, petrol tank, right front signal lamp, left front footrest and left rear signal lamp, amongst others.

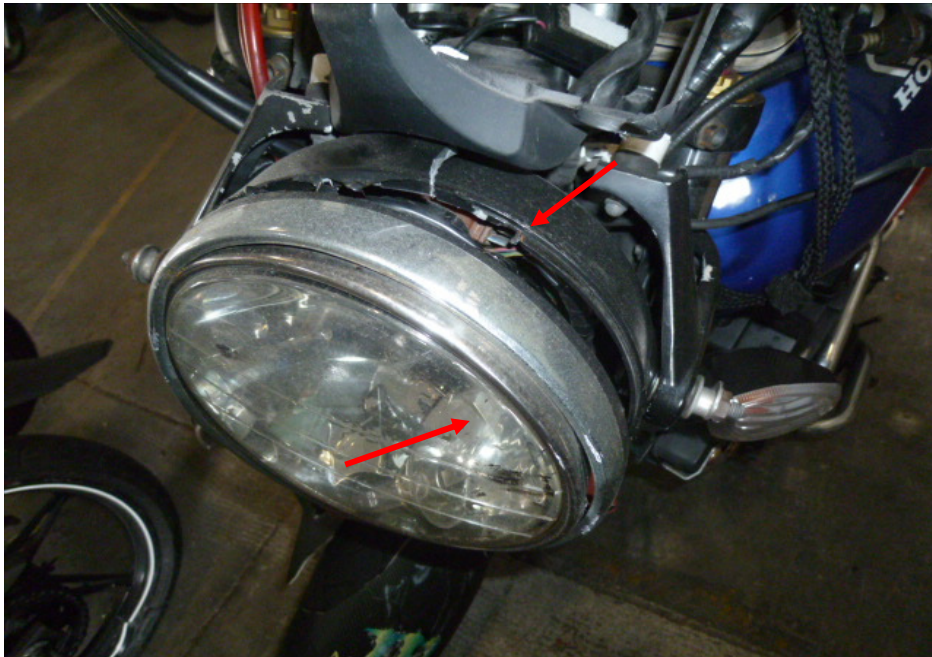
**Photo 4** shows a closer view of the cracked headlight cover and scratched headlight (arrowed) of the Motorcycle as a result of the accident.

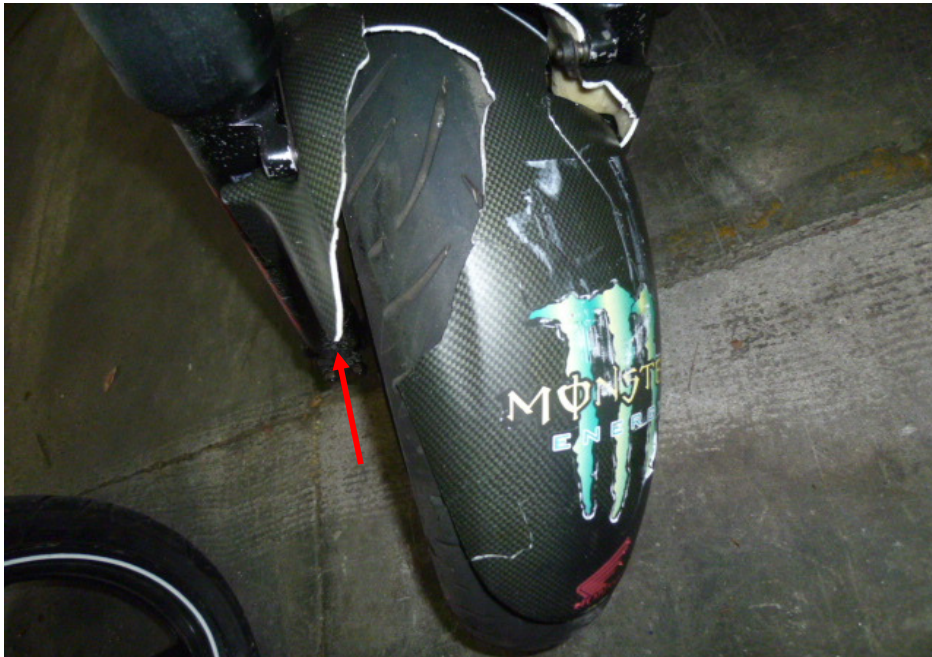
**Photo 5** shows a closer view of the front mudguard which were amongst the body parts at the front body of the Motorcycle that had sustained damage as a result of the accident (arrowed).

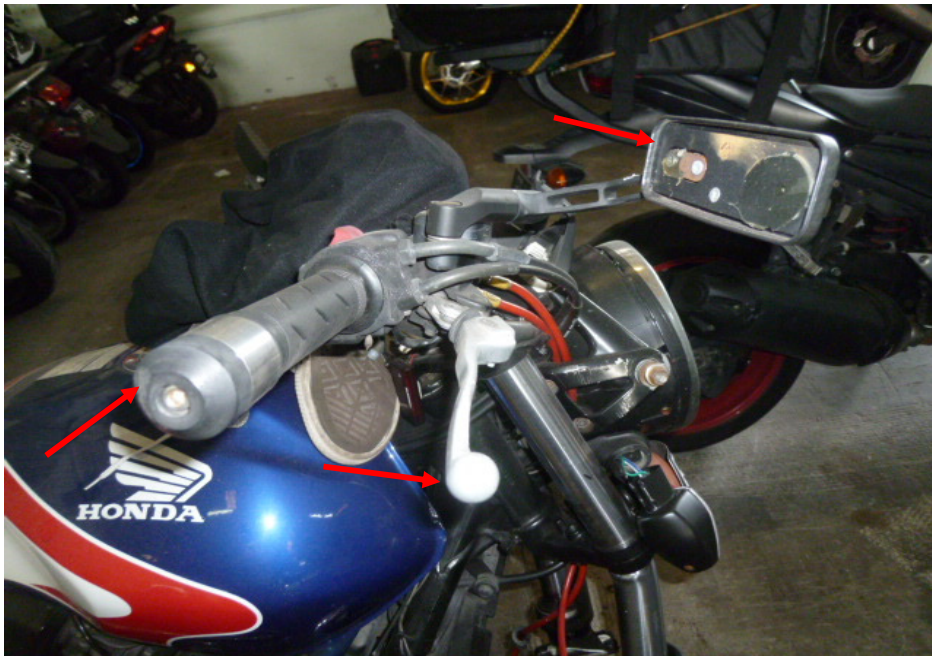
**Photo 6** shows a closer view of the front brake lever, right side mirror and right handlebar end (arrowed) which were amongst the body parts at the front body of the Motorcycle that had sustained damage as a result of the accident.

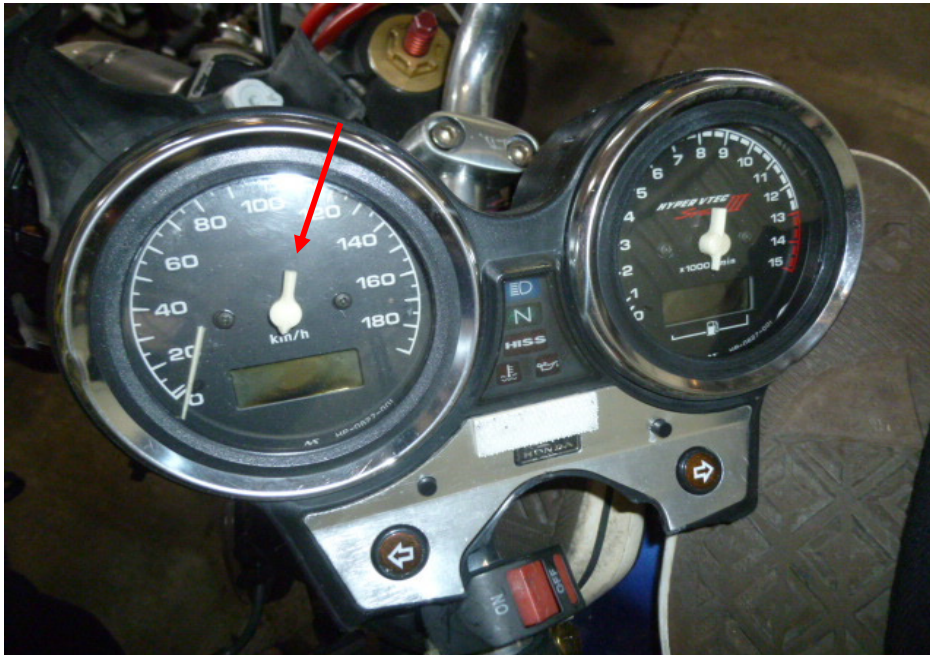
**Photo 7** shows the damaged speedometer of the Motorcycle as a result of the accident (arrowed).

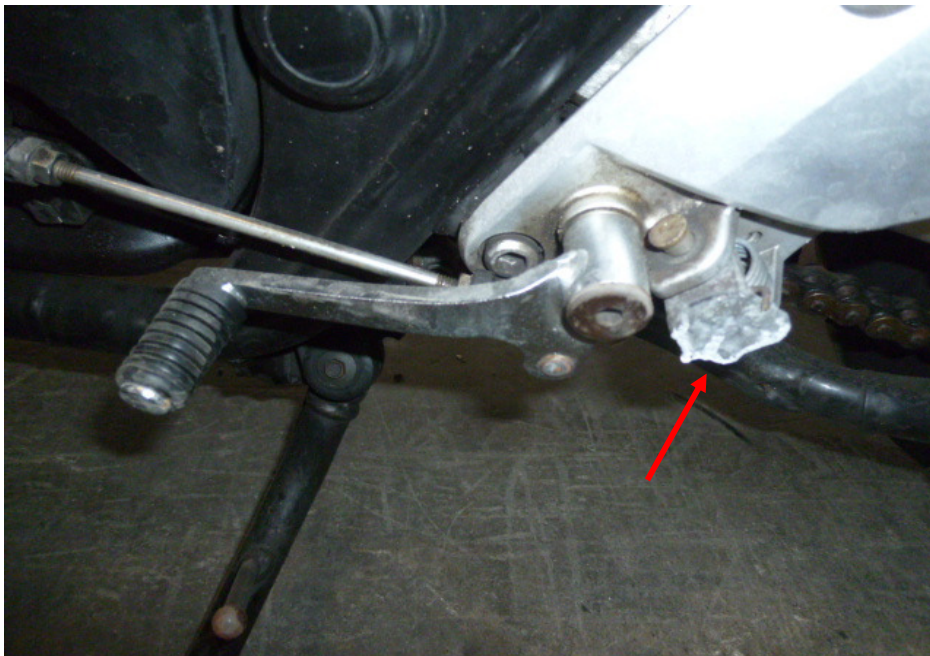
**Photo 8** shows the broken left front footrest of the Motorcycle as a result of the accident (arrowed).

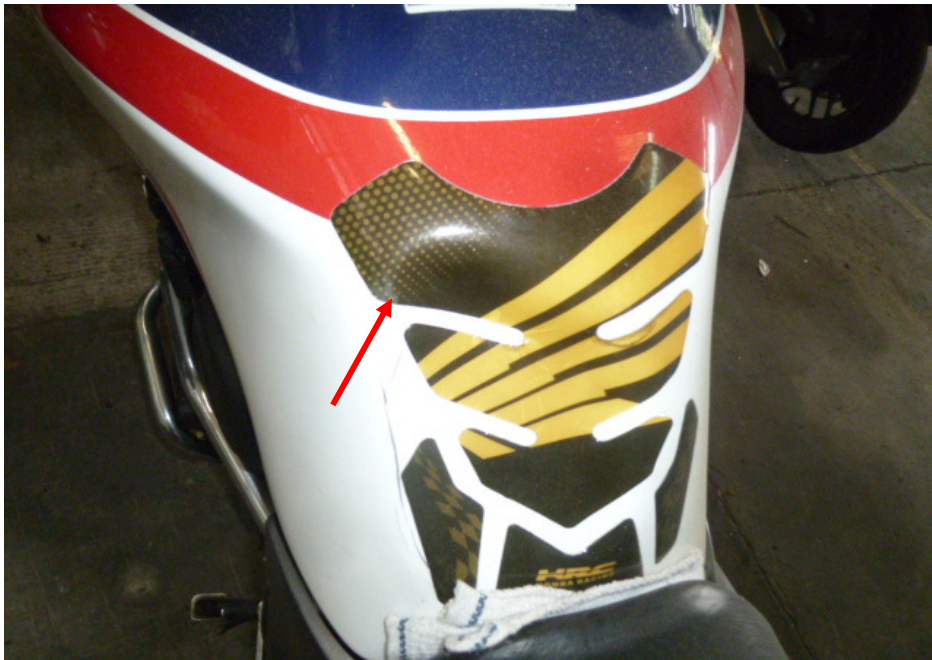
**Photo 9** shows a closer view of the dented petrol tank of the Motorcycle as a result of the accident (circled).

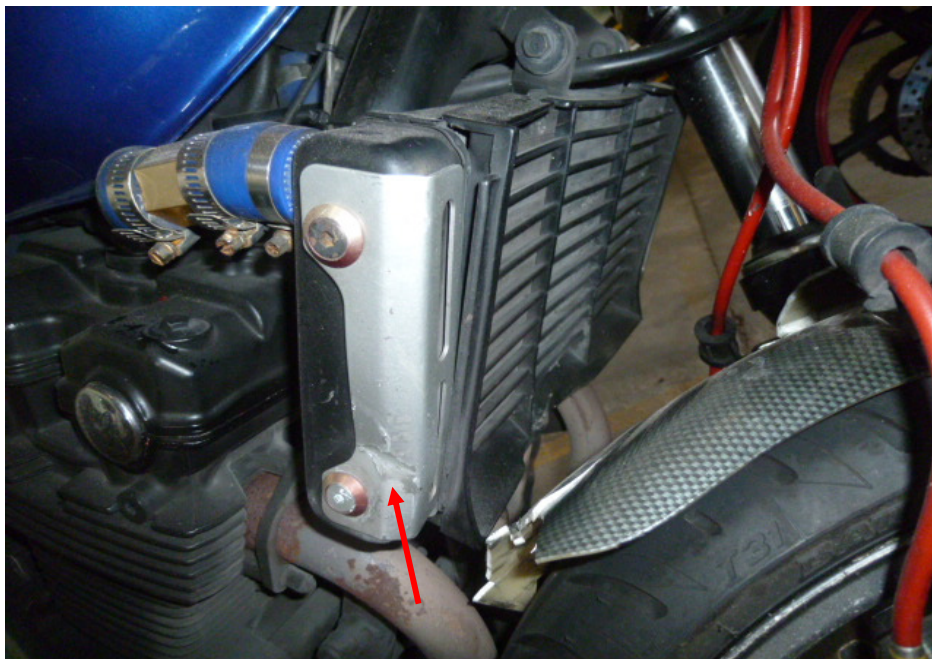
**Photo 10** shows a closer view of the deformed radiator (arrowed) of the Motorcycle as a result of the accident.

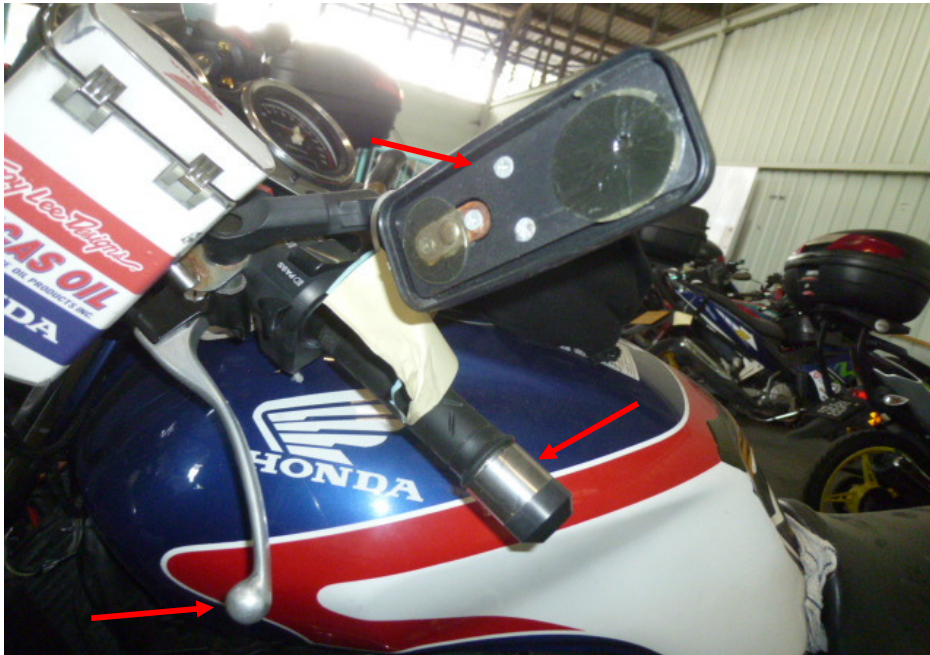
**Photo 11** shows a closer view of the clutch lever, left side mirror and left handlebar end (arrowed) which were amongst the body parts at the front body of the Motorcycle that had sustained damage as a result of the accident.

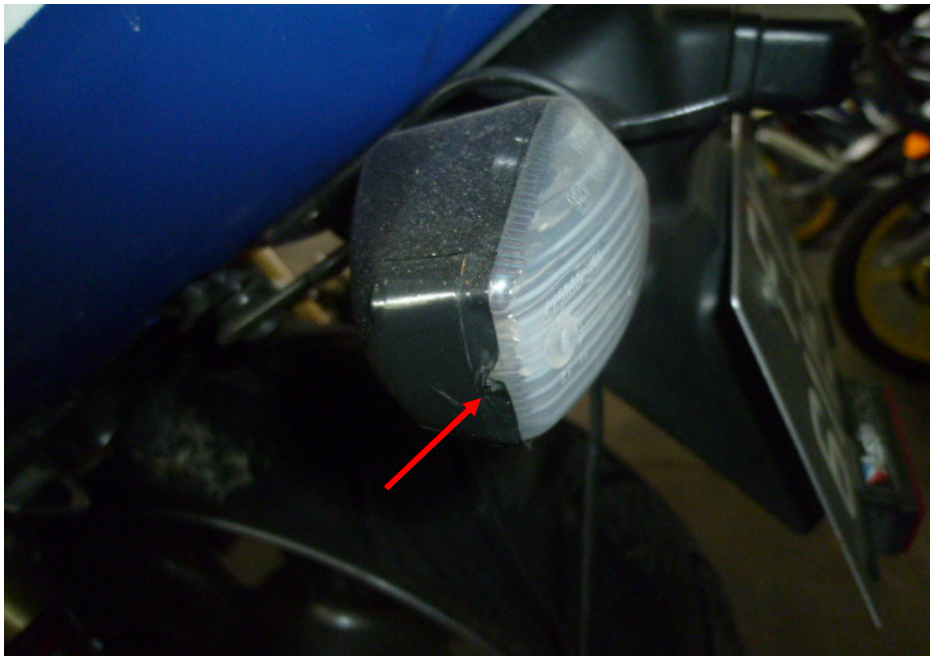
**Photo 12** shows a closer view of the grazed left rear signal lamp (arrowed) of the Motorcycle as a result of the accident.

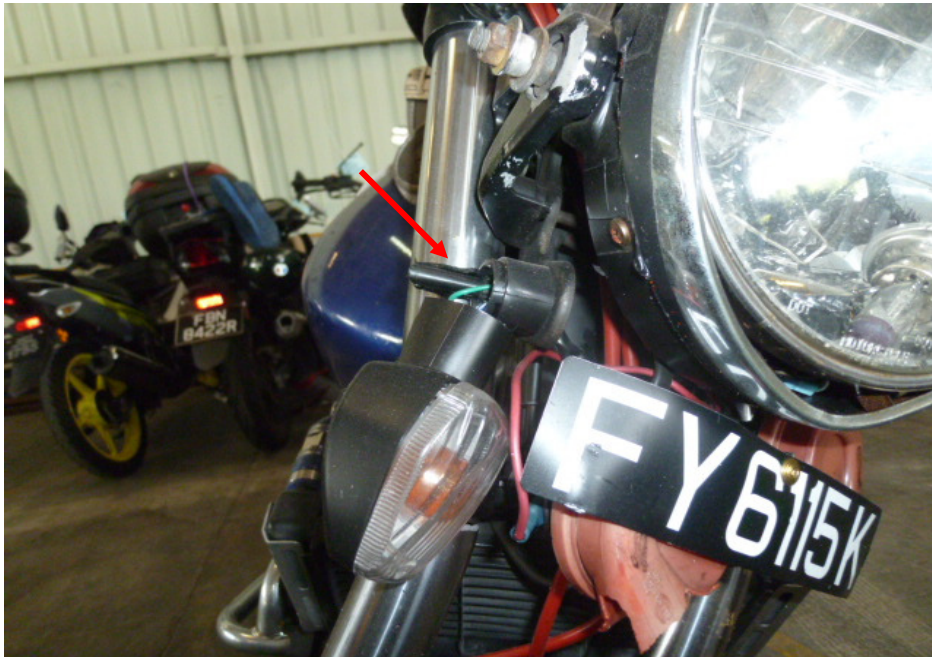
**Photo 13** shows the broken right front signal lamp (arrowed) of the Motorcycle as a result of the accident.

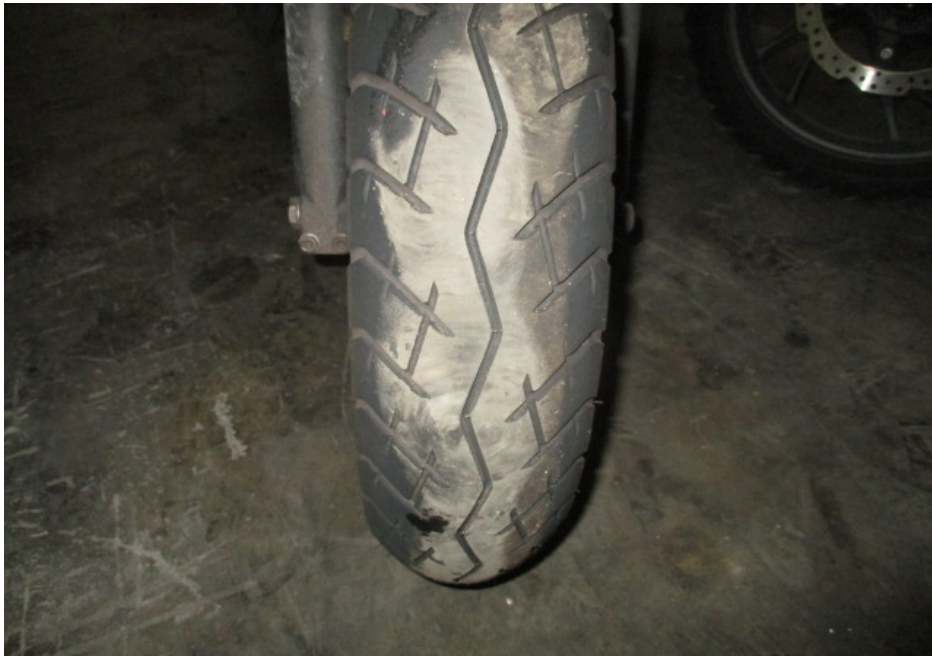
**Photo 14** shows the front tyre of the Motorcycle at the time of our inspection. The front tyre was observed to be in serviceable condition with remaining tread depth of approximately 3mm. The pattern of the tread was also clearly visible. There was no tear, burst mark(s) and/or punctured hole(s) on the sidewalls as well as across the tread of the front tyre.

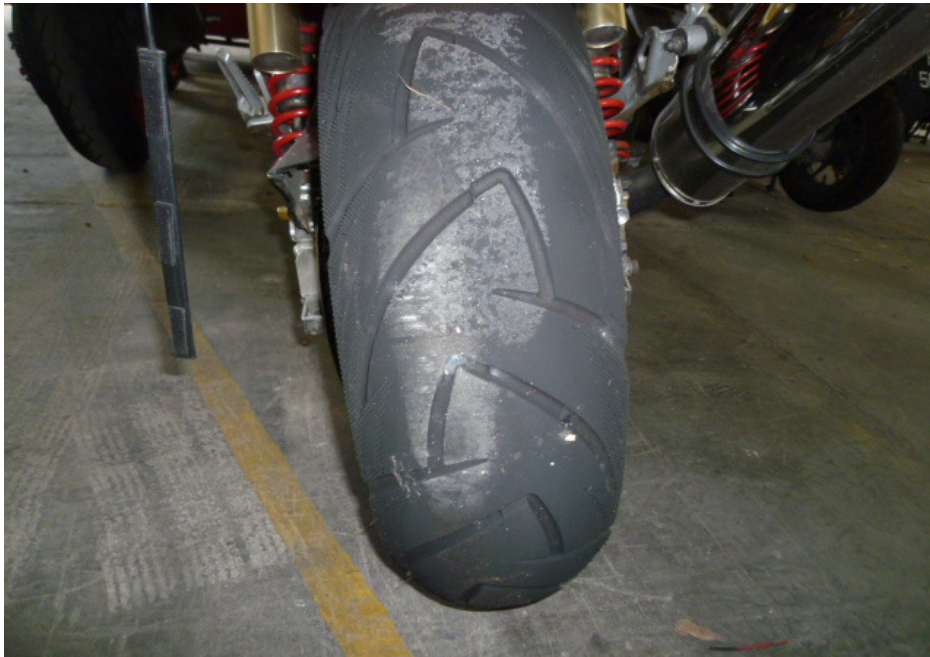
**Photo 15** shows the condition of the Motorcycle's rear tyre. The rear tyre was observed to be in serviceable condition with remaining tread depth of approximately 4mm. The tyre was also observed to be sufficiently inflated for vehicular operation. We did not observe any tear, burst mark(s) and/or punctured hole(s) on the sidewalls as well as across the tread of the rear tyre.

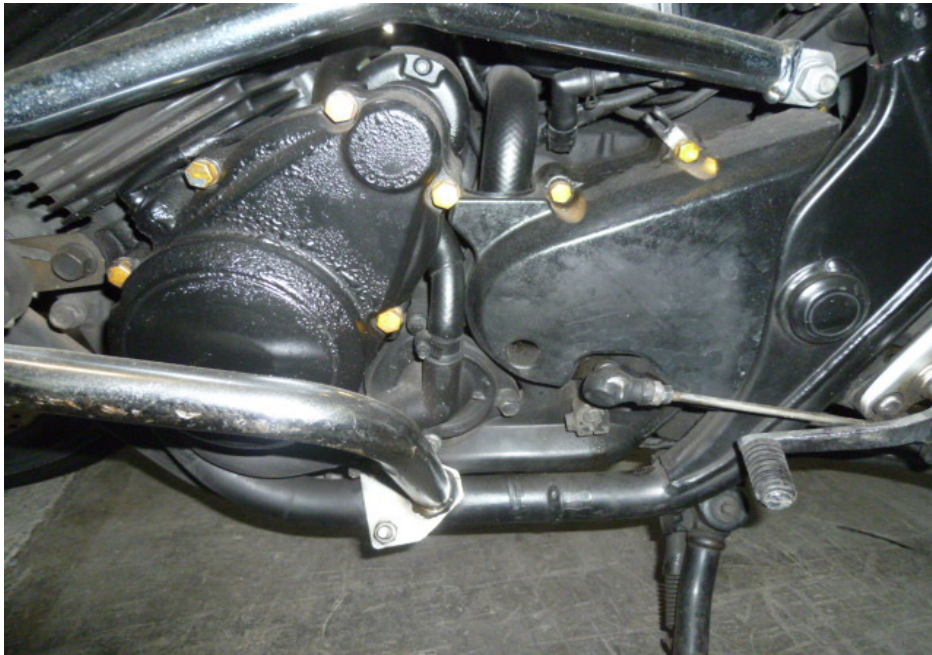
**Photo 16** shows the left side of the engine of the Motorcycle at the time of our inspection. The various engine related parts and components were found to be intact with no visible damage. There was also no sign(s) or indication(s) of fluid leak observed around the left engine area of the Motorcycle.

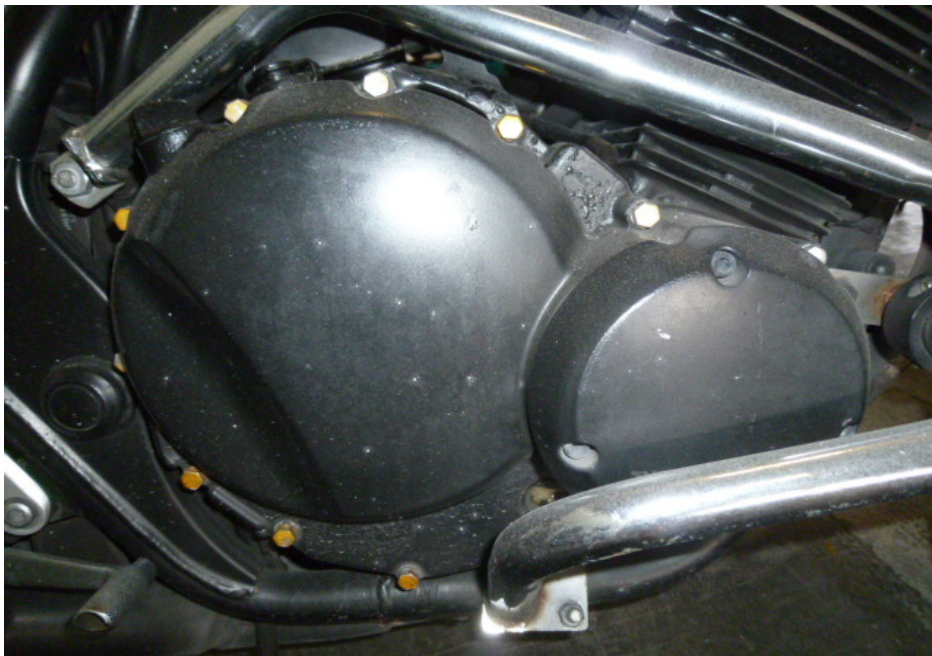
**Photo 17** shows the right side of the engine of the Motorcycle at the time of our inspection. The various engine related parts and components were found to be intact with no visible damage. There was also no sign(s) or indication(s) of fluid leak observed around the right engine area of the Motorcycle.

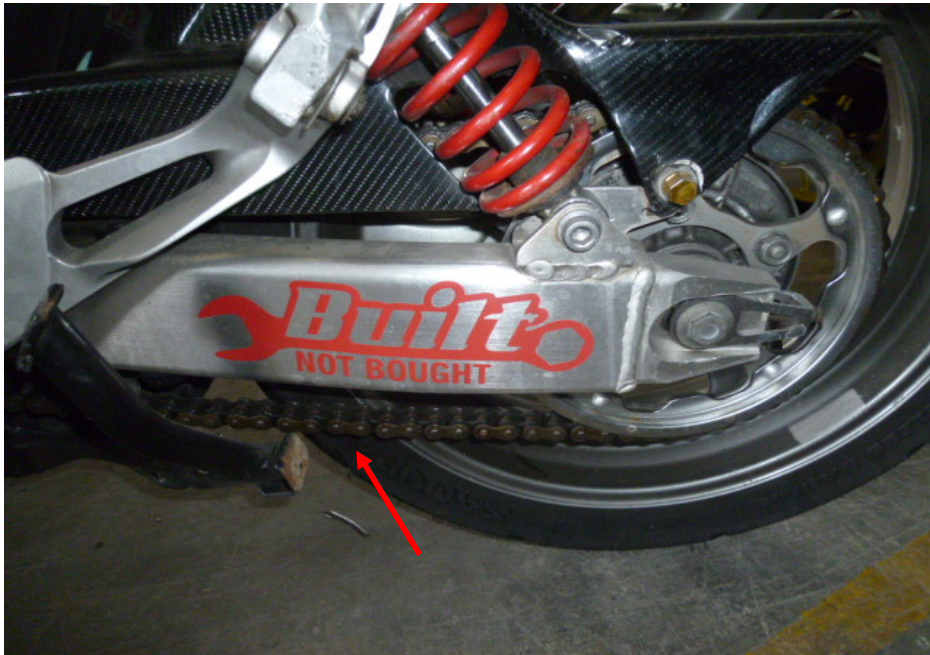
**Photo 18** shows the general view of the gear train (arrowed) of the Motorcycle, which was observed to be intact with no misalignment. It was also adequately lubricated for operating purposes.

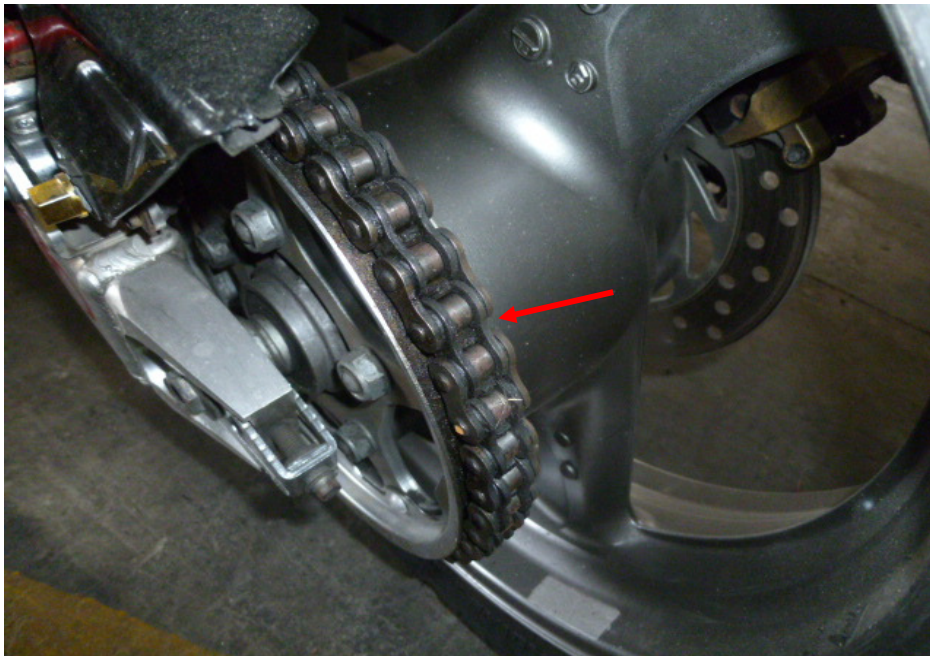
**Photo 19** shows a closer view of the gear train (arrowed) of the Motorcycle, which was observed to be intact with no misalignment. It was also adequately lubricated for operating purposes.

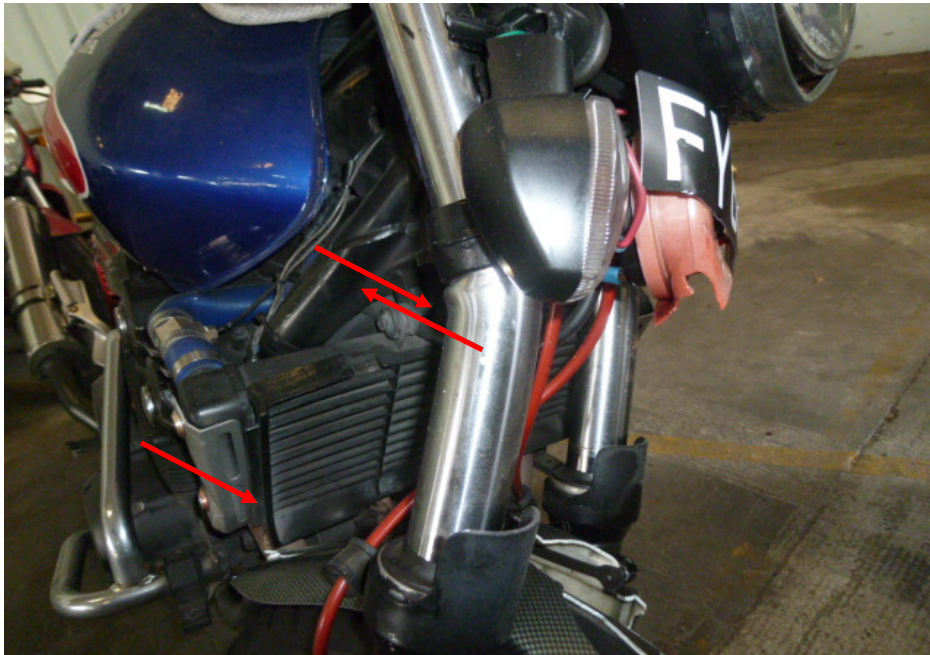
11. For this case, we were not able to conduct any test(s) on the steering system of the Motorcycle due to the damage of its front forks. The front forks were found to be bent inwards as a result of the accident which had rendered the Motorcycle immobile.

**Photo 20** shows the right front fork of the Motorcycle. The right front fork (arrowed) was observed to be bent inwards as a result of the accident. We were hence not able to conduct any tests on the steering system of the Motorcycle.

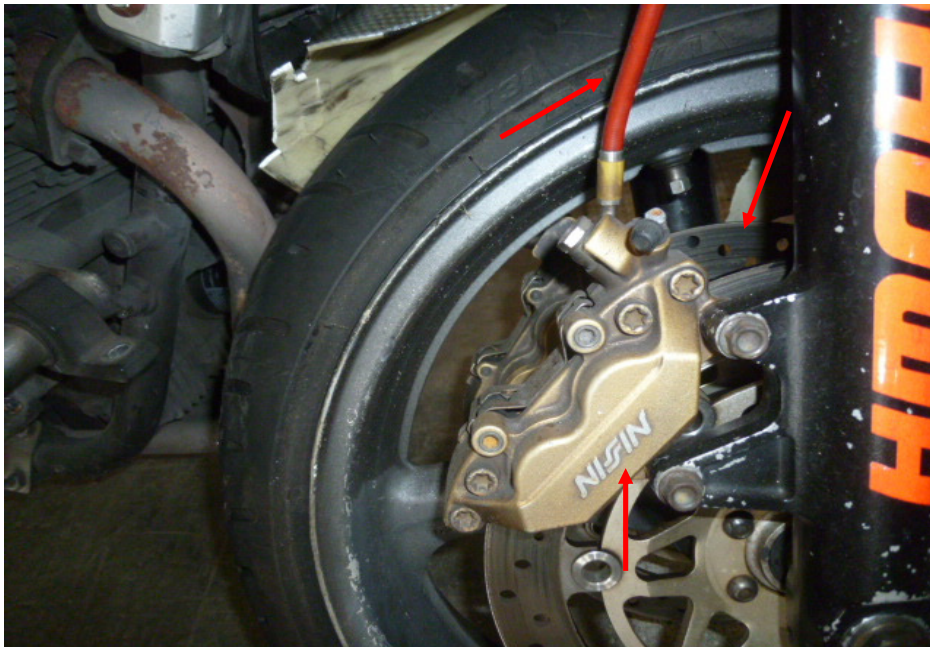
**Photo 21** shows a close up view of the front brake caliper, front brake disc and front brake hose (arrowed) at the right side of the Motorcycle's front wheel, which are all part of the components in the hydraulic front brake system of the Motorcycle. Our visual checks of these various components had revealed all to be intact with no visible damage. No leakage of brake fluid was also observed.

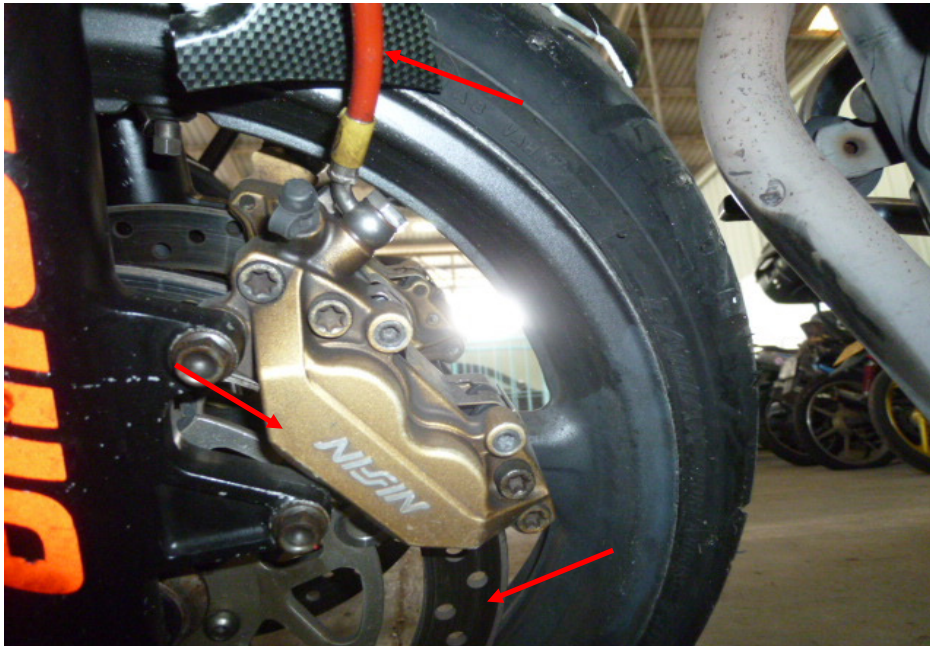
**Photo 22** shows a close up view of the front brake caliper, front brake disc and front brake hose (arrowed) at the left side of the Motorcycle's front wheel, which are all part of the components in the hydraulic front brake system of the Motorcycle. Our visual checks of these various components had revealed all to be intact with no visible damage. No leakage of brake fluid was also observed.

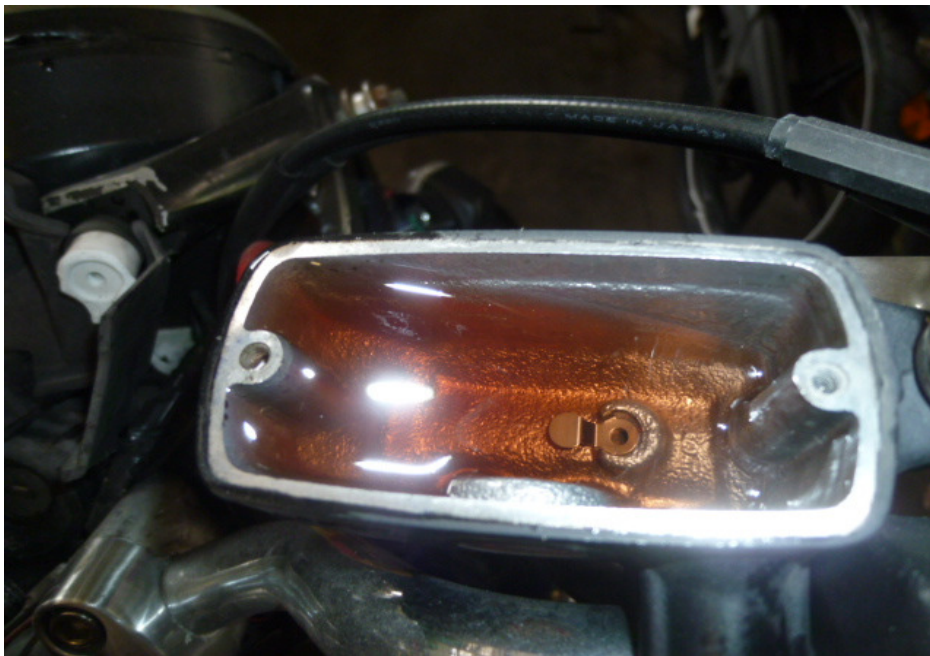
**Photo 23** shows the brake fluid reservoir for the front brake of the Motorcycle. The brake fluid was observed to be of sufficient level and without contamination for operational purposes.

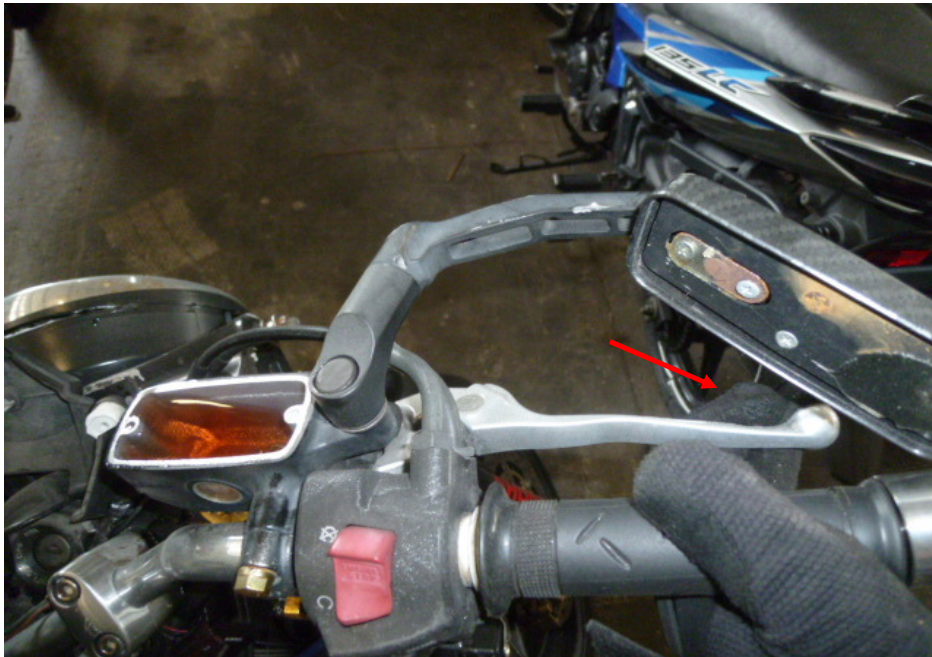
**Photo 24** shows the front brake lever being depressed. There was some resistance felt (spongy like feel) upon pressing the front brake lever (arrowed). This would indicate that there is no leakage of pressure/vacuum in the brake system.

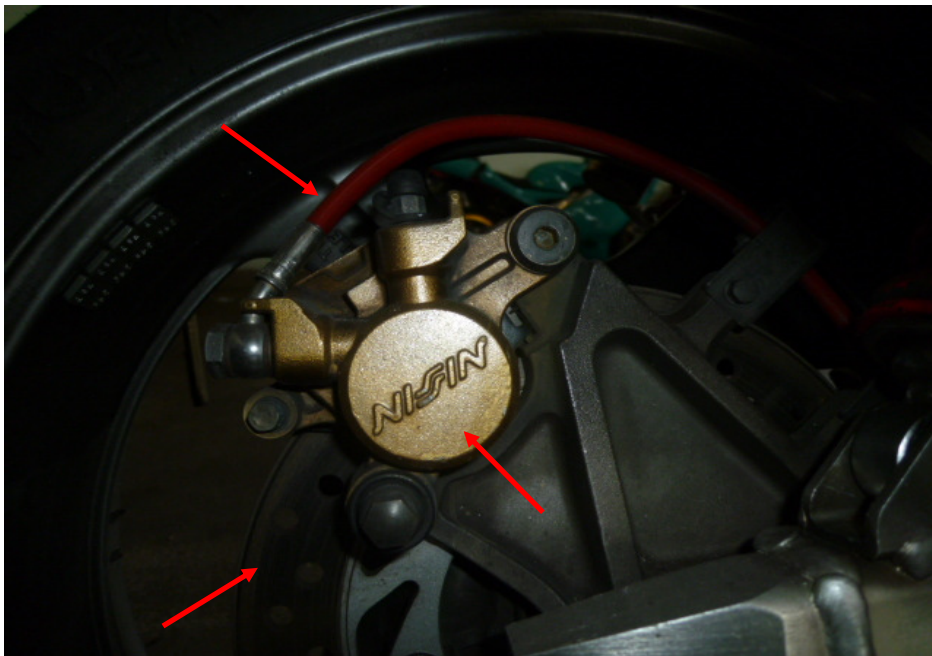
**Photo 25** shows a close up view of the rear brake caliper, rear brake disc and rear brake hose (arrowed) of the Motorcycle, which are all part of the components in the hydraulic rear brake system of the Motorcycle. Our visual checks of these various components had revealed all to be intact with no visible damage. No leakage of brake fluid was also observed.

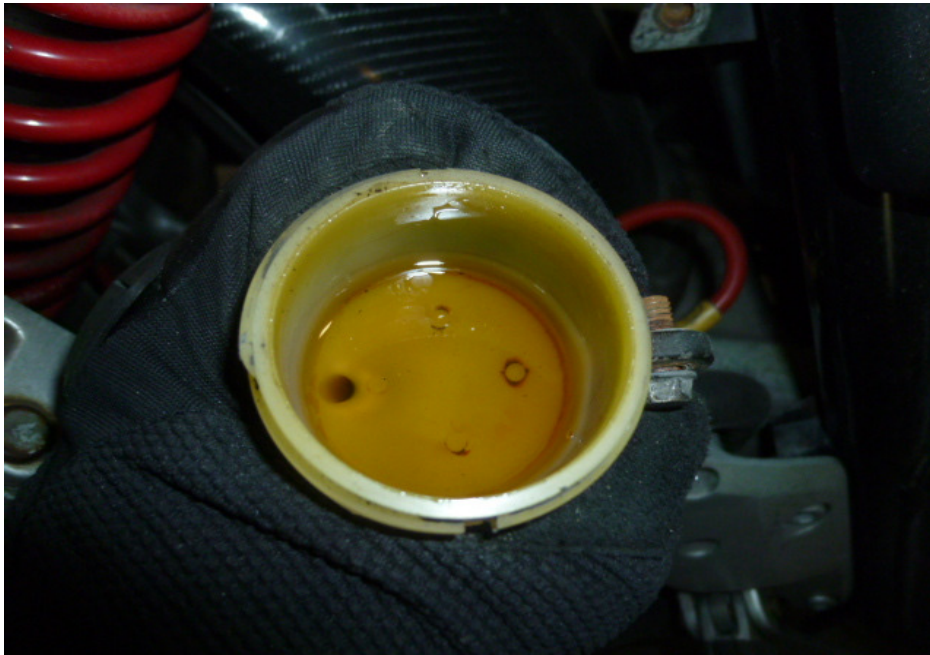
**Photo 26** shows the brake fluid reservoir for the rear brake of the Motorcycle. The brake fluid was observed to be of sufficient level and without contamination for operational purposes.
