Your Ref: Porsche Marcan  
(chassis number WP1ZZZ95ZKLB02986)  
Our Ref : CI/TP21008709/D

22 August 2021

### **INSPECTION REPORT OF AN UNREGISTERED PORSCHE MARCAN MOTOR CAR WITH CHASSIS NUMBER WP1ZZZ95ZKLB02986**

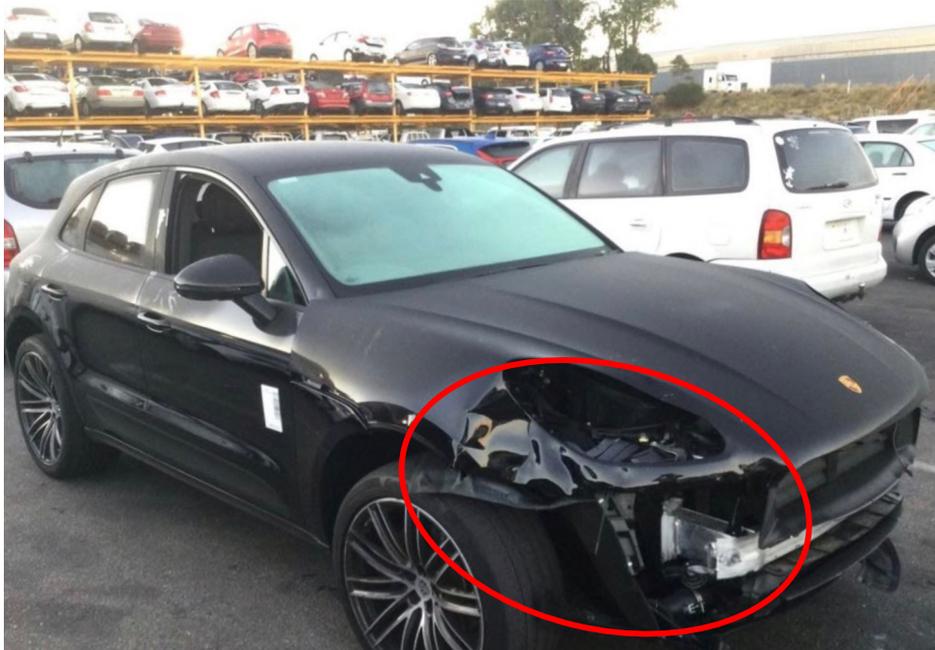
**Photo 1** shows the front right body of the Motor Car (photograph provided to me). The photographs provided to me had showed damage to the front right portion (circled) of the Motor Car. Body parts damaged include the front bumper reinforcement, front bonnet and front right fender inner shield amongst others.

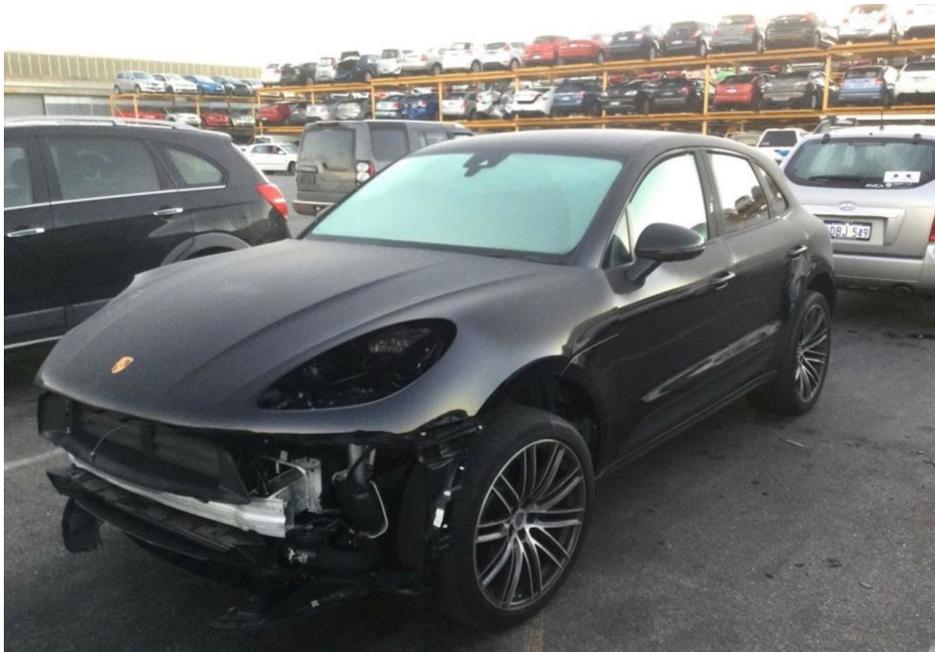
**Photo 2** shows the front left body of the Motor Car (photograph provided to me). The Motor Car's front bumper and all its related parts and attachments like the front bumper centre lower grille, front bumper lower lip, front bumper left grille, front bumper left grille side garnish, front bumper left lower grille, radiator grille, front left headlamp and front sensors amongst others were observed to be missing/dislodged/damaged.

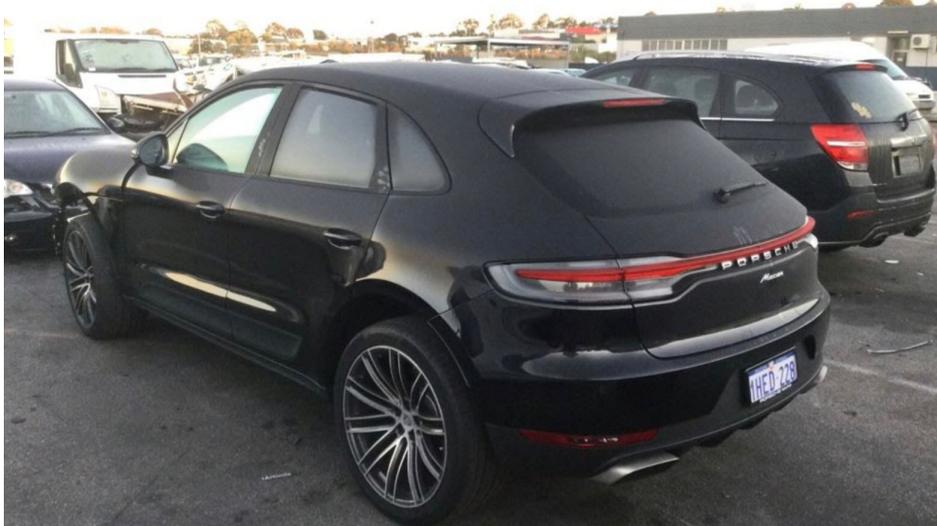
**Photo 3** shows the rear left body of the Motor Car (photograph provided to me). Apart for the front right portion, there was no physical damage observed to other areas of the Motor Car. The airbags were also not deployed as seen from the photographs that were provided to me.

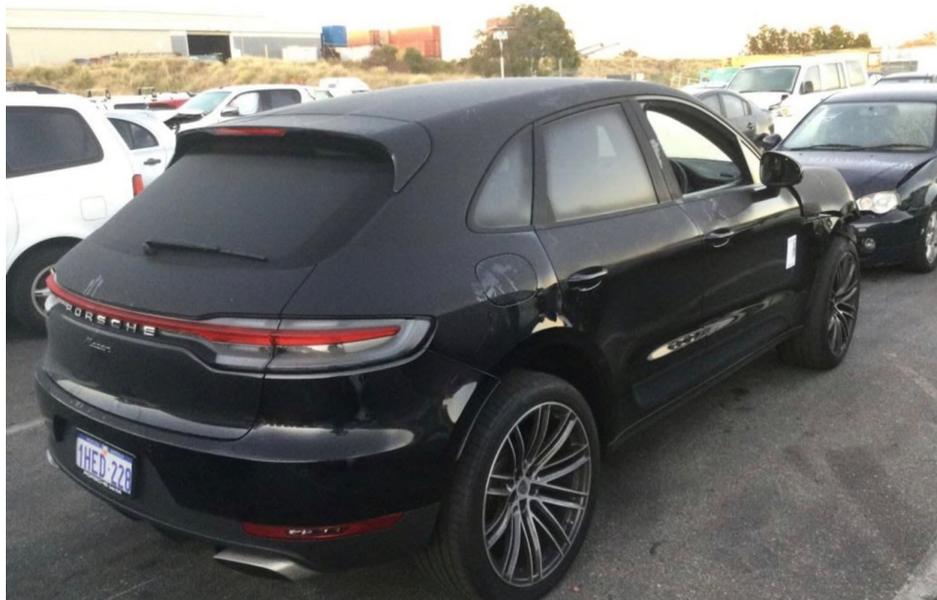
**Photo 4** shows the rear right body of the Motor Car (photograph provided to me). Apart for the front right portion, there was no physical damage observed to other areas of the Motor Car. The airbags were also not deployed as seen from the photographs that were provided to me.

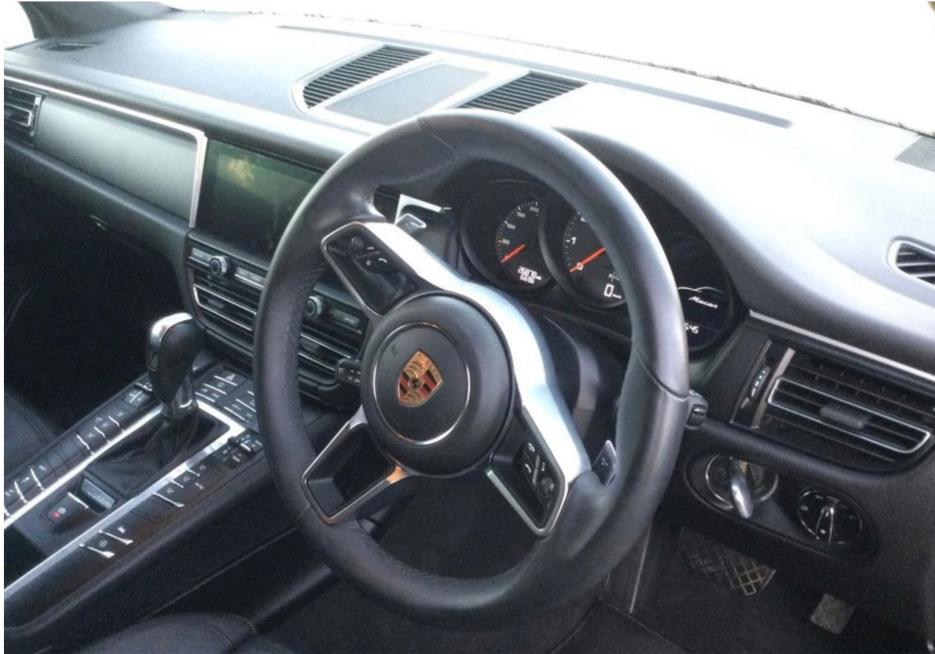
**Photo 5** shows the front dashboard of the Motor Car (photograph provided to me). Parts and components within the interior compartment were observed to be unaffected. The airbags of the Motor Car were also not deployed as seen from the photographs that were provided to me.

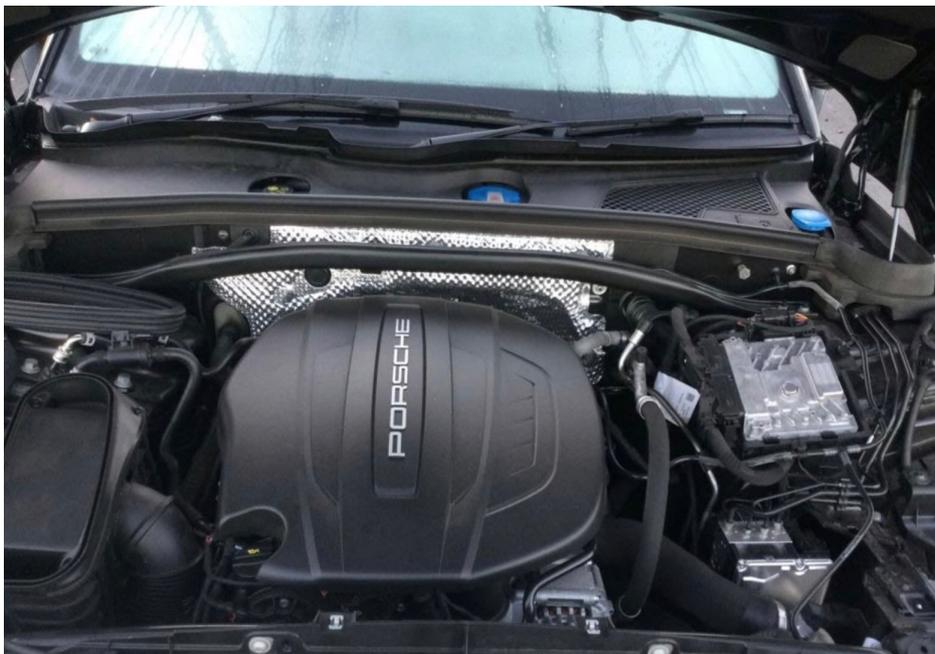
**Photo 6** shows the engine compartment of the Motor Car (photograph provided to me). Parts and components within the engine compartment were observed to be intact and unaffected.

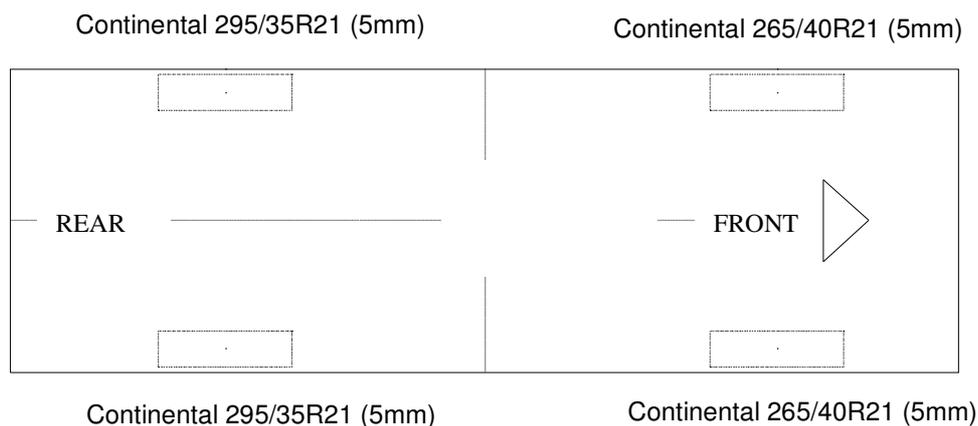
9. It was fitted with 21inch sport wheel rims that were wrapped with tyres that were observed to be of serviceable condition. The tyres were also sufficiently inflated for vehicular operation. The tyre brand, tyre size and approximate remaining tread depth of the 4 tyres of the Motor Car were recorded as follows: -

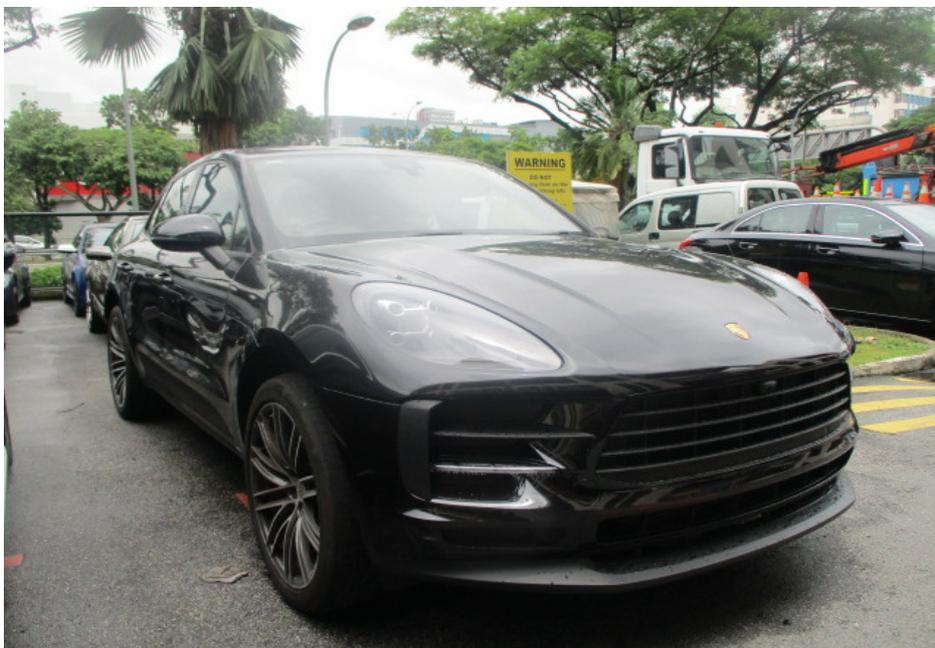
**Photo 7** shows a general view of the front right body of the Motor Car at the time of my inspection. The Motor Car was observed to be in a relatively good general condition with no loose exterior fittings observed. The body parts at the front right portion of the Motor Car were visually examined and it was observed that the repair/restoration works carried out to the damaged area of the Motor Car (refer to photograph 1 & 2 above) were reasonably adequate and in order.

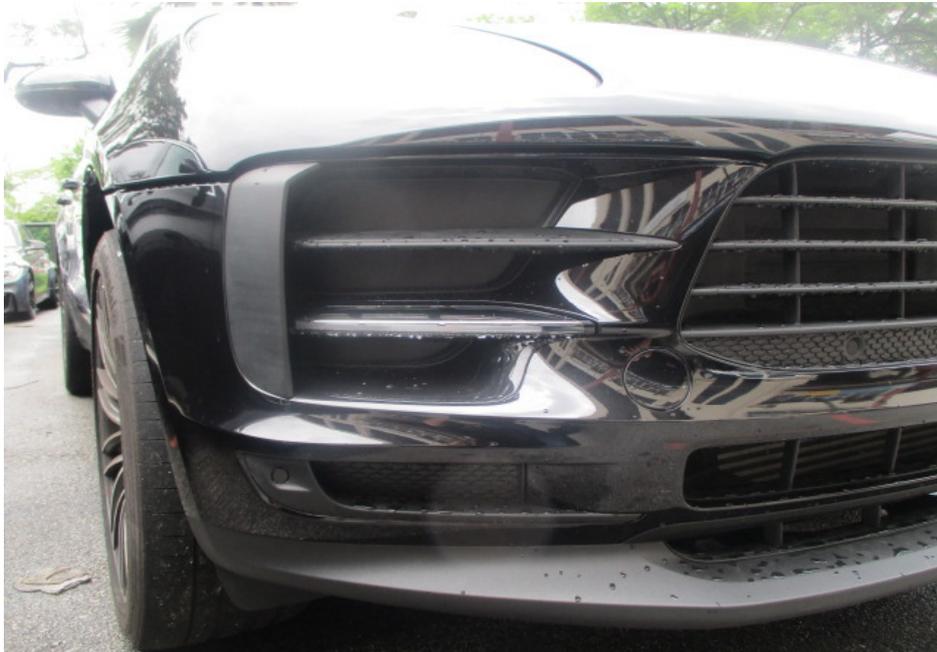
**Photo 8** shows a closer view of the Motor Car's front bumper, front bumper lower lip, front bumper right grille, front bumper right grille side garnish and front bumper right lower grille at the time of my inspection. The body parts at the front right portion of the Motor Car were visually examined and it was observed that the repair/restoration works carried out to the damaged area of the Motor Car (refer to photograph 1 & 2 above) were reasonably adequate and in order.

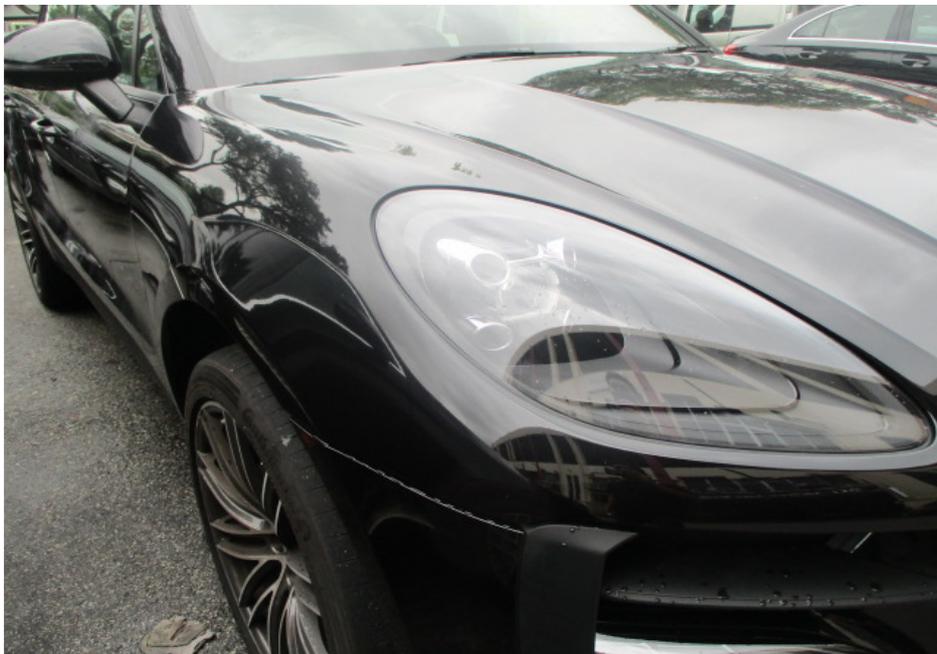
**Photo 9** shows a closer view of the Motor Car's front right headlamp and front bonnet at the time of my inspection. The body parts at the front right portion of the Motor Car were visually examined and it was observed that the repair/restoration works carried out to the damaged area of the Motor Car (refer to photograph 1 & 2 above) were reasonably adequate and in order.

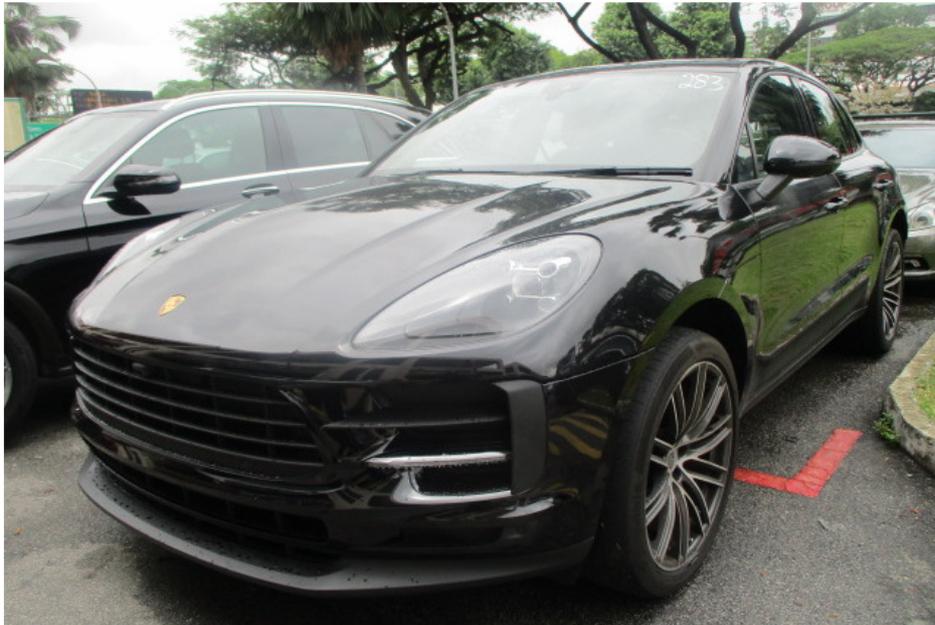
**Photo 10** shows a general view of the front left body of the Motor Car at the time of my inspection. The Motor Car was observed to be in a relatively good general condition with no loose exterior fittings observed. The body parts at the frontal portion of the Motor Car were visually examined and it was observed that the repair/restoration works carried out to the damaged area of the Motor Car (refer to photograph 1 & 2 above) were reasonably adequate and in order.

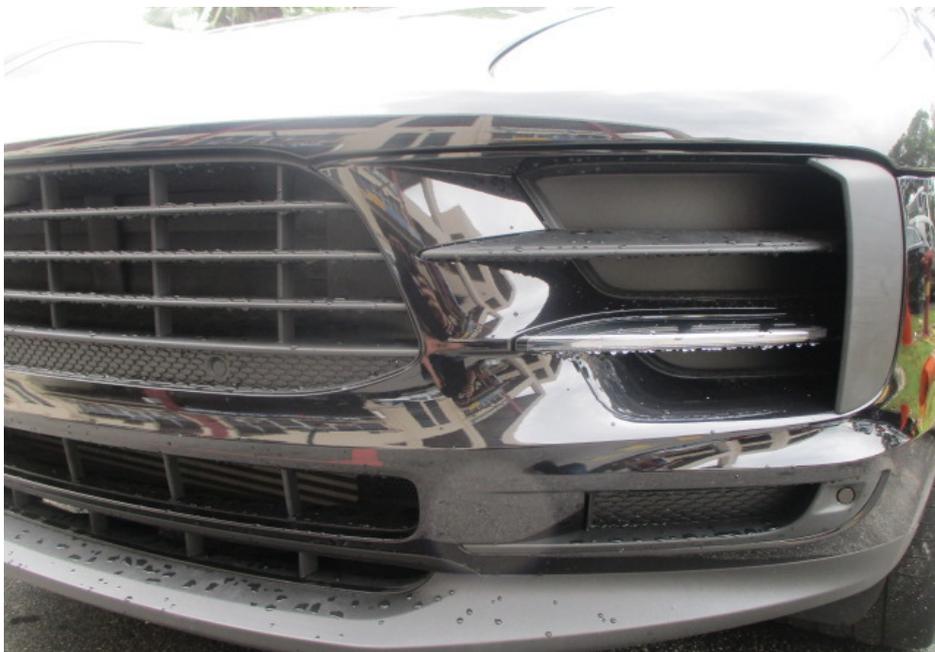
**Photo 11** shows a closer view of the Motor Car's front bumper, front bumper lower lip, front bumper left grille, front bumper left grille side garnish and front bumper centre lower grille at the time of my inspection. The body parts at the frontal portion of the Motor Car were visually examined and it was observed that the repair/restoration works carried out to the damaged area of the Motor Car (refer to photograph 1 & 2 above) were reasonably adequate and in order.

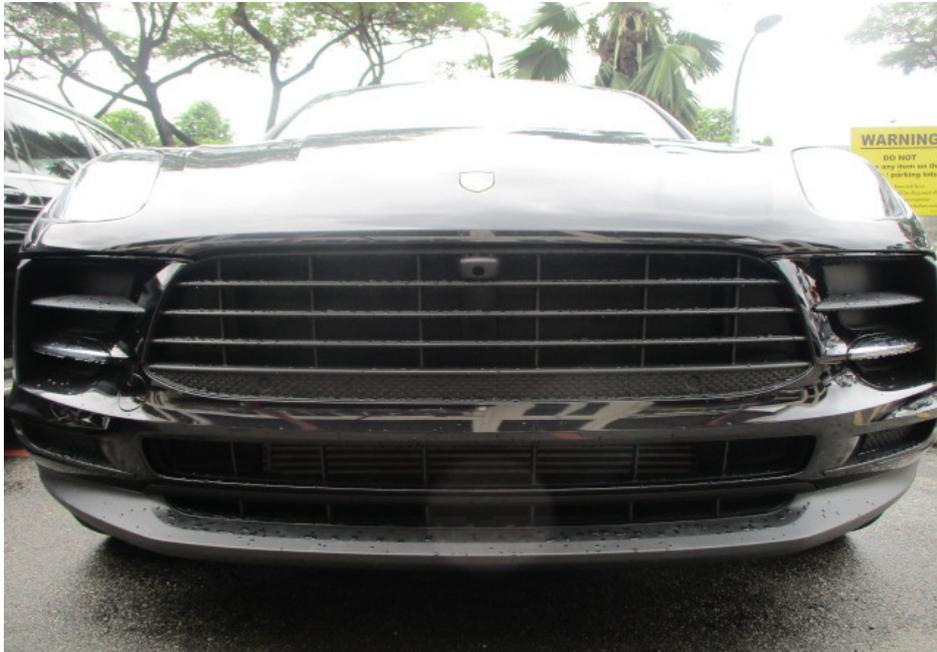
**Photo 12** shows a closer view of the Motor Car's frontal body at the time of my inspection. The body parts at the frontal portion of the Motor Car were visually examined and it was observed that the repair/restoration works carried out to the damaged area of the Motor Car (refer to photograph 1 & 2 above) were reasonably adequate and in order.

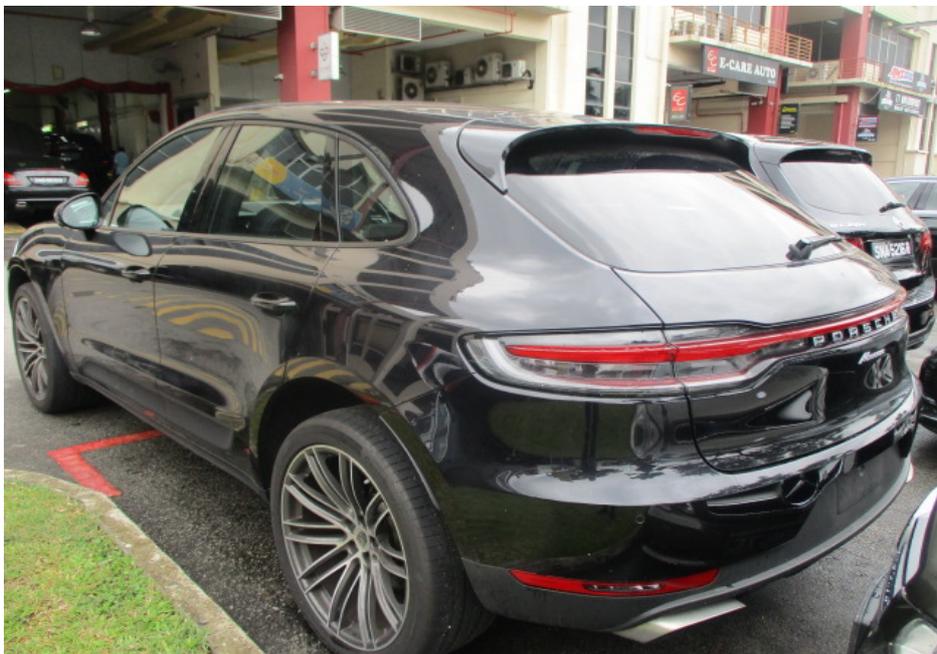
**Photo 13** shows a general view of the rear left body of the Motor Car at the time of my inspection. The Motor Car was observed to be in a relatively good general condition with no loose exterior fittings observed. The mileage of the Motor Car recorded at the time of my inspection was 26,892km.

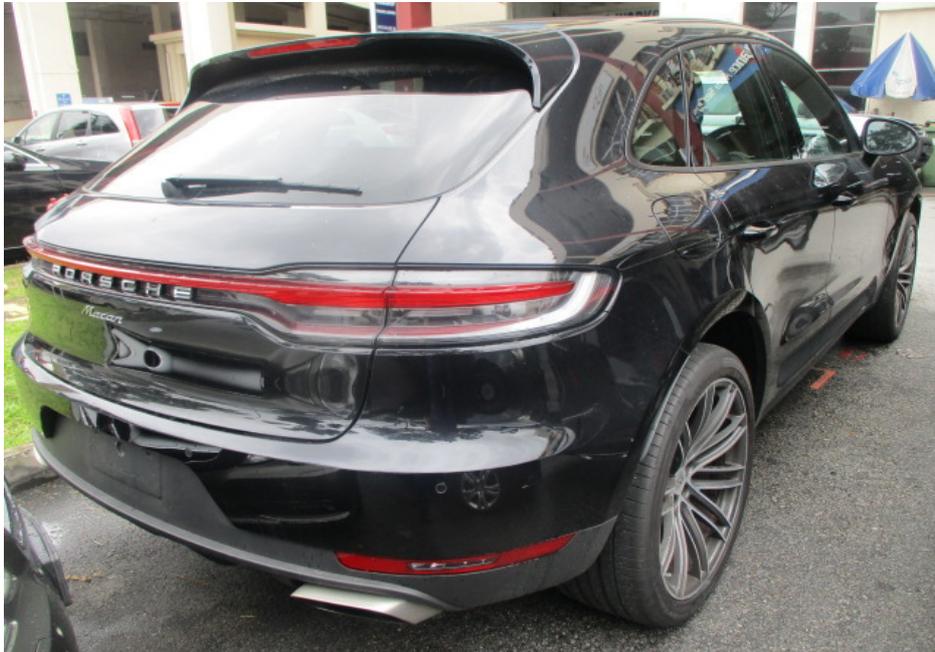
**Photo 14** shows a general view of the rear right body of the Motor Car at the time of my inspection. The Motor Car was observed to be in a relatively good general condition with no loose exterior fittings observed. The mileage of the Motor Car recorded at the time of my inspection was 26,892km.

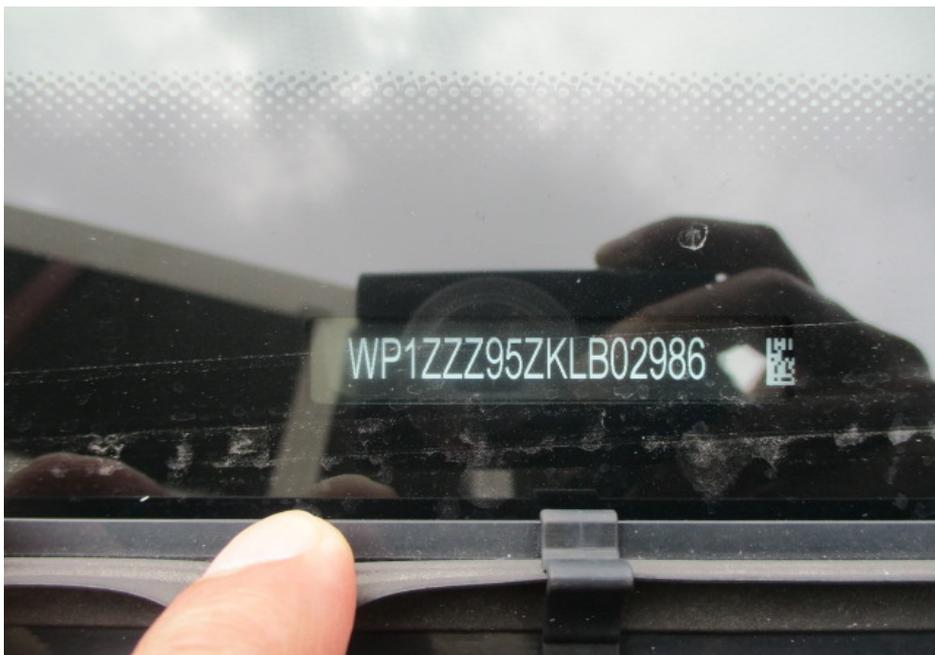
**Photo 15** shows the chassis number of the Motor Car. The chassis number recorded was WP1ZZZ95ZKLB02986.

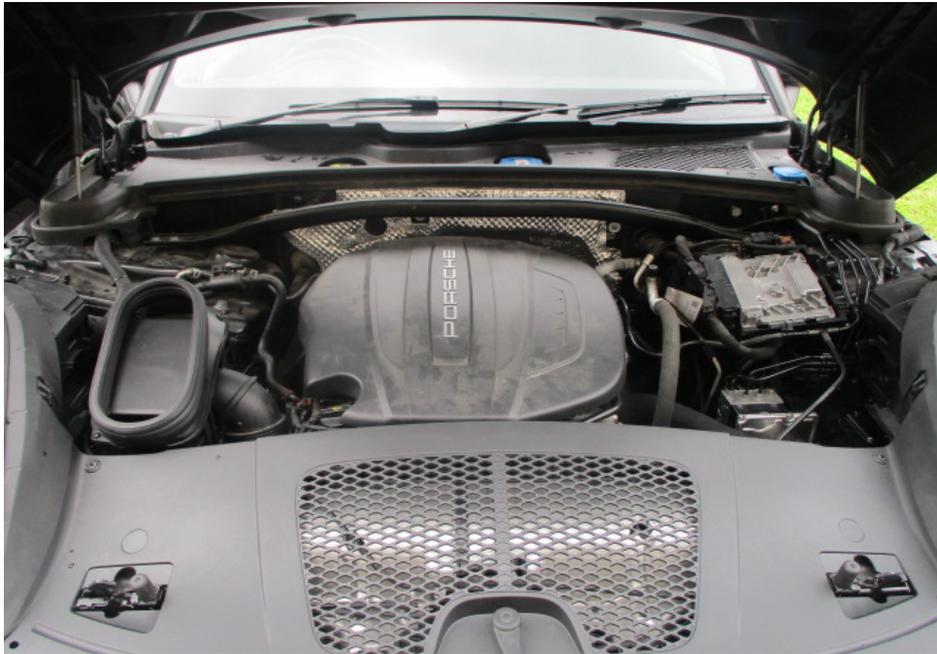
**Photo 16** shows a general view of the engine compartment of the Motor Car at the time of my inspection. The various parts and components inside the engine compartment were all observed to be intact and properly fitted. There was also no sign(s) or indication(s) of fluid leak and/or fluid stain found inside the engine compartment.

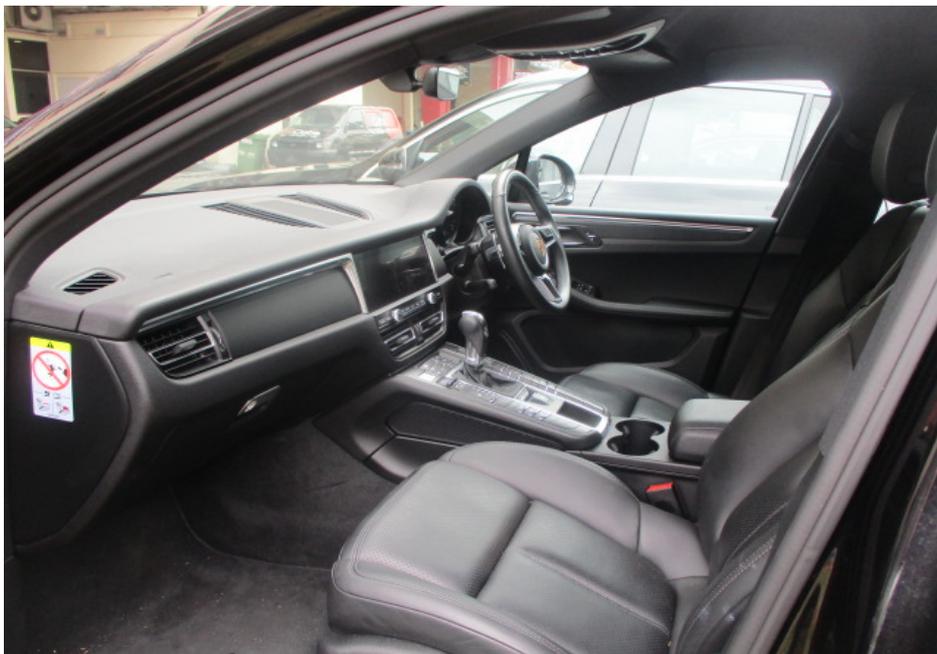
**Photo 17** shows the interior compartment of the Motor Car at the time of my inspection. The various parts and components, trims, carpet, and upholstery inside the interior compartment were all observed to be intact and properly fitted.

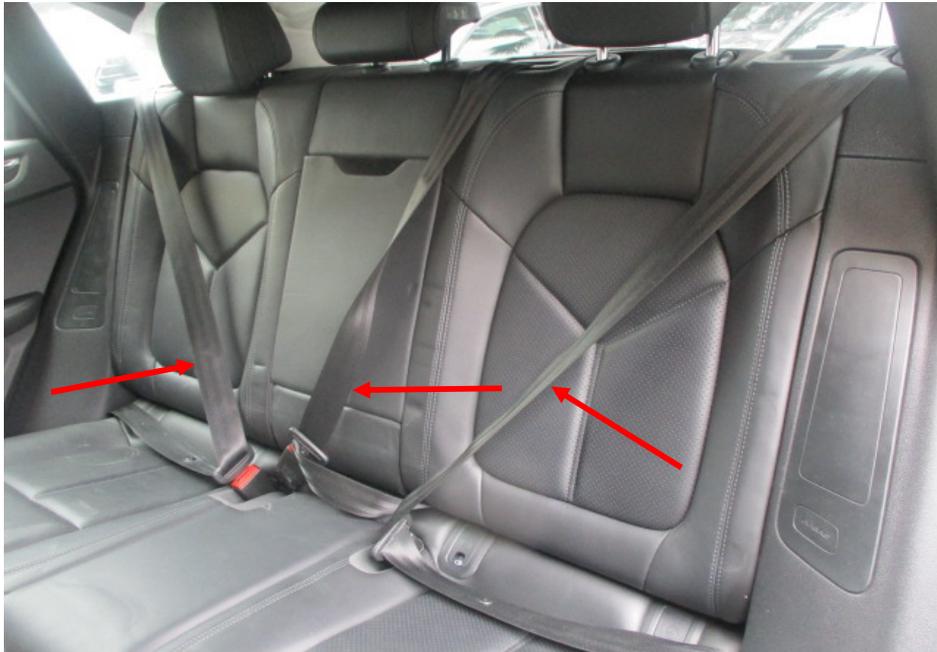
**Photo 18** shows the rear seats of the Motor Car. All the seats of the Motor Car were secured via seat rails to the floorboard. They were also fitted with a retractable seat belt reel and a pre-tensioner. The seat belts (arrowed) were tested and were able to be fastened into the respective pre-tensions that were fitted on the side of each individual seat.

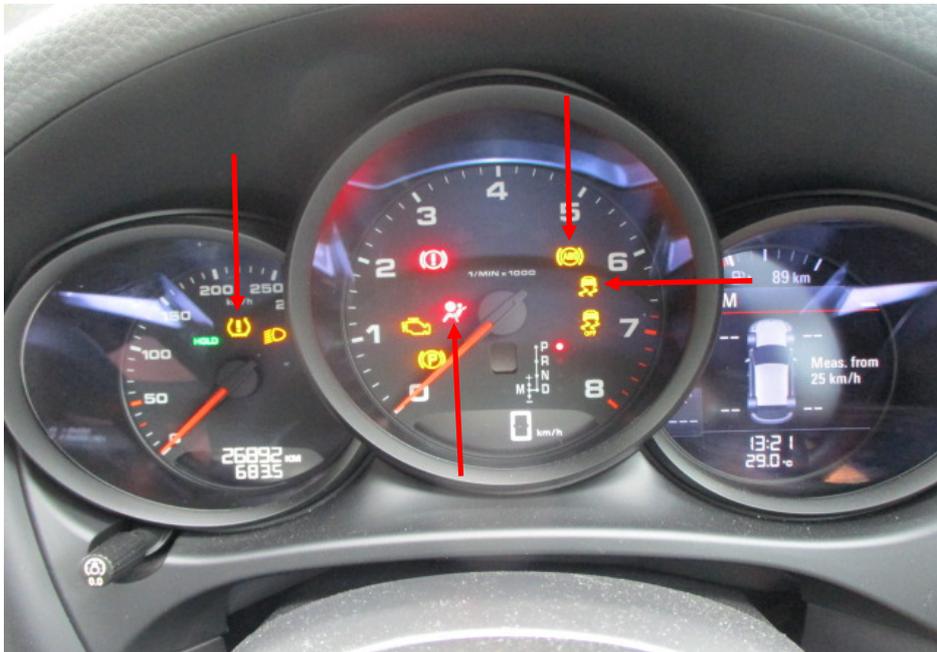
**Photo 19** shows the warning lights for the various electronic safety features appearing on the instrument panel of the Motor Car during its self-test when the engine is cranked, in particular the ABS, SRS, TPM and TCS lights (arrowed).

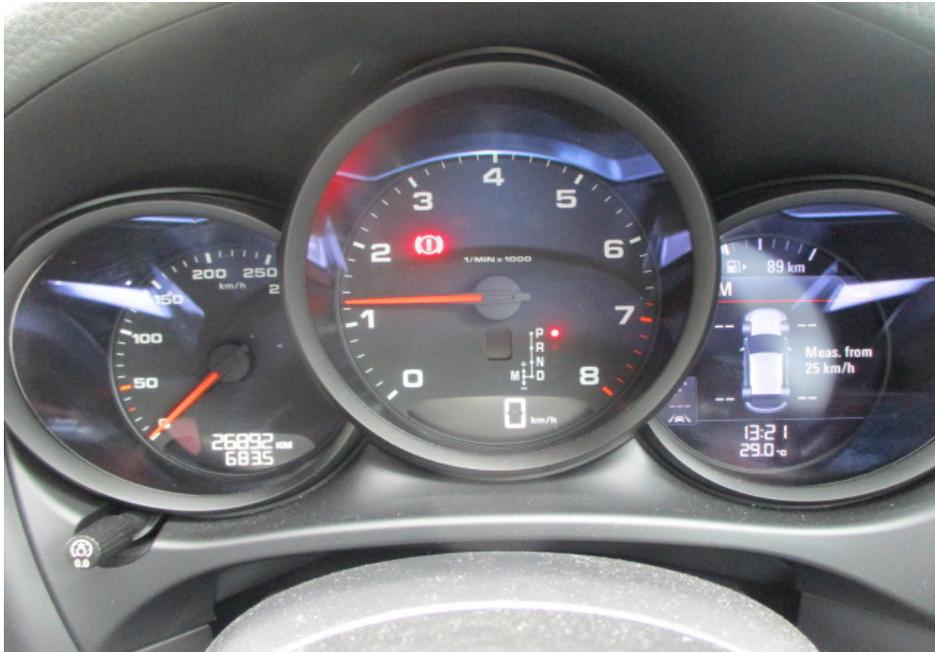
**Photo 20** shows the respective warning lights no longer illuminated, indicating that there is no fault detected to the ABS, SRS, TPM and TCS systems of the Motor Car during the self-test. These electronic systems were hence in working condition at the time of my inspection.

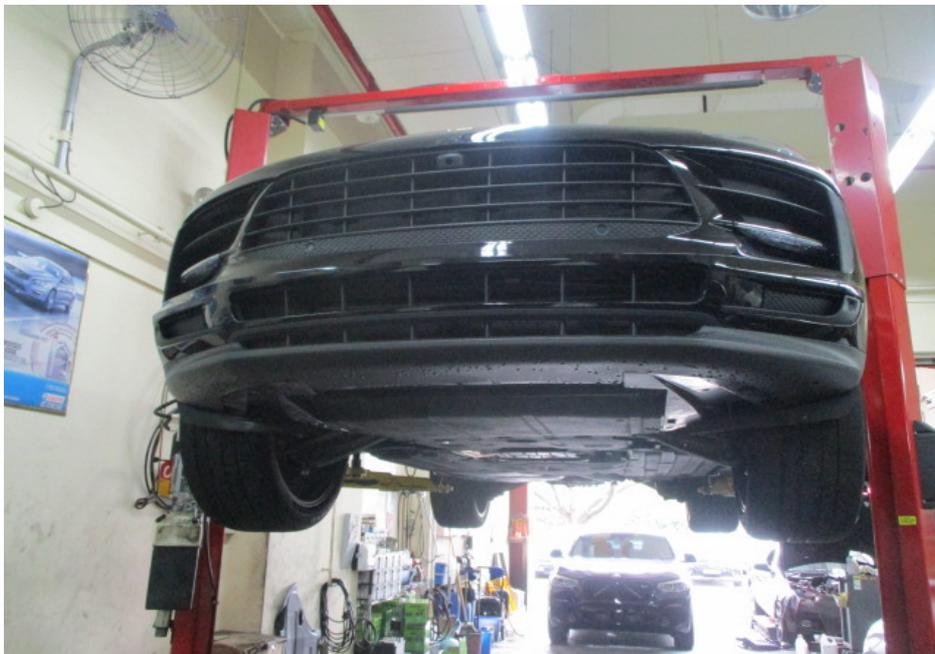
**Photo 21** shows the Motor Car hoisted up for checks on its undercarriage. There was no sign(s) or indication(s) of fluid leakage and/or fluid stain(s) on the underside of the Motor Car. The undercarriage components of the Motor Car were also all observed to be intact and secured in an appropriate manner.

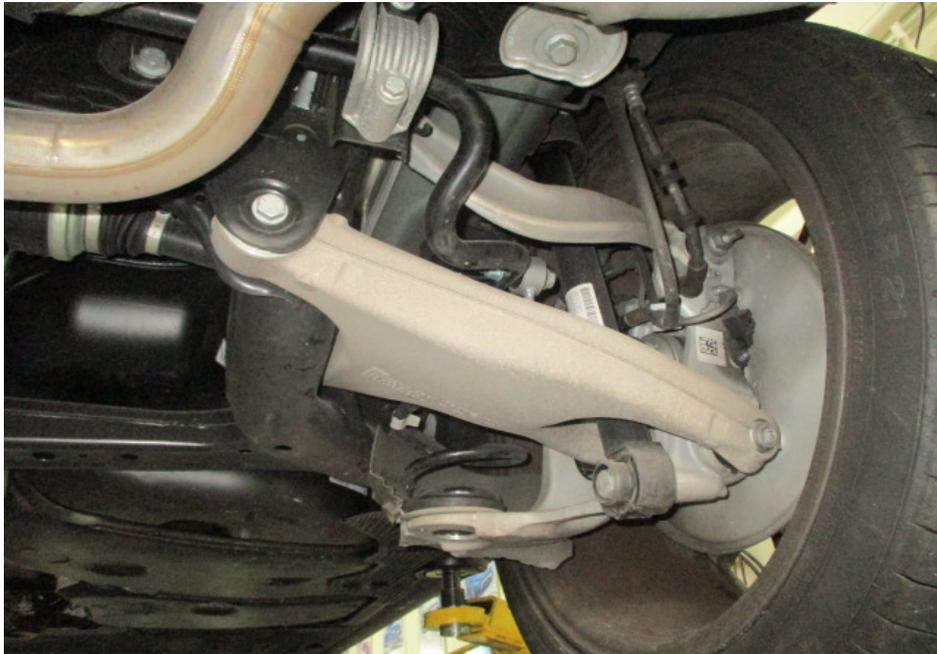
**Photo 22** shows a general view of the control arms and linkages at the rear right wheel of the Motor Car. I did not observe any fluid leak and/or fluid stain on the underside of the Motor Car. All of the Motor Car's undercarriage components were observed to be intact and secured in an appropriate manner.

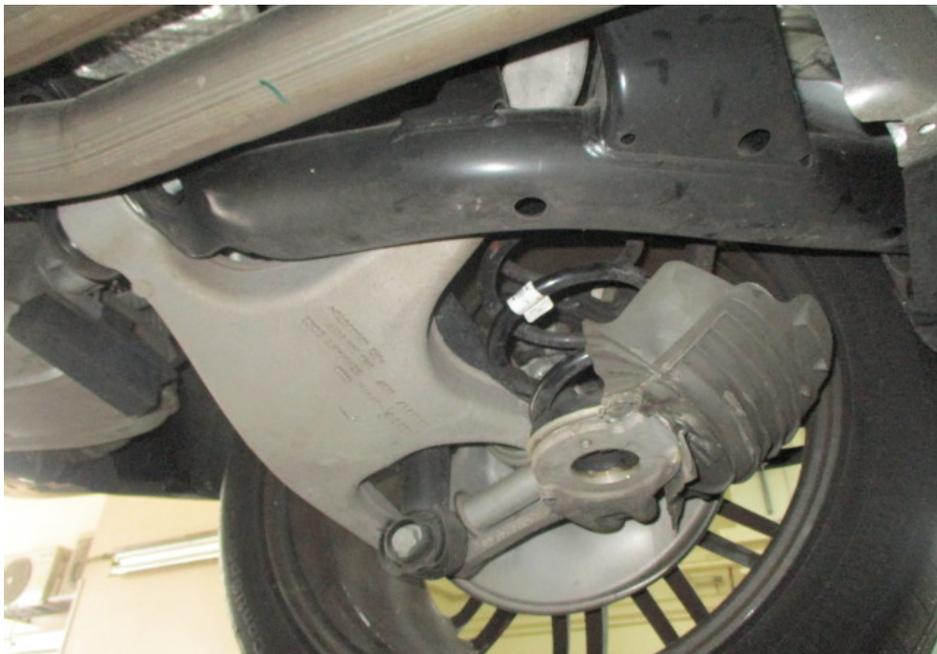
**Photo 23** shows a general view of the control arms and linkages at the rear left wheel of the Motor Car. I did not observe any fluid leak and/or fluid stain on the underside of the Motor Car. All of the Motor Car's undercarriage components were observed to be intact and secured in an appropriate manner.

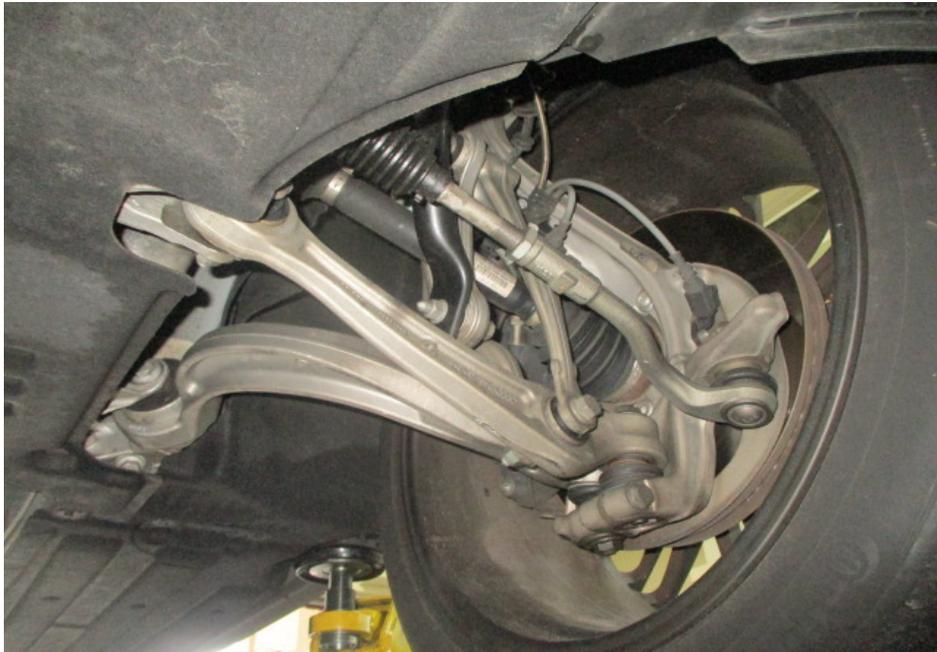
**Photo 24** shows the various undercarriage components at the front left wheel of the Motor Car. The mechanical components, control arms and linkages were all found to be intact and secured in an appropriate manner.

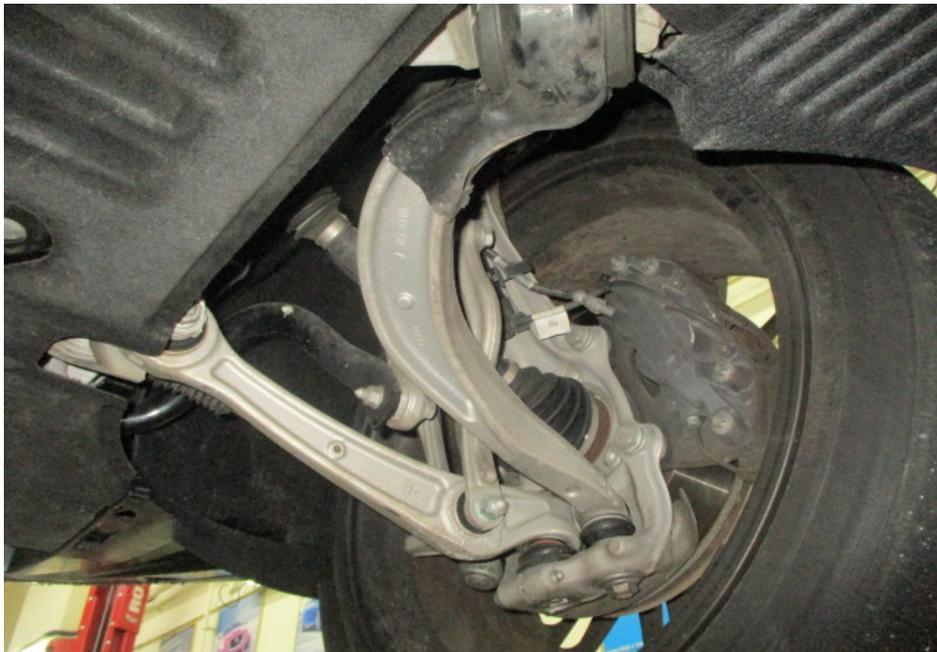
**Photo 25** shows the various undercarriage components at the front right wheel of the Motor Car. The mechanical components, control arms and linkages were all found to be intact and secured in an appropriate manner. I also did not observe any fluid leak and/or fluid stain on the underside of the Motor Car.

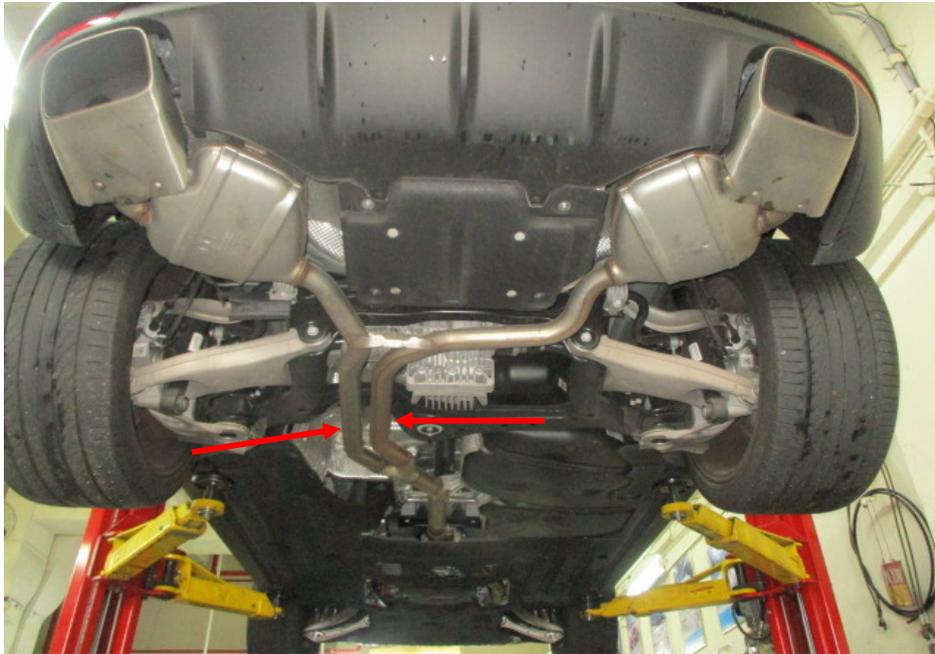
**Photo 26** shows the rear section of the Motor Car's exhaust system. My examination of the Motor Car's exhaust system revealed no sign(s) or indication(s) of any cut or weld marks along its exhaust pipes (arrowed), on its rear mufflers and on its catalytic converter.

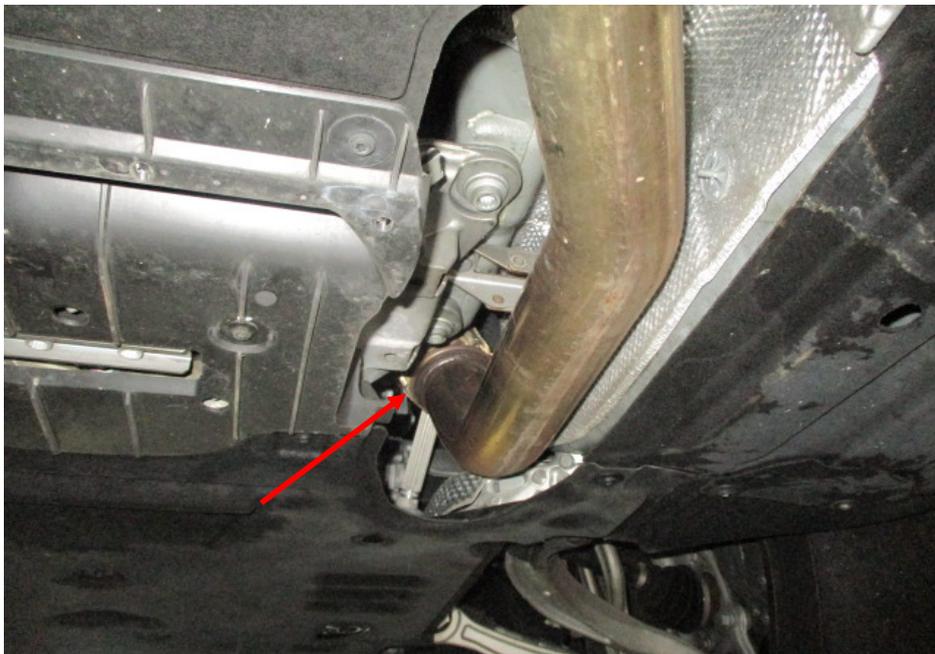
**Photo 27** shows the front section of the Motor Car's exhaust system. My examination of the Motor Car's exhaust system revealed no sign(s) or indication(s) of any cut or weld marks along its exhaust pipes, on its rear mufflers and on its catalytic converter (arrowed).

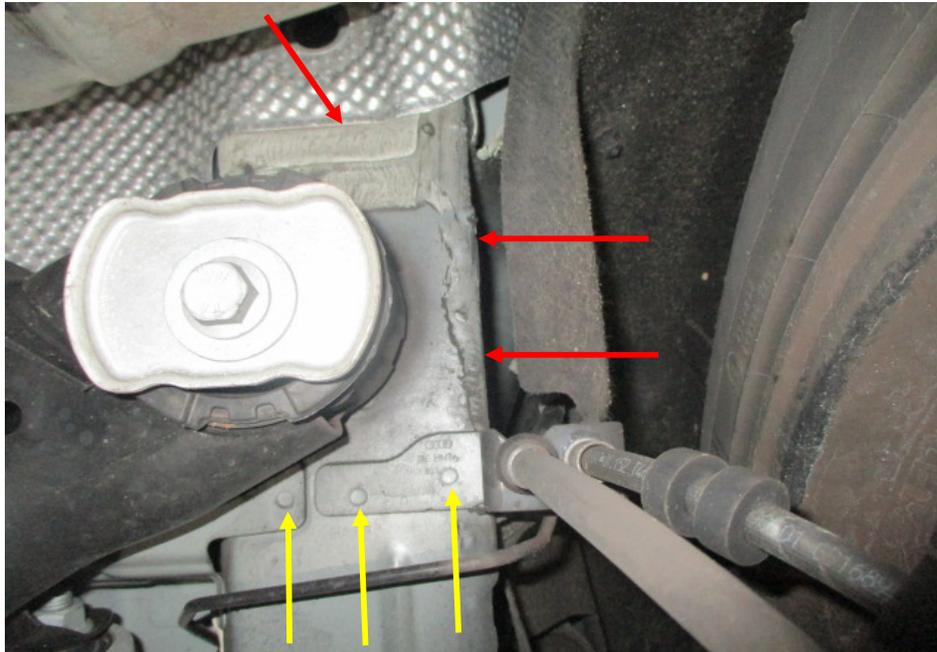
**Photo 28** shows the chassis/structural body at the underside rear right of the Motor Car. I did not find any weld marks other than original spot weld marks (yellow arrow) on the chassis/structural body of the Motor Car. The original factory sealant (red arrow) at the joints along the chassis/structural body was untouched, indicating no work was done on the chassis/structural body of the Motor Car and that the chassis/structural body was originally fitted.

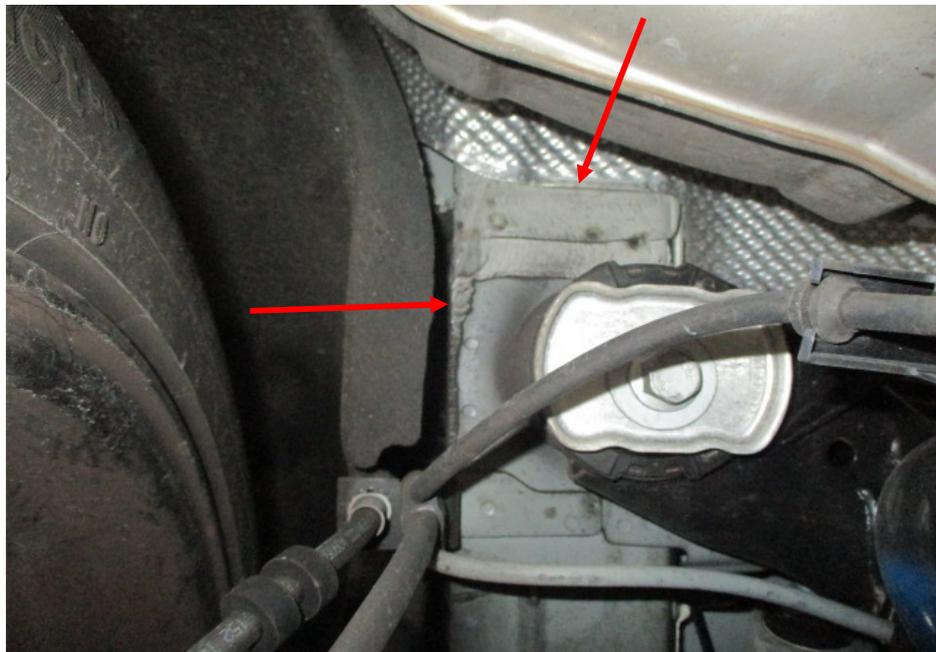
**Photo 29** shows the chassis/structural body at the underside rear left of the Motor Car. The original factory sealant (arrowed) at the joints along the chassis/structural body was observed to be untouched. In general, I had found no work was carried out on the chassis/structural body of the Motor Car. The chassis/structural body of the Motor Car was originally fitted.

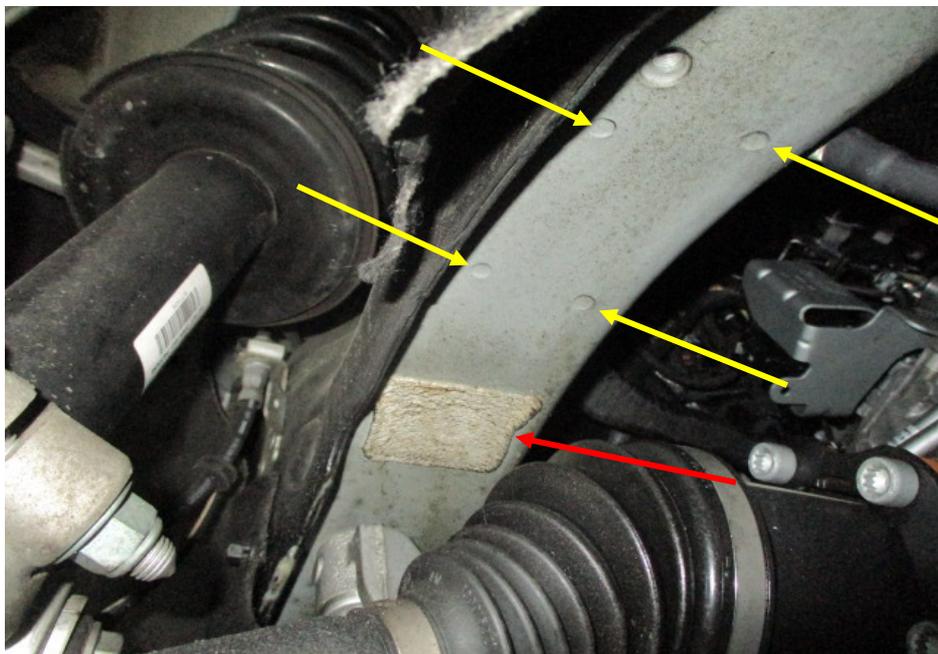
**Photo 30** shows the chassis/structural body at the underside front left of the Motor Car. I did not find any weld marks other than original spot weld marks (yellow arrow) on the chassis/structural body of the Motor Car. The original factory sealant (red arrow) at the joints along the chassis/structural body was untouched, indicating no work was done on the chassis/structural body of the Motor Car and that the chassis/structural body was originally fitted.

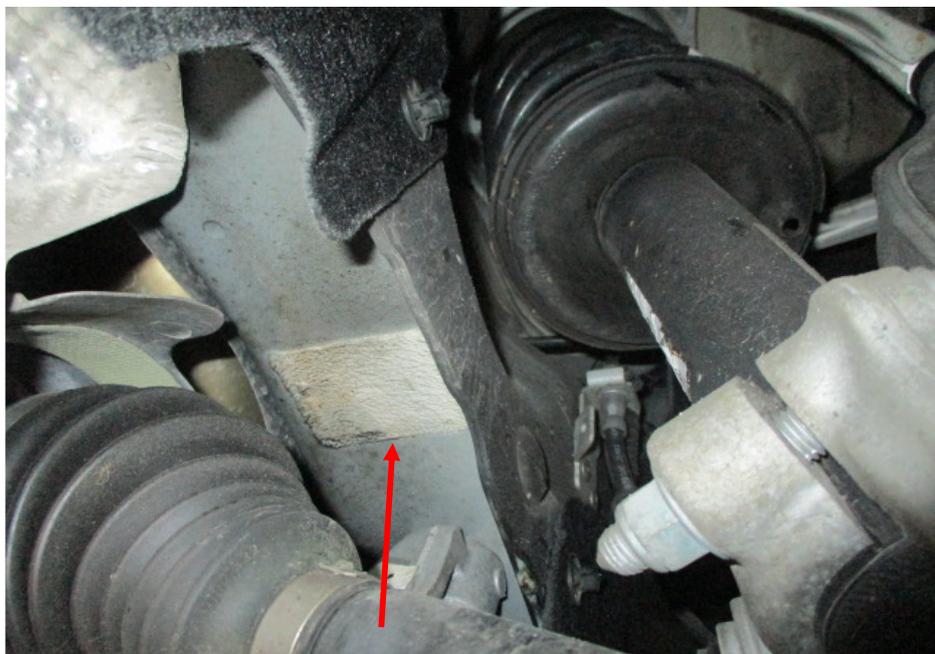
**Photo 31** shows the chassis/structural body at the underside front right of the Motor Car. The original factory sealant (arrowed) at the joints along the chassis/structural body was observed to be untouched. In general, I had found no work was carried out on the chassis/structural body of the Motor Car. The chassis/structural body of the Motor Car was originally fitted.

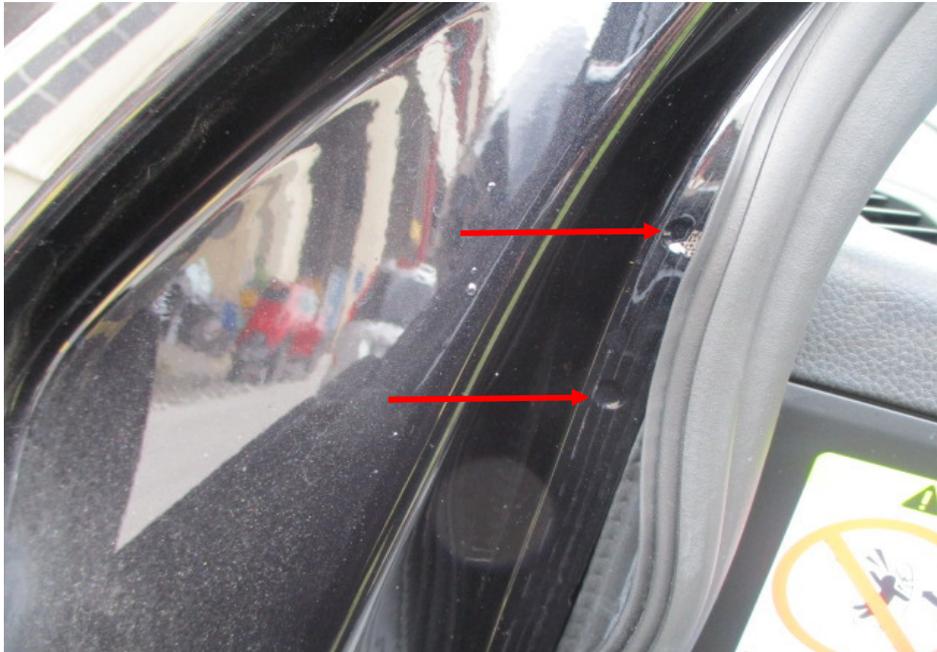
**Photo 32** shows the left side "A" pillar of the Motor Car. I did not find any weld marks other than original spot weld marks (arrowed) on the left side "A" pillar of the Motor Car which, indicates that there was no re-welding works carried out. In general, I had found all the non-detachable body panels of the Motor Car to be originally fitted at the time of my inspection.
