Your Ref: Porsche Marcan  
(chassis number WP1ZZZ95ZKLB02986)  
Our Ref : CI/TP21008709/D

22 August 2021

### **INSPECTION REPORT OF AN UNREGISTERED PORSCHE MARCAN MOTOR CAR WITH CHASSIS NUMBER WP1ZZZ95ZKLB02986**

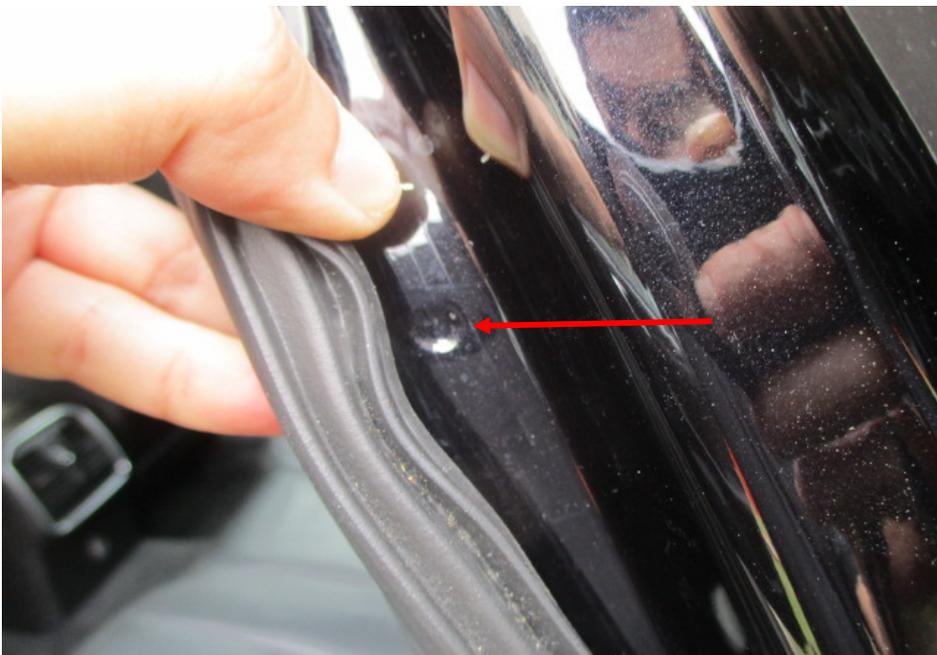
**Photo 33** shows the left side "C" pillar of the Motor Car. I did not find any weld marks other than original spot weld marks (arrowed) on the left side "C" pillar of the Motor Car which, indicates that there was no re-welding works carried out. In general, I had found all the non-detachable body panels of the Motor Car to be originally fitted at the time of my inspection.

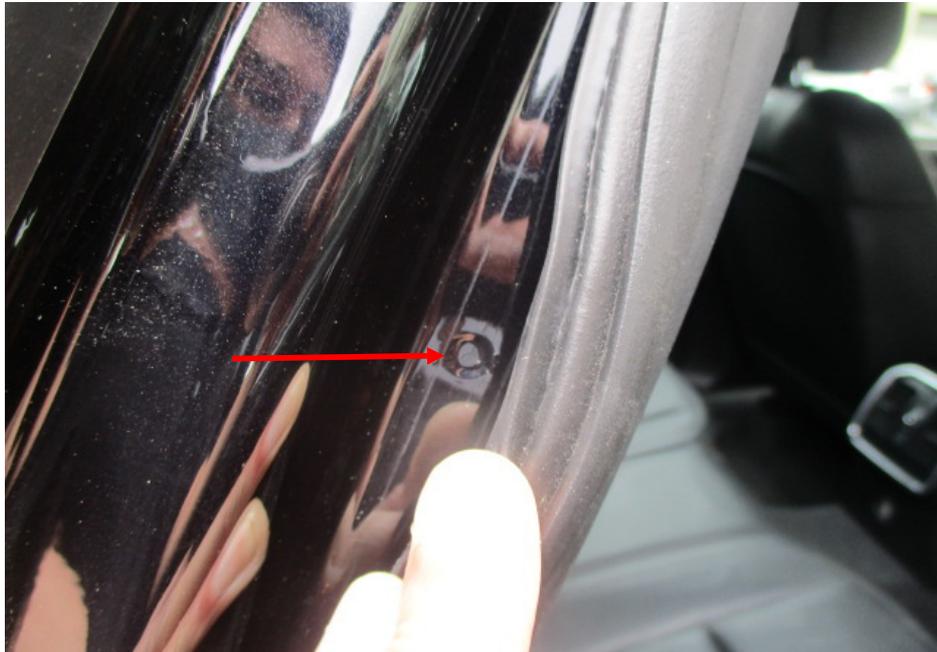
**Photo 34** shows the right side "C" pillar of the Motor Car. I did not find any weld marks other than original spot weld marks (arrowed) on the right side "C" pillar of the Motor Car which, indicates that there was no re-welding works carried out. In general, I had found all the non-detachable body panels of the Motor Car to be originally fitted at the time of my inspection.
