Your Ref: BMW X4
(chassis number WBA2V120X09C54047)
Our Ref : CI/TP21008710/D

19 August 2021

INSPECTION REPORT OF AN UNREGISTERED BMW X4 MOTOR CAR WITH CHASSIS NUMBER WBA2V120X09C54047

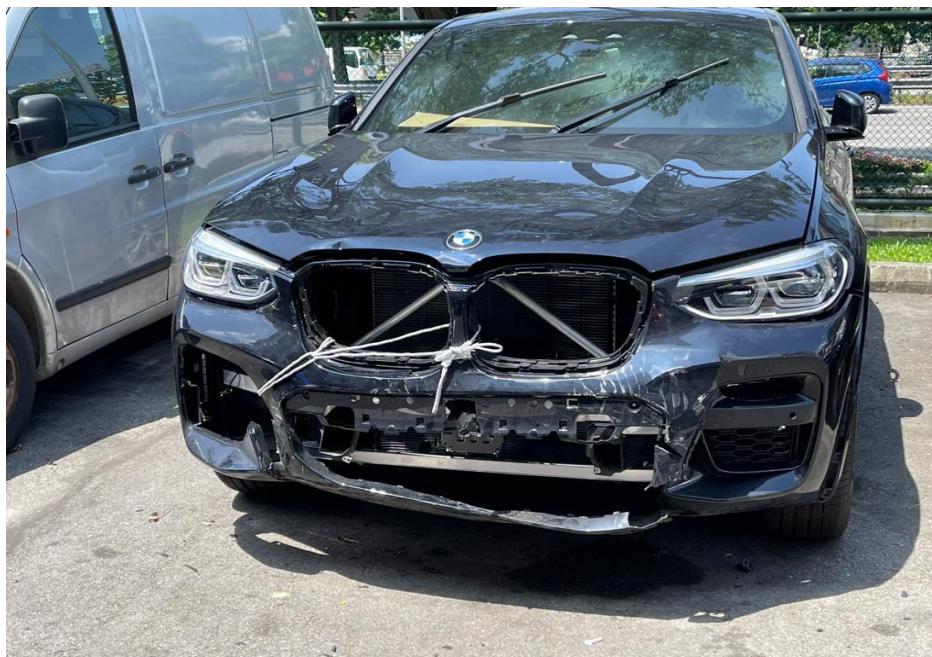
3. The photographs provided to me had showed damage to the frontal portion and rear right portion of the Motor Car. Body parts observed to be damaged at the frontal portion include the front bumper, front bumper centre lower grille, front bumper right lower grille, front bumper reinforcement, front radar unit, front sensors, front right day running light, front left day running light, front radiator grilles and front bonnet amongst others.
4. As for the rear right portion, I had observed relatively minor damage to the right side of the Motor Car's rear bumper. The rear right fender was also observed to be slightly dented.
5. No physical damage was observed to other areas of the Motor Car. The airbags were not deployed as seen from the photographs that were provided to me. See photo 1 – 5 below.

Photo 1 shows the frontal body of the Motor Car (photograph provided to me). The photographs provided to me had showed damage to the frontal portion of the Motor Car. Body parts damaged include the front bumper, front bumper centre lower grille, front bumper right lower grille, front bumper reinforcement, front radar unit, front sensors, front right day running light, front left day running light, front radiator grilles and front bonnet amongst others.

23. The body parts at the frontal portion and rear right portion of the Motor Car were visually examined and it was noted that the repair/restoration works carried out to the damaged area of the Motor Car (refer to photograph 1 & 3 above) were reasonably adequate and in order.

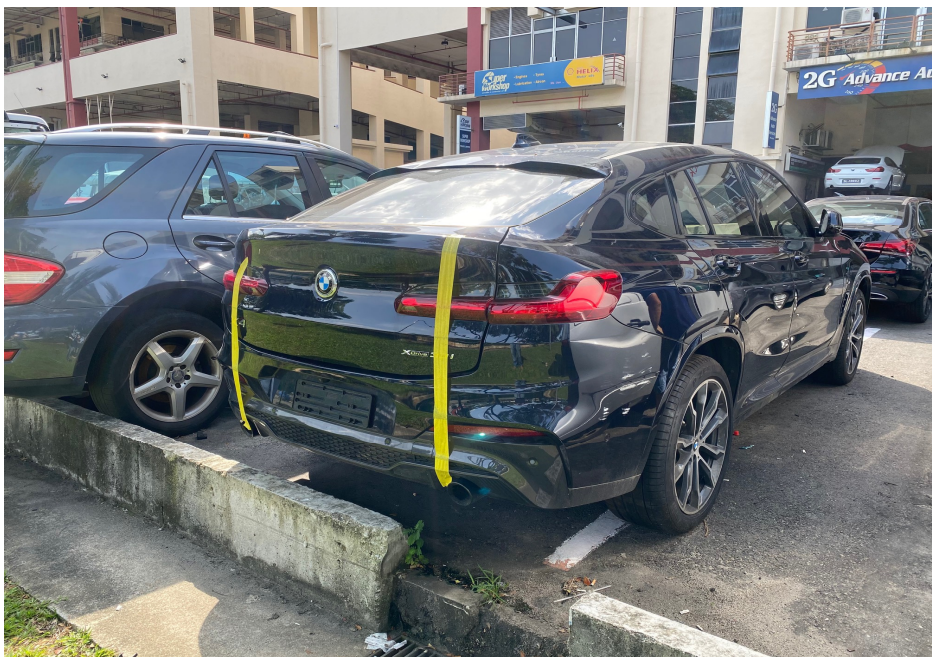
Photo 2 shows the rear right body of the Motor Car (photograph provided to me). Apart for the frontal portion, I had also observed damage to the Motor Car's rear right portion. The rear bumper and rear right fender were observed to be with relatively minor damage.

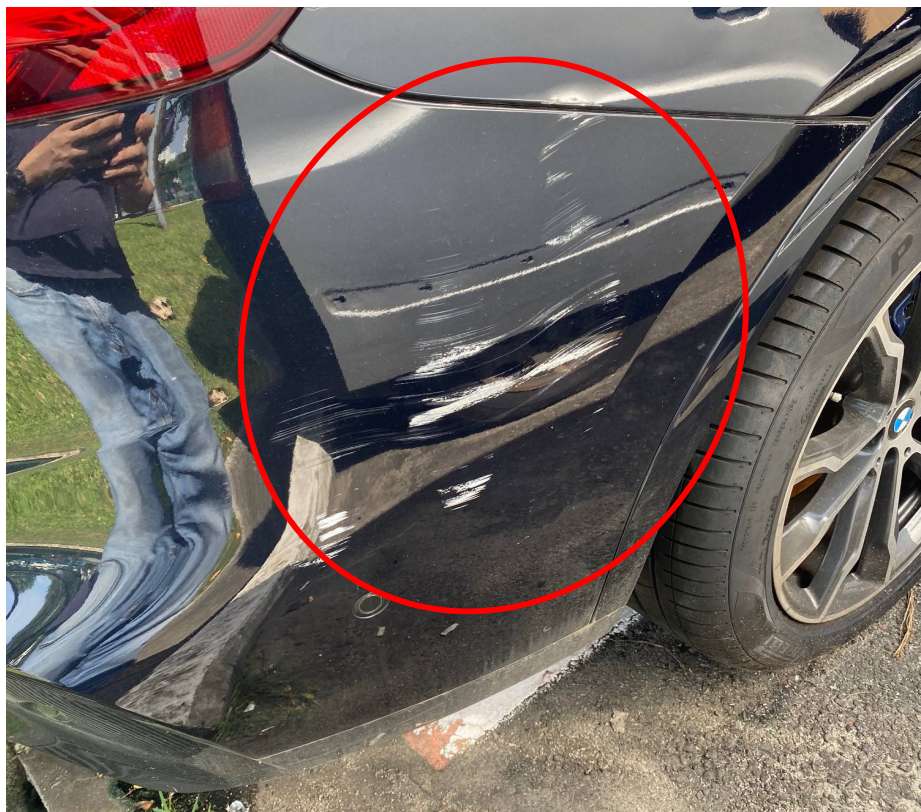
Photo 3 shows a closer view of the damage (circled) at the rear right portion of the Motor Car (photograph provided to me). The rear bumper and rear right fender of the Motor Car were observed to be with relatively minor damage.

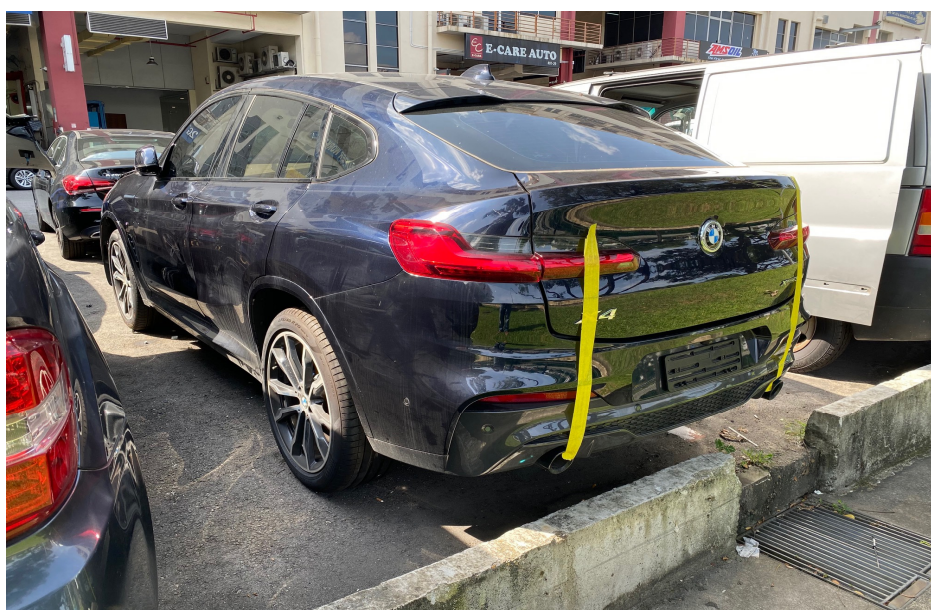
Photo 4 shows the rear left body of the Motor Car (photograph provided to me). Apart for the frontal portion and rear right portion, there was no physical damage observed to other areas of the Motor Car. The airbags of the Motor Car were also not deployed as seen from the photographs that were provided to me.

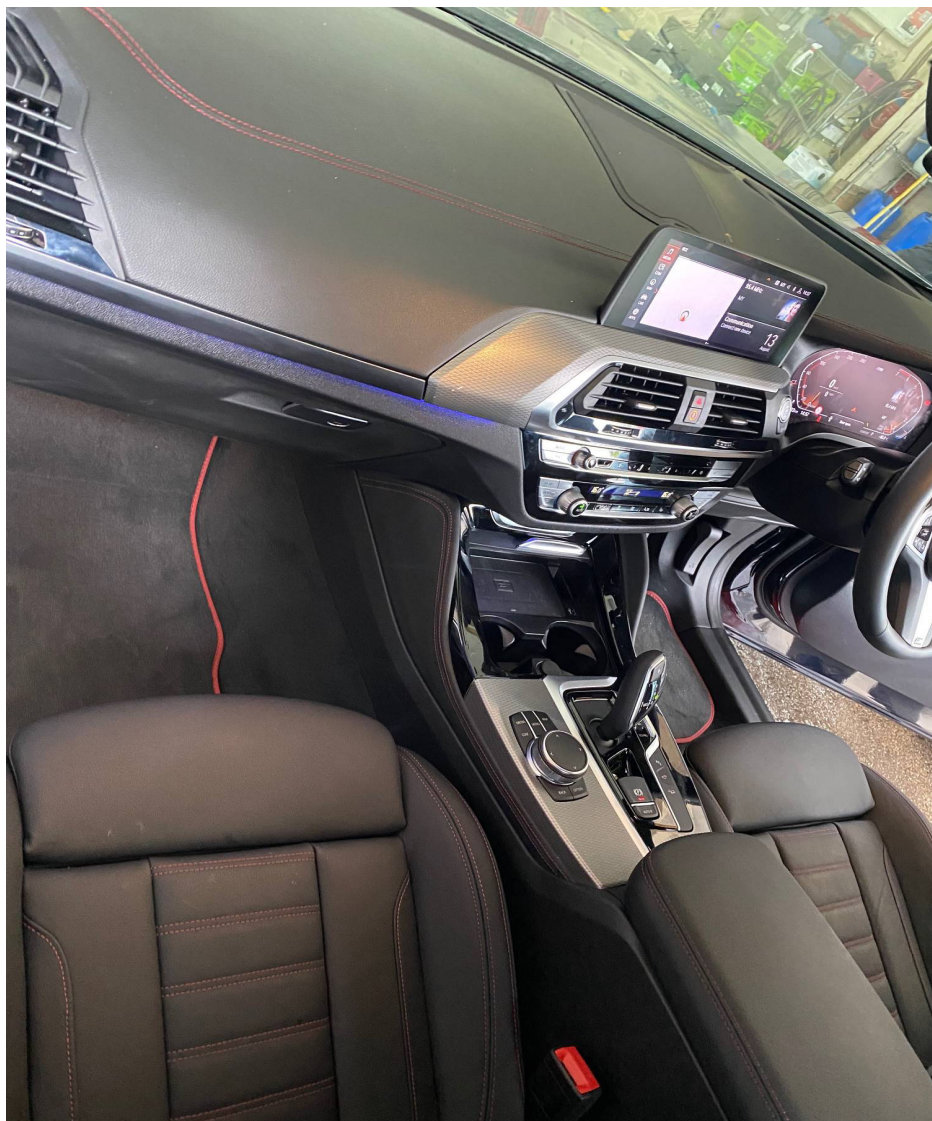
Photo 5 shows the front dashboard of the Motor Car (photograph provided to me). Parts and components within the interior compartment were observed to be unaffected. The airbags of the Motor Car were also not deployed as seen from the photographs that were provided to me.

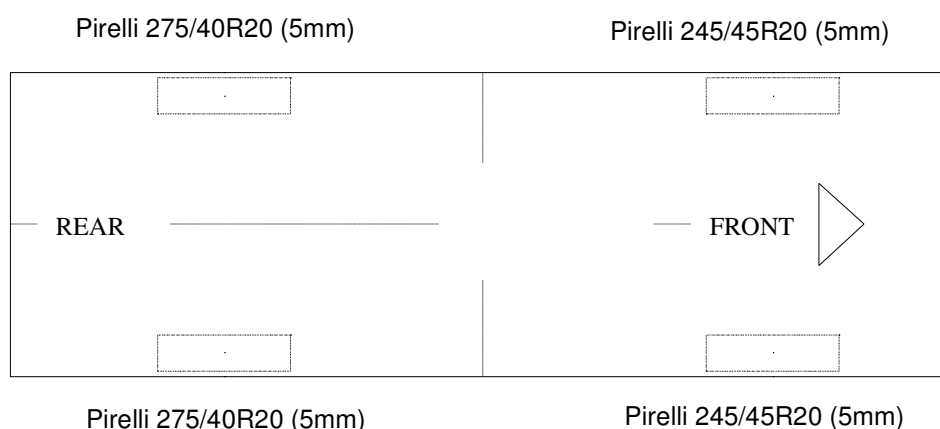
9. It was fitted with 20inch sport wheel rims that were wrapped with tyres that were observed to be of serviceable condition. The tyres were also sufficiently inflated for vehicular operation. The tyre brand, tyre size and approximate remaining tread depth of the 4 tyres of the Motor Car were recorded as follows: -

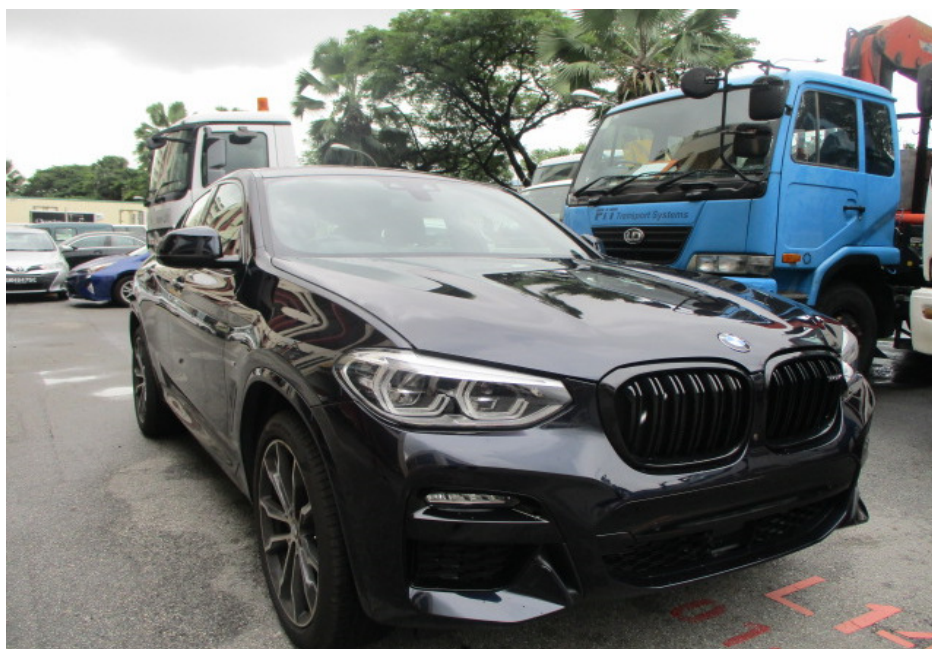
Photo 6 shows a general view of the front right body of the Motor Car at the time of my inspection. The Motor Car was observed to be in a relatively good general condition with no loose exterior fittings observed. The body parts at the frontal portion of the Motor Car were visually examined and it was observed that the repair/restoration works carried out to the damaged area of the Motor Car (refer to photograph 1 above) were reasonably adequate and in order.

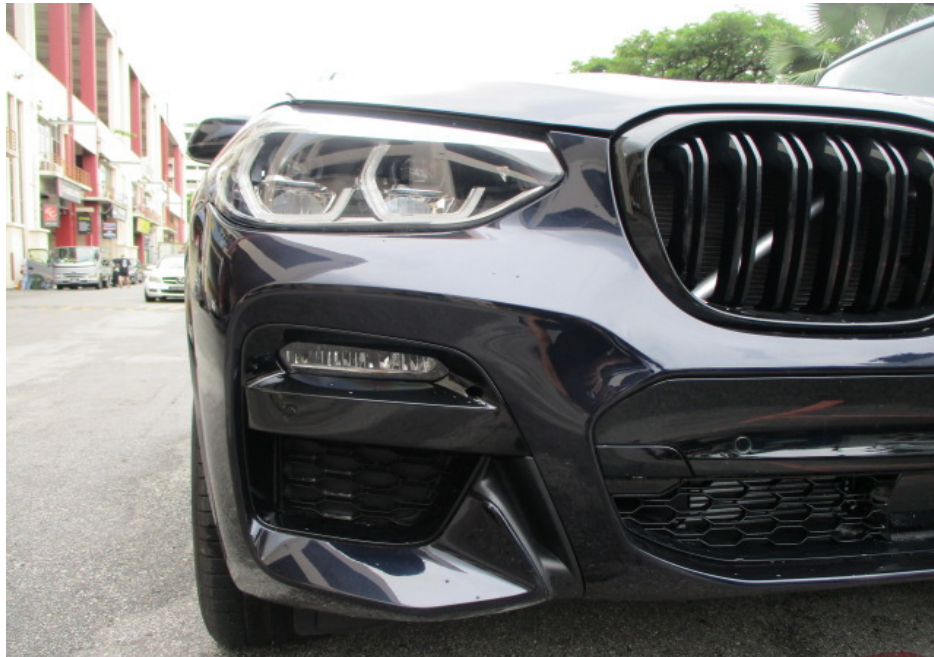
Photo 7 shows a closer view of the Motor Car's front bumper, front bumper right lower grille, front right day running light and front right headlamp at the time of my inspection. The body parts at the frontal portion of the Motor Car were visually examined and it was observed that the repair/restoration works carried out to the damaged area of the Motor Car (refer to photograph 1 above) were reasonably adequate and in order.

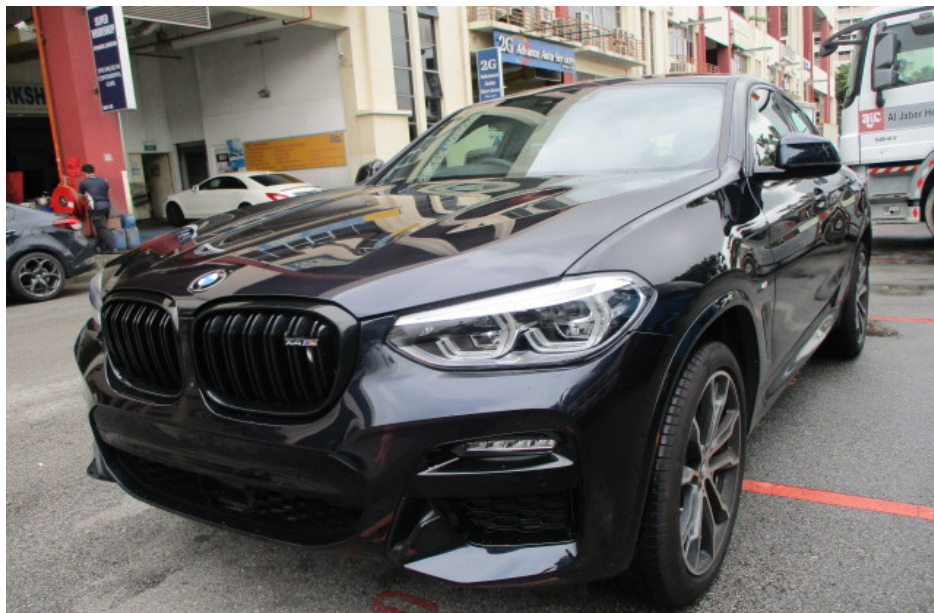
Photo 8 shows a general view of the front left body of the Motor Car at the time of my inspection. The Motor Car was observed to be in a relatively good general condition with no loose exterior fittings observed. The body parts at the frontal portion of the Motor Car were visually examined and it was observed that the repair/restoration works carried out to the damaged area of the Motor Car (refer to photograph 1 above) were reasonably adequate and in order.

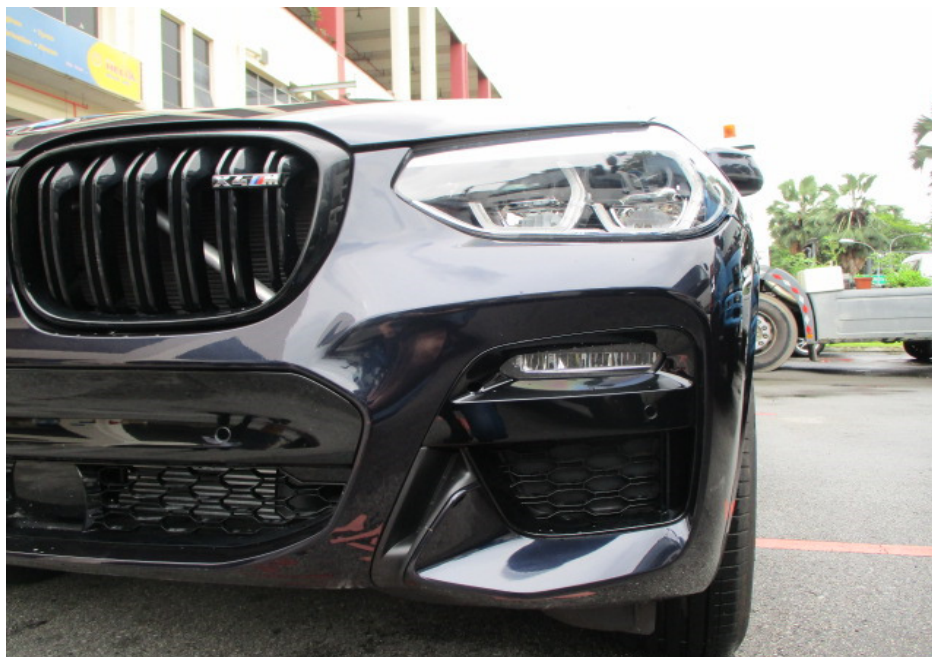
Photo 9 shows a closer view of the Motor Car's front bumper, front left lower grille, front left day running light and front left headlamp at the time of my inspection. The body parts at the frontal portion of the Motor Car were visually examined and it was observed that the repair/restoration works carried out to the damaged area of the Motor Car (refer to photograph 1 above) were reasonably adequate and in order.

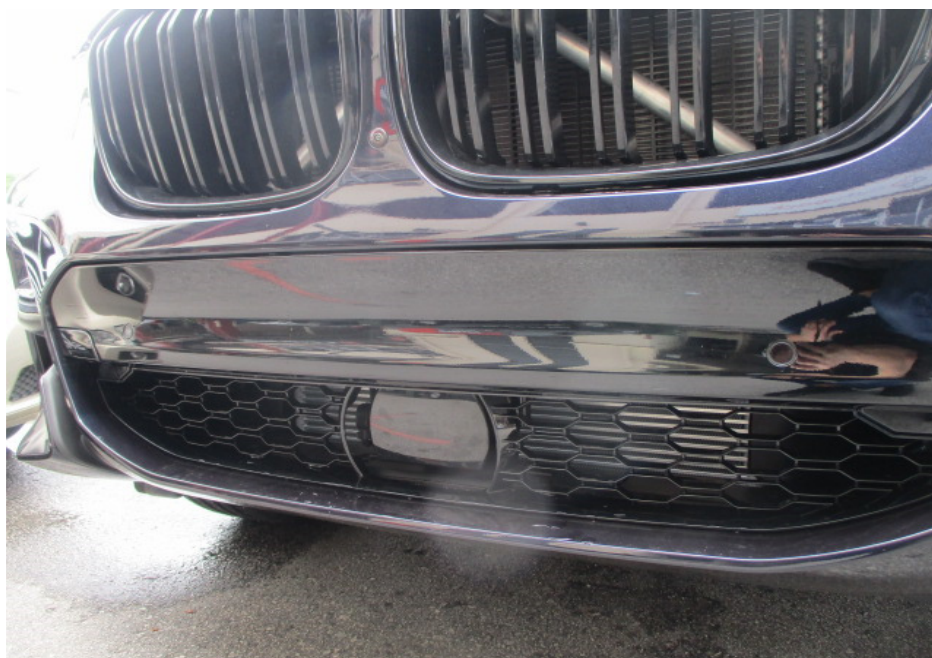
Photo 10 shows a closer view of the Motor Car's front bumper centre lower grille, front radar unit and front radiator grilles at the time of my inspection. The body parts at the frontal portion of the Motor Car were visually examined and it was observed that the repair/restoration works carried out to the damaged area of the Motor Car (refer to photograph 1 above) were reasonably adequate and in order.

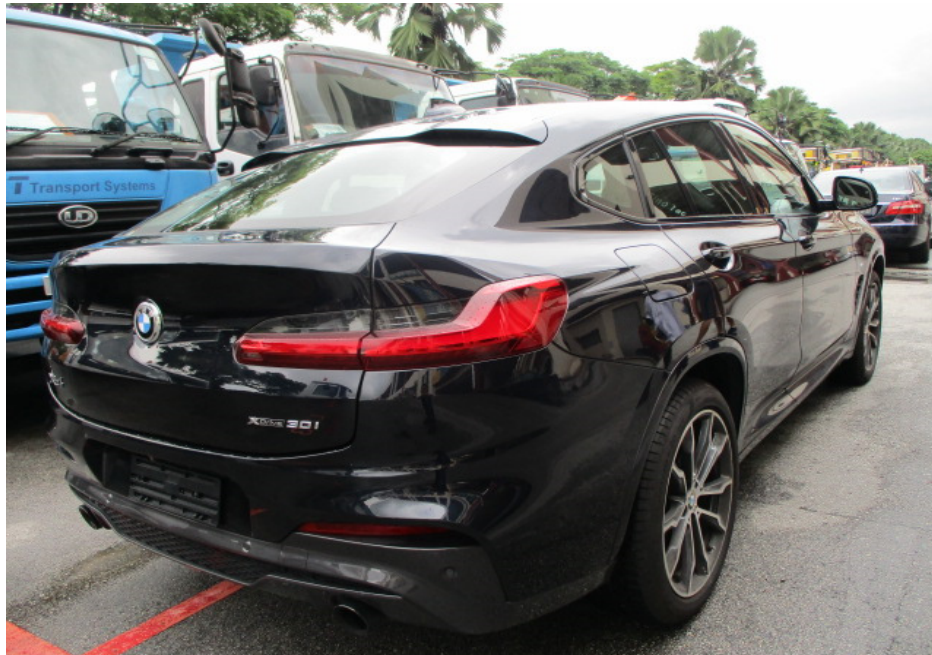
Photo 11 shows a general view of the rear right body of the Motor Car at the time of my inspection. The Motor Car was observed to be in a relatively good general condition with no loose exterior fittings observed. The body parts at the rear right portion of the Motor Car were visually examined and it was observed that the repair/restoration works carried out to the damaged area of the Motor Car (refer to photograph 3 above) were reasonably adequate and in order.

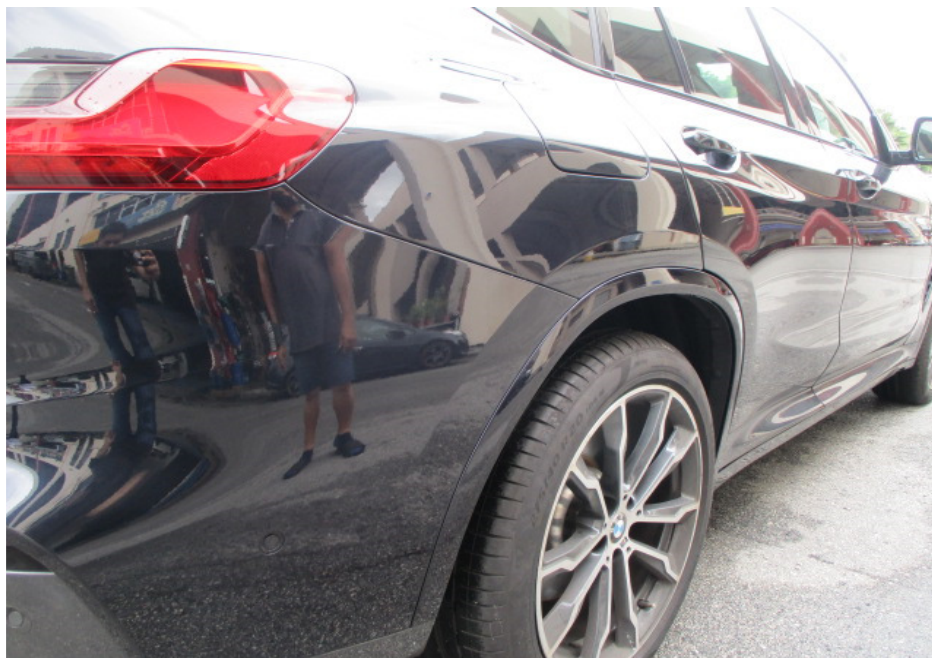
Photo 12 shows a closer view of the Motor Car's rear bumper and rear right fender at the time of my inspection. The body parts at the rear right portion of the Motor Car were visually examined and it was observed that the repair/restoration works carried out to the damaged area of the Motor Car (refer to photograph 3 above) were reasonably adequate and in order.

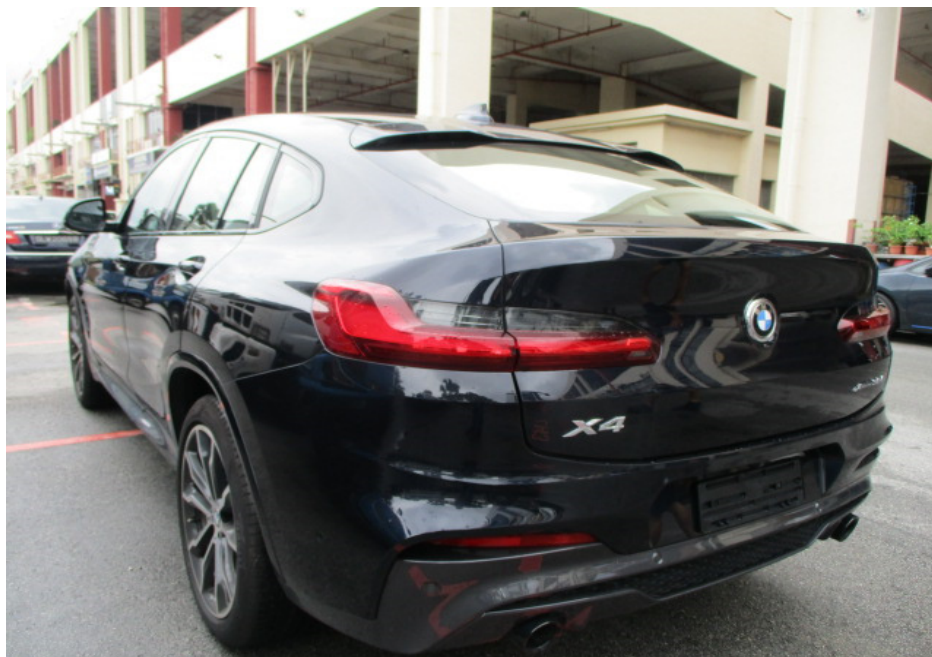
Photo 13 shows a general view of the rear left body of the Motor Car at the time of my inspection. The Motor Car was observed to be in a relatively good general condition with no loose exterior fittings observed. The mileage of the Motor Car recorded at the time of my inspection was 1,438km.

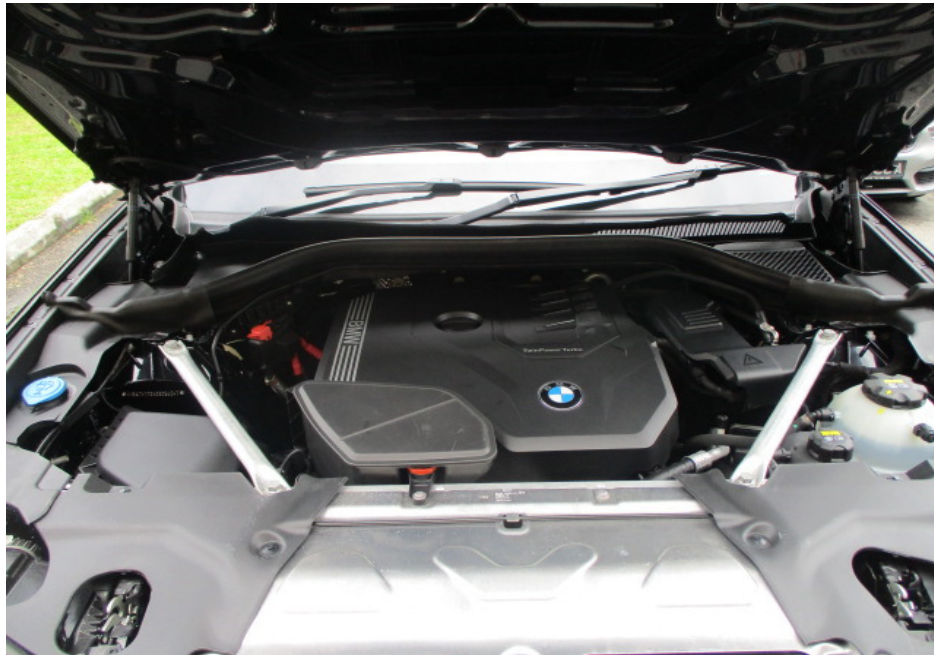
Photo 15 shows a general view of the engine compartment of the Motor Car at the time of my inspection. The various parts and components inside the engine compartment were all observed to be intact and properly fitted. There was also no sign(s) or indication(s) of fluid leak and/or fluid stain found inside the engine compartment.

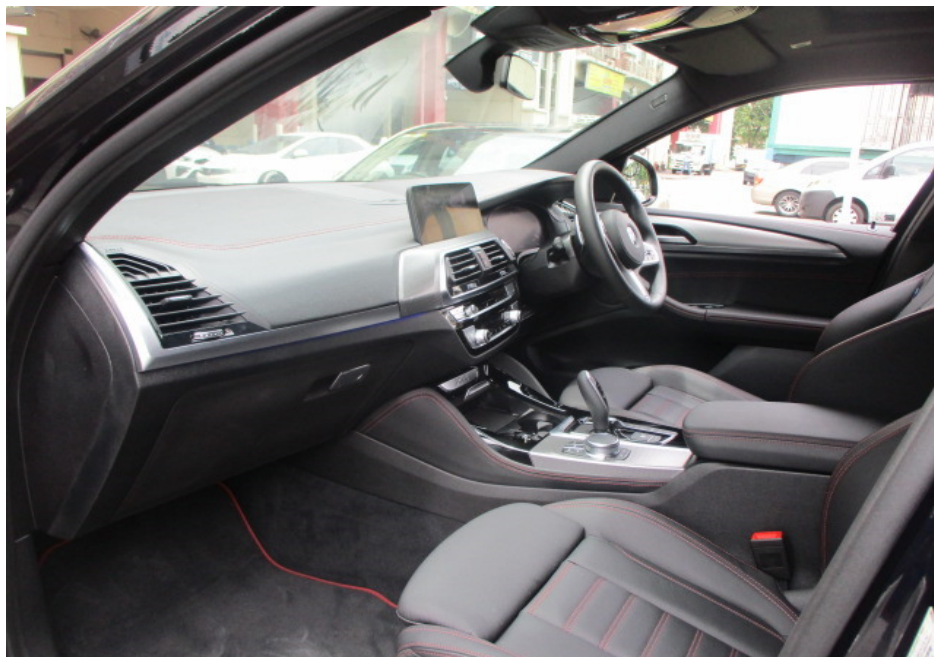
Photo 16 shows the interior compartment of the Motor Car at the time of my inspection. The various parts and components, trims, carpet, and upholstery inside the interior compartment were all observed to be intact and properly fitted.

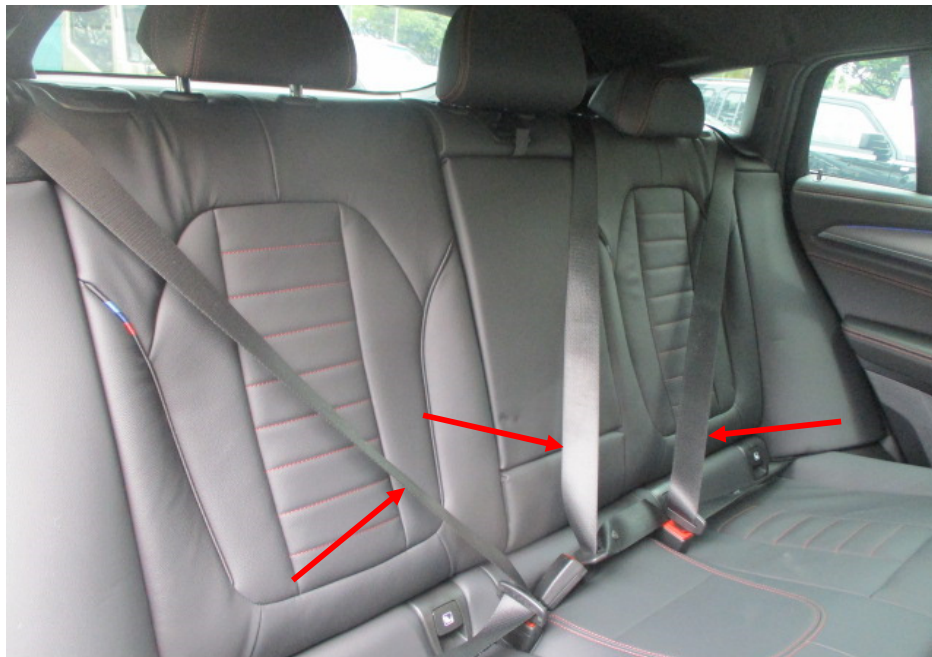
Photo 17 shows the rear seats of the Motor Car. All the seats of the Motor Car were secured via seat rails to the floorboard. They were also fitted with a retractable seat belt reel and a pre-tensioner. The seat belts (arrowed) were tested and were able to be fastened into the respective pre-tensions that were fitted on the side of each individual seat.

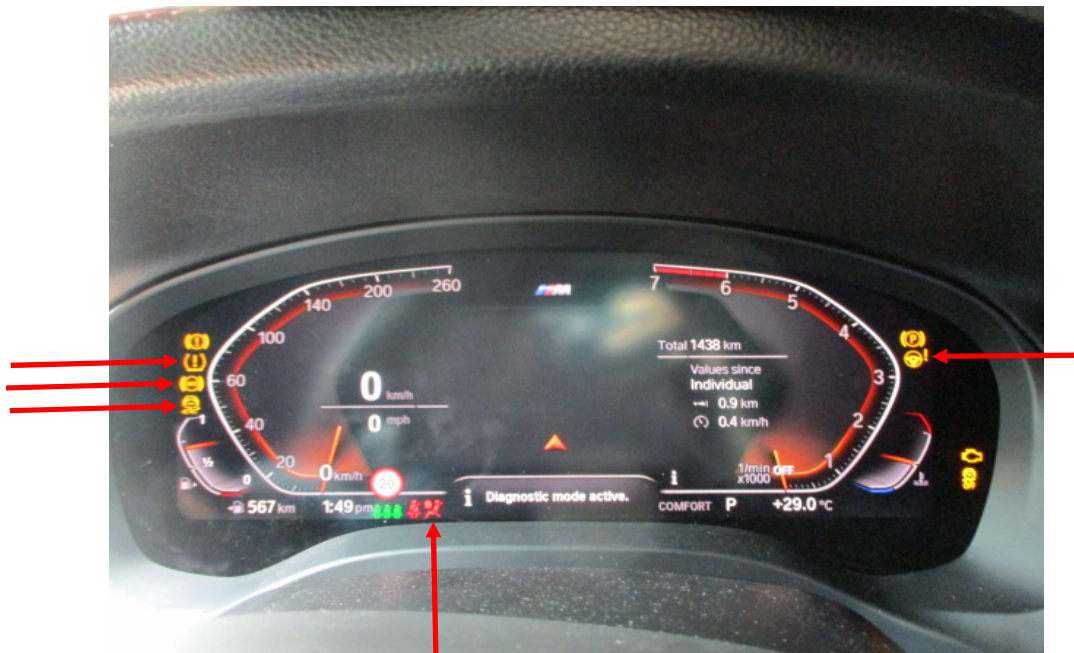
Photo 18 shows the warning lights for the various electronic safety features appearing on the instrument panel of the Motor Car during its self-test when the engine is cranked, in particular the ABS, SRS, IAS, TPM and DSC lights (arrowed).

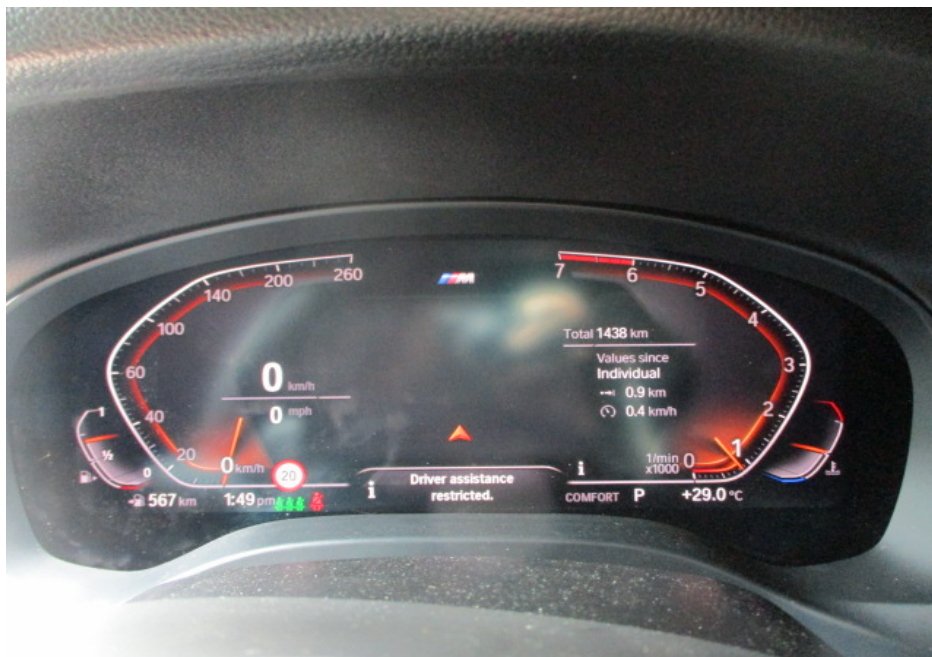
Photo 19 shows the respective warning lights no longer illuminated, indicating that there is no fault detected to the ABS, SRS, IAS, TPM and DSC systems of the Motor Car during the self-test. These electronic systems were hence in working condition at the time of my inspection.

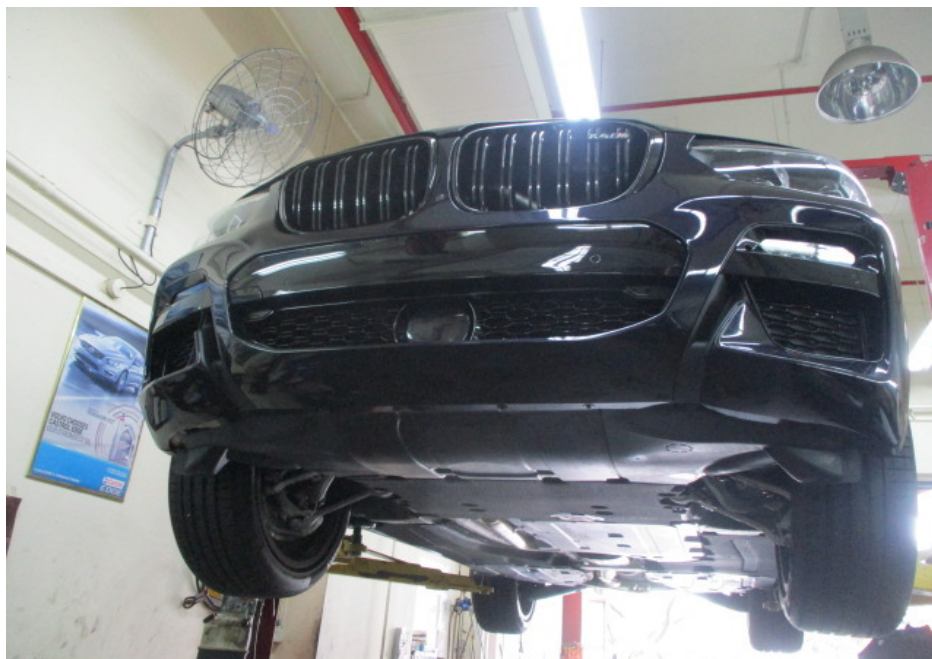
Photo 20 shows the Motor Car hoisted up for checks on its undercarriage. There was no sign(s) or indication(s) of fluid leakage and/or fluid stain(s) on the underside of the Motor Car. The undercarriage components of the Motor Car were also all observed to be intact and secured in an appropriate manner.

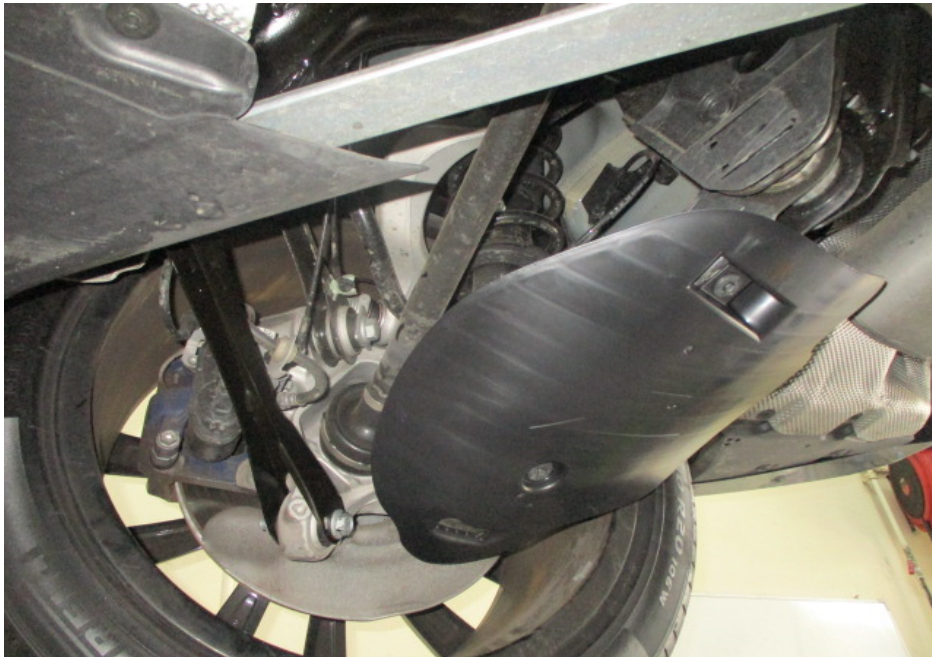
Photo 21 shows a general view of the control arms and linkages at the rear right wheel of the Motor Car. I did not observe any fluid leak and/or fluid stain on the underside of the Motor Car. All of the Motor Car's undercarriage components were observed to be intact and secured in an appropriate manner.

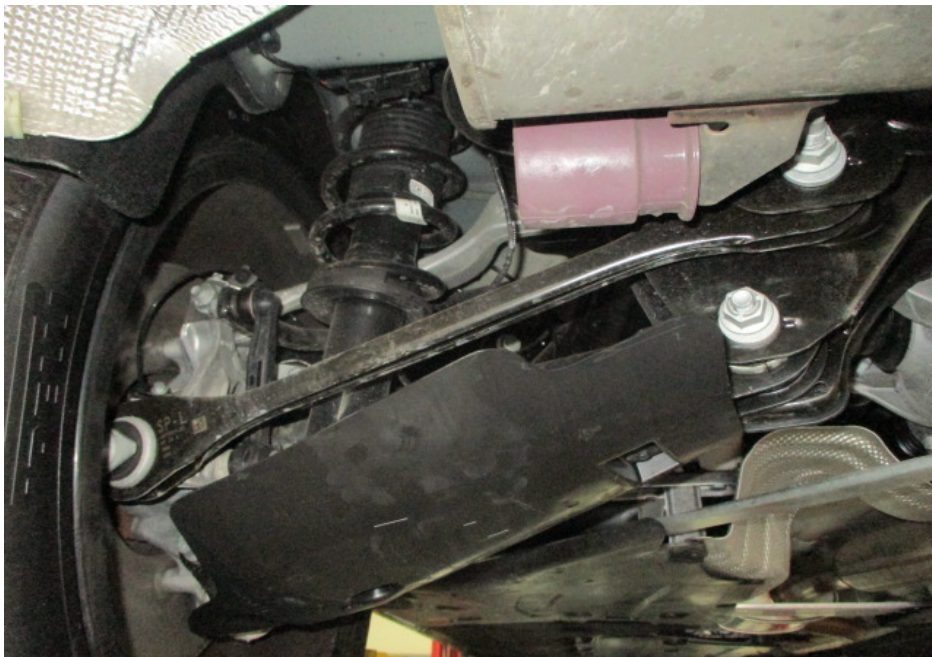
Photo 22 shows a general view of the control arms and linkages at the rear left wheel of the Motor Car. I did not observe any fluid leak and/or fluid stain on the underside of the Motor Car. All of the Motor Car's undercarriage components were observed to be intact and secured in an appropriate manner.

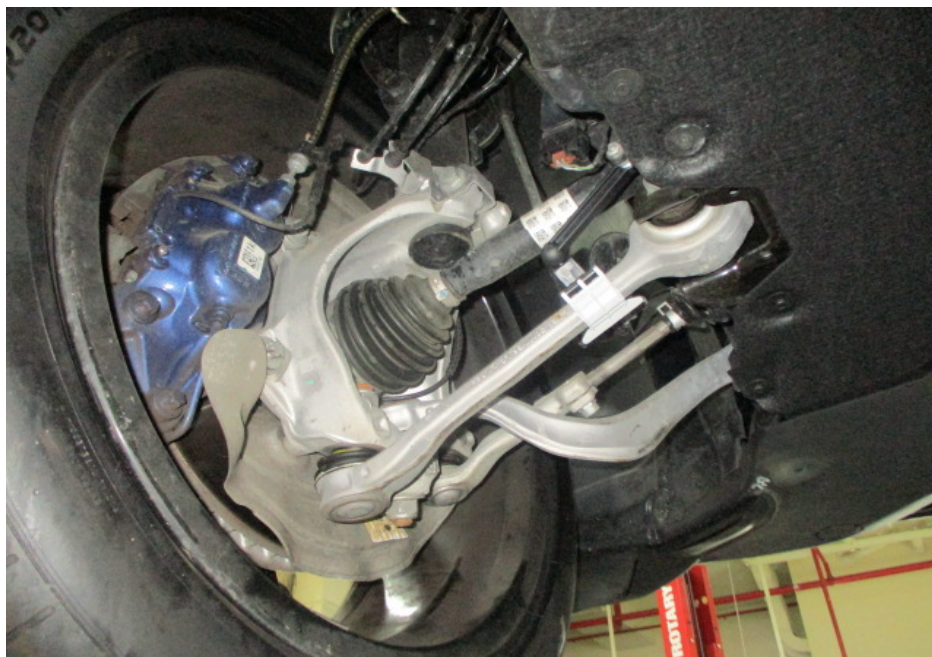
Photo 23 shows the various undercarriage components at the front left wheel of the Motor Car. The mechanical components, control arms and linkages were all found to be intact and secured in an appropriate manner.

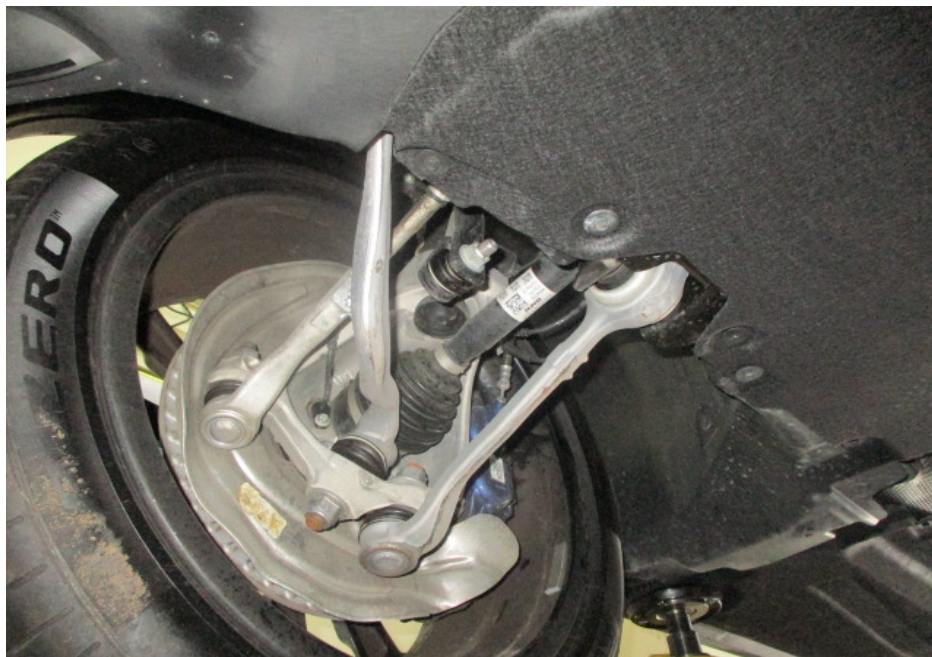
Photo 24 shows the various undercarriage components at the front right wheel of the Motor Car. The mechanical components, control arms and linkages were all found to be intact and secured in an appropriate manner. I also did not observe any fluid leak and/or fluid stain on the underside of the Motor Car.

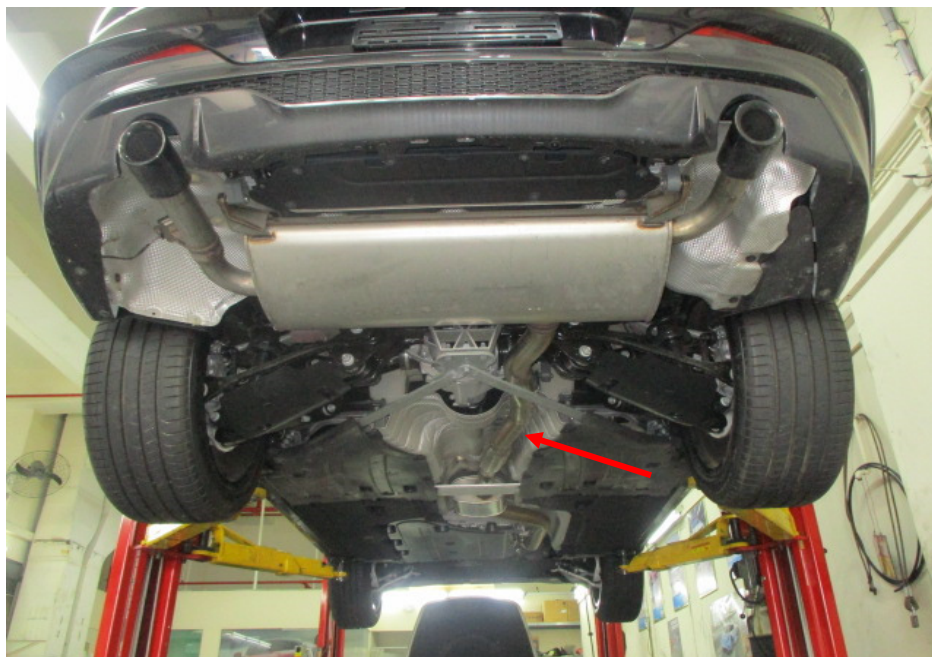
Photo 25 shows the rear section of the Motor Car's exhaust system. My examination of the Motor Car's exhaust system revealed no sign(s) or indication(s) of any cut or weld marks along its exhaust pipes (arrowed), on its rear muffler, on its centre resonator box and on its catalytic converter.

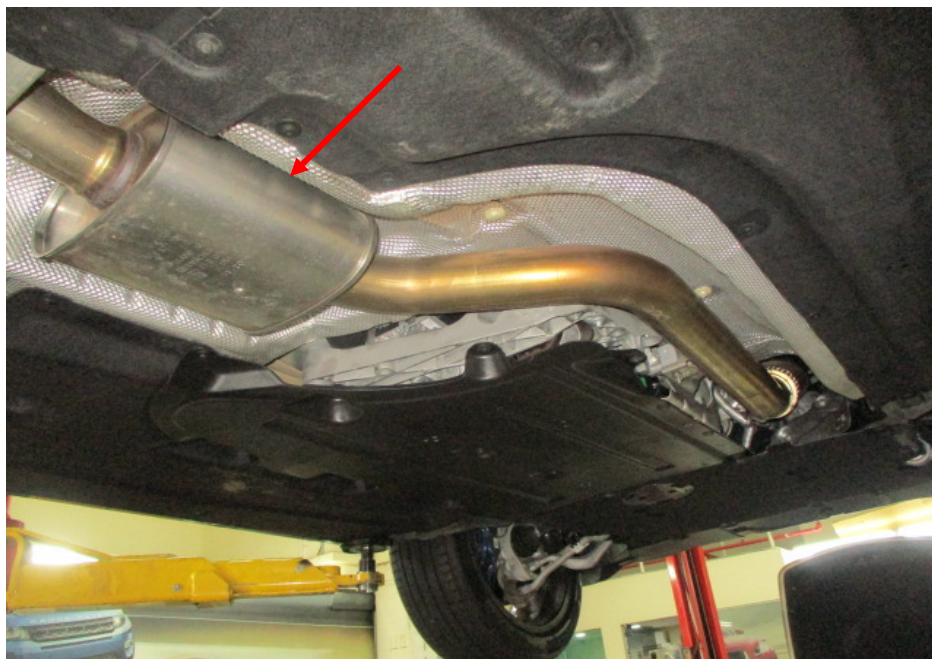
Photo 26 shows the front section of the Motor Car's exhaust system. My examination of the Motor Car's exhaust system revealed no sign(s) or indication(s) of any cut or weld marks along its exhaust pipes, on its rear muffler, on its centre resonator box (arrowed) and on its catalytic converter.

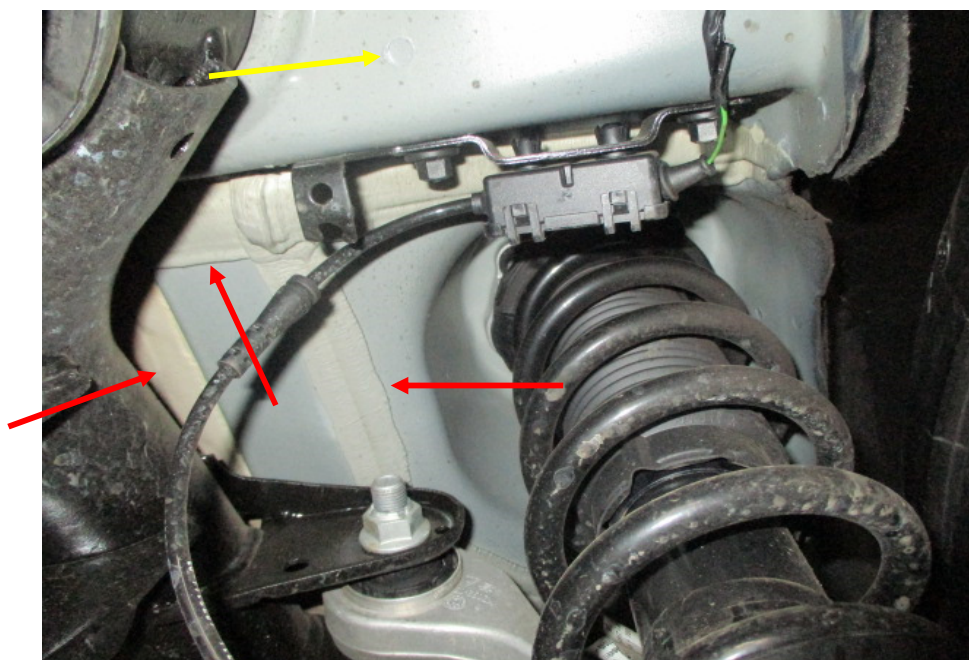
Photo 27 shows the chassis/structural body at the underside rear right of the Motor Car. I did not find any weld marks other than original spot weld marks (yellow arrow) on the chassis/structural body of the Motor Car. The original factory sealant (red arrow) at the joints along the chassis/structural body was untouched, indicating no work was done on the chassis/structural body of the Motor Car and that the chassis/structural body was originally fitted.

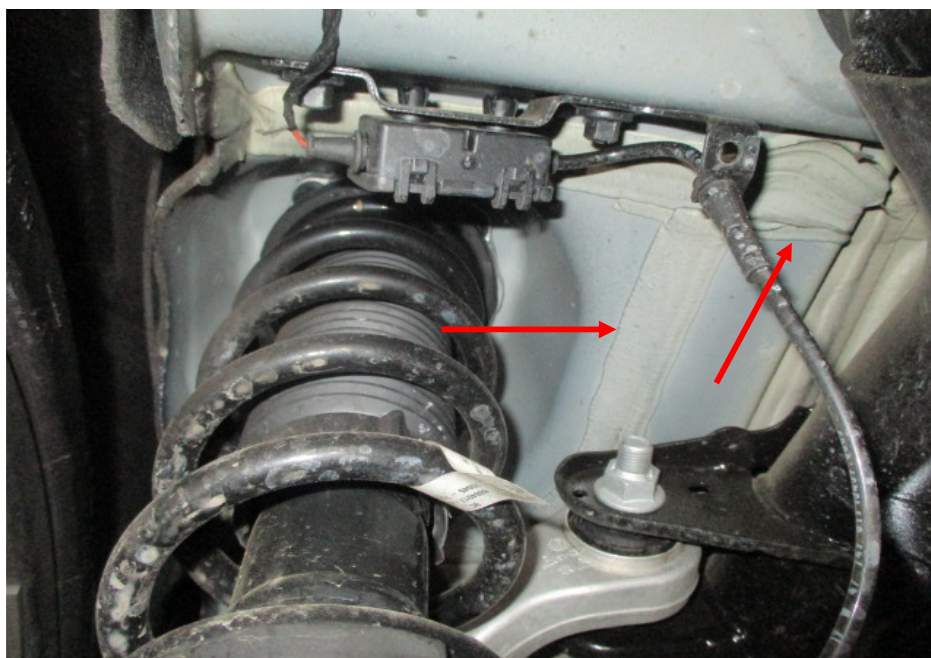
Photo 28 shows the chassis/structural body at the underside rear left of the Motor Car. The original factory sealant (arrowed) at the joints along the chassis/structural body was observed to be untouched. In general, I had found no work was carried out on the chassis/structural body of the Motor Car. The chassis/structural body of the Motor Car was originally fitted.

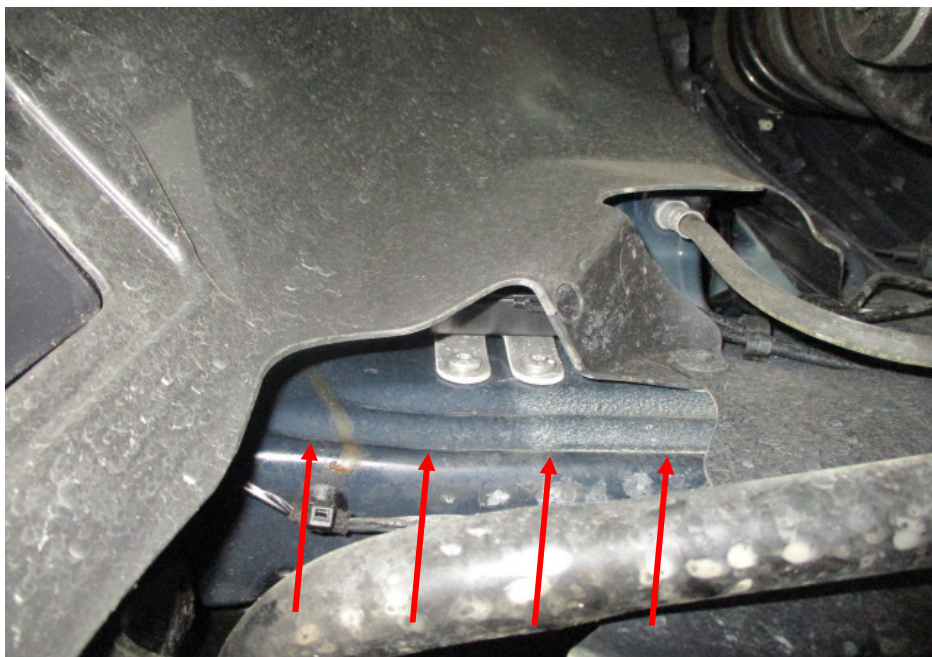
Photo 29 shows the chassis/structural body at the underside front left of the Motor Car. I did not find any weld marks other than original spot weld marks on the chassis/structural body of the Motor Car. The original factory sealant (arrowed) at the joints along the chassis/structural body was untouched, indicating no work was done on the chassis/structural body of the Motor Car and that the chassis/structural body was originally fitted.

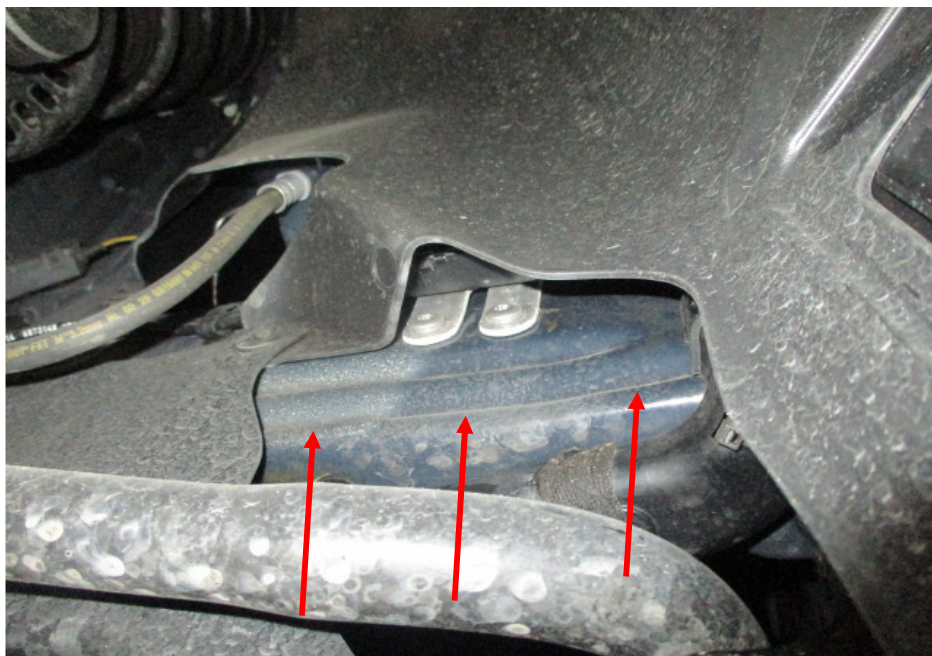
Photo 30 shows the chassis/structural body at the underside front right of the Motor Car. The original factory sealant (arrowed) at the joints along the chassis/structural body was observed to be untouched. In general, I had found no work was carried out on the chassis/structural body of the Motor Car. The chassis/structural body of the Motor Car was originally fitted.

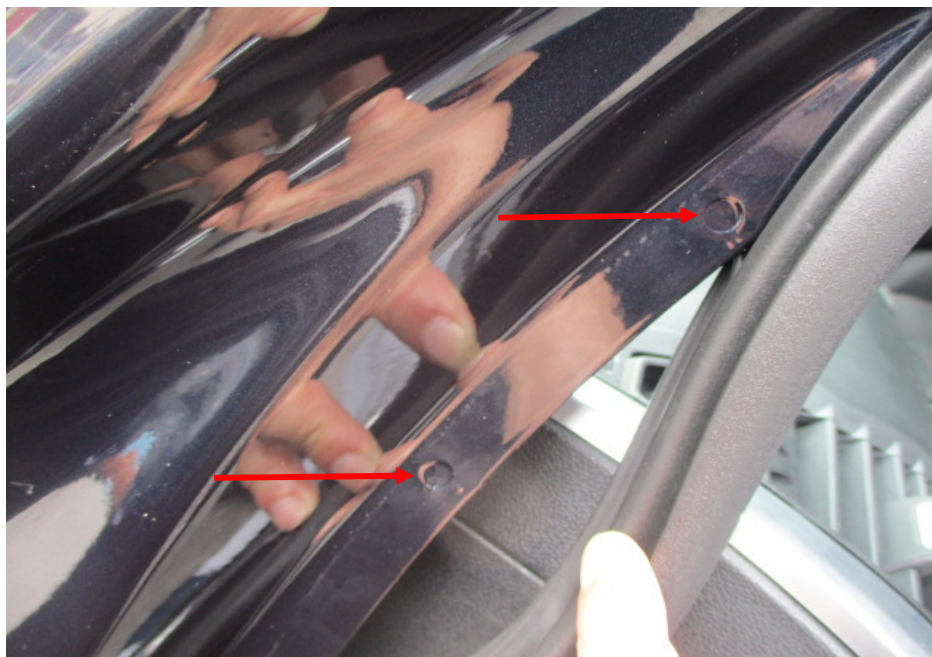
Photo 31 shows the left side "A" pillar of the Motor Car. I did not find any weld marks other than original spot weld marks (arrowed) on the left side "A" pillar of the Motor Car which, indicates that there was no re-welding works carried out. In general, I had found all the non-detachable body panels of the Motor Car to be originally fitted at the time of my inspection.
