Your Ref: BMW X4
(chassis number WBA2V120X09C54047)
Our Ref : CI/TP21008710/D

19 August 2021

INSPECTION REPORT OF AN UNREGISTERED BMW X4 MOTOR CAR WITH CHASSIS NUMBER WBA2V120X09C54047

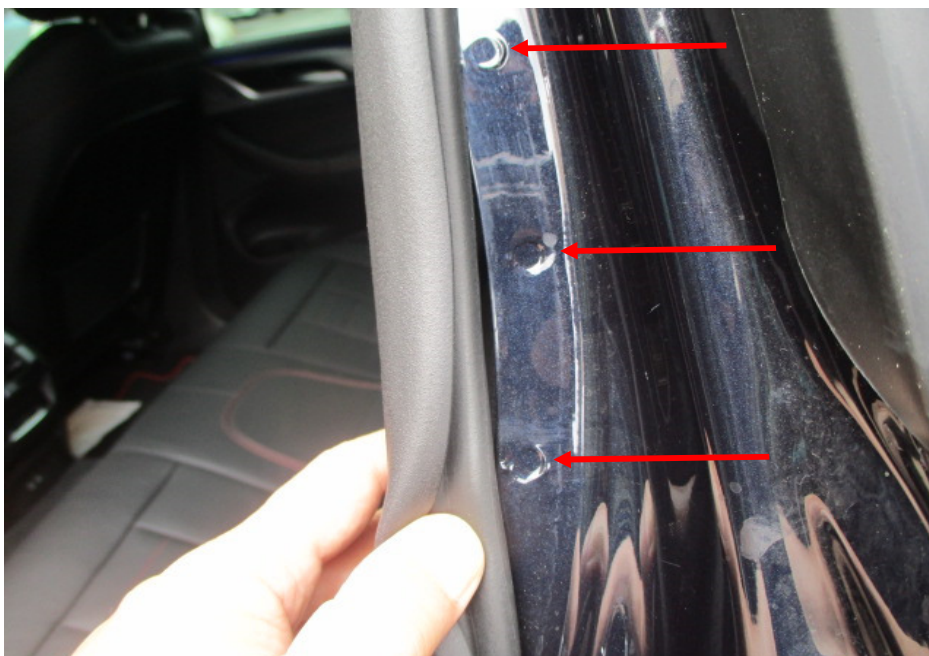
Photo 32 shows the left side "C" pillar of the Motor Car. I did not find any weld marks other than original spot weld marks (arrowed) on the left side "C" pillar of the Motor Car which, indicates that there was no re-welding works carried out. In general, I had found all the non-detachable body panels of the Motor Car to be originally fitted at the time of my inspection.

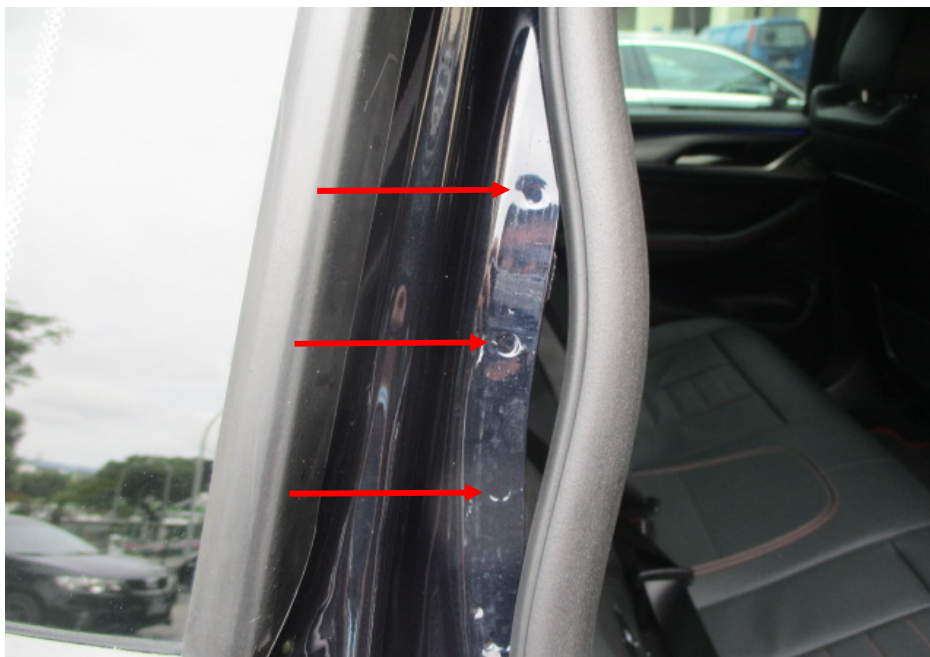
Photo 33 shows the right side "C" pillar of the Motor Car. I did not find any weld marks other than original spot weld marks (arrowed) on the right side "C" pillar of the Motor Car which, indicates that there was no re-welding works carried out. In general, I had found all the non-detachable body panels of the Motor Car to be originally fitted at the time of my inspection.
