## LKK Auto Consultants Pte Ltd

## ADJUSTMENT ON REPAIR COST FOR VEHICLE NO. SHB 6188Y

PHOTOGRAPHS FOR VEHICLE NO. SHB 6188Y

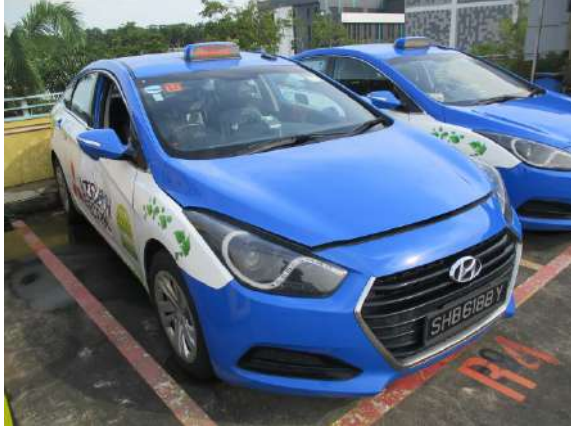
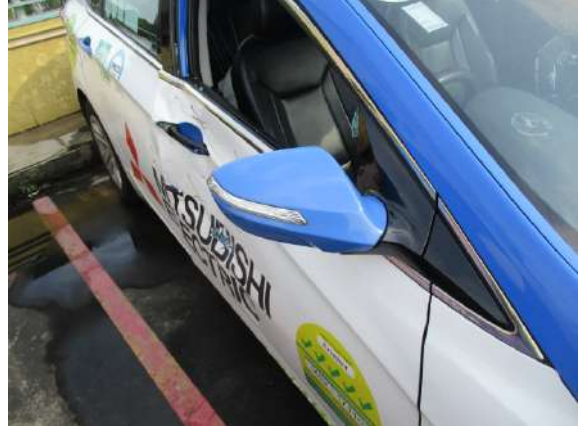
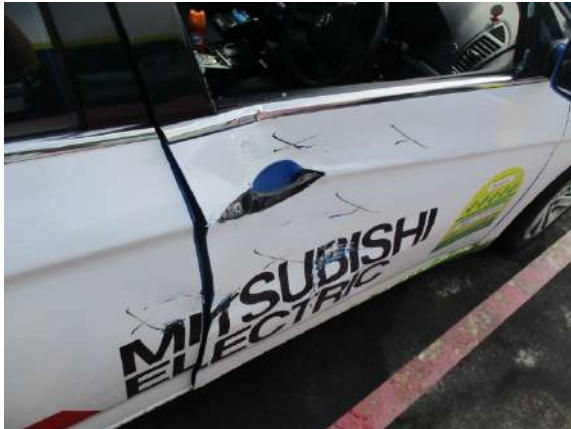
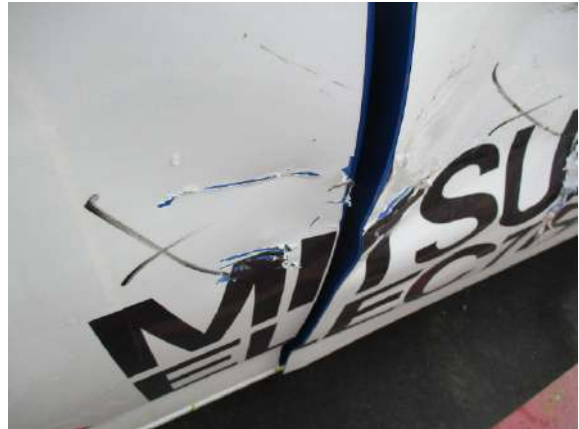
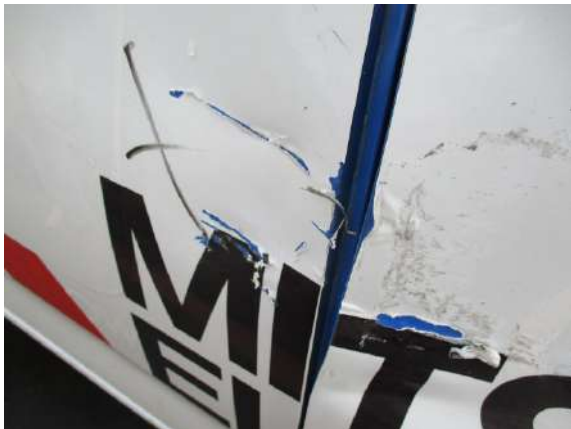
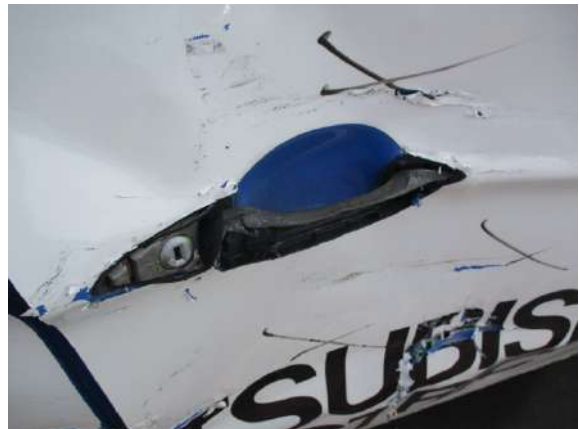
<b>4. Description of Damages</b>				
THE VEHICLE SUSTAINED DAMAGES AT THE O/S BODY. DAMAGES SEE DETAILS.				
<b>5. General Information</b>				
Accident Date	21/08/2021	Inspection Date	23/08/2021	
Survey held at	COMFORTDELGRO ENGINEERING PTE LTD 59 LOYANG DRIVE SINGAPORE 508969			
<b>5a. Remarks</b>				
A)THE INSPECTION WAS CONDUCTED ON A"WITHOUT PREJUDICE" BASIS. B)IN ACCORDANCE TO YOUR INSTRUCTIONS, WE HAVE NOT AUTHORISED REPAIRS.				
<b>5b. Estimate Days of Repair</b>				
ESTIMATED NORMAL PERIOD FOR REPAIR:			4 Working Days

Qty	Description of Parts	Condition	Estimate By Workshop (\$)	Our Adjusted (\$)
	<b><u>REPLACEMENT OF PARTS</u></b>			
1	PANEL ASSY -RR DR RH	BUCKLED	2,201.10	2,201.10
1	PANEL ASSY -FR DR RH	BUCKLED	2,256.40	2,256.40
1	LATCH ASSY -FR DR RH	NOT NECESSARY	490.80	-
1	KEY SUB SET -DOOR RH	DAMAGED	93.25	93.25
1	W/STRIP -FR DR BODY SIDE R	NOT NECESSARY	81.30	-
1	W/STRIP ASSY -FR DR BELT O	NOT NECESSARY	75.40	-
1	MOULDING ASSY -FR DR FRAME	DEFORMED	153.10	153.10
1	HANDLE ASSY -DR O/S	DISTORTED	132.30	132.30
1	COVER -FR DR O/S HDL DRIVE	MISSING	12.60	12.60
1	GLASS -FR DR WINDOW RH	SMASHED	316.30	316.30
1	MIRROR ASSY -RR VIEW O/S R	CRACKED	670.00	670.00
	LESS 20% DISCOUNT		-1,296.51	-1,167.01
			5,186.04	4,668.04
	<b><u>SPECIAL NETT ITEMS</u></b>			
1	FRT DOOR LOGO SONATA CTPL (SN)	NECESSARY	75.00	75.00
1	APP LOGO REAR DOOR L/R CT (SN)	NECESSARY	80.00	80.00
