Your Ref: TP/IP/17949/2021  
Our Ref : CI/TPD21008843/N

2 August 2021

**MECHANICAL INSPECTION REPORT OF MOTORCYCLE FBE 5320T**

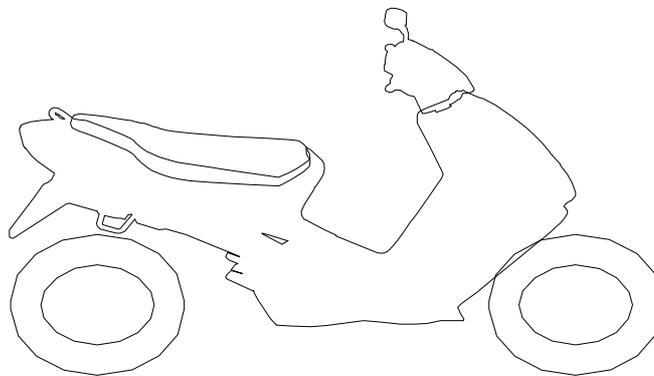
Maxxis 70/90 R17 (3mm)

Maxxis 70/90 R17 (3mm)  
(Deflated)

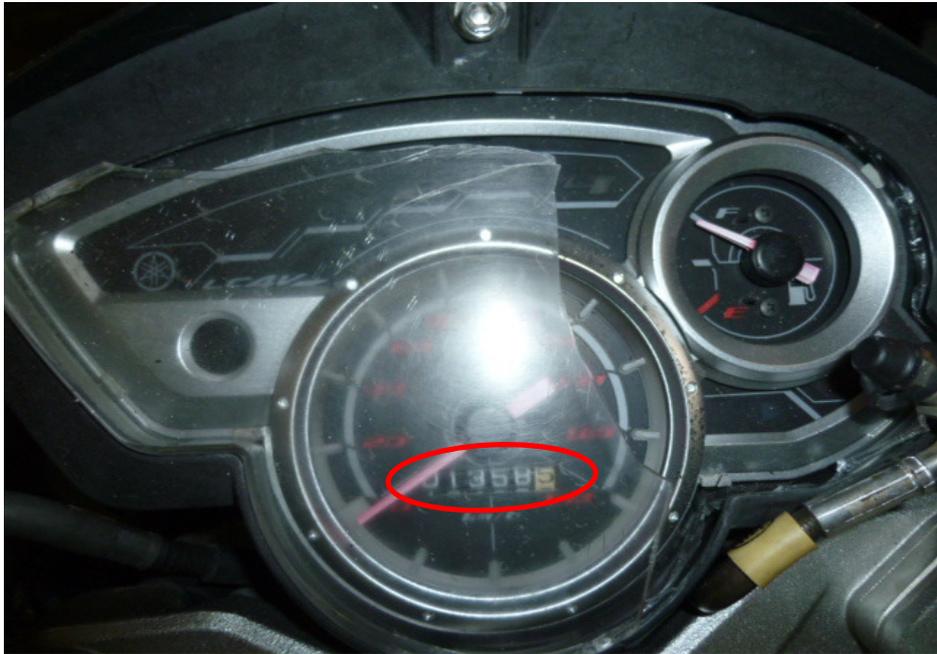
**Photo 1** shows the speedometer gauge of the Motorcycle. The mileage of the Motorcycle at the time of our inspection was 1, 358km (circled).

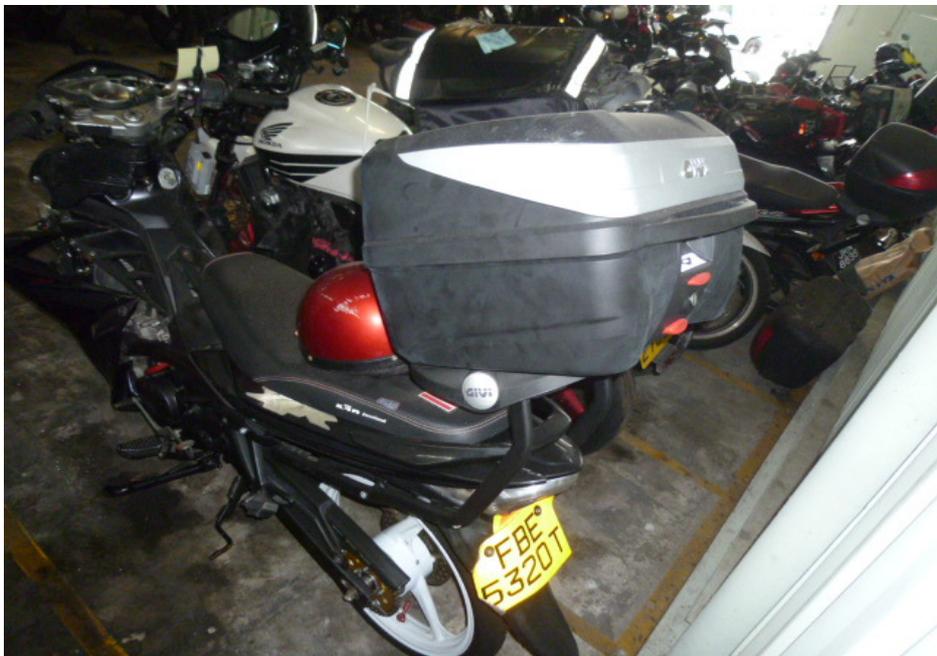
**Photo 2** shows a general view of the rear portion of the Motorcycle at the time of our inspection. The Motorcycle had sustained damages all around.

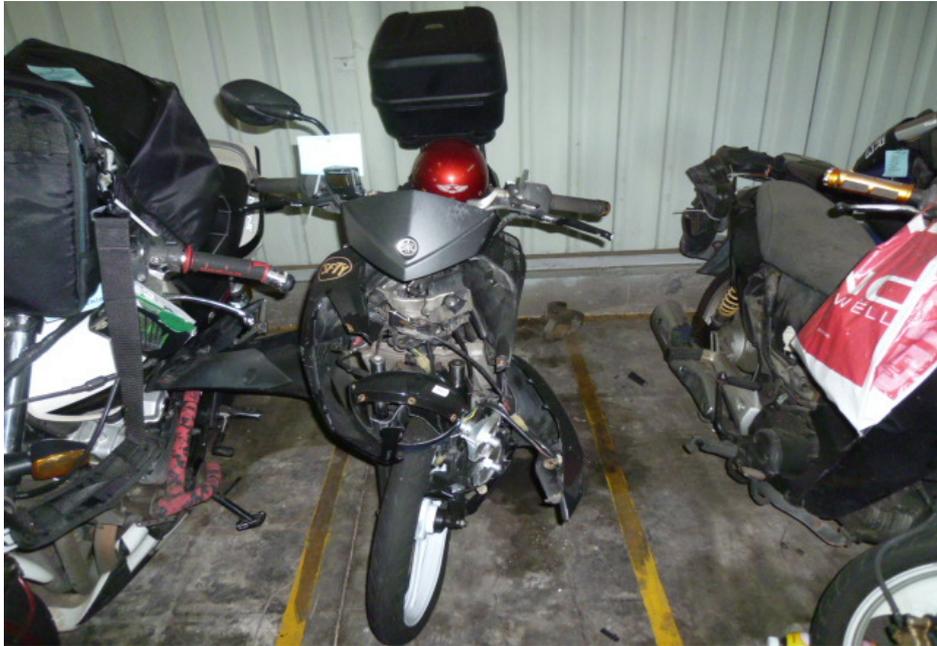
**Photo 3** shows a general view of the frontal portion of the Motorcycle at the time of our inspection. The Motorcycle had sustained damages all around. Body parts that were found to have been damaged include its front fork assembly, headlight assembly, head cowling, side cowlings, front mudguard, left side mirror, left handlebar end, clutch lever, front basket, radiator, top box bracket and rear number plate, amongst others.

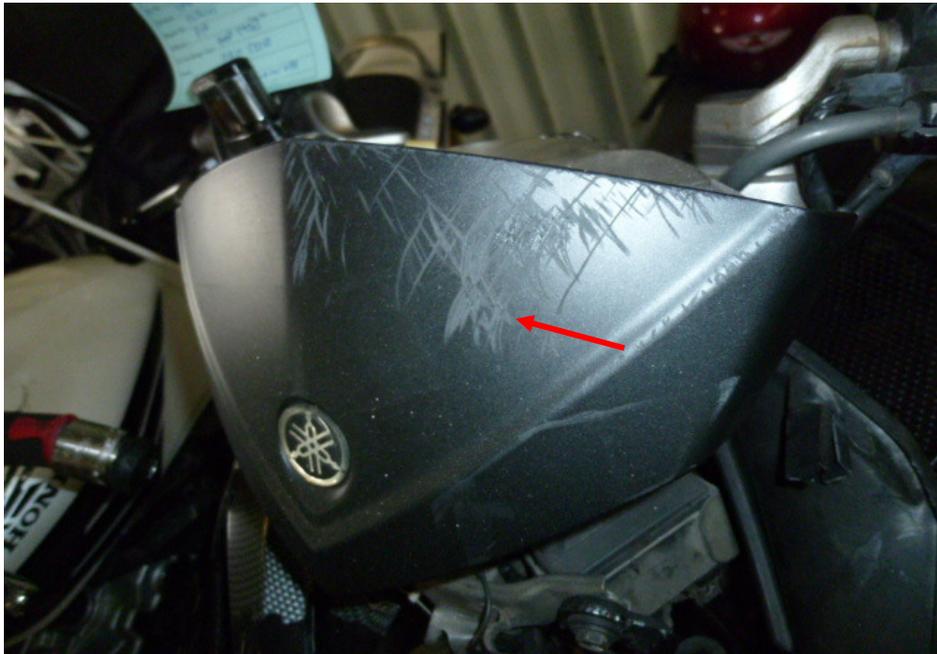
**Photo 4** shows the general view of the head cowling (arrowed) of the Motorcycle which was amongst the body parts of the Motorcycle that had sustained damage as a result of the accident.

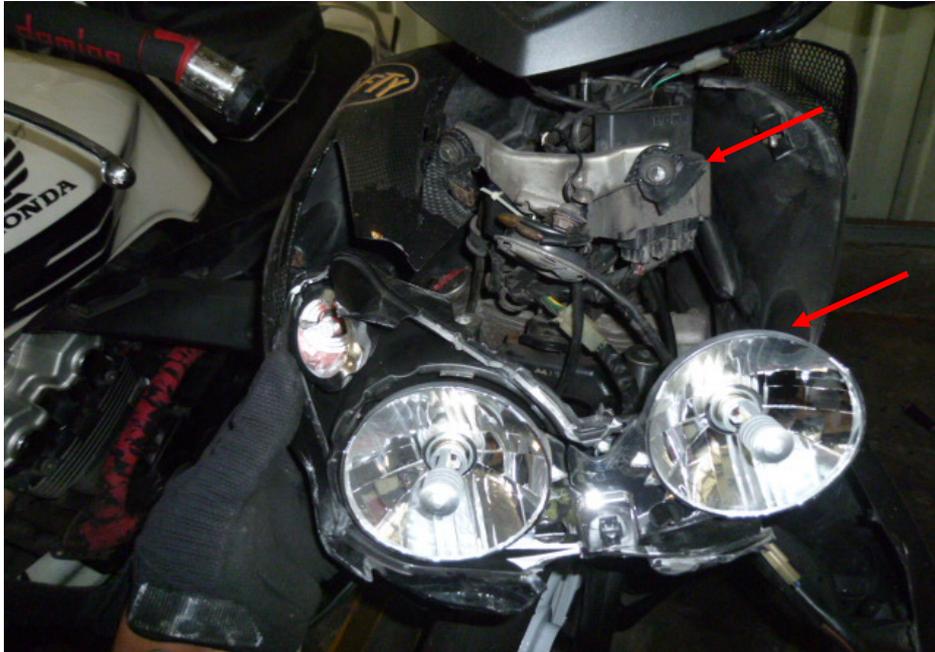
**Photo 5** shows the general view of the front cowling and headlight assembly of which were amongst the body parts of the Motorcycle that had sustained damage as a result of the accident (arrowed).

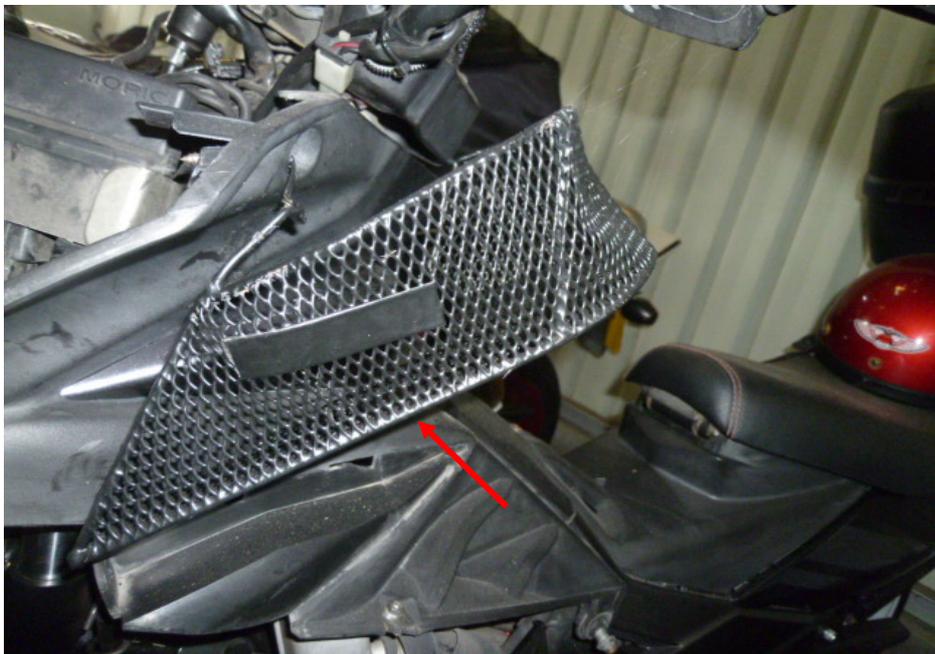
**Photo 6** shows the deformed front basket of the Motorcycle as a result of the accident (arrowed).

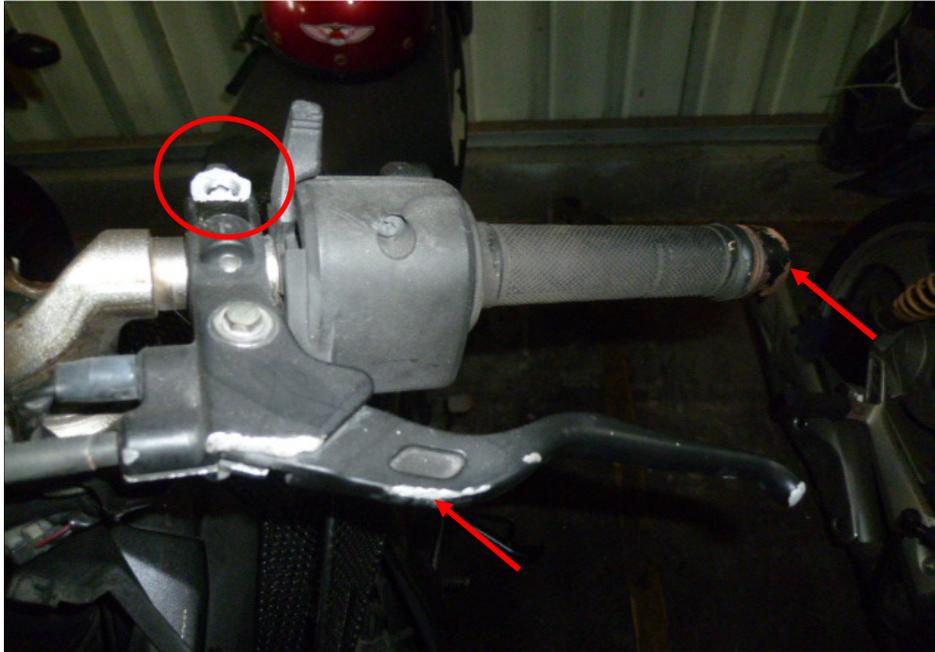
**Photo 7** shows a close up view of the broken left side mirror (circled) as well as the clutch lever and left handlebar end (arrowed) of the Motorcycle. These parts were amongst the body parts of the Motorcycle which were damaged as a result of the accident.

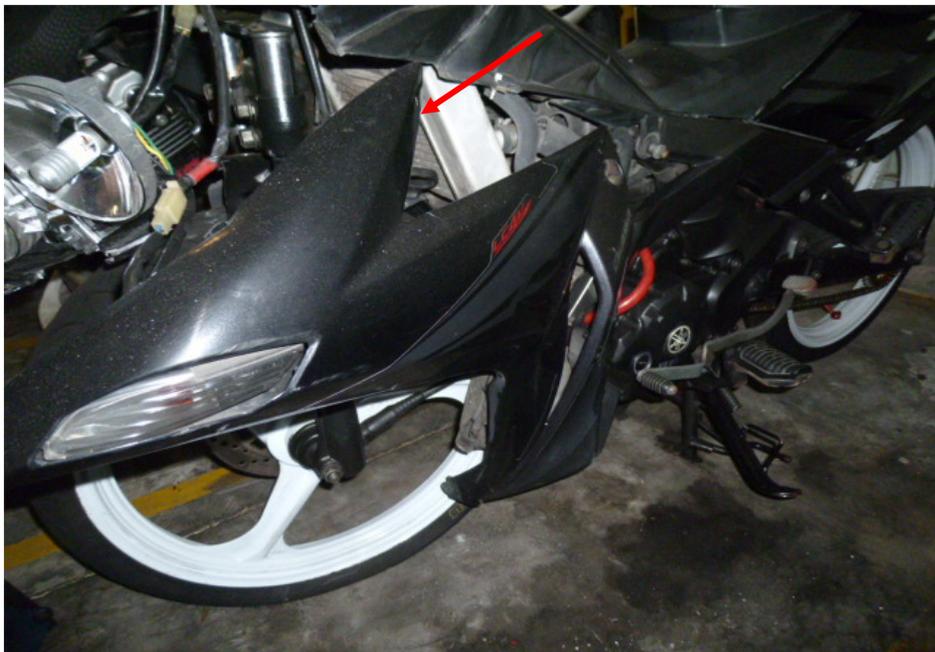
**Photo 8** shows a close up view of the deformed left cowling (arrowed) of the Motorcycle as a result of the accident (arrowed).

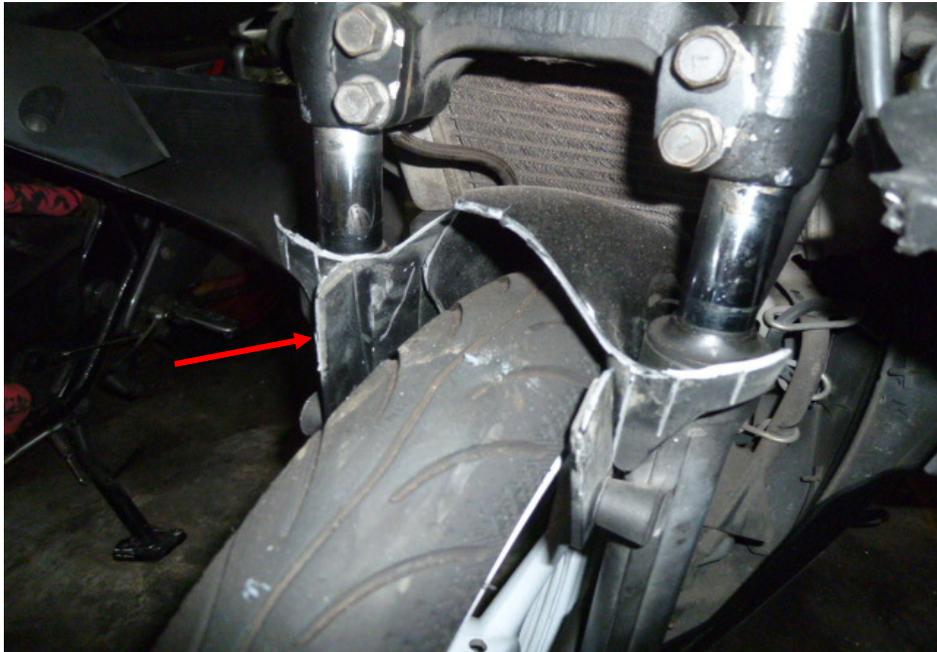
**Photo 9** shows a close up view of the cracked front mudguard of the Motorcycle as a result of the accident (arrowed).

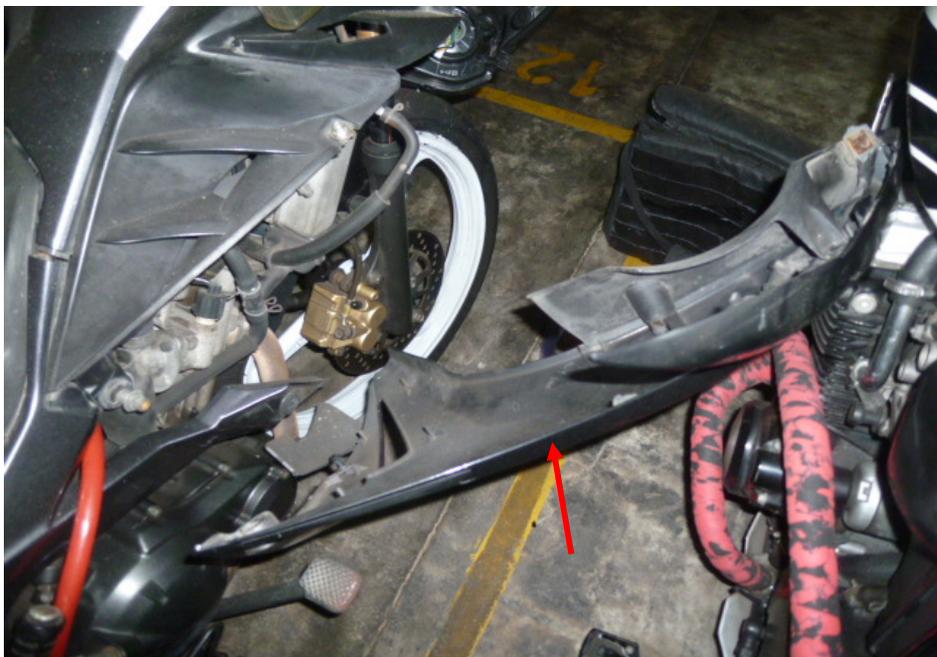
**Photo 10** shows a closer view of the cracked right cowling of the Motorcycle as a result of the accident (arrowed).

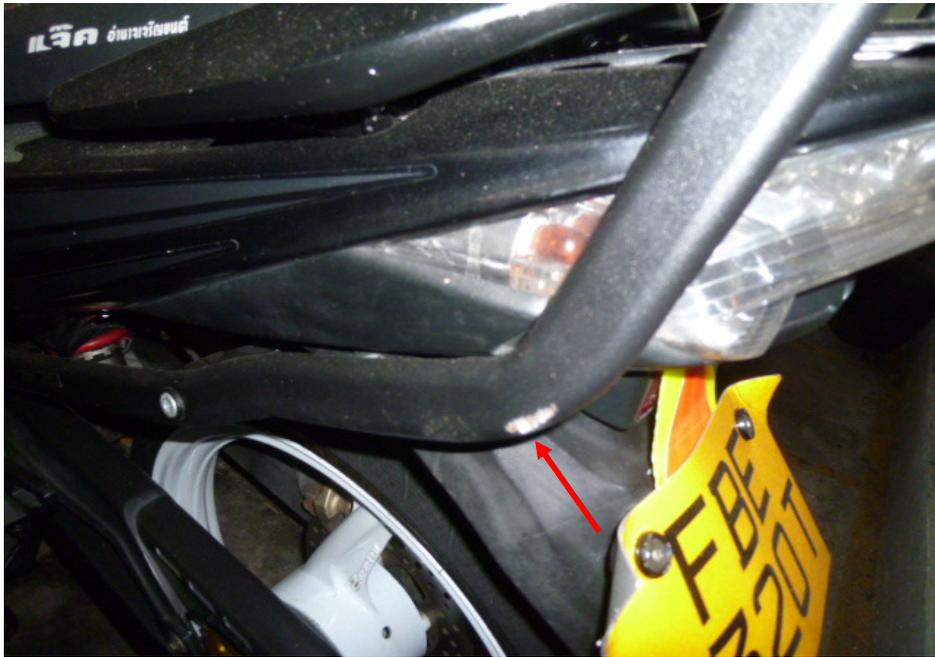
**Photo 11** shows the grazed top box bracket (arrowed) of the Motorcycle as a result of the accident (arrowed).

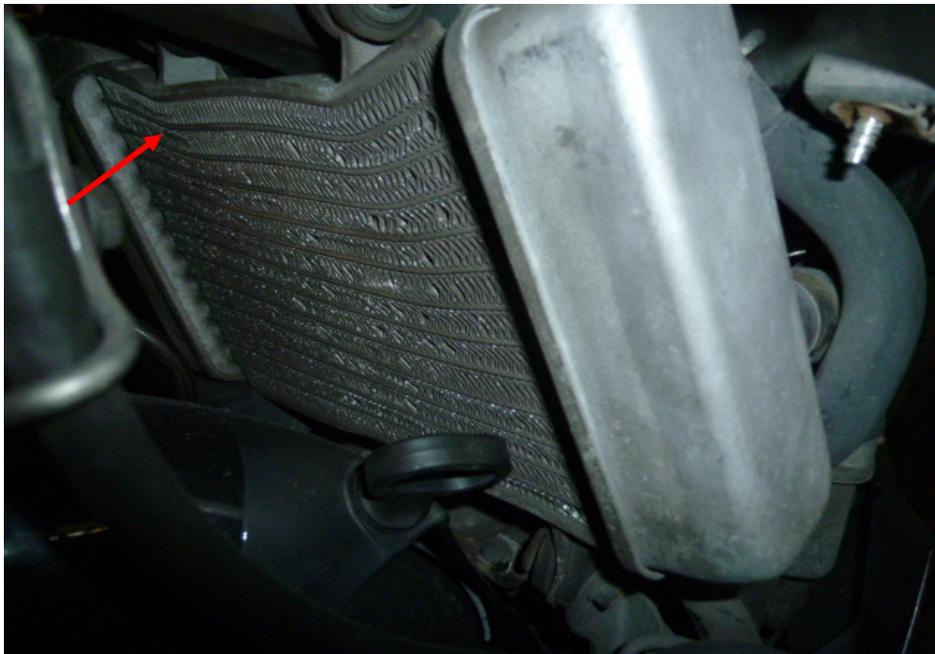
**Photo 12** shows the deformed radiator which was amongst the body parts of the Motorcycle that had sustained damage as a result of the accident (arrowed).

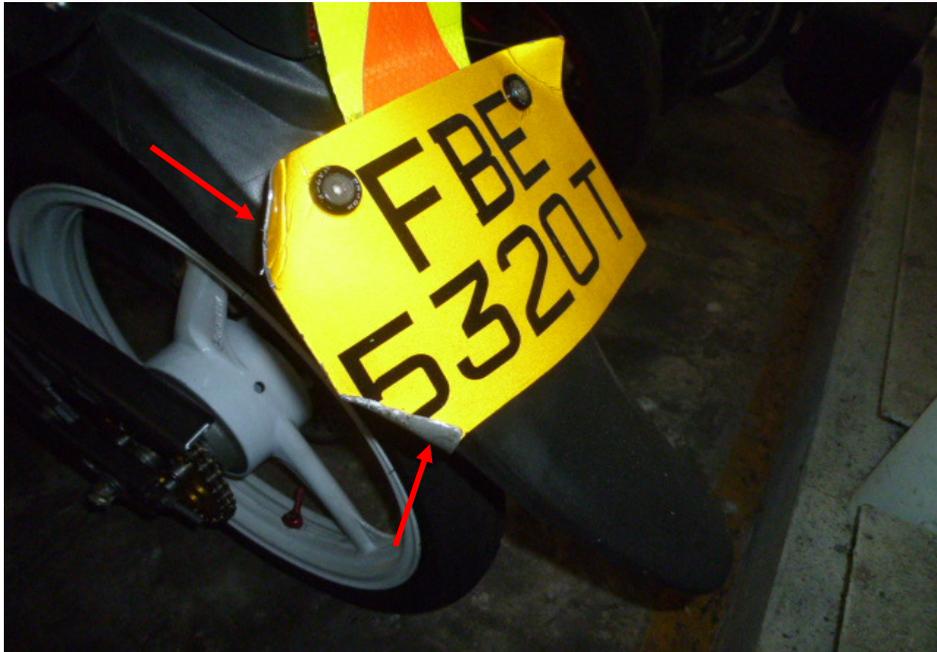
**Photo 13** shows the dented rear number plate (arrowed) of the Motorcycle as a result of the accident.

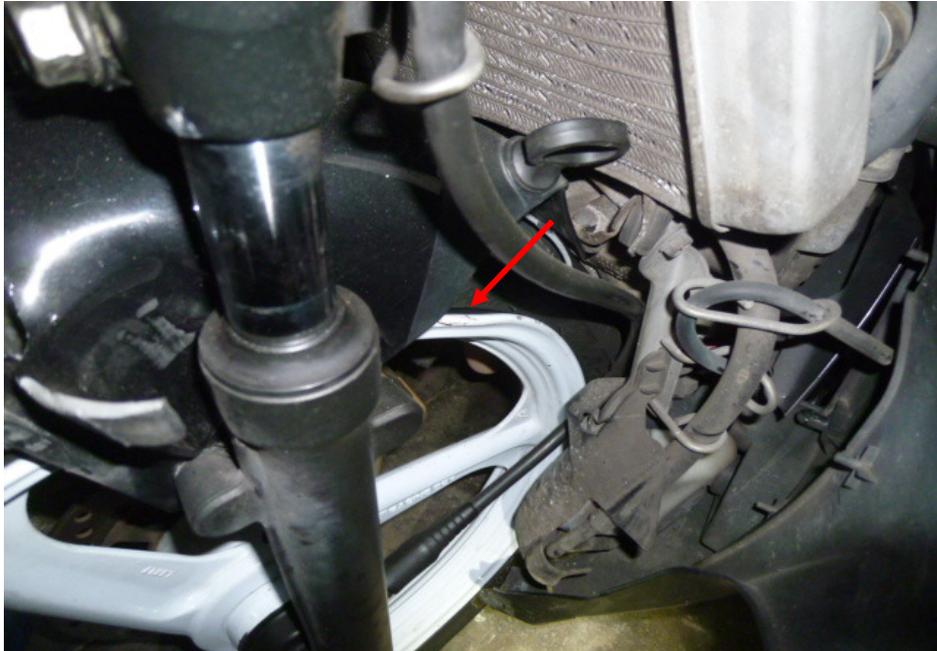
7. The 2 tyres were wrapped around alloy wheel rims. At the time of our inspection, we did not observe any visible damage on the rear wheel rim of the Motorcycle. However we did observe that the front wheel rim was bent as a result of the accident. See photos 1 – 16 below.

**Photo 14** shows a closer view of the bent front wheel rim of the Motorcycle as a result of the accident (arrowed).

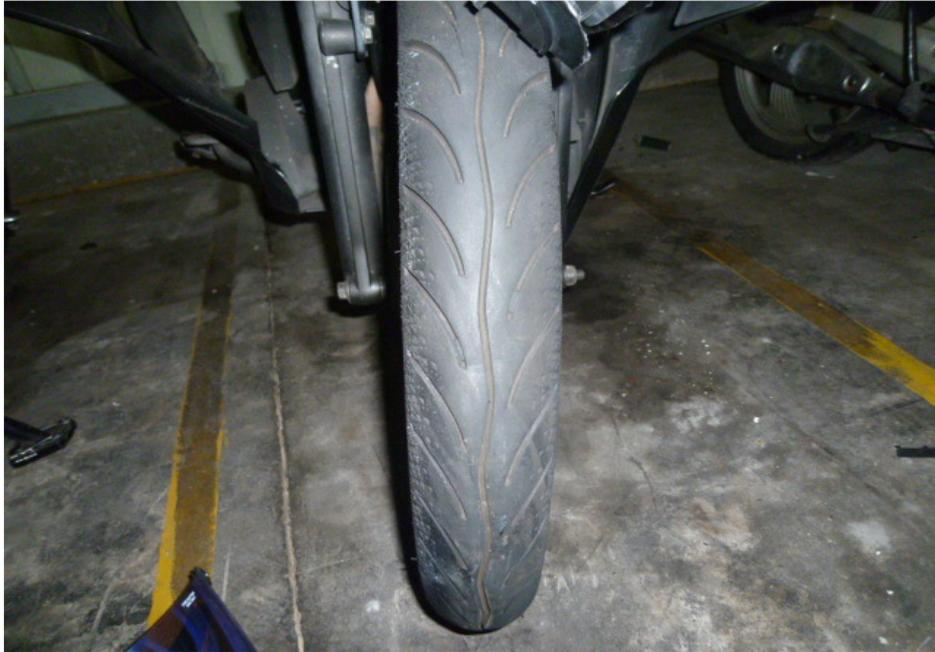
**Photo 15** shows the condition of the Motorcycle's front tyre. The front tyre was observed to be in serviceable condition with remaining tread depth of approximately 3mm. We did not observe any tear, burst mark(s) and/or punctured hole(s) on the sidewalls as well as across the tread of the front tyre. However the front tyre was observed to be deflated as a result of the accident.

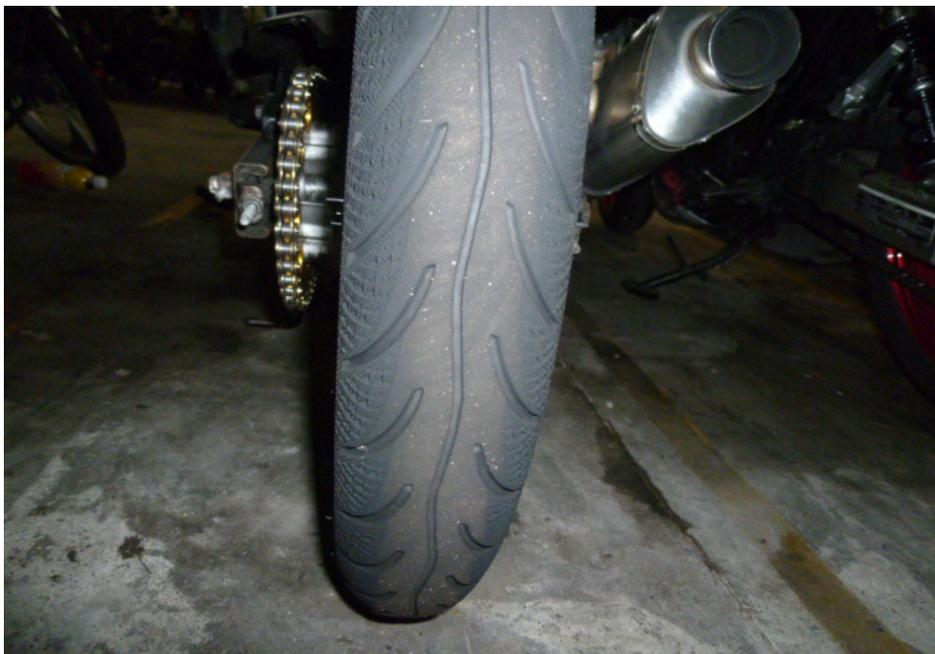
**Photo 16** shows the condition of the Motorcycle's rear tyre. The rear tyre was observed to be in serviceable condition with remaining tread depth of approximately 3mm. The tyre was also observed to be sufficiently inflated for vehicular operation. We did not observe any tear, burst mark(s) and/or punctured hole(s) on the sidewalls as well as across the tread of the rear tyre.

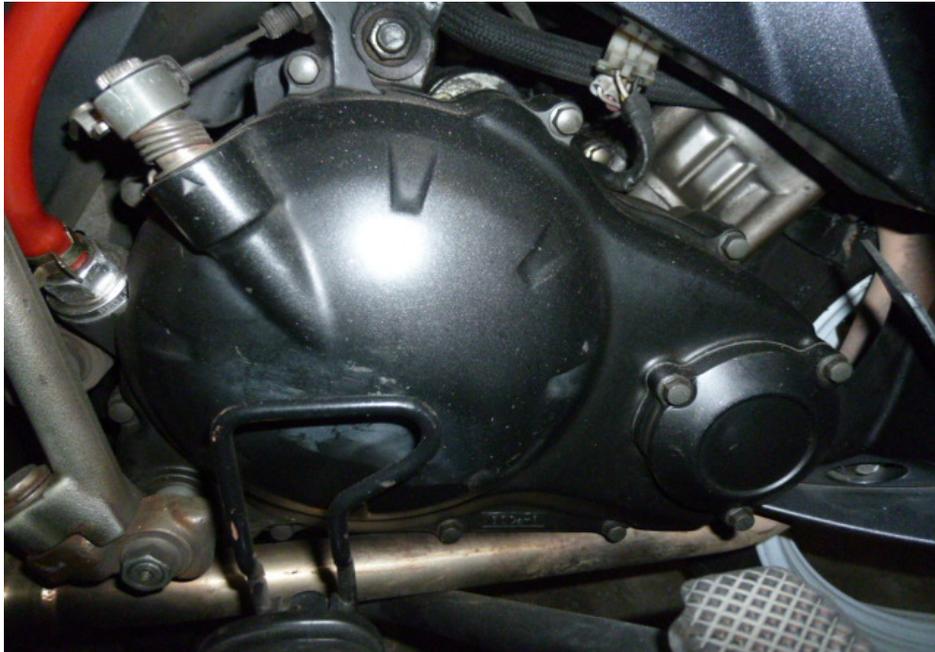
**Photo 17** shows the right side of the engine of the Motorcycle at the time of our inspection. The various engine related parts and components were found to be intact with no visible damage. There was also no sign(s) or indication(s) of fluid leak observed around the right engine area of the Motorcycle.

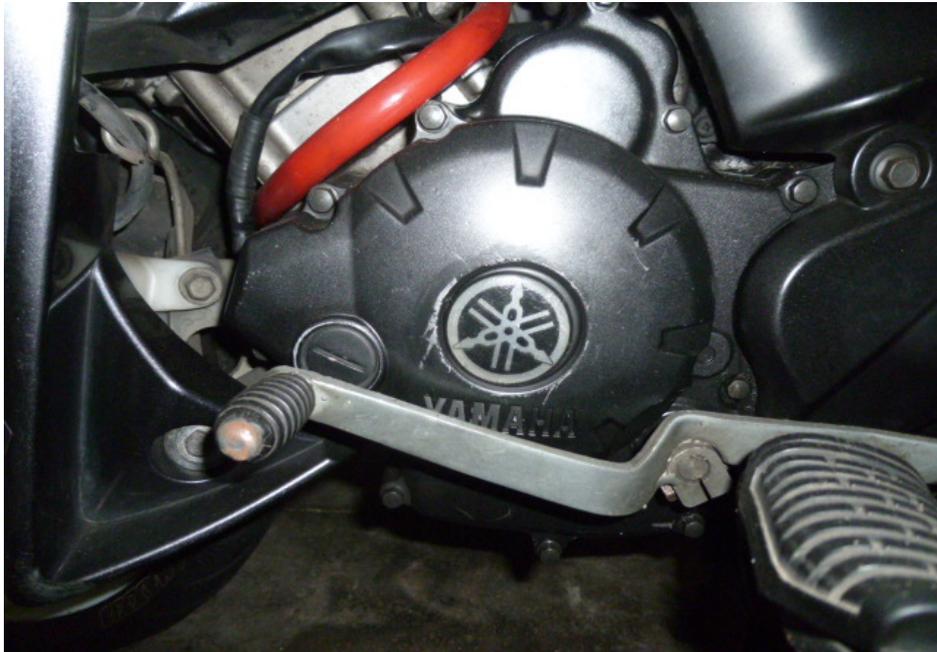
**Photo 18** shows the left side of the engine of the Motorcycle at the time of our inspection. The various engine related parts and components were found to be intact with no visible damage. There was also no sign(s) or indication(s) of fluid leak observed around the left engine area of the Motorcycle.

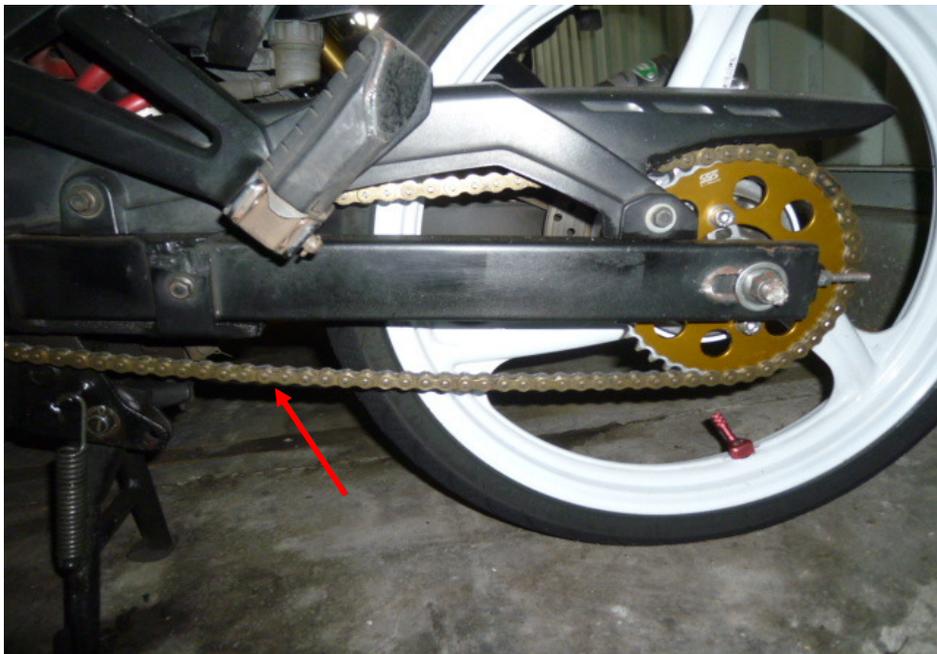
**Photo 19** shows the general view of the gear train (arrowed) of the Motorcycle, which was observed to be intact with no misalignment. It was also adequately lubricated for operating purposes.

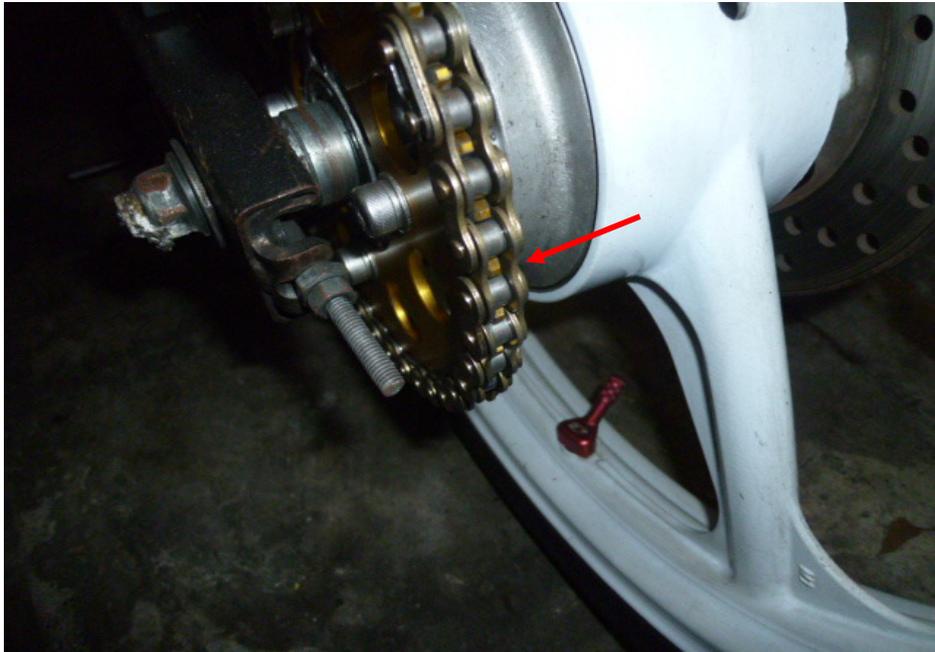
**Photo 20** shows a closer view of the gear train (arrowed) of the Motorcycle, which was observed to be intact with no misalignment. It was also adequately lubricated for operating purposes.

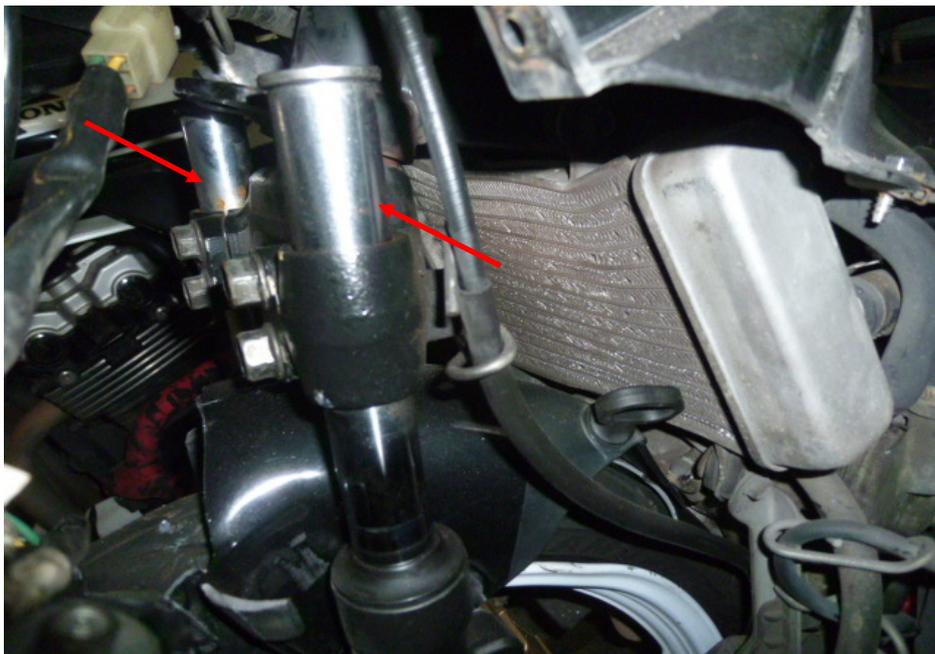
10. For this case, we were not able to conduct any test(s) on the steering system of the Motorcycle due to the damage of its front forks. The front forks were found to be bent inwards as a result of the accident which had rendered the Motorcycle immobile.

**Photo 21** shows the front forks of the Motorcycle. The front forks (arrowed) were observed to be bent inwards as a result of the accident. We were hence not able to conduct any tests on the steering system of the Motorcycle.

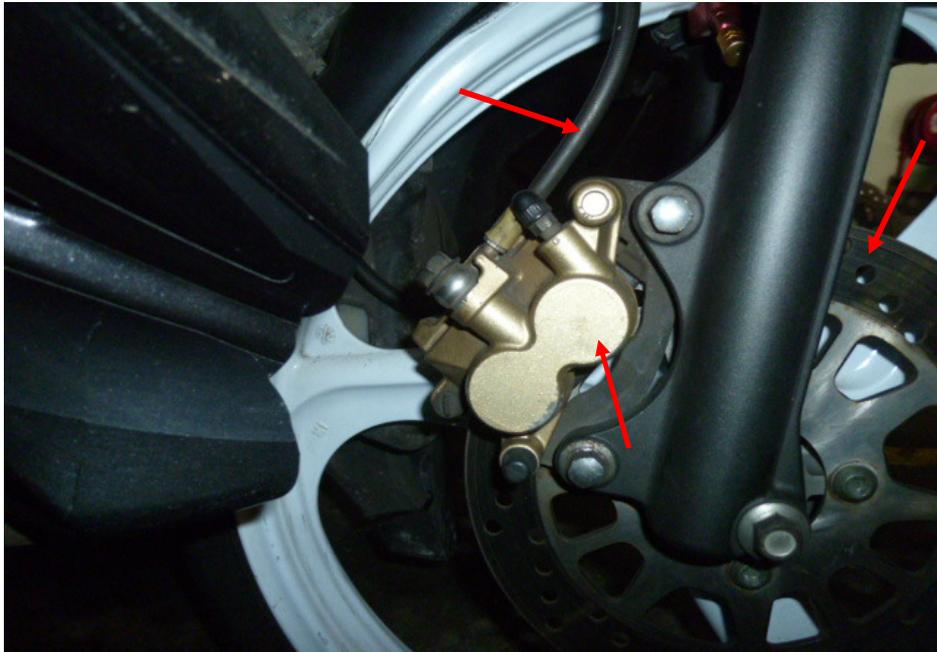
**Photo 22** shows a close up view of the front brake caliper, front brake disc and front brake hose (arrowed) of the Motorcycle, which are all part of the components in the hydraulic front brake system of the Motorcycle. Our visual checks of these various components had revealed all to be intact with no visible damage. No leakage of brake fluid was also observed.

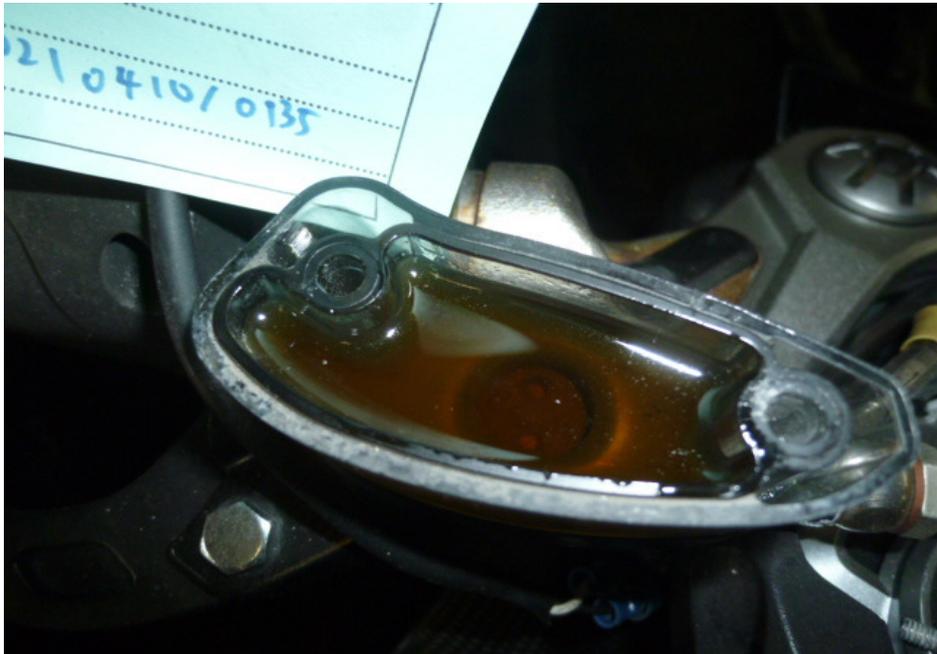
**Photo 23** shows the brake fluid reservoir for the front brake of the Motorcycle. The brake fluid was observed to be of sufficient level for operational purposes and without contamination.

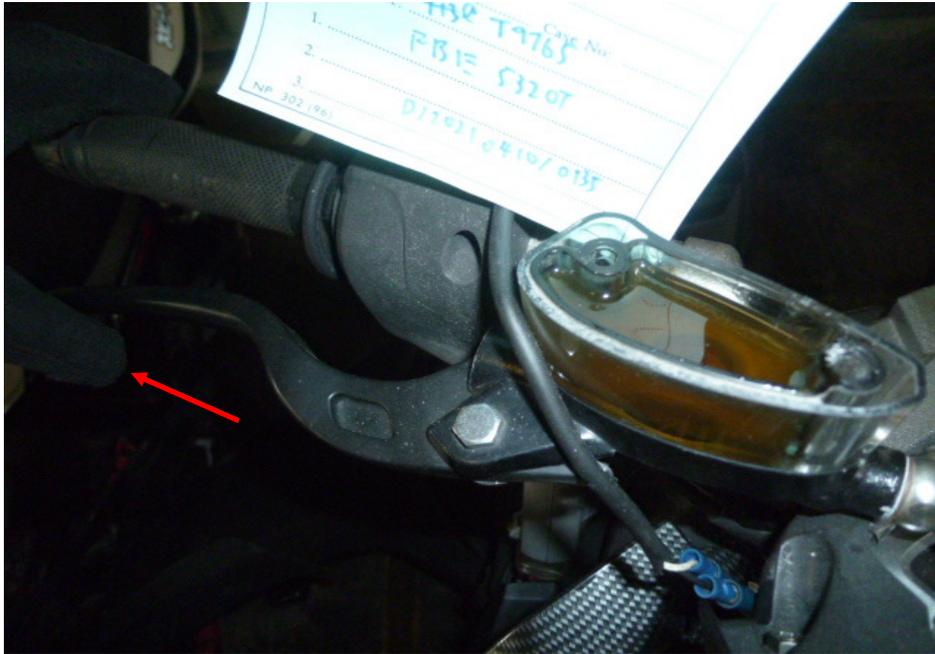
**Photo 24** shows the front brake lever being depressed. There was some resistance felt (spongy like feel) upon pressing the front brake lever (arrowed). This would indicate that there is no leakage of pressure/vacuum in the brake system.

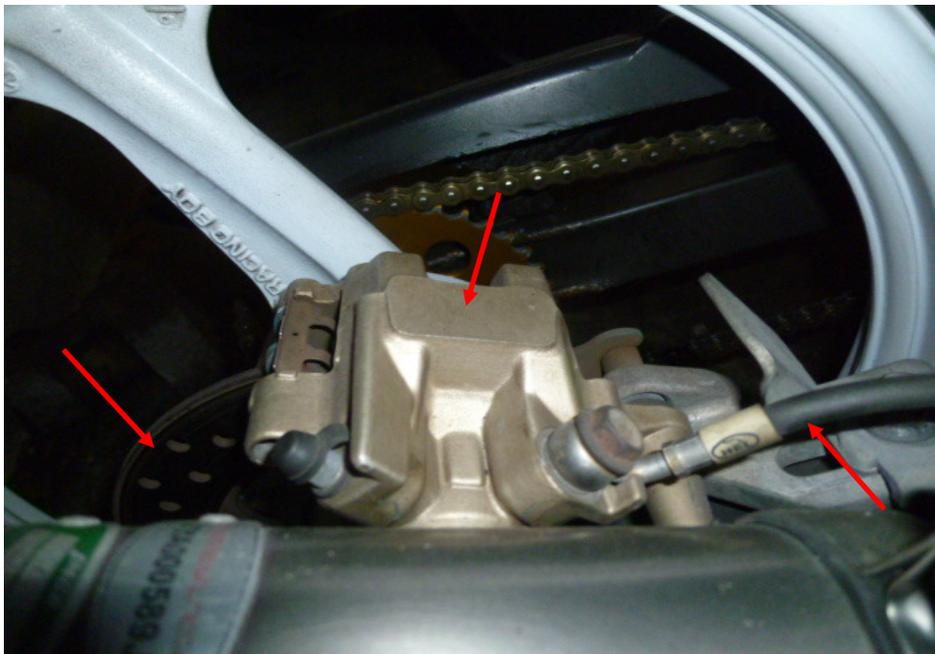
**Photo 25** shows a close up view of the rear brake caliper, rear brake disc and rear brake hose (arrowed) of the Motorcycle, which are all part of the components in the hydraulic rear brake system of the Motorcycle. Our visual checks of these various components had revealed all to be intact with no visible damage. No leakage of brake fluid was also observed.
