Your Ref: TP/IP/24033/2021
Our Ref : CI/TPD21008846/N

Fatal Accident Investigation Team

MECHANICAL INSPECTION REPORT OF MOTORCYCLE FBE 9254A

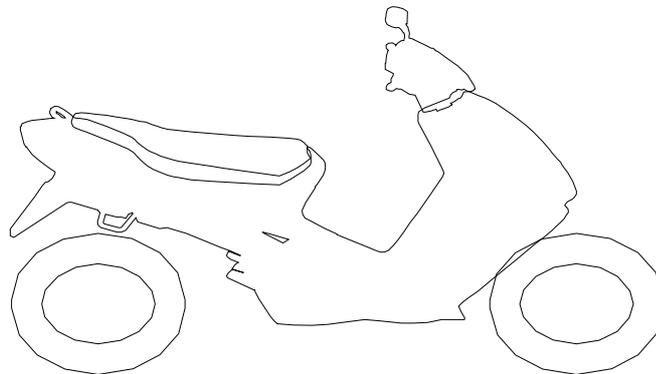
Maxxis 80/90 - 17 (4mm)

Maxxis 70/90 - 17 (3mm)
(Deflated)

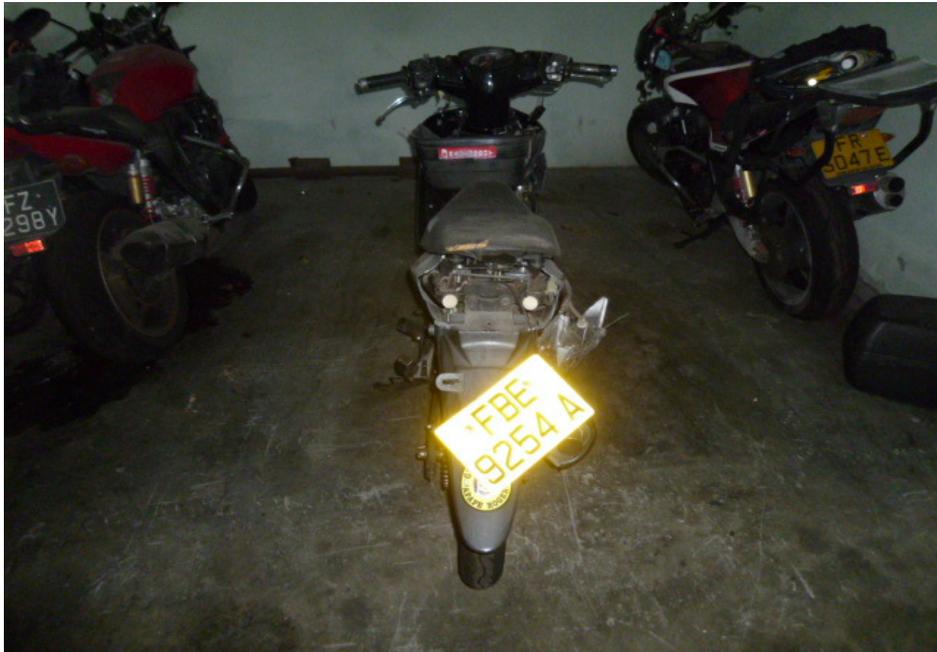
Photo 1 shows a general view of the rear portion of the Motorcycle at the time of our inspection. The Motorcycle was observed to have sustained damages all around. The mileage of the Motorcycle could not be recorded as the ignition key was not available at the time of our inspection.

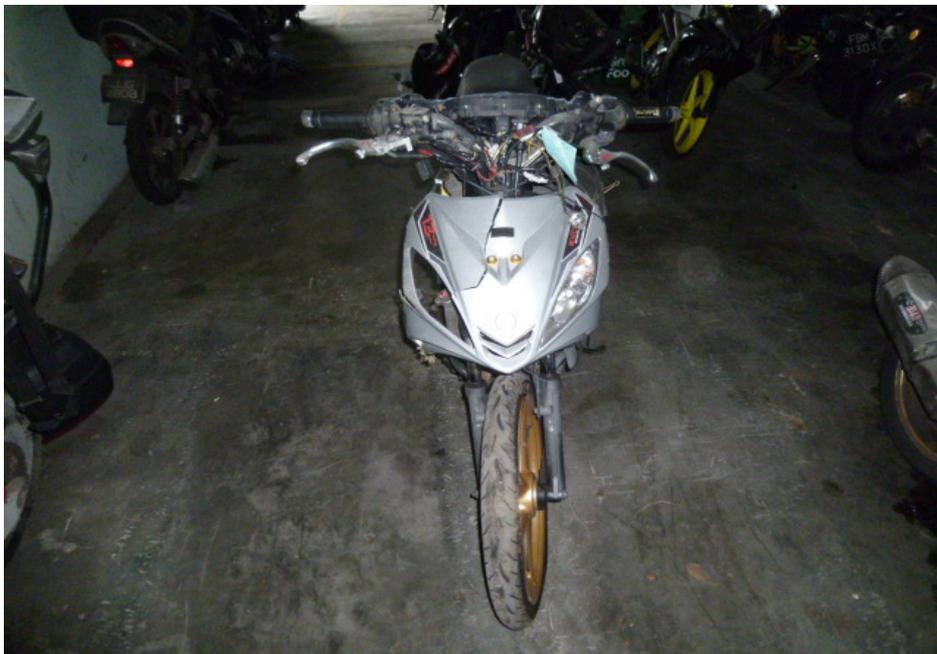
Photo 2 shows a general view of the frontal portion of the Motorcycle at the time of our inspection. The Motorcycle had sustained damages all around.

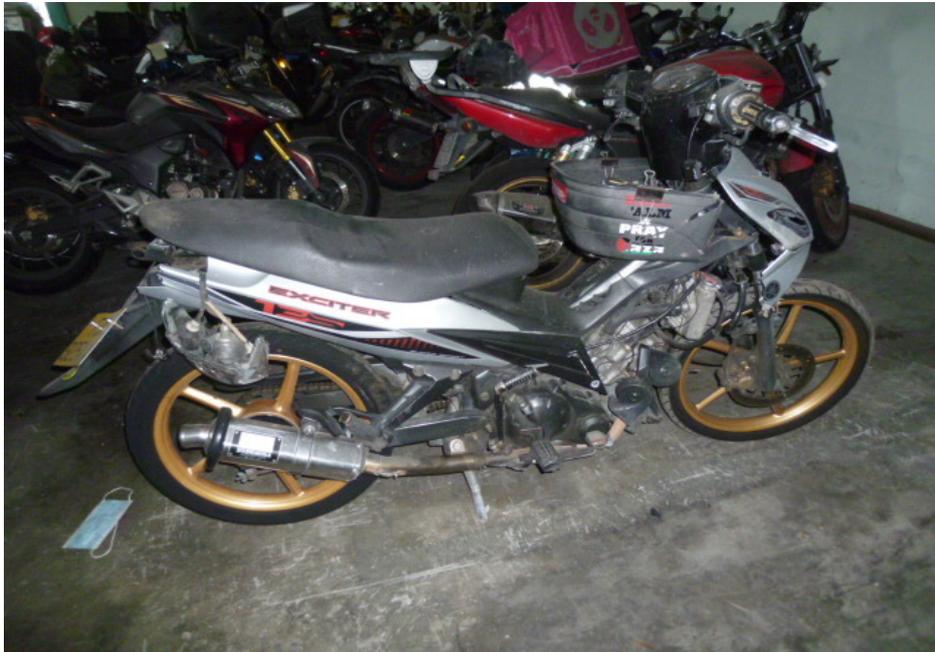
Photo 3 shows a general view of the right body of the Motorcycle at the time of our inspection. The Motorcycle had sustained damages all around. Body parts that were found to have been damaged include its headlight assembly, front mudguard, front cowling, front fork assembly, right cowling, side mirrors, front brake lever, clutch lever, handlebar ends, gear shift pedal, left front footrest and tail light assembly, amongst others.

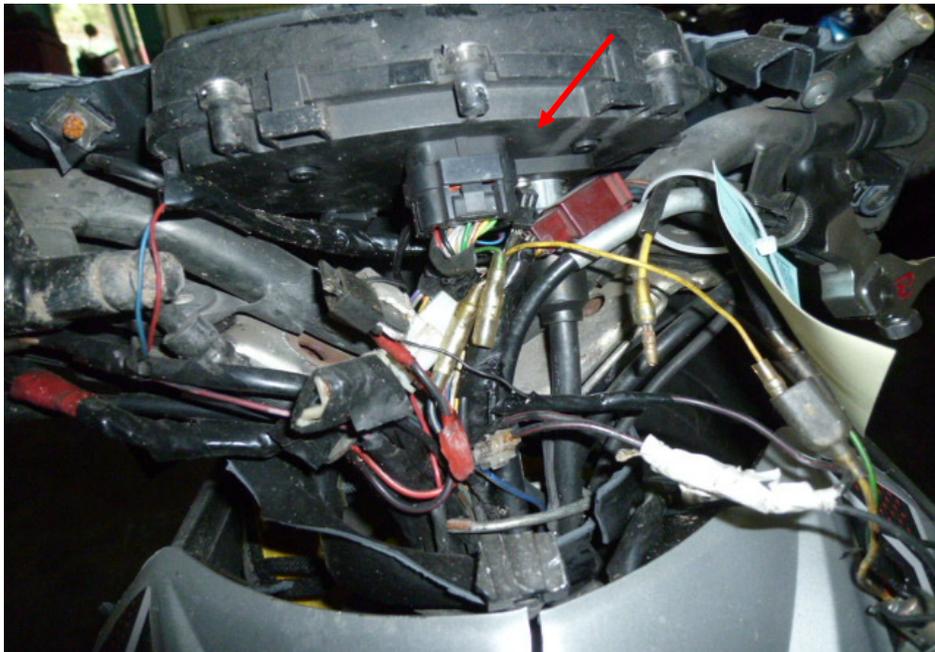
Photo 4 shows a closer view of the missing headlight which was amongst the body parts at the front body of the Motorcycle that had sustained damages as a result of the accident (arrowed).

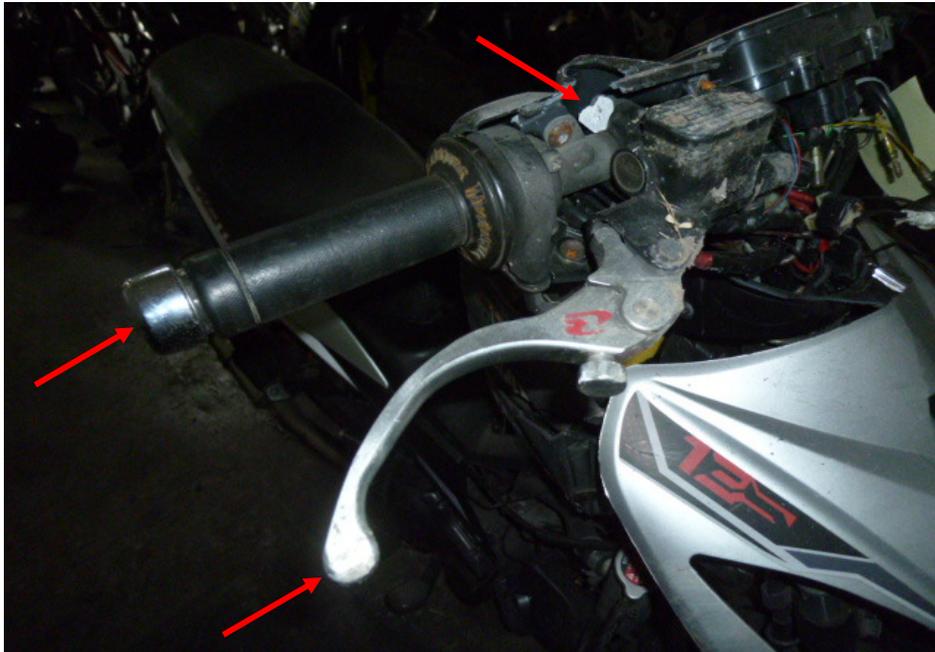
Photo 5 shows a closer view of the front brake lever, right side mirror and right handlebar end (arrowed) of the Motorcycle. These parts were amongst the body parts of the Motorcycle which were damaged as a result of the accident.

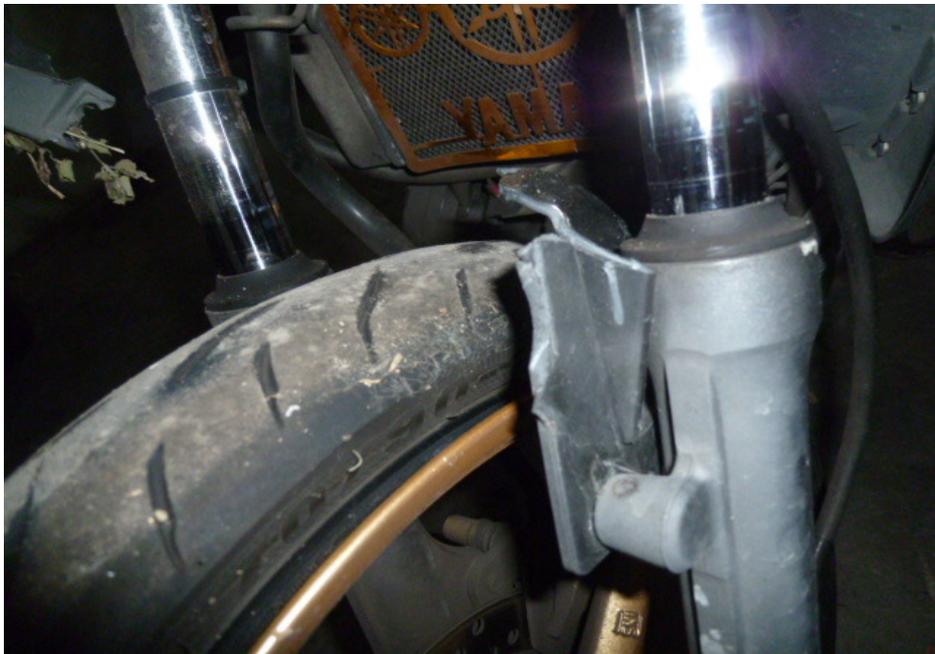
Photo 6 shows a closer view of the front mudguard, which was amongst the body parts of the Motorcycle that had sustained damage as a result of the accident.

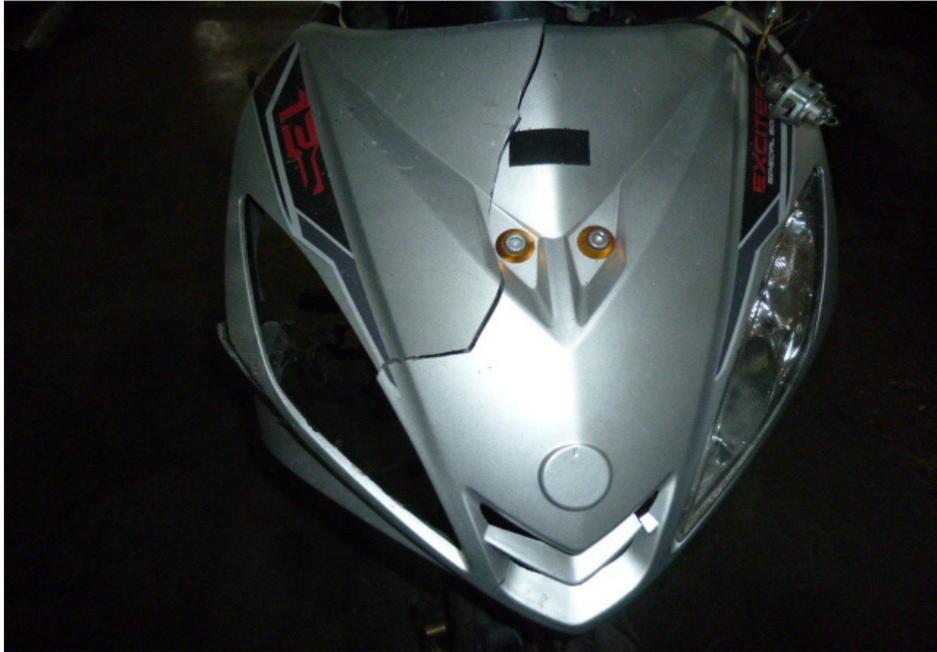
Photo 7 shows a closer view of the front cowling which was amongst the body parts at the front body of the Motorcycle that had sustained damages as a result of the accident.

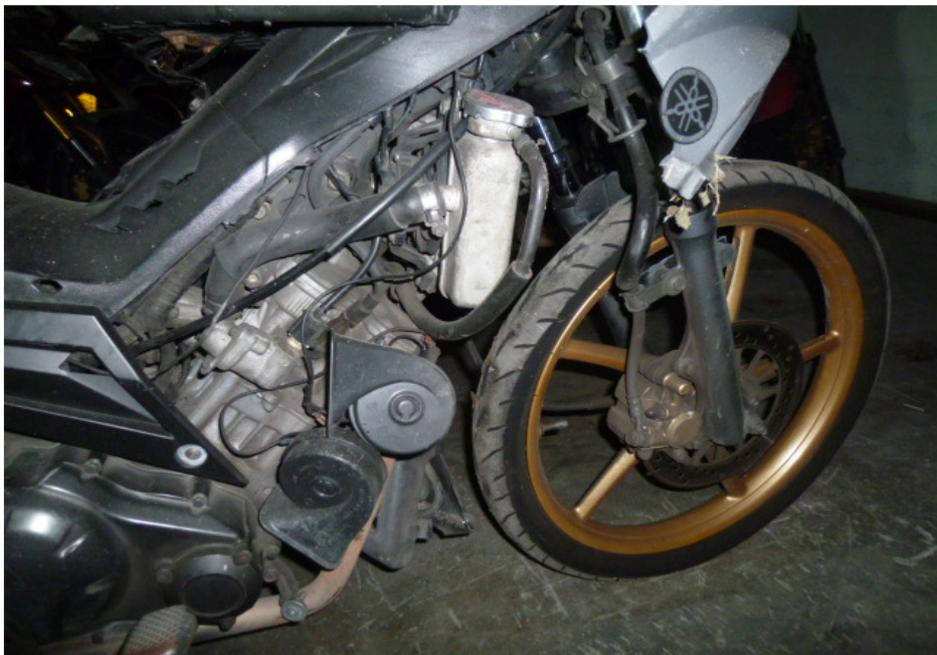
Photo 8 shows a closer view of the right cowling which was amongst the body parts at the front body of the Motorcycle that had sustained damages as a result of the accident.

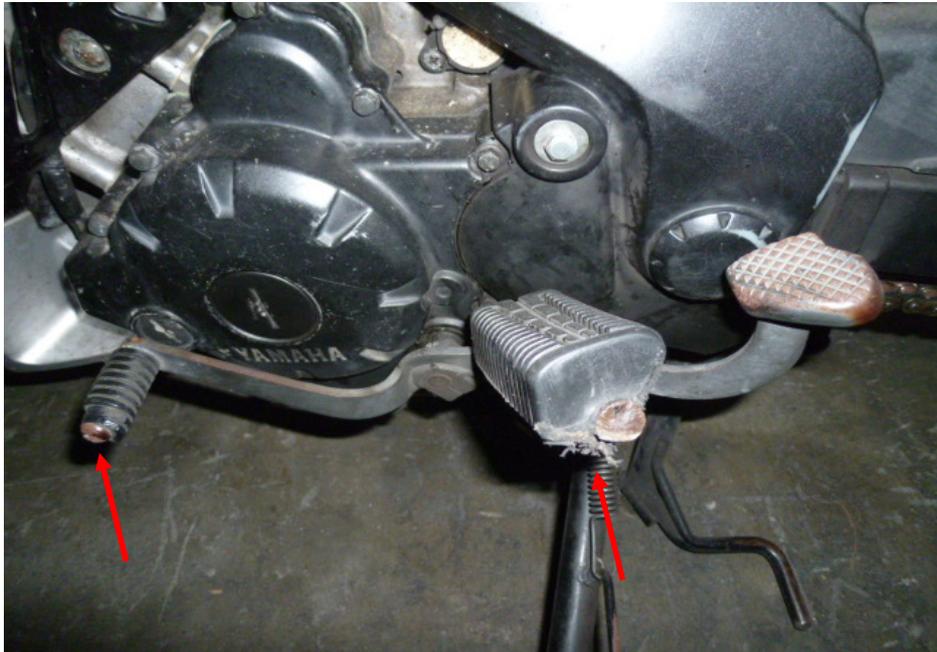
Photo 9 shows a closer view of the gear shift pedal and left front footrest (arrowed) which were amongst the body parts at the front body of the Motorcycle that had sustained damages as a result of the accident.

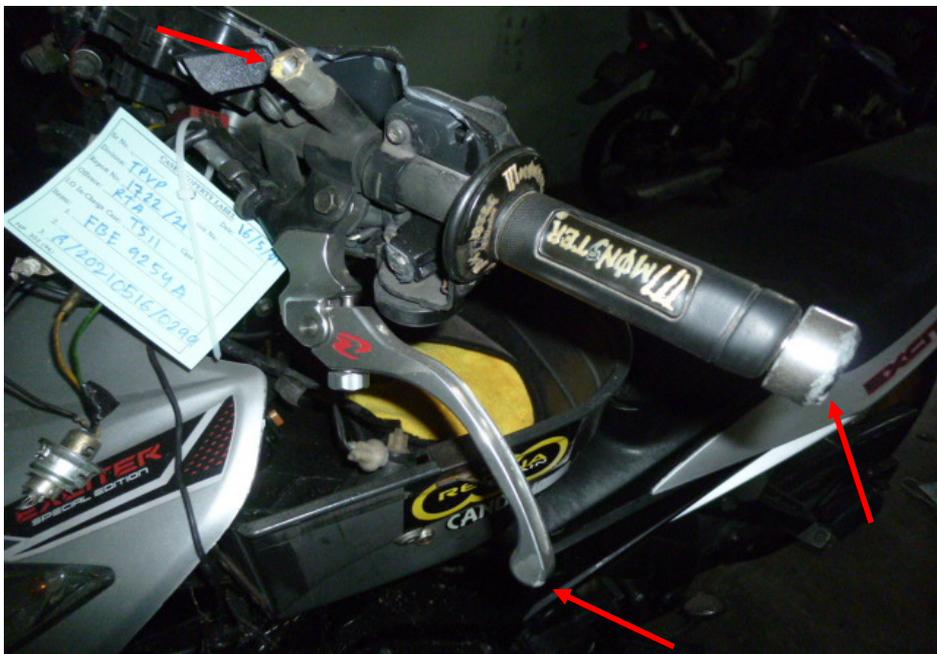
Photo 10 shows a closer view of the missing left side mirror, clutch lever and left handlebar end (arrowed), which were amongst the body parts of the Motorcycle that had sustained damage as a result of the accident.

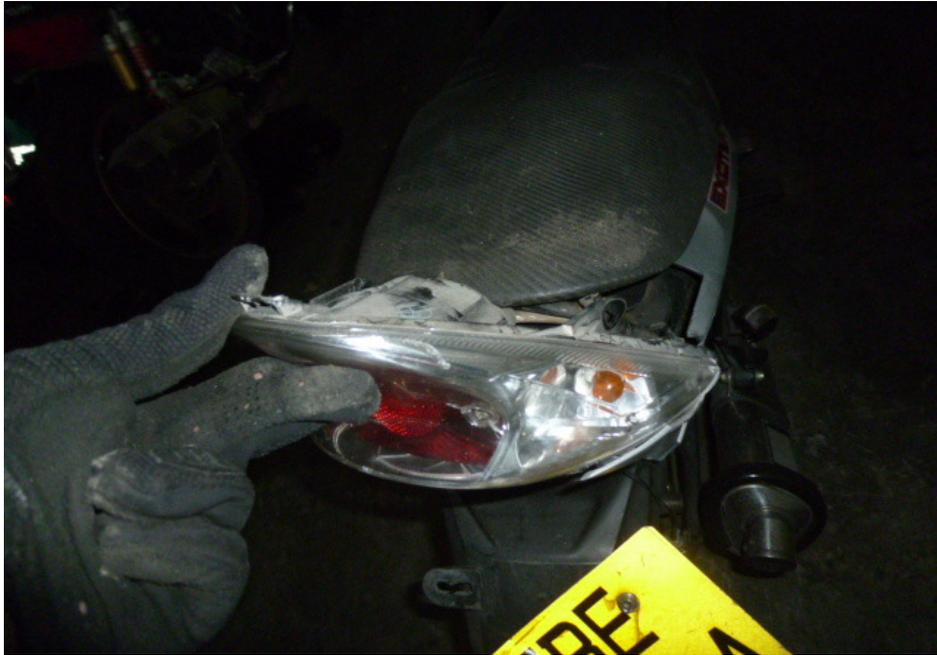
Photo 11 shows the cracked tail light assembly of the Motorcycle as a result of the accident.

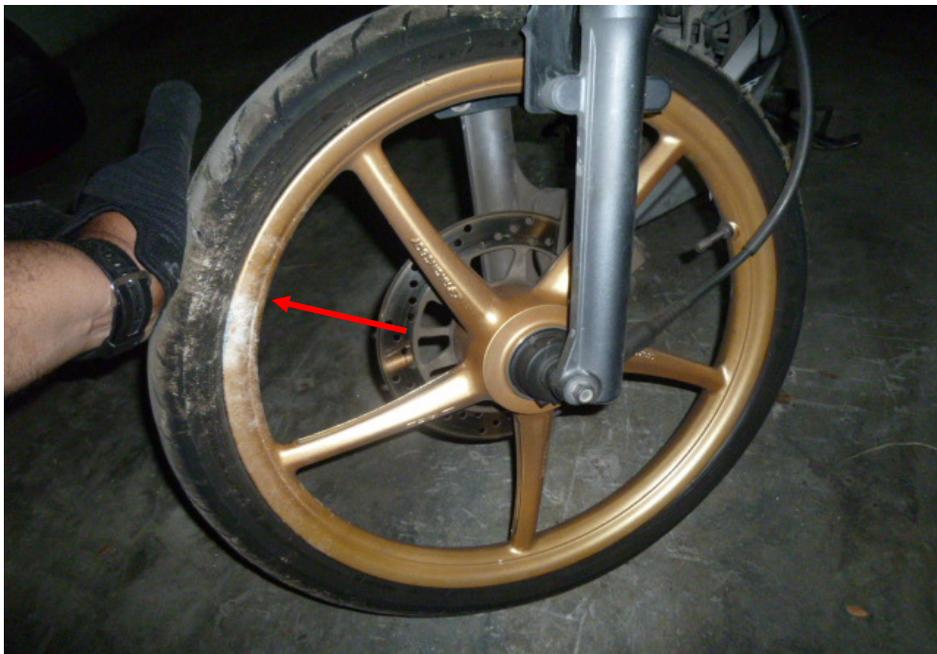
Photo 12 shows the deflated front tyre (arrowed) of the Motorcycle as a result of the accident at the time of our inspection.

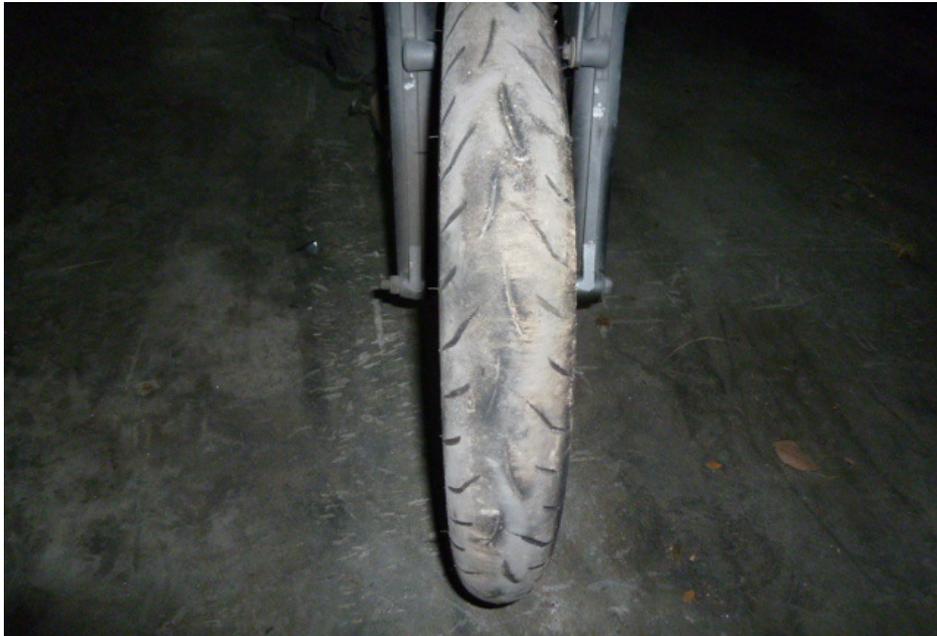
Photo 13 shows the deflated front tyre of the Motorcycle most likely as a result of the accident at the time of our inspection. The front tyre was observed to be in serviceable condition with remaining tread depth of approximately 3mm. The pattern of the tread was also clearly visible. There was no tear, burst mark(s) and/or punctured hole(s) on the sidewalls as well as across the tread of the front tyre.

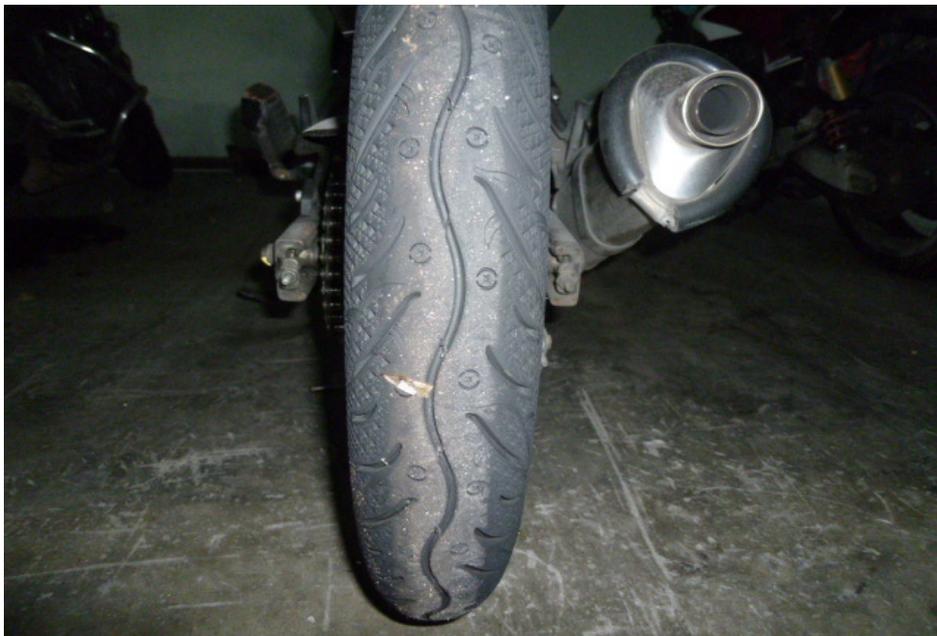
Photo 14 shows the condition of the Motorcycle's rear tyre. The rear tyre was observed to be in serviceable condition with remaining tread depth of approximately 4mm. The tyre was also observed to be sufficiently inflated for vehicular operation. We did not observe any tear, burst mark(s) and/or punctured hole(s) on the sidewalls as well as across the tread of the rear tyre.

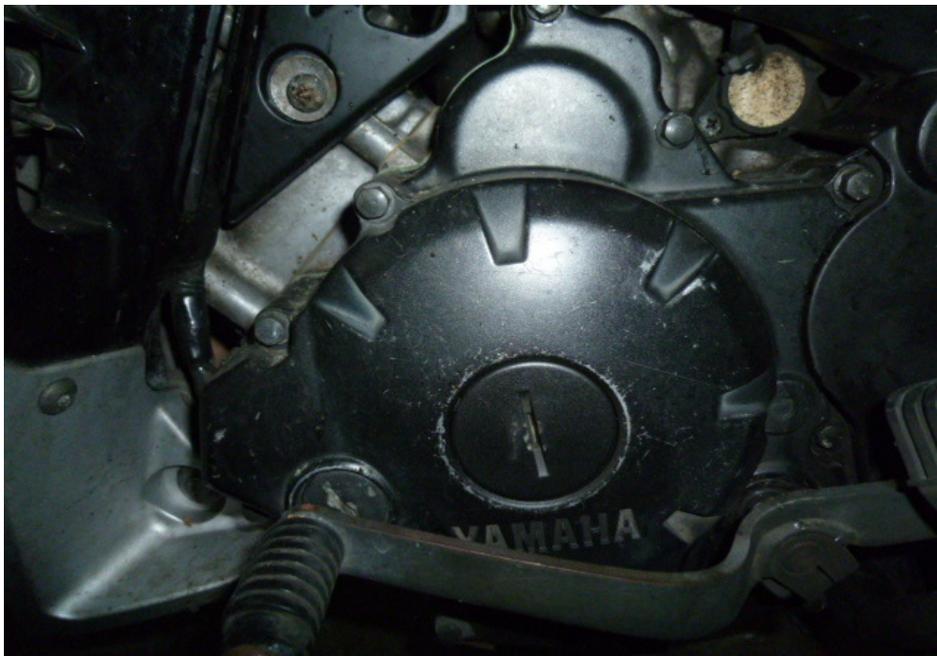
Photo 15 shows the left side of the engine of the Motorcycle at the time of our inspection. The various engine related parts and components were found to be intact with no visible damage. There was also no sign(s) or indication(s) of fluid leak observed around the left engine area of the Motorcycle.

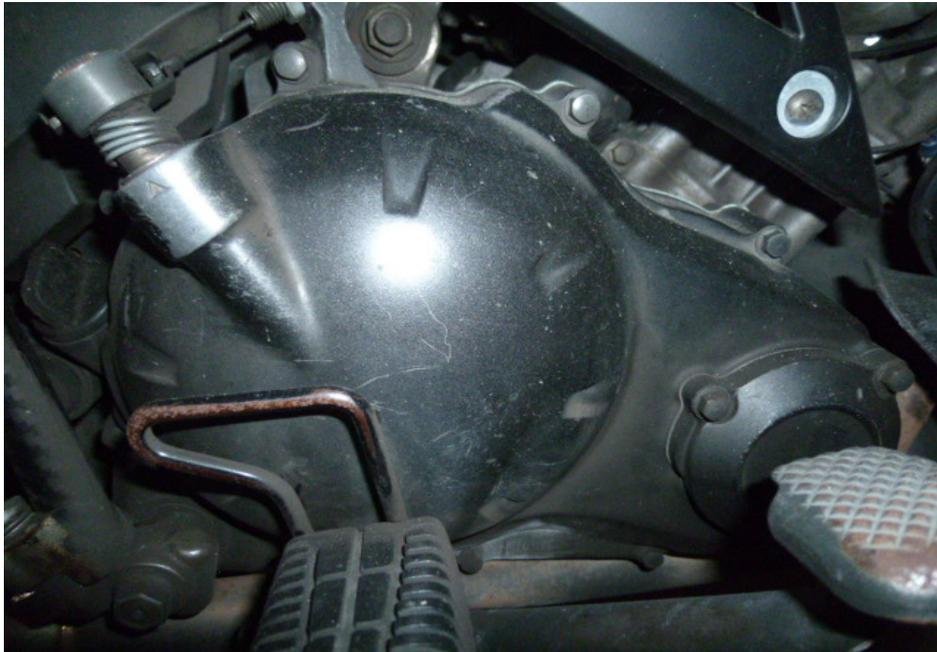
Photo 16 shows the right side of the engine of the Motorcycle at the time of our inspection. The various engine related parts and components were found to be intact with no visible damage. There was also no sign(s) or indication(s) of fluid leak observed around the right engine area of the Motorcycle.

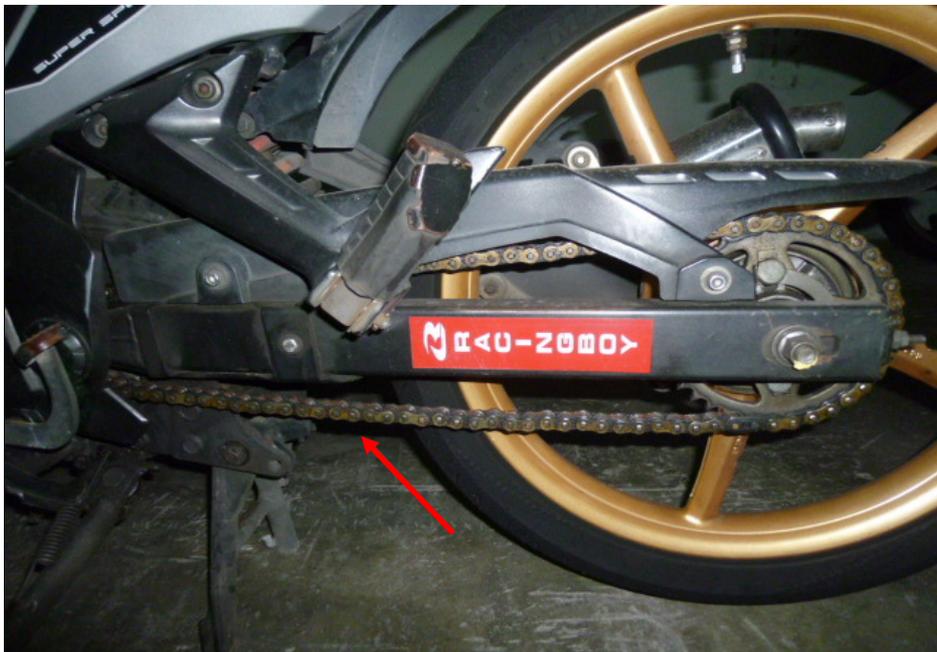
Photo 17 shows the gear chain (arrowed) of the Motorcycle, which was observed to be intact with no misalignment. It was also adequately lubricated for operating purposes. The gear chain rotates the rear wheel of the Motorcycle.

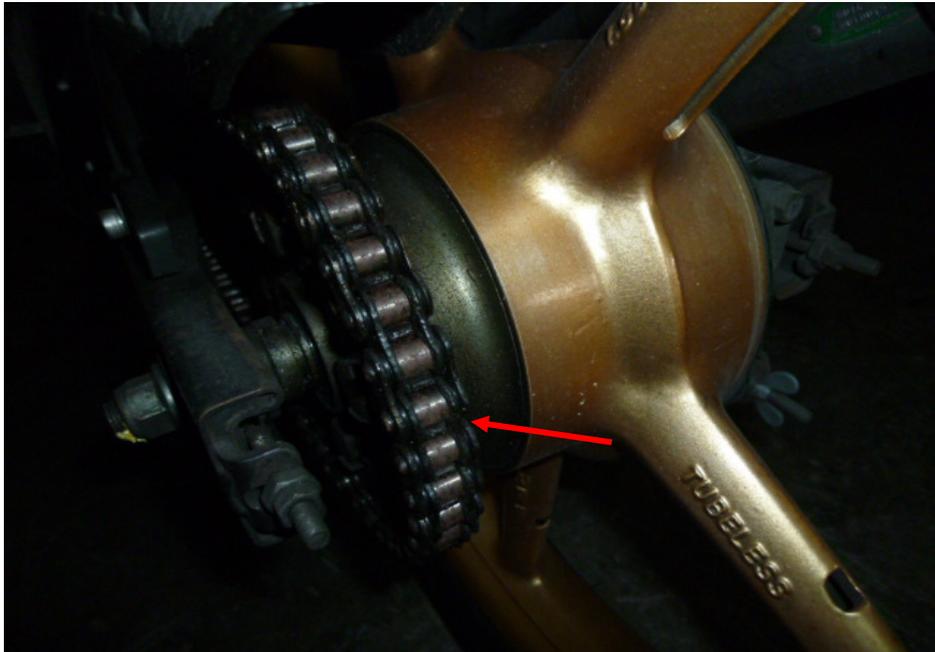
Photo 18 shows the closer view of the gear chain (arrowed) of the Motorcycle, which was observed to be intact with no misalignment. It was also adequately lubricated for operating purposes.

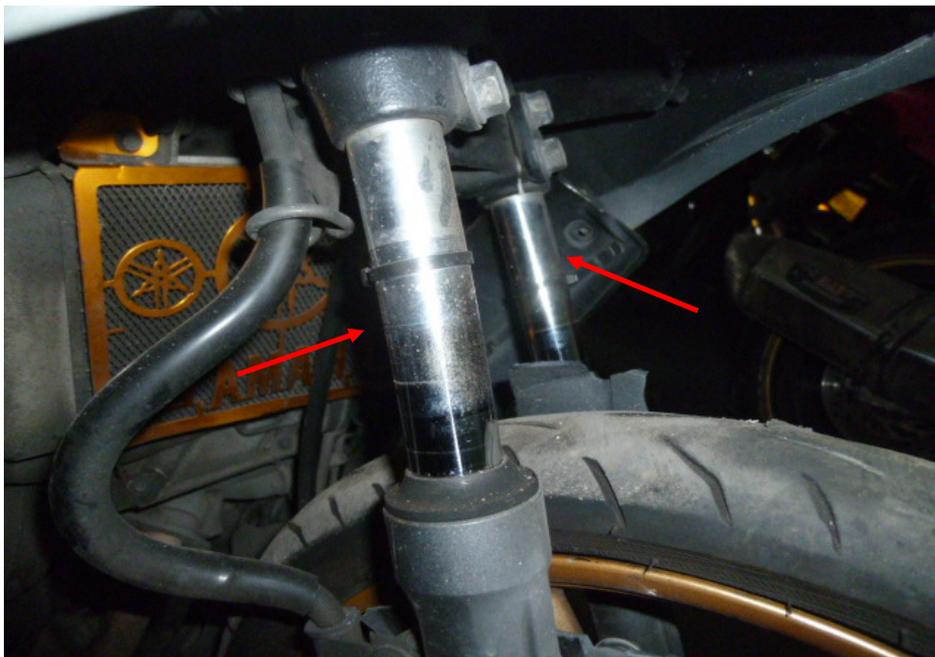
12. For this case, we were not able to conduct any test(s) on the steering system of the Motorcycle due to the damage of its front forks. The front forks were found to be bent inwards as a result of the accident which had rendered the Motorcycle immobile.

Photo 19 shows the front forks of the Motorcycle. The front forks (arrowed) were observed to be bent inwards as a result of the accident. We were hence not able to conduct any tests on the steering system of the Motorcycle.

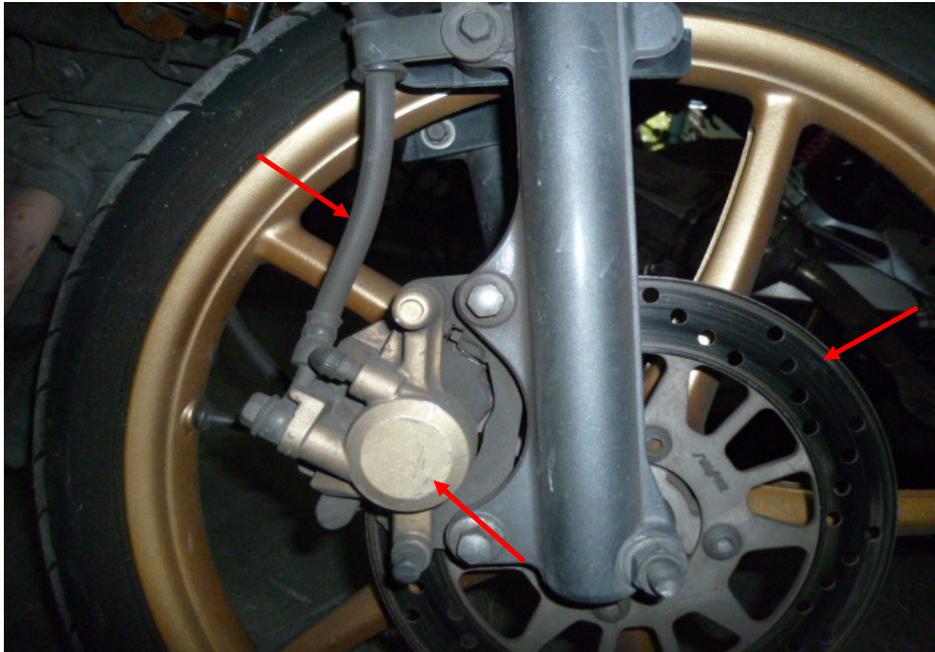
Photo 20 shows a close up view of the front brake caliper, front brake disc and front brake hose (arrowed) of the Motorcycle, which are all part of the components in the hydraulic front brake system of the Motorcycle. Our visual checks of these various components had revealed all to be intact with no visible damage. No leakage of brake fluid was also observed.

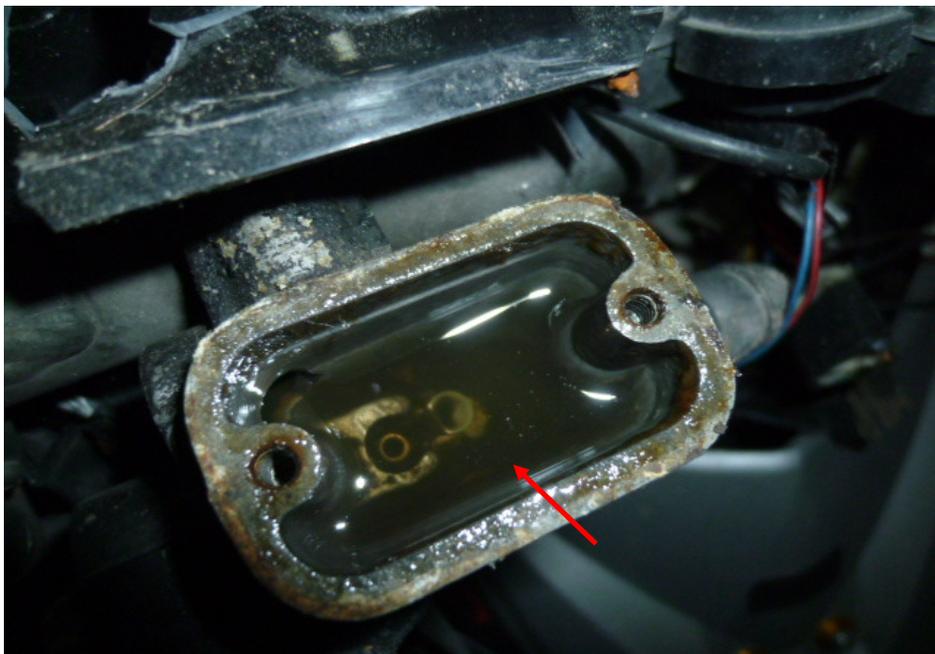
Photo 21 shows the brake fluid reservoir for the front brake of the Motorcycle. The brake fluid was found to be of sufficient level for operating purposes. However the brake fluid was found to be slightly contaminated (arrowed).

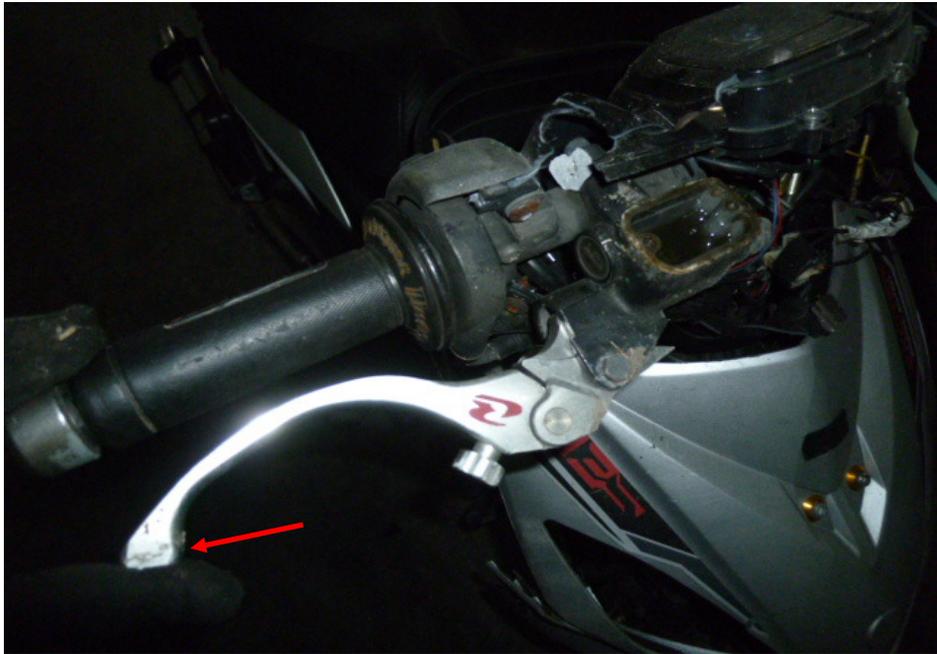
Photo 22 shows the front brake lever being depressed. There was some resistance felt (spongy like feel) upon pressing the front brake lever (arrowed). This would indicate that there is no leakage of pressure/vacuum in the brake system.

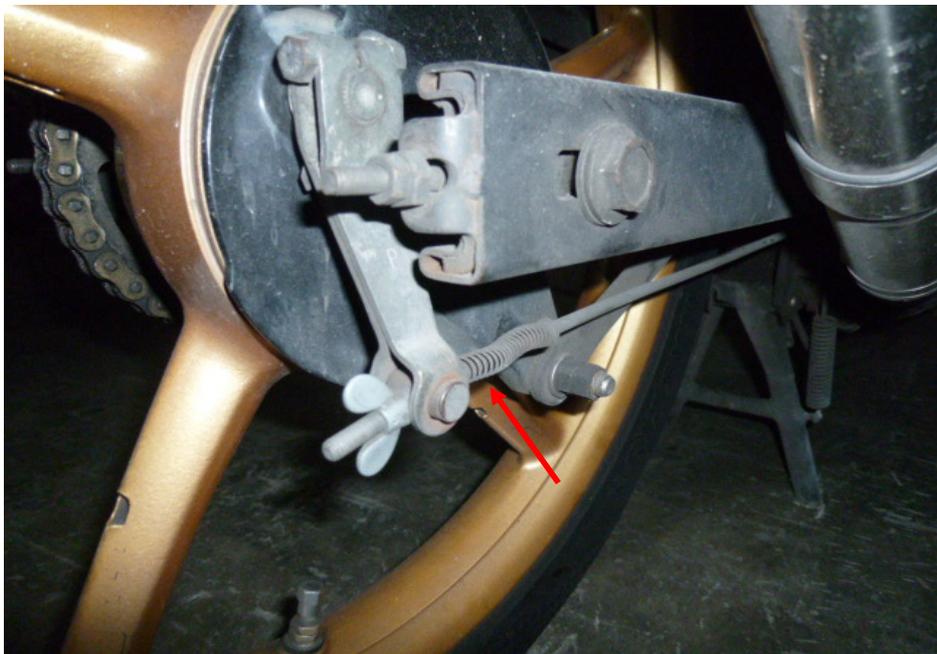
Photo 23 shows the rear wheel of the Motorcycle. The type of brake system for the rear wheel was of a mechanical type, controlled by the brake foot pedal of the Motorcycle. Our checks of the cable (arrowed), spring and drum which are all part of the components in the rear brake system of the Motorcycle reveal all to be intact and without damage.
