Your Ref: Toyota Alphard  
(chassis number AGH309003695)  
Our Ref : CI/TP21008872/D

28 August 2021

**INSPECTION REPORT OF AN UNREGISTERED TOYOTA ALPHARD MOTOR CAR WITH CHASSIS NUMBER AGH309003695**

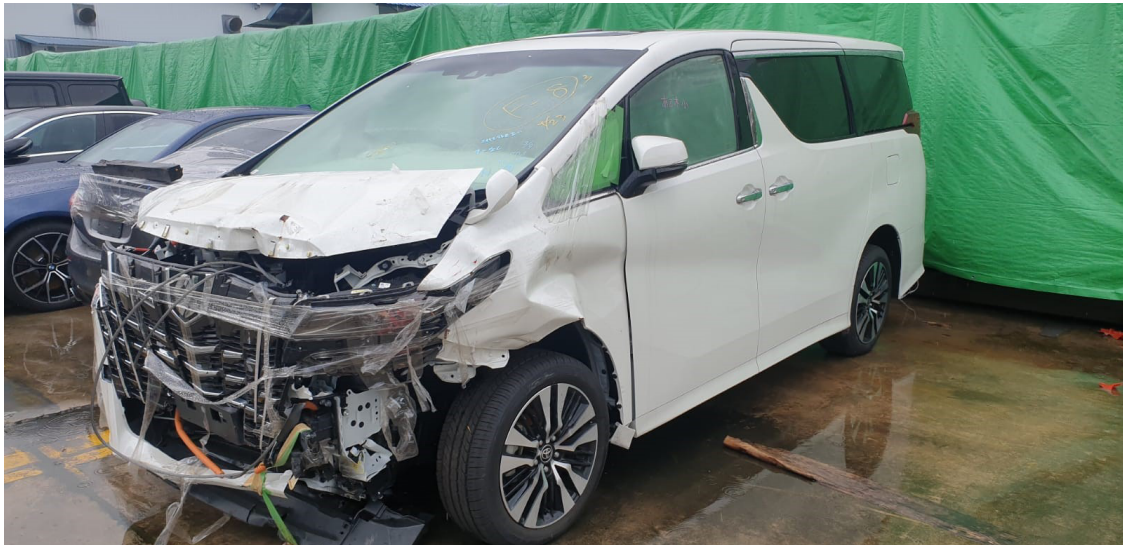
3. The photographs provided to me had showed damage to the frontal body of the Motor Car. Body parts damaged include the front bumper, front bumper reinforcement, front bumper centre lower grille, front bumper left lower grille chrome moulding, front bumper left lower grille, front bumper right lower grille chrome moulding, radiator grille, front emblem, front headlamps, front bonnet, front bonnet chrome moulding, front bonnet lock, front bonnet hinges, front left fog lamp, front undercover, front sensors, front support panel, front support panel top garnish, front fenders and front left fender inner shield amongst others. The extent of damage to the frontal body of the Motor Car suggests possible damage to its aircon condenser and radiator.

**Photo 1** shows the front left body of the Motor Car (photograph provided to me). The Motor Car was observed to have sustained damage at its frontal body. The front bumper, front bumper reinforcement, front bumper centre lower grille, front bumper left lower grille chrome moulding, front bumper left lower grille, radiator grille, front emblem, front left headlamp, front bonnet, front bonnet chrome moulding, front bonnet lock, front bonnet hinges, front left fog lamp, front undercover, front sensors, front support panel, front support panel top garnish, front left fender and front left fender inner shield were amongst the body parts that were observed to have been damaged. The extent of damage to the frontal body of the Motor Car suggests possible damage to its aircon condenser and radiator.

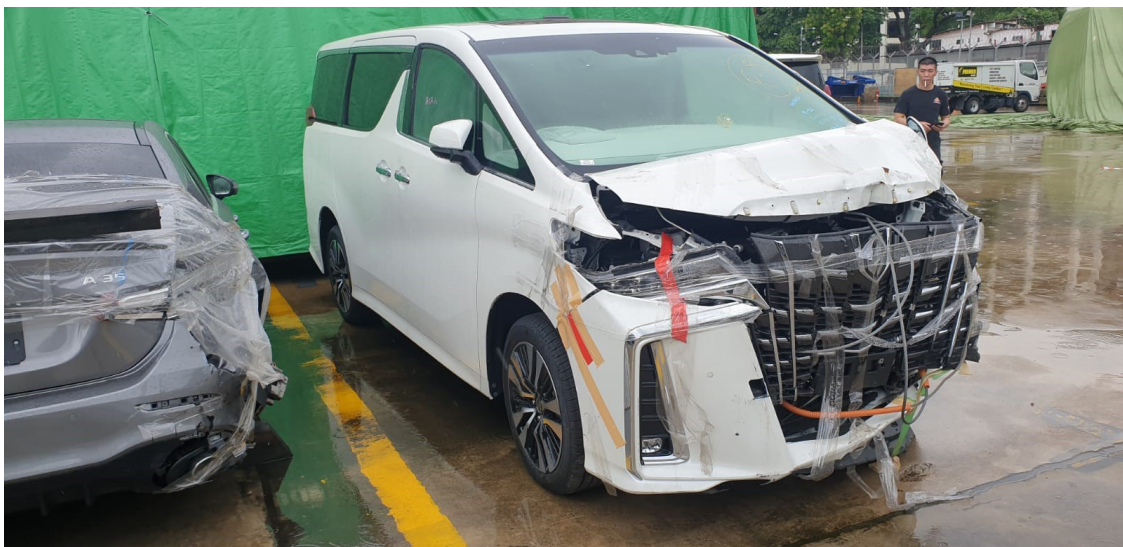
**Photo 2** shows the front right body of the Motor Car (photograph provided to me). The Motor Car was observed to have sustained damage at its frontal body. The front bumper, front bumper centre lower grille, front bumper right lower grille chrome moulding, radiator grille, front emblem, front right headlamp, front bonnet, front bonnet chrome moulding, front bonnet lock, front bonnet hinges, front support panel, front support panel top garnish and front right fender were amongst the body parts that were observed to have been damaged. The extent of damage suggests possible damage to the aircon condenser and radiator of the Motor Car. The photographs provided appear to also show the Motor Car's airbags not deployed.

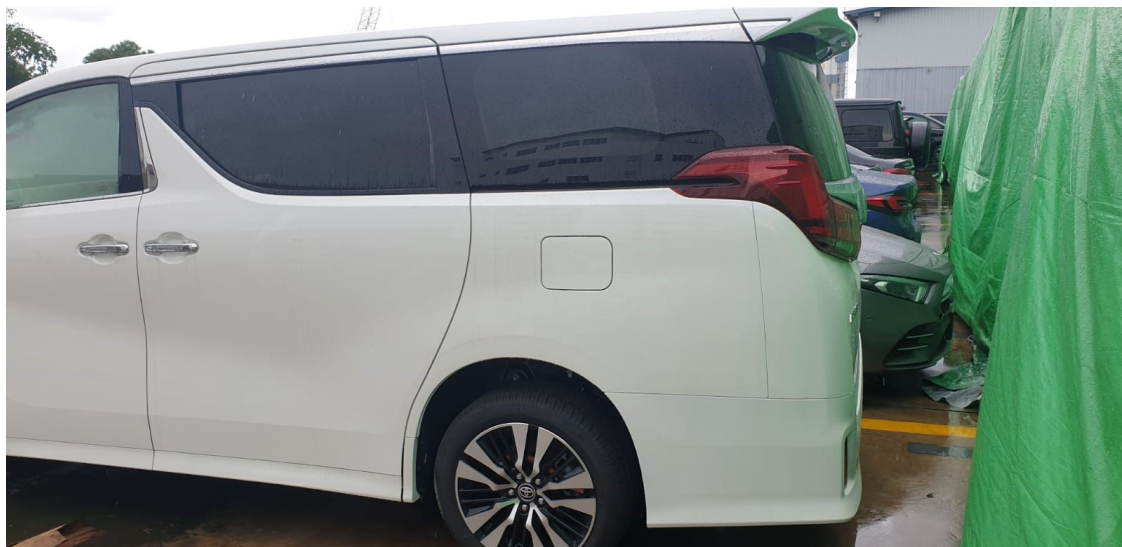
**Photo 3** shows the rear left body of the Motor Car (photograph provided to me). Apart for the frontal body, the photographs provided to me did not show physical damage to other areas of the Motor Car.

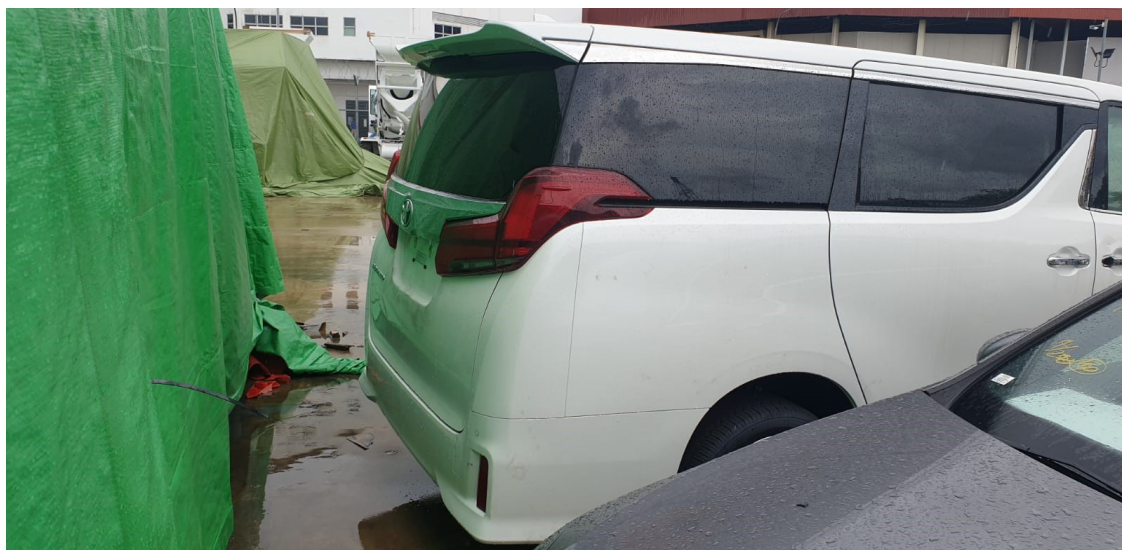
**Photo 4** shows the rear right body of the Motor Car (photograph provided to me). Apart for the frontal body, the photographs provided to me did not show physical damage to other areas of the Motor Car.

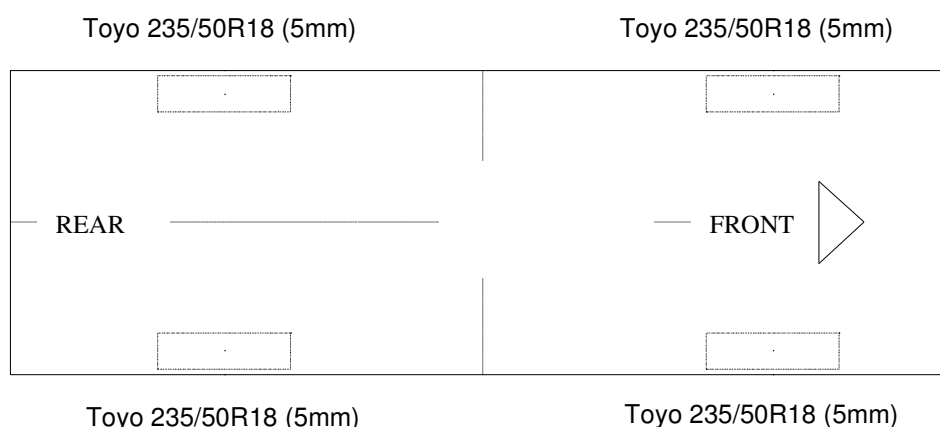
8. It was fitted with 18inch sport wheel rims that were wrapped with tyres that were observed to be of serviceable condition. The tyres were also sufficiently inflated for vehicular operation. The tyre brand, tyre size and approximate remaining tread depth of the 4 tyres of the Motor Car were recorded as follows: -

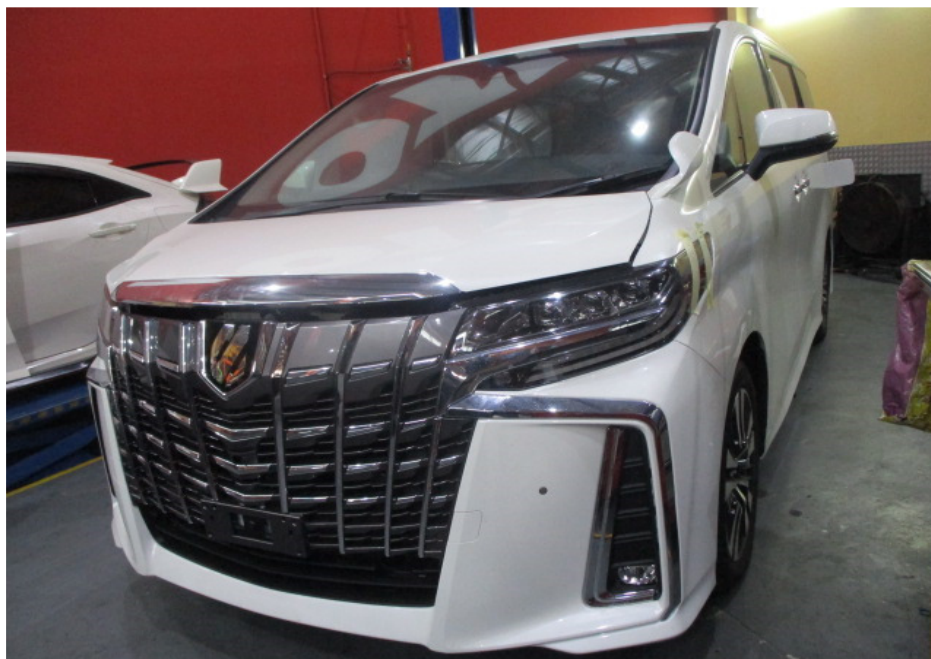
**Photo 5** shows a general view of the front left body of the Motor Car at the time of my inspection. The Motor Car was observed to be in a relatively good general condition with no loose exterior fittings observed. The body parts at the frontal body of the Motor Car were visually examined and it was observed that the repair/restoration works carried out to the damaged area of the Motor Car (refer to photograph 1 & 2 above) were reasonably adequate and in order.

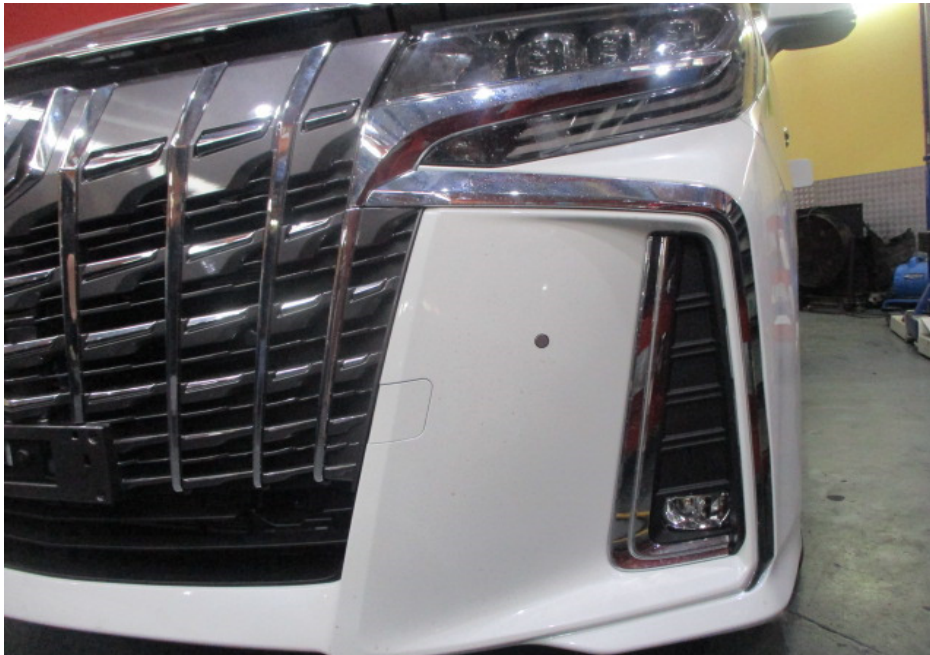
**Photo 6** shows a closer view of the Motor Car's front bumper, front bumper left lower grille chrome moulding, front bumper left lower grille, front left fog lamp and front left headlamp. The body parts at the frontal body of the Motor Car were visually examined and it was observed that the repair/restoration works carried out to the damaged area of the Motor Car (refer to photograph 1 above) were reasonably adequate and in order.

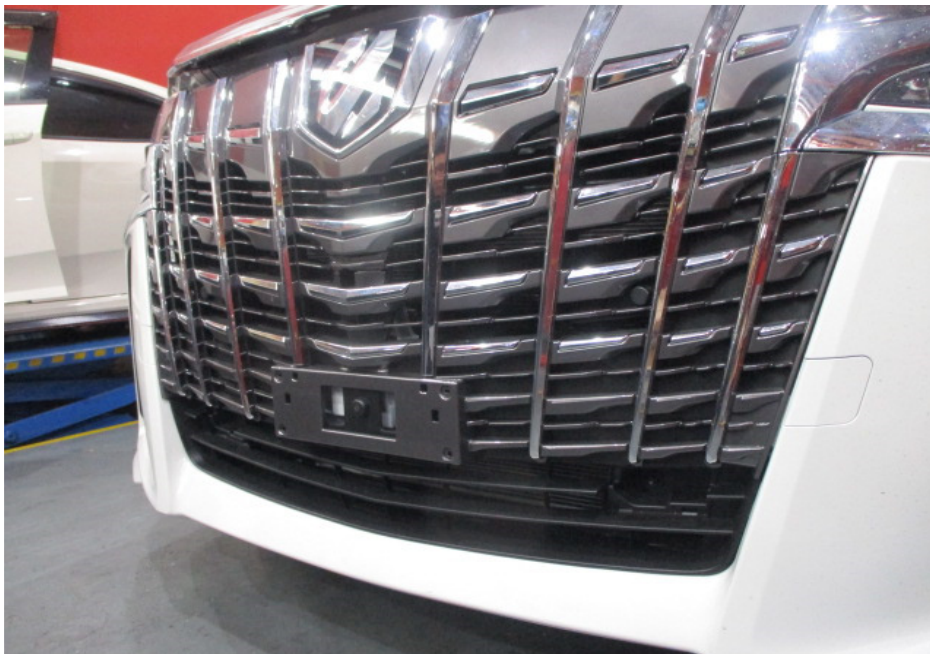
**Photo 7** shows a closer view of the Motor Car's front bumper, front bumper centre lower grille, radiator grille and front emblem. The body parts at the frontal body of the Motor Car were visually examined and it was observed that the repair/restoration works carried out to the damaged area of the Motor Car (refer to photograph 1 above) were reasonably adequate and in order.

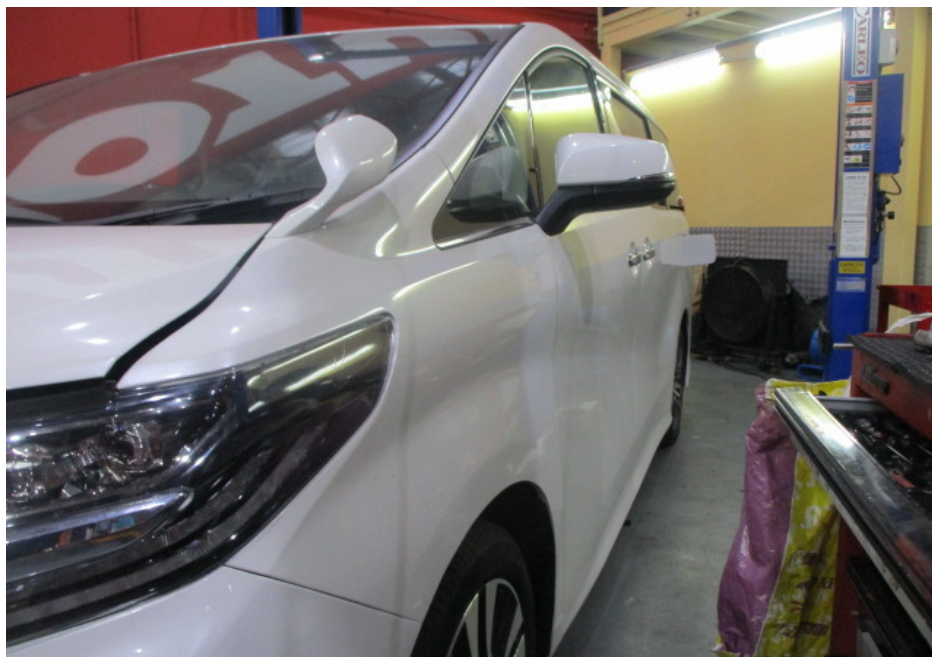
**Photo 8** shows a closer view of the Motor Car's front left headlamp and front left fender. The body parts at the frontal body of the Motor Car were visually examined and it was observed that the repair/restoration works carried out to the damaged area of the Motor Car (refer to photograph 1 above) were reasonably adequate and in order.

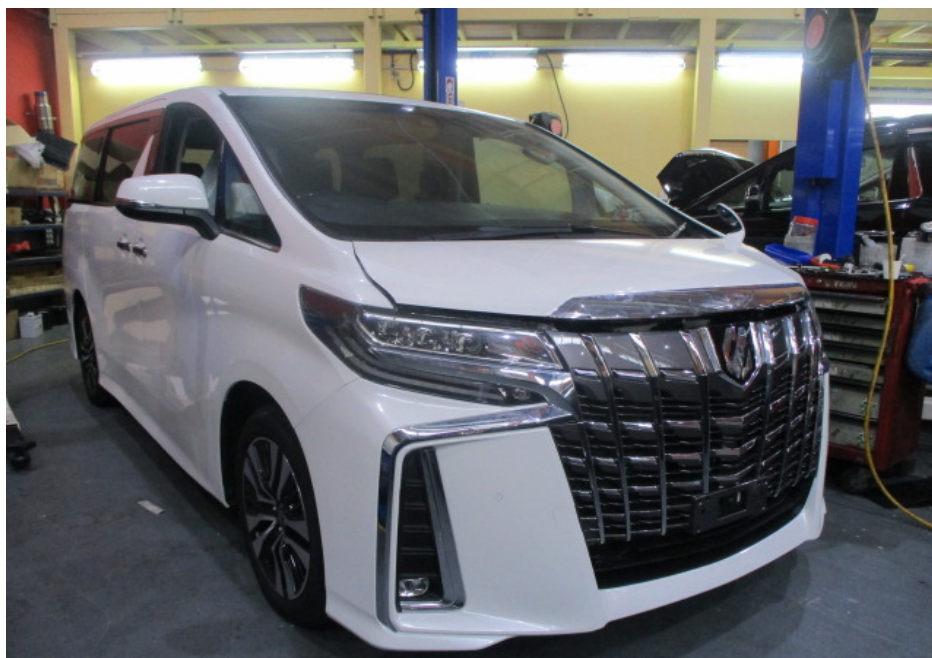
**Photo 9** shows a general view of the front right body of the Motor Car at the time of my inspection. The Motor Car was observed to be in a relatively good general condition with no loose exterior fittings observed. The body parts at the frontal body of the Motor Car were visually examined and it was observed that the repair/restoration works carried out to the damaged area of the Motor Car (refer to photograph 1 & 2 above) were reasonably adequate and in order.

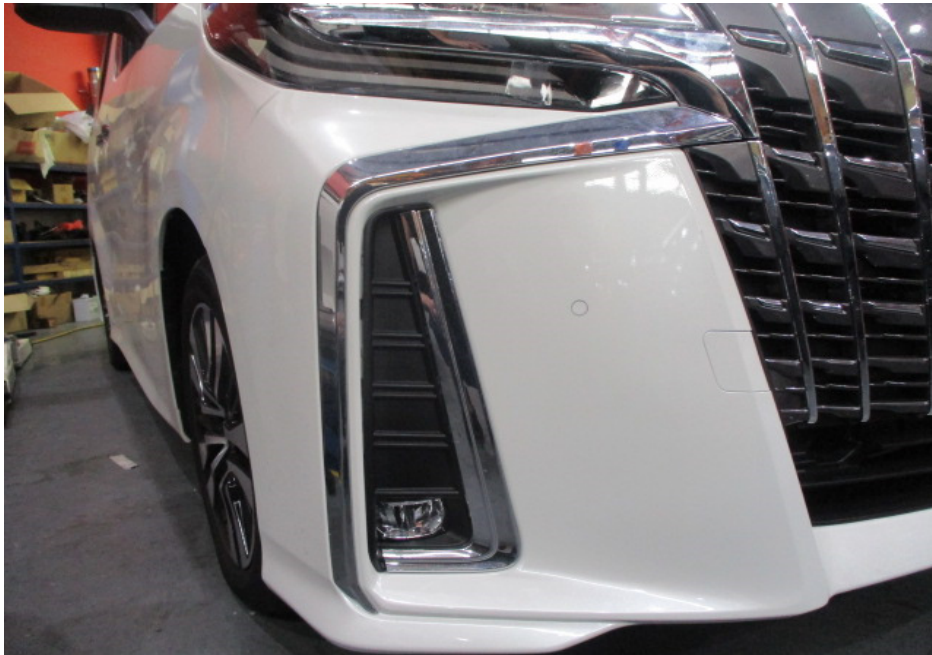
**Photo 10** shows a closer view of the Motor Car's front bumper, front bumper right lower grille chrome moulding, front bumper right lower grille and front right fog lamp. The body parts at the frontal body of the Motor Car were visually examined and it was observed that the repair/restoration works carried out to the damaged area of the Motor Car (refer to photograph 2 above) were reasonably adequate and in order.

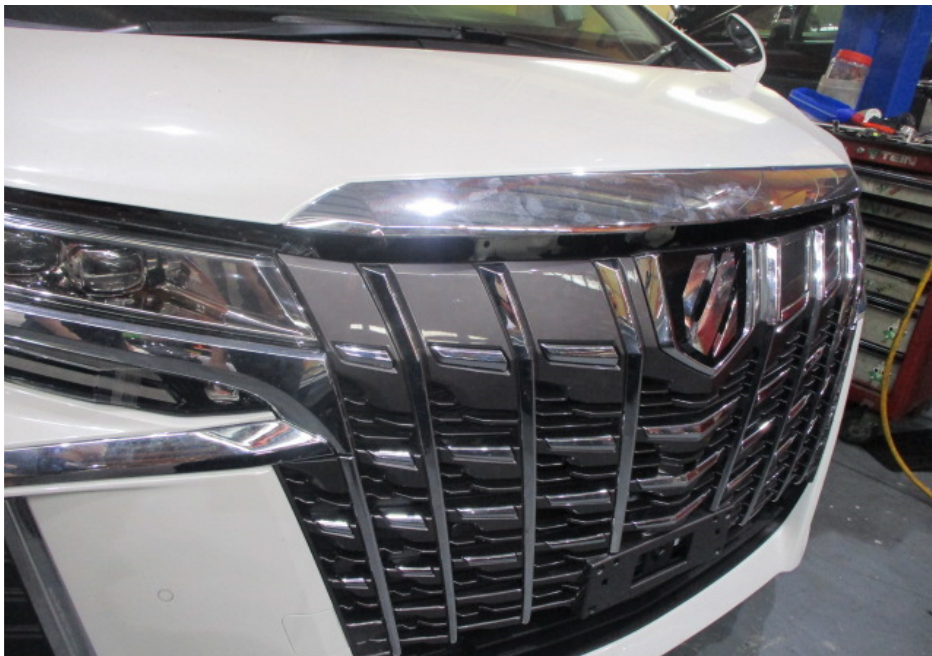
**Photo 11** shows a closer view of the Motor Car's front right headlamp, radiator grille, front bonnet and front bonnet chrome moulding. The body parts at the frontal body of the Motor Car were visually examined and it was observed that the repair/restoration works carried out to the damaged area of the Motor Car (refer to photograph 2 above) were reasonably adequate and in order.

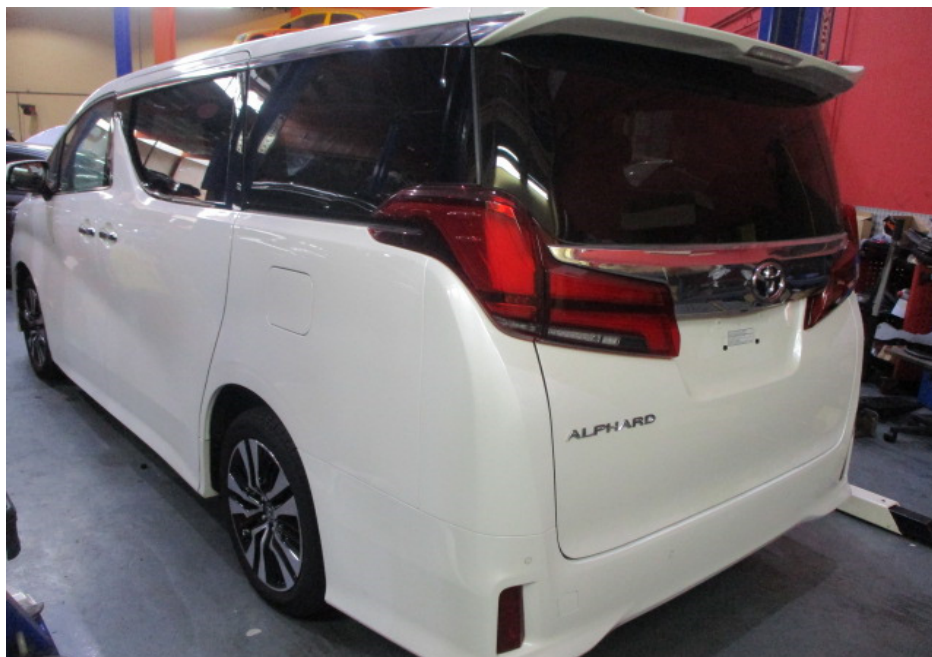
**Photo 12** shows a general view of the rear left body of the Motor Car at the time of my inspection. The Motor Car was observed to be in a relatively good general condition with no loose exterior fittings observed. The mileage of the Motor Car recorded at the time of my inspection was 281km.

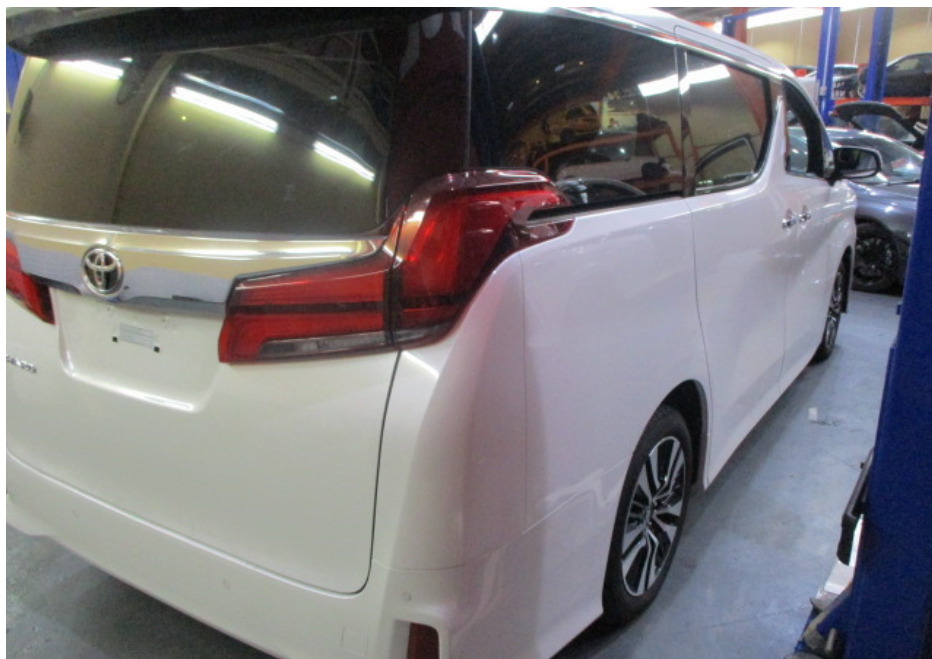
**Photo 13** shows a general view of the rear right body of the Motor Car at the time of my inspection. The Motor Car was observed to be in a relatively good general condition with no loose exterior fittings observed. The mileage of the Motor Car recorded at the time of my inspection was 281km.

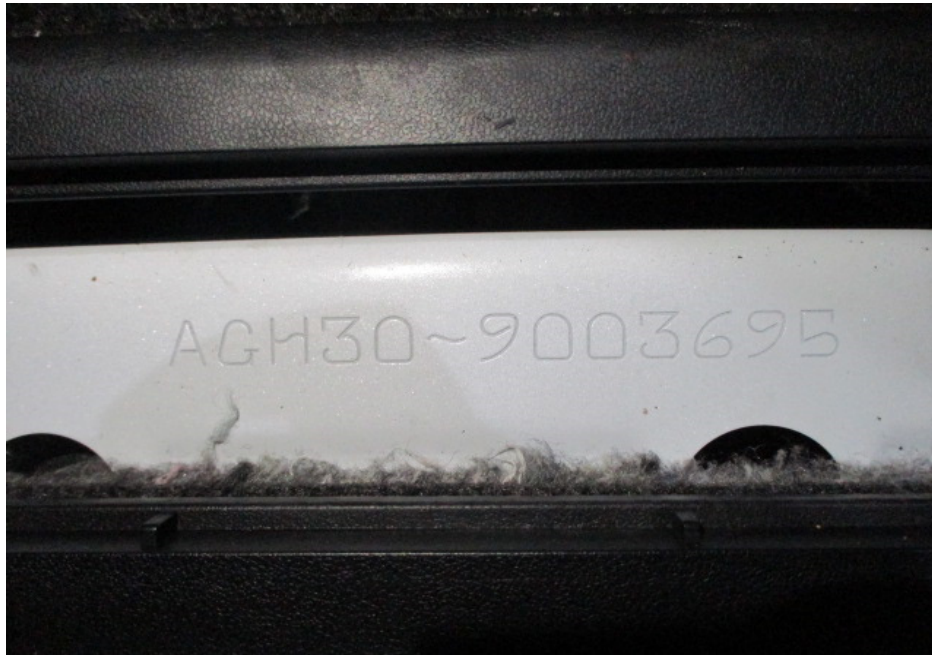
**Photo 14** shows the chassis number of the Motor Car. The chassis number recorded was AGH309003695.

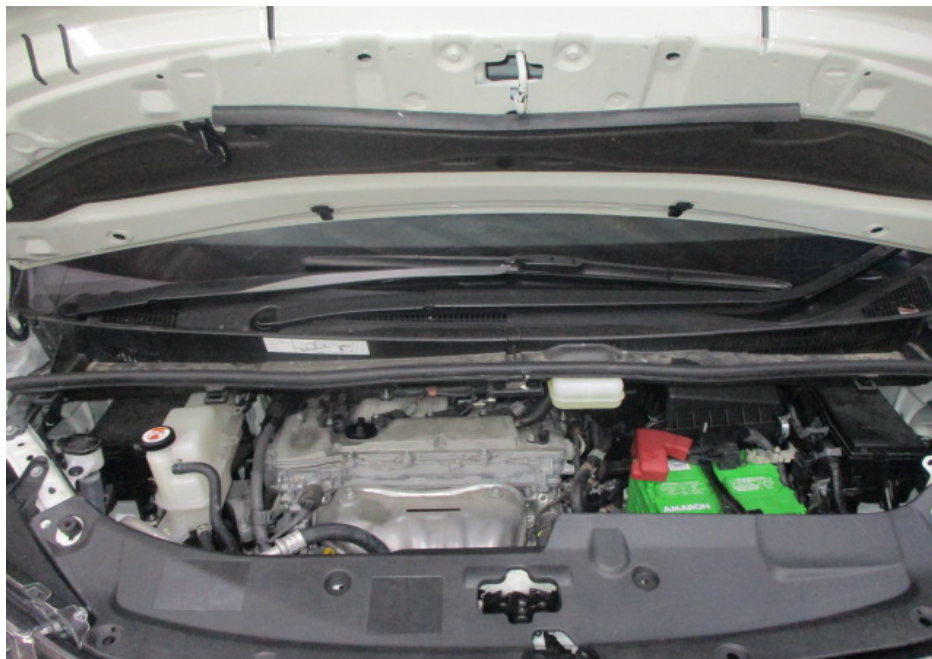
**Photo 15** shows a general view of the engine compartment of the Motor Car at the time of my inspection. The various parts and components inside the engine compartment were all observed to be intact and properly fitted. There was also no sign(s) or indication(s) of fluid leak and/or fluid stain found inside the engine compartment.

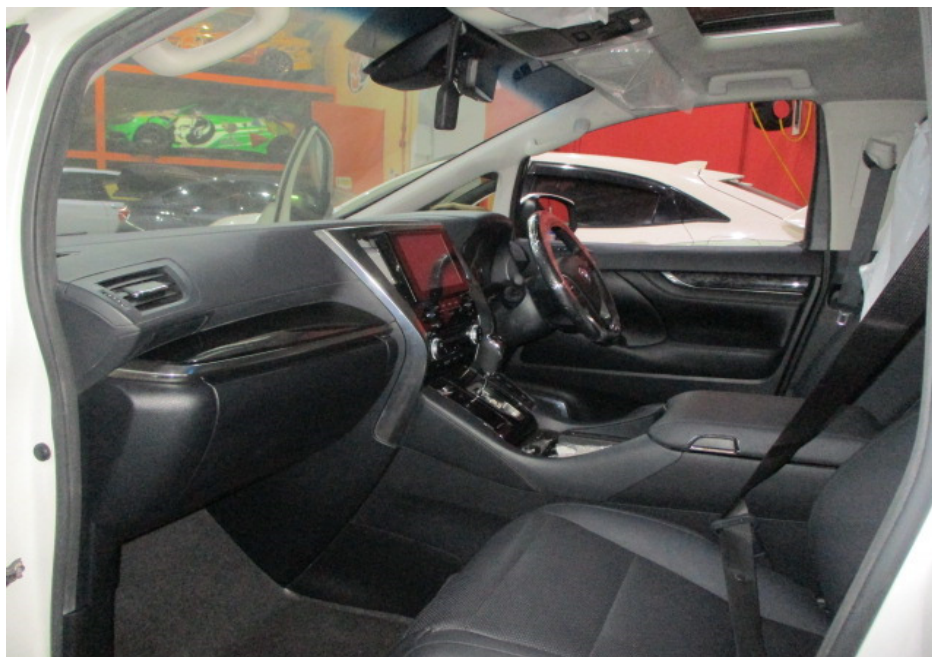
**Photo 16** shows the interior compartment of the Motor Car at the time of my inspection. The various parts and components, trims, carpet and upholstery inside the interior compartment were all observed to be intact and properly fitted.

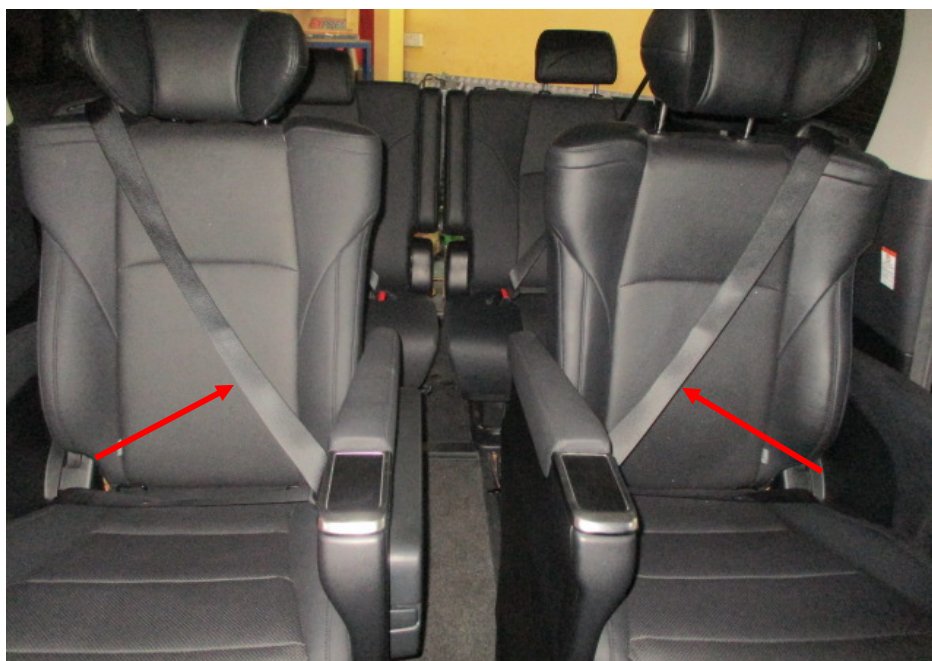
**Photo 17** shows the rear seats at the 1<sup>st</sup> row of the Motor Car. All the seats of the Motor Car were secured via seat rails to the floorboard. They were also fitted with a retractable seat belt reel and a pre-tensioner. The seat belts (arrowed) were tested and were able to be fastened into the respective pre-tensions that were fitted on the side of each individual seat.

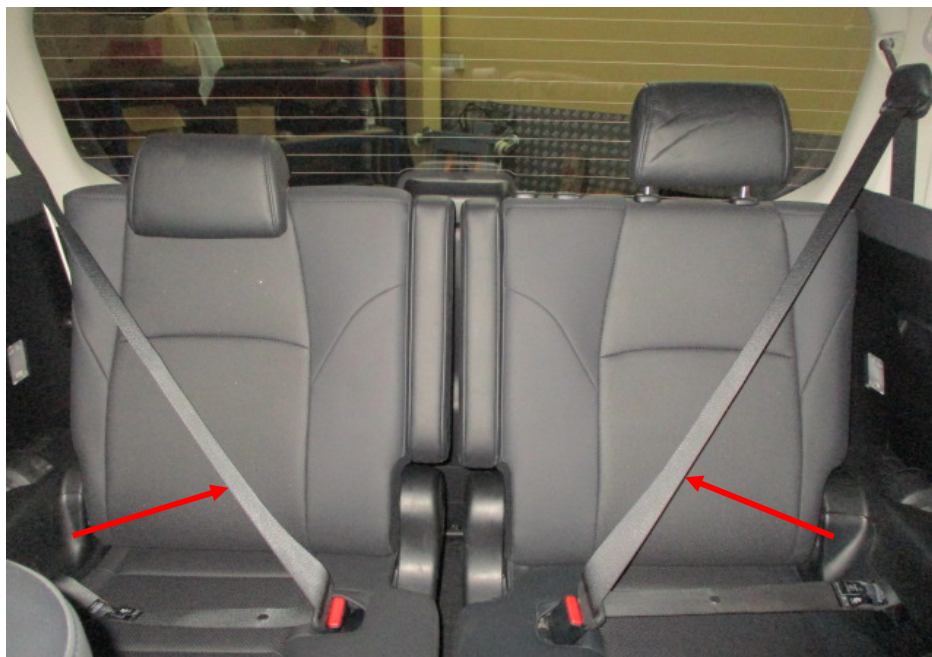
**Photo 18** shows the rear seats at the 2<sup>nd</sup> row of the Motor Car. All the seats of the Motor Car were secured via seat rails to the floorboard. They were also fitted with a retractable seat belt reel and a pre-tensioner. The seat belts (arrowed) were tested and were able to be fastened into the respective pre-tensions that were fitted on the side of each individual seat.

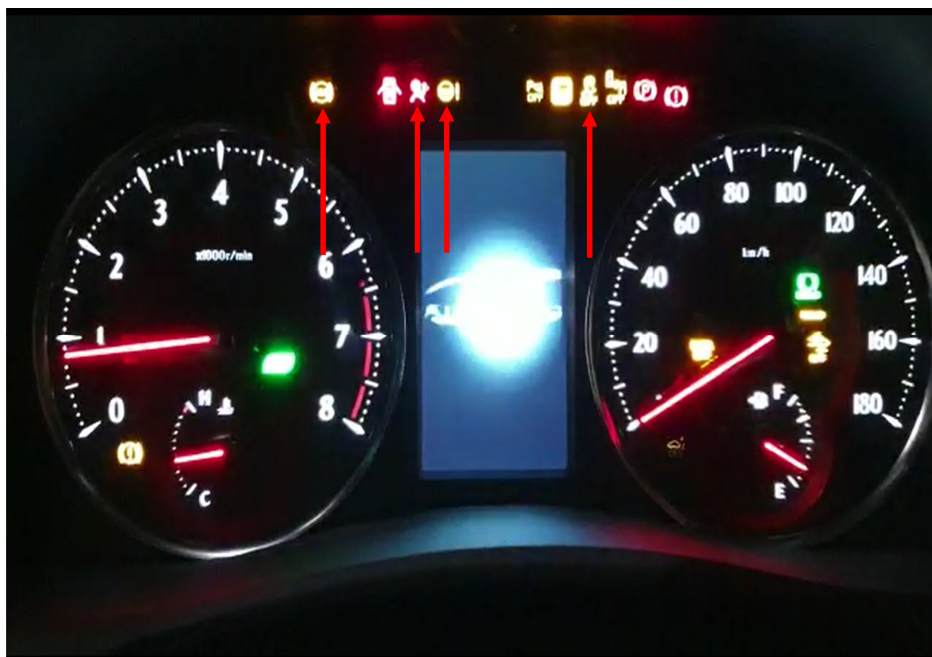
**Photo 19** shows the warning lights for the various electronic safety features appearing on the instrument panel of the Motor Car during its self-test when the engine is cranked, in particular the lights for the ABS, SRS, EPS, VSC (arrowed) and various pre-collision systems.

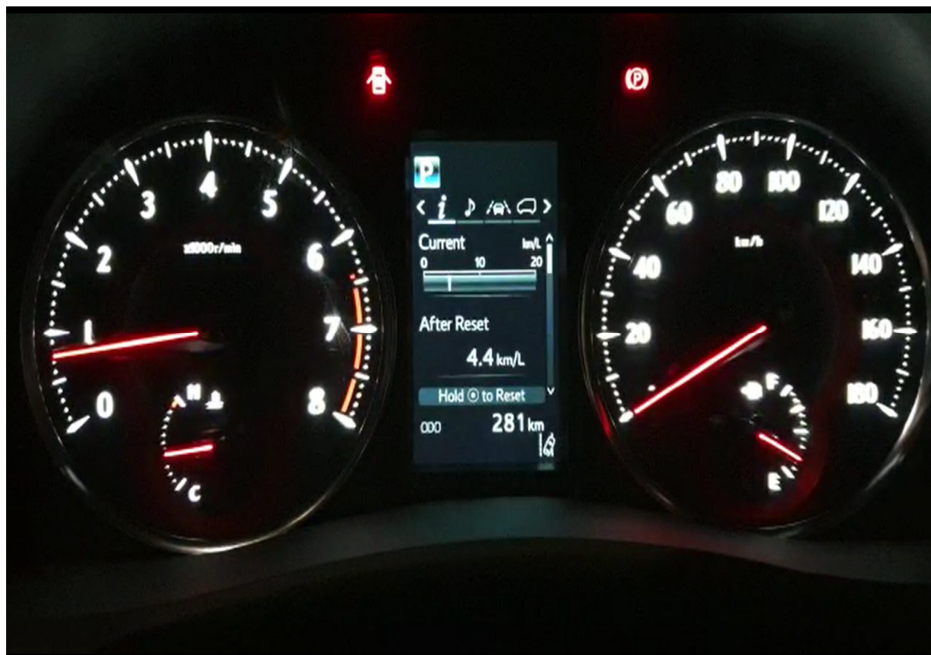
**Photo 20** shows the respective warning lights no longer illuminated, indicating that there is no fault detected to the ABS, SRS, EPS, VSC and various pre-collision systems of the Motor Car during the self-test. These electronic systems were hence in working condition at the time of my inspection.

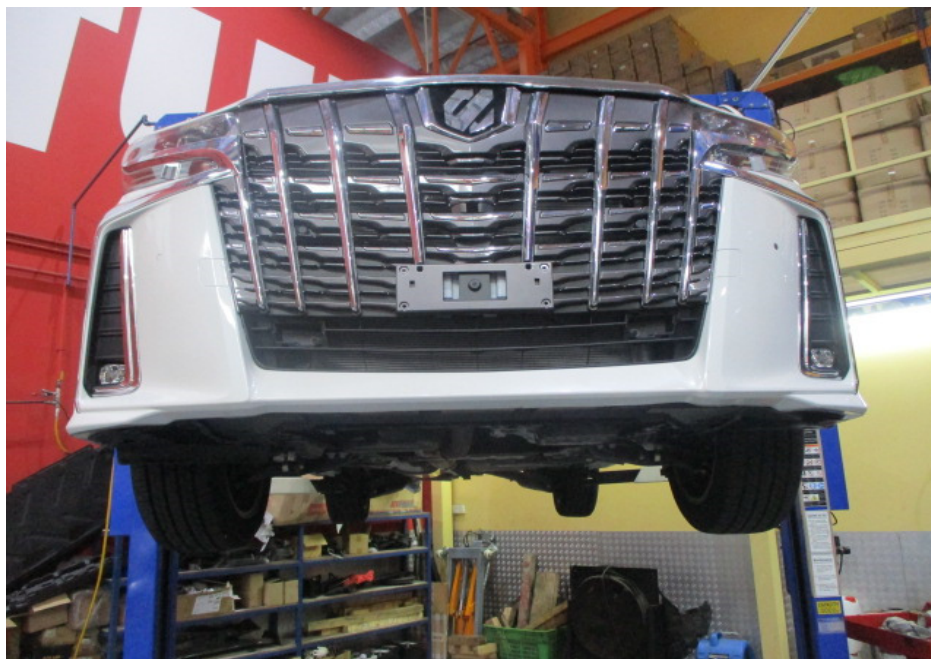
**Photo 21** shows the Motor Car hoisted up for checks on its undercarriage. There was no sign(s) or indication(s) of fluid leakage and/or fluid stain(s) on the underside of the Motor Car. The undercarriage components of the Motor Car were also all observed to be intact and secured in an appropriate manner.

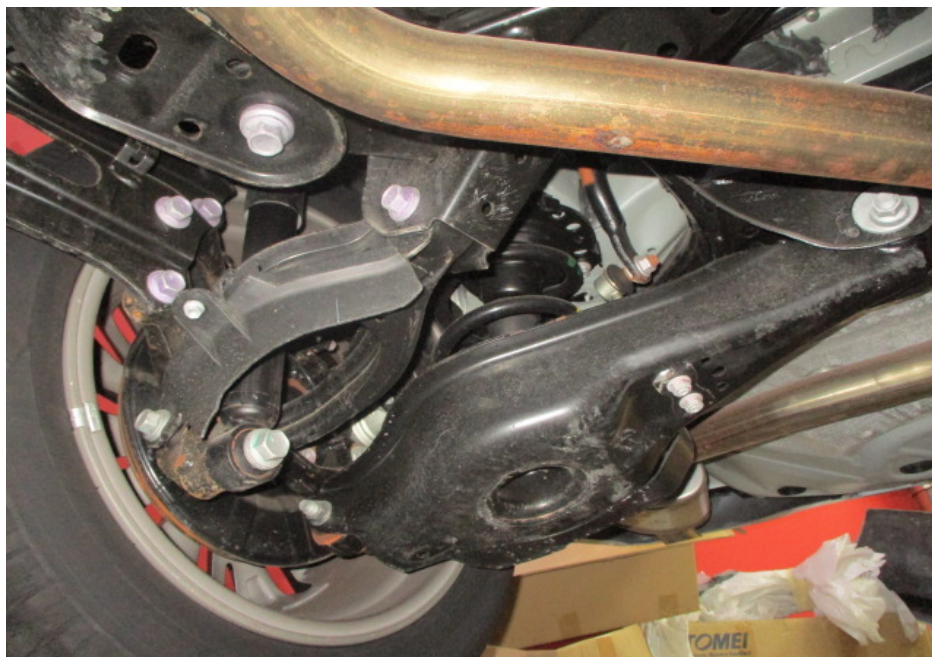
**Photo 22** shows a general view of the control arms and linkages at the rear right wheel of the Motor Car. I did not observe any fluid leak and/or fluid stain on the underside of the Motor Car. All of the Motor Car's undercarriage components were observed to be intact and secured in an appropriate manner.

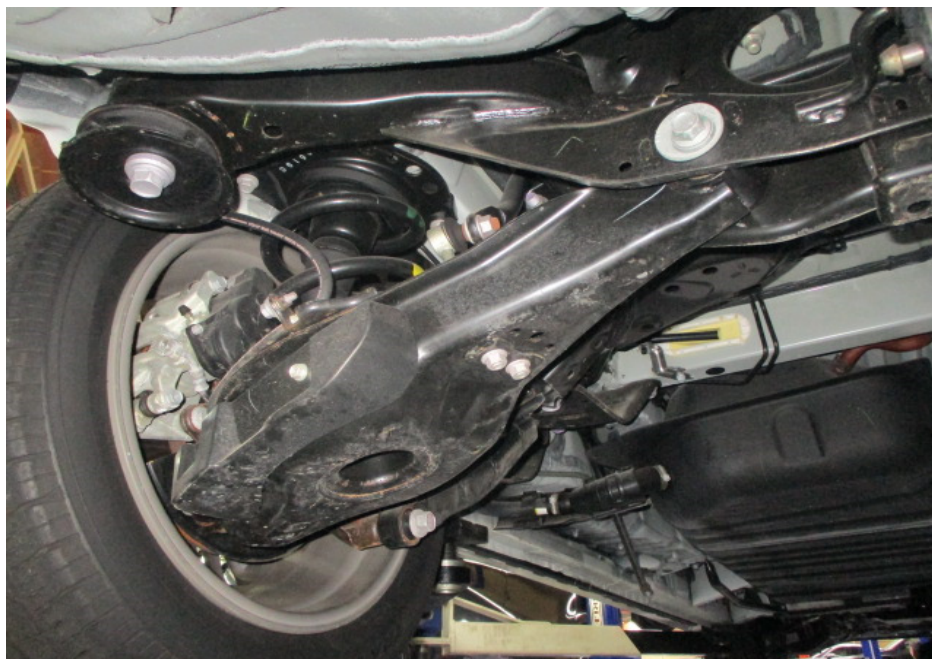
**Photo 23** shows a general view of the control arms and linkages at the rear left wheel of the Motor Car. I did not observe any fluid leak and/or fluid stain on the underside of the Motor Car. All of the Motor Car's undercarriage components were observed to be intact and secured in an appropriate manner.

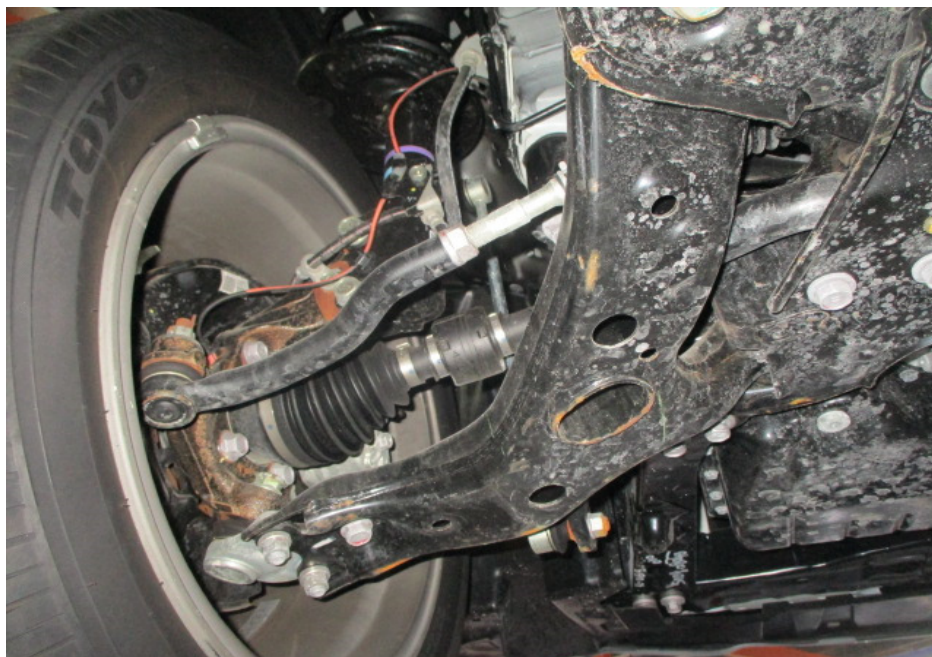
**Photo 24** shows the various undercarriage components at the front left wheel of the Motor Car. The mechanical components, control arms and linkages were all found to be intact and secured in an appropriate manner.

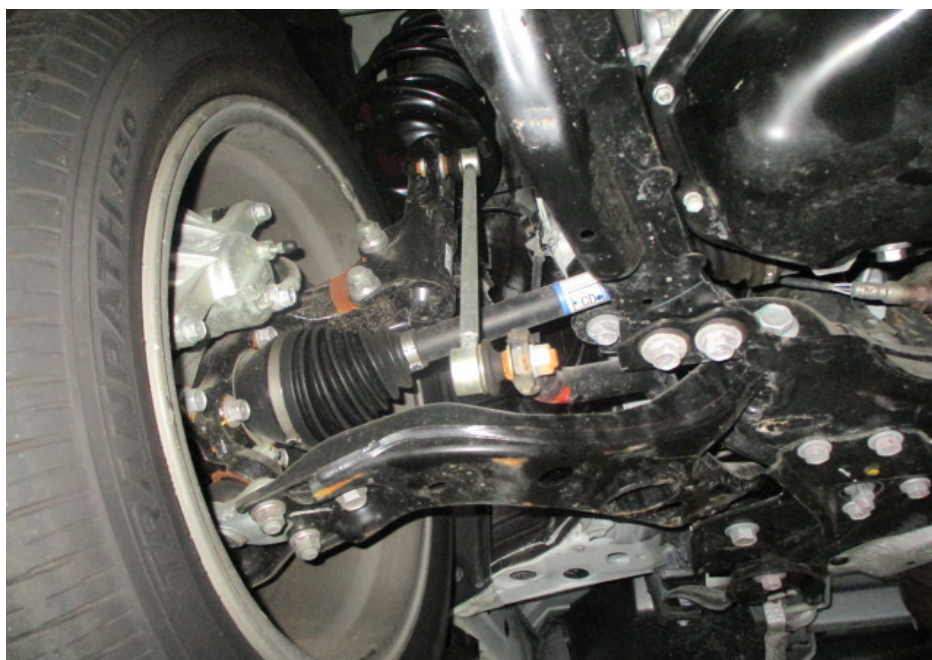
**Photo 25** shows the various undercarriage components at the front right wheel of the Motor Car. The mechanical components, control arms and linkages were all found to be intact and secured in an appropriate manner. I also did not observe any fluid leak and/or fluid stain on the underside of the Motor Car.

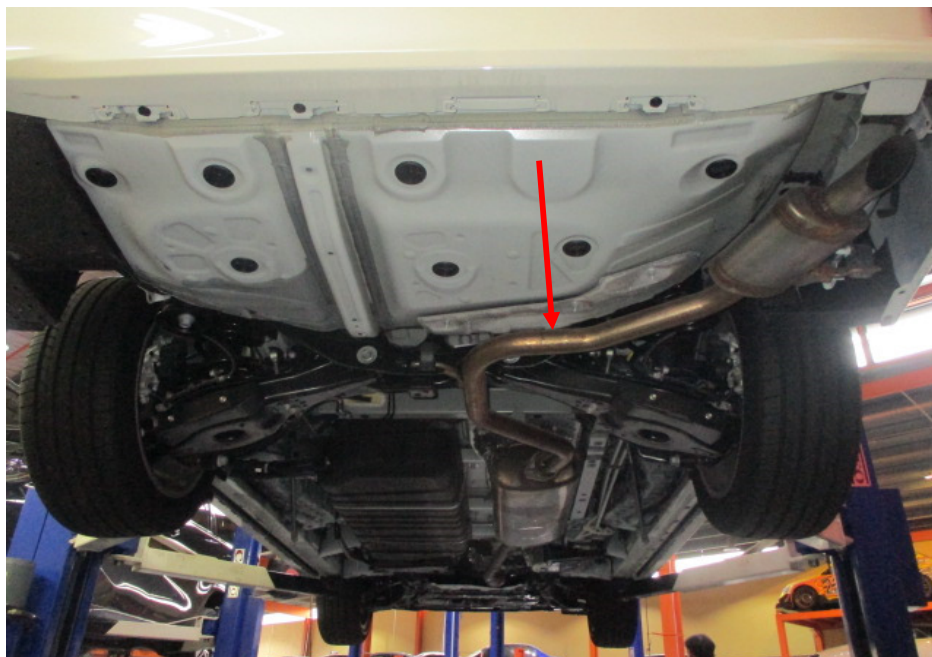
**Photo 26** shows a general view of the rear section of the Motor Car's exhaust system. My examination of the Motor Car's exhaust system revealed no sign(s) or indication(s) of any cut or weld marks along its exhaust pipe (arrowed), on its catalytic converter, on its centre resonator box and on its rear muffler.

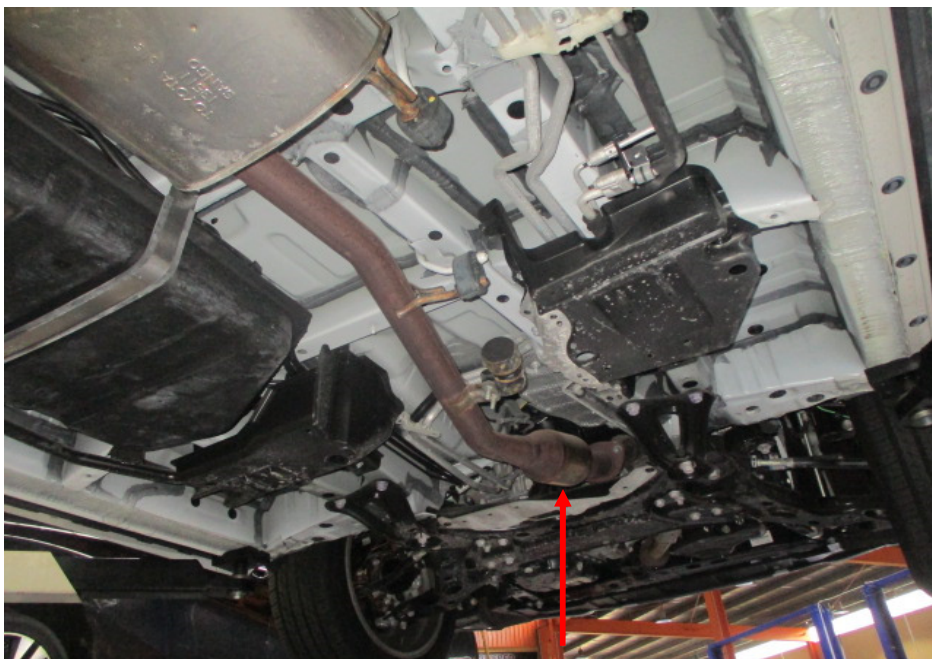
**Photo 27** shows a general view of the front section of the Motor Car's exhaust system. My examination of the Motor Car's exhaust system revealed no sign(s) or indication(s) of any cut or weld marks along its exhaust pipe, on its catalytic converter (arrowed), on its centre resonator box and on its rear muffler.

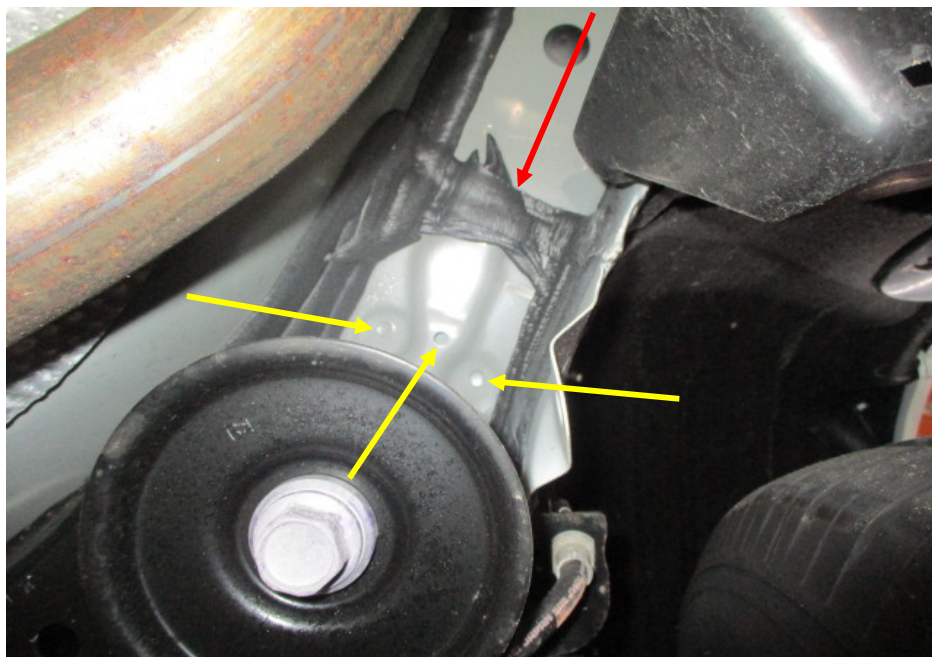
**Photo 28** shows the chassis/structural body at the underside rear right of the Motor Car. I did not find any weld marks other than original spot weld marks (yellow arrow) on the chassis/structural body of the Motor Car. The original factory sealant (red arrow) at the joints along the chassis/structural body was untouched, indicating no work was done on the chassis/structural body of the Motor Car and that the chassis/structural body was originally fitted.

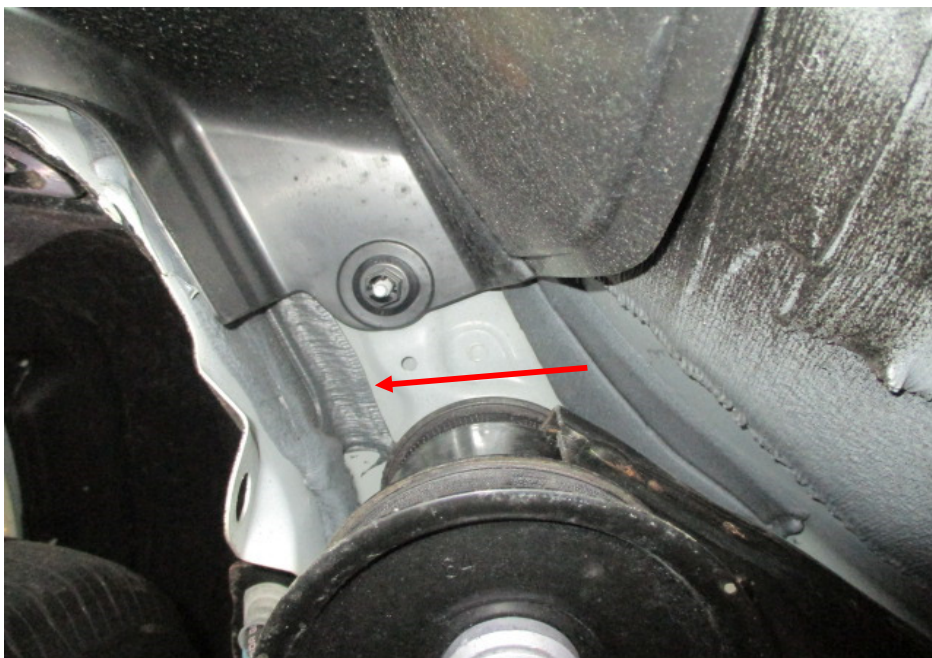
**Photo 29** shows the chassis/structural body at the underside rear left of the Motor Car. The original factory sealant (arrowed) at the joints along the chassis/structural body was observed to be untouched. In general, I had found no work was carried out on the chassis/structural body of the Motor Car. The chassis/structural body of the Motor Car was originally fitted

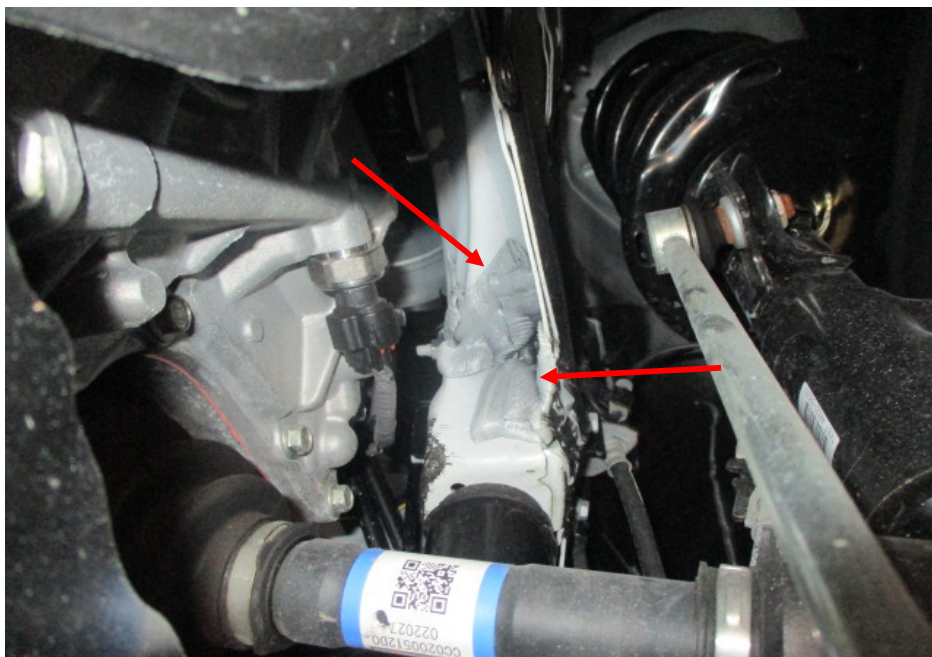
**Photo 30** shows the chassis/structural body at the underside front left of the Motor Car. The original factory sealant (arrowed) at the joints along the chassis/structural body was observed to be untouched. In general, I had found no work was carried out on the chassis/structural body of the Motor Car. The chassis/structural body of the Motor Car was originally fitted.

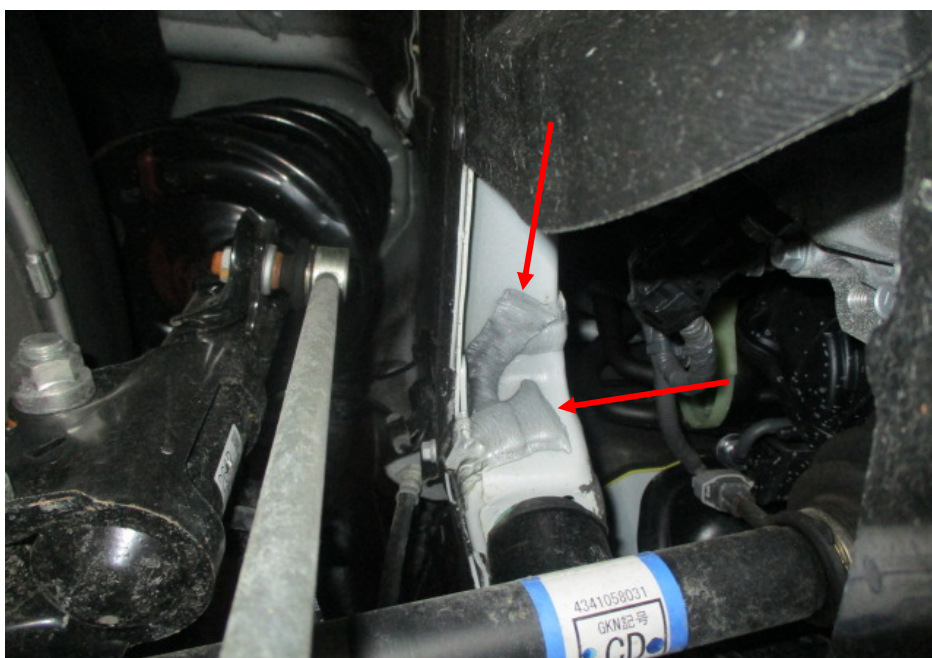
**Photo 31** shows the chassis/structural body at the underside front right of the Motor Car. The original factory sealant (arrowed) at the joints along the chassis/structural body was observed to be untouched. In general, I had found no work was carried out on the chassis/structural body of the Motor Car. The chassis/structural body of the Motor Car was originally fitted.
