Your Ref: Toyota Alphard  
(chassis number AGH309003695)  
Our Ref : CI/TP21008872/D

28 August 2021

**INSPECTION REPORT OF AN UNREGISTERED TOYOTA ALPHARD MOTOR CAR WITH CHASSIS NUMBER AGH309003695**

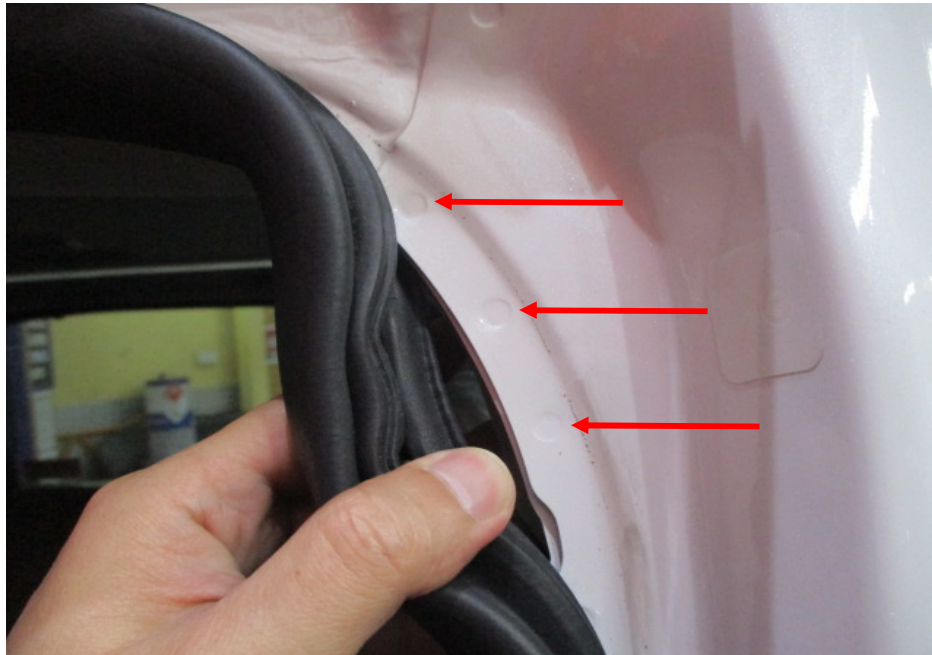
**Photo 32** shows the right side “B” pillar of the Motor Car. I did not find any weld marks other than original spot weld marks (arrowed) on the right side “B” pillar of the Motor Car, which indicates that there was no re-welding works carried out. In general, I had found all the non-detachable body panels of the Motor Car to be originally fitted at the time of my inspection.

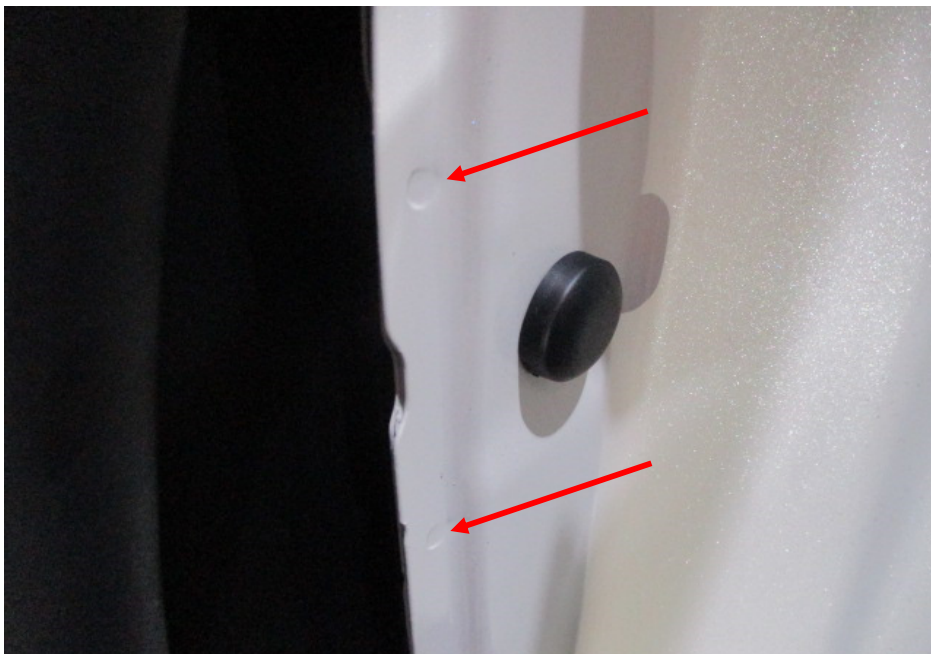
**Photo 33** shows the right side “A” pillar of the Motor Car. I did not find any weld marks other than original spot weld marks (arrowed) on the right side “A” pillar of the Motor Car, which indicates that there was no re-welding works carried out. In general, I had found all the non-detachable body panels of the Motor Car to be originally fitted at the time of my inspection.

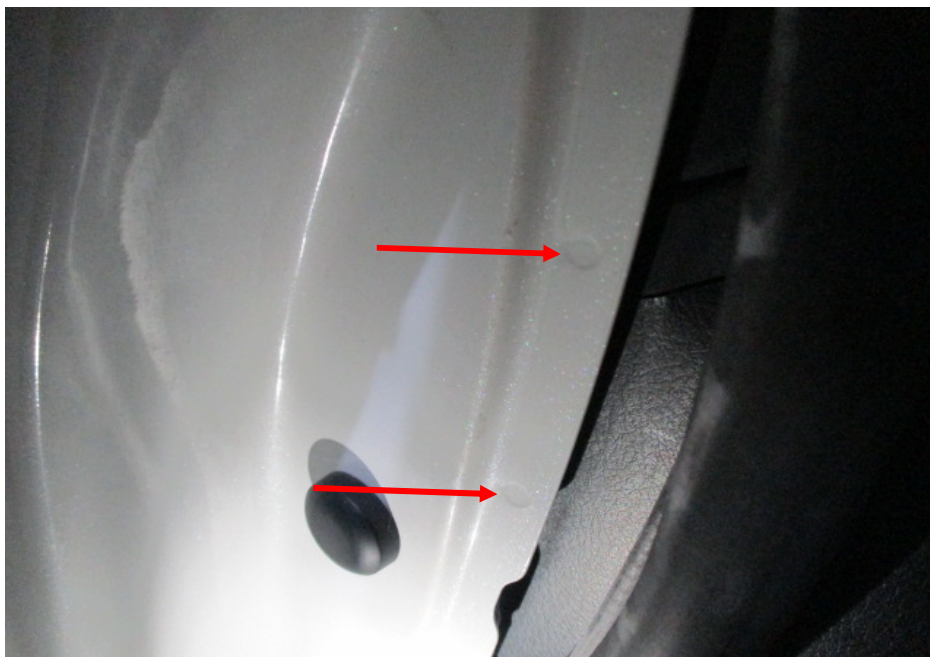
**Photo 34** shows the left side "A" pillar of the Motor Car. I did not find any weld marks other than original spot weld marks (arrowed) on the left side "A" pillar of the Motor Car, which indicates that there was no re-welding works carried out. In general, I had found all the non-detachable body panels of the Motor Car to be originally fitted at the time of my inspection.
