Your Ref: BMW X1
(chassis number WBA72AA0703M57770)
Our Ref : CI/TP21008873/D

28 August 2021

**INSPECTION REPORT OF AN UNREGISTERED BMW X1 MOTOR CAR WITH
CHASSIS NUMBER WBA72AA0703M57770**

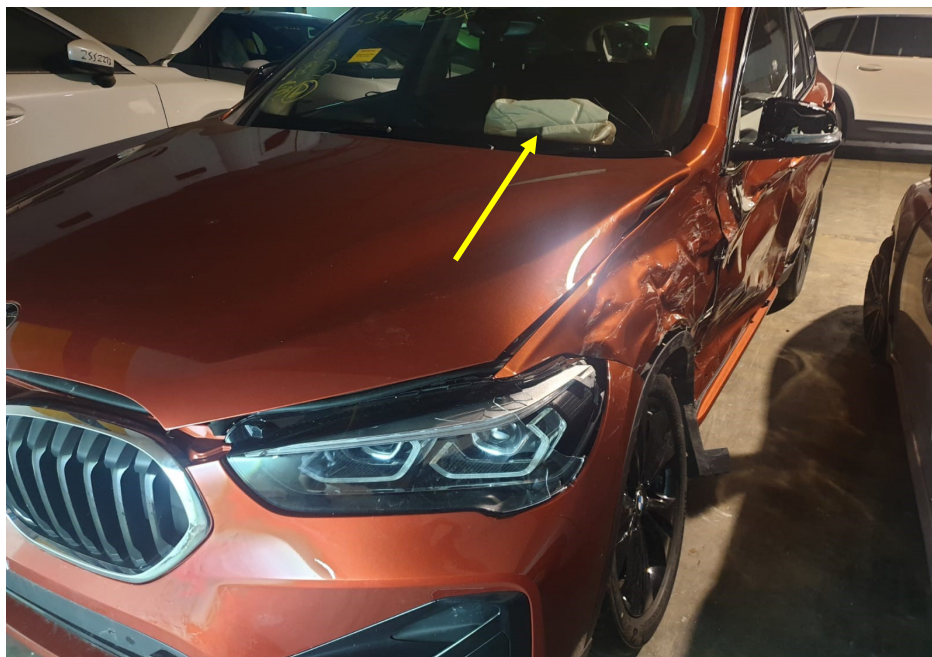
5. The orientation of the Motor Car's front wheels indicate damage to its front undercarriage parts. Possible damaged undercarriage parts include the front left and front right lower arms, front left and front right shock absorbers amongst others. The photographs provided had also showed the Motor Car's front left passenger airbag deployed. See photo 1 – 4 below.

Photo 1 shows the front left body of the Motor Car (photograph provided to me). The Motor Car was observed to have sustained damages along its left side portion. Body parts damaged include the front bumper, front left headlamp, front bonnet, front left fender, front left fender wheel arc garnish, front left door, front left door lower garnish and left side wing mirror amongst others. The front left passenger airbag (arrowed) was deployed.

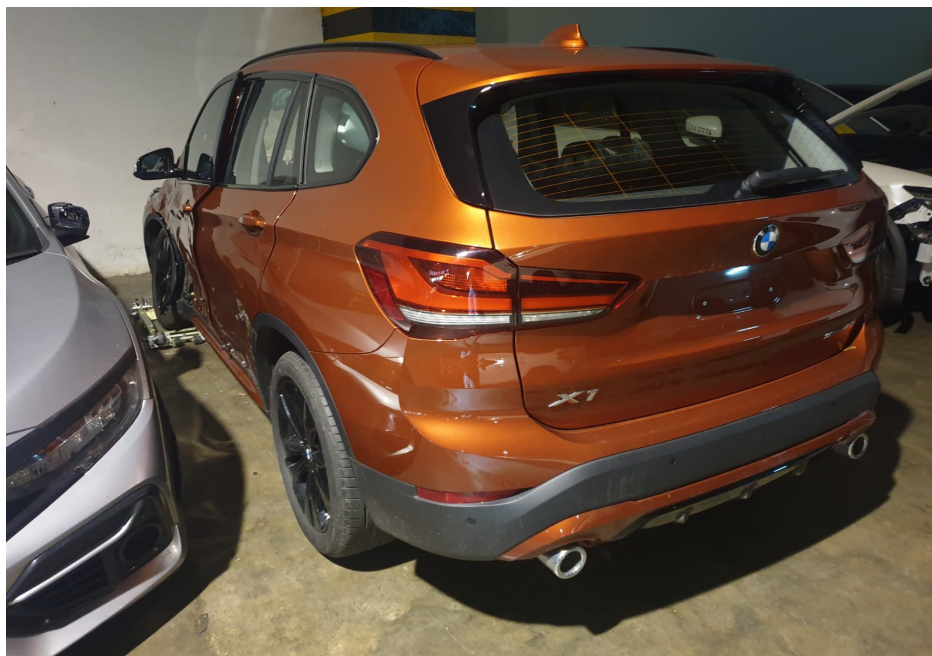
Photo 2 shows the rear left body of the Motor Car (photograph provided to me). Close examination of this photograph had showed damage to the Motor Car's rear left fender wheel arc garnish, rear left door and left side rocker panel garnish amongst others. The front left wheel was also seen to be tilted inwards on a vertical axis, indicating damage to the Motor Car's front left undercarriage parts.

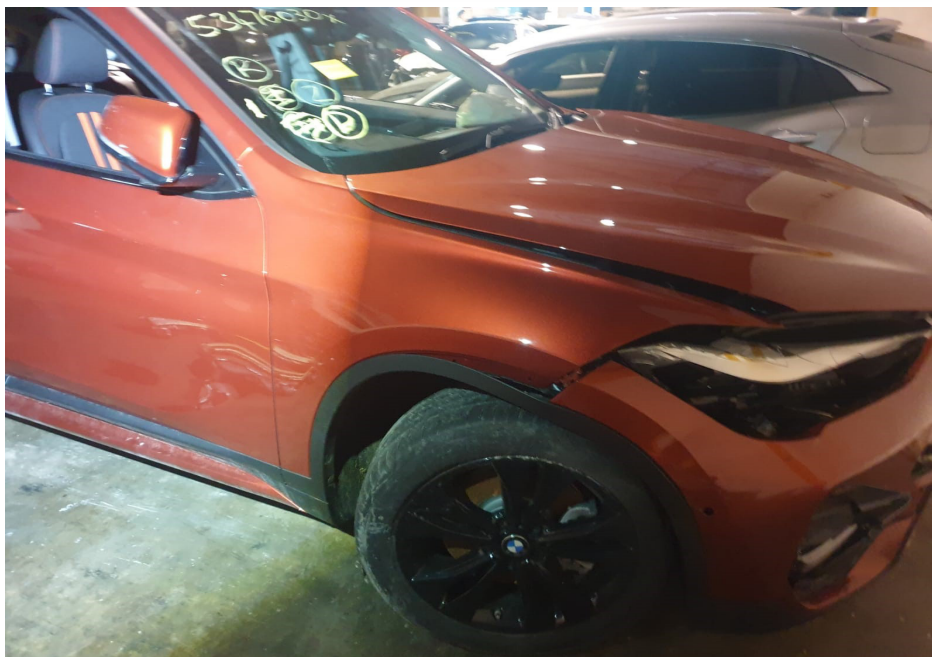
4. Body parts damage at the right front portion include the front bumper right lower grille, front bumper right lower grille garnish, front right headlamp, front right fender wheel arc garnish and front right wheel rim amongst others.

Photo 3 shows the front right body of the Motor Car (photograph provided to me). Apart for the left front portion, there was also physical damage seen to the right front portion of the Motor Car. Body parts damaged include the front bumper right lower grille, front bumper right lower grille garnish, front right headlamp, front right fender wheel arc garnish and front right wheel rim amongst others. The orientation of the Motor Car's front right wheel and front left wheel (refer to photograph 1 and 3 above) indicate damage to its front undercarriage parts. Possible damaged undercarriage parts include the front left and front right lower arms, front left and front right shock absorbers amongst others

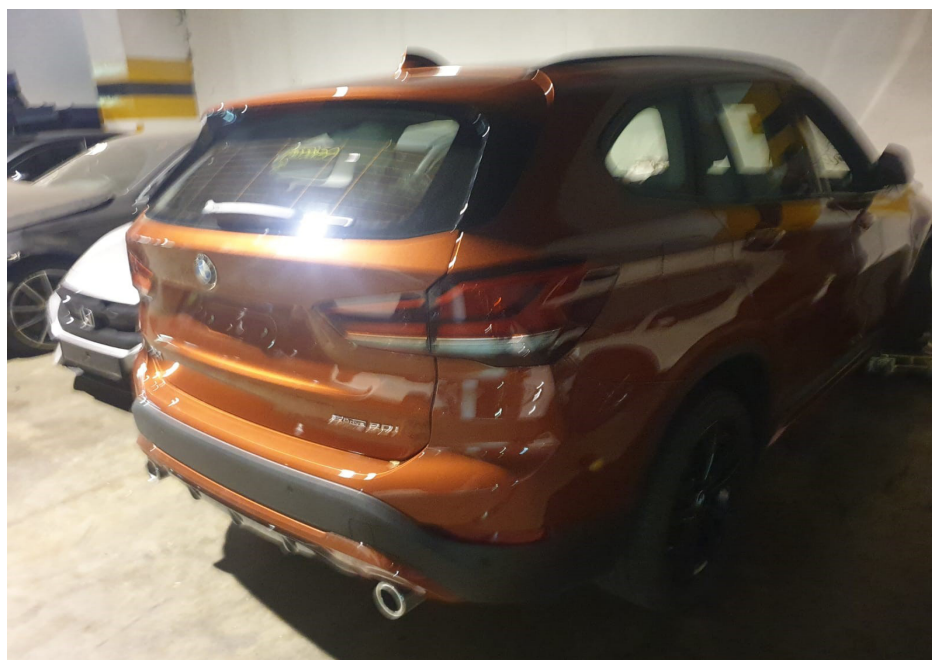
Photo 4 shows the rear right body of the Motor Car (photograph provided to me). No physical damage was observed to the rear portion of the Motor Car.

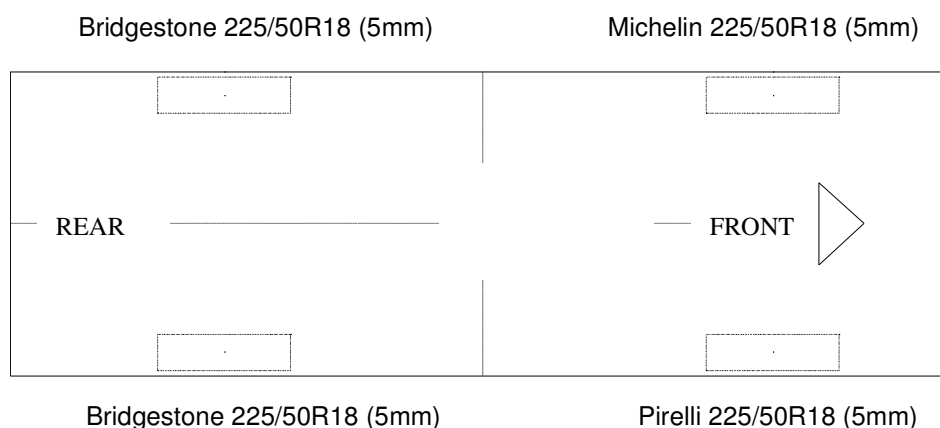
9. It was fitted with 18inch sport wheel rims that were wrapped with tyres that were observed to be of serviceable condition. The tyres were also sufficiently inflated for vehicular operation. The tyre brand, tyre size and approximate remaining tread depth of the 4 tyres of the Motor Car were recorded as follows: -

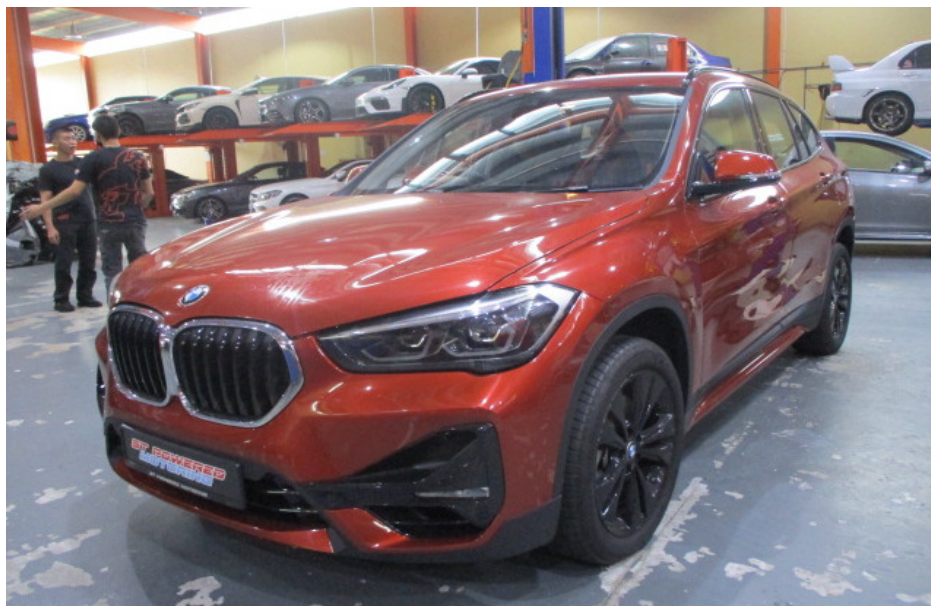
Photo 5 shows a general view of the front left body of the Motor Car at the time of my inspection. The Motor Car was observed to be in a relatively good general condition with no loose exterior fittings observed. The body parts along the left side portion of the Motor Car were visually examined and it was observed that the repair/restoration works carried out to the damaged area of the Motor Car (refer to photograph 1 & 2 above) were reasonably adequate and in order.

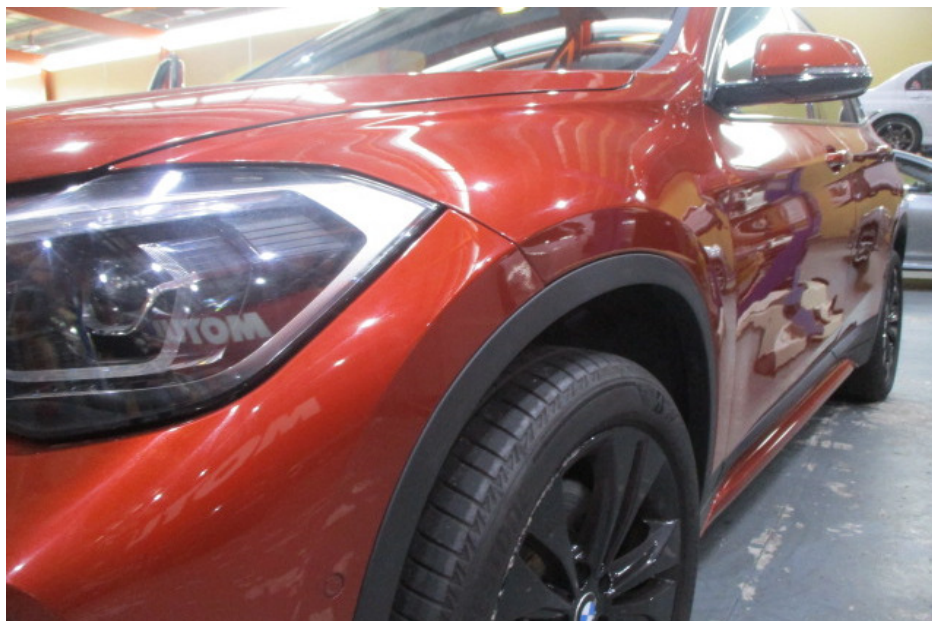
Photo 6 shows a closer view of the front bumper, front left headlamp, front bonnet, front left fender and front left fender wheel arc garnish of the Motor Car at the time of my inspection. The body parts along the left side portion of the Motor Car were visually examined and it was observed that the repair/restoration works carried out to the damaged area of the Motor Car (refer to photograph 1 above) were reasonably adequate and in order.

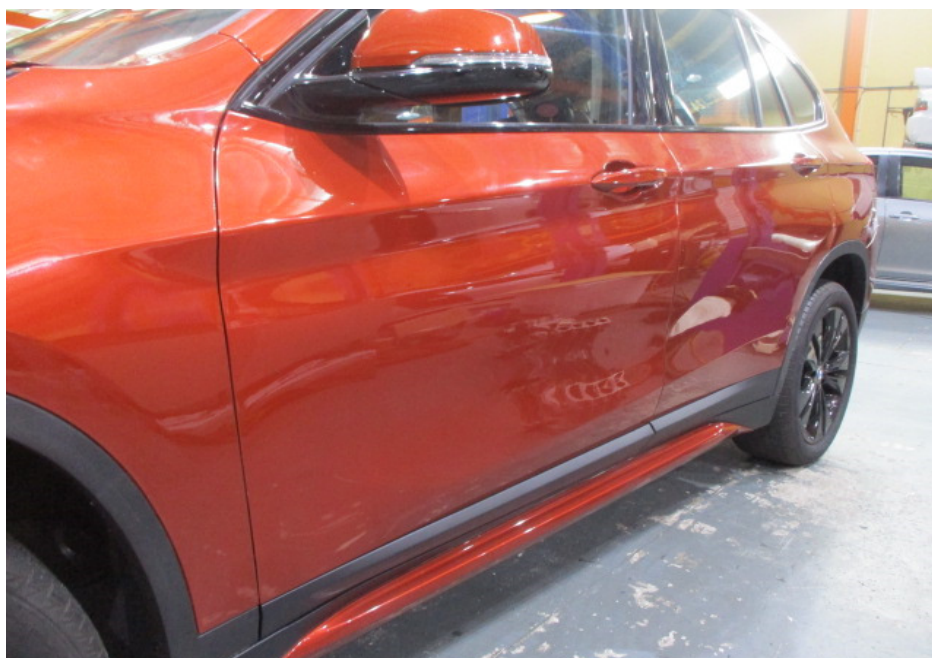
Photo 7 shows a closer view of the Motor Car's left side wing mirror, left side rocker panel garnish, front left door, front left door lower garnish, rear left door and rear left door lower garnish. The body parts along the left side portion of the Motor Car were visually examined and it was observed that the repair/restoration works carried out to the damaged area of the Motor Car (refer to photograph 1 & 2 above) were reasonably adequate and in order.

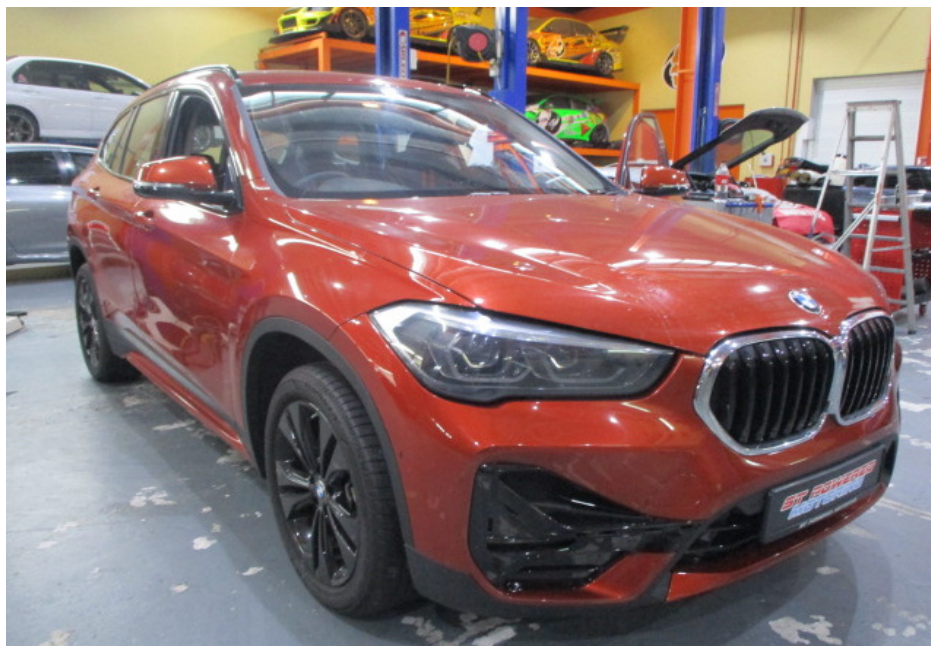
Photo 8 shows a general view of the front right body of the Motor Car at the time of my inspection. The Motor Car was observed to be in a relatively good general condition with no loose exterior fittings observed. The body parts at the right front portion of the Motor Car were visually examined and it was observed that the repair/restoration works carried out to the damaged area of the Motor Car (refer to photograph 3 above) were reasonably adequate and in order.

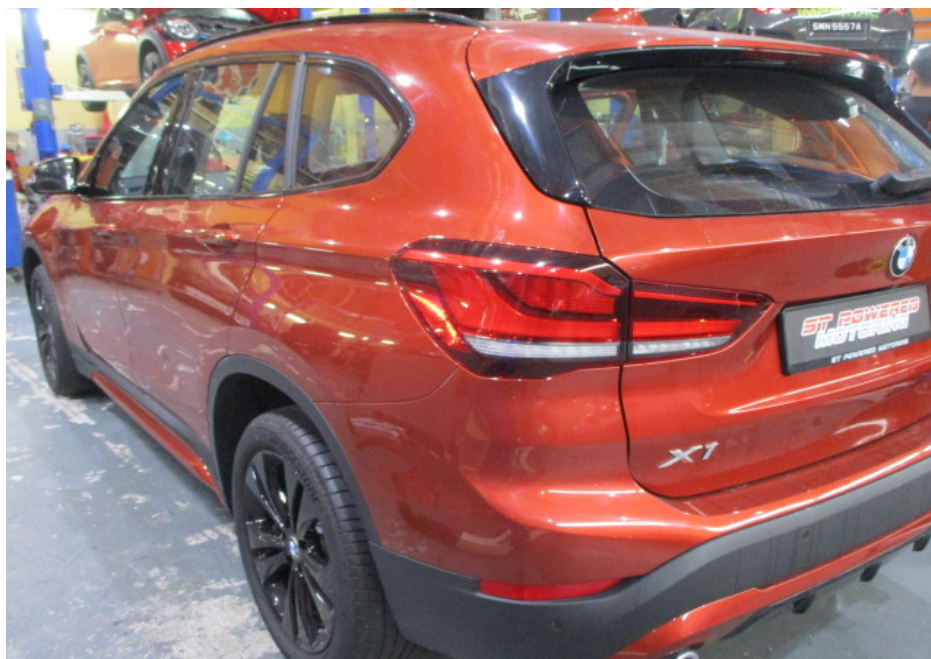
Photo 9 shows a general view of the rear left body of the Motor Car at the time of my inspection. The body parts along the left side portion of the Motor Car were visually examined and it was observed that the repair/restoration works carried out to the damaged area of the Motor Car (refer to photograph 2 above) were reasonably adequate and in order.

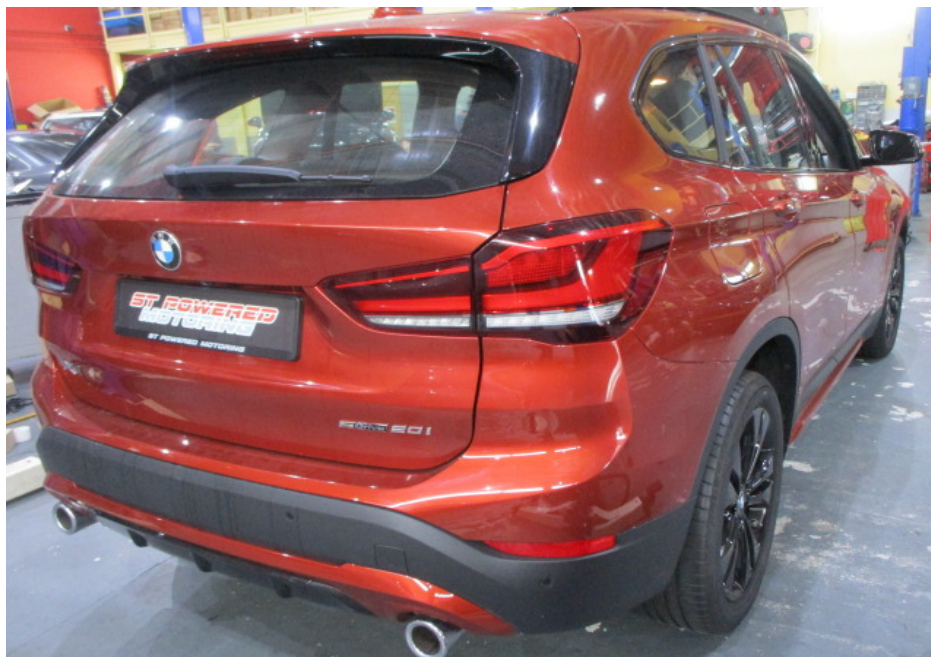
Photo 10 shows a general view of the rear right body of the Motor Car at the time of my inspection. The Motor Car was observed to be in a relatively good general condition with no loose exterior fittings observed. The mileage of the Motor Car recorded at the time of my inspection was 534km.

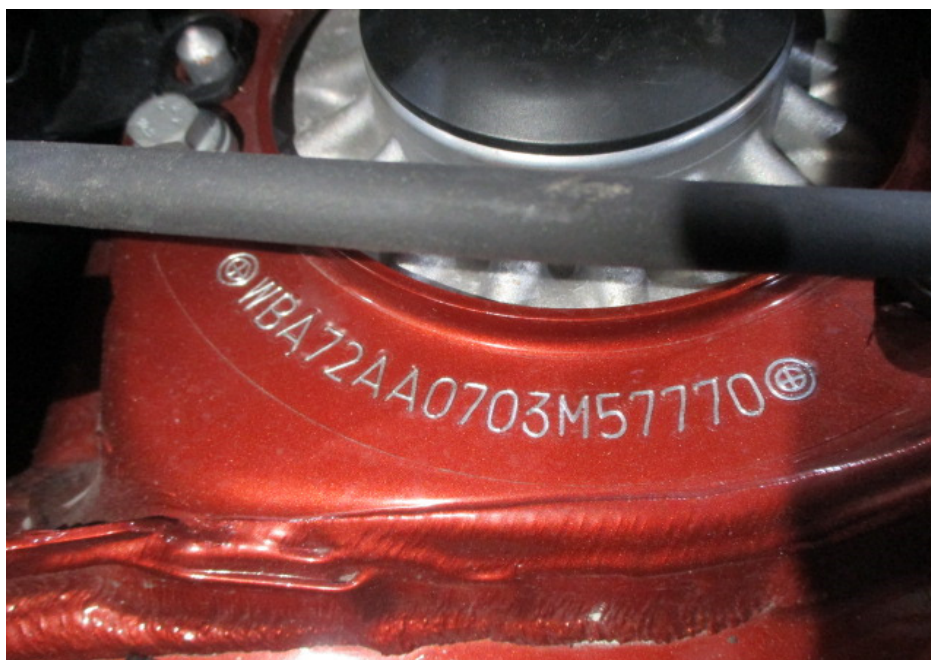
Photo 11 shows the chassis number of the Motor Car. The chassis number recorded was WBA72AA0703M57770.

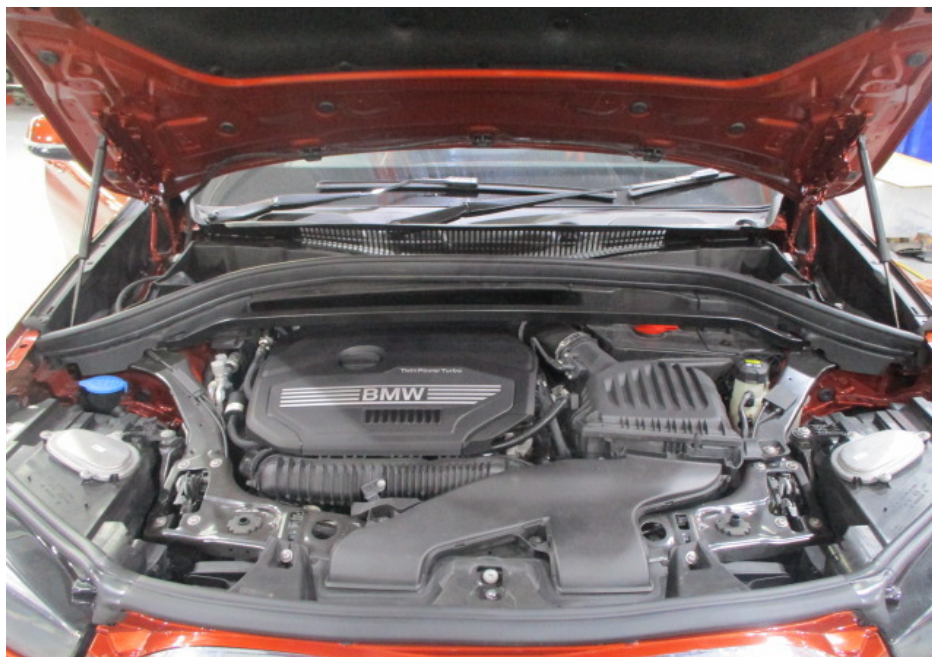
15. My examination of the engine compartment of the Motor Car revealed that the various parts and components inside the engine compartment were all intact and properly fitted. The engine oil, brake fluid and engine coolant were all found to be of sufficient level for operating purposes. Visually, there was also no contamination found to these fluids.

Photo 12 shows a general view of the engine compartment of the Motor Car at the time of my inspection. The various parts and components inside the engine compartment were all observed to be intact and properly fitted. There was also no sign(s) or indication(s) of fluid leak and/or fluid stain found inside the engine compartment.

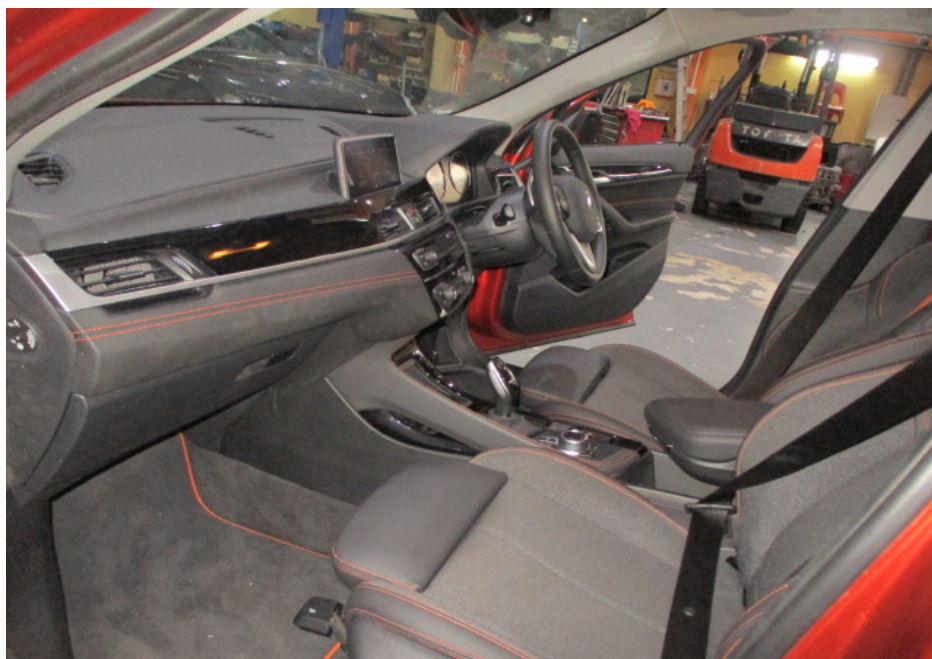
Photo 13 shows a general view of the interior compartment of the Motor Car at the time of my inspection. The various parts and components, trims, carpet and upholstery inside the interior compartment were all observed to be intact and properly fitted.

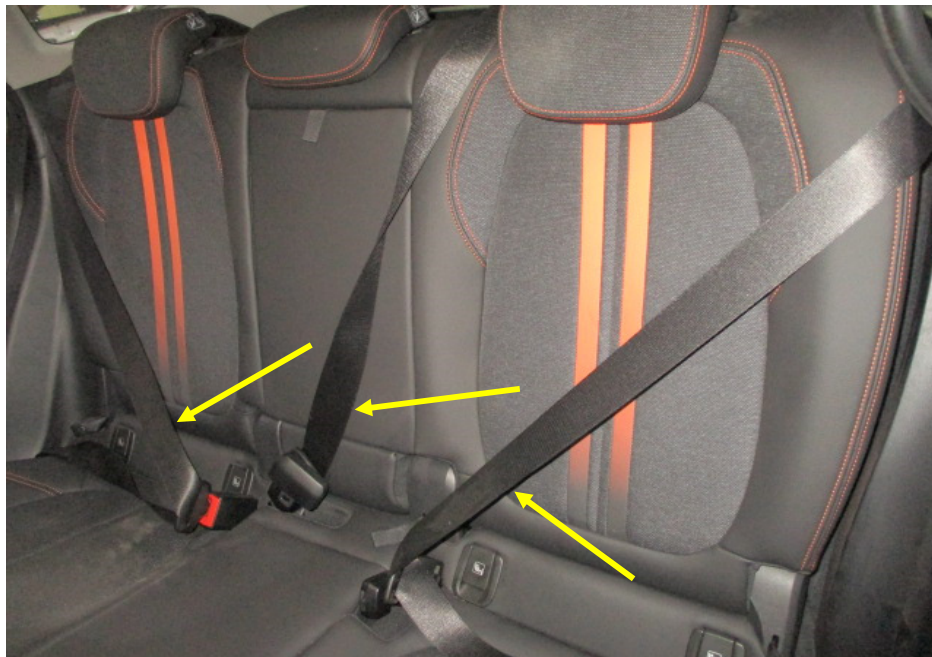
13. The seats of the Motor Car were found to be secured to the floorboard of the Motor Car via seat rails bolted onto the floorboard. Retractable seat belt reels and pre-tensioners were fitted on all seats of the Motor Car. The seat belts were tested and were able to be fastened securely into the respective pre-tensioners that were fixed to the side of all the seats.

Photo 14 shows the rear seats of the Motor Car. All the seats of the Motor Car were secured via seat rails to the floorboard. They were also fitted with a retractable seat belt reel and a pre-tensioner. The seat belts (arrowed) were tested and were able to be fastened into the respective pre-tensions that were fitted on the side of each individual seat.

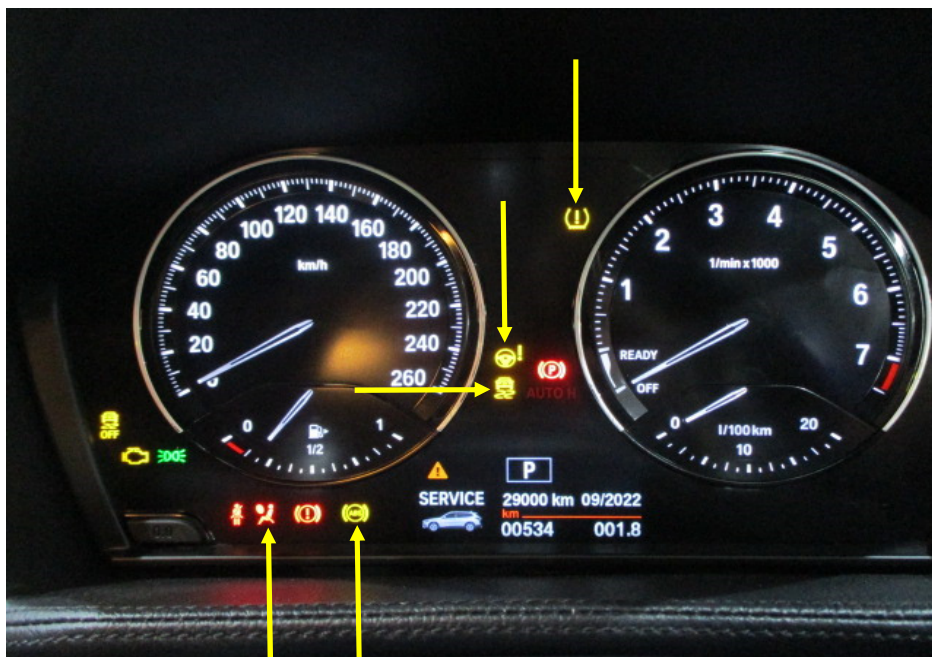
Photo 15 shows the warning lights for the various electronic safety features appearing on the instrument panel of the Motor Car during its self-test when the engine is cranked, in particular the ABS, SRS, IAS, TPM and DSC lights (arrowed).

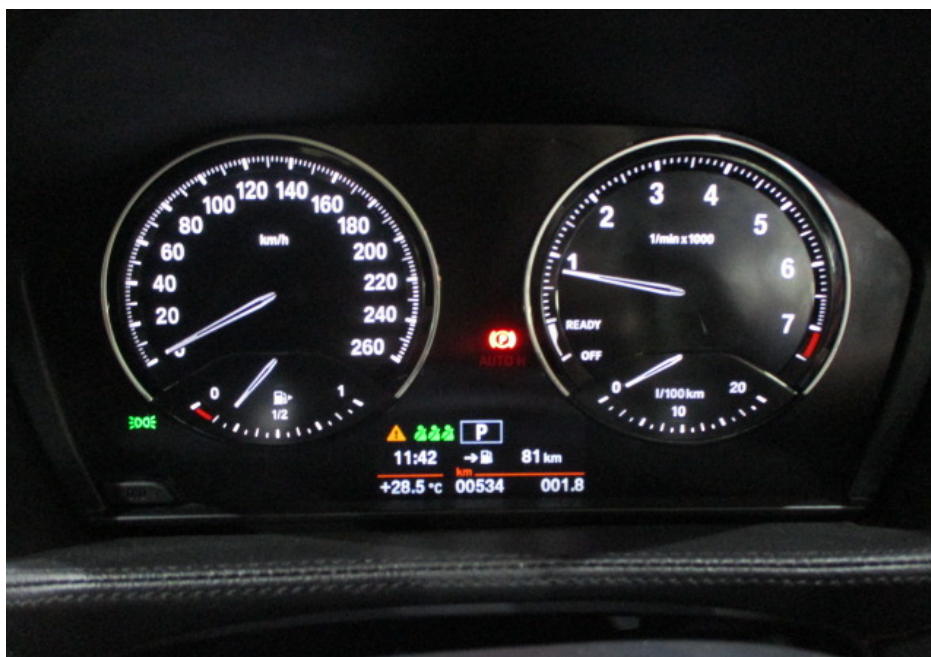
14. The Motor Car's automatic self-test of the functionality of its various electronic safety features like the Anti-Lock Brake System (ABS), Supplemental Restraint System (SRS), Integral Active Steering (IAS), Tyre Pressure Monitor (TPM) and Dynamic Stability Control (DSC) during cranking of the engine had indicated that these electronic systems were in working condition. This was determined from the respective warning lights disappearing from the instrument panel after the self-test.

Photo 16 shows the respective warning lights no longer illuminated, indicating that there is no fault detected to the ABS, SRS, IAS, TPM and DSC systems of the Motor Car during the self-test. These electronic systems were hence in working condition at the time of my inspection.

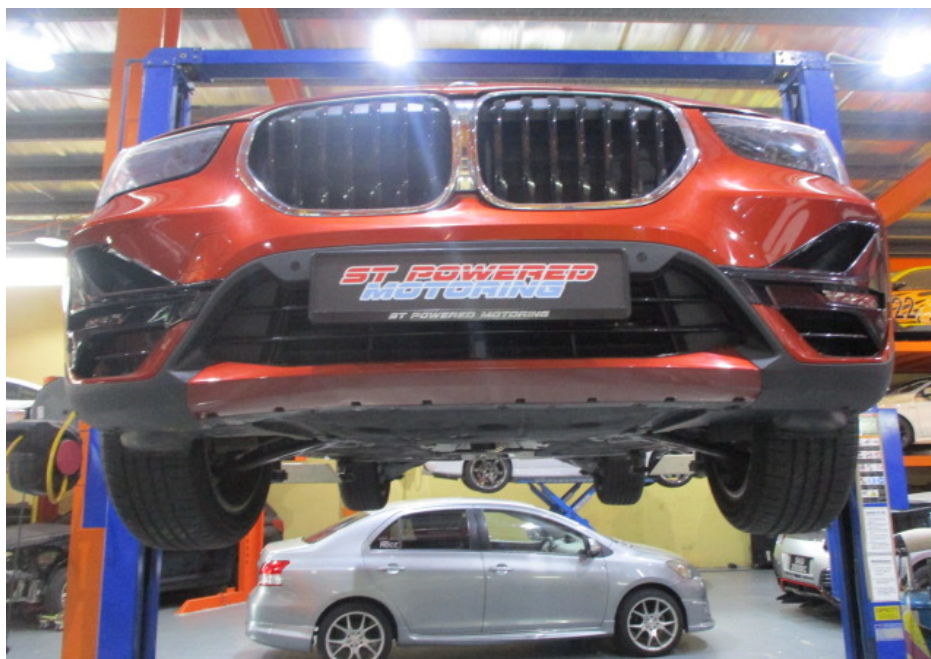
16. My checks on the underside of the Motor Car revealed no sign(s) or indication(s) of fluid leakage and/or fluid stain(s). The engine block and automatic transmission assembly were both secured properly. All undercarriage components of the Motor Car were also observed to be intact and secured in an appropriate manner.

Photo 17 shows the Motor Car hoisted up for checks on its undercarriage. There was no sign(s) or indication(s) of fluid leakage and/or fluid stain(s) on the underside of the Motor Car. The undercarriage components of the Motor Car were also all observed to be intact and secured in an appropriate manner.

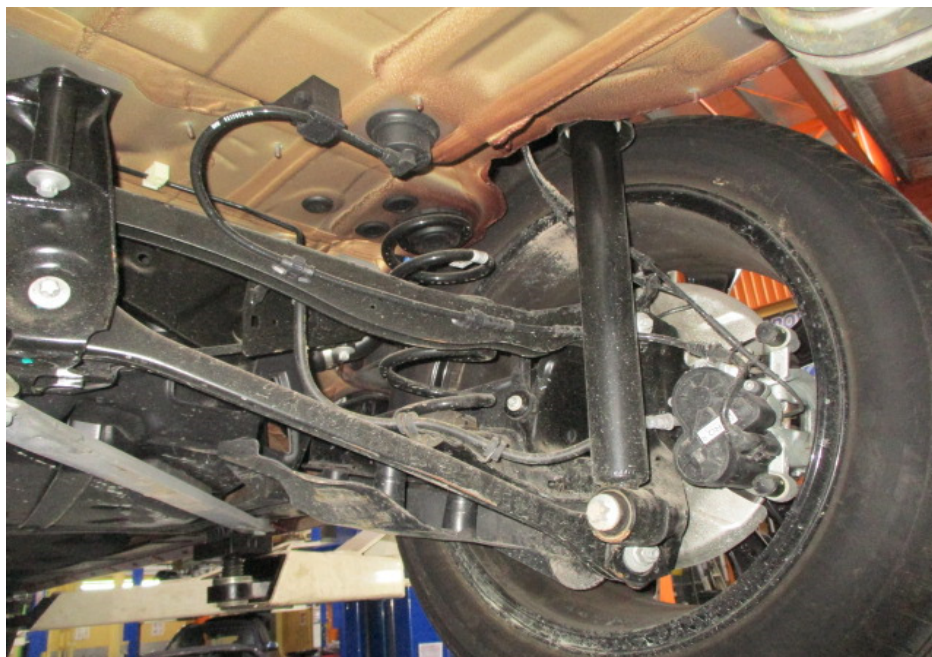
Photo 18 shows a general view of the control arms and linkages at the rear right wheel of the Motor Car. I did not observe any fluid leak and/or fluid stain on the underside of the Motor Car. All of the Motor Car's undercarriage components were observed to be intact and secured in an appropriate manner.

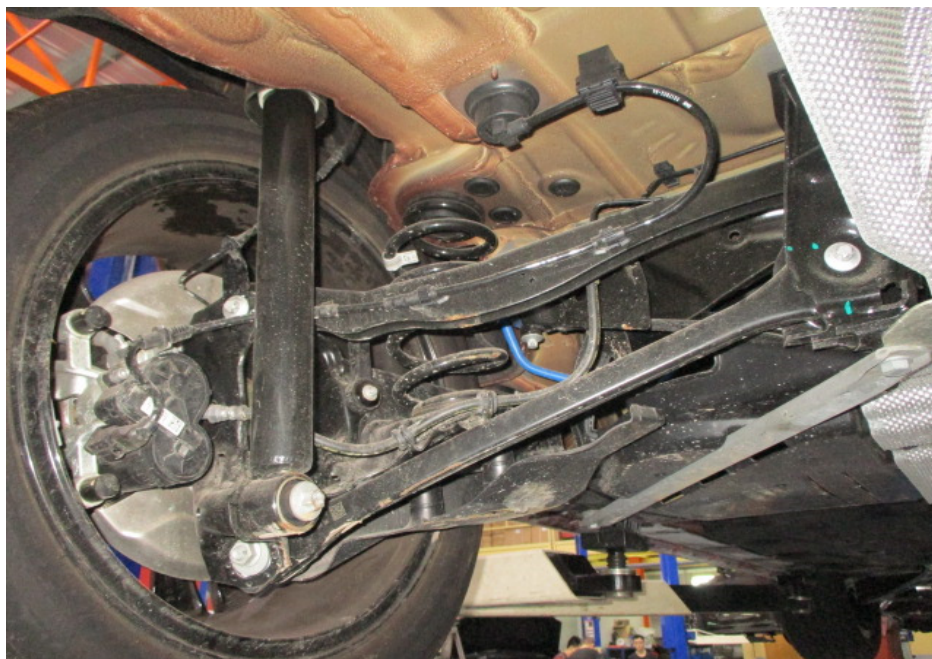
Photo 19 shows a general view of the control arms and linkages at the rear left wheel of the Motor Car. I did not observe any fluid leak and/or fluid stain on the underside of the Motor Car. All of the Motor Car's undercarriage components were observed to be intact and secured in an appropriate manner.

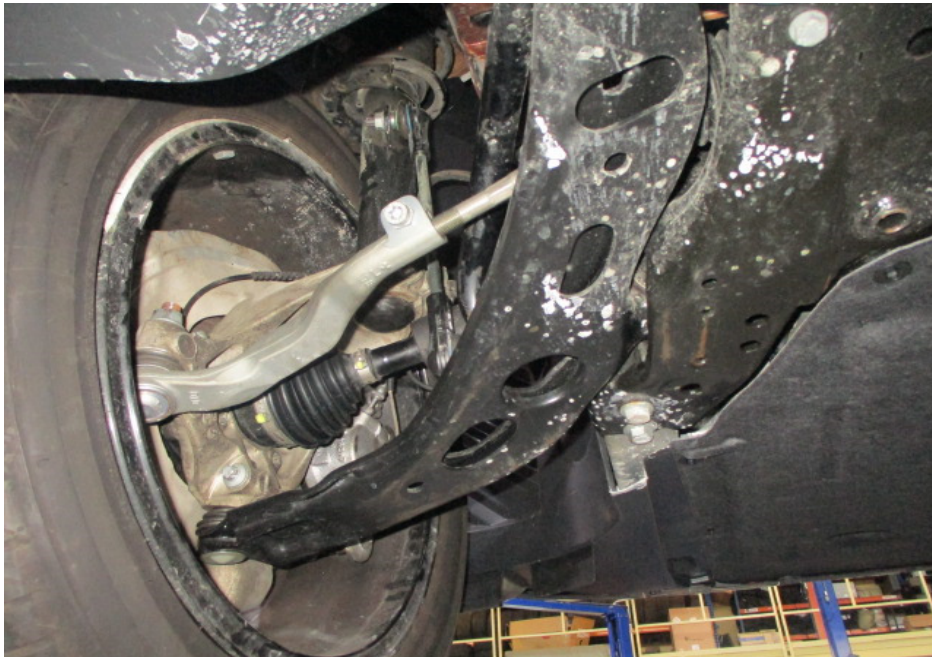
Photo 20 shows the various undercarriage components at the front left wheel of the Motor Car. The mechanical components, control arms and linkages were all found to be intact and secured in an appropriate manner.

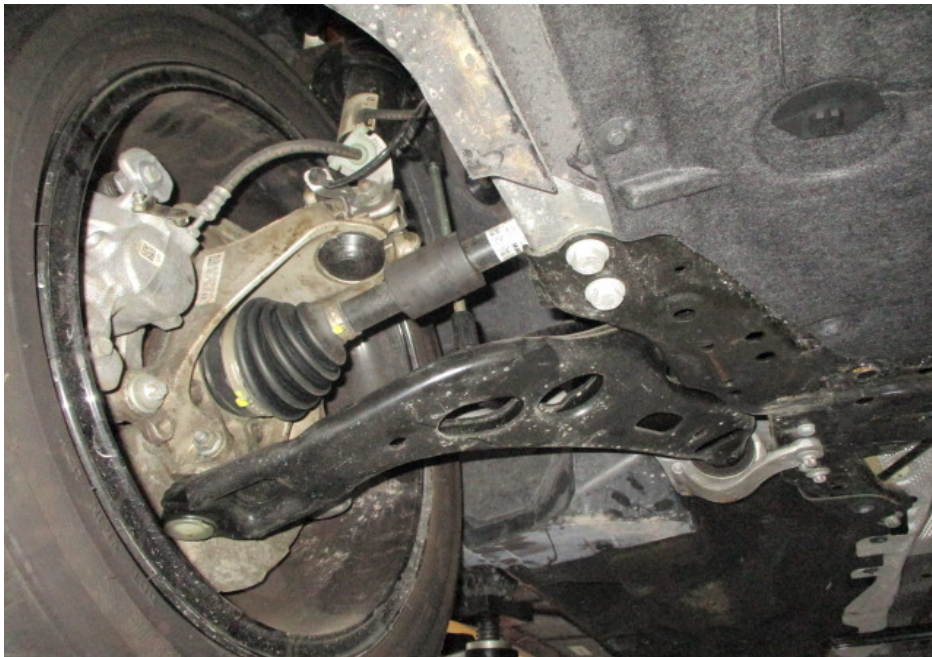
Photo 21 shows the various undercarriage components at the front right wheel of the Motor Car. The mechanical components, control arms and linkages were all found to be intact and secured in an appropriate manner. I also did not observe any fluid leak and/or fluid stain on the underside of the Motor Car.

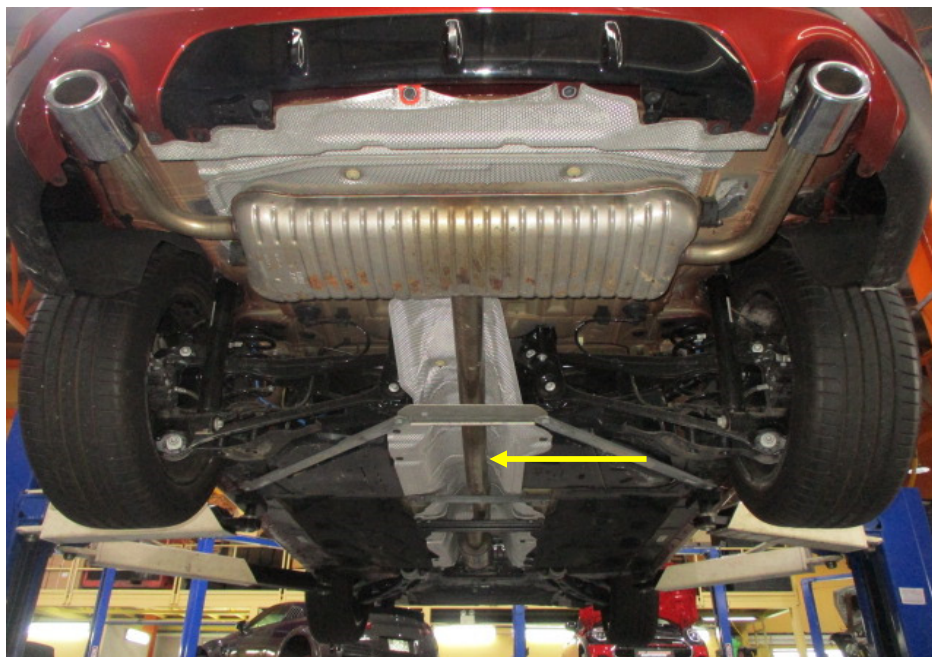
Photo 22 shows a general view of the rear section of the Motor Car's exhaust system. My examination of the Motor Car's exhaust system revealed no sign(s) or indication(s) of any cut or weld marks along its exhaust pipes (arrowed), on its catalytic converter, on its centre resonator box and on its rear muffler.

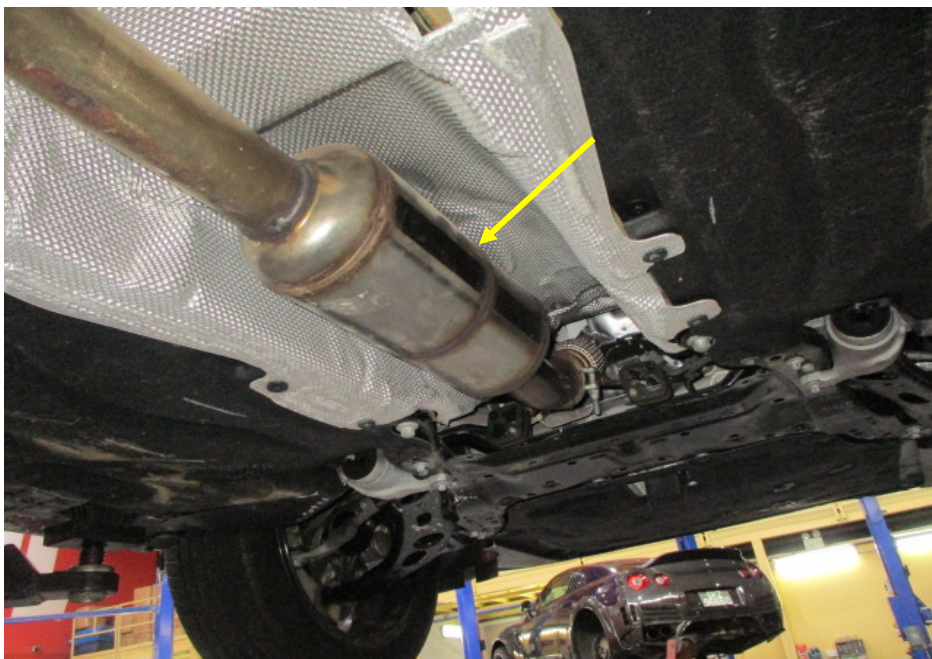
Photo 23 shows a general view of the front section of the Motor Car's exhaust system. My examination of the Motor Car's exhaust system revealed no sign(s) or indication(s) of any cut or weld marks along its exhaust pipes, on its catalytic converter, on its centre resonator box (arrowed) and on its rear muffler.

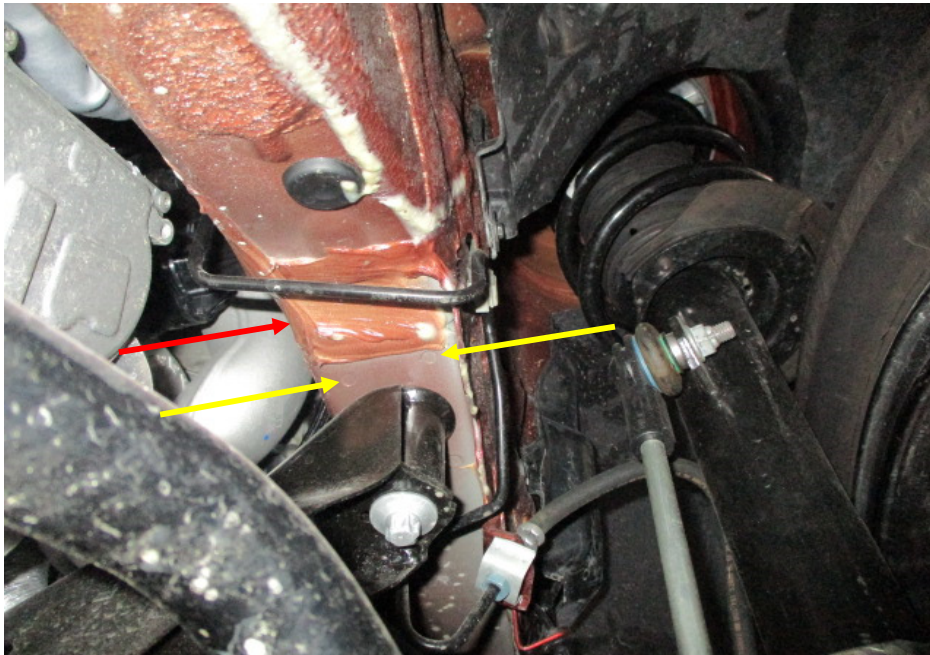
12. Visually, I did not find any weld marks, other than the original spot weld marks, on the chassis/structural body of the Motor Car. The original factory sealant at the joints along the chassis/structural body was also untouched, again indicating that no replacement of the chassis/structural body was carried out; and that the chassis/structural body was originally fitted.

Photo 24 shows the chassis/structural body at the underside front right of the Motor Car. I did not find any weld marks other than original spot weld marks (yellow arrow) on the chassis/structural body of the Motor Car. The original factory sealant (red arrow) at the joints along the chassis/structural body was untouched, indicating no work was done on the chassis/structural body of the Motor Car and that the chassis/structural body was originally fitted.

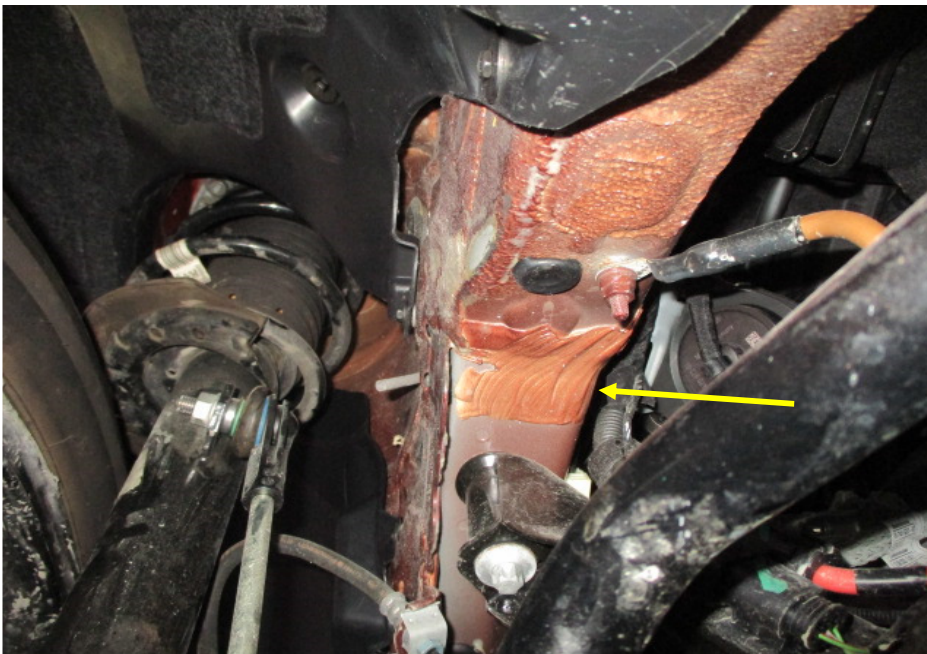
Photo 25 shows the chassis/structural body at the underside front left of the Motor Car. The original factory sealant (arrowed) at the joints along the chassis/structural body was observed to be untouched. In general, I had found no work was carried out on the chassis/structural body of the Motor Car. The chassis/structural body of the Motor Car was originally fitted.

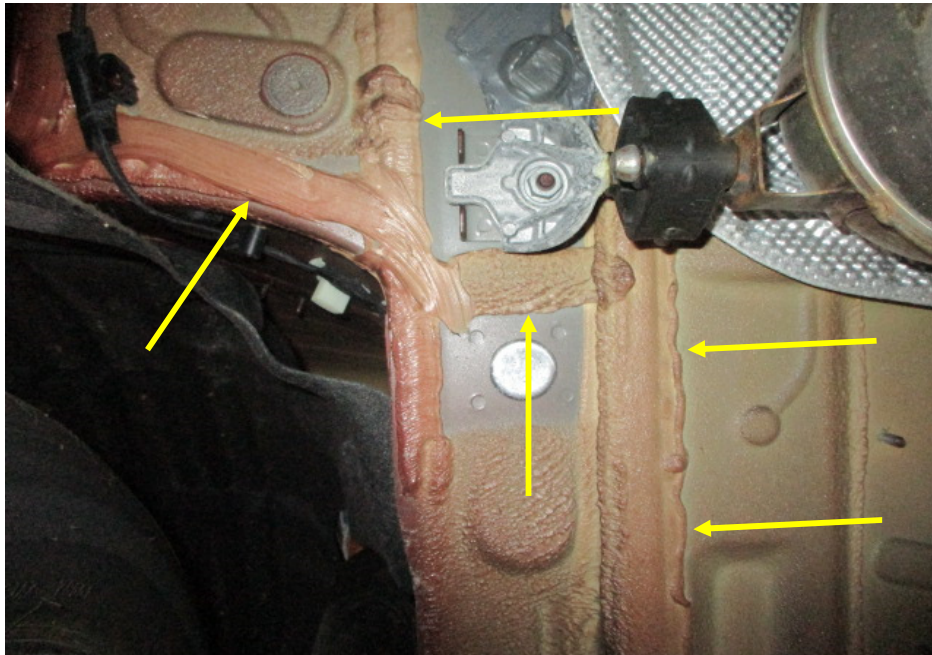
Photo 26 shows the chassis/structural body at the underside rear left of the Motor Car. The original factory sealant (arrowed) at the joints along the chassis/structural body was observed to be untouched. In general, I had found no work was carried out on the chassis/structural body of the Motor Car. The chassis/structural body of the Motor Car was originally fitted.

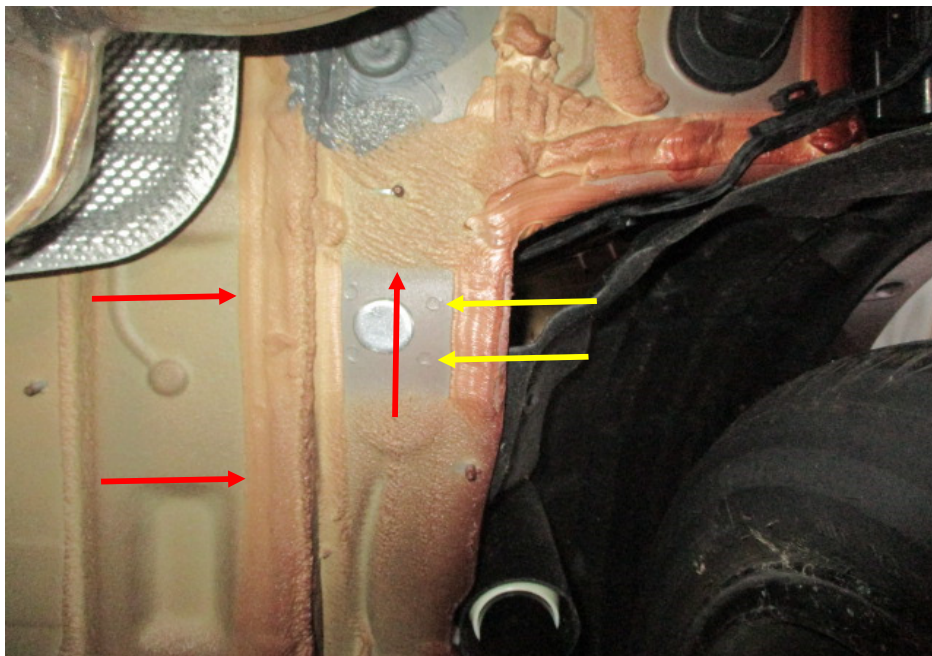
Photo 27 shows the chassis/structural body at the underside rear right of the Motor Car. I did not find any weld marks other than original spot weld marks (yellow arrow) on the chassis/structural body of the Motor Car. The original factory sealant (red arrow) at the joints along the chassis/structural body was untouched, indicating no work was done on the chassis/structural body of the Motor Car and that the chassis/structural body was originally fitted.

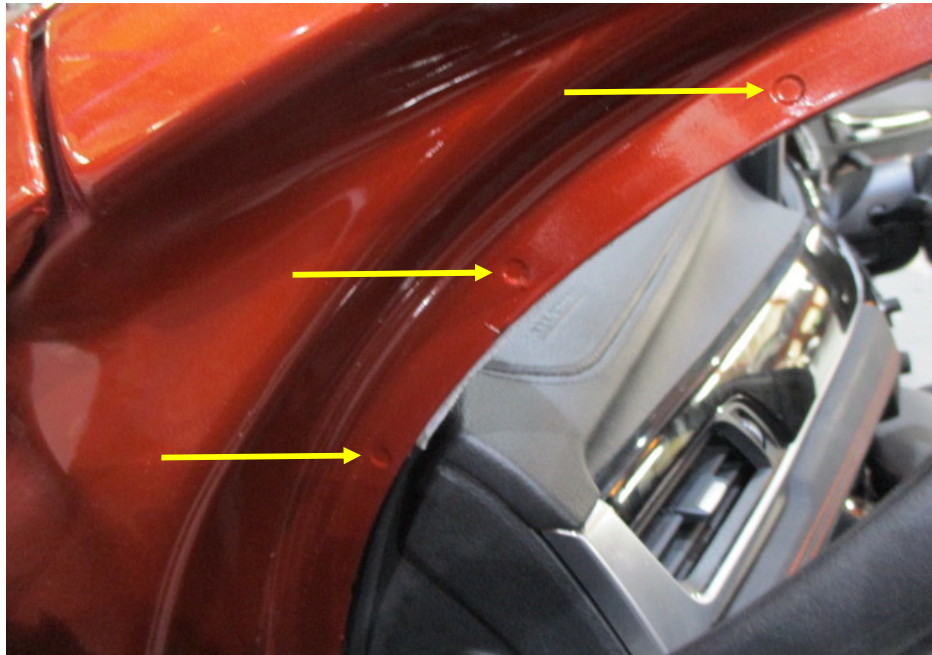
Photo 28 shows the left side "A" pillar of the Motor Car. I did not find any weld marks other than original spot weld marks (arrowed) on the left side "A" pillar of the Motor Car, which indicates that there was no re-welding works carried out. In general, I had found all the non-detachable body panels of the Motor Car to be originally fitted at the time of my inspection.

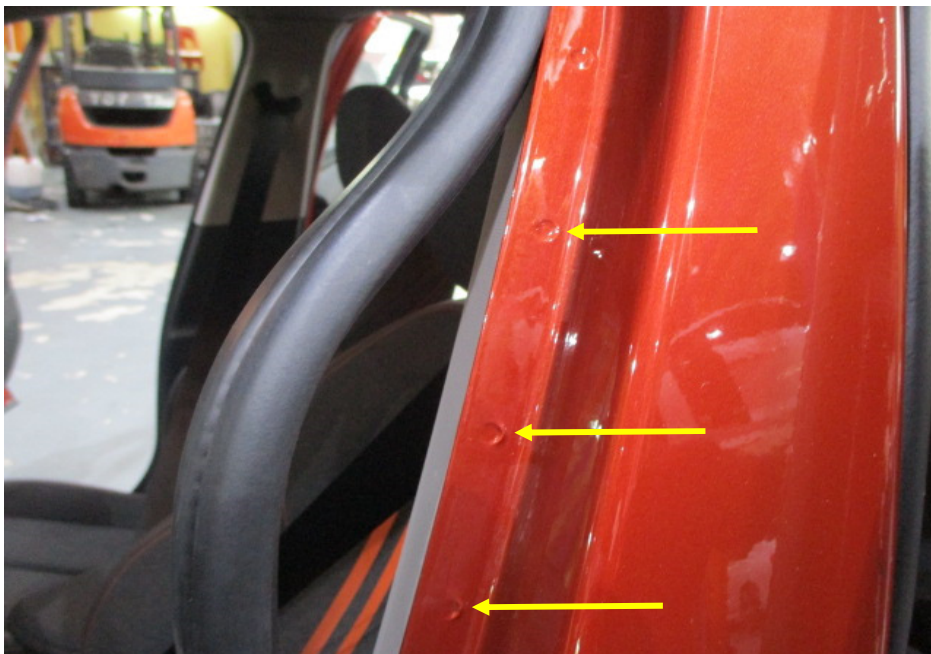
Photo 29 shows the left side "B" pillar of the Motor Car. I did not find any weld marks other than original spot weld marks (arrowed) on the left side "B" pillar of the Motor Car, which indicates that there was no re-welding works carried out. In general, I had found all the non-detachable body panels of the Motor Car to be originally fitted at the time of my inspection.

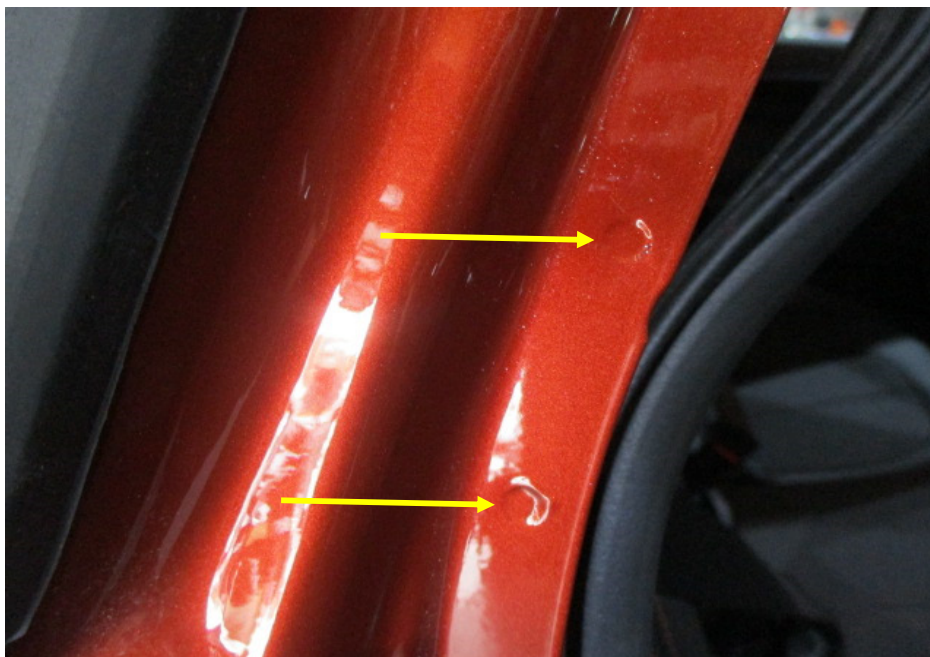
Photo 30 shows the right side "C" pillar of the Motor Car. I did not find any weld marks other than original spot weld marks (arrowed) on the right side "C" pillar of the Motor Car, which indicates that there was no re-welding works carried out. In general, I had found all the non-detachable body panels of the Motor Car to be originally fitted at the time of my inspection.
