**MAKE/MODEL: HONDA CBR1000RR FIREBLADE
REGISTRATION NO: FBJ2330H**

VEHICLE APPRAISAL REPORT

The vehicle sustained damages on front & both sides.

ASSESSMENT FOR REPAIR : FBJ2330H

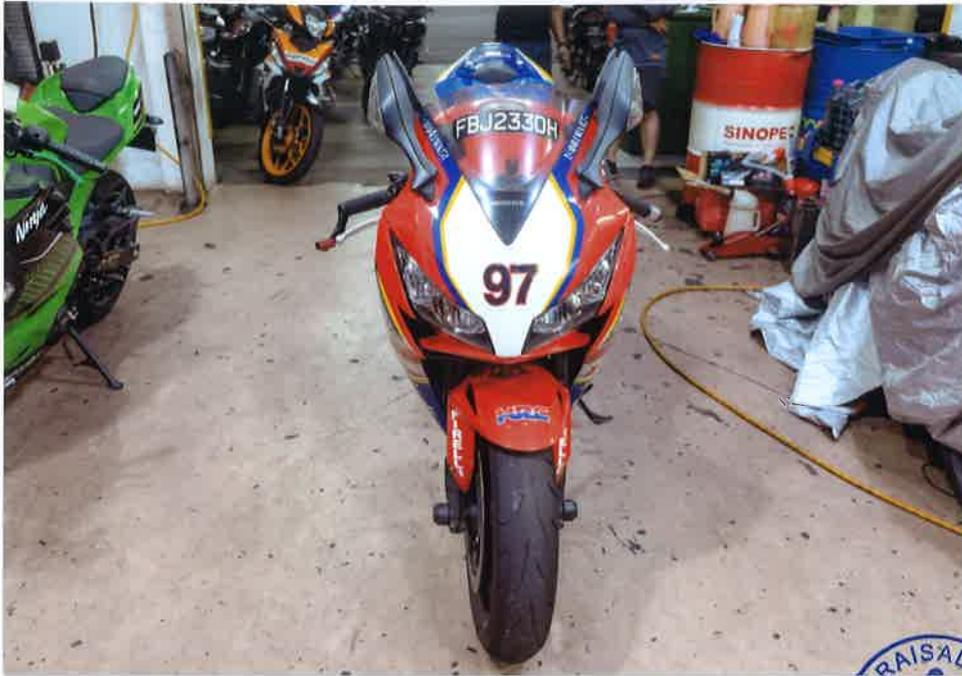
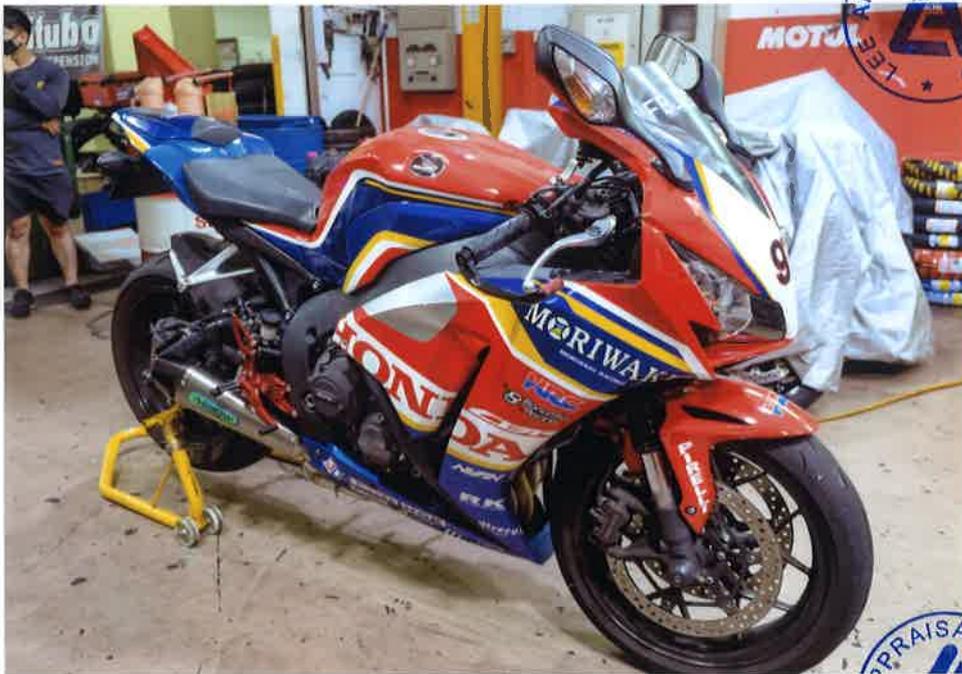
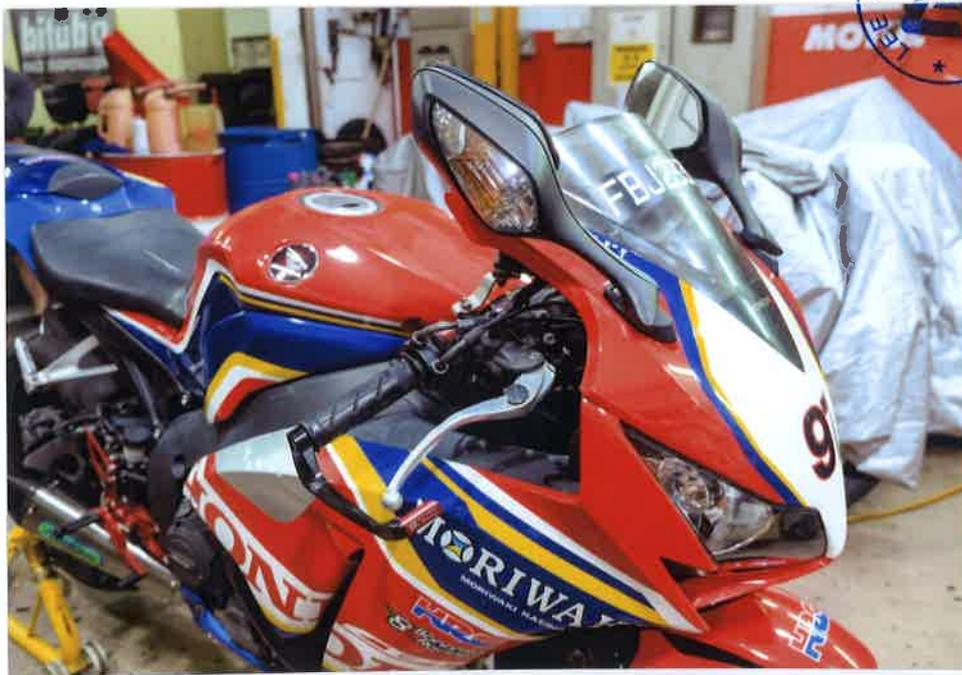
After Repair

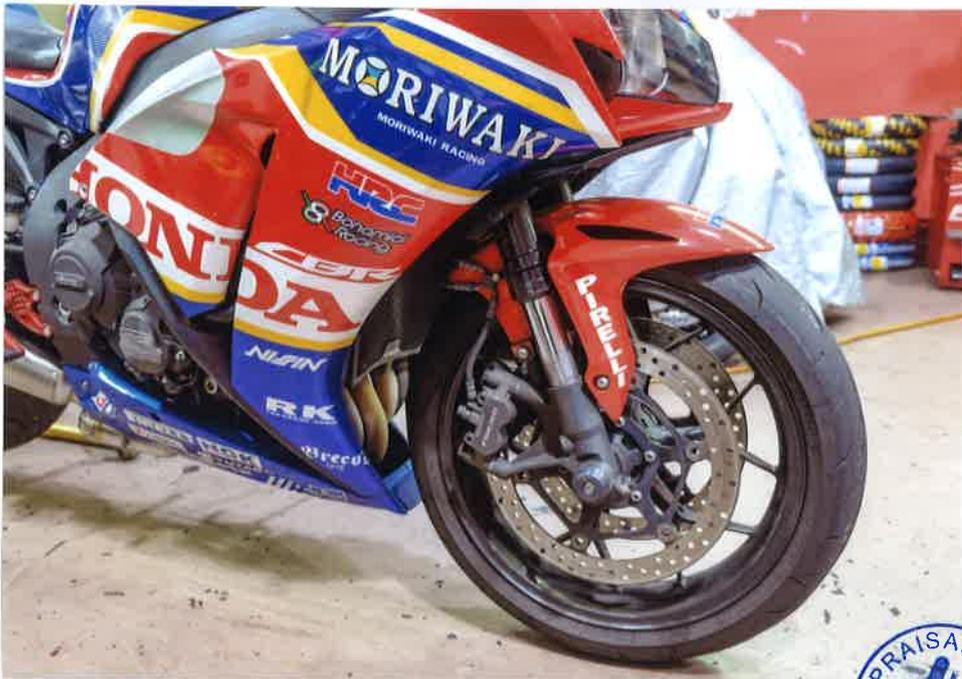
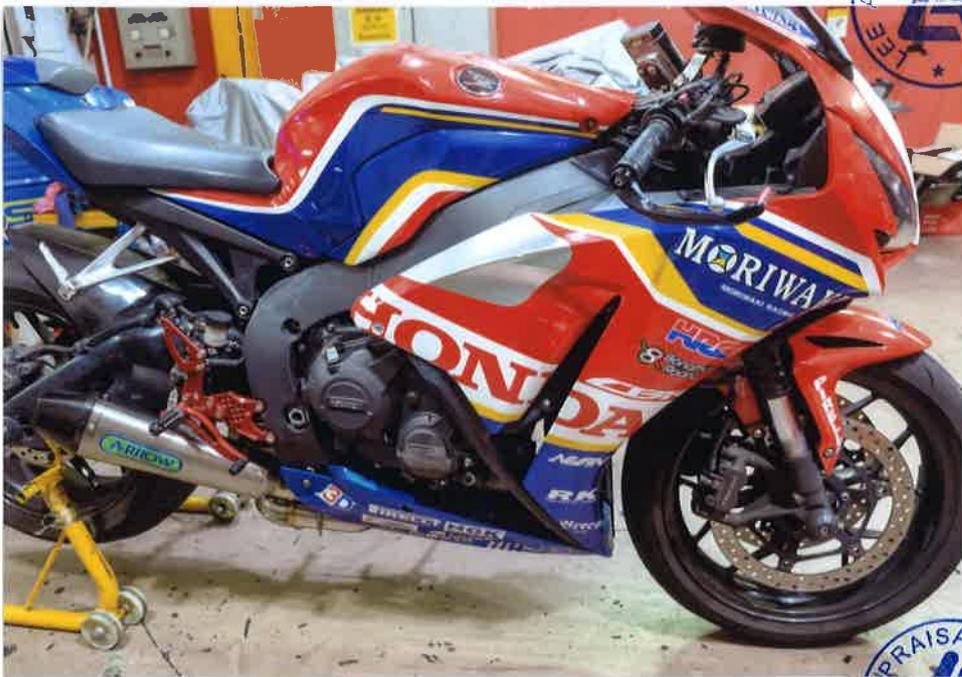
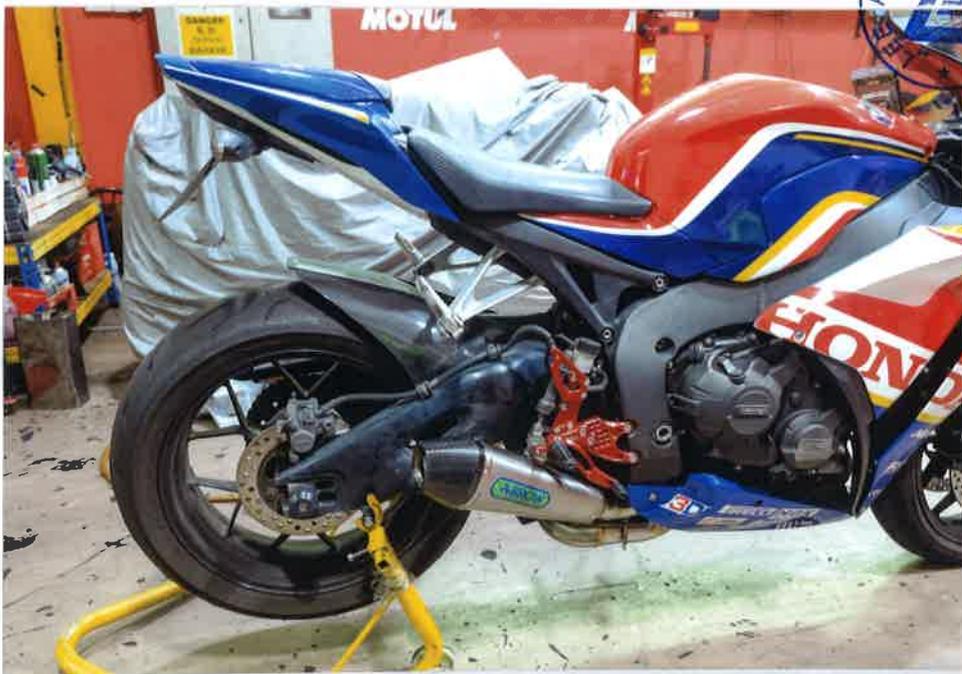
After Repair

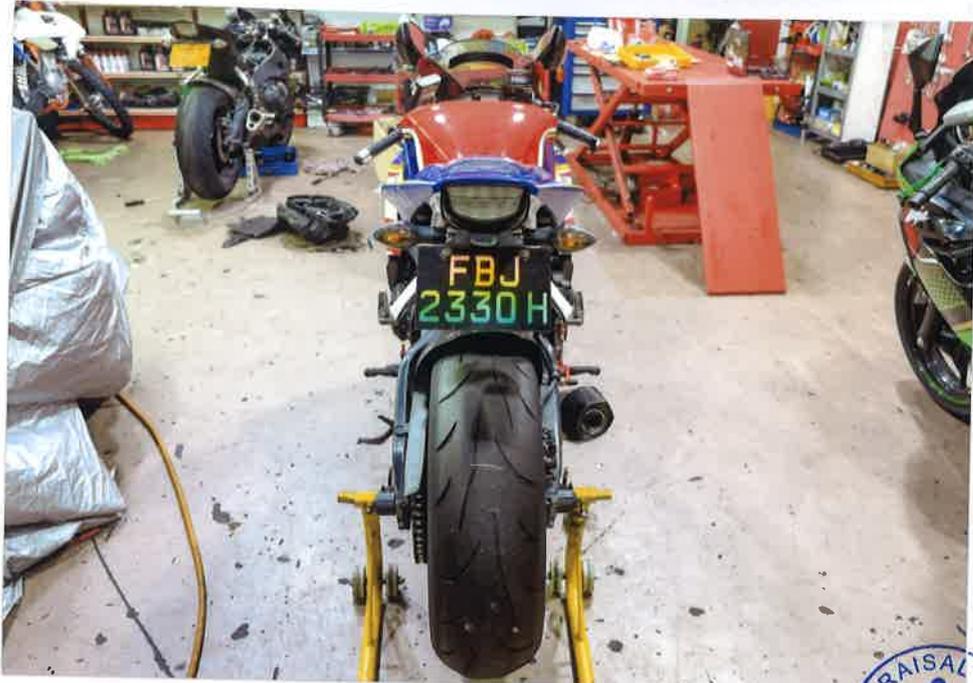
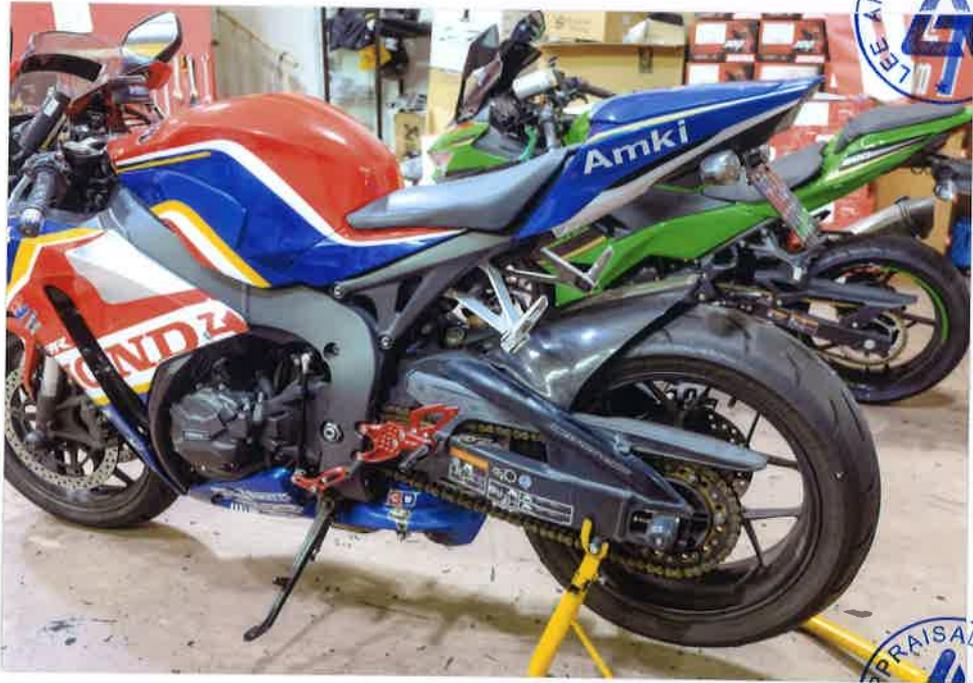
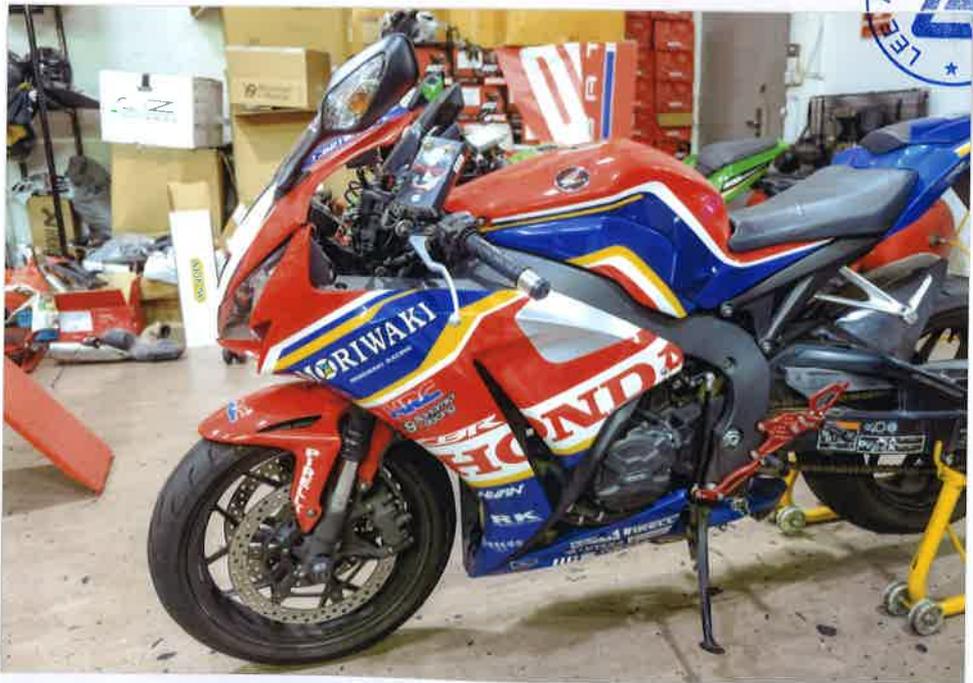
After Repair

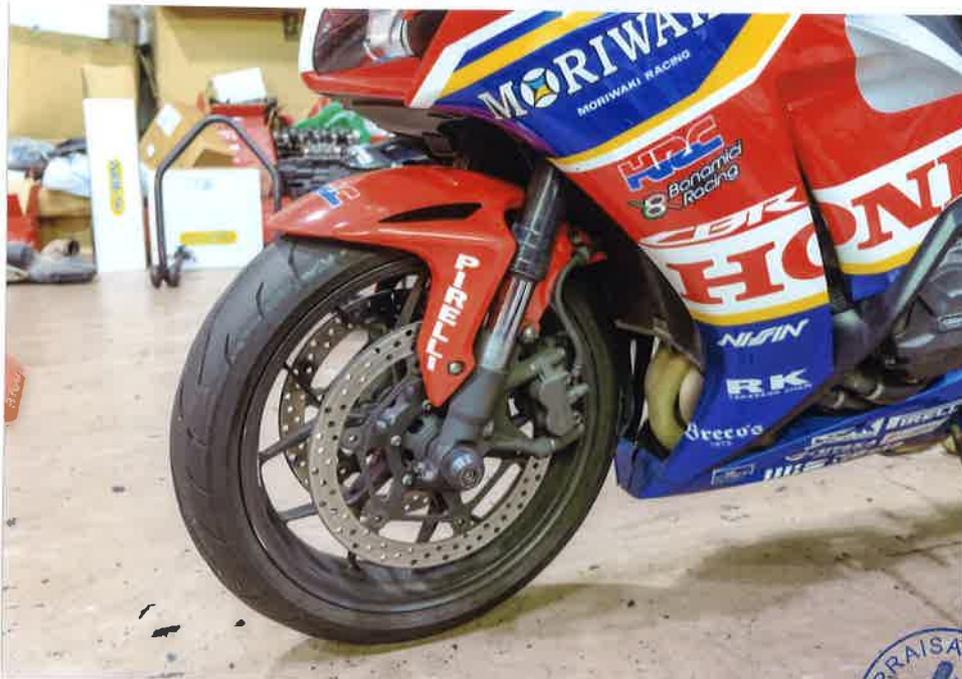
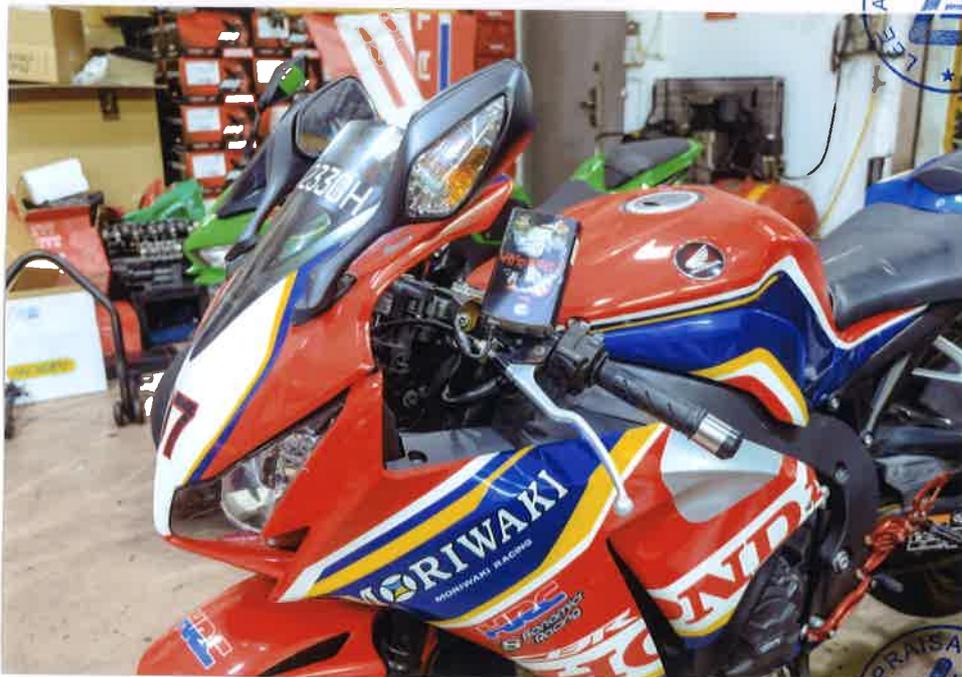
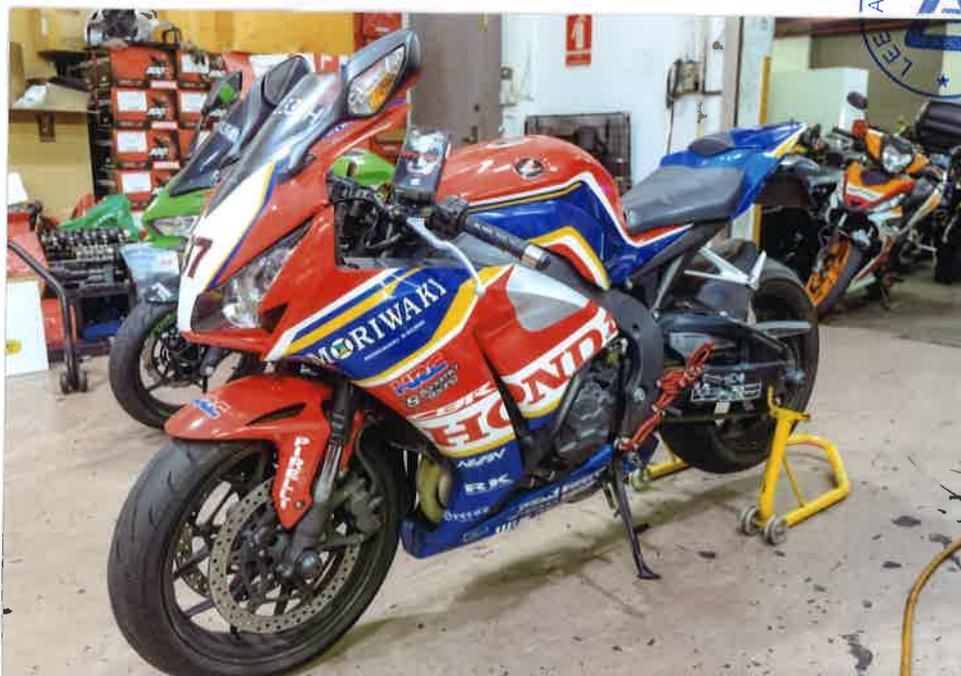
After Repair

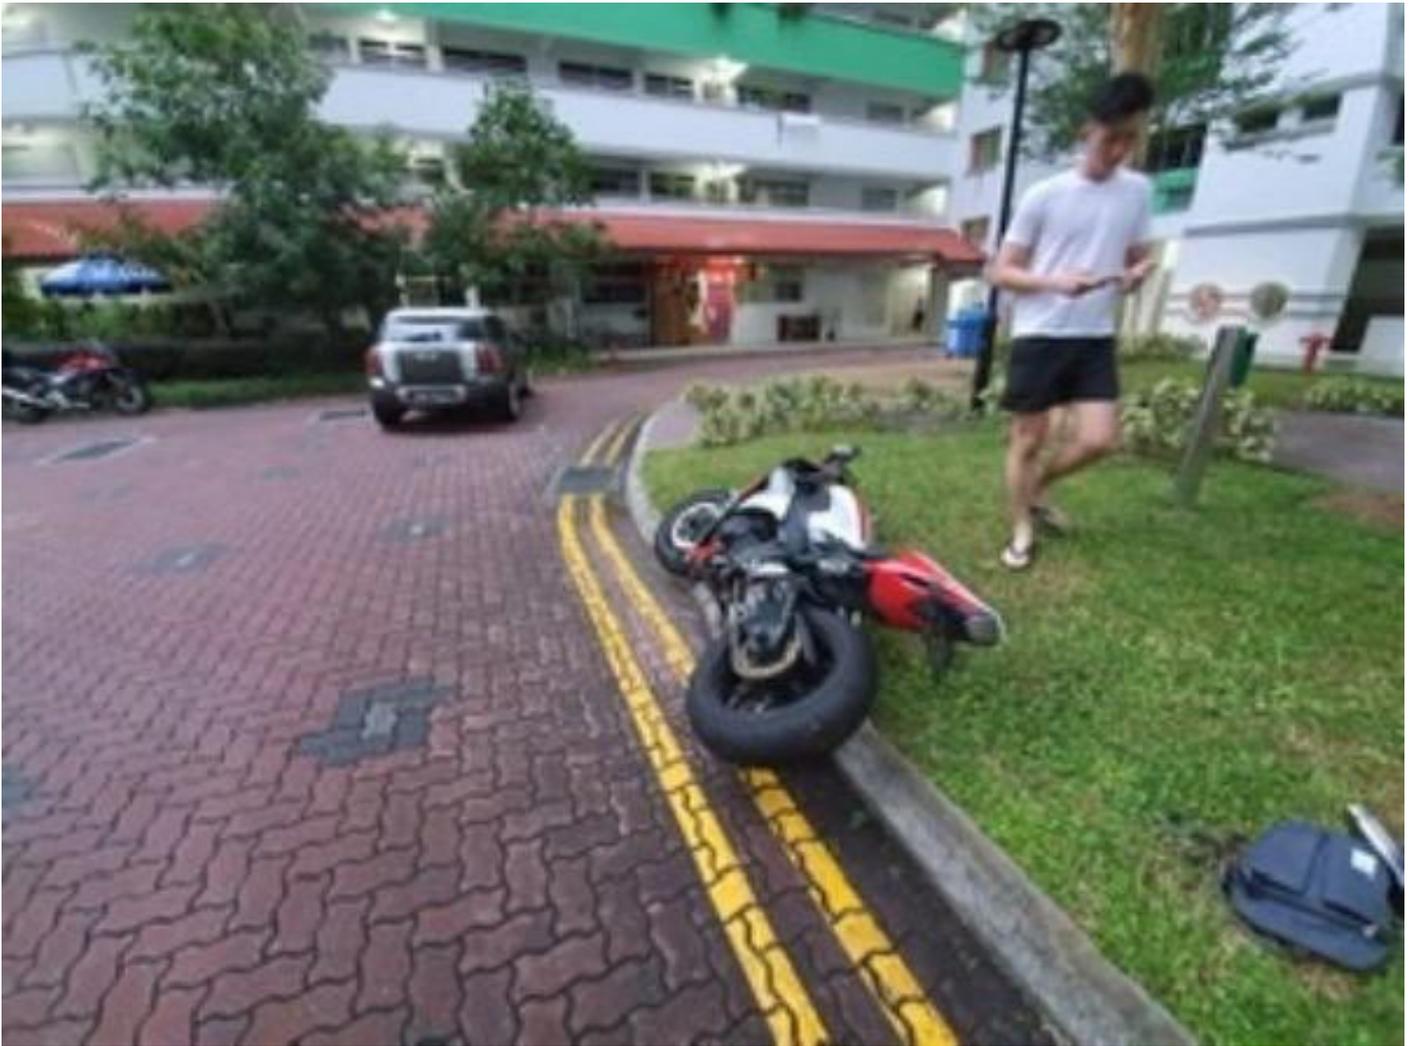
Accident Photo

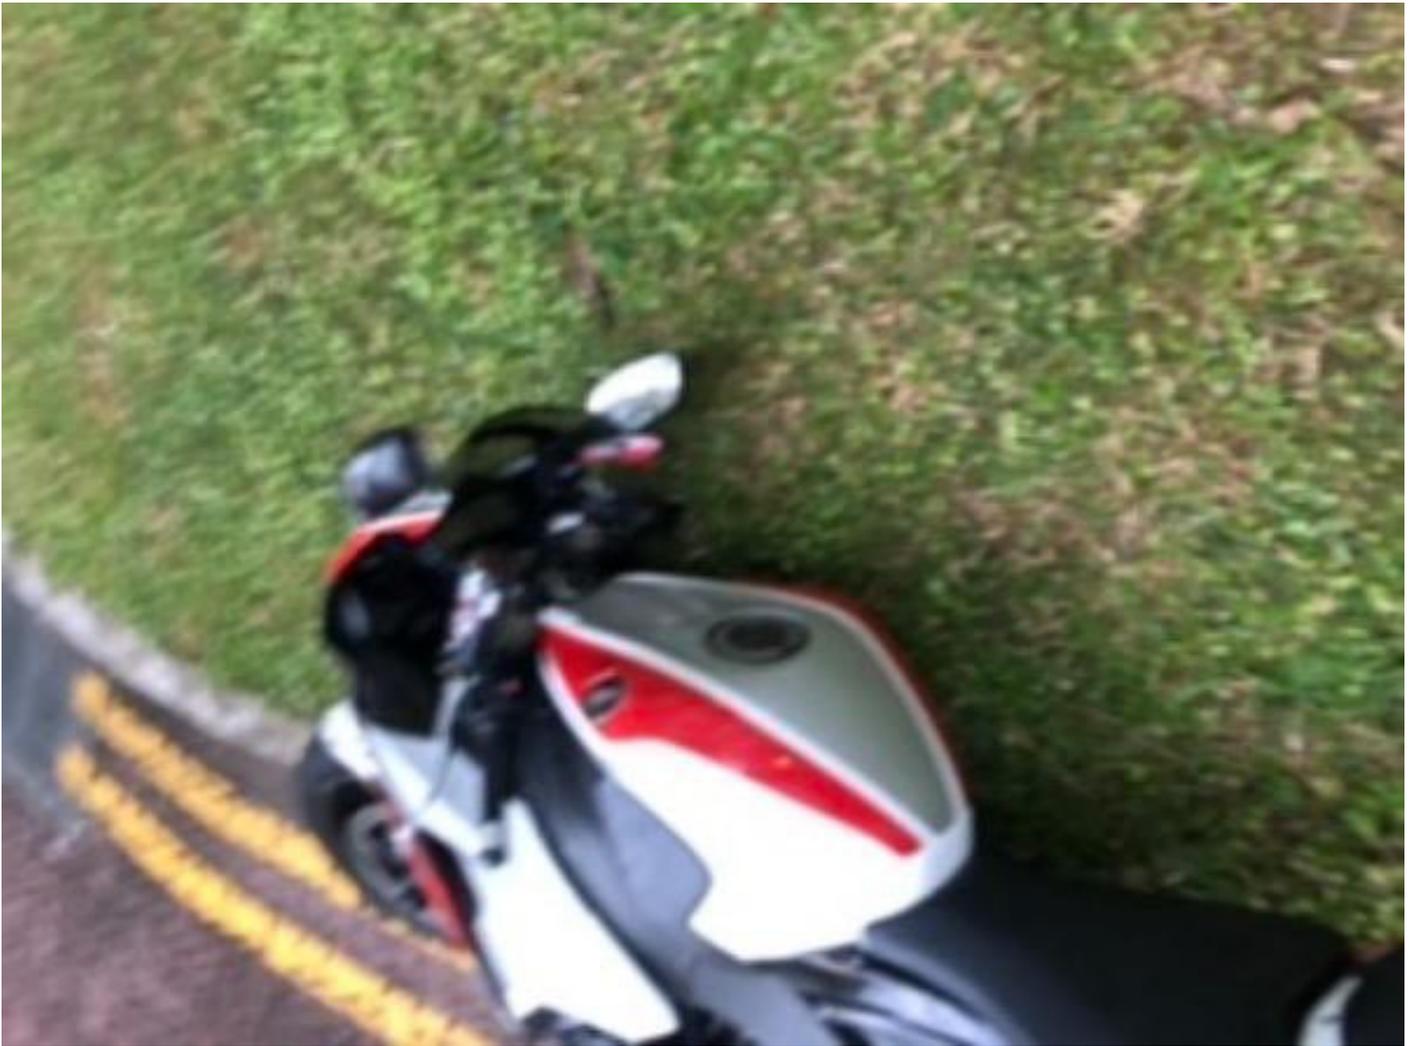
Accident Photo

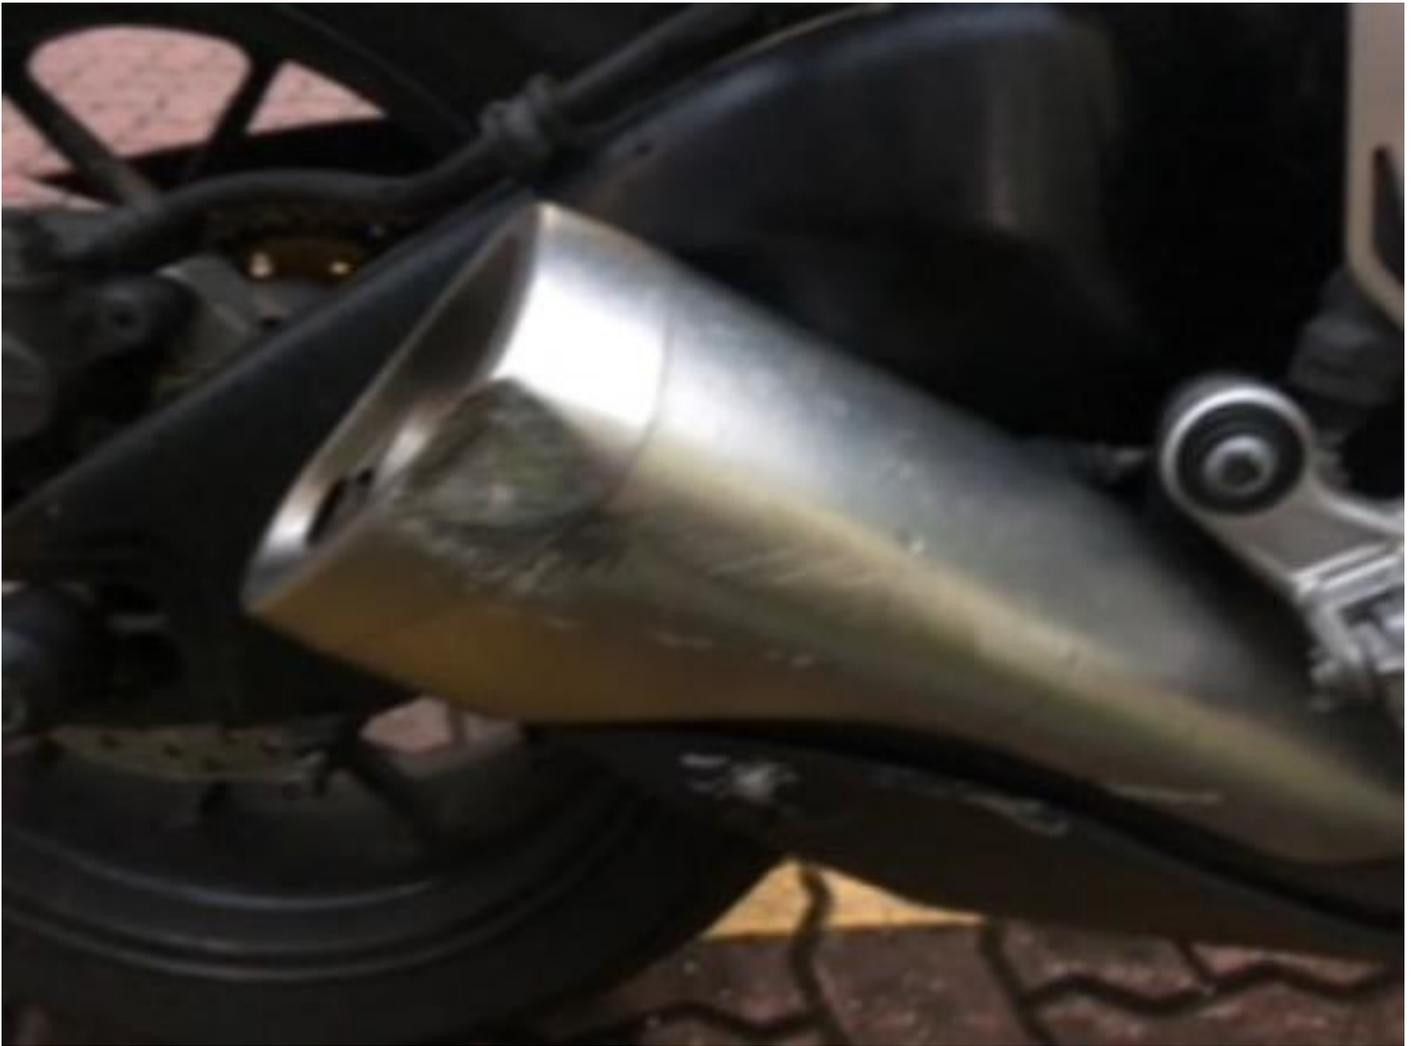
Accident Photo

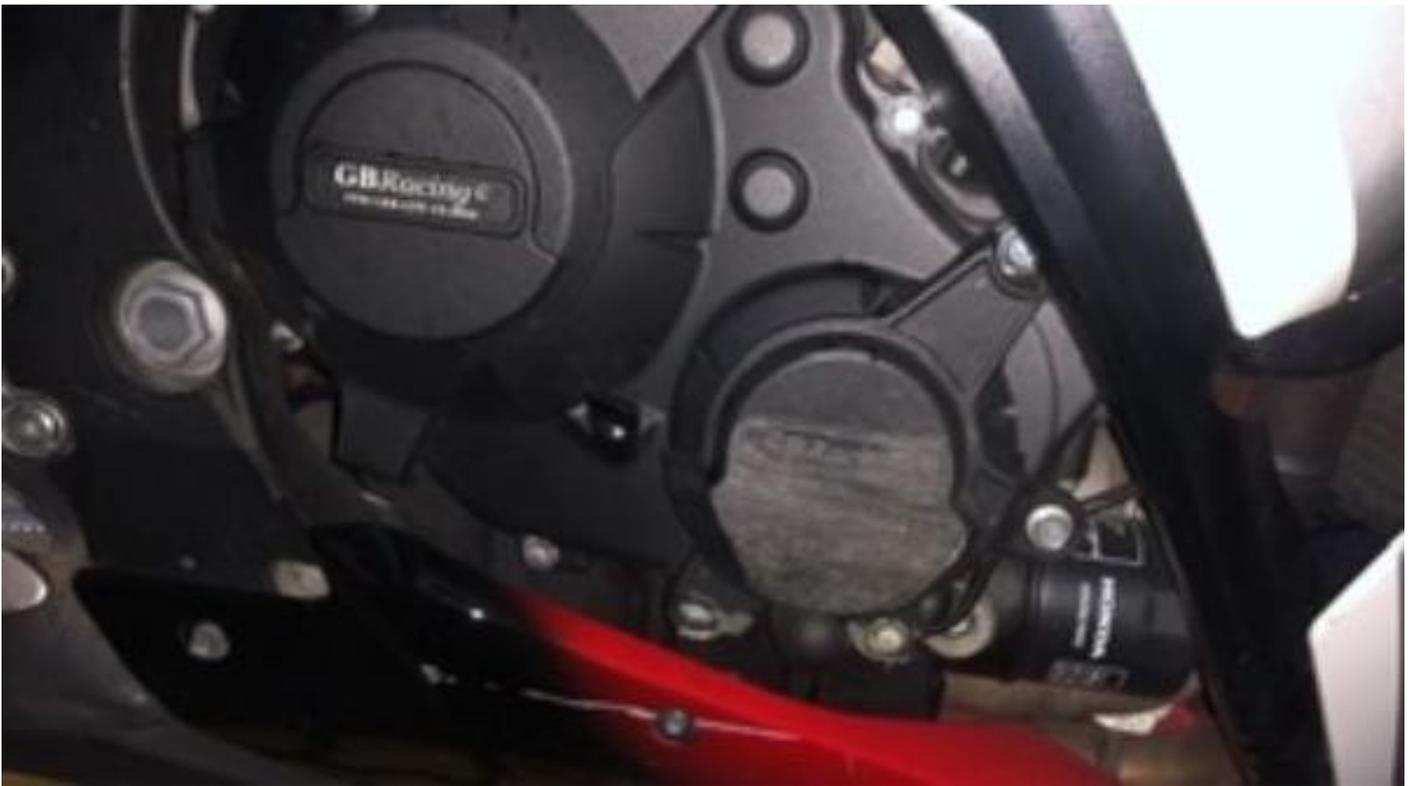
Accident Photo
