SURVEY OF VEHICLE NO. SLJ 2794J

AUTOMOBILE ASSESSMENT REPORT

Assessment of Vehicle No : **SLJ 2794J**
Date of Accident : **18-January-2019**
Date of Inspection : **22-January-2019**
Address of Inspection : **25 Kaki Bukit Road 4 #01-55 S'417800**

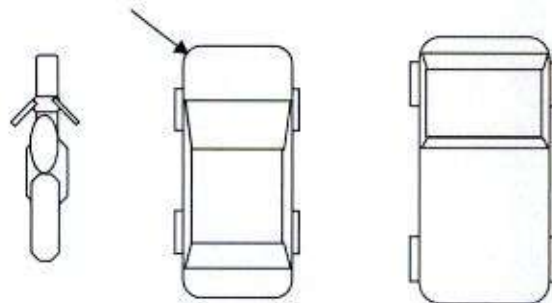
At the time of inspection, this vehicle sustained damages to the **Front LH** portion. Please see attached scheduled for details.
