Our Reference : KAAS/TA/5348/2794/TP/01.19
Date : 10 February 2019

VEHICLE APPRAISAL REPORT

Registration No.	: SLJ 2794J	Chassis Frame No.	: WBA3X32020DZ23268
Make / Model	: BMW 328i GT 5Dr ABD HID DSC NAV	Engine No. (Logcard)	: B4870553N20B20A
Year of Manufacture/Reg	: 2013	Odometer Reading	: 82,357 KM
Colour	: White		
Class / Type	: Saloon

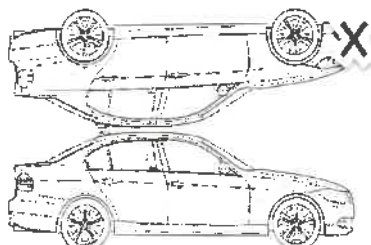
Damages sustained were consistent with the subject vehicle being involved in a collision with another vehicle and the impact was delivered **Diagonally to the LH Front from left to right; rear to front;** portion of the vehicle.

The general area of damages is at the **LH Front portion**
(Please refer to the parts list and photographs as attached for more information)
