KAAS/TA/5348/2794/TP/01.19
10 February 2019

VEHICLE APPRAISAL REPORT

Name of Workshop : Apex Motoring
Place of inspection : 25 Kaki Bukit Road 4 #01-55, Synergy @ Kaki Bukit, Singapore 417800
Date of Assignment : 21 January 2019
Date of Accident : 18 January 2019
Date of Inspection : 21 January 2019

Registration No.	: SLJ 2794J	Chassis Frame No.	: WBA3X32020DZ23268
Make / Model	: BMW 328i GT 5Dr ABD HID DSC NAV	Engine No. (Logcard)	: B4870553N20B20A
Year of Manufacture/Reg	: 2013	Odometer Reading	: 82,357 KM
Colour	: White		
Class / Type	: Saloon

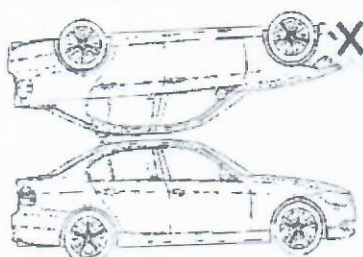
Damages sustained were consistent with the subject vehicle being involved in a collision with another vehicle and the impact was delivered **Diagonally to the LH Front from left to right; rear to front;** portion of the vehicle.

The general area of damages is at the **LH Front portion**
(Please refer to the parts list and photographs as attached for more information)
