## LKK Auto Consultants Pte Ltd

Vehicle No. GV 2541T  
Insured Veh. XE 2634Y  
Claim No. D21002422MFVS/2  
Policy No. D-21097029MFVS  
Accident Date 26/08/2021  
Inspection Date 27/08/2021

## ADJUSTMENT ON REPAIR COST FOR VEHICLE NO. GV 2541T

PHOTOGRAPHS FOR VEHICLE NO. GV 2541T

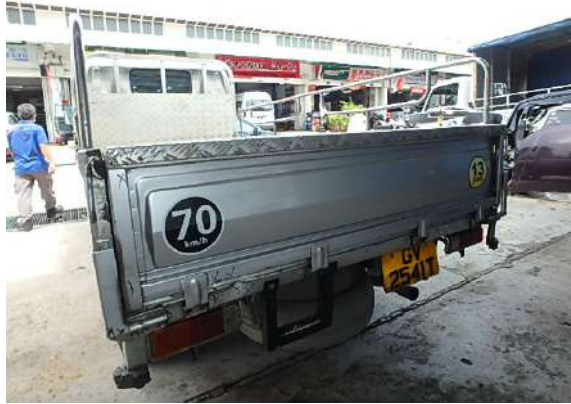
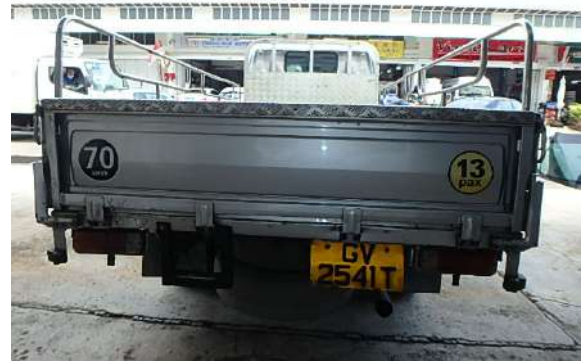
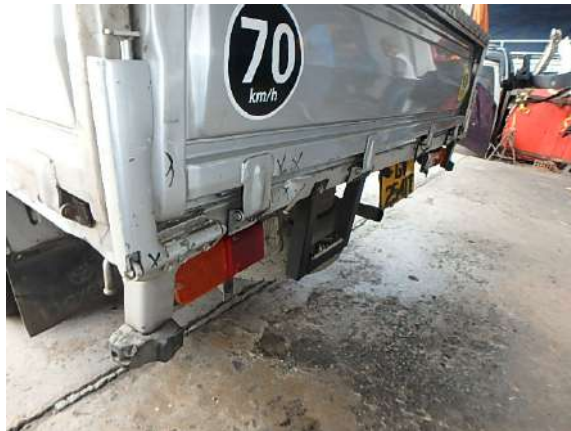
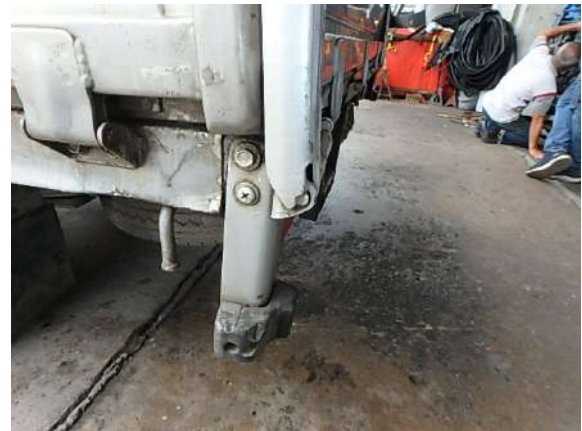
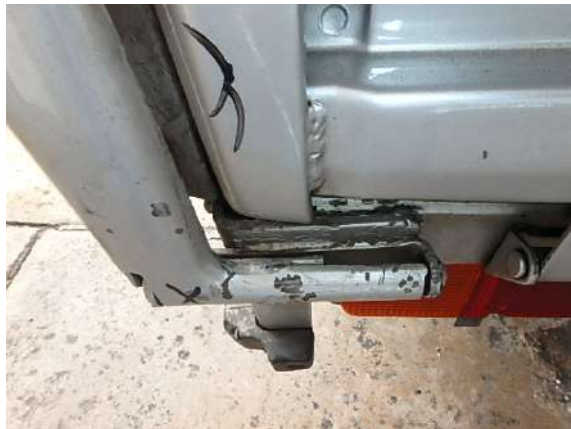
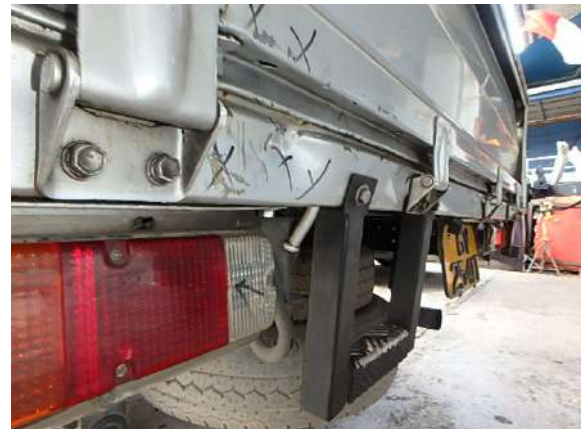
INSPECTION

| Affiliated to Federation Internationale Des Experts En Automobile | | | | |
|---|---|---|---|---|
| | THE VEHICLE SUSTAINED DAMAGES AT THE REAR N/S PORTION.<br><br>DAMAGES SEE DETAILS. | | | |
