Your Ref: Mercedes Benz S63 Coupe
(chassis number W1K2173872A050176)
Our Ref : CI/TP21009072/D

30 August 2021

**INSPECTION REPORT OF AN UNREGISTERD MERCEDES BENZ S63
COUPE MOTOR CAR WITH CHASSIS NUMBER W1K2173872A050176**

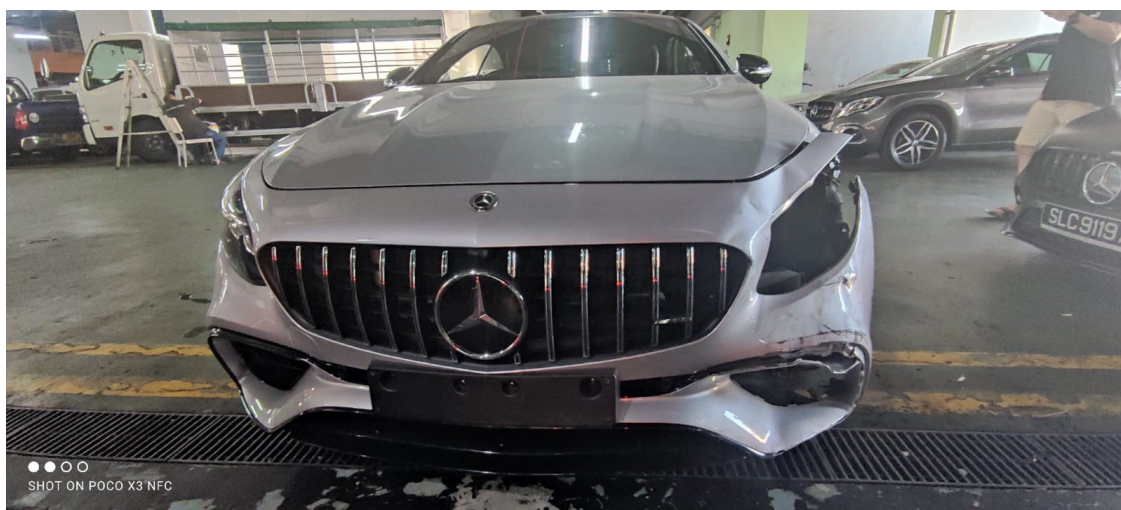
Photo 1 shows the frontal body of the Motor Car (photograph provided to me). The Motor Car was observed to have sustained damage at its front left portion. The front bumper, front bumper garnish, front bumper left sensors, front left headlamp, front bonnet and front left fender were amongst the body parts that were observed to be damaged.

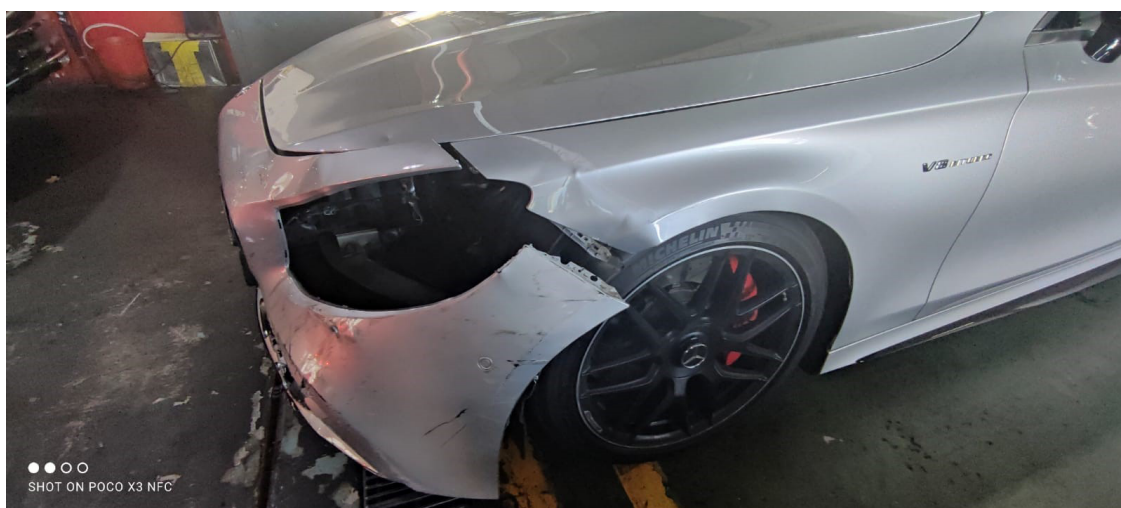
Photo 2 shows the front left body of the Motor Car (photograph provided to me). The Motor Car was observed to have sustained damage at its front left portion. The front bumper, front bumper garnish, front bumper left sensors, front left headlamp, front bonnet and front left fender were amongst the body parts that were observed to be damaged.

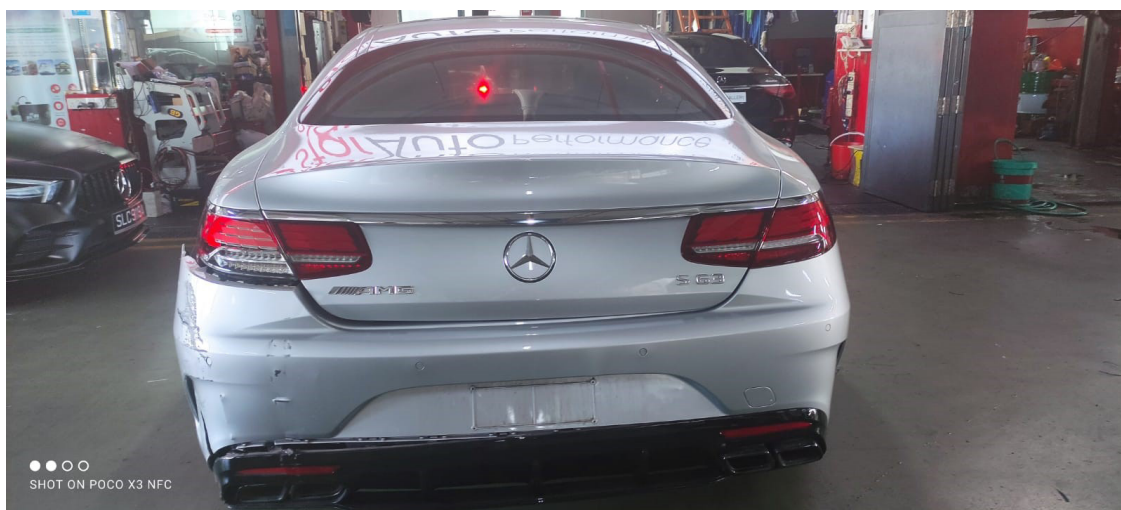
Photo 3 shows the rear body of the Motor Car (photograph provided to me). Apart for the front left portion, I had also observed damage to the rear left portion of the Motor Car. The rear bumper, rear bumper lower diffuser, rear bumper left sensors and rear left taillamp were amongst the body parts that were observed to be damaged.

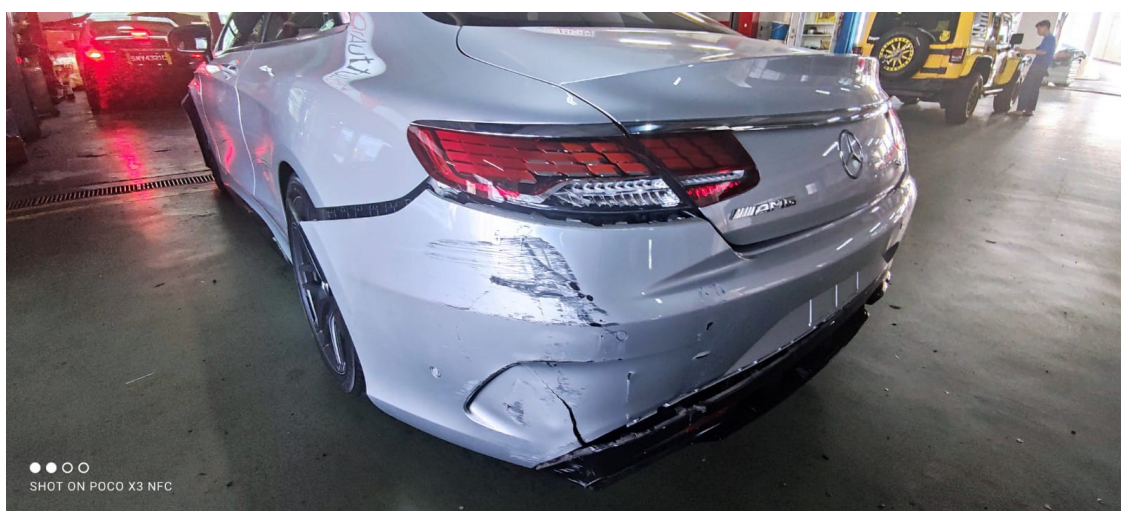
Photo 4 shows the rear left body of the Motor Car (photograph provided to me). Apart for the front left portion, I had also observed damage to the rear left portion of the Motor Car. The rear bumper, rear bumper lower diffuser, rear bumper left sensors and rear left taillamp were amongst the body parts that were observed to be damaged.

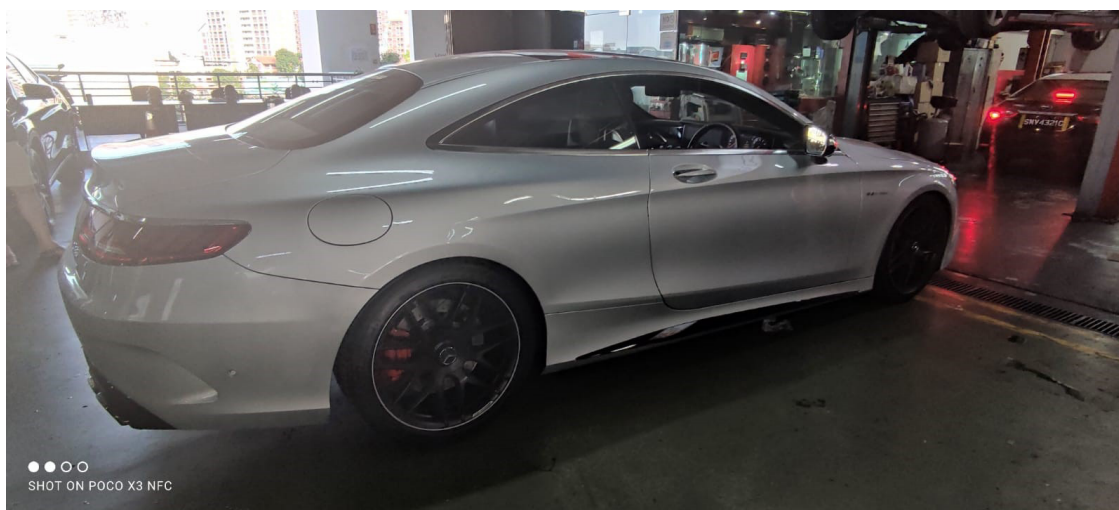
Photo 5 shows the right body of the Motor Car (photograph provided to me). No physical damage was observed to the right body of the Motor Car. The airbags of the Motor Car were not deployed as seen from the photographs that were provided to me.

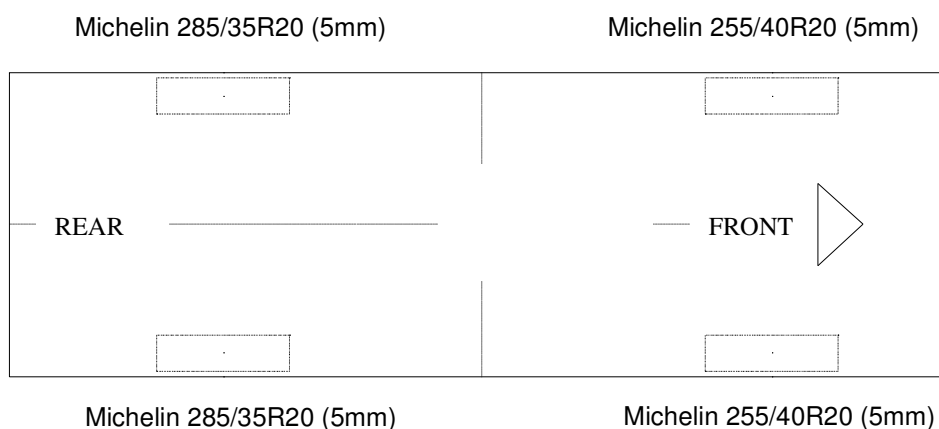
8. It was fitted with 20inch sport wheel rims that were wrapped with tyres that were observed to be of serviceable condition. The tyres were also sufficiently inflated for vehicular operation. The tyre brand, tyre size and approximate remaining tread depth of the 4 tyres of the Motor Car were recorded as follows: -

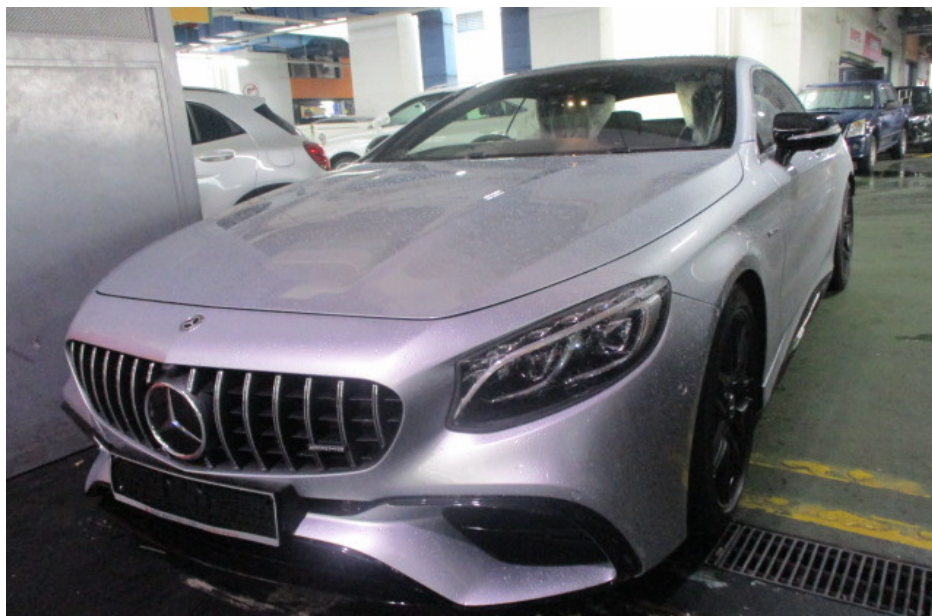
Photo 6 shows a general view of the front left body of the Motor Car at the time of my inspection. The Motor Car was observed to be in a relatively good general condition with no loose exterior fittings observed. The body parts at the front left portion of the Motor Car were visually examined, and it was observed that the repair/restoration works carried out to the damaged area of the Motor Car (refer to photograph 1 & 2) were reasonably adequate and in order.

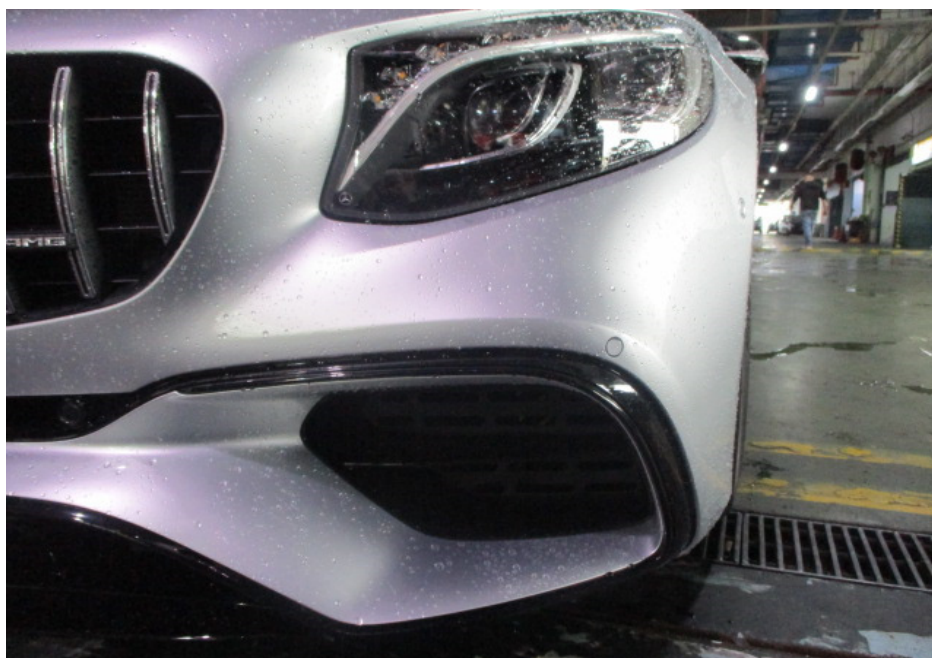
Photo 7 shows a closer view of the Motor Car's front bumper, front bumper garnish, front bumper sensors and front left headlamp at the time of my inspection. The body parts at the front left portion of the Motor Car were visually examined, and it was observed that the repair/restoration works carried out to the damaged area of the Motor Car (refer to photograph 1 & 2 above) were reasonably adequate and in order.

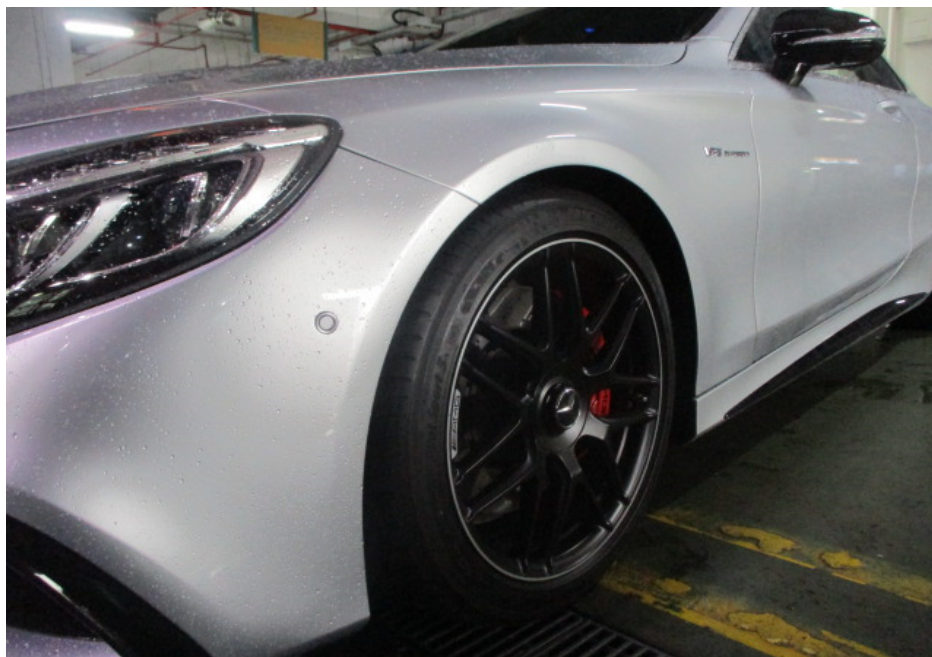
Photo 8 shows a closer view of the Motor Car's front bumper, front bumper sensors, front bonnet, front left fender and front left headlamp at the time of my inspection. The body parts at the front left portion of the Motor Car were visually examined, and it was observed that the repair/restoration works carried out to the damaged area of the Motor Car (refer to photograph 1 & 2 above) were reasonably adequate and in order.

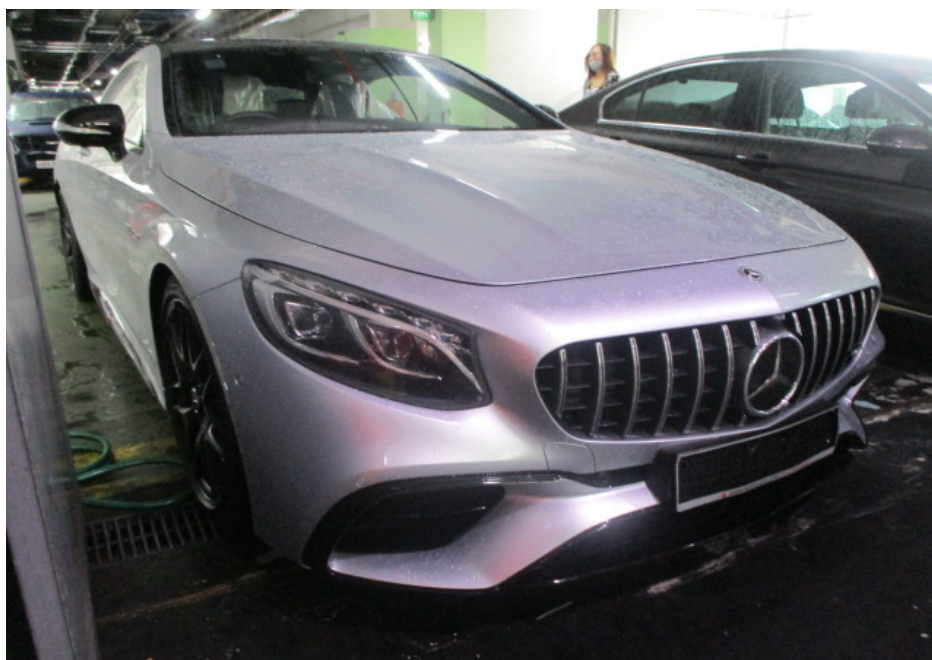
Photo 9 shows a general view of the front right body of the Motor Car at the time of my inspection. The Motor Car was observed to be in a relatively good general condition with no loose exterior fittings observed. The mileage of the Motor Car recorded at the time of my inspection was 9,154km.

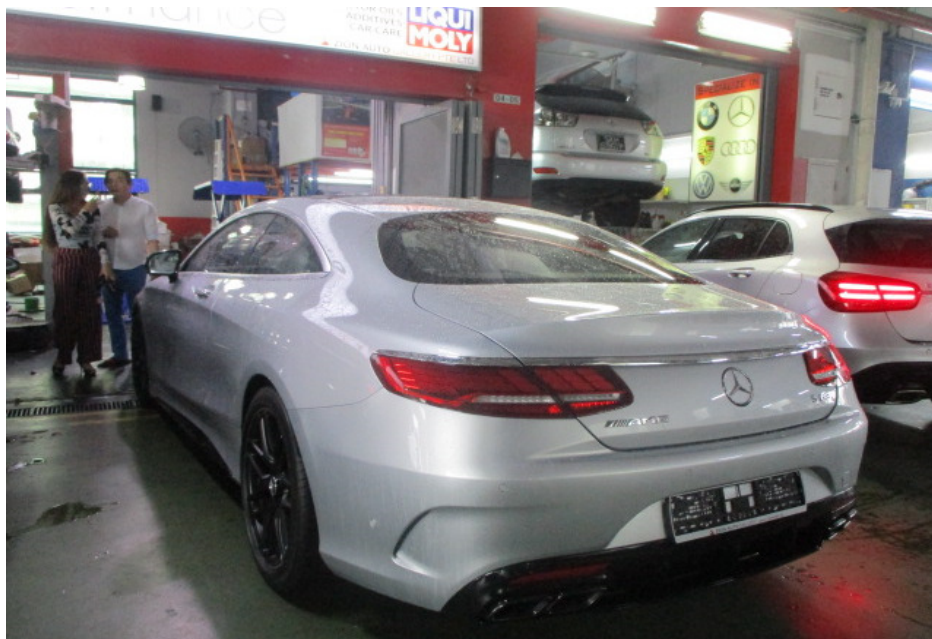
Photo 10 shows a general view of the rear left body of the Motor Car at the time of my inspection. The Motor Car was observed to be in a relatively good general condition with no loose exterior fittings observed. The body parts at the rear left portion of the Motor Car were visually examined, and it was observed that the repair/restoration works carried out to the damaged area of the Motor Car (refer to photograph 3 & 4) were reasonably adequate and in order.

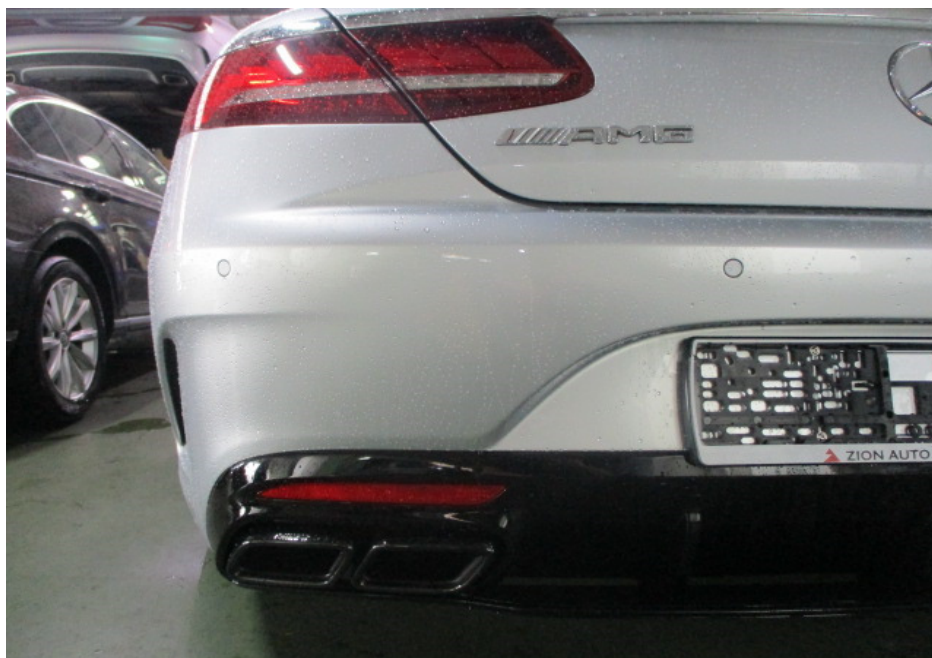
Photo 11 shows a closer view of the Motor Car's rear bumper, rear bumper lower diffuser and rear left taillamp at the time of my inspection. The body parts at the rear left portion of the Motor Car were visually examined, and it was observed that the repair/restoration works carried out to the damaged area of the Motor Car (refer to photograph 3 & 4 above) were reasonably adequate and in order.

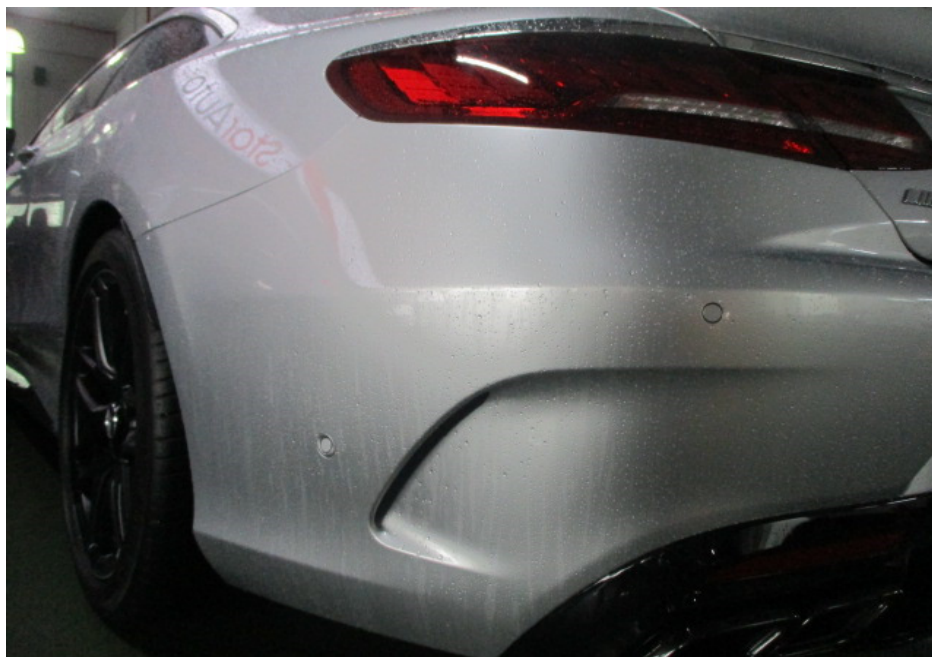
Photo 12 shows a closer view of the Motor Car's rear bumper, rear bumper left sensors and rear left taillamp at the time of my inspection. The body parts at the rear left portion of the Motor Car were visually examined, and it was observed that the repair/restoration works carried out to the damaged area of the Motor Car (refer to photograph 3 & 4 above) were reasonably adequate and in order.

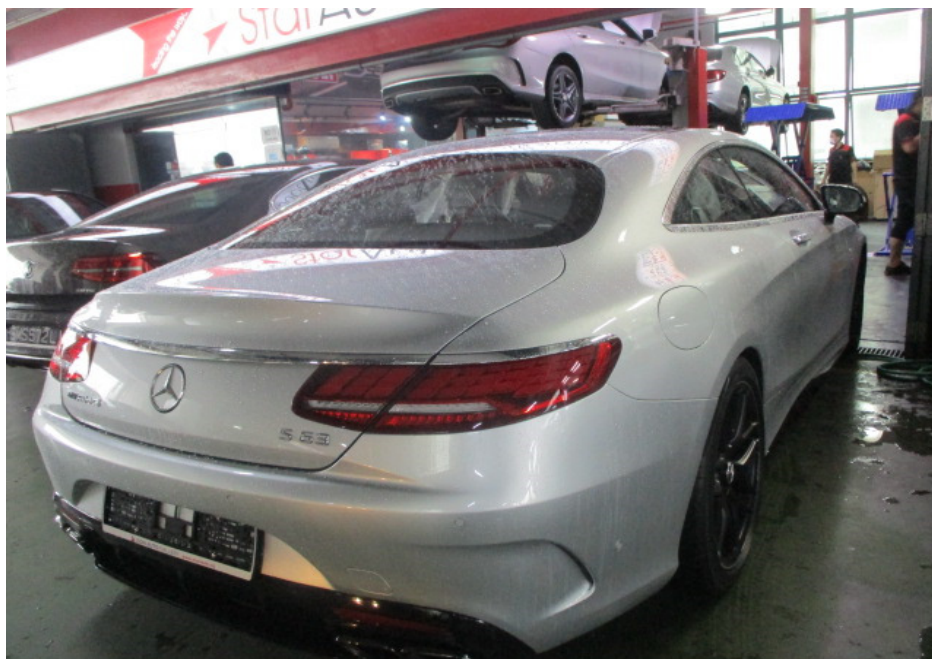
Photo 13 shows a general view of the rear right body of the Motor Car at the time of my inspection. The Motor Car was observed to be in a relatively good general condition with no loose exterior fittings observed. The mileage of the Motor Car recorded at the time of my inspection was 9,154km.

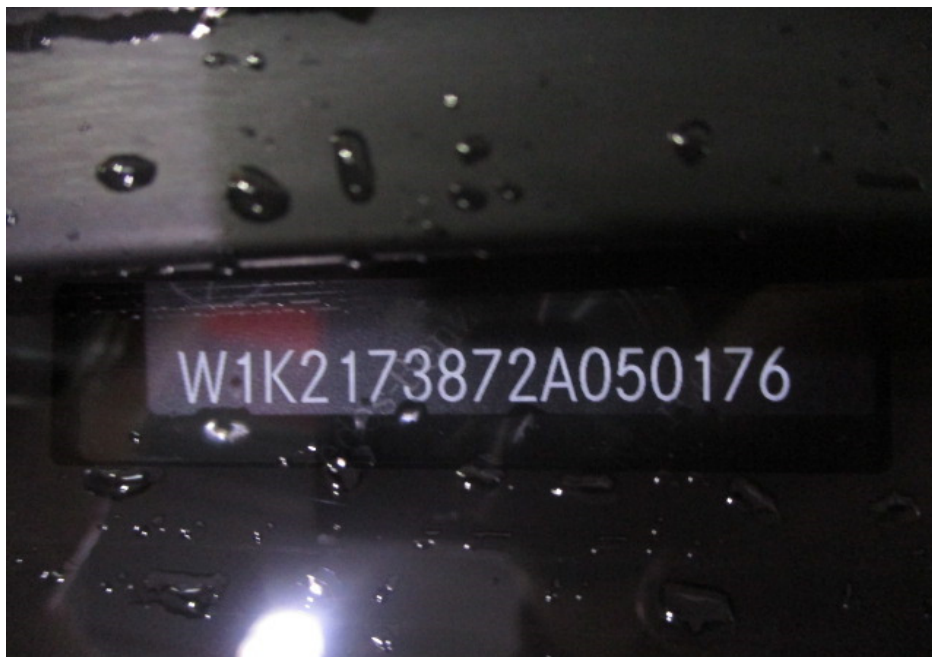
Photo 14 shows the chassis number of the Motor Car. The chassis number recorded was W1K2173872A050176.

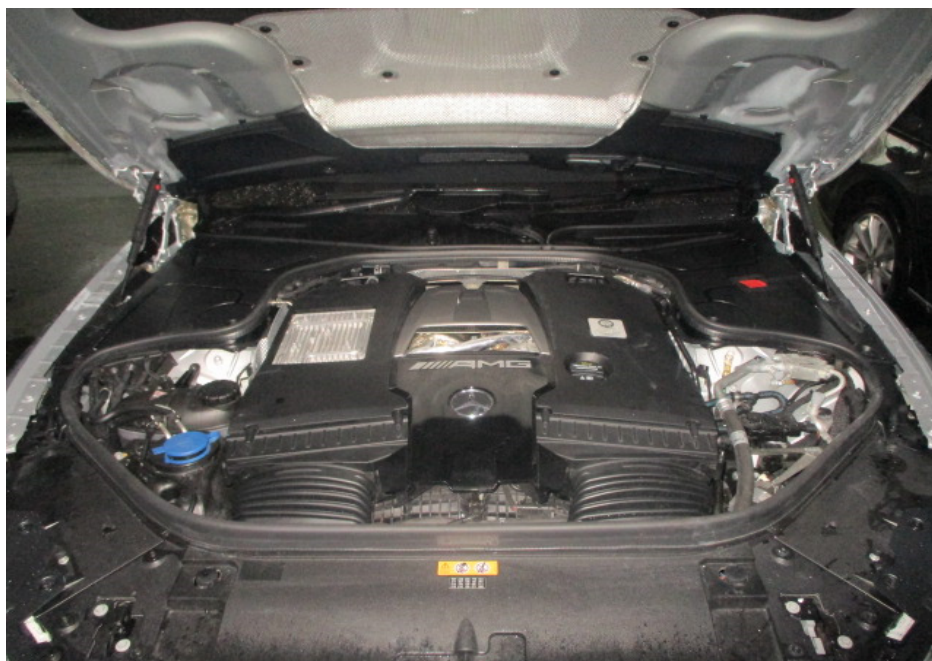
Photo 15 shows a general view of the engine compartment of the Motor Car at the time of my inspection. The various parts and components inside the engine compartment were all observed to be intact and properly fitted. There was also no sign(s) or indication(s) of fluid leak and/or fluid stain found inside the engine compartment.

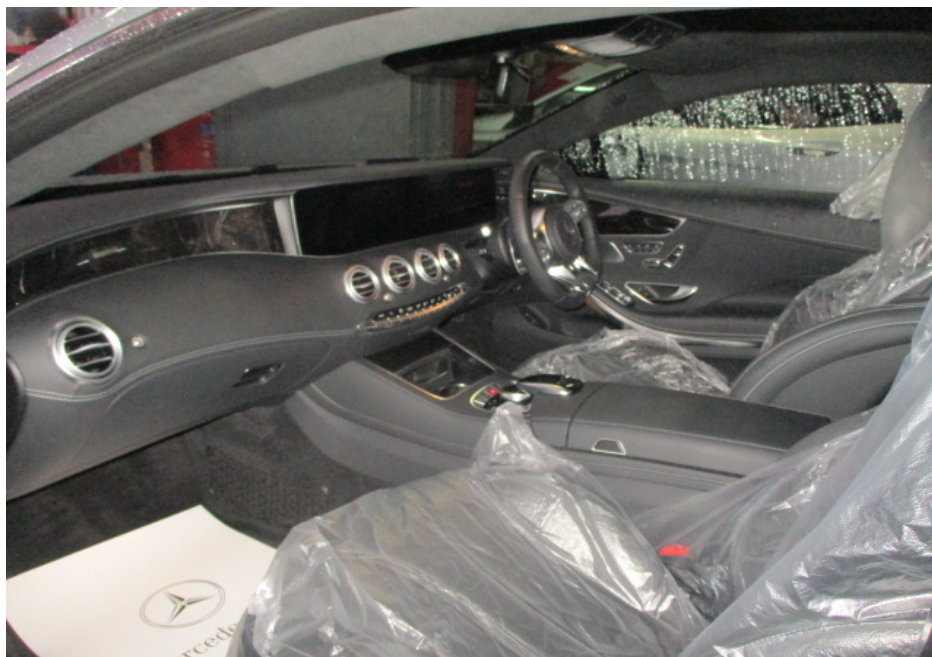
Photo 16 shows the interior compartment of the Motor Car at the time of my inspection. The various parts and components, trims, carpet and upholstery inside the interior compartment were all observed to be intact and properly fitted.

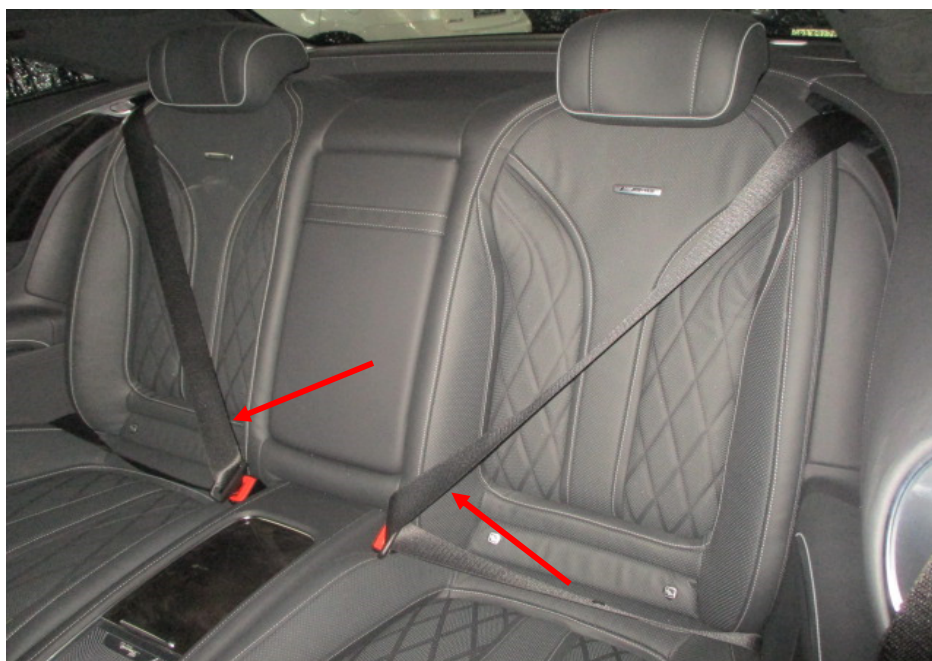
Photo 17 shows the rear seats of the Motor Car. All the seats of the Motor Car were secured via seat rails to the floorboard. They were also fitted with a retractable seat belt reel and a pre-tensioner. The seat belts (arrowed) were tested and were able to be fastened into the respective pre-tensions that were fitted on the side of each individual seat.

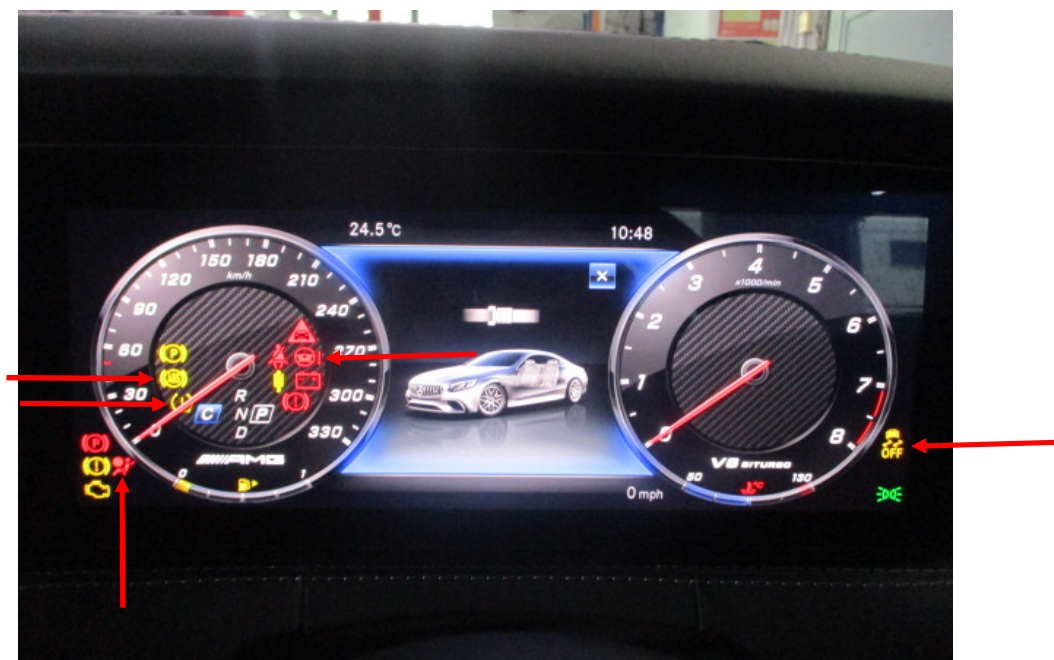
Photo 18 shows the warning lights for the various electronic safety features appearing on the instrument panel of the Motor Car during its self-test when the engine is cranked, in particular the ABS, SRS, EPS, TPM and TCS lights (arrowed).

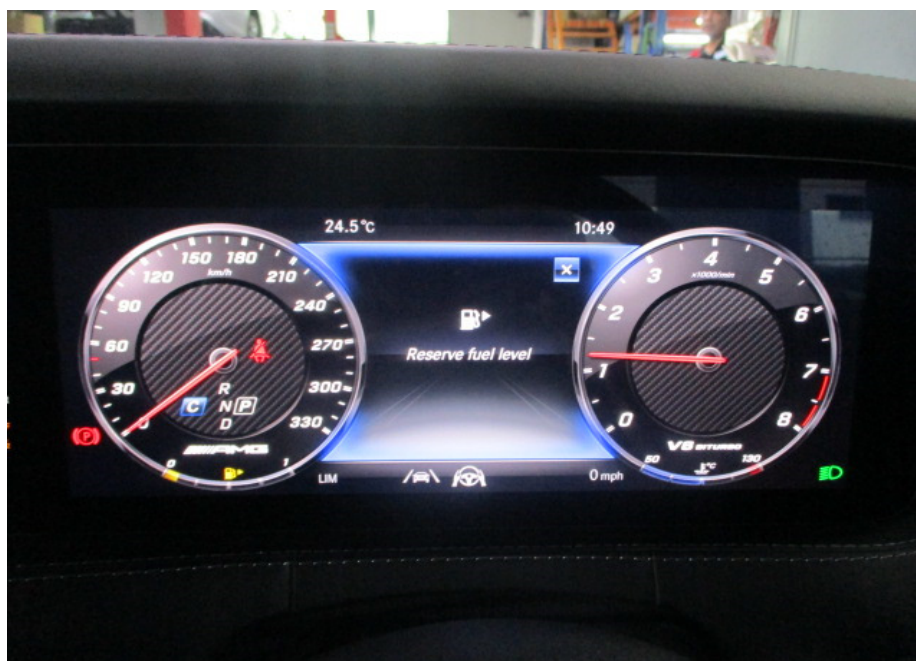
Photo 19 shows the respective warning lights no longer illuminated, indicating that there is no fault detected to the ABS, SRS, EPS, TPM and TCS systems of the Motor Car during the self-test. These electronic systems were hence in working condition at the time of my inspection.

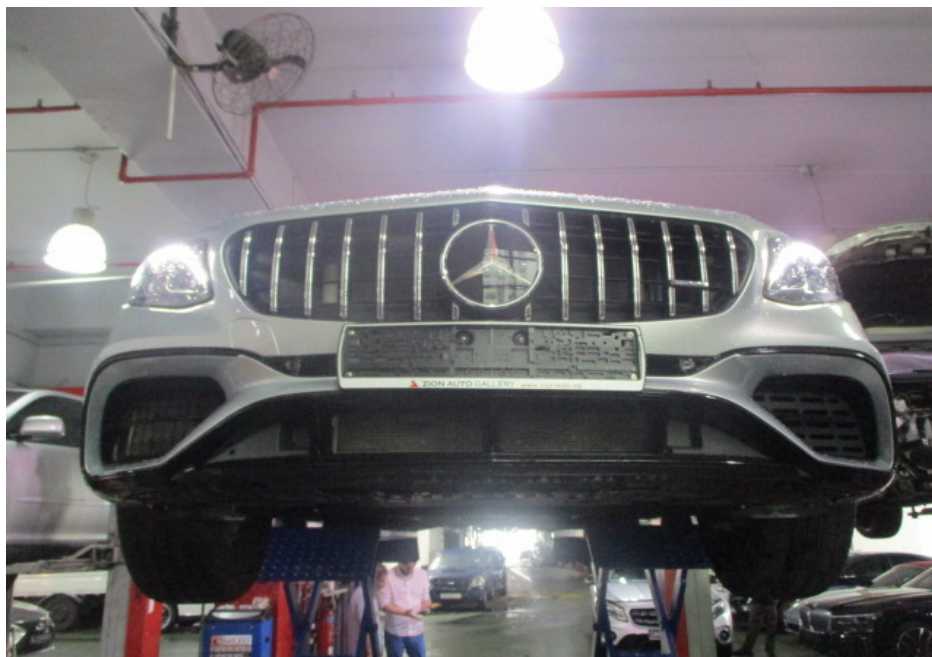
Photo 20 shows the Motor Car hoisted up for checks on its undercarriage. There was no sign(s) or indication(s) of fluid leakage and/or fluid stain(s) on the underside of the Motor Car. The undercarriage components of the Motor Car were also all observed to be intact and secured in an appropriate manner.

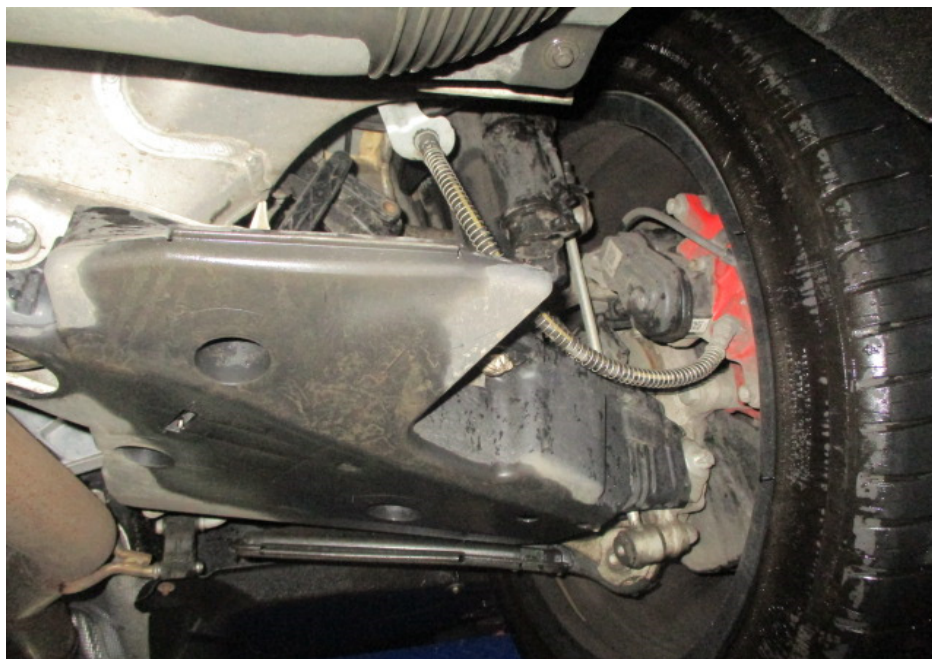
Photo 21 shows a general view of the control arms and linkages at the rear right wheel of the Motor Car. I did not observe any fluid leak and/or fluid stain on the underside of the Motor Car. All of the Motor Car's undercarriage components were observed to be intact and secured in an appropriate manner.

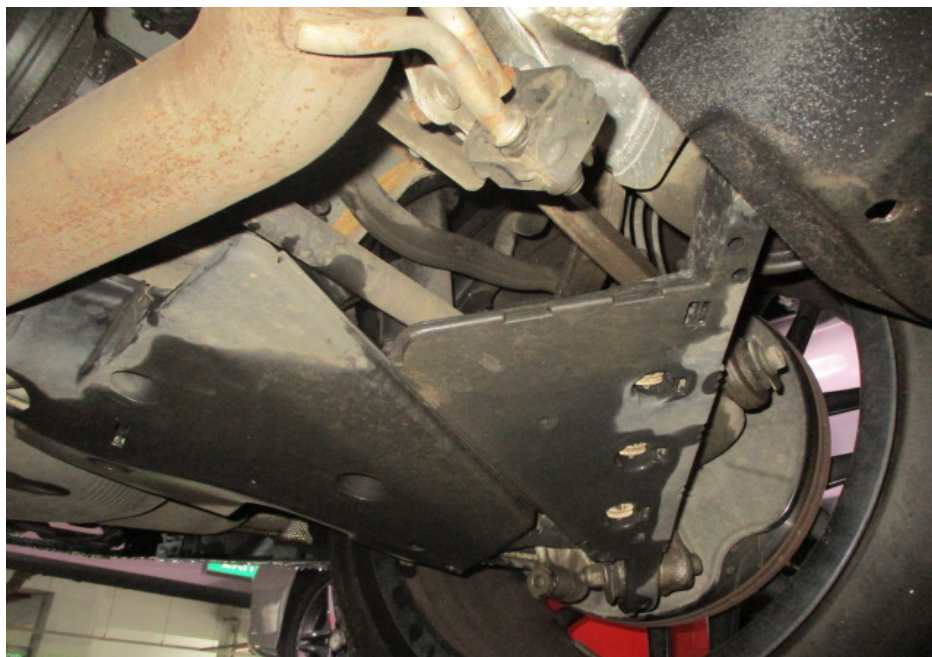
Photo 22 shows a general view of the control arms and linkages at the rear left wheel of the Motor Car. I did not observe any fluid leak and/or fluid stain on the underside of the Motor Car. All of the Motor Car's undercarriage components were observed to be intact and secured in an appropriate manner.

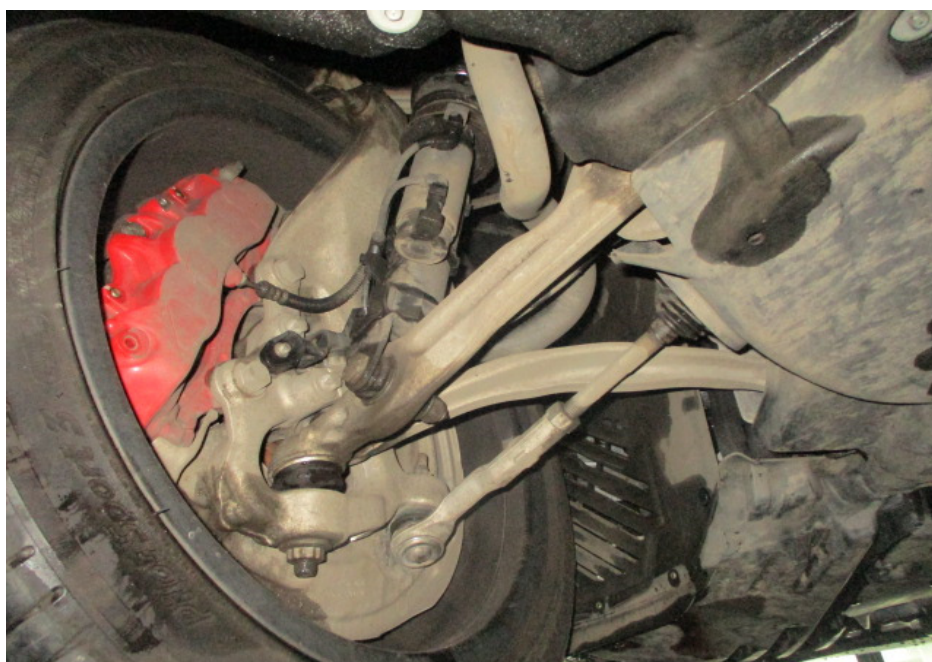
Photo 23 shows the various undercarriage components at the front left wheel of the Motor Car. The mechanical components, control arms and linkages were all found to be intact and secured in an appropriate manner.

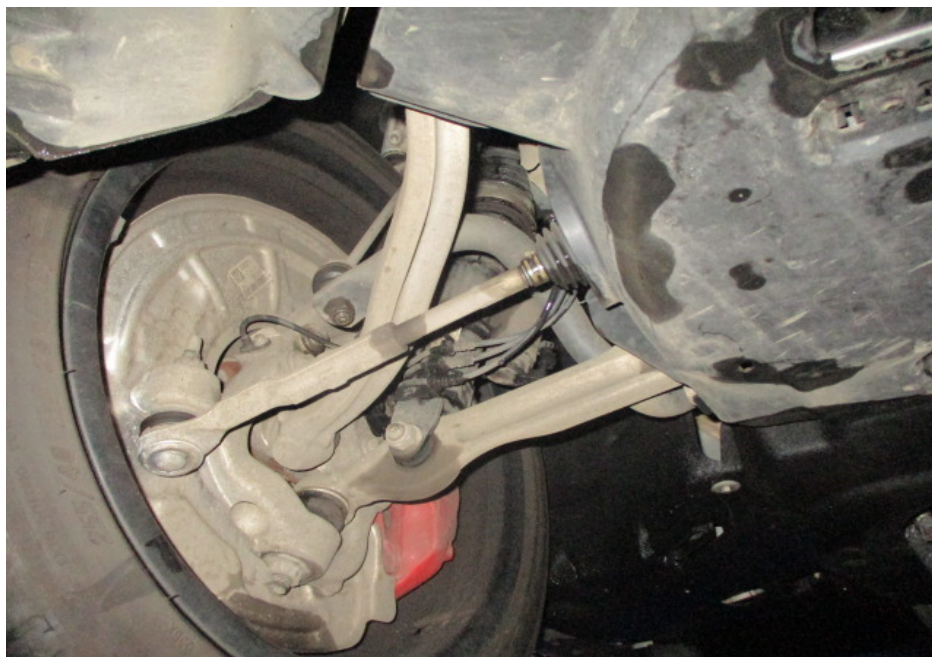
Photo 24 shows the various undercarriage components at the front right wheel of the Motor Car. The mechanical components, control arms and linkages were all found to be intact and secured in an appropriate manner. I also did not observe any fluid leak and/or fluid stain on the underside of the Motor Car.

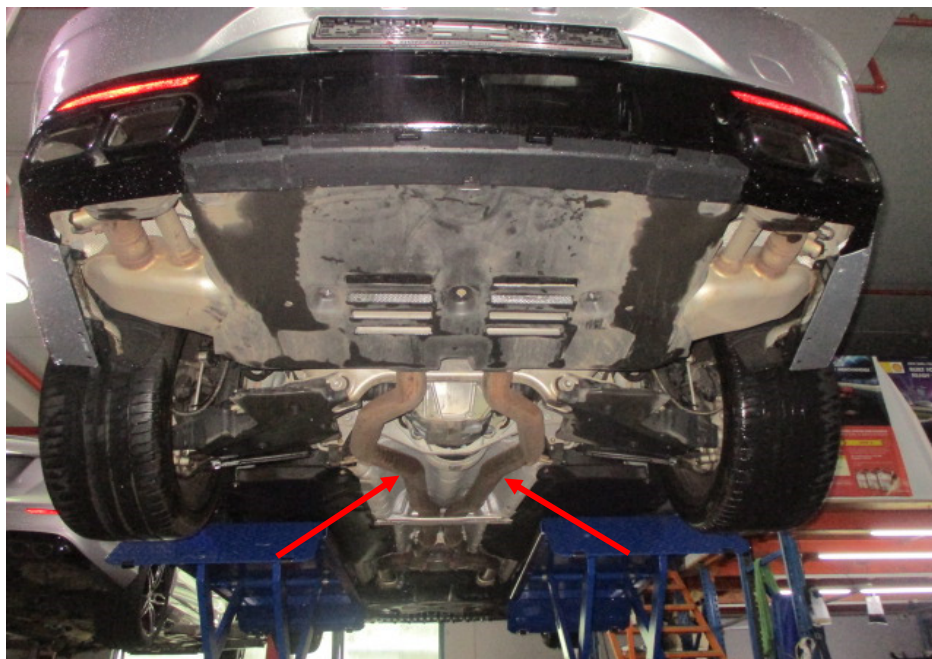
Photo 25 shows a general view of the rear section of the Motor Car's exhaust system. My examination of the Motor Car's exhaust system revealed no sign(s) or indication(s) of any cut or weld marks along its exhaust pipes (arrowed), on its catalytic converters and on its rear mufflers.

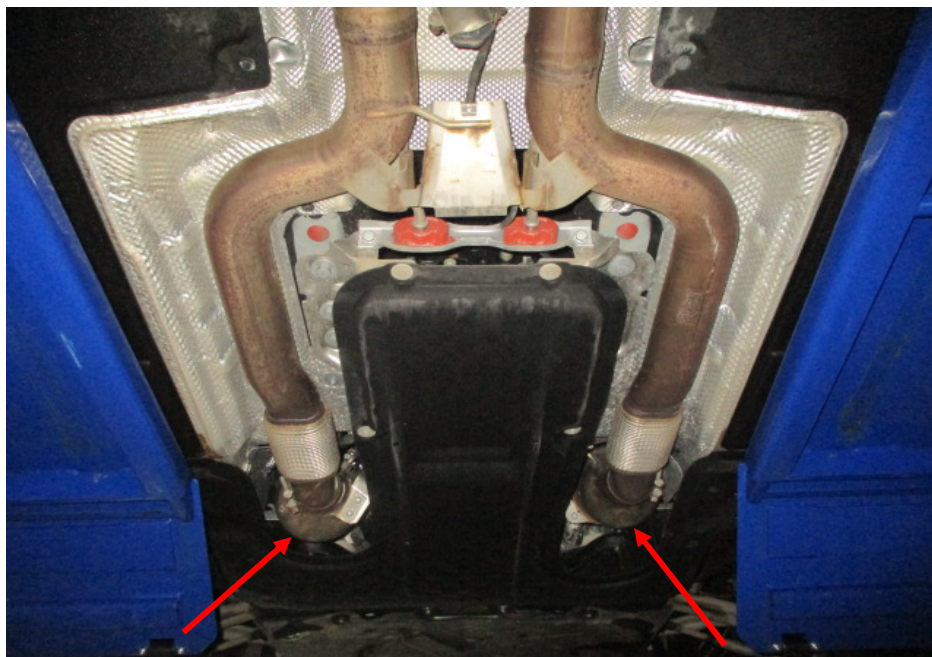
Photo 26 shows a general view of the front section of the Motor Car's exhaust system. My examination of the Motor Car's exhaust system revealed no sign(s) or indication(s) of any cut or weld marks along its exhaust pipes, on its catalytic converters (arrowed) and on its rear mufflers.

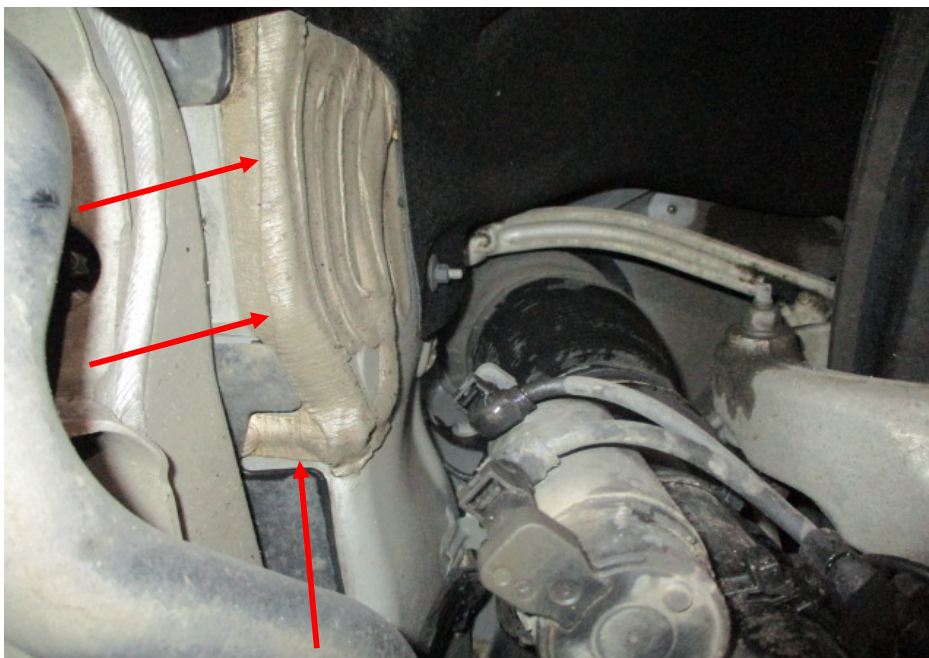
Photo 27 shows the chassis/structural body at the underside front right of the Motor Car. I did not find any weld marks other than original spot weld marks on the chassis/structural body of the Motor Car. The original factory sealant (arrowed) at the joints along the chassis/structural body was untouched, indicating no work was done on the chassis/structural body of the Motor Car and that the chassis/structural body was originally fitted.

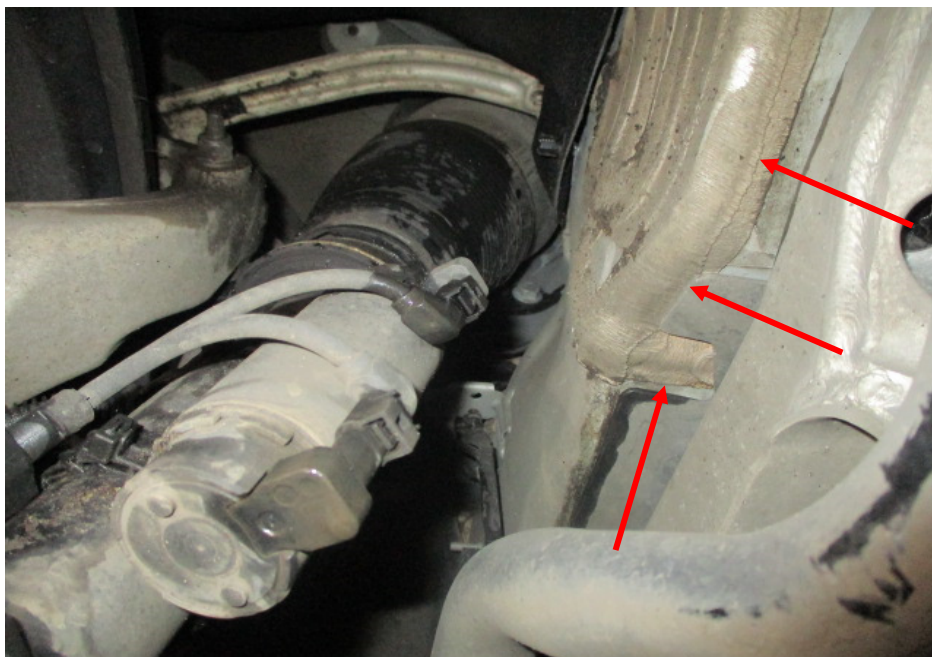
Photo 28 shows the chassis/structural body at the underside front left of the Motor Car. The original factory sealant (arrowed) at the joints along the chassis/structural body was observed to be untouched. In general, I had found no work was carried out on the chassis/structural body of the Motor Car. The chassis/structural body of the Motor Car was originally fitted.

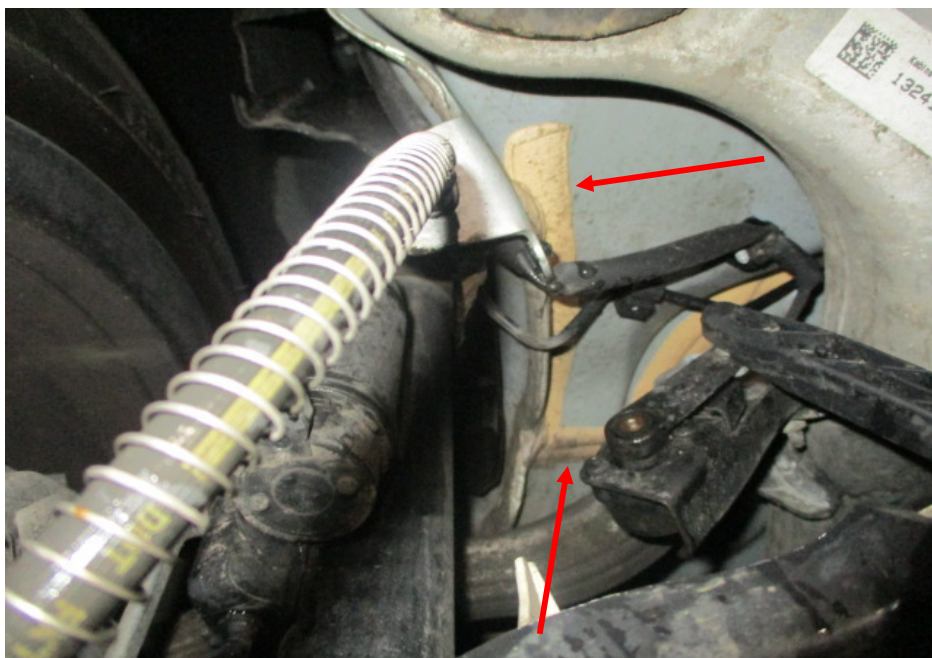
Photo 29 shows the chassis/structural body at the underside rear left of the Motor Car. I did not find any weld marks other than original spot weld marks on the chassis/structural body of the Motor Car. The original factory sealant (arrowed) at the joints along the chassis/structural body was untouched, indicating no work was done on the chassis/structural body of the Motor Car and that the chassis/structural body was originally fitted.

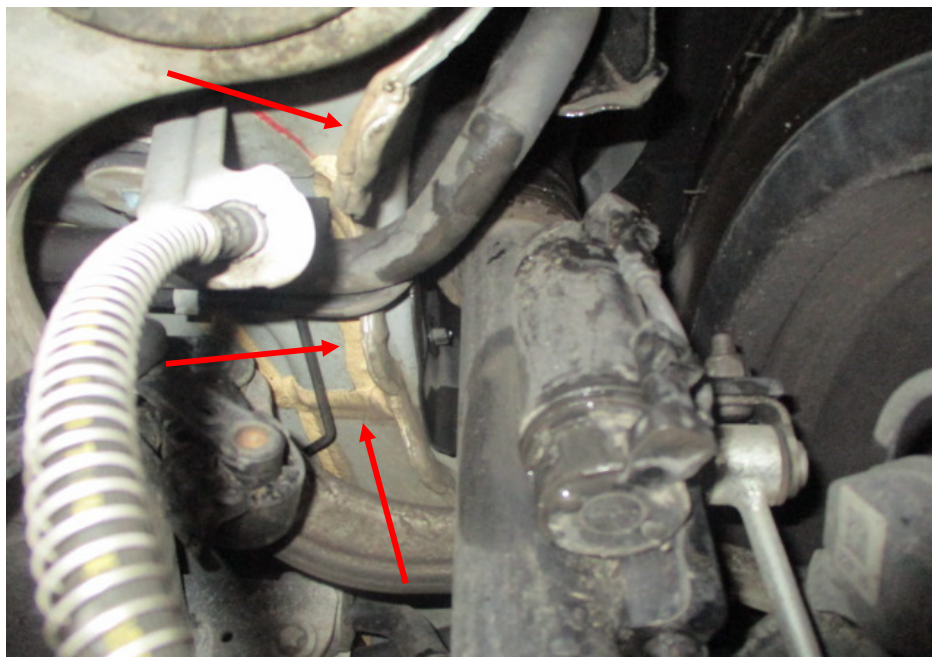
Photo 30 shows the chassis/structural body at the underside rear right of the Motor Car. The original factory sealant (arrowed) at the joints along the chassis/structural body was observed to be untouched. In general, I had found no work was carried out on the chassis/structural body of the Motor Car. The chassis/structural body of the Motor Car was originally fitted.

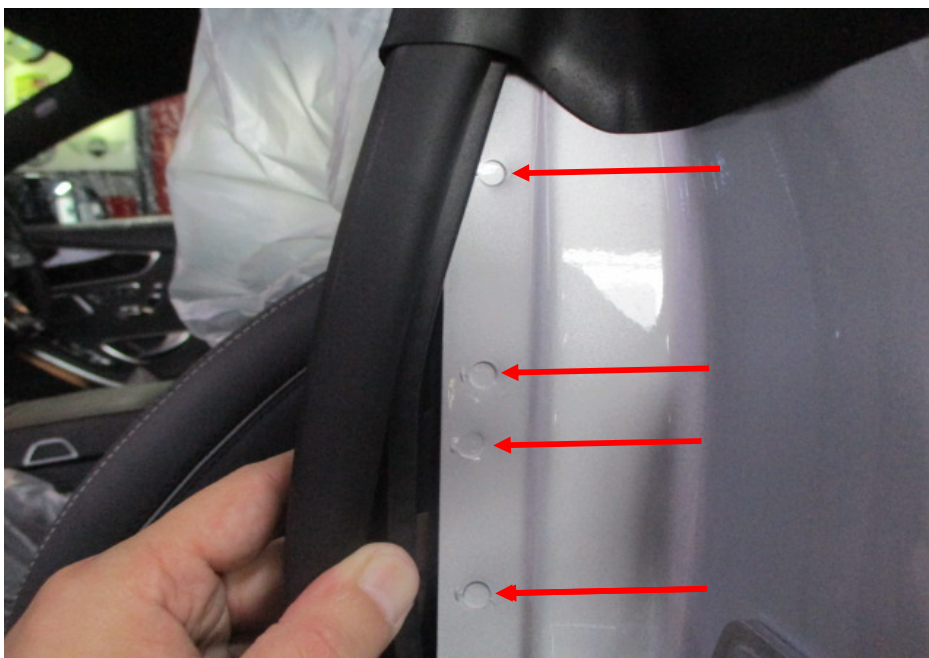
Photo 31 shows the left side rear body panel of the Motor Car. I did not find any weld marks other than original spot weld marks (arrowed) on the left side rear body panel of the Motor Car which, indicates that there was no re-welding works carried out. In general, I had found all the non-detachable body panels of the Motor Car to be originally fitted at the time of my inspection.

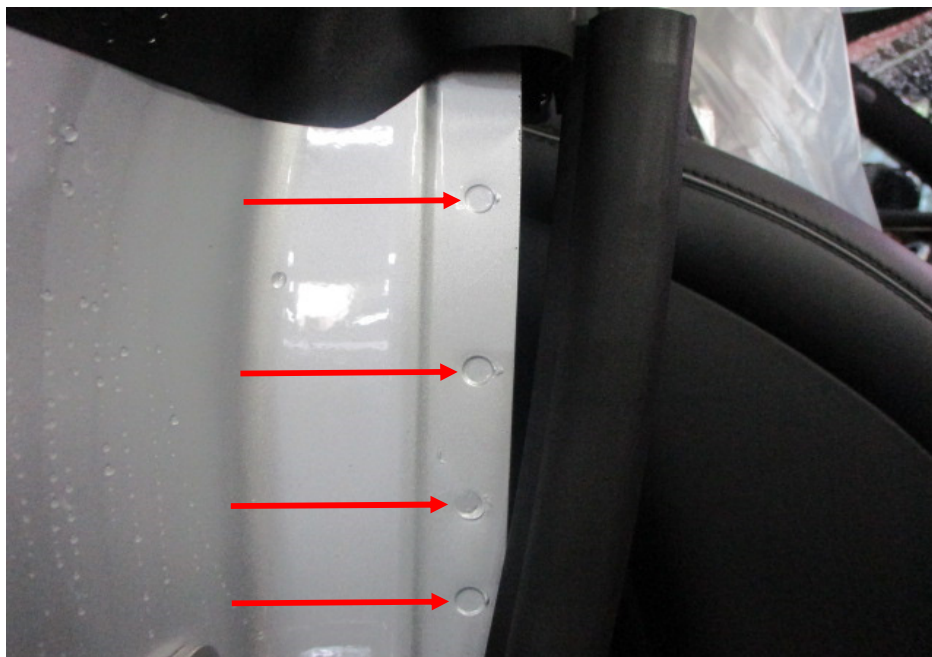
Photo 32 shows the right side rear body panel of the Motor Car. I did not find any weld marks other than original spot weld marks (arrowed) on the right side rear body panel of the Motor Car which, indicates that there was no re-welding works carried out. In general, I had found all the non-detachable body panels of the Motor Car to be originally fitted at the time of my inspection.
