SURVEY OF VEHICLE NO. SLF 2167R

AUTOMOBILE ASSESSMENT REPORT

Assessment of Vehicle No : **SLF 2167R**
Date of Accident : **10-May-2018**
Date of Inspection : **12-May-2018**
Address of Inspection : **2 Kaki Bukit Ave 2 #01-17 S'417921**

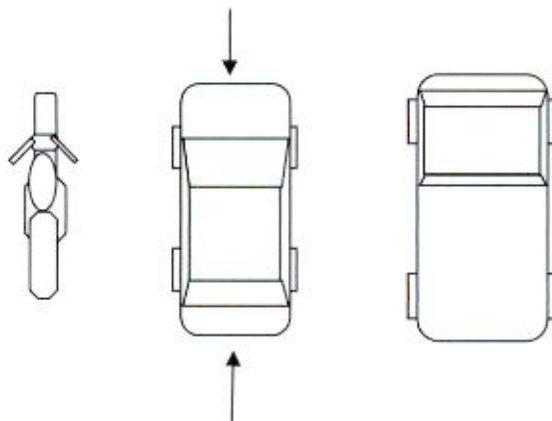
At the time of inspection, this vehicle sustained damages to the **Front & Rear** portion. Please see attached scheduled for details.
