You're Ref: TP/IP/36995/2021  
Our Ref: CI/TPD21009367/P

9<sup>th</sup> September 2021

**MECHANICAL INSPECTION REPORT OF MOTOR CAR SJQ 8668M**

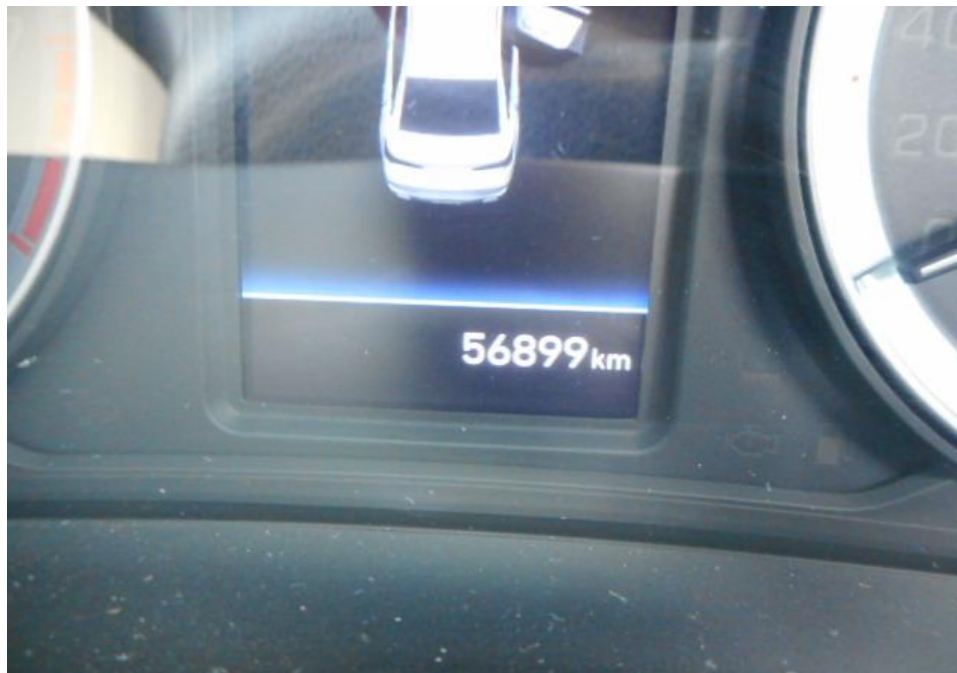
**Photo 1** shows the mileage of the Motor Car at the time of my inspection. The mileage observed was 56,899km.

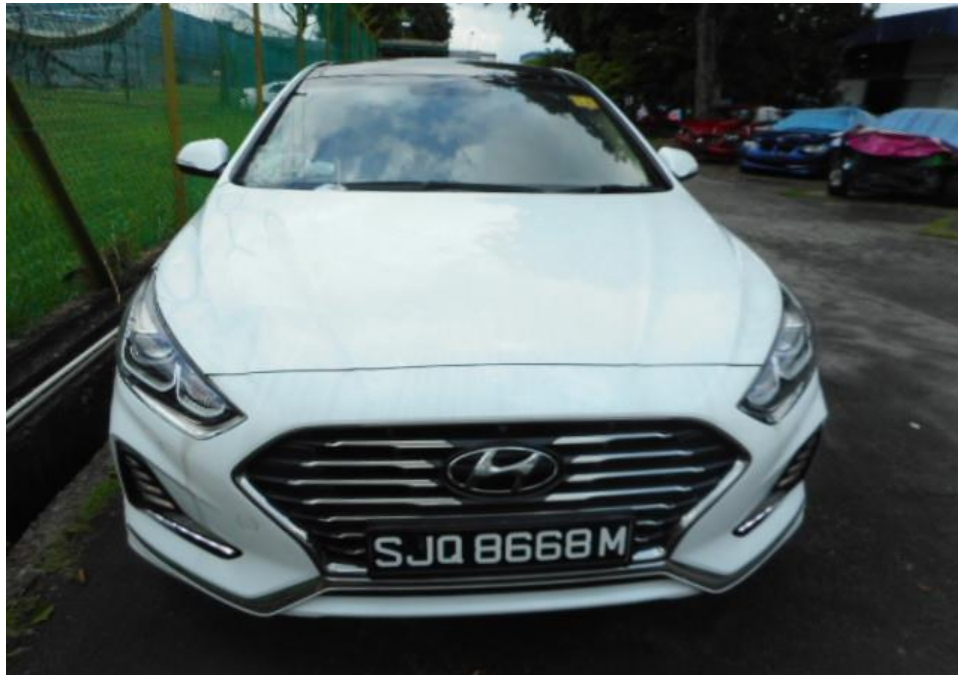
4. The mileage of the Motor Car at the time of my inspection was 56,899km.
5. The Motor Car was observed to have sustained damage at its front portion. Its front windscreen and front bonnet was the body parts that were damaged as a result of the accident.

**Photo 2** shows a general view of the Motor Car's front body at the time of my inspection. The front portion of the Motor Car was observed to have sustained damage. Its front windscreen and front bonnet was the body parts that were damaged as a result of the accident.

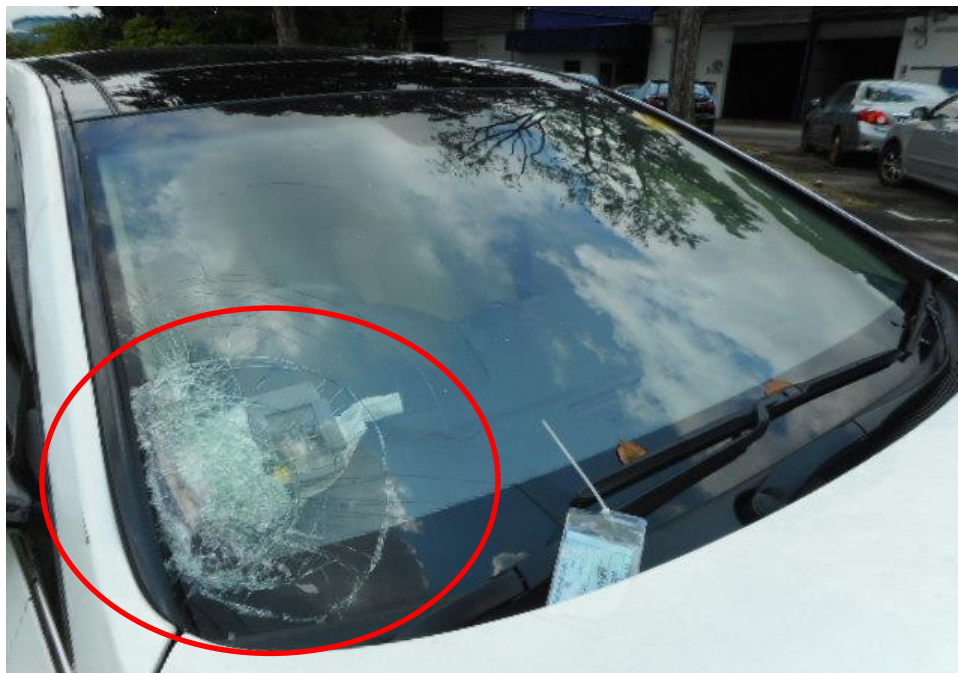
**Photo 3** shows a close up view of the Motor Car's front body at the time of my inspection. The front portion of the Motor Car was observed to have sustained damage. Its front windscreen (circled) was the body part that were damaged as a result of the accident.

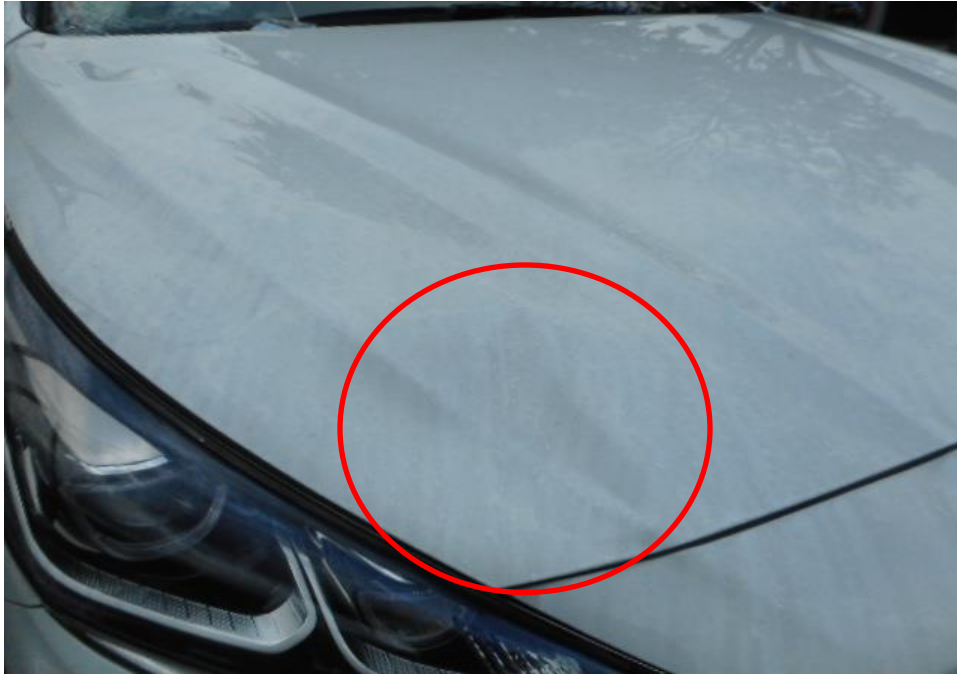
**Photo 4** shows a close up view of the Motor Car's front body at the time of my inspection. The front portion of the Motor Car was observed to have sustained damage. Its front bonnet (circled) was the body part that were damaged as a result of the accident.

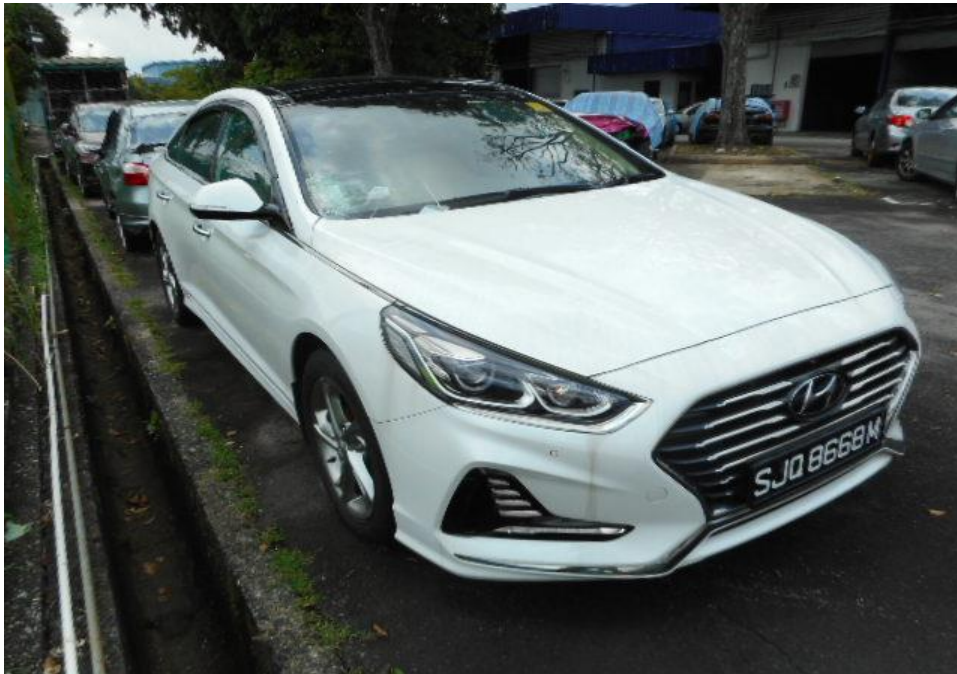
**Photo 5** shows a general view of the Motor Car's right body at the time of my inspection. The right portion of the Motor Car was observed to have been unaffected by the accident.

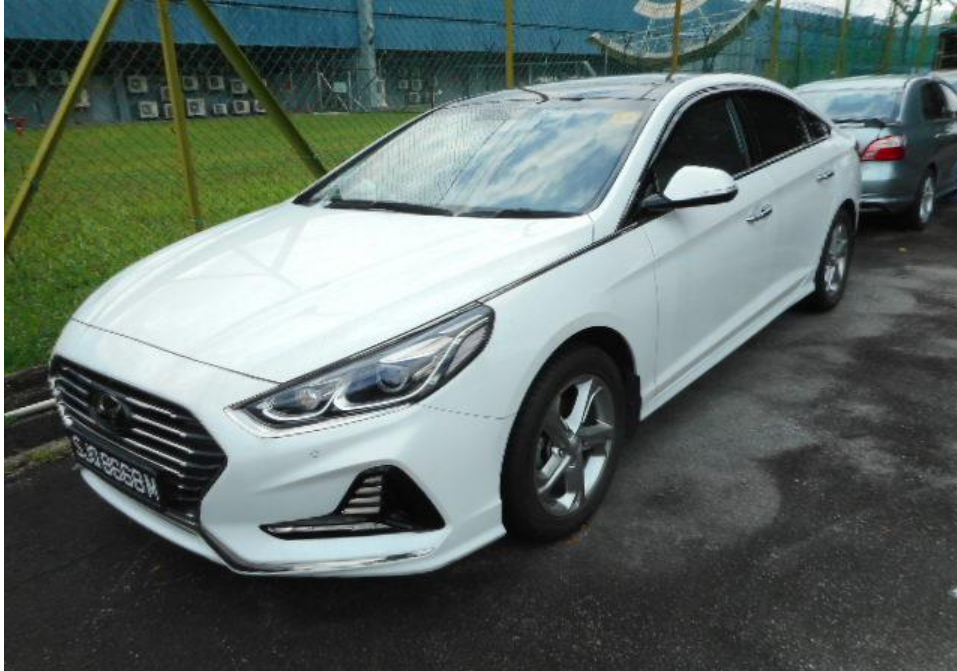
**Photo 6** shows a general view of the Motor Car's left body at the time of my inspection. The left portion of the Motor Car was observed to have been unaffected by the accident.

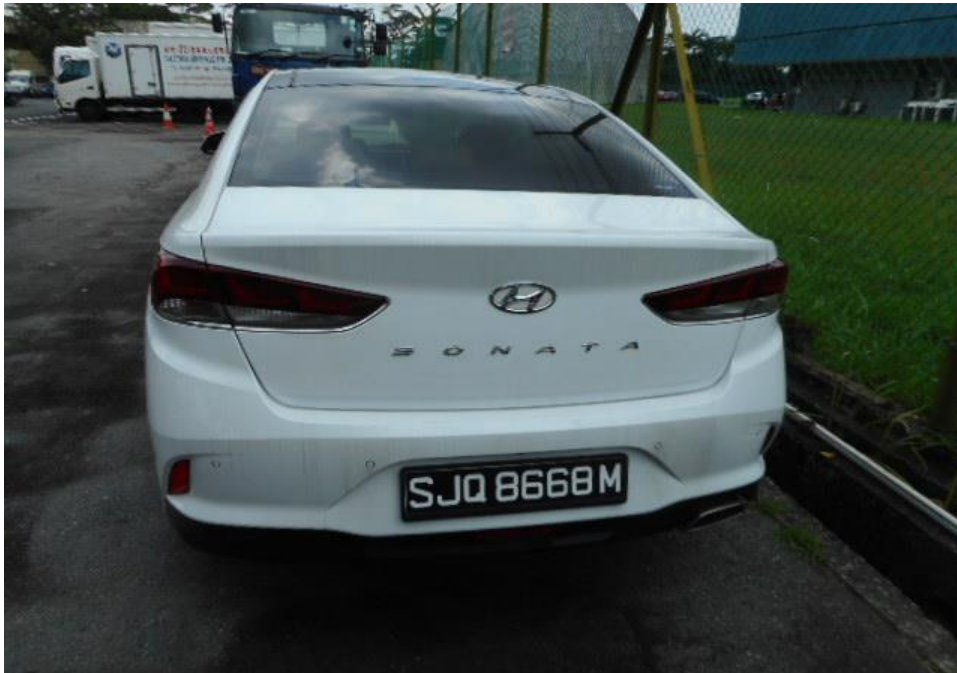
**Photo 7** shows the general view of the Motor Car's rear body at the time of my inspection. The Motor Car rear was observed to be unaffected by the accident.

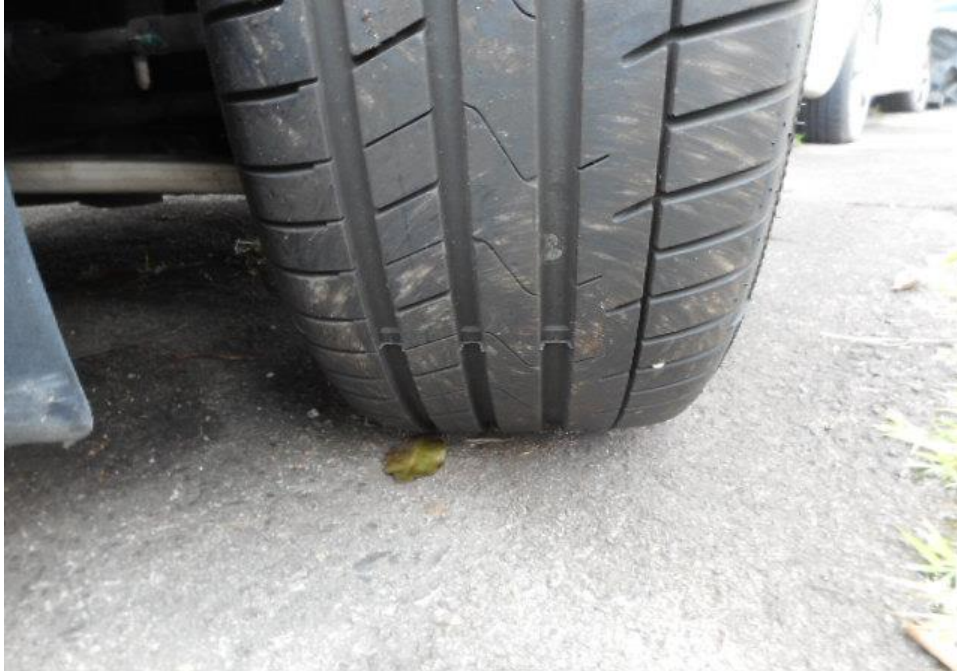
**Photo 8** shows the condition of the front right tyre of the Motor Car, which was observed to be in serviceable condition with remaining tread depth of approximately 6.6mm. The tyre was sufficiently inflated for vehicular operation with no tear, cut or burst mark(s) on the outer and the inner sidewalls as well as across the tread. The 4 tyres of the Motor Car were wrapped around standard steel wheel rims without any damage.

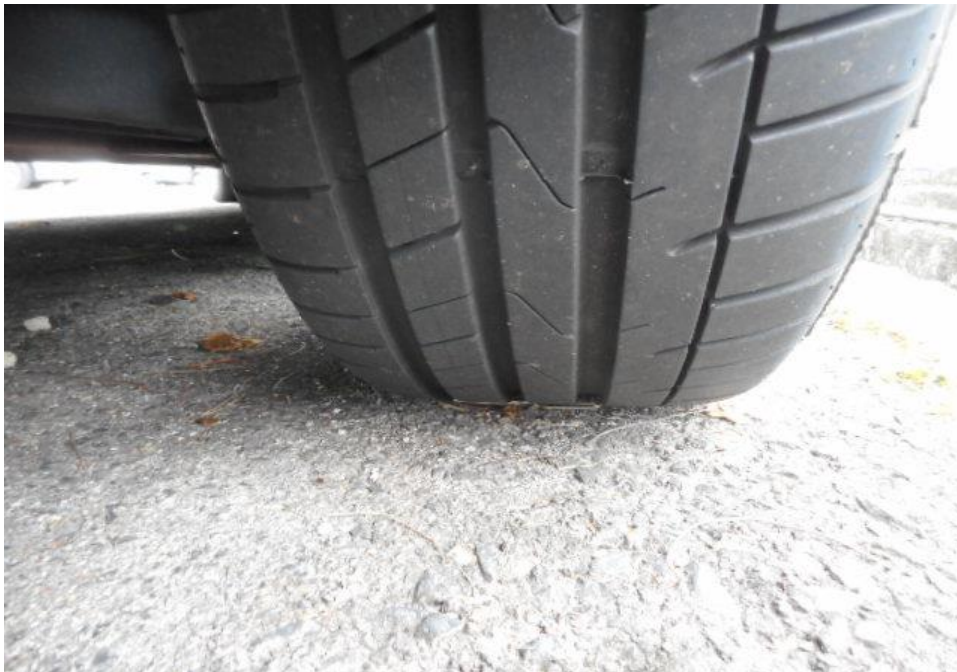
**Photo 9** shows the condition of the rear right tyre of the Motor Car, which was observed to be in serviceable condition with remaining tread depth of approximately 6.2mm. The tyre was also observed to be sufficiently inflated for vehicular operation with no tear, cut or burst mark(s).

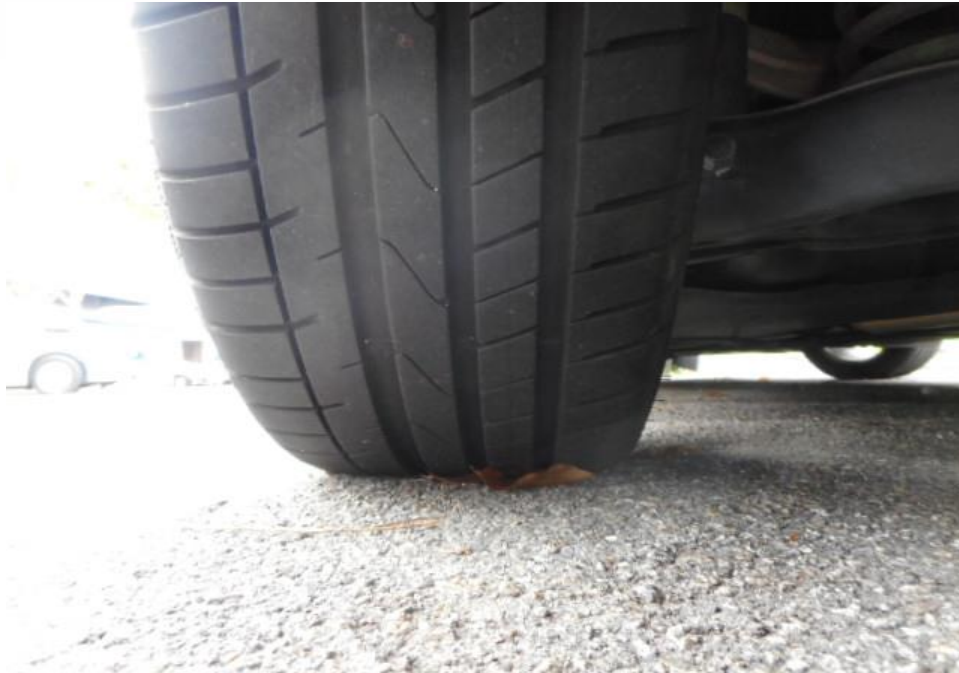
**Photo 10** shows the condition of the rear left tyre of the Motor Car, which was observed to be in serviceable condition with remaining tread depth of approximately 6.2mm. The tyre, which was wrapped around steel wheel rim, was also observed to be sufficiently inflated for vehicular operation. The 4 tyres of the Motor Car were wrapped around standard steel wheel rims.

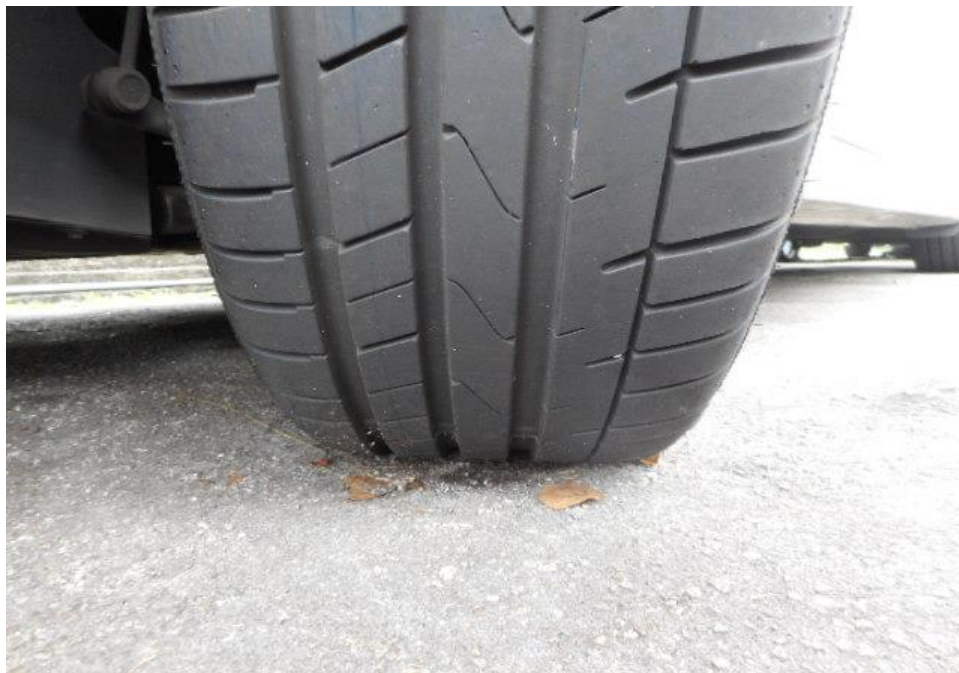
**Photo 11** shows the condition of the front left tyre of the Motor Car, which was observed to be in serviceable condition with remaining tread depth of approximately 6.6mm. There was also no tear, cut or burst mark(s) on the outer and the inner sidewalls as well as across the tread of the Motor Car's 4 tyres.

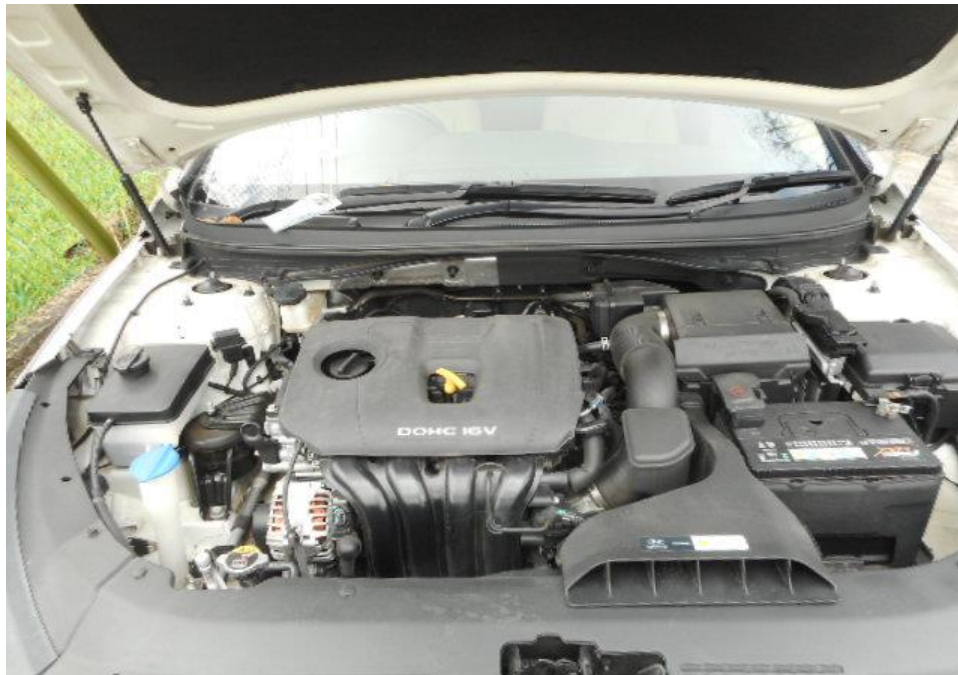
**Photo 12** shows a general view of the Motor Car's engine compartment. The various parts and components inside the engine compartment were unaffected by the accident. There was also no sign(s) or indication(s) of fluid leakage and/or fluid stain within the engine compartment.

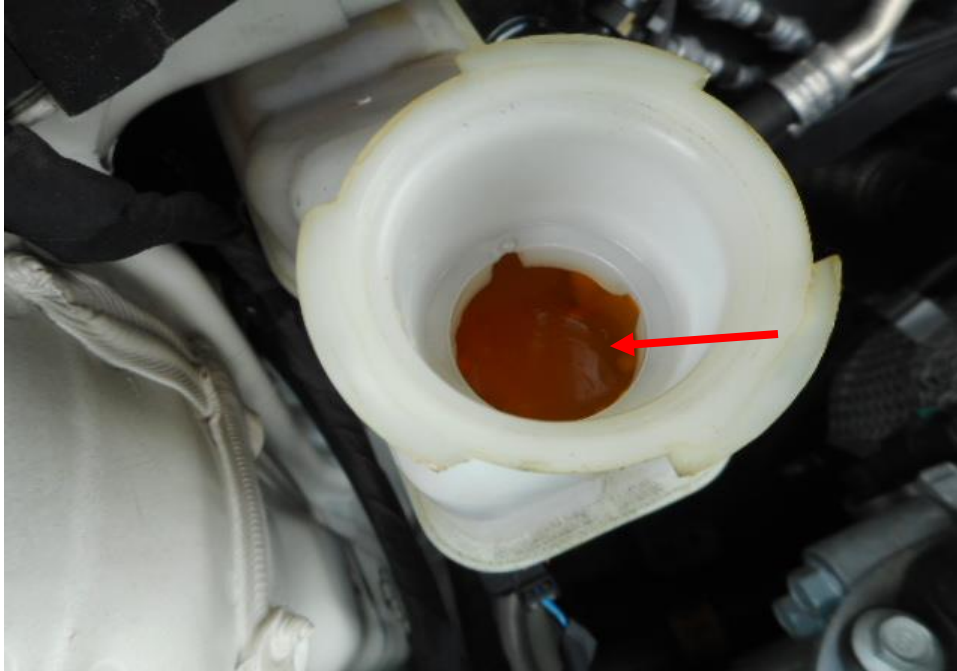
**Photo 13** shows the brake fluid reservoir of the Motor Car at the time of my inspection. The brake fluid was observed to be of sufficient level (arrowed) and without any visible contamination.

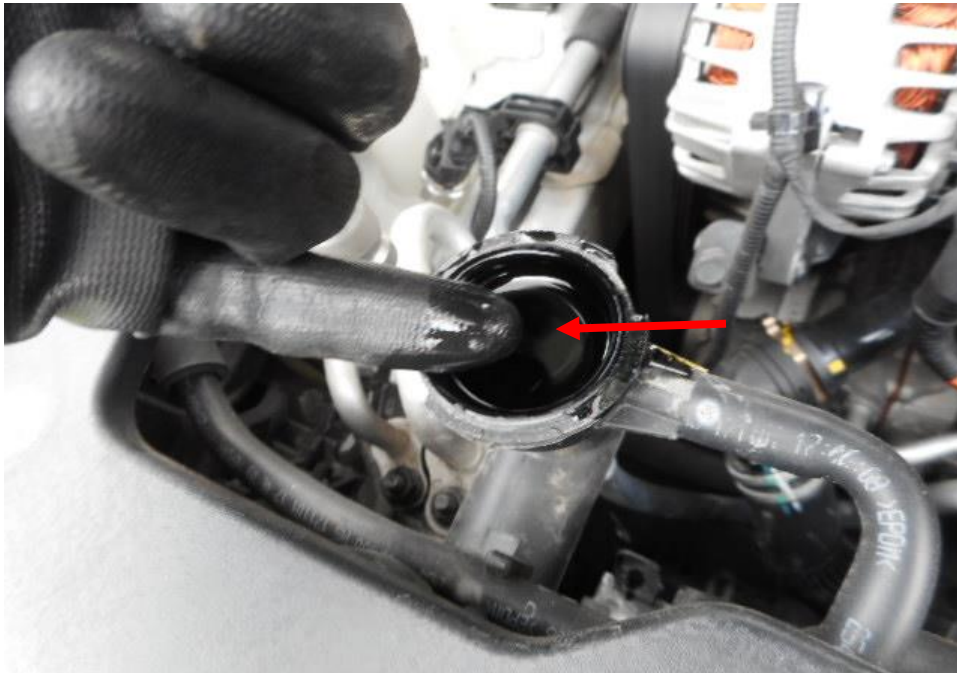
**Photo 14** shows checks being carried out to the engine coolant of the Motor Car at the time of my inspection. The engine coolant was observed to be of sufficient level (arrowed) and without any visible contamination.

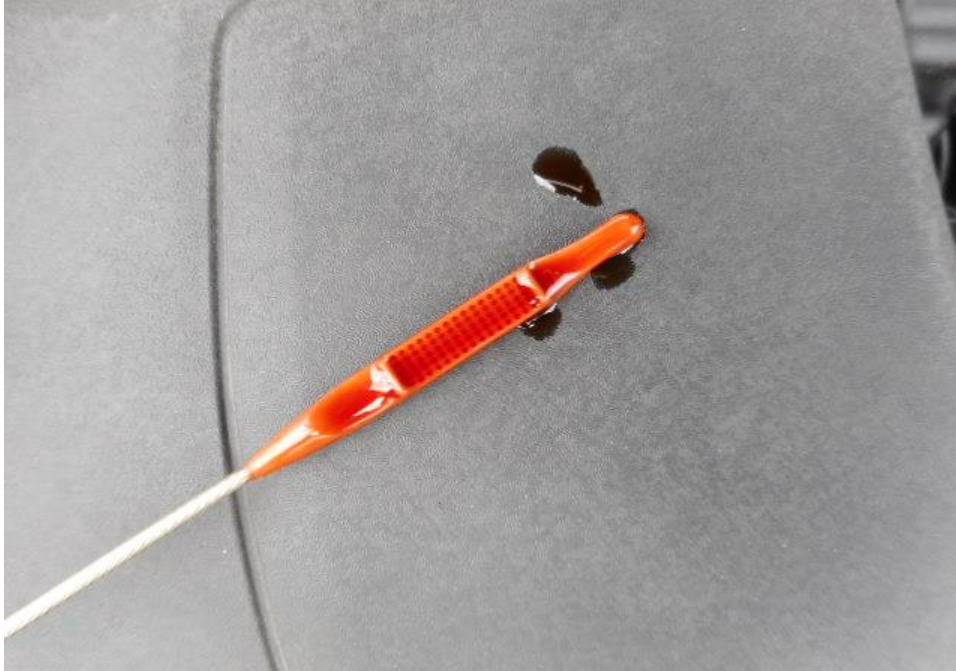
**Photo 15** shows the engine oil dipstick of the Motor Car at the time of my inspection. The engine oil was observed to be of sufficient level and without any visible contamination.

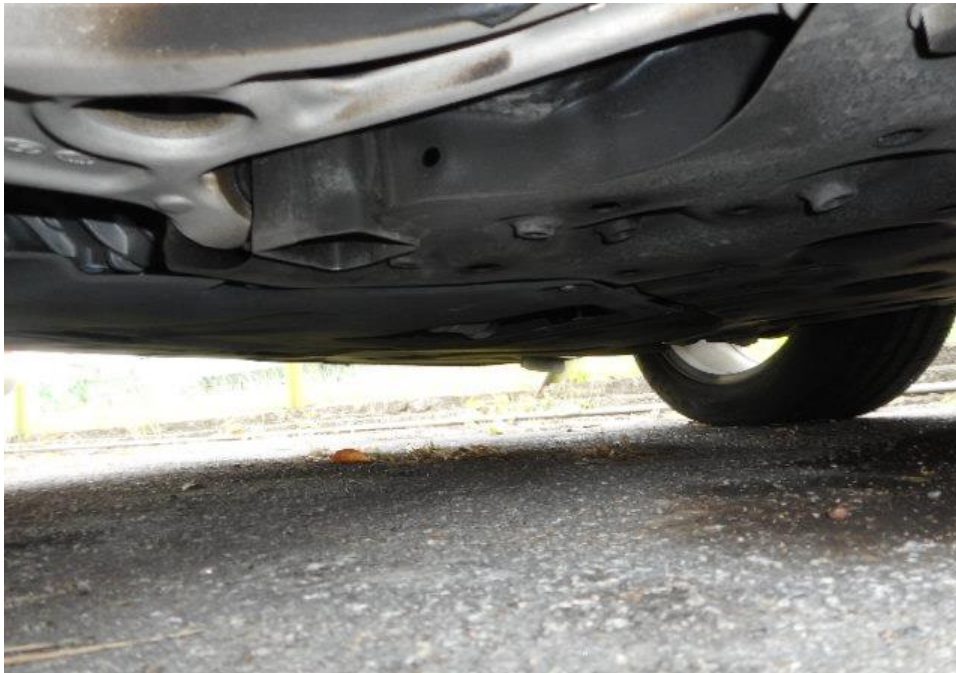
**Photo 16** shows the undercarriage of the Motor Car, at the area where the engine housing and transmission housing are located. I did not find any sign(s) or indication(s) of fluid leak and/or fluid stain(s) on the underside of the Motor Car.

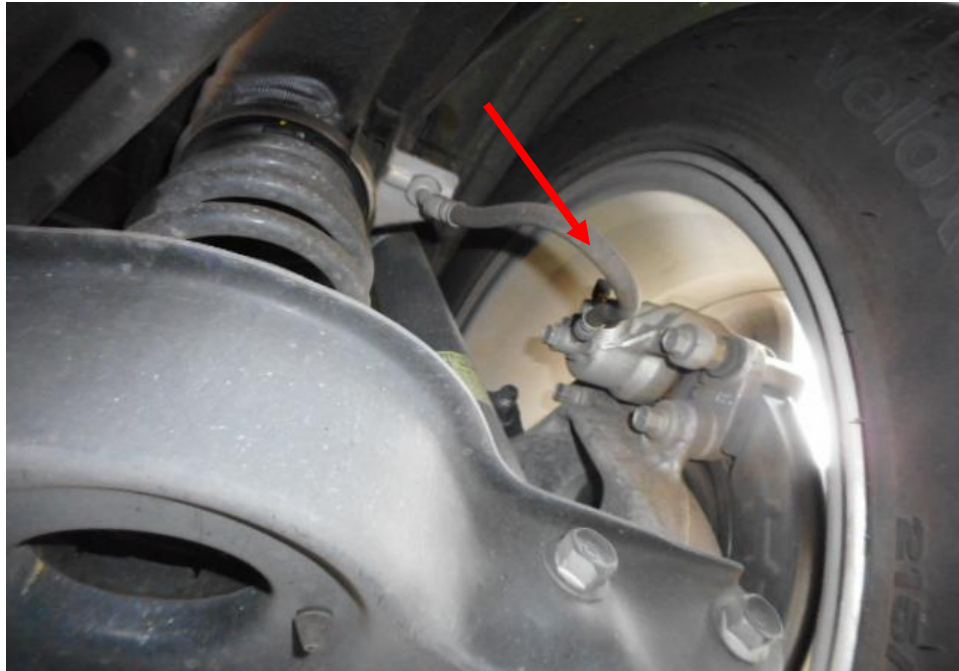
**Photo 17** shows the brake hose/pipe (arrowed) at the rear right wheel of the Motor Car. No leakage of brake fluid was observed. Visual examination of the various components of the braking system like the drum brake, brake booster, brake pedal etc. had revealed all to be intact and without visible damage.

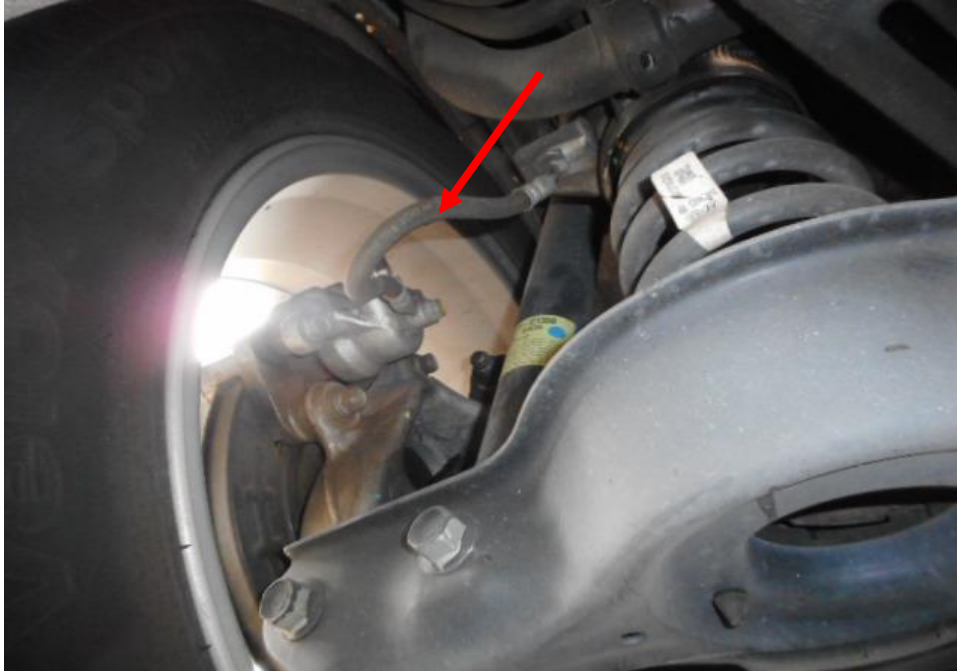
**Photo 18** shows the brake hose/pipe (arrowed) at the rear left wheel of the Motor Car. I did not observe any leakage of brake fluid at the time of my inspection of the Motor Car. Static tests of the Motor Car's braking system had indicated that there was no internal leakage of pressure/vacuum. The undercarriage components of the Motor Car were also all found to be intact and without any visible damage.

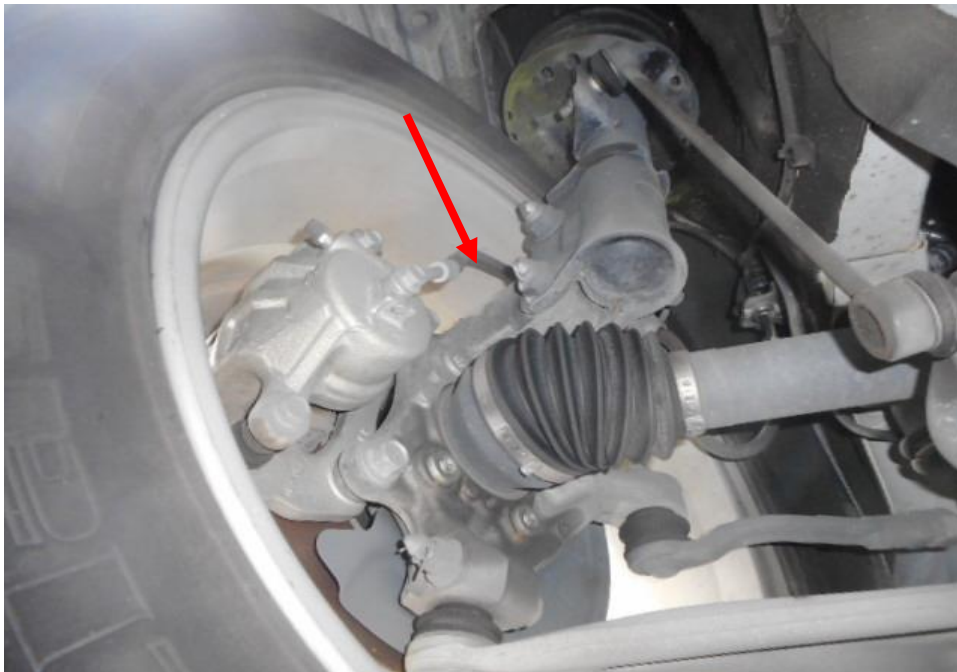
**Photo 19** shows the brake hose/pipe (arrowed) at the front right wheel of the Motor Car. I did not observe any leakage of brake fluid at the time of my inspection of the Motor Car. Static tests of the Motor Car's braking system had indicated that there was no internal leakage of pressure/vacuum. The undercarriage components of the Motor Car were also all found to be intact and without any visible damage.

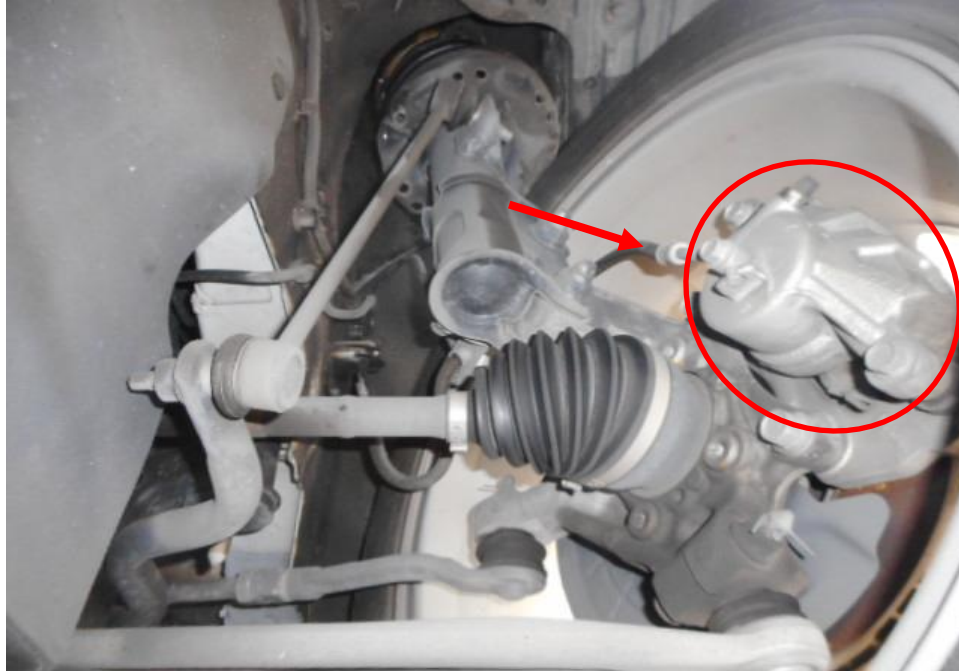
**Photo 20** shows the brake hose/pipe (arrowed) at the front left wheel of the Motor Car. No leakage of brake fluid was observed. Visual examination of the various components of the braking system like the brake caliper (circled), brake booster, brake pedal etc had revealed all to be intact and without visible damage.

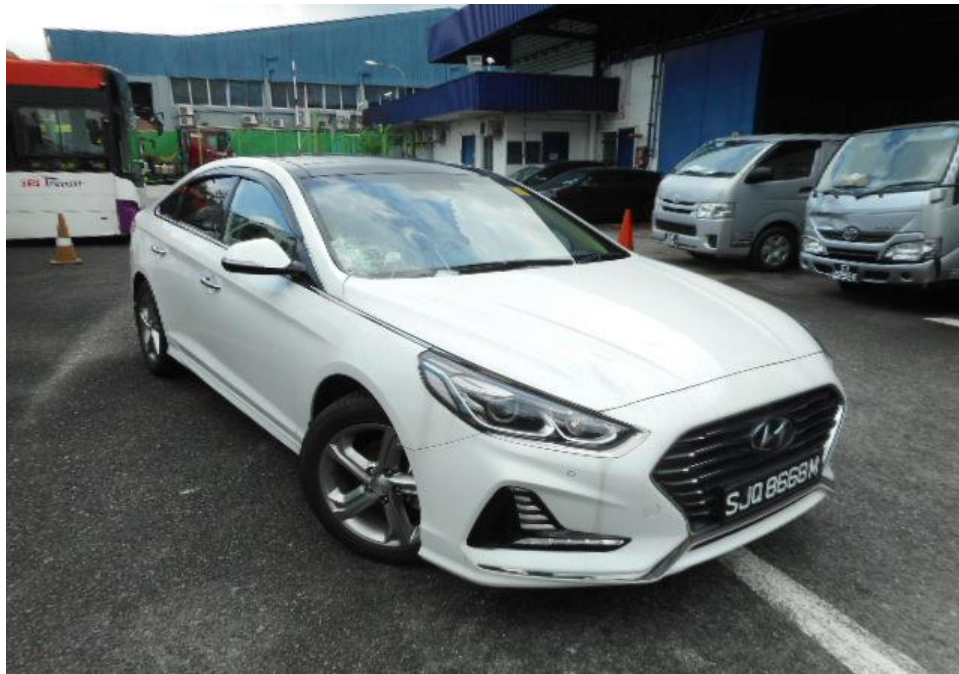
**Photo 21** shows the front right wheel of the Motor Car turned to its full left. During my steering system test, I did not experience any abnormal free play and/or resistance when I had turned the steering wheel towards the left and right. This would suggest that the steering system of the Motor Car was likely to be in serviceable condition at the material time of accident.

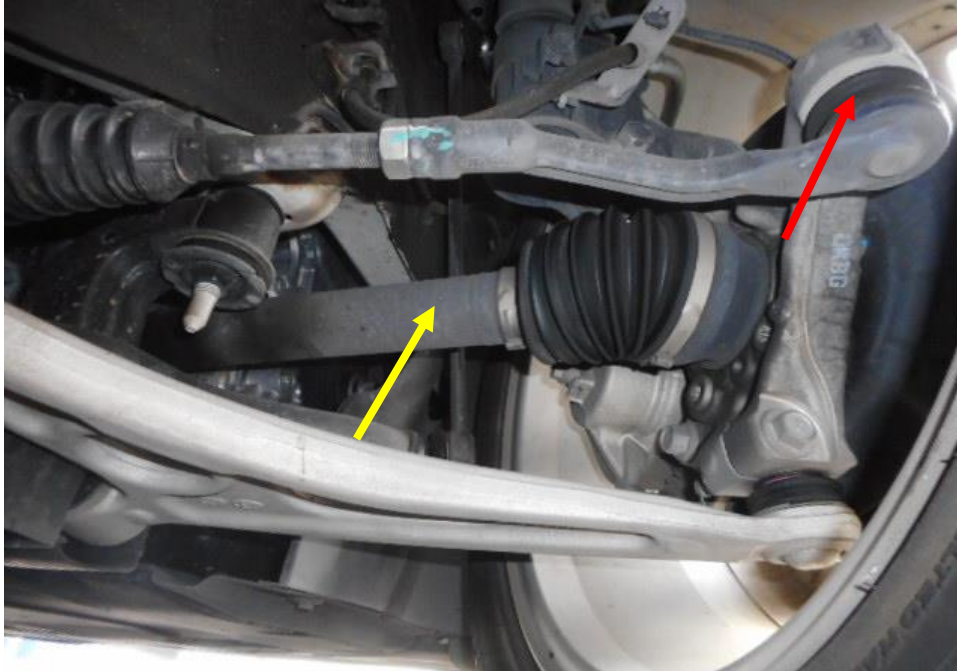
**Photo 22** shows the various undercarriage components at the front right wheel of the Motor Car, in particular the steering tie rod (red arrow) and drive shaft (yellow arrow). The various steering components were all found to be intact, suggesting that the steering system of the Motor Car was likely to be in serviceable condition at the material time of accident. There was also no sign of fluid stain observed on the various undercarriage components at the front right wheel of the Motor Car.

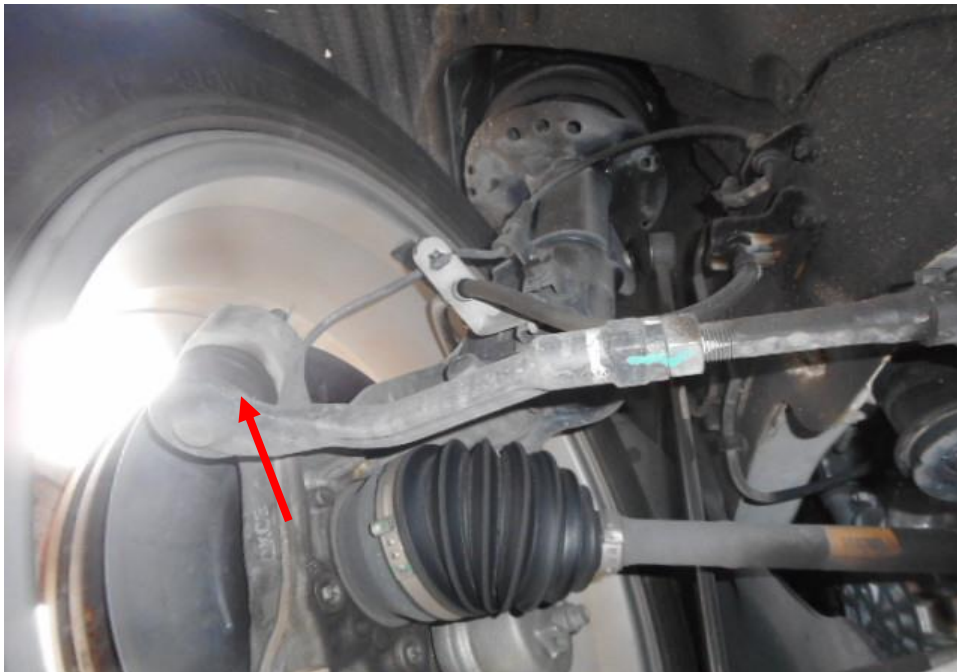
**Photo 23** shows the various undercarriage components at the front left wheel of the Motor Car, which had included the steering tie rod (red arrow). The various undercarriage components of the Motor Car were all found to be intact without any visible damage.

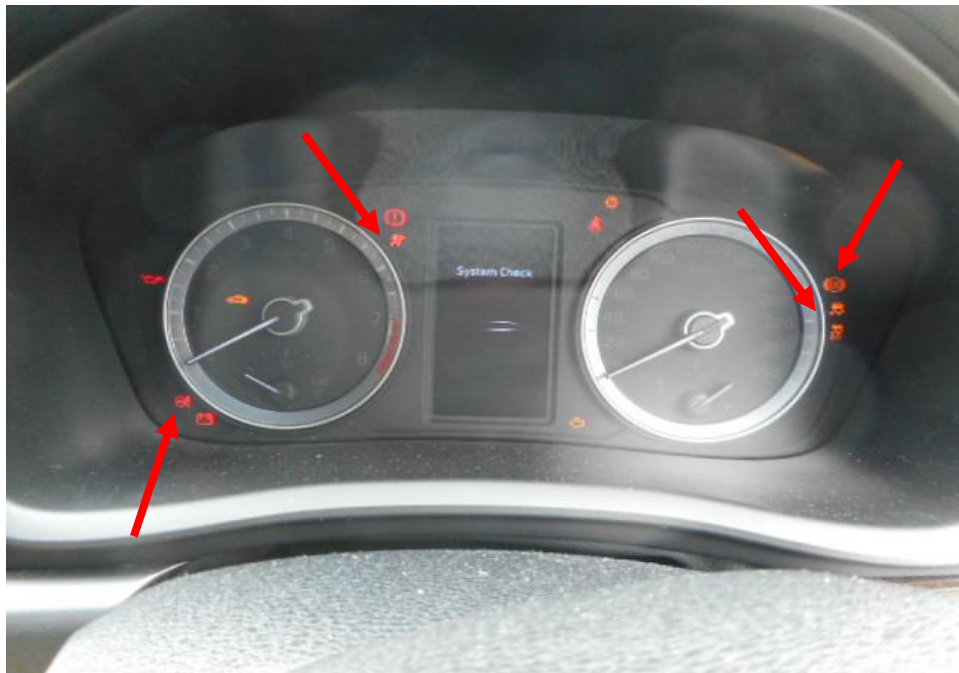
**Photo 24** shows the warning light for Anti-Lock Brake System (ABS), Electric Power Steering System (EPS), Traction Control System (TCS) and Supplemental Restraint System (SRS) (arrowed) appearing on the instrument panel of the Motor Car during the self-test of its various electronic operating systems when its engine was cranked.

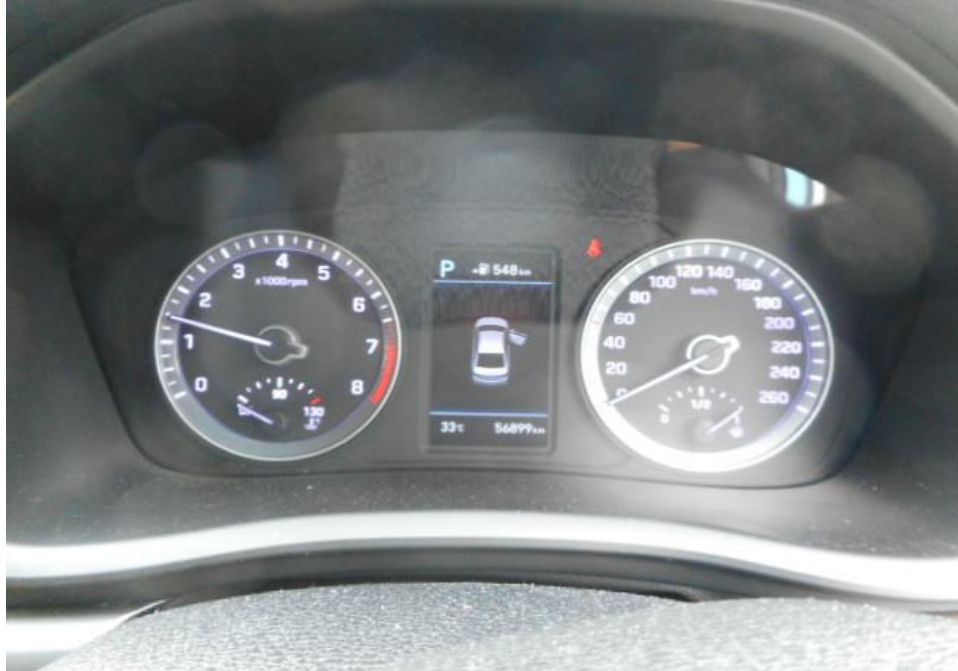
**Photo 25** shows no warning lights illuminated on the instrument panel of the Motor Car after the engine was cranked. This would suggest that there was no abnormality to the electronic operating system of the Motor Car, like the ABS, EPS, TCS and SRS etc.
