Your Ref: TP/IP/37403/2021
Our Ref : CI/TPD21009368/P

22nd September 2021

MECHANICAL INSPECTION REPORT OF MOTOR CAR SKQ 5047M

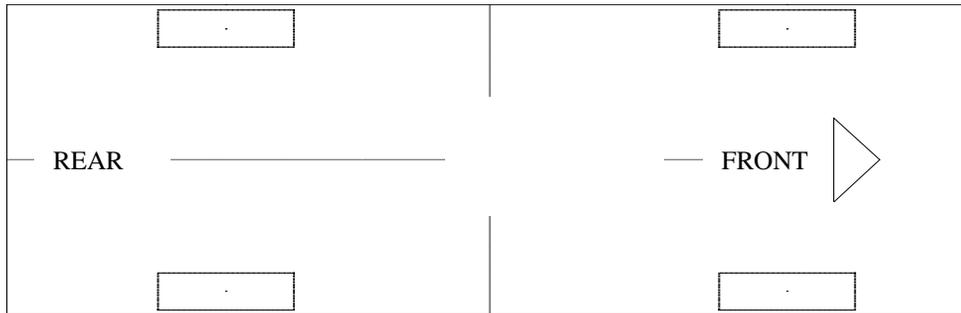
6. The condition of the Motor Car's front left tyre was observed to be in damaged as a result of the accident. However, the other 3 tyres was observed to be in serviceable condition. I did not find any tear, cut or burst mark(s) on the outer and the inner sidewalls as well as across the tread of the 3 tyres. The 3 tyres were also observed to be sufficiently inflated for vehicular operation. The tyre brand, tyre size and remaining tread depth of the 4 tyres were recorded as follows:-

Tourador 195/65R15 (5.9mm)

Tourador 195/65R15 (4.8mm)
(Cut) (Deflated)

Tourador 195/65R15 (5mm)

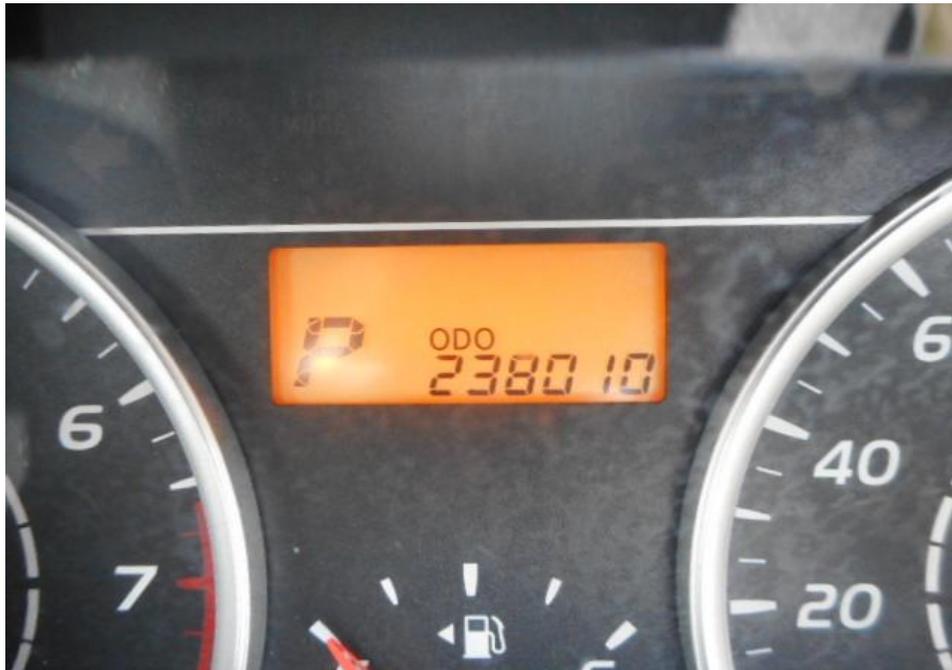
4. The mileage of the Motor Car at the time of my inspection was 238,010km.
5. The Motor Car was observed to have sustained damage at its front and left portion. Its front windscreen, left side skirts were amongst the body parts that were damaged as a result of the accident.

Photo 1 shows the mileage of the Motor Car at the time of my inspection. The mileage observed was 238,010km.

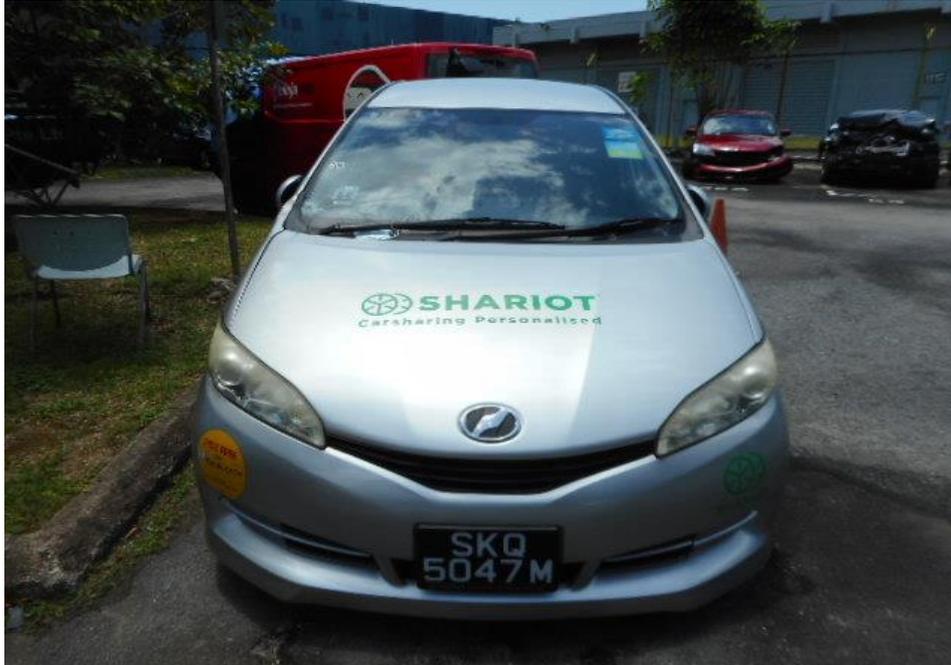
Photo 2 shows a general view of the Motor Car's front body at the time of my inspection. The Motor Car was observed to have sustained damage at its front and left portion. Its front windscreen, left side skirts were amongst the body parts that were damaged as a result of the accident.

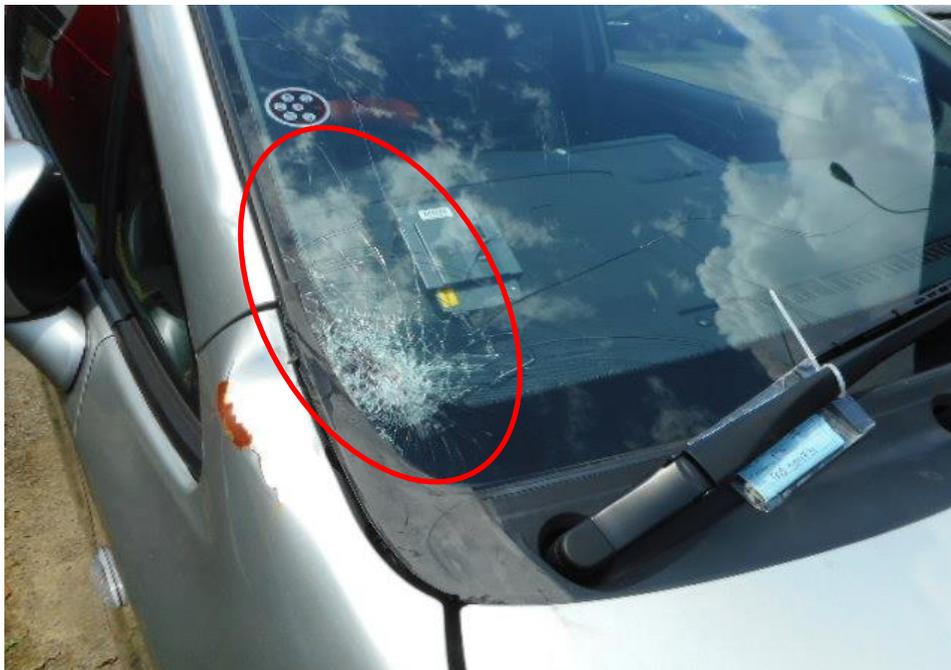
Photo 3 shows the close up view of the Motor Car's front body at the time of my inspection. The Motor Car was observed to have sustained damage at its front portion. Its front windscreen (circled) were amongst the body parts that were damaged as a result of the accident.

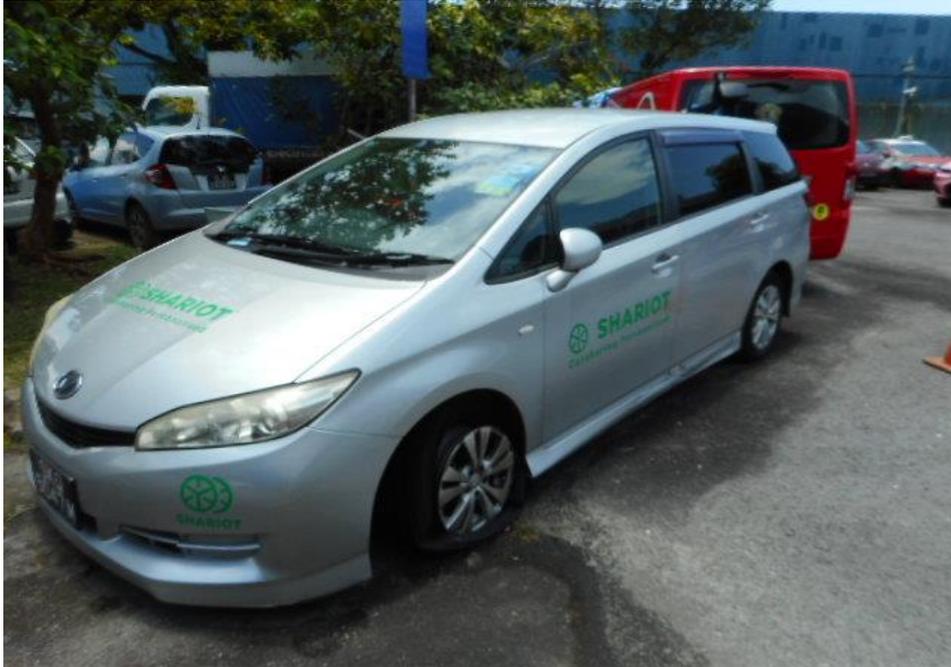
Photo 4 shows a general view of the Motor Car's left body at the time of my inspection. The Motor Car was observed to have sustained damage at its front portion. Its left side skirts were amongst the body parts that were damaged as a result of the accident.

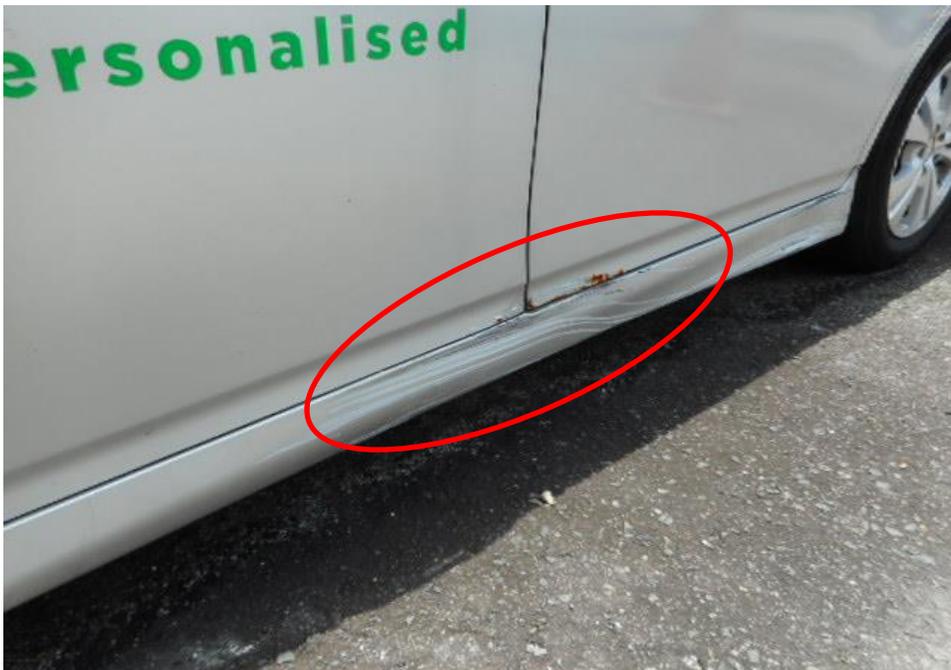
Photo 5 shows a close up view of the Motor Car's left body at the time of my inspection. The Motor Car was observed to have sustained damage at its front portion. Its left side skirts (circled) were amongst the body parts that were damaged as a result of the accident.

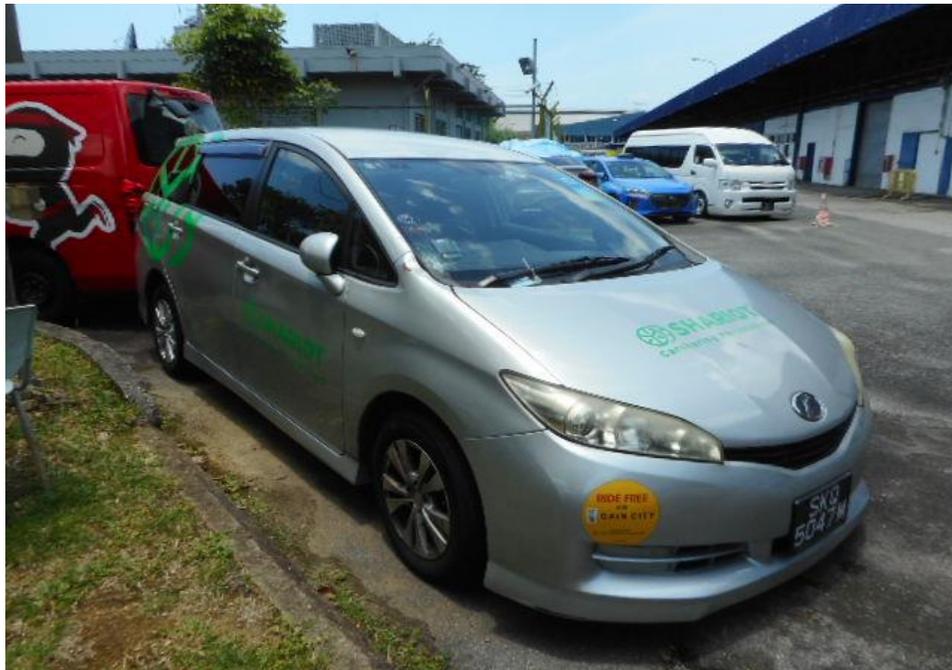
Photo 6 shows a general view of the Motor Car's right body at the time of my inspection. The right portion of the Motor Car was observed to have been unaffected by the accident.

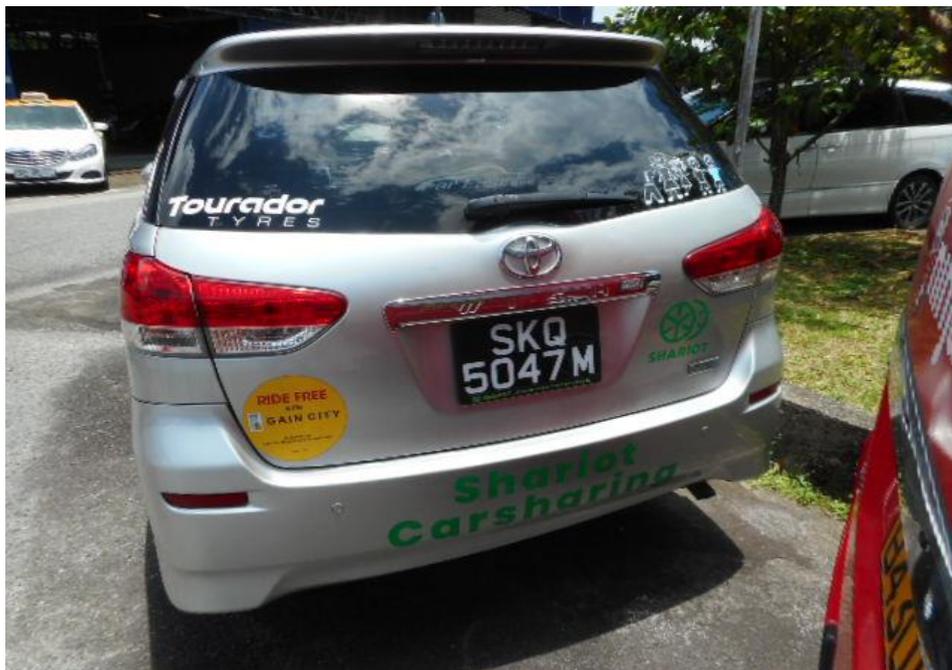
Photo 7 shows the general view of the Motor Car's rear body at the time of my inspection. The Motor Car rear was observed to be unaffected by the accident.

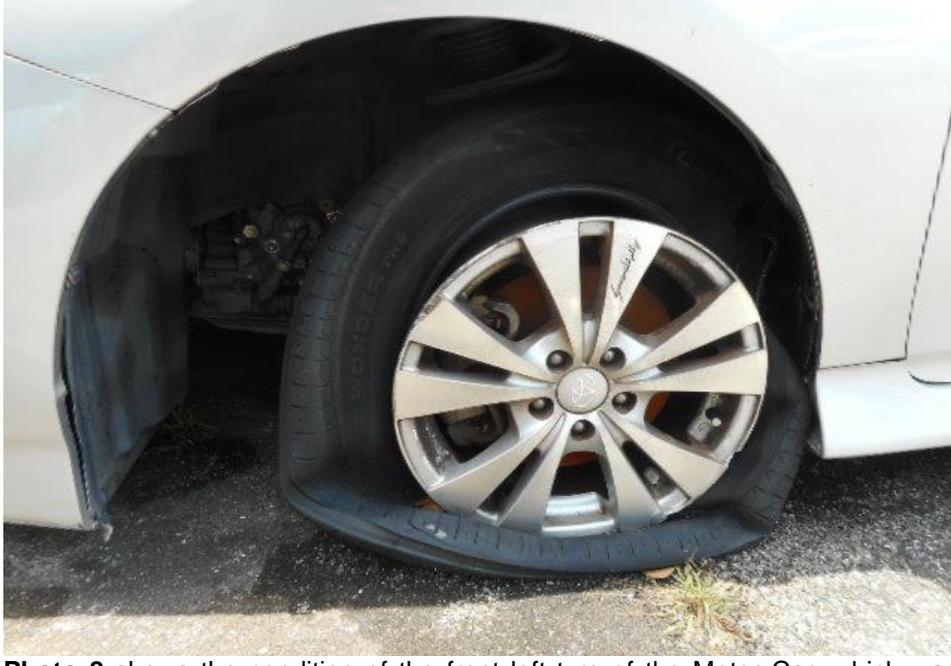
Photo 8 shows the condition of the front left tyre of the Motor Car, which was observed to be unserviceable condition with remaining tread depth of approximately 4.8mm. The tyre was observed with cut mark(s) on the outer sidewalls and there was damage observed on the wheel rims as a result of the accident.

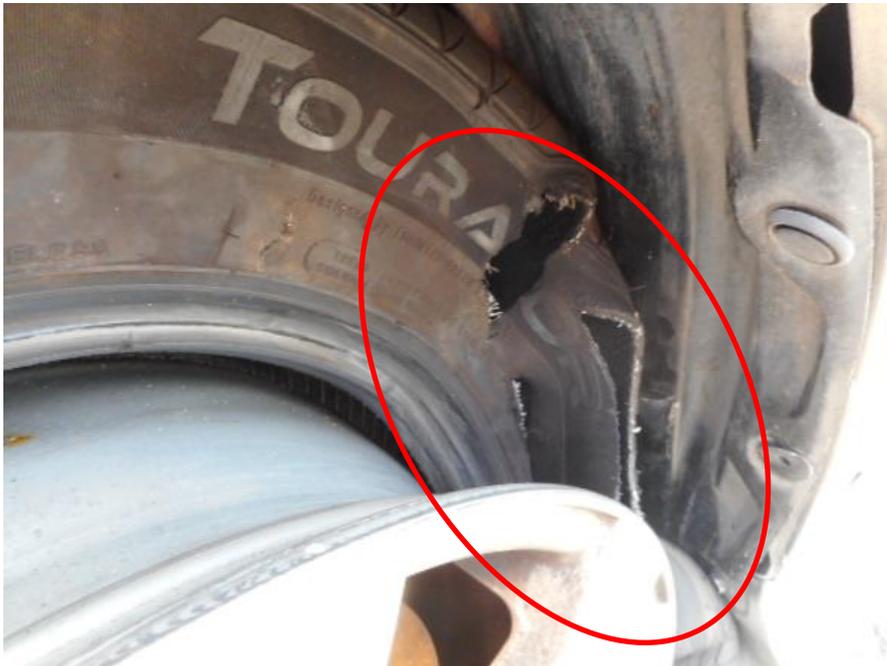
Photo 9 shows the close up view of the condition of the front left tyre of the Motor Car, which was observed to be unserviceable condition. The tyre was observed with cut mark(s) on the outer sidewalls and there was damage observed on the wheel rims (circled) as a result of the accident.

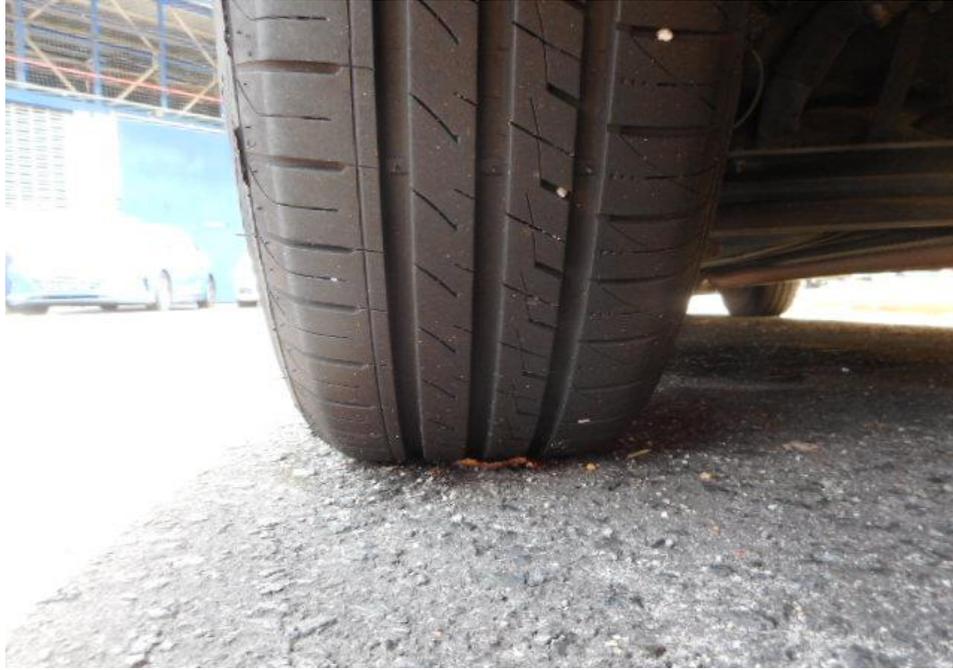
Photo 10 shows the condition of the rear left tyre of the Motor Car, which was observed to be in serviceable condition with remaining tread depth of approximately 5.9mm. The tyre was observed with cut marks and wheel rim damage as a result of the accident, however it was observed to be sufficiently inflated for vehicular operation

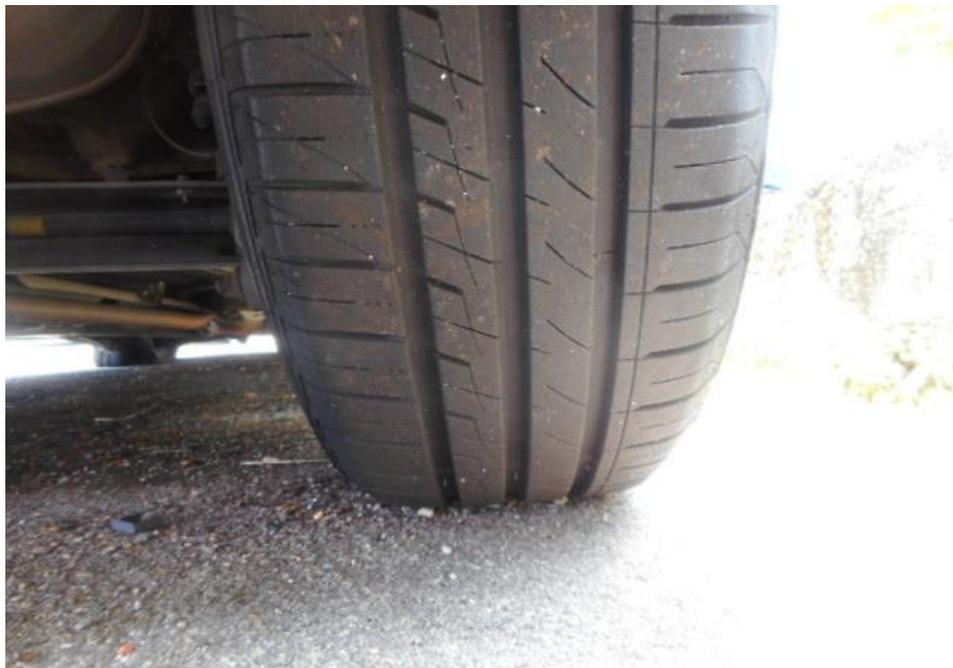
Photo 11 shows the condition of the rear right tyre of the Motor Car, which was observed to be in serviceable condition with remaining tread depth of approximately 5.9mm. The tyre was observed with cut marks and wheel rim damage as a result of the accident, however it was observed to be sufficiently inflated for vehicular operation

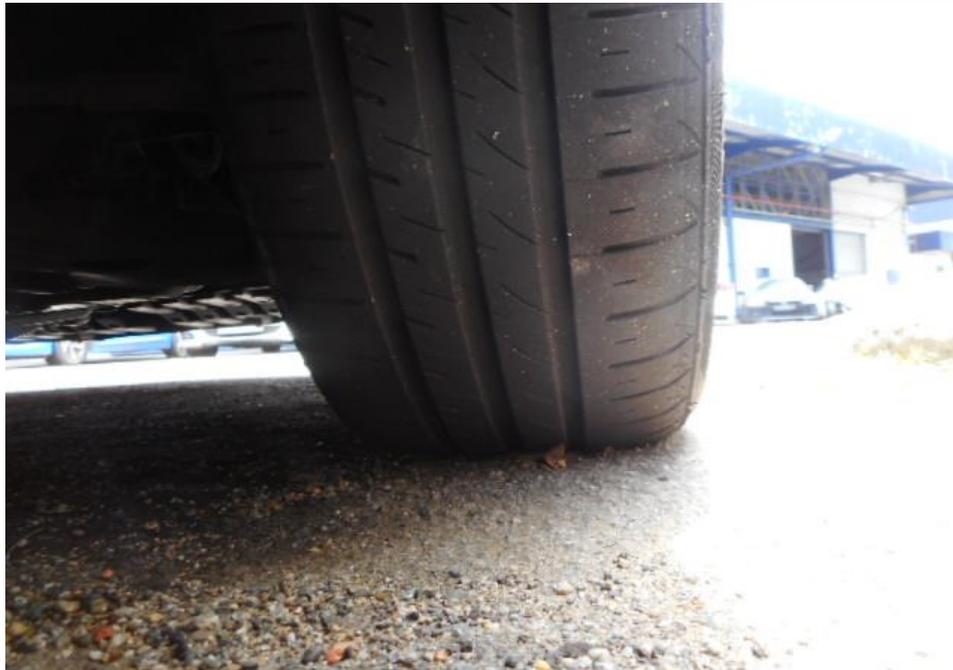
Photo 12 shows the condition of the front right tyre of the Motor Car, which was observed to be in serviceable condition with remaining tread depth of approximately 5mm. The tyre was observed with cut marks and wheel rim damage as a result of the accident, however it was observed to be sufficiently inflated for vehicular operation

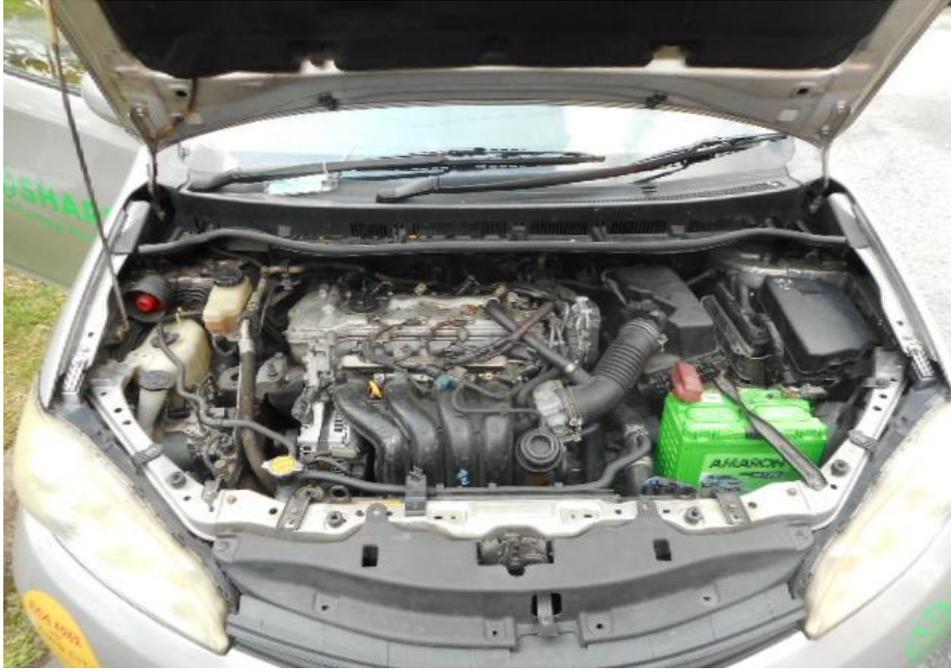
Photo 13 shows a general view of the Motor Car's engine compartment. The various parts and components inside the engine compartment were unaffected by the accident. There was also no sign(s) or indication(s) of fluid leakage and/or fluid stain within the engine compartment.

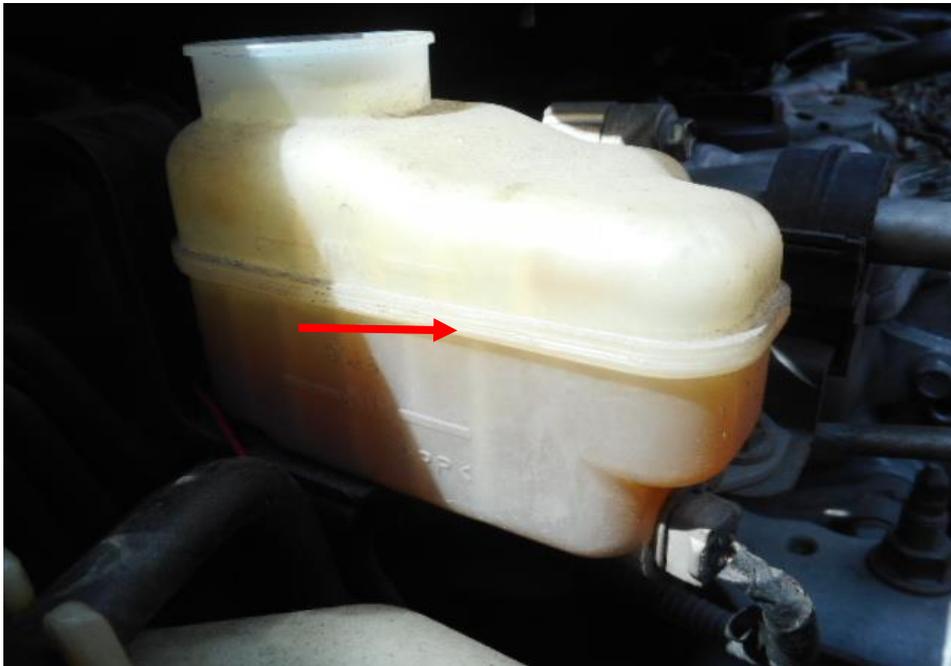
Photo 14 shows the brake fluid reservoir of the Motor Car at the time of my inspection. The brake fluid was observed to be of sufficient level (arrowed) and without any visible contamination.

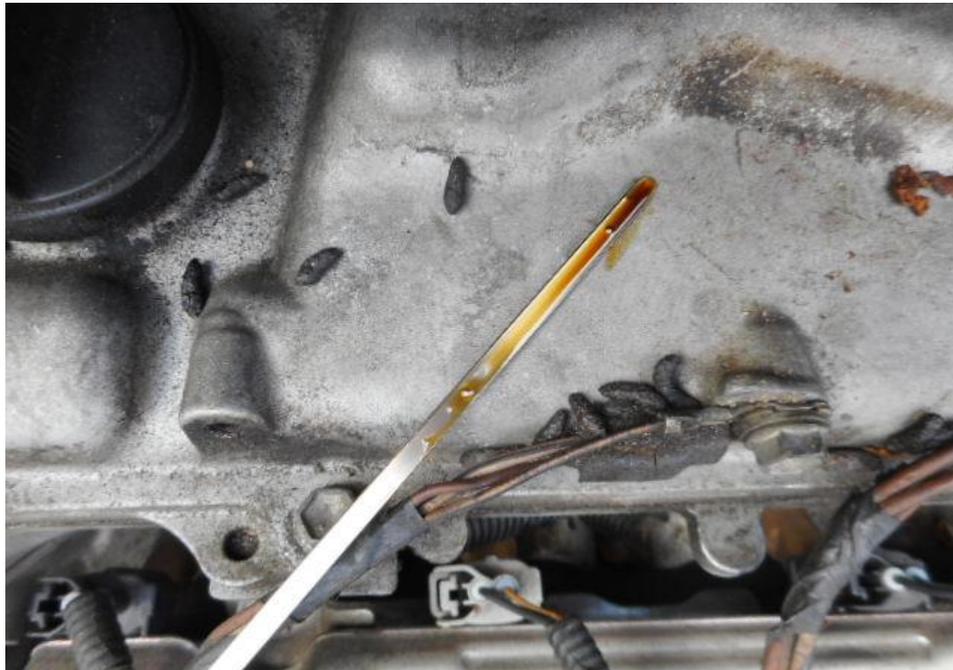
Photo 15 shows the engine oil dip stick of the Motor Car at the time of my inspection. The engine oil was observed to be of sufficient level and without any visible contamination.

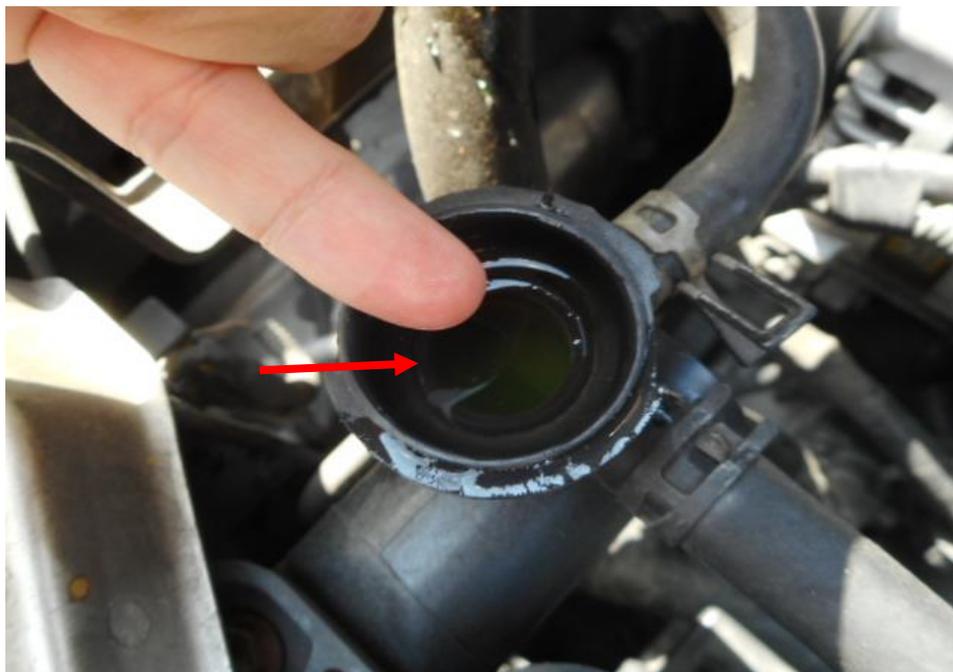
Photo 16 shows checks being carried out to the engine coolant of the Motor Car at the time of my inspection. The engine coolant was observed to be of sufficient level (arrowed) and without any visible contamination.

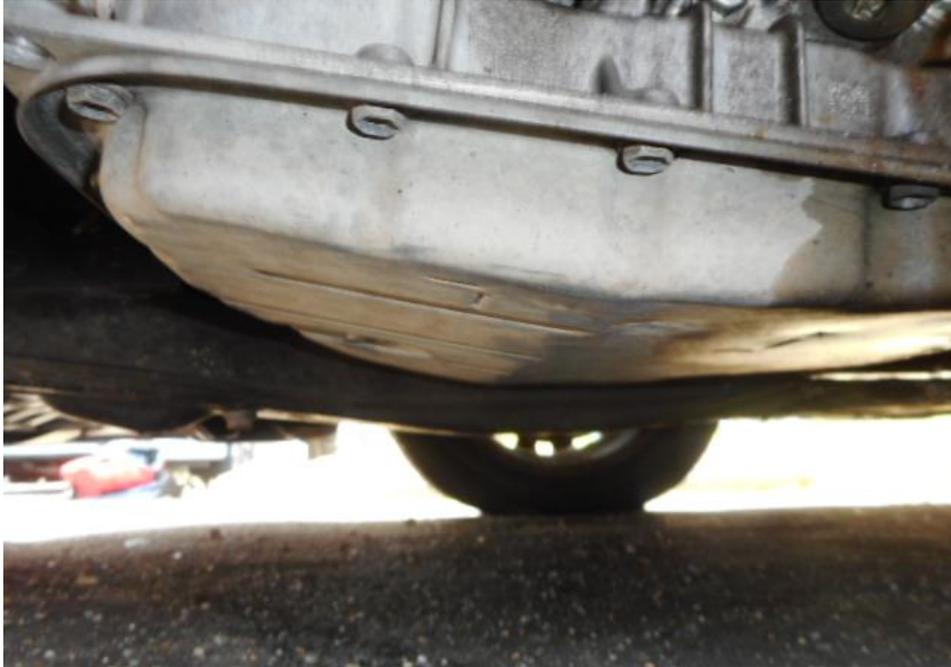
Photo 17 shows the undercarriage of the Motor Car, at the area where the engine housing and transmission housing are located. I did not find any sign(s) or indication(s) of fluid leak and/or fluid stain(s) on the underside of the Motor Car.

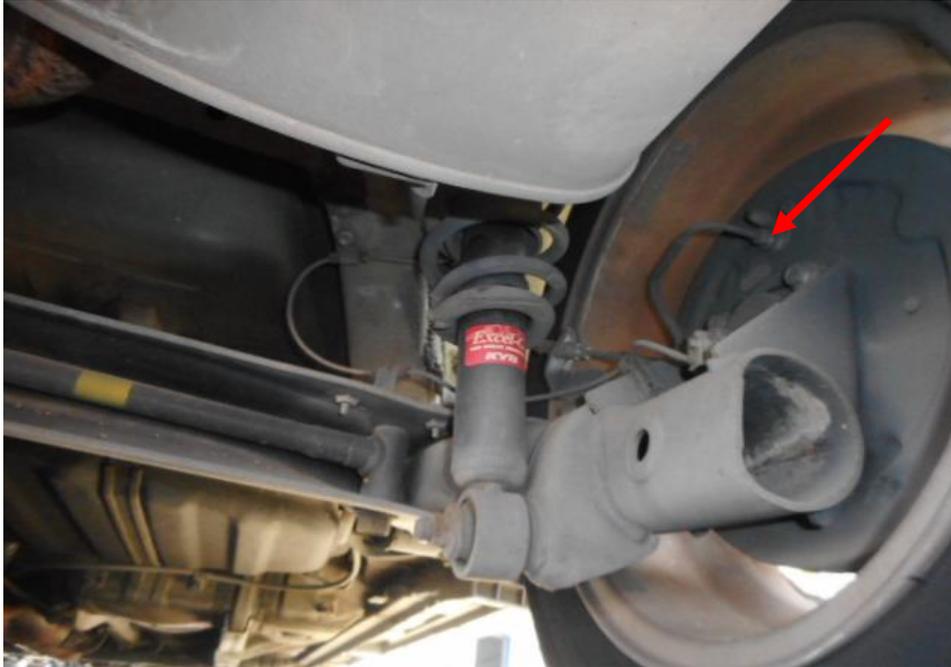
Photo 18 shows the brake hose/pipe (arrowed) at the rear right wheel of the Motor Car. No leakage of brake fluid was observed. Visual examination of the various components of the braking system like the drum brake, brake booster, brake pedal etc. had revealed all to be intact and without visible damage.

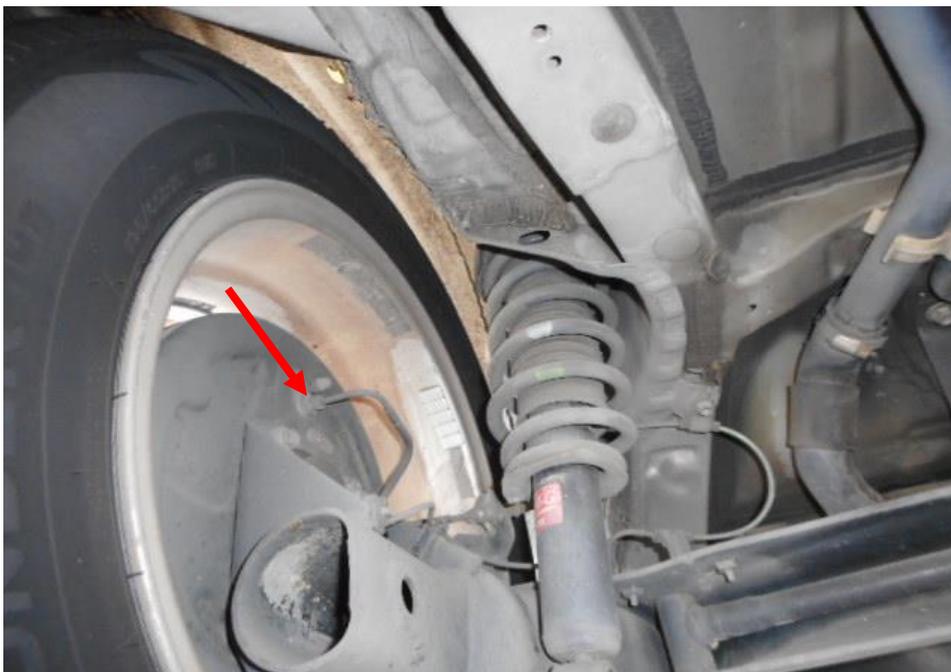
Photo 19 shows the brake hose/pipe (arrowed) at the rear left wheel of the Motor Car. I did not observe any leakage of brake fluid at the time of my inspection of the Motor Car. Static tests of the Motor Car's braking system had indicated that there was no internal leakage of pressure/vacuum. The undercarriage components of the Motor Car were also all found to be intact and without any visible damage.

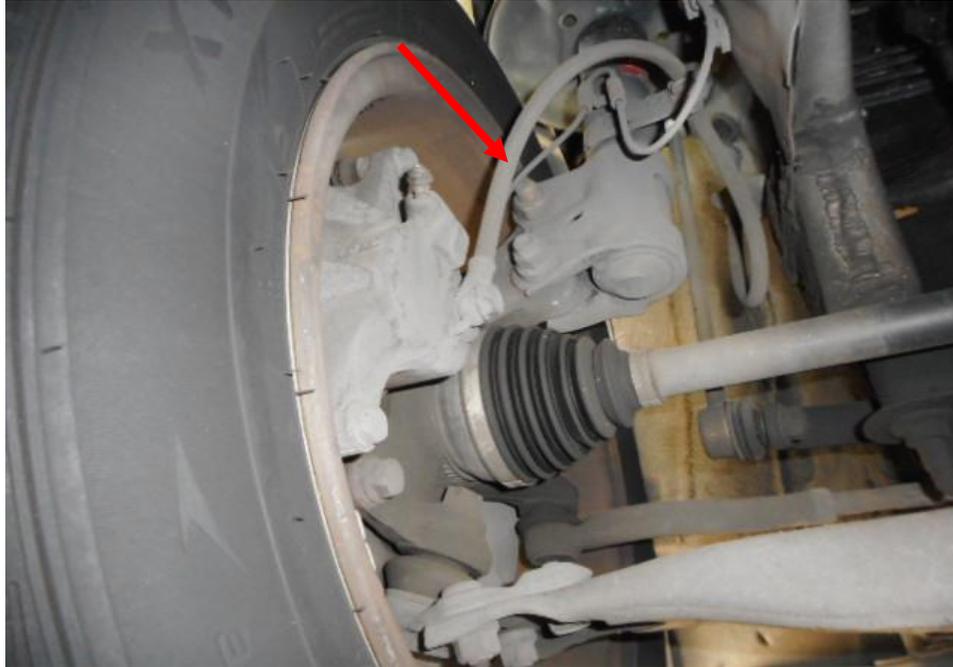
Photo 20 shows the brake hose/pipe (arrowed) at the front right wheel of the Motor Car. I did not observe any leakage of brake fluid at the time of my inspection of the Motor Car. Static tests of the Motor Car's braking system had indicated that there was no internal leakage of pressure/vacuum. The undercarriage components of the Motor Car were also all found to be intact and without any visible damage.

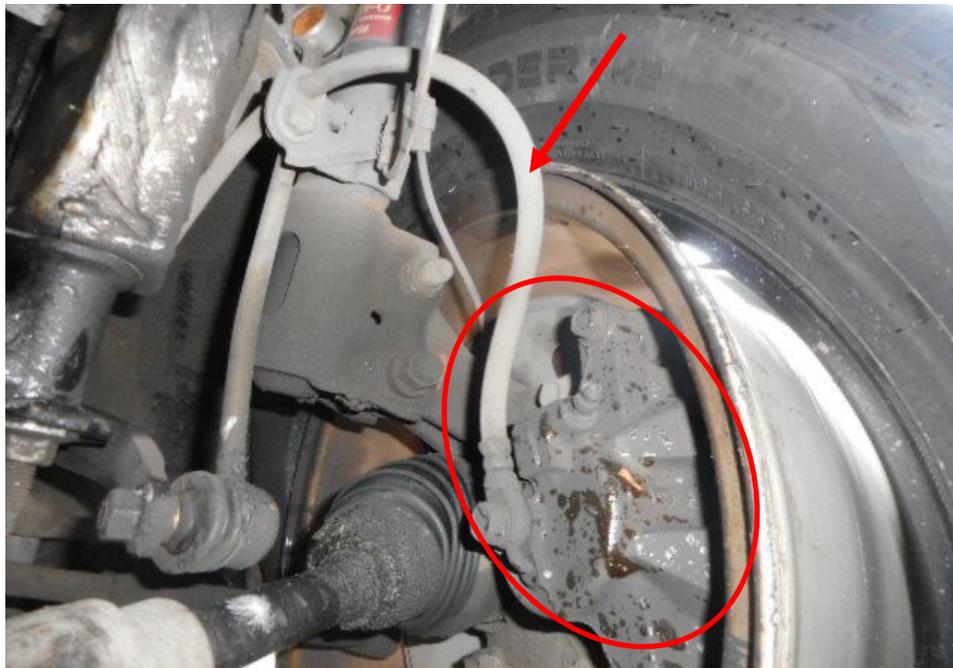
Photo 21 shows the brake hose/pipe (arrowed) at the front left wheel of the Motor Car. No leakage of brake fluid was observed. Visual examination of the various components of the braking system like the brake caliper (circled), brake booster, brake pedal etc had revealed all to be intact and without visible damage.

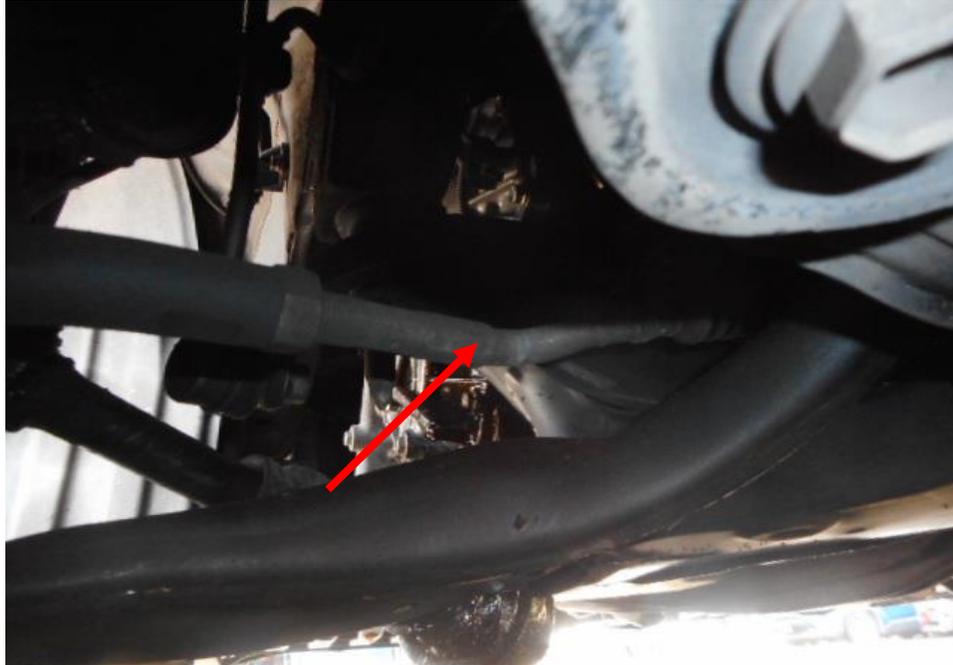
13. Static test on the steering system of the Motor Car was not conducted as we observed that the front left driveshaft and the tie rod was damaged as a result of the accident. However, my visual examination of the other various steering components which had included the steering rack and pinion, the right tie rod ends and ball joints revealed that these components were all generally in good condition. See photo 18 - 24 below.

Photo 22 shows the various undercarriage components at the front left wheel of the Motor Car, in particular the steering tie rod (arrowed). The various steering components were all found to be damaged as a result of the accident.

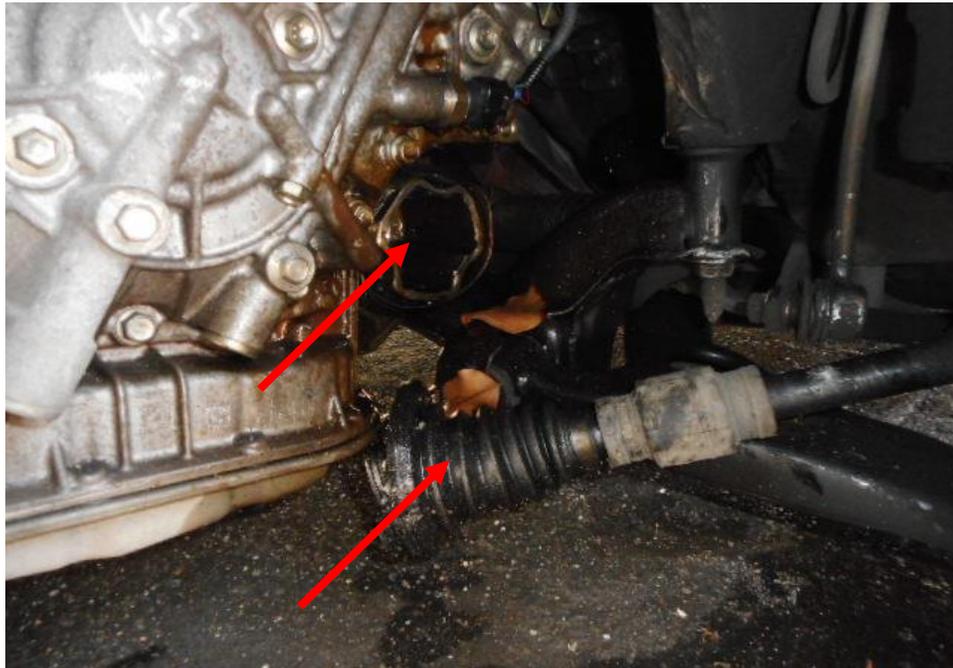
Photo 23 shows the various undercarriage components at the front left wheel of the Motor Car, in particular the right driveshaft (arrowed). The various steering components were all found to be damaged as a result of the accident.

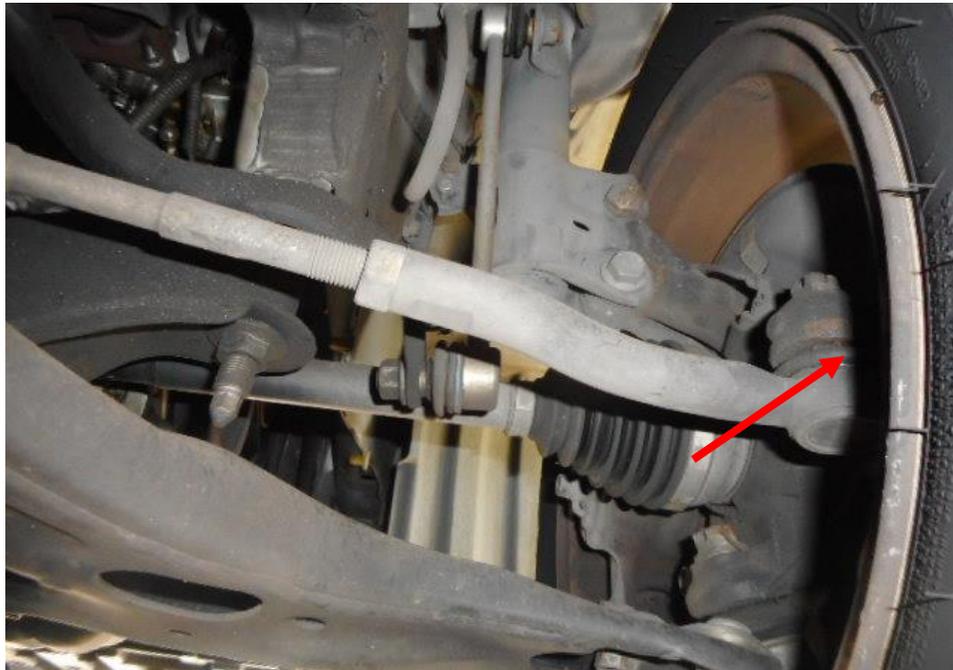
Photo 24 shows the various undercarriage components at the front right wheel of the Motor Car, in particular the steering tie rod (red arrow). The various steering components were all found to be intact, suggesting that the steering system of the Motor Car was likely to be in serviceable condition at the material time of accident. There was also no sign of fluid stain observed on the various undercarriage components at the front right wheel of the Motor Car.

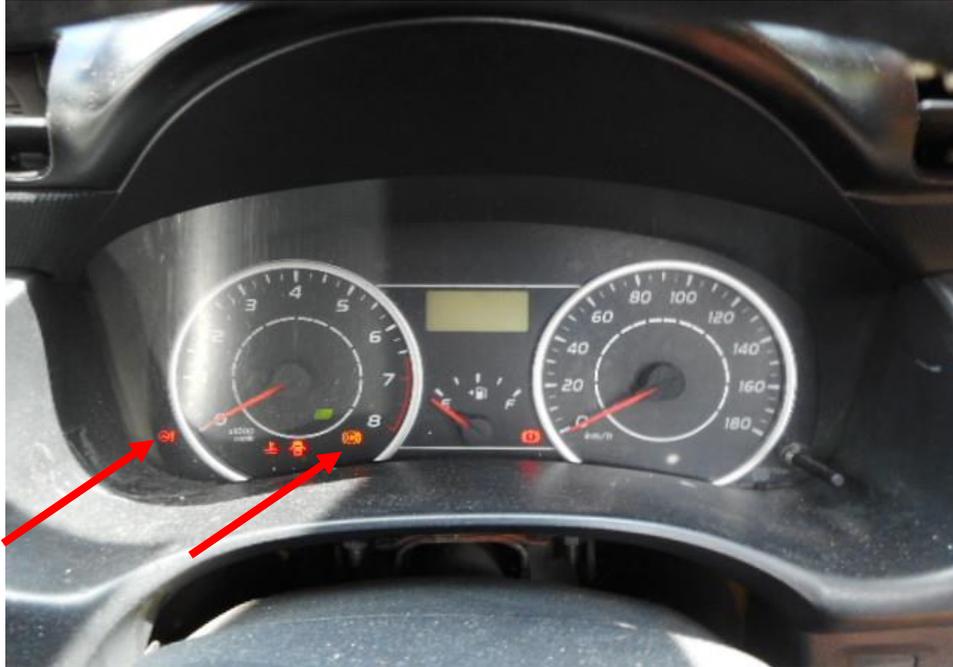
Photo 25 shows the warning light for Anti-Lock Brake System (ABS), Electric Power Steering System (EPS) (arrowed) appearing on the instrument panel of the Motor Car during the self-test of its various electronic operating systems when its engine was cranked.

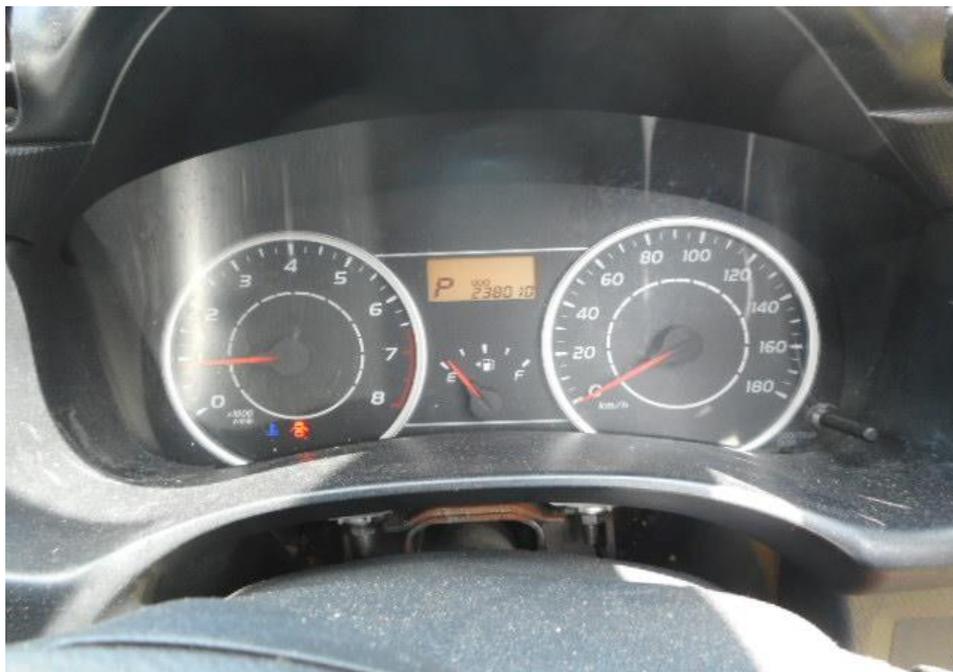
Photo 26 shows no warning lights illuminated on the instrument panel of the Motor Car after the engine was cranked. This would suggest that there was no abnormality to the electronic operating system of the Motor Car, like the ABS, EPS and etc.
