You're Ref: TP/IP/41469/2021  
Our Ref: CI/TPD21009372/P

**Fatal Accident Investigation Team**

**MECHANICAL INSPECTION REPORT OF MOTOR CAR SML 8036C**

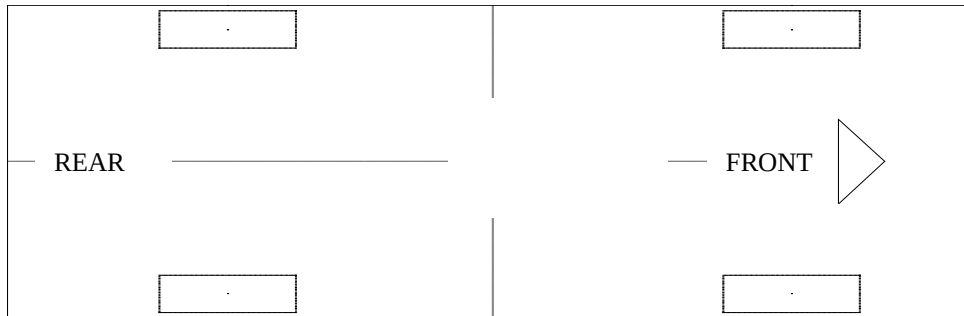
Michelin 215/45R17 (3.6mm)

Michelin 215/45R17 (3mm)

Michelin 215/45R17 (3.3mm)

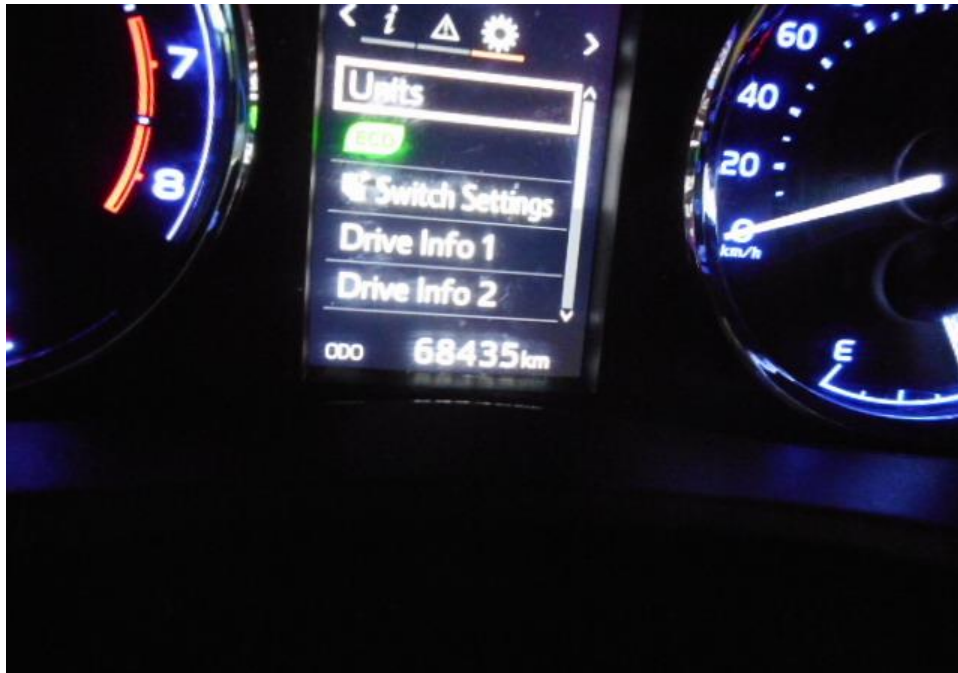
**Photo 1** shows the mileage of the Motor Car at the time of my inspection. The mileage observed was 68,435km.

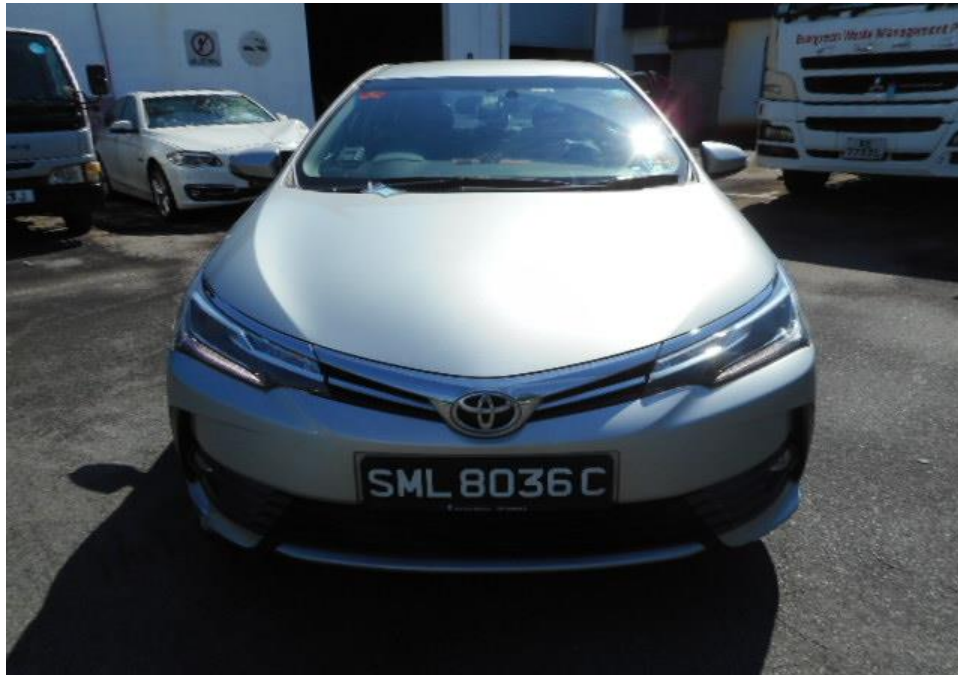
4. The mileage of the Motor Car at the time of my inspection was 68,435km.
5. The Motor Car was observed to have sustained damage at its front portion. Its front bumper was the body part that were damaged as a result of the accident.

**Photo 2** shows a general view of the Motor Car's front body at the time of my inspection. The front portion of the Motor Car was observed to have sustained damage. Its front bumper was the body part that were damaged as a result of the accident.

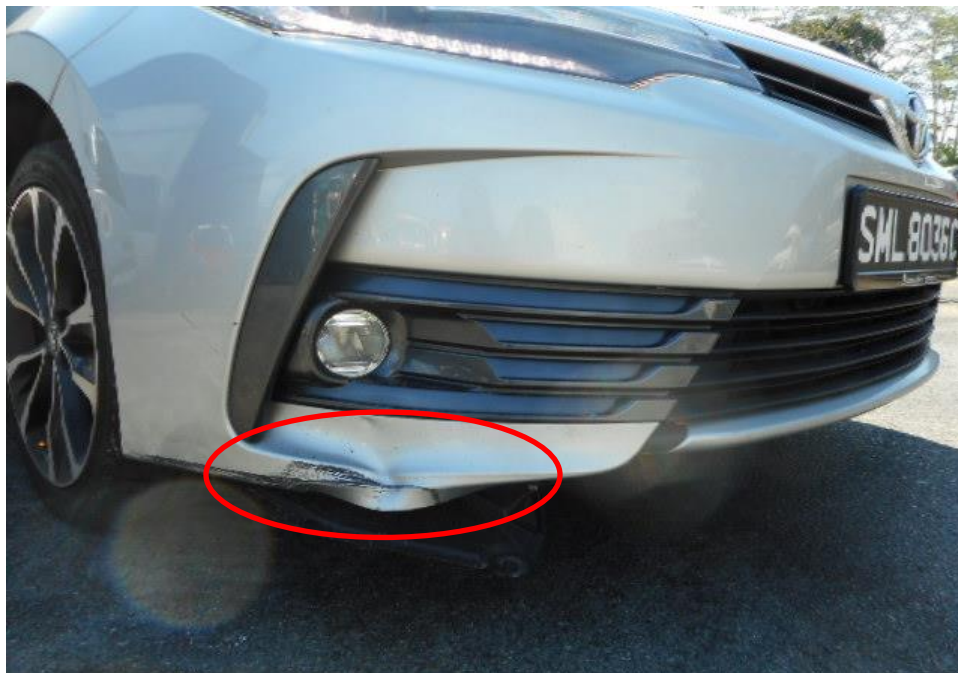
**Photo 3** shows a close up view of the Motor Car's front body at the time of my inspection. The front portion of the Motor Car was observed to have sustained damage. Its front bumper (circled) was the body part that were damaged as a result of the accident.

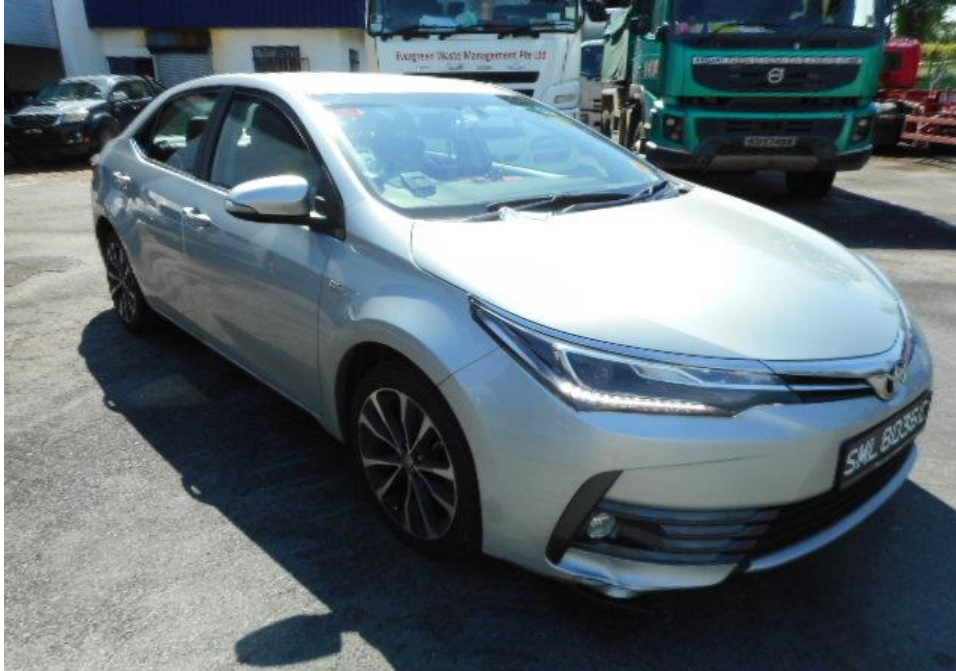
**Photo 4** shows a general view of the Motor Car's right body at the time of my inspection. The right portion of the Motor Car was observed to have been unaffected by the accident.

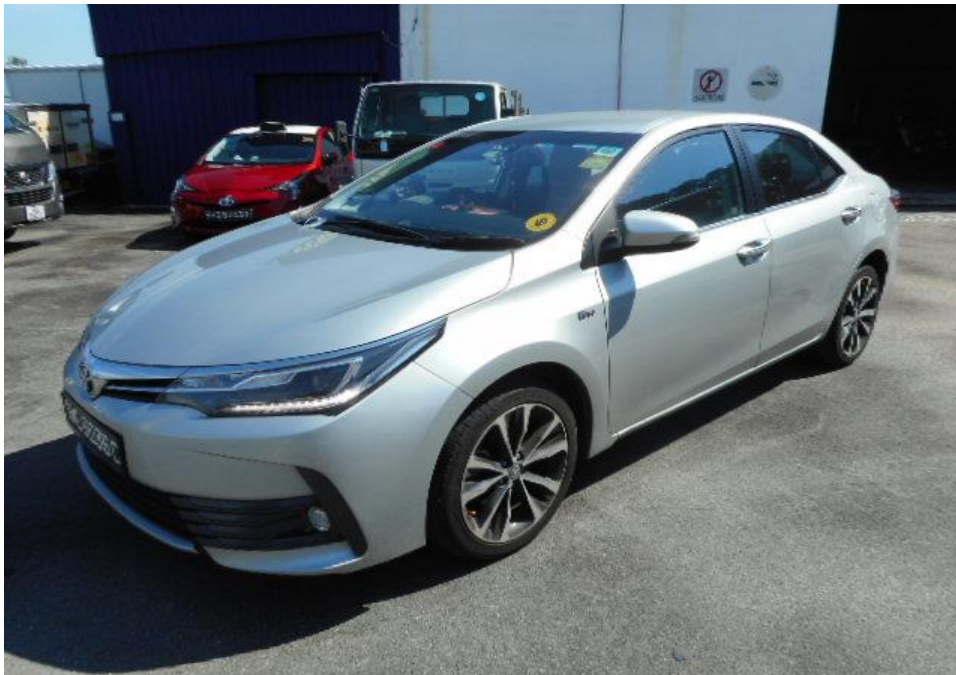
**Photo 5** shows a general view of the Motor Car's left body at the time of my inspection. The left portion of the Motor Car was observed to have been unaffected by the accident.

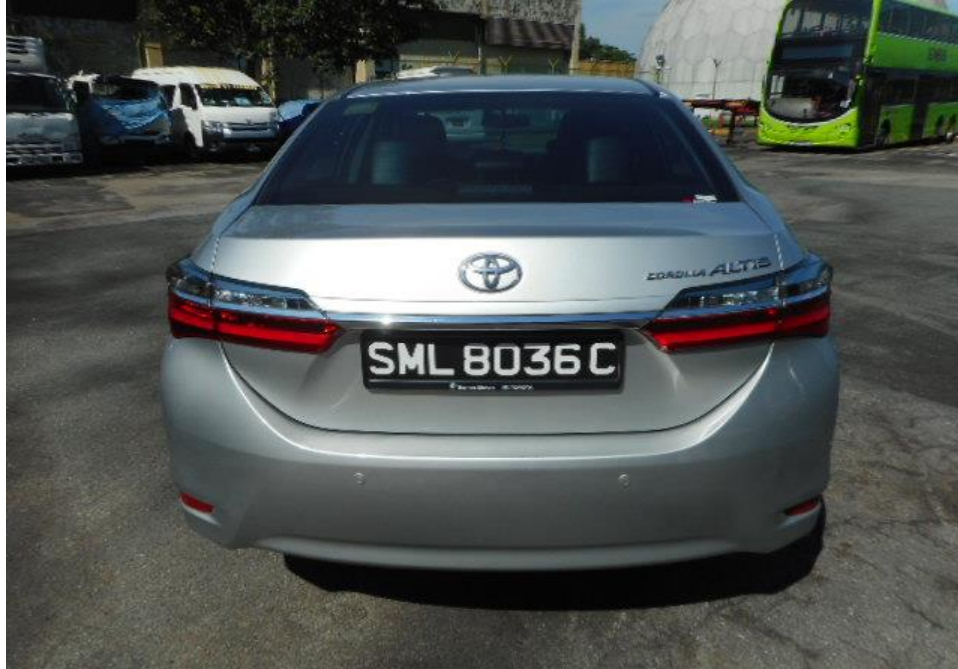
**Photo 6** shows the general view of the Motor Car's rear body at the time of my inspection. The Motor Car rear was observed to be unaffected by the accident.

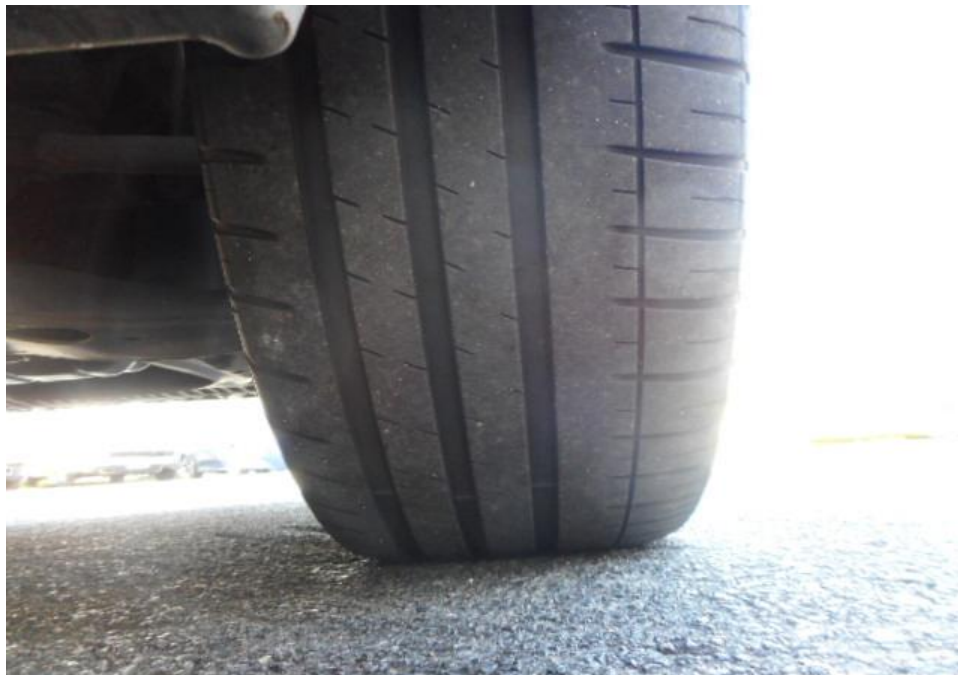
**Photo 7** shows the condition of the front right tyre of the Motor Car, which was observed to be in serviceable condition with remaining tread depth of approximately 3.3mm. The tyre was sufficiently inflated for vehicular operation with no tear, cut or burst mark(s) on the outer and the inner sidewalls as well as across the tread. The 4 tyres of the Motor Car were wrapped around standard steel wheel rims without any damage.

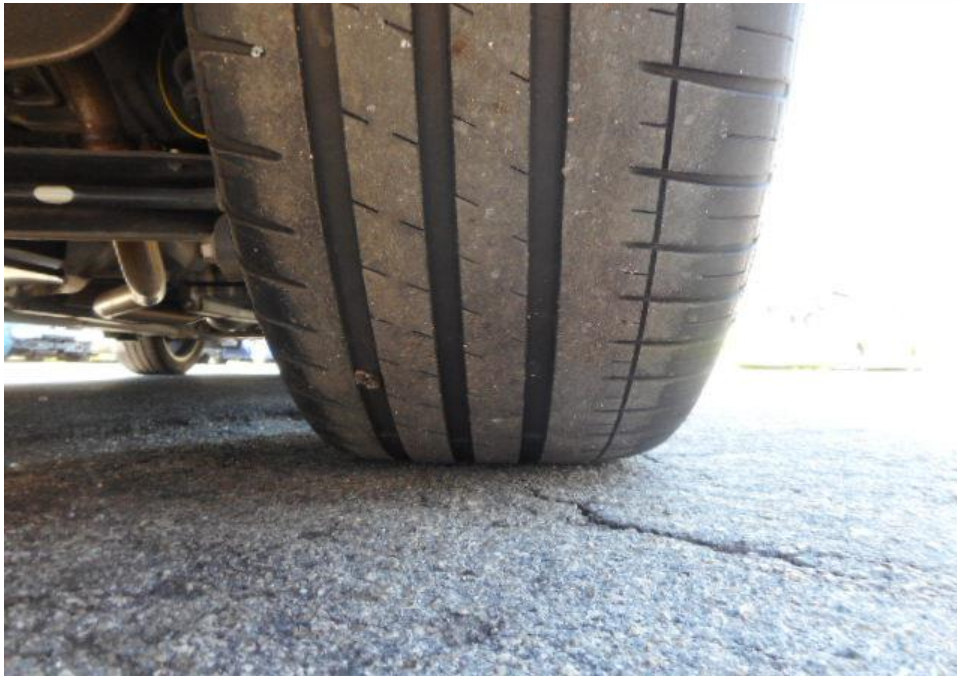
**Photo 8** shows the condition of the rear right tyre of the Motor Car, which was observed to be in serviceable condition with remaining tread depth of approximately 3.6mm. The tyre was also observed to be sufficiently inflated for vehicular operation with no tear, cut or burst mark(s).

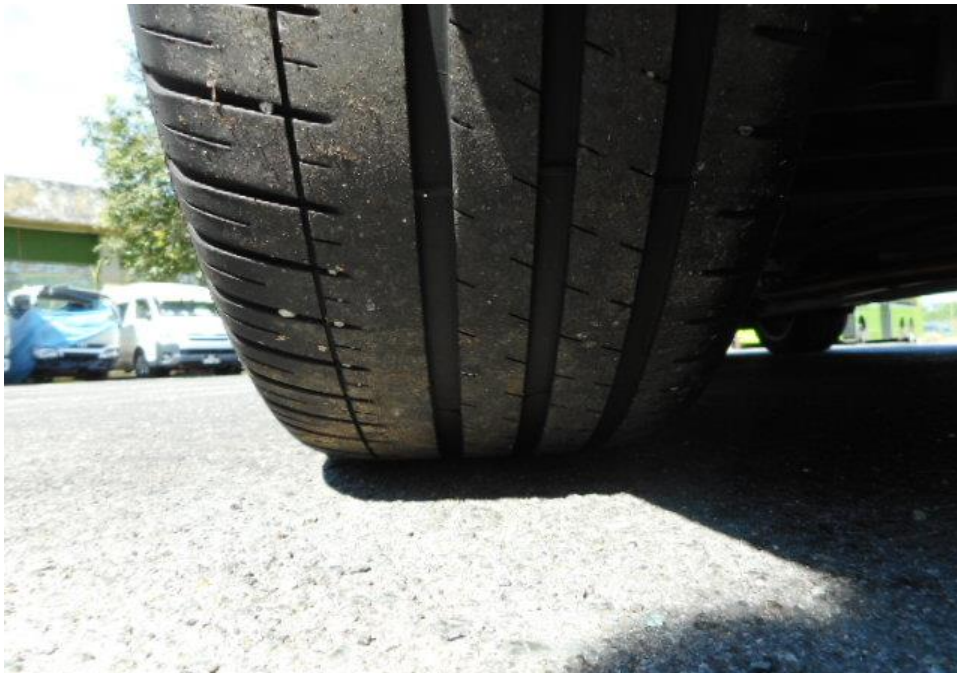
**Photo 9** shows the condition of the rear left tyre of the Motor Car, which was observed to be in serviceable condition with remaining tread depth of approximately 3.6mm. The tyre, which was wrapped around steel wheel rim, was also observed to be sufficiently inflated for vehicular operation. The 4 tyres of the Motor Car were wrapped around standard steel wheel rims.

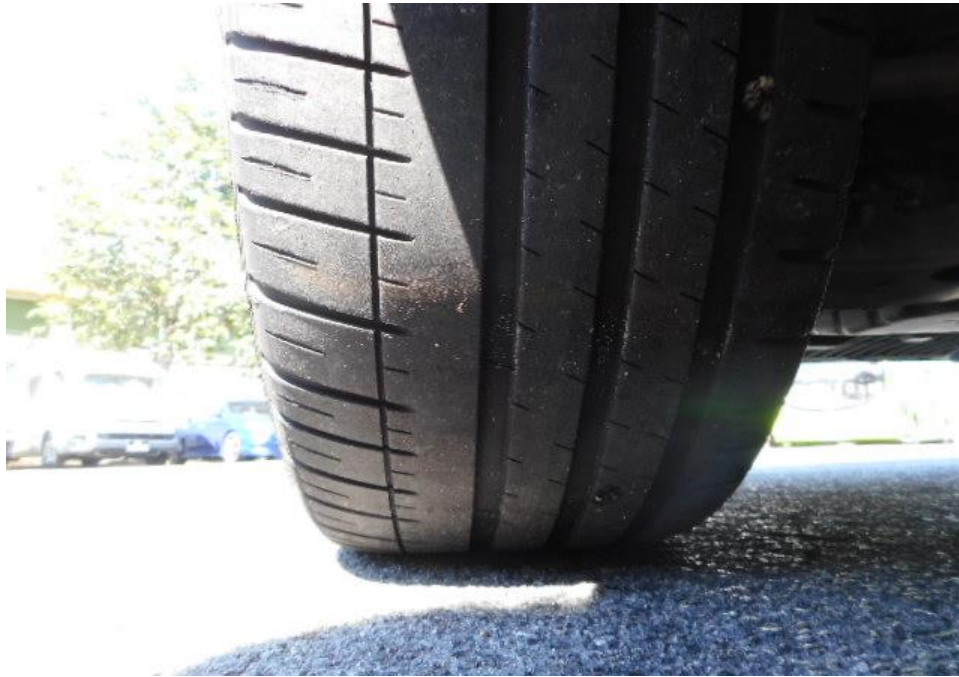
**Photo 10** shows the condition of the front left tyre of the Motor Car, which was observed to be in serviceable condition with remaining tread depth of approximately 3mm. There was also no tear, cut or burst mark(s) on the outer and the inner sidewalls as well as across the tread of the Motor Car's 4 tyres.

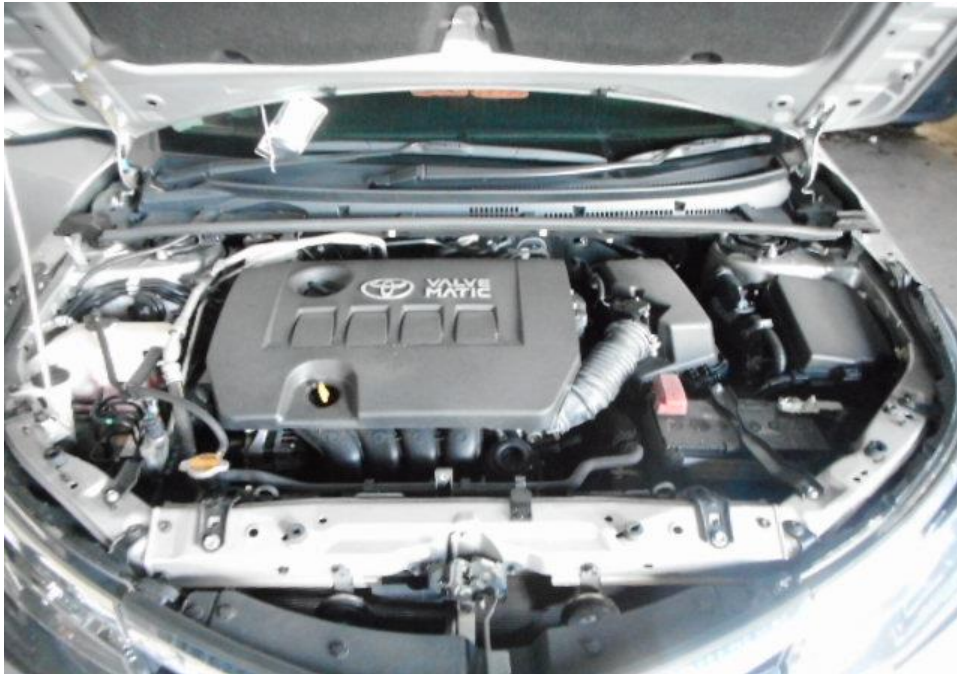
**Photo 11** shows a general view of the Motor Car's engine compartment. The various parts and components inside the engine compartment were unaffected by the accident. There was also no sign(s) or indication(s) of fluid leakage and/or fluid stain within the engine compartment.

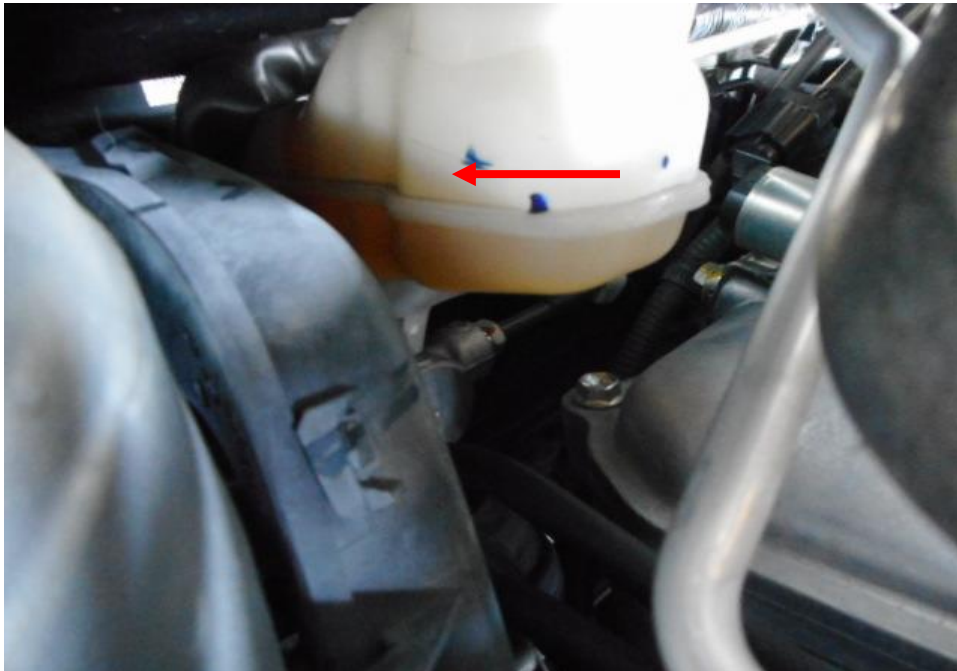
**Photo 12** shows the brake fluid reservoir of the Motor Car at the time of my inspection. The brake fluid was observed to be of sufficient level (arrowed) and without any visible contamination.

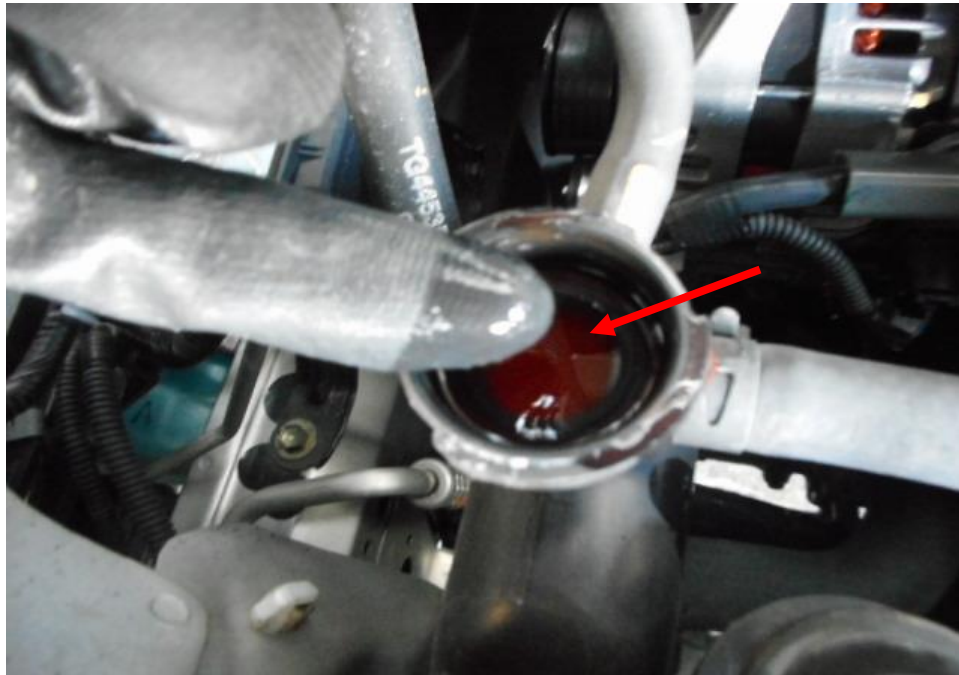
**Photo 13** shows checks being carried out to the engine coolant of the Motor Car at the time of my inspection. The engine coolant was observed to be of sufficient level (arrowed) and without any visible contamination.

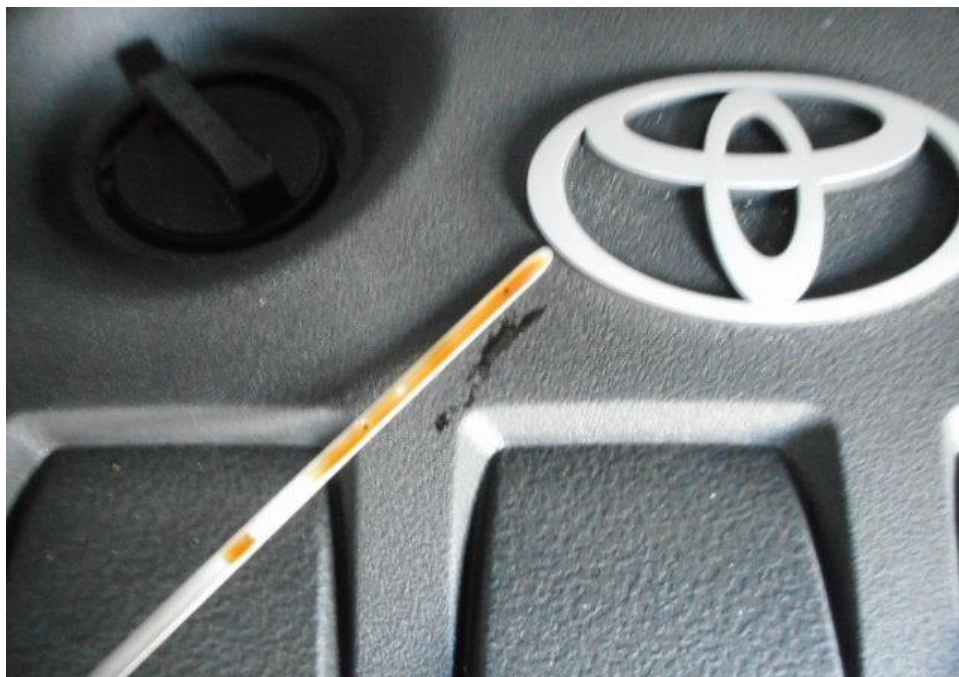
**Photo 14** shows the engine oil dipstick of the Motor Car at the time of my inspection. The engine oil was observed to be of sufficient level and without any visible contamination.

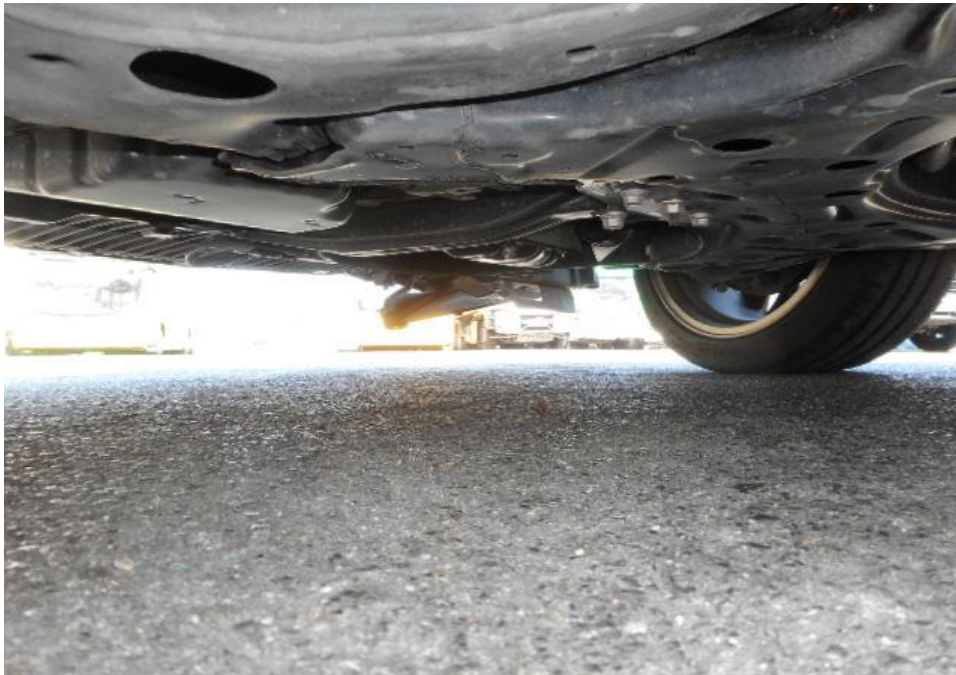
**Photo 15** shows the undercarriage of the Motor Car, at the area where the engine housing and transmission housing are located. I did not find any sign(s) or indication(s) of fluid leak and/or fluid stain(s) on the underside of the Motor Car.

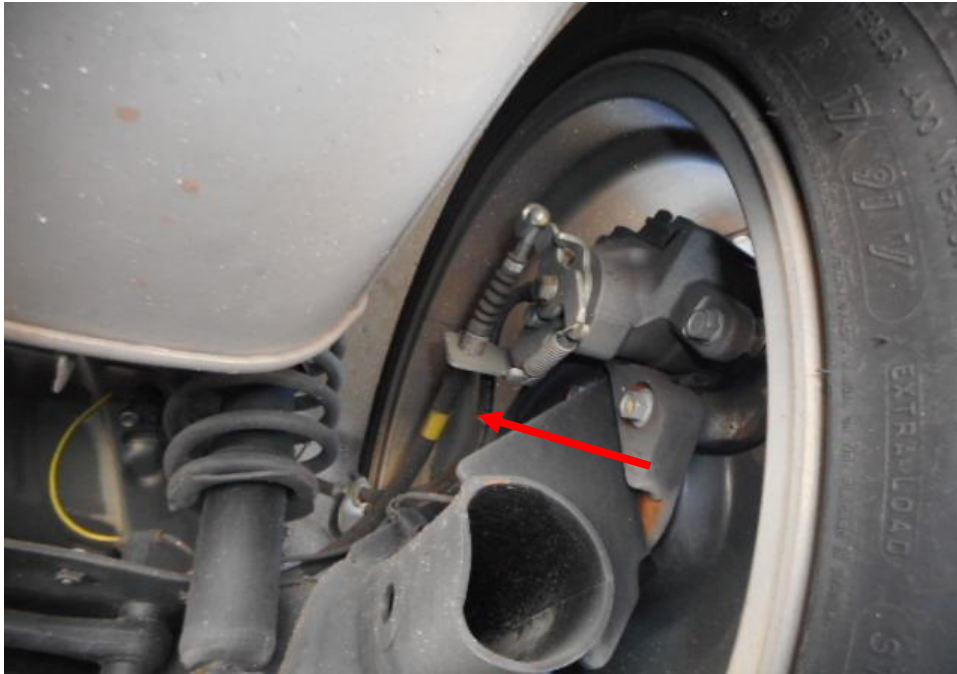
**Photo 16** shows the brake hose/pipe (arrowed) at the rear right wheel of the Motor Car. No leakage of brake fluid was observed. Visual examination of the various components of the braking system like the drum brake, brake booster, brake pedal etc. had revealed all to be intact and without visible damage.

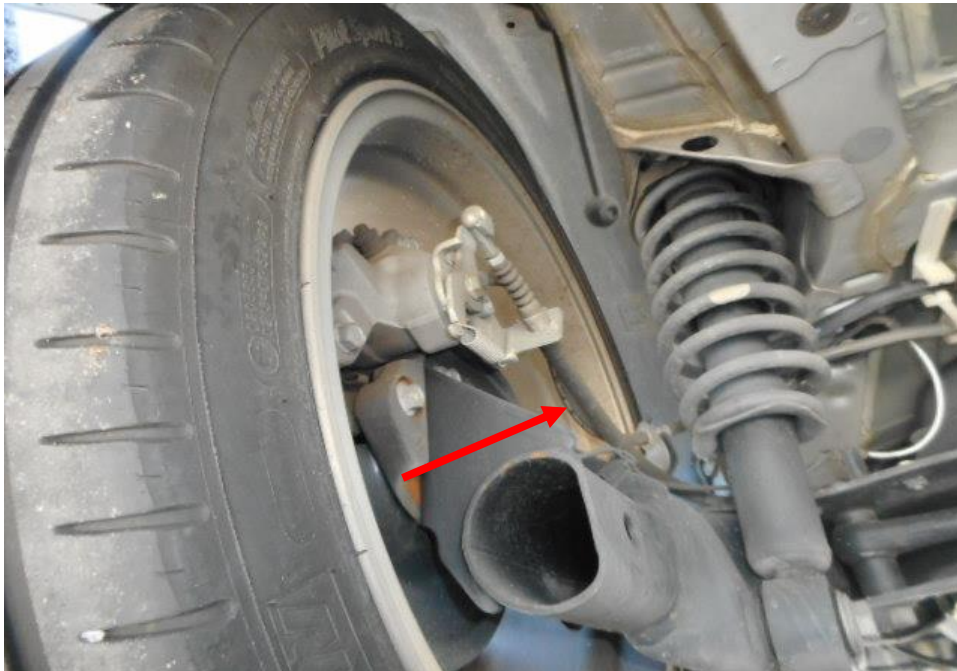
**Photo 17** shows the brake hose/pipe (arrowed) at the rear left wheel of the Motor Car. I did not observe any leakage of brake fluid at the time of my inspection of the Motor Car. Static tests of the Motor Car's braking system had indicated that there was no internal leakage of pressure/vacuum. The undercarriage components of the Motor Car were also all found to be intact and without any visible damage.

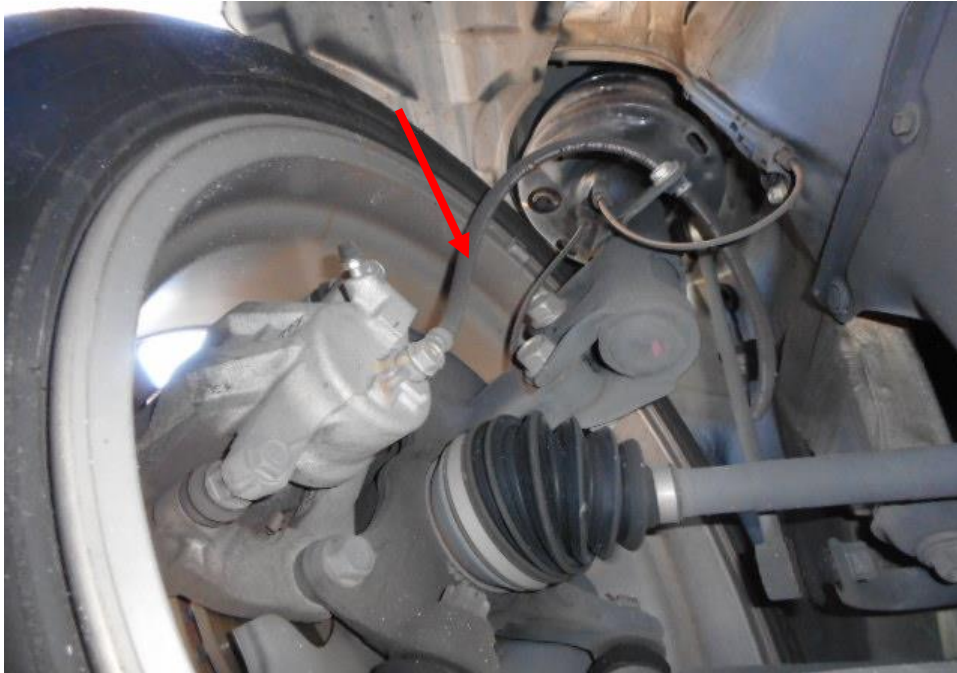
**Photo 18** shows the brake hose/pipe (arrowed) at the front right wheel of the Motor Car. I did not observe any leakage of brake fluid at the time of my inspection of the Motor Car. Static tests of the Motor Car's braking system had indicated that there was no internal leakage of pressure/vacuum. The undercarriage components of the Motor Car were also all found to be intact and without any visible damage.

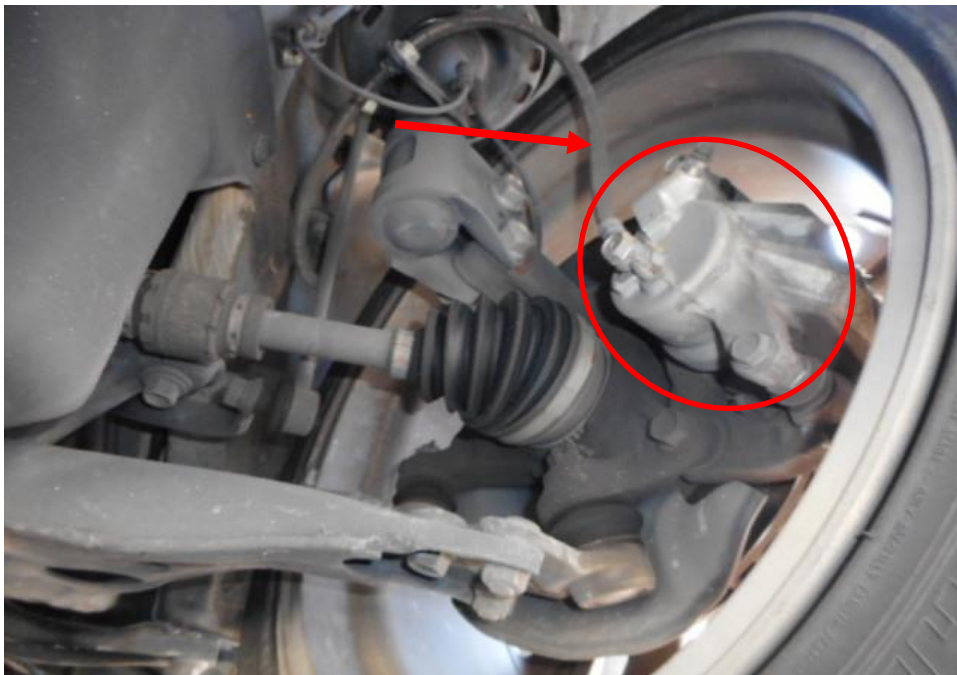
**Photo 19** shows the brake hose/pipe (arrowed) at the front left wheel of the Motor Car. No leakage of brake fluid was observed. Visual examination of the various components of the braking system like the brake caliper (circled), brake booster, brake pedal etc had revealed all to be intact and without visible damage.

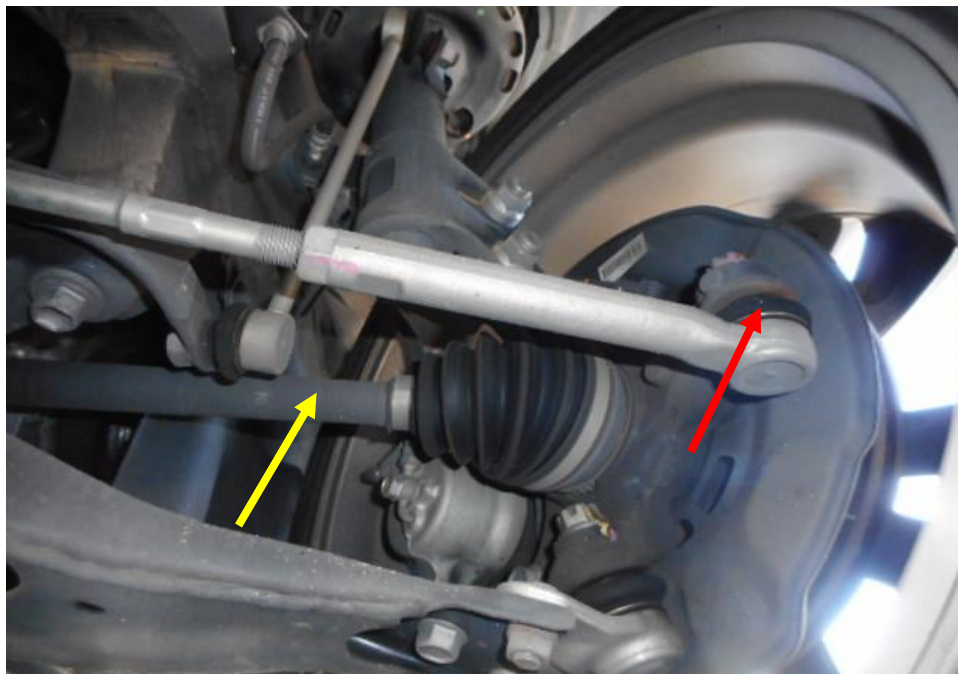
**Photo 21** shows the various undercarriage components at the front right wheel of the Motor Car, in particular the steering tie rod (red arrow) and drive shaft (yellow arrow). The various steering components were all found to be intact, suggesting that the steering system of the Motor Car was likely to be in serviceable condition at the material time of accident. There was also no sign of fluid stain observed on the various undercarriage components at the front right wheel of the Motor Car.

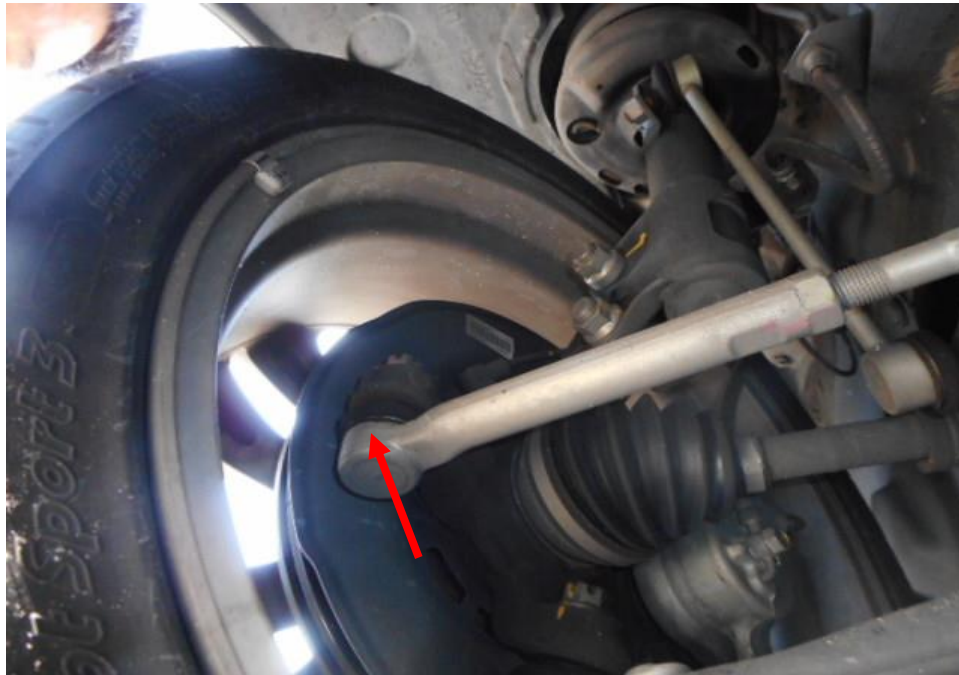
**Photo 22** shows the various undercarriage components at the front left wheel of the Motor Car, which had included the steering tie rod (red arrow). The various undercarriage components of the Motor Car were all found to be intact without any visible damage.

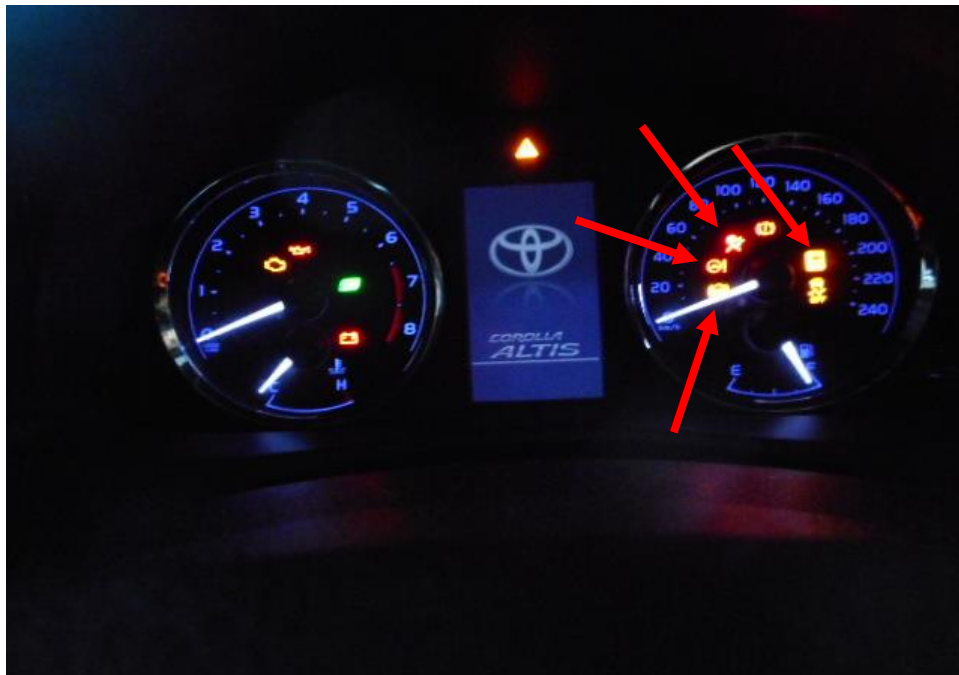
**Photo 23** shows the warning light for Anti-Lock Brake System (ABS), Electric Power Steering System (EPS), Traction Control System (TCS) and Supplemental Restraint System (SRS) (arrowed) appearing on the instrument panel of the Motor Car during the self-test of its various electronic operating systems when its engine was cranked.

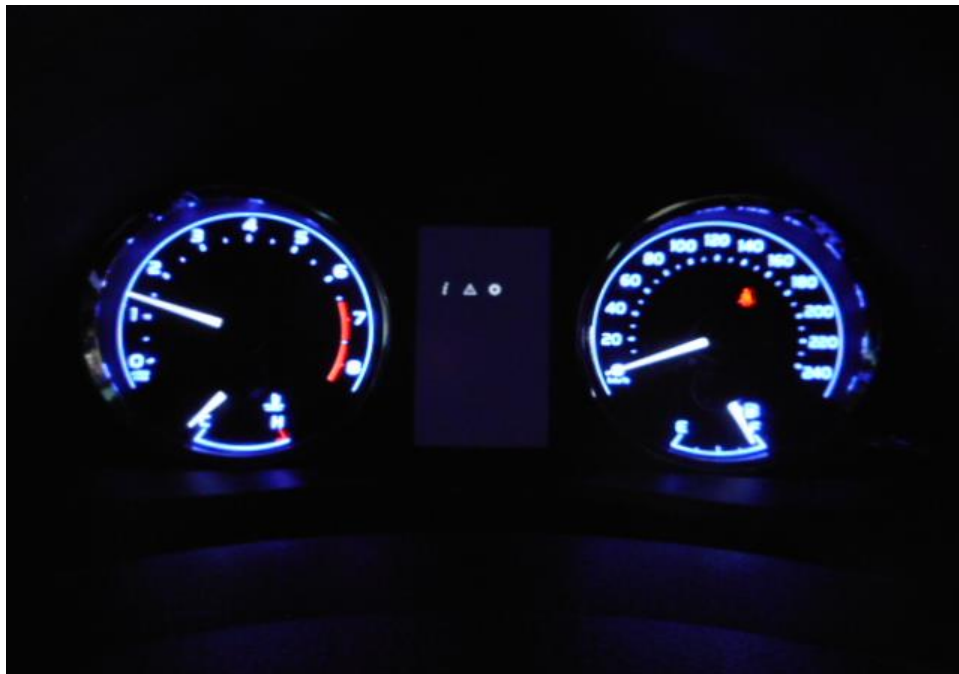
**Photo 24** shows no warning lights illuminated on the instrument panel of the Motor Car after the engine was cranked. This would suggest that there was no abnormality to the electronic operating system of the Motor Car, like the ABS, EPS, TCS and SRS etc.
