Your Ref: TP/IP/41879/2021
Our Ref : CI/TPD21009373/P

1st October 2021

MECHANICAL INSPECTION REPORT OF MOTOR LORRY YQ 1660C

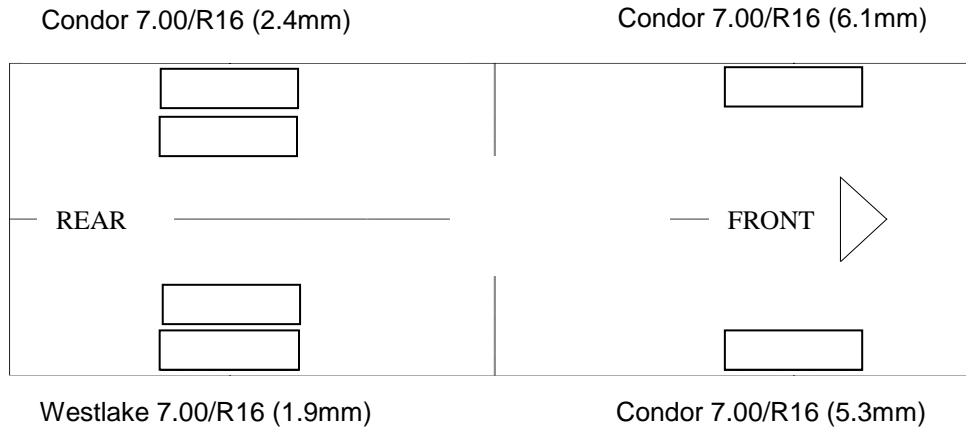
6. The 6 tyres of the Motor Lorry were observed to be in serviceable condition and sufficiently inflated for vehicular operation. I did not find any tear, cut or burst mark(s) on the outer and the inner sidewalls as well as across the tread of the 6 tyres. The tyre brand, tyre size and remaining tread depth of the 6 tyres of the Motor Lorry were recorded as follows:-

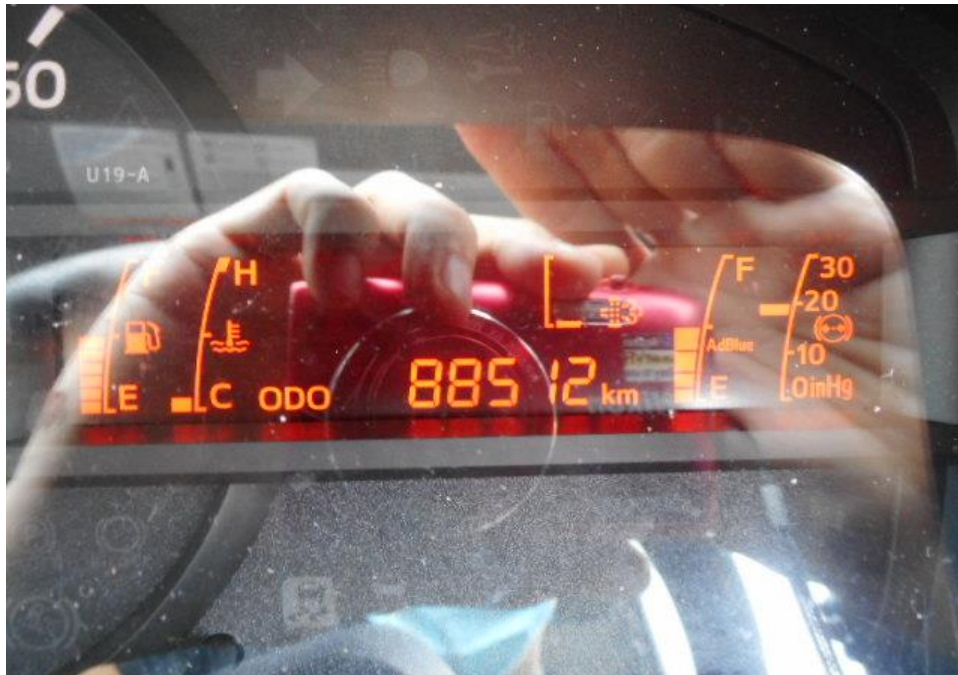
Photo 1 shows a general view of the instrument cluster of the Motor Lorry at the time of my inspection. The mileage of the Motor Lorry was 88,512 km

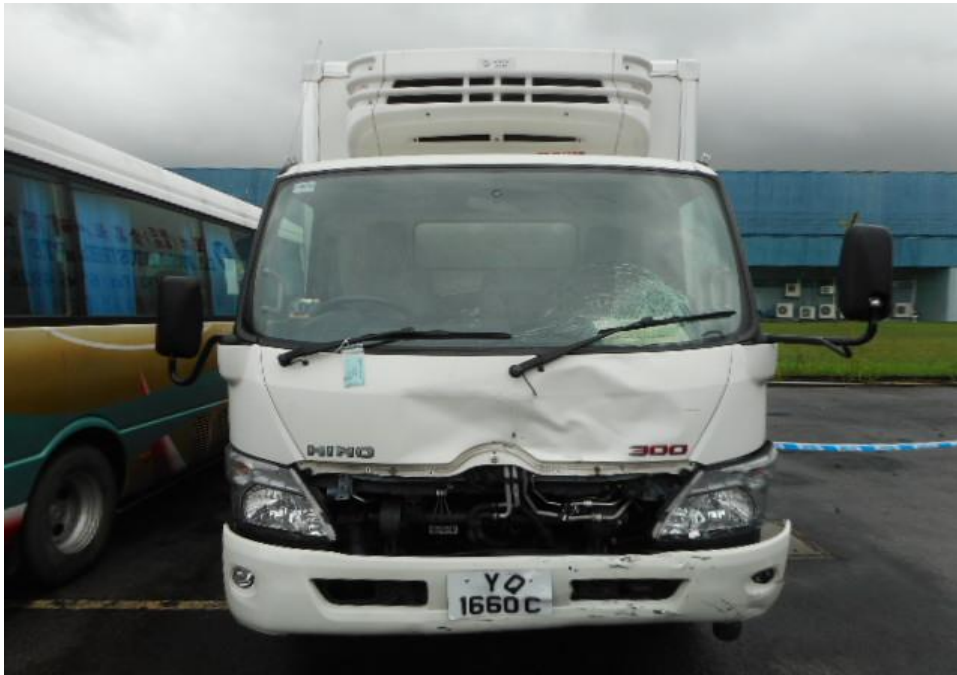
4. The mileage of the Motor Lorry at the time of my inspection was 88,512km.
5. The Motor Lorry was observed to sustained damage at its front portion. Its front windscreen, front body panel, front left headlamp and front bumper were damage at the time of my inspection as a result of the accident.

Photo 2 shows a general view of the Motor Lorry's frontal portion at the time of my inspection. It appeared to have sustained damage at its front portion. Its front windscreen, front body panel, front left headlamp and front bumper were damage at the time of my inspection as a result of the accident.

15. During the operational test, the various transmission gears of the Motor Lorry were able to be engaged without any difficulty by stepping on the clutch pedal and manually shifting the gear lever. There were no abnormal sounds heard and/or abnormal behaviour of the Motor Lorry's engine system. It was able to move forward and backward normally. The braking system was also found to be in working condition as the Motor Lorry was able to slow down and come to a complete stop upon depressing of the brake pedal. Refer to photo 2 & 24

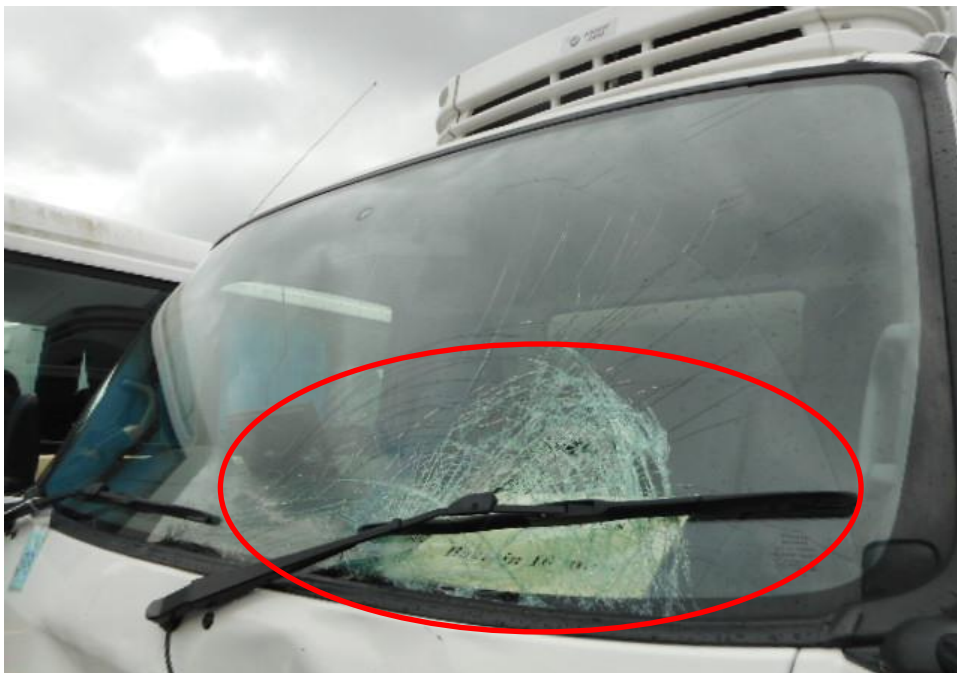
Photo 3 shows a close up view of the Motor Lorry's front portion at the time of my inspection. Its front windscreen (circled) was damage at the time of my inspection as a result of the accident.

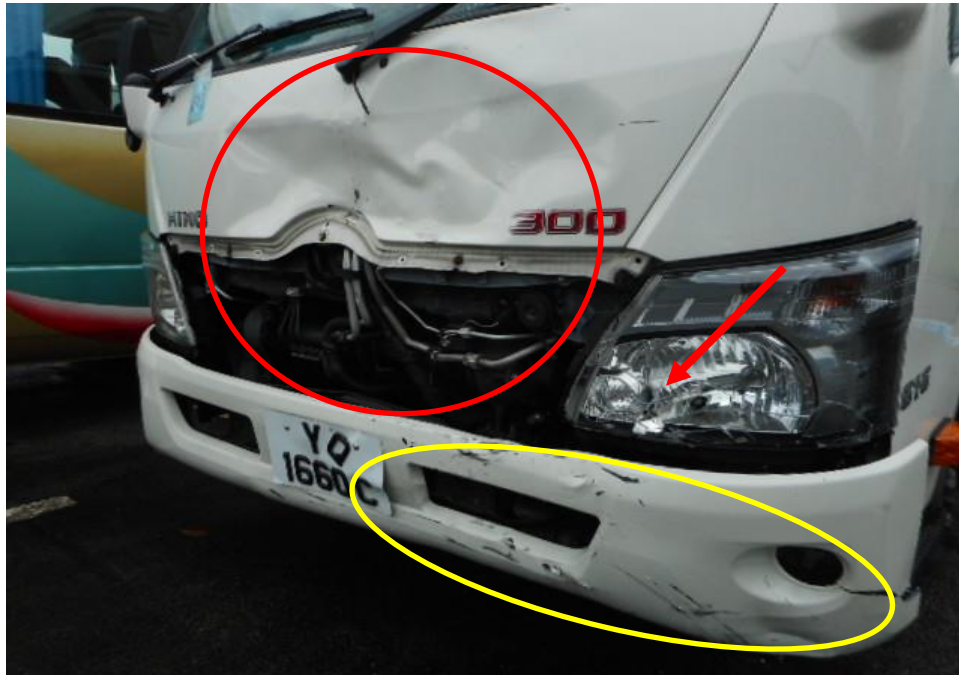
Photo 4 shows a close up view of the Motor Lorry's front portion at the time of my inspection. Its front bumper (yellow circle) and front body panel (red circle) and front left headlamp (arrowed) was damage at the time of my inspection as a result of the accident.

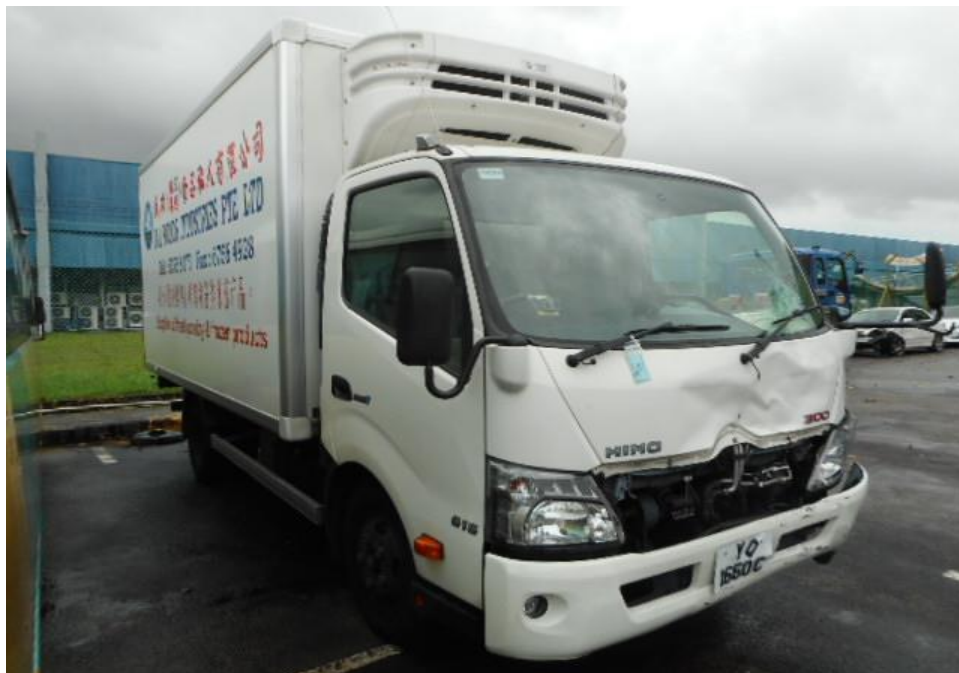
Photo 5 shows a general view of the right body of the Motor Lorry at the time of my inspection. The Motor Lorry was observed to be intact and unaffected by the accident.

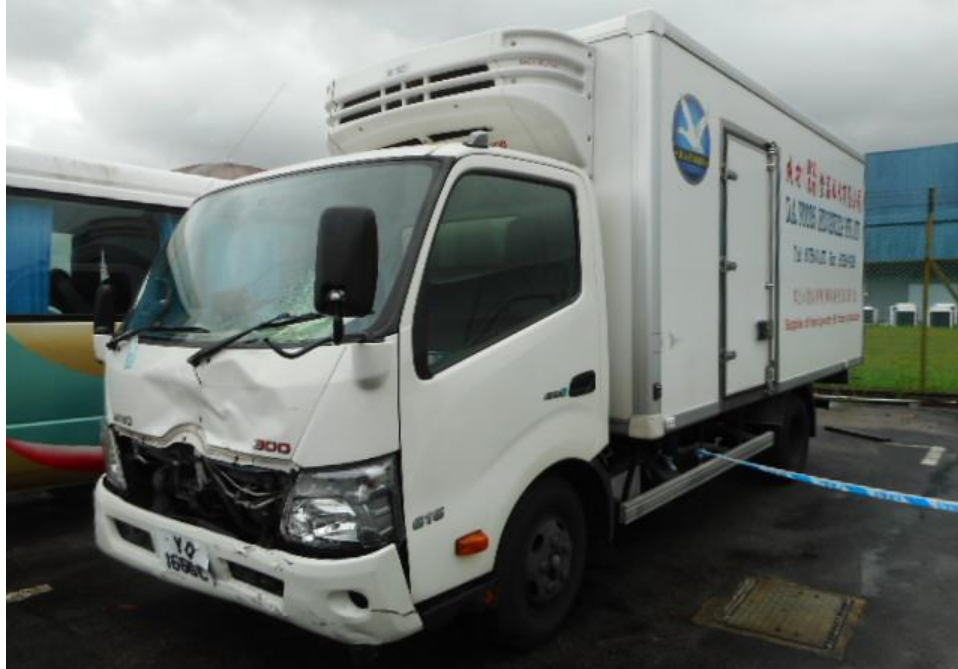
Photo 6 shows a general view of the left body of the Motor Lorry at the time of my inspection. The Motor Lorry was observed to be intact and unaffected by the accident.

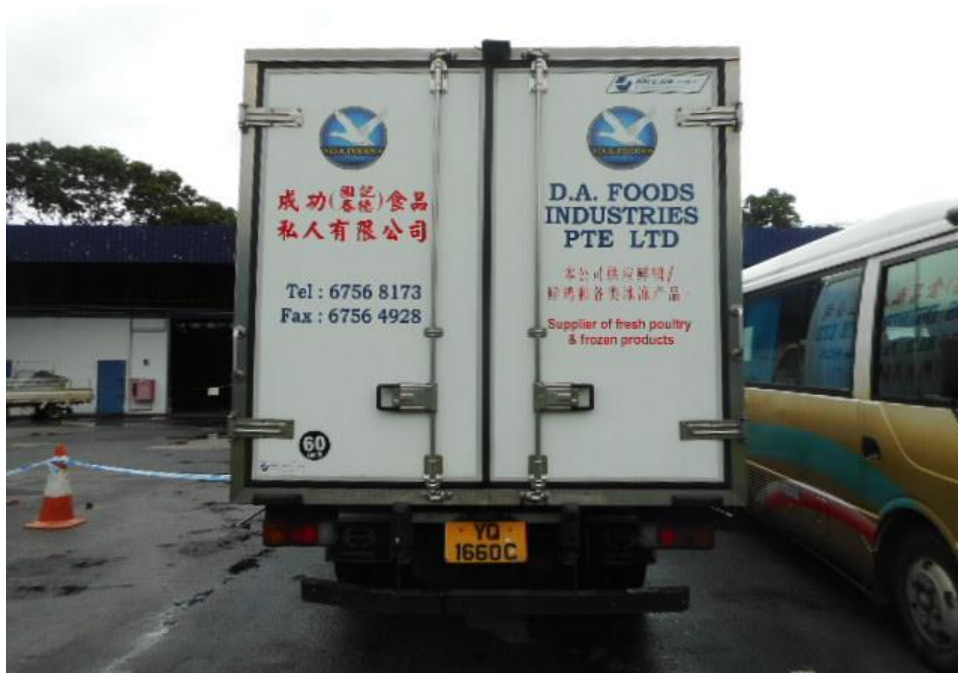
Photo 7 shows a general view of the rear body of the Motor Lorry at the time of my inspection. The Motor Lorry was observed to be intact and unaffected by the accident.

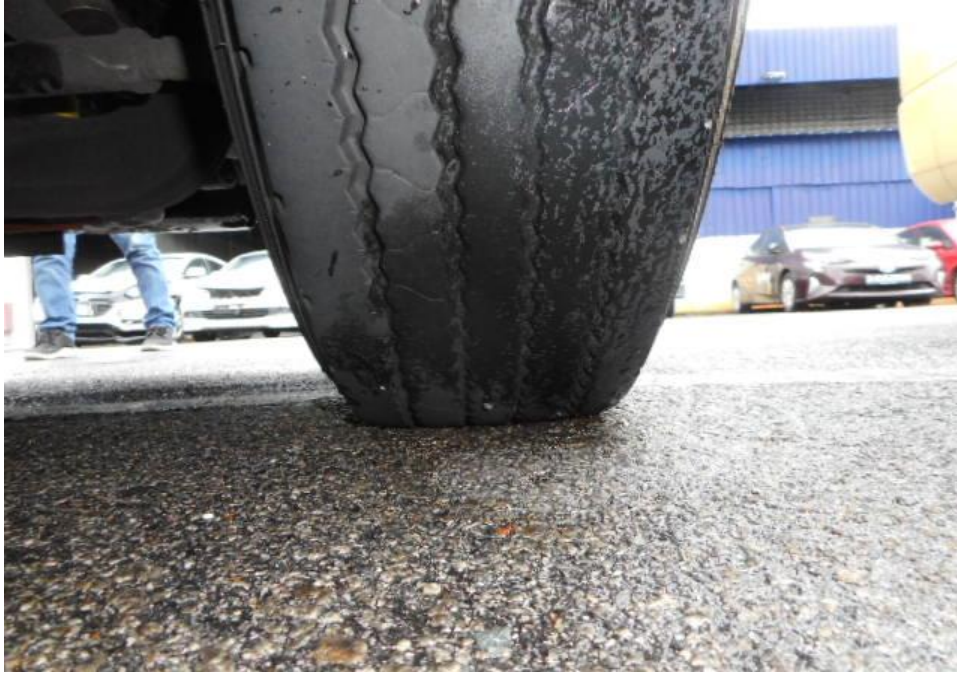
Photo 8 shows the condition of the front right tyre of the Motor Lorry, which was observed to be in serviceable condition with remaining tread depth of approximately 5.3mm. The tyre, which was wrapped around standard steel wheel rim, was also observed to be sufficiently inflated for vehicular operation. There was no tear, cut or burst mark(s) on the outer and the inner sidewalls as well as across the tread of the 6 tyres that were fitted on the Motor Lorry.

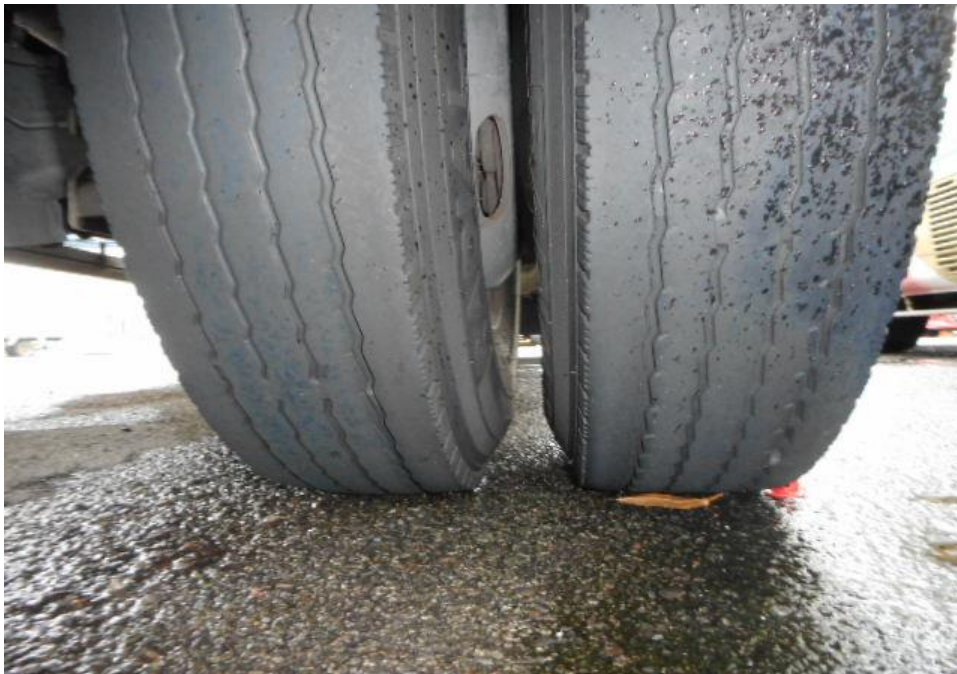
Photo 9 shows the condition of the rear right tyre of the Motor Lorry, which was observed to be in serviceable condition with remaining tread depth of approximately 1.9mm. The tyre, which was wrapped around standard steel wheel rim, it was observed to be sufficiently inflated for vehicular operation.

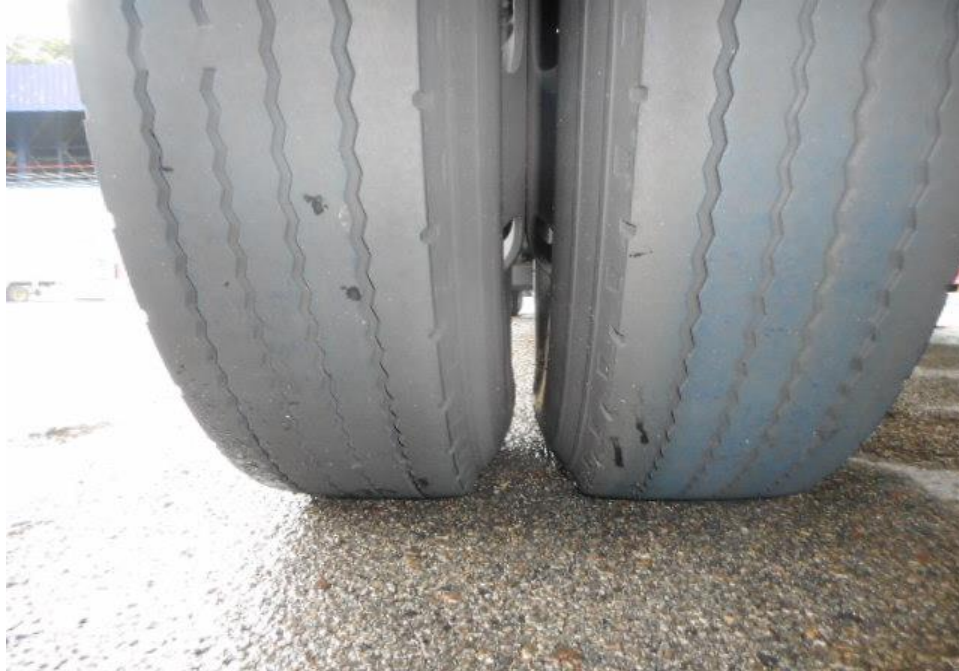
Photo 10 shows the condition of the rear left tyres of the Motor Lorry, which was observed to be in serviceable condition with remaining tread depth of approximately 2.4mm. The tyres, which were wrapped around standard steel wheel rim, were also observed to be sufficiently inflated for vehicular operation. There was also no damage found on all 6 steel wheel rims of the Motor Lorry.

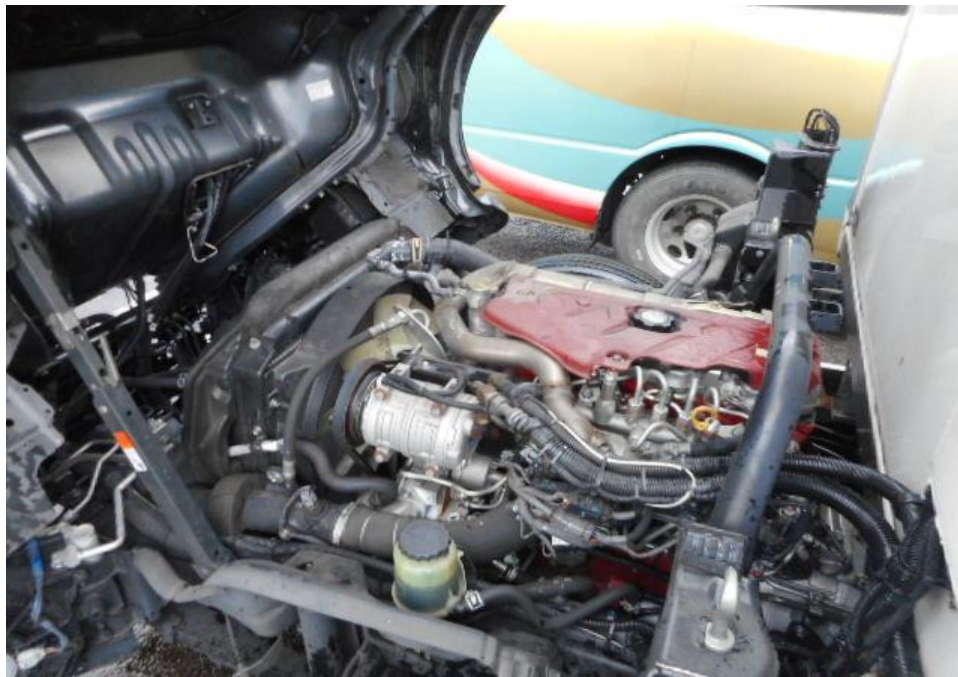
Photo 12 shows a general view of the Motor Lorry's engine compartment, which was accessed by lifting the front cabin of the Motor Lorry. The various parts and components inside the engine compartment were unaffected by the accident. There was also no sign(s) or indication(s) of fresh fluid leakage and/or fluid stain within the engine compartment

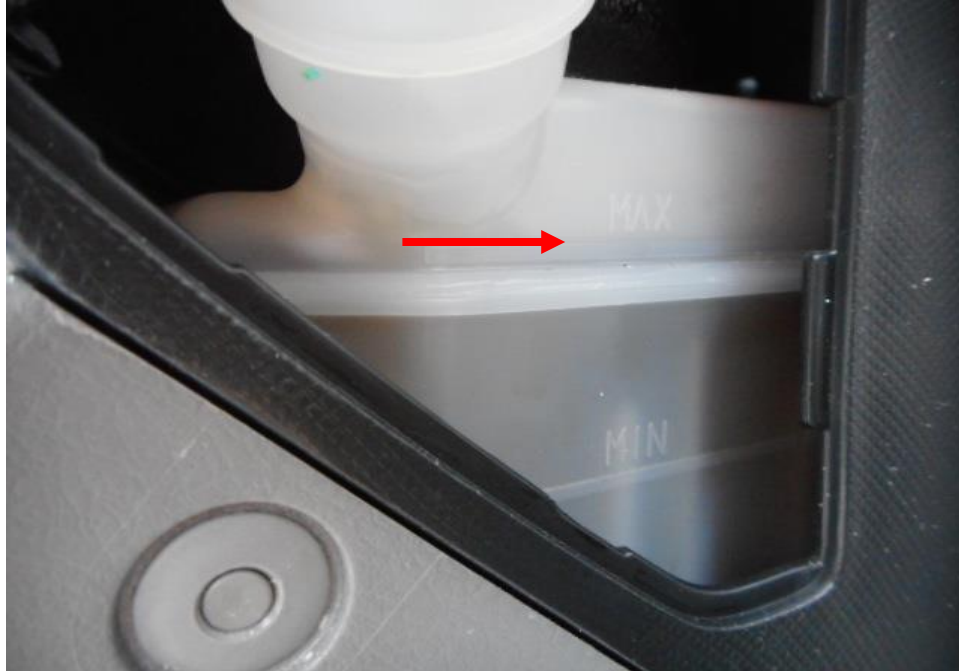
Photo 13 shows the brake fluid reservoir of the Motor Lorry at the time of my inspection. The brake fluid was observed to be of sufficient level (arrowed) and without any visible contamination.

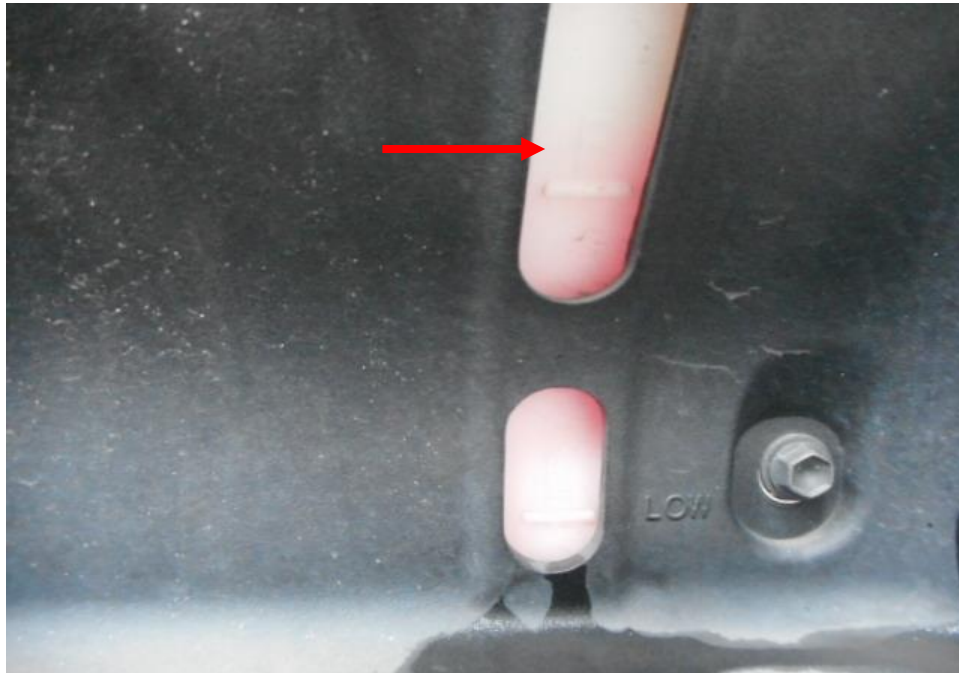
Photo 14 shows the engine coolant reservoir of the Motor Lorry at the time of my inspection. The engine coolant was observed to be of sufficient level (arrowed) and without any visible contamination.

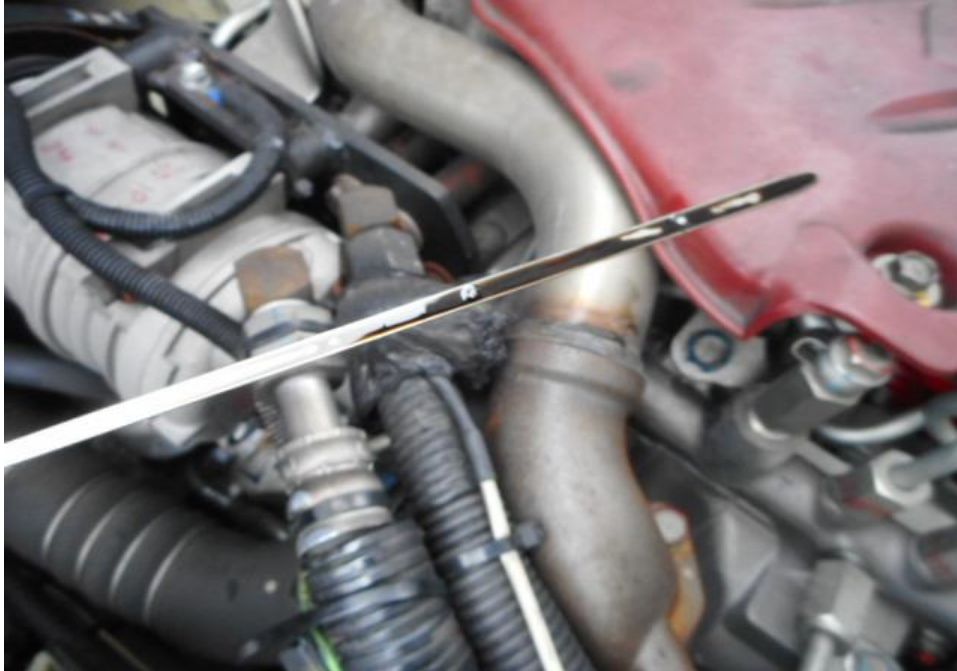
Photo 15 shows the engine oil dip stick of the Motor Lorry at the time of my inspection. The engine oil was observed to be of sufficient level and without any visible contamination.

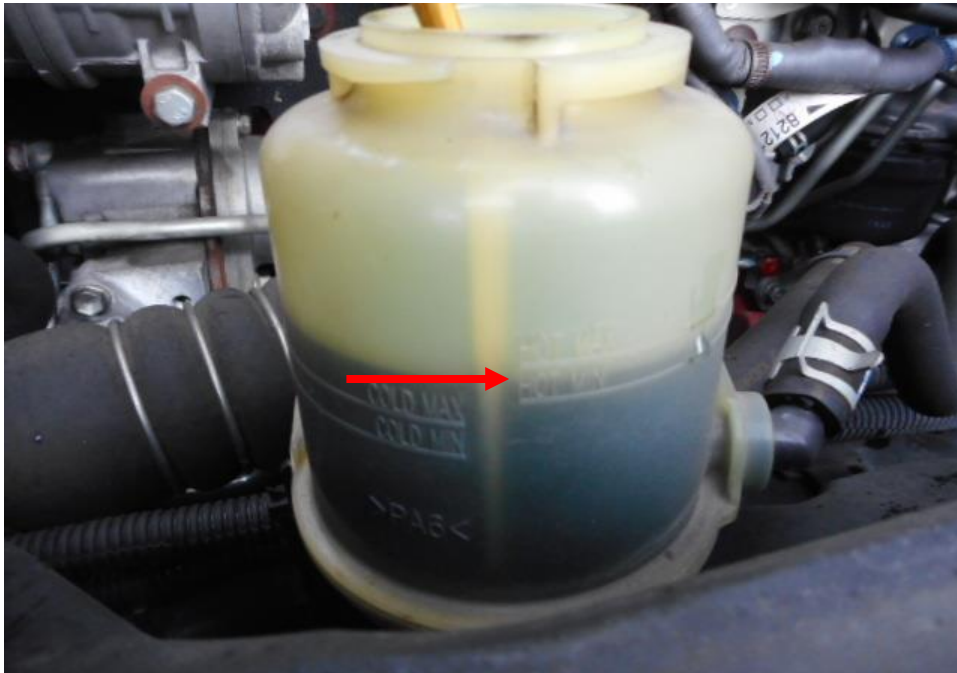
Photo 16 shows the power steering fluid reservoir of the Motor Lorry at the time of my inspection. The power steering fluid was observed to be of sufficient level (arrowed) and without any visible contamination.

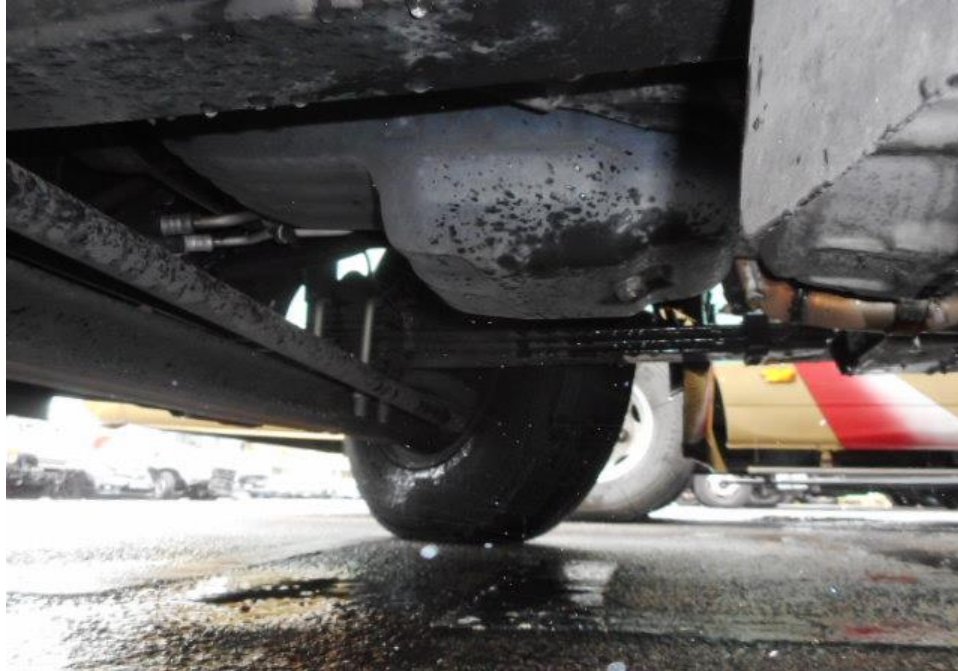
Photo 17 shows the undercarriage of the Motor Lorry, at the area where the engine housing and transmission housing are located. I did not find any sign(s) or indication(s) of fluid leak and/or fluid stain(s) on the underside of the Motor Lorry.

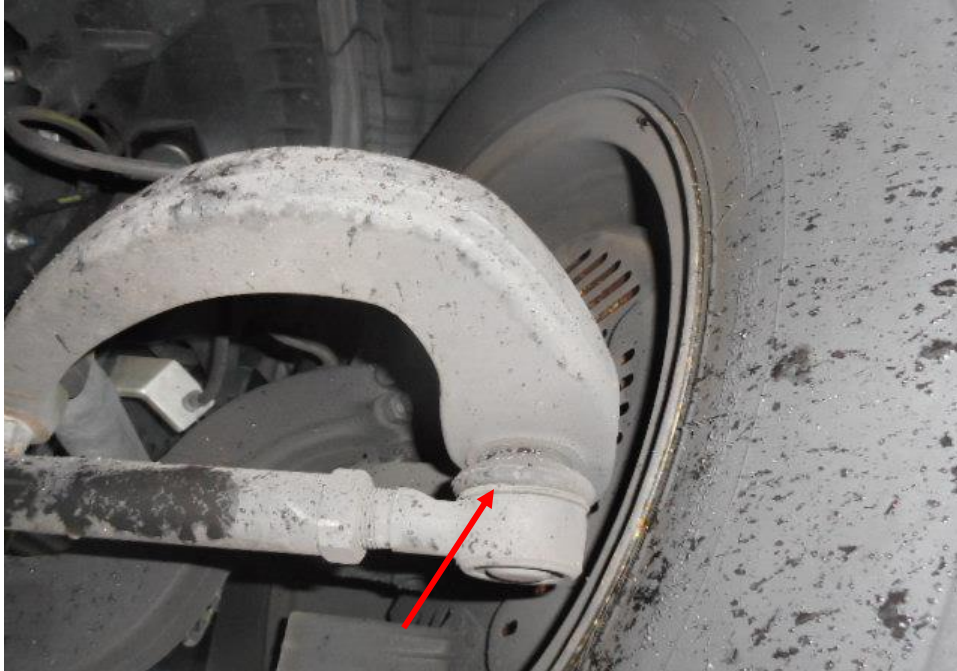
Photo 18 shows the various undercarriage components at the front right wheel of the Motor Lorry, in particular the steering tie rod end (arrowed). The various steering components were all found to be intact, suggesting that the steering system of the Motor Lorry was likely to be in serviceable condition at the material time of accident. There was also no sign of fluid stain(s) observed on the various undercarriage components.

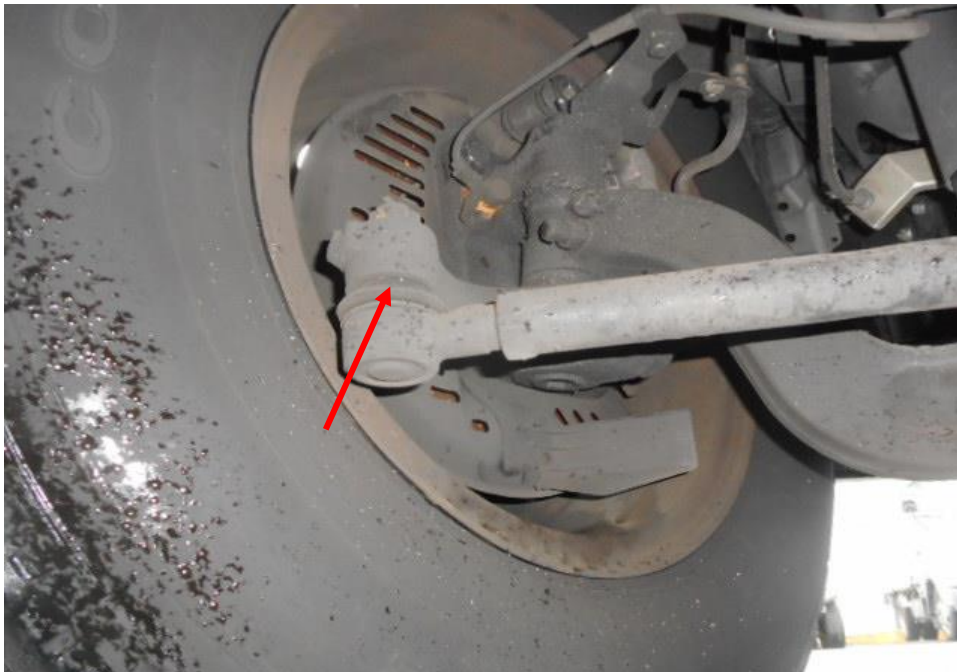
Photo 19 shows the various undercarriage components at the front left wheel of the Motor Lorry, in particular the steering tie rod end (arrowed). The various undercarriage components of the Motor Lorry were all found to be intact without any visible damage. There was also no sign of fluid stain(s) observed on the various undercarriage components.

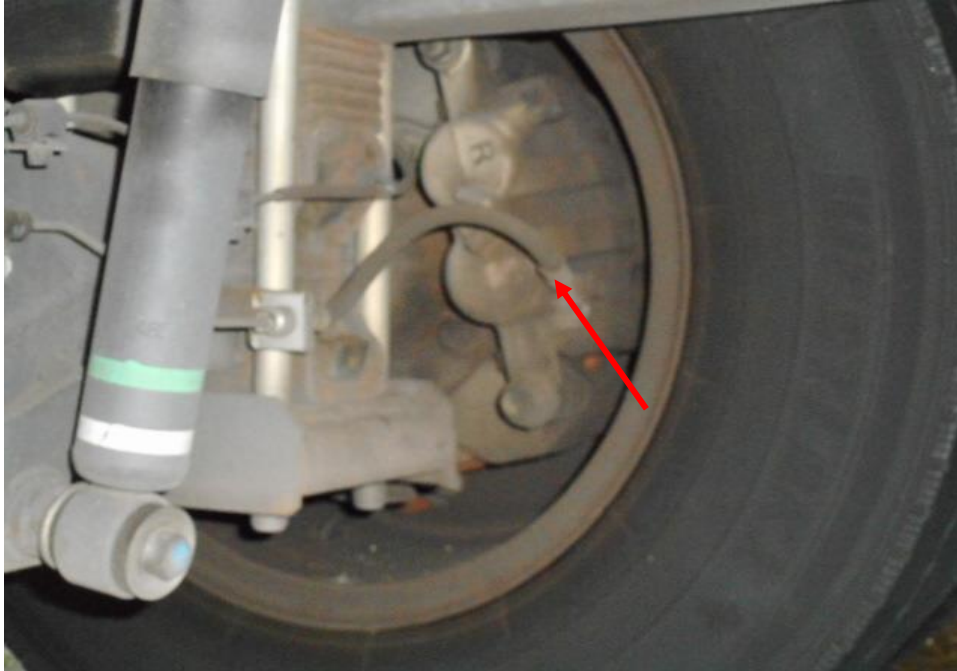
Photo 20 shows the brake pipe (arrowed) at the rear right wheel of the Motor Lorry. I did not observe any leakage of brake fluid at the time of my inspection of the Motor Lorry. My static tests of the Motor Lorry's braking system, along with my visual examination of the various mechanical components in the braking system, had indicated that there was no internal leakage of pressure/vacuum. Hence the braking system of the Motor Lorry was likely to be in serviceable condition at the material time of accident.

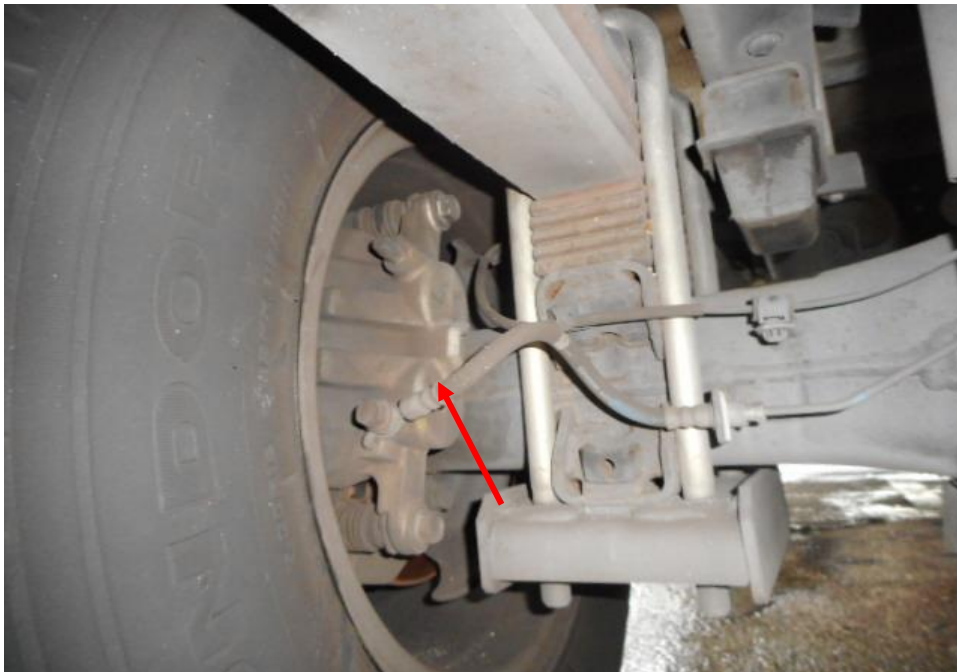
Photo 21 shows the brake pipe (arrowed) at the rear left wheel of the Motor Lorry. I did not observe any leakage of brake fluid at the time of my inspection of the Motor Lorry. My static tests of the Motor Lorry's braking system, along with my visual examination of the various mechanical components in the braking system had indicated that there was no internal leakage of pressure/vacuum. Hence the braking system of the Motor Lorry was likely to be in serviceable condition at the material time of accident.

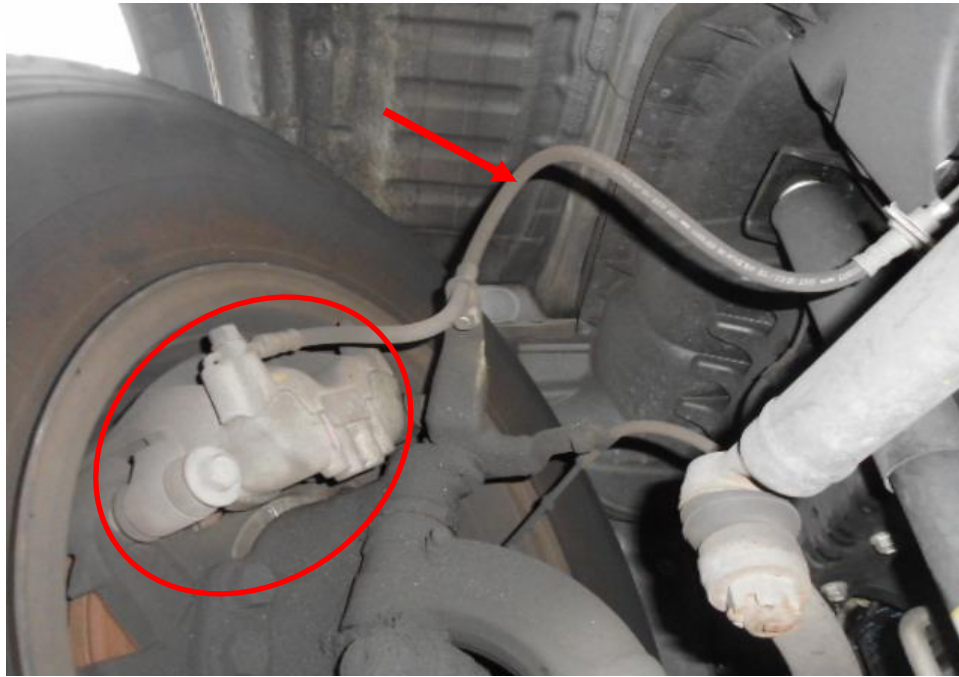
Photo 22 shows the brake hose/pipe (arrowed) at the front right wheel of the Motor Lorry. No leakage of brake fluid was observed. Visual examination of the various components of the braking system like the brake caliper (circled), brake booster, brake pedal etc had revealed all to be intact and without visible damage at the time of accident. There was also no sign of fluid stain(s) observed on the various undercarriage components.

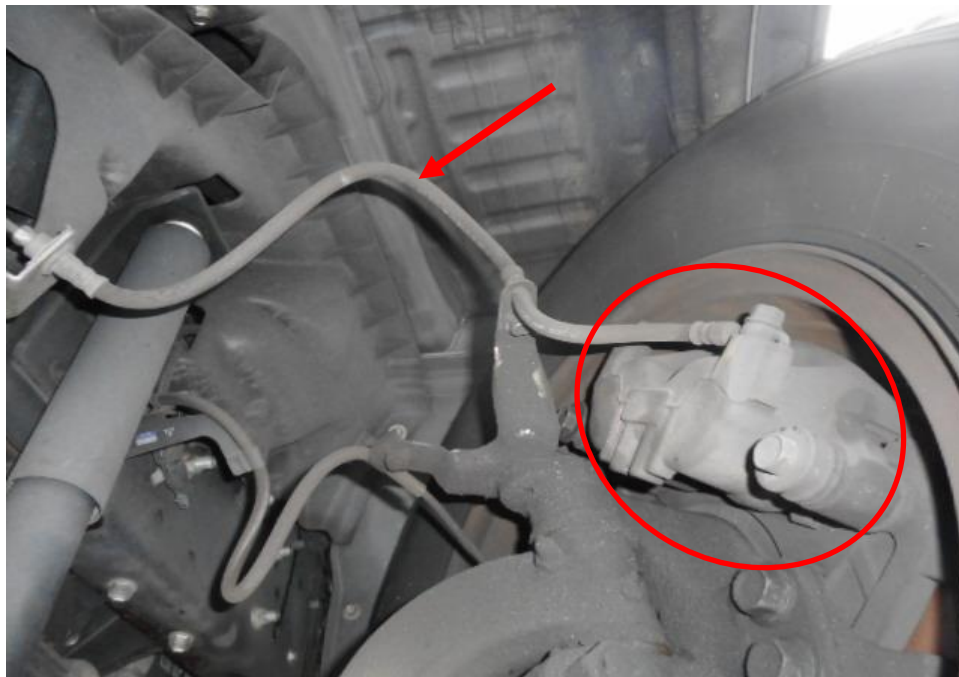
Photo 23 shows the brake hose/pipe (arrowed) at the front left wheel of the Motor Lorry. No leakage of brake fluid was observed. Visual examination of the various components of the braking system like the brake caliper (circled), brake booster, brake pedal etc had revealed all to be intact and without visible damage at the time of accident. There was also no sign of fluid stain(s) observed on the various undercarriage components.

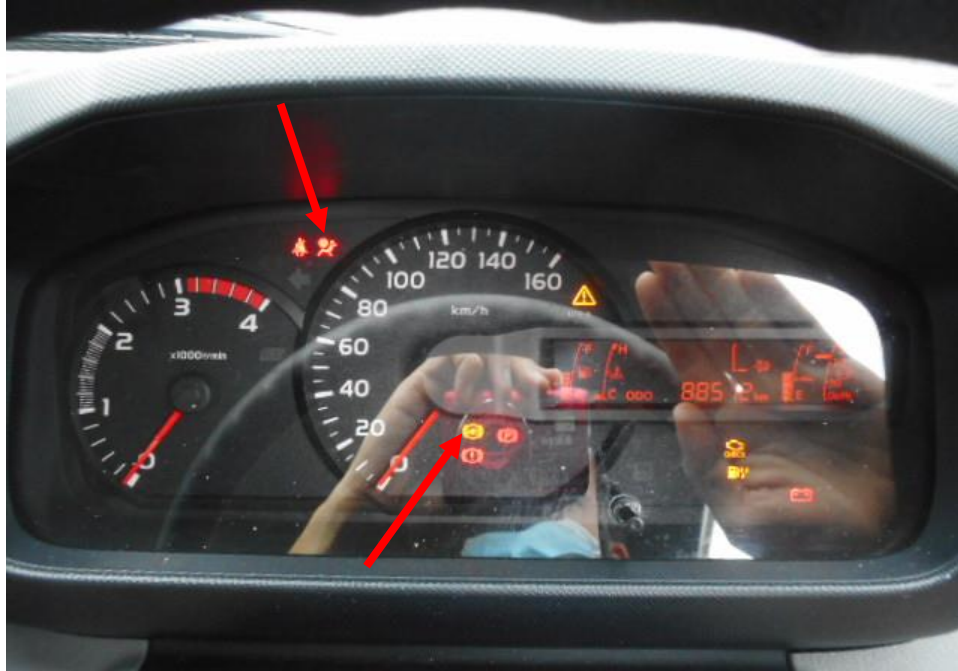
Photo 25 shows the warning light for Anti-Lock Brake System (ABS), and Supplemental Restraint System (SRS) (arrowed) appearing on the instrument panel of the Motor Car during the self-test of its various electronic operating systems when its engine was cranked.

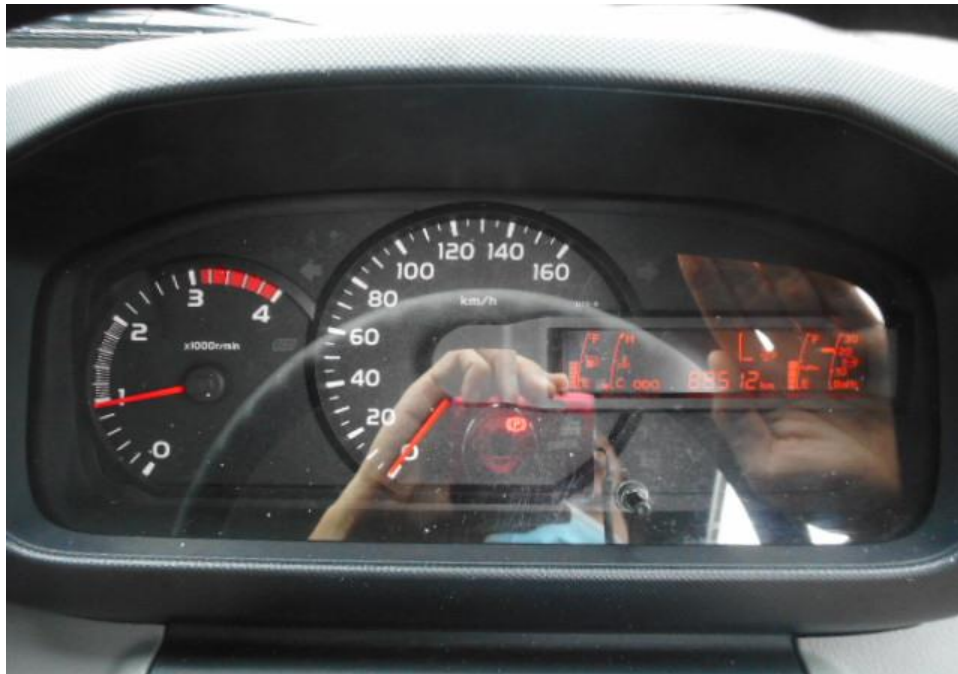
Photo 26 shows no warning lights illuminated on the instrument panel of the Motor Car after the engine was cranked. This would suggest that there was no abnormality to the electronic operating system of the Motor Car, like the ABS, TCS and SRS etc.
