# PRO-OPTION SERVICES

## **ACCIDENT VEHICLE INSPECTION REPORT**

Report no : 273M0821.UEM  
Vehicle no : SGT3380U

Make/model : **HONDA CITY CVT**  
Chassis no : MRHGD86907P030111  
Engine no : L15A25801199  
Date of registration : 09 April 2007 COE Expiry Date: 8 April 2022  
Engine capacity : 1497 cc  
Colour : Black

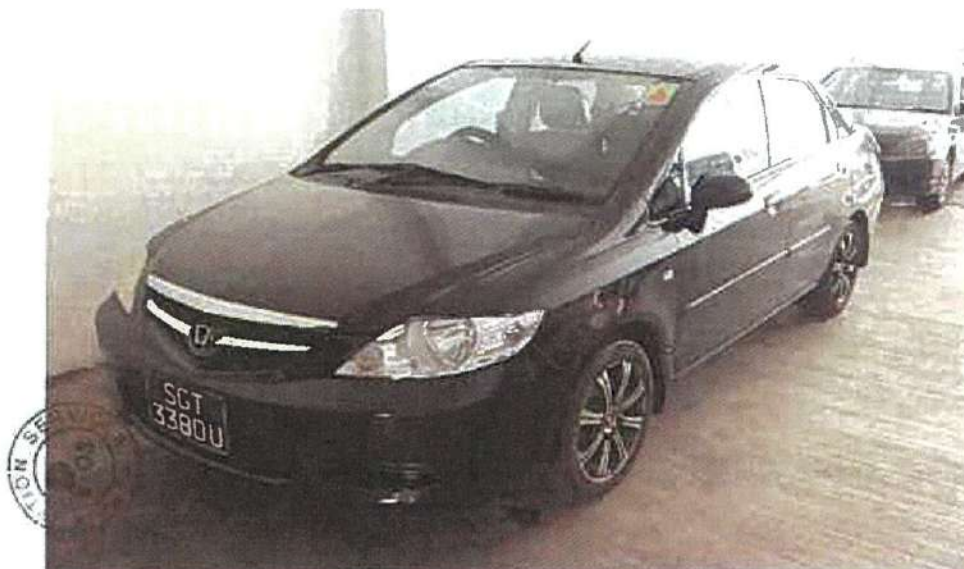
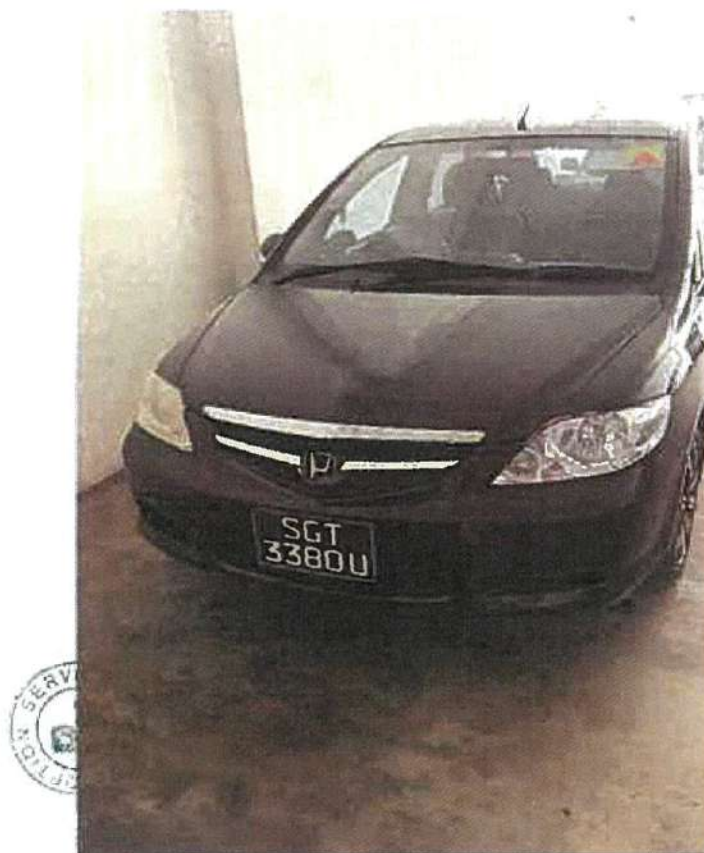
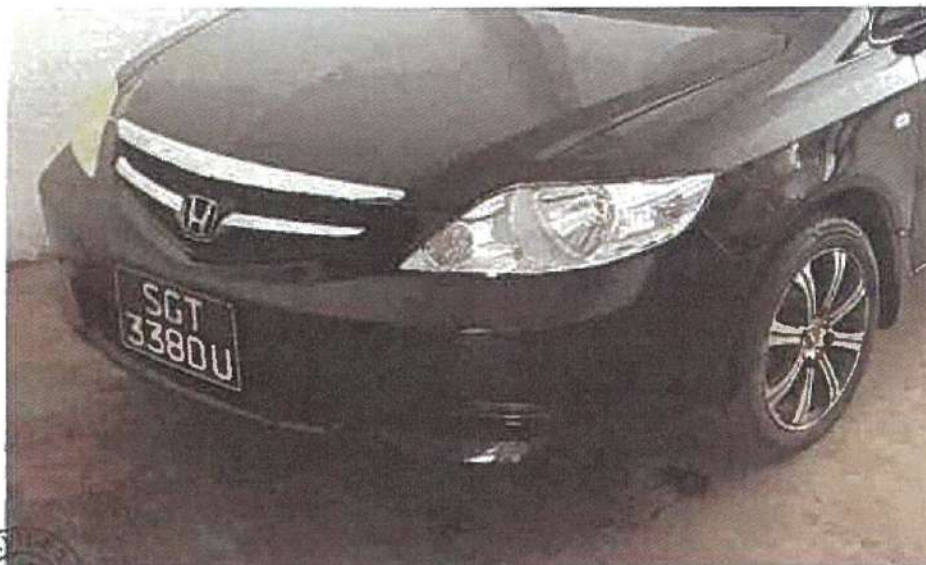
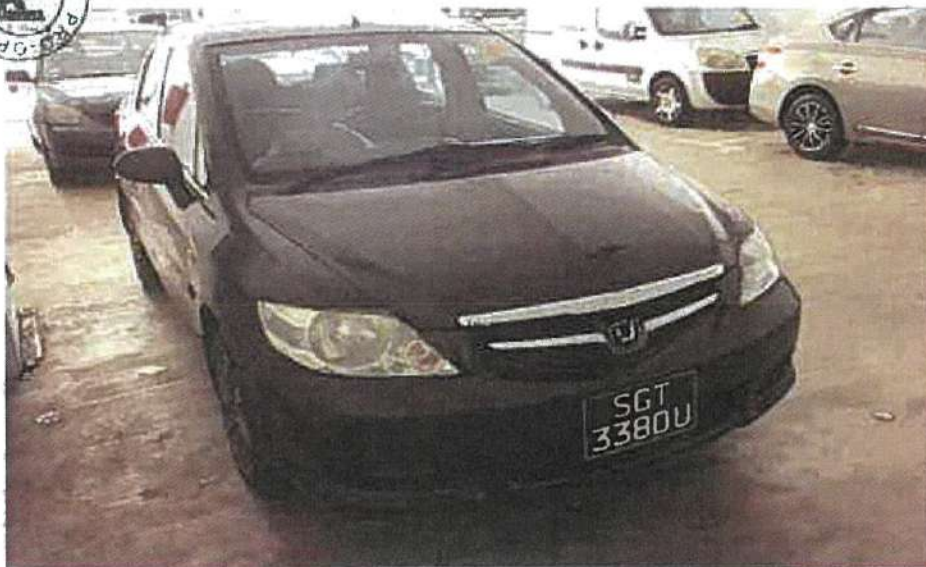
**POST REPAIR**

(b) The estimated number of days for the repairs would be Six (6)  
(1<sup>st</sup> Re-inspection conducted on 17 August 2021)  
(Post Repair Inspection conducted on 21 August 2021)
