LKK Auto Consultants Pte Ltd

ADJUSTMENT ON REPAIR COST FOR VEHICLE NO. SLD 9473X

PHOTOGRAPHS FOR VEHICLE NO. SLD 9473X

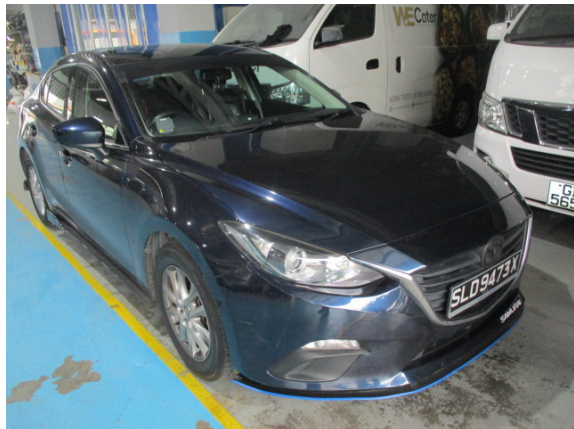
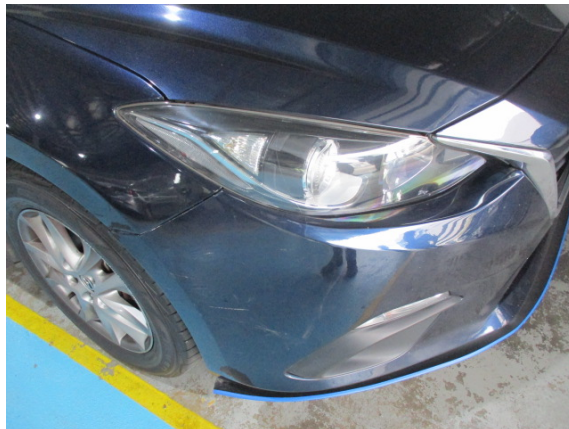
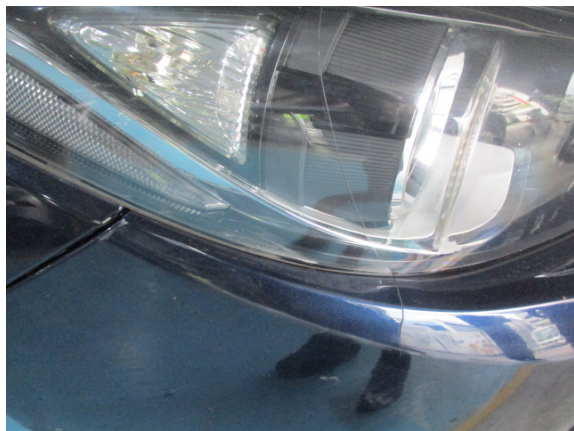
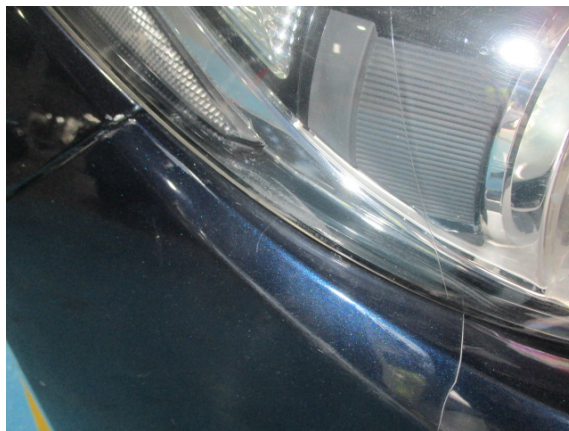
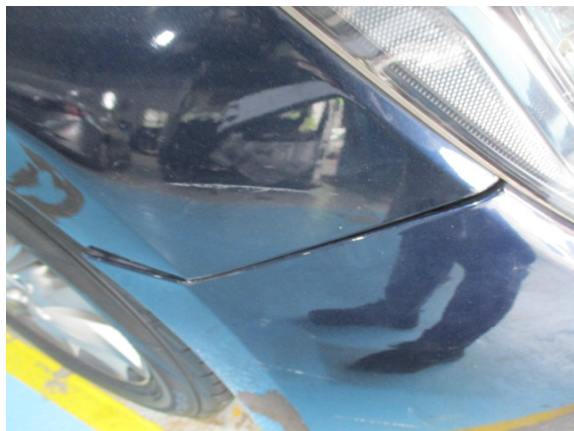
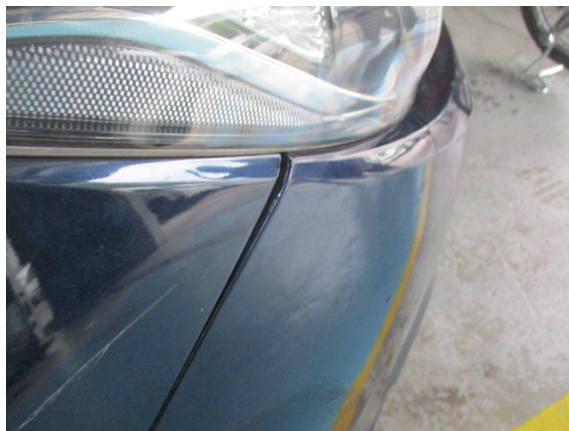
4. Description of Damages				
	THE VEHICLE SUSTAINED DAMAGES AT THE O/S FRONT PORTION.			
	DAMAGES SEE DETAILS.			
5. General Information				
	Accident Date	06/09/2021	Inspection Date	10/09/2021
	Survey held at	ETHOZ GROUP LTD 30 BUKIT BATOK CRESCENT SINGAPORE 658075		
5a. Remarks				
	A)THE INSPECTION WAS CONDUCTED ON A"WITHOUT PREJUDICE" BASIS. B)IN ACCORDANCE TO YOUR INSTRUCTIONS, WE HAVE NOT AUTHORISED REPAIRS.			
5b. Estimate Days of Repair				
	ESTIMATED NORMAL PERIOD FOR REPAIR:			4 Working Days

Qty	Description of Parts	Condition	Estimate By Workshop (\$)	Our Adjusted (\$)
	<u>REPLACEMENT OF PARTS</u>			
1	FRONT BUMPER	CRACKED	925.10	925.10
1	FRONT BUMPER RETAINER RH	DEFORMED	38.70	38.70
10	FRONT BUMPER CLIPS	NECESSARY	50.00	50.00
10	FRONT TOP PANEL RIVET	NOT NECESSARY	100.00	-
1	HEADLAMP RH	CUT	773.30	773.30
1	FRONT GRILLE TOP PANEL (NPA)	NOT NECESSARY	-	-
1	FRONT FENDER RH (NPA)	TO REPAIR SEE LABOUR	-	-
	LESS 20% DISCOUNT		-377.42	-357.42
			1,509.68	1,429.68
	<u>LABOUR</u>			
	LABOUR TO FACILITATE REPAIR.INCLUSIVE OF THE REPAIR OF FRONT FENDER RH.		600.00	400.00
	TO RESPRAY AFFECTED AREAS .		600.00	400.00
	TO CHECK AND RECONNECT ALL NECESSARY WIRINGS.		30.00	30.00
			1,230.00	830.00
GRAND TOTAL			2,739.68	2,259.68
RECOMMENDED COST OF REPAIRS				2,259.68
