Vehicle No. SDD 5443D

PRE-REPAIR INSPECTION REPORT				
EQ INSURANCE COMPANY LTD 5 MAXWELL ROAD #17-00 TOWER BLOCK MND COMPLEXSINGAPORE 069110			Ref: CS3/EQI21009562/Ntf3e2 Date: 22/10/2021 Code: EQI

PHOTOGRAPHS FOR VEHICLE NO. SDD 5443D

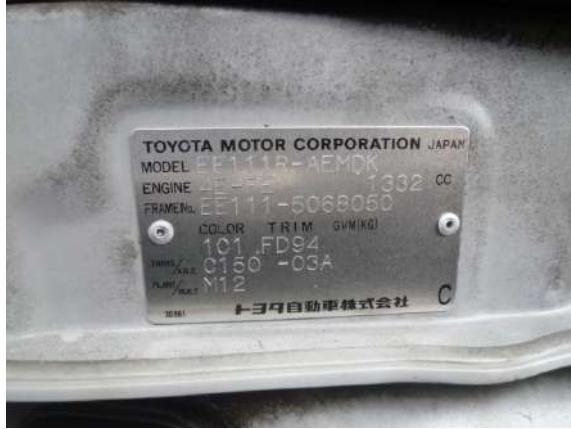
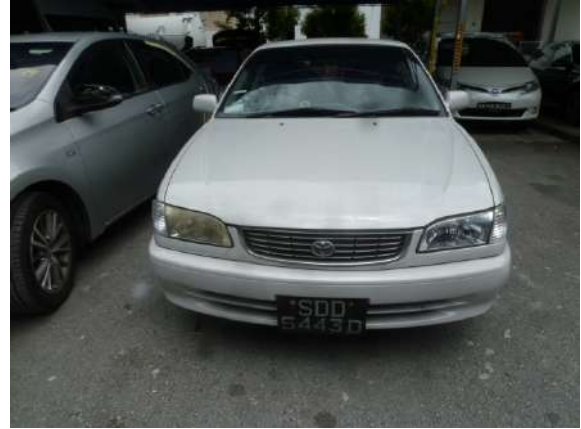
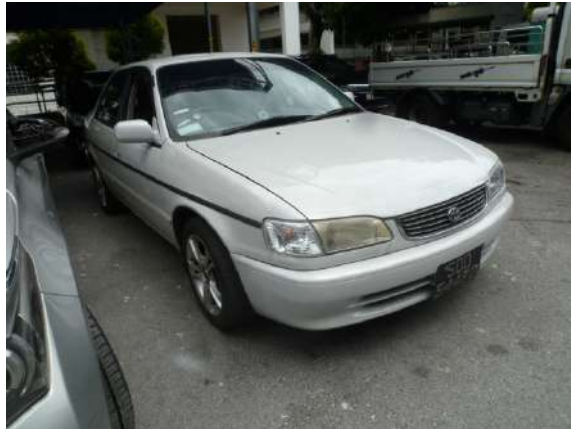
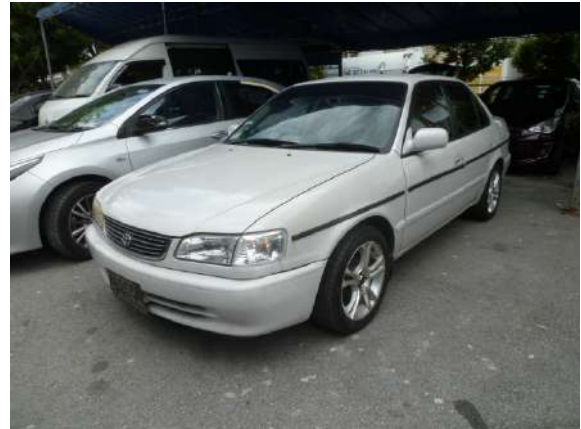
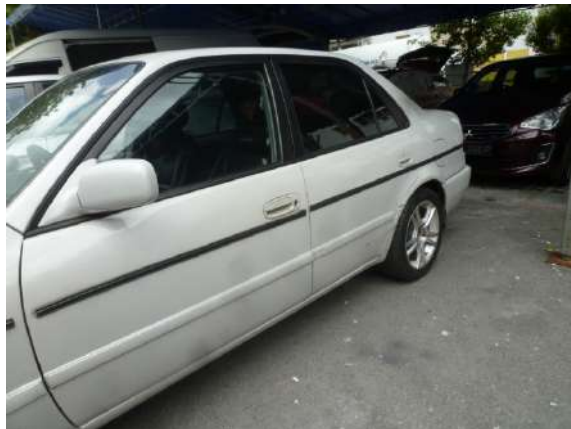
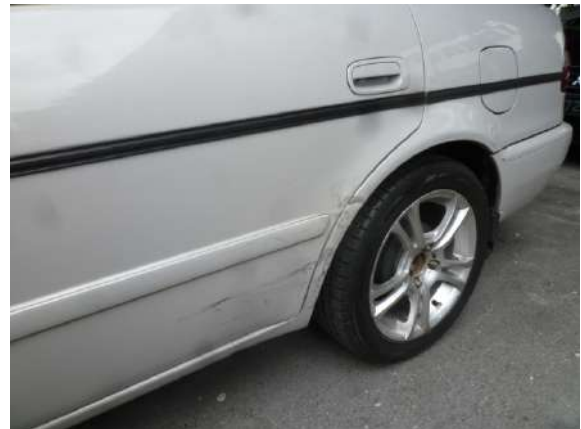
4. Description of Damages				
THE VEHICLE SUSTAINED DAMAGES AT THE N/S BODY.

A) THE INSPECTION WAS CONDUCTED ON A "WITHOUT PREJUDICE" BASIS. B) THE REPAIR ESTIMATE WAS NOT PRESENTED AT THE TIME OF INSPECTION. THE REPAIRER WAS TOLD TO PREPARE THE ESTIMATE. C) ENCLOSED PLEASE FIND DAMAGED VEHICLE PHOTOGRAPHS. D) THE ESTIMATED REPAIR COST OF THE DAMAGED VEHICLE IS IN THE REGION OF \$3,000-\$4,000				
5b. Estimate Days of Repair				
ESTIMATED NORMAL PERIOD FOR REPAIR:		4 Working Days
