**ACCIDENT DAMAGED VEHICLE INSPECTION REPORT**

Date : 11 August 2021  
Our Ref : TP/ABM/GBB2941L/8563

Registration No : GBB 2941 L  
Make : Suzuki  
Model : Every GA 660 M  
Year : 2007 (COE Expiry 17/11/2023)

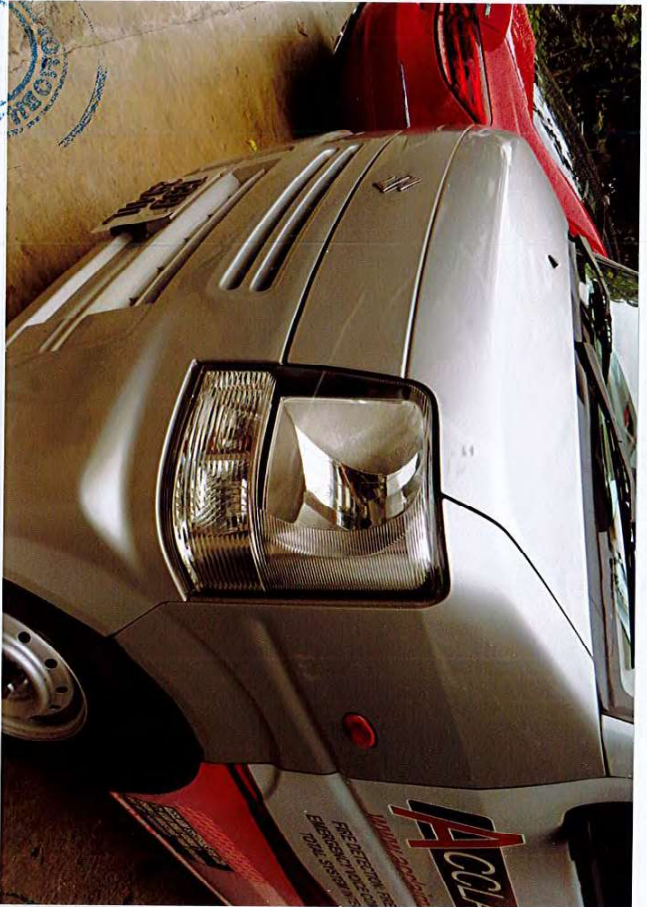
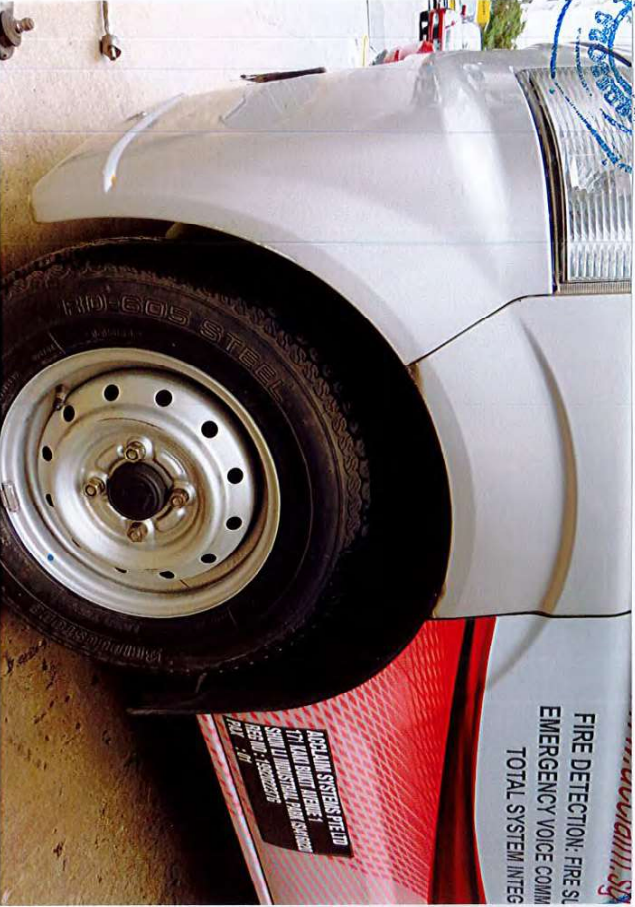
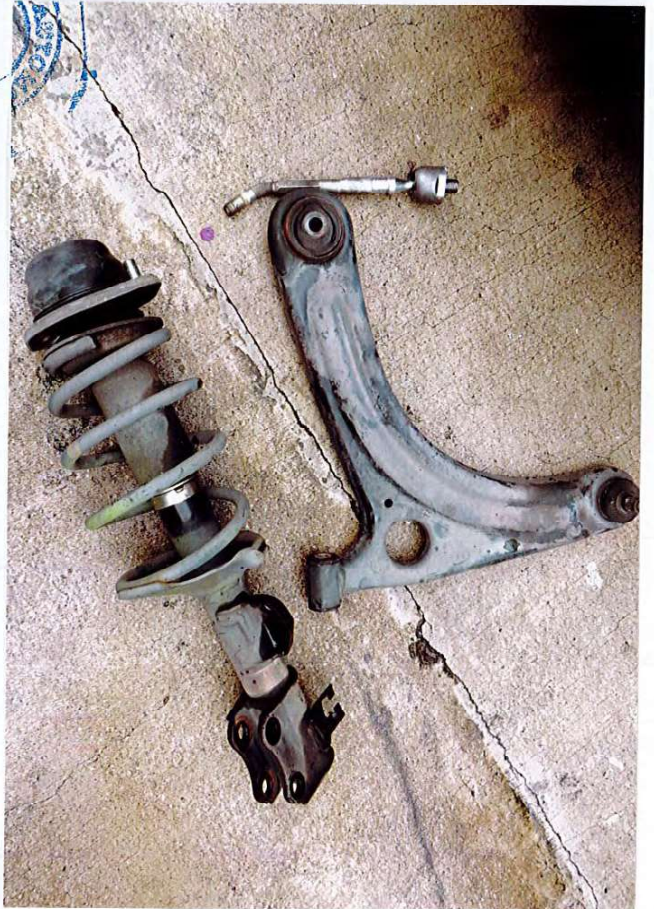
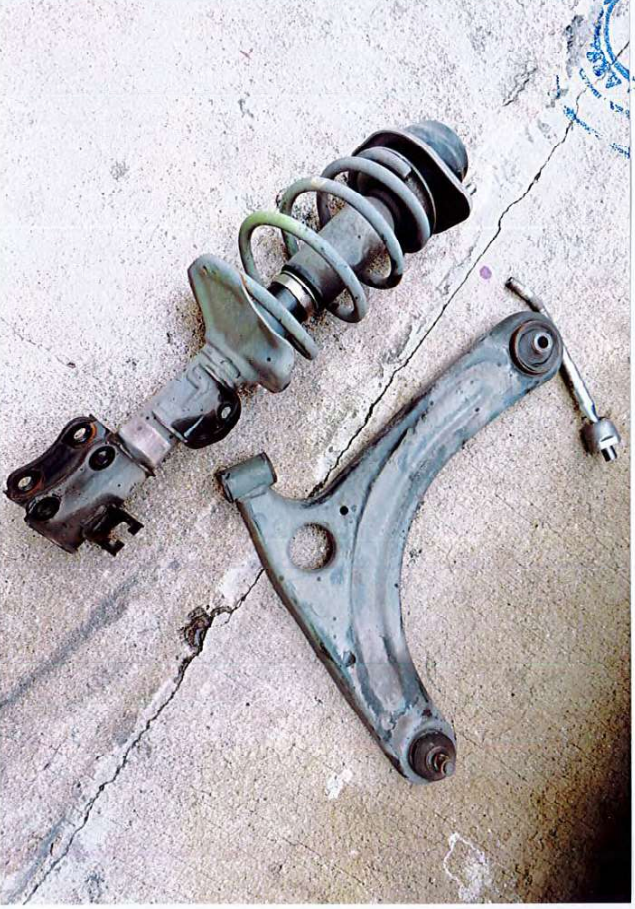
RE-INSPECTION AFTER REPAIR

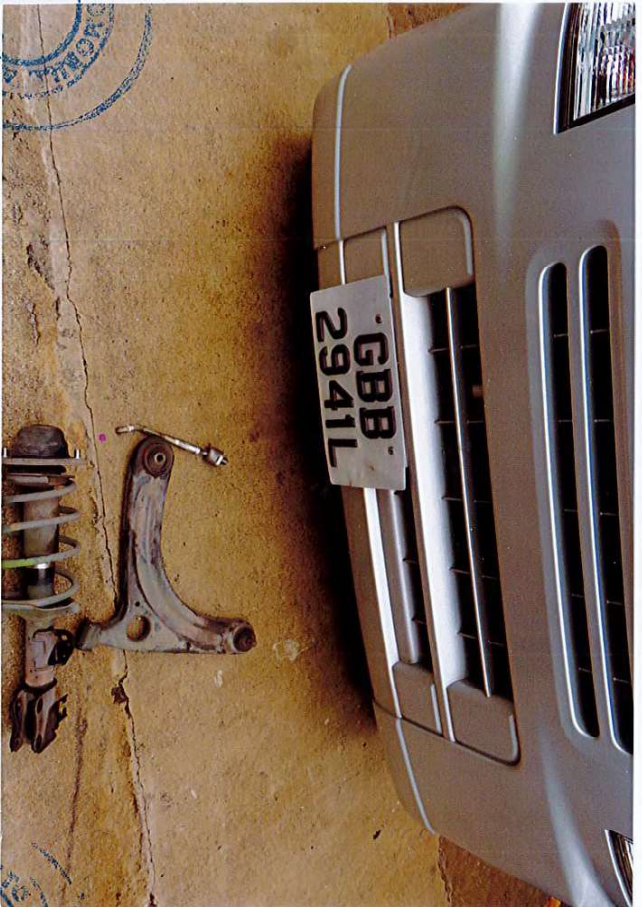
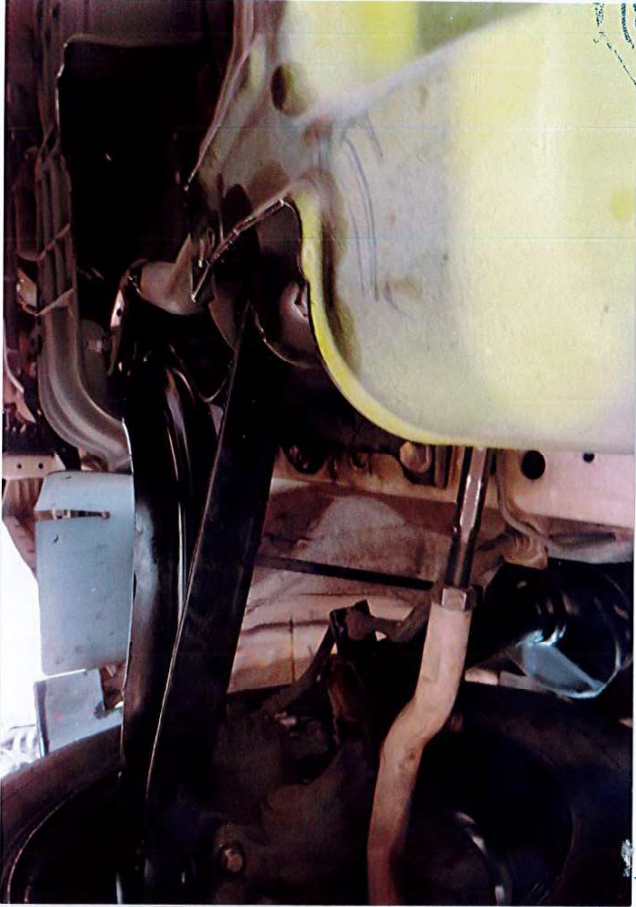
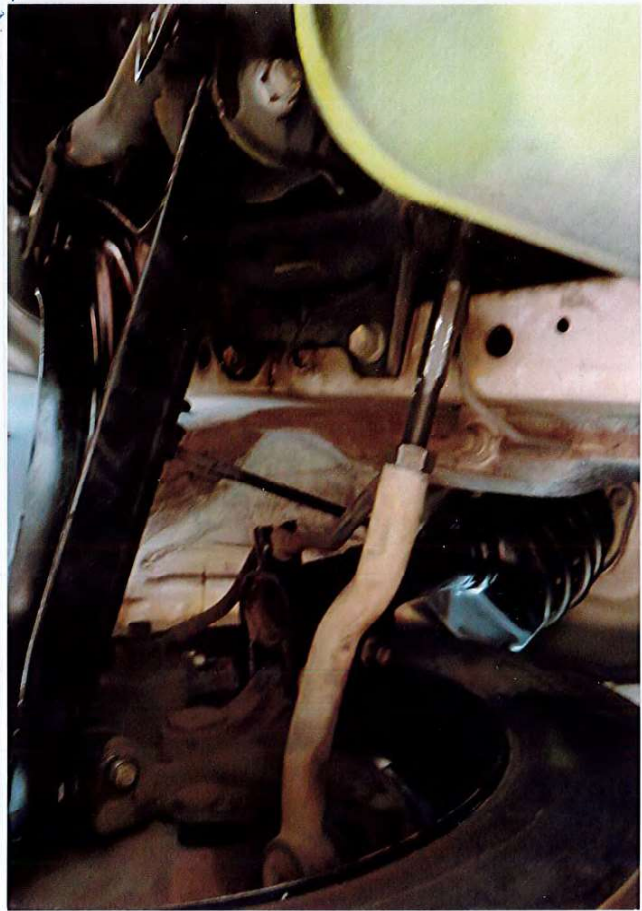
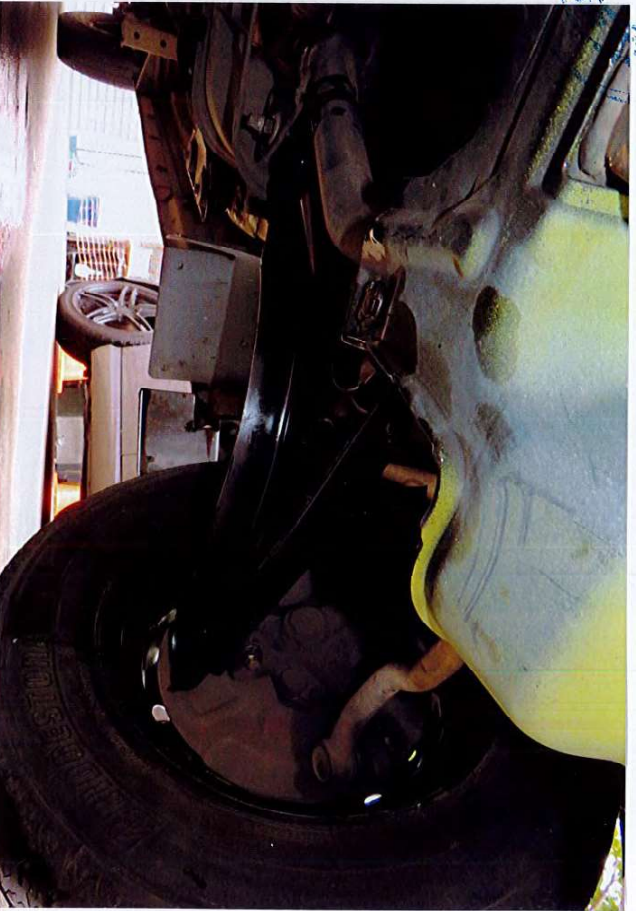
RE-INSPECTION AFTER REPAIR

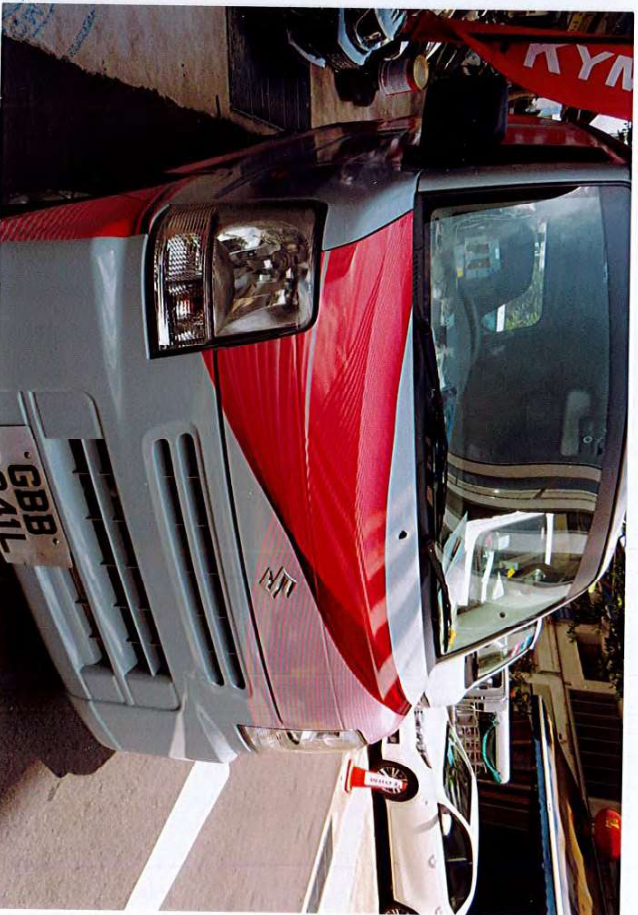
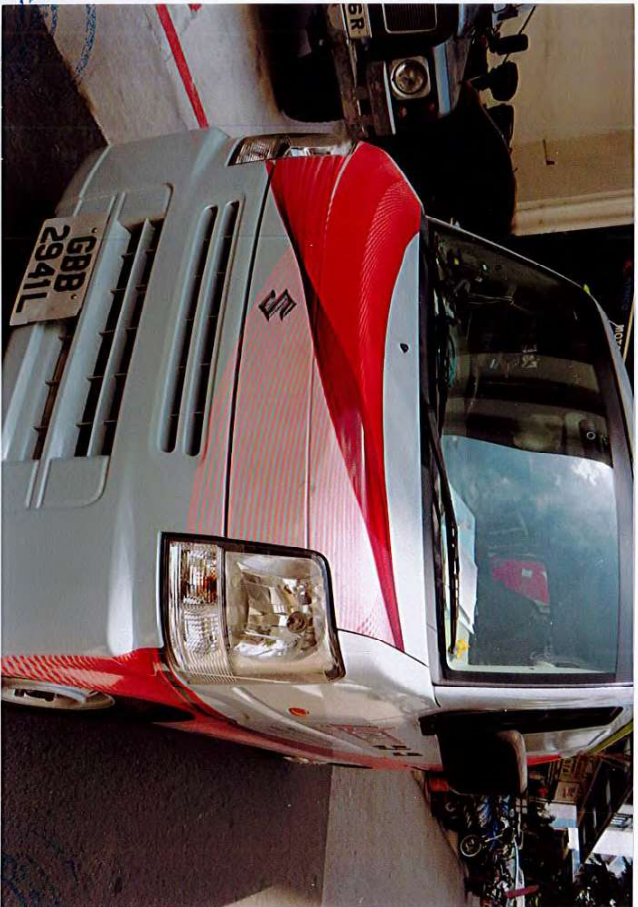
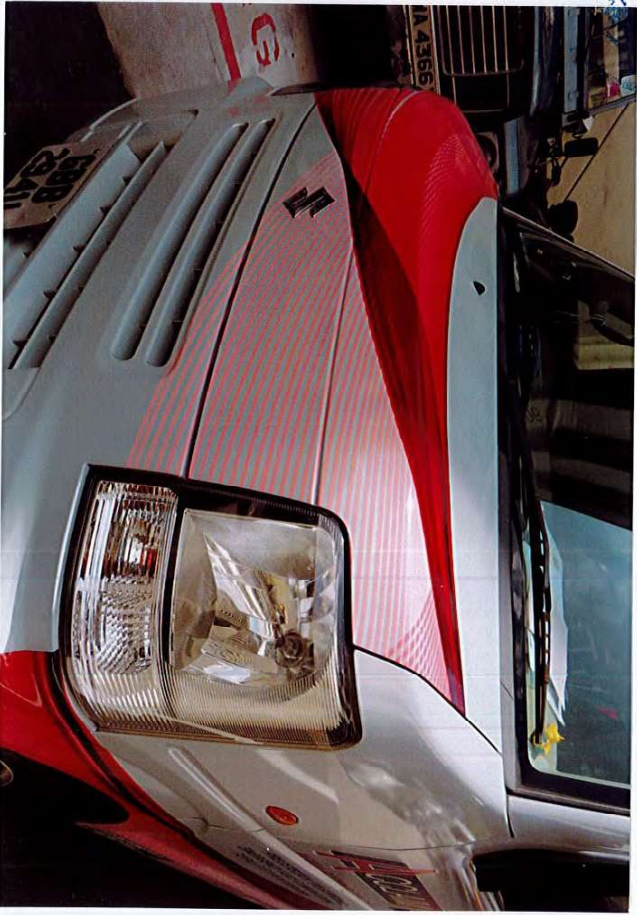
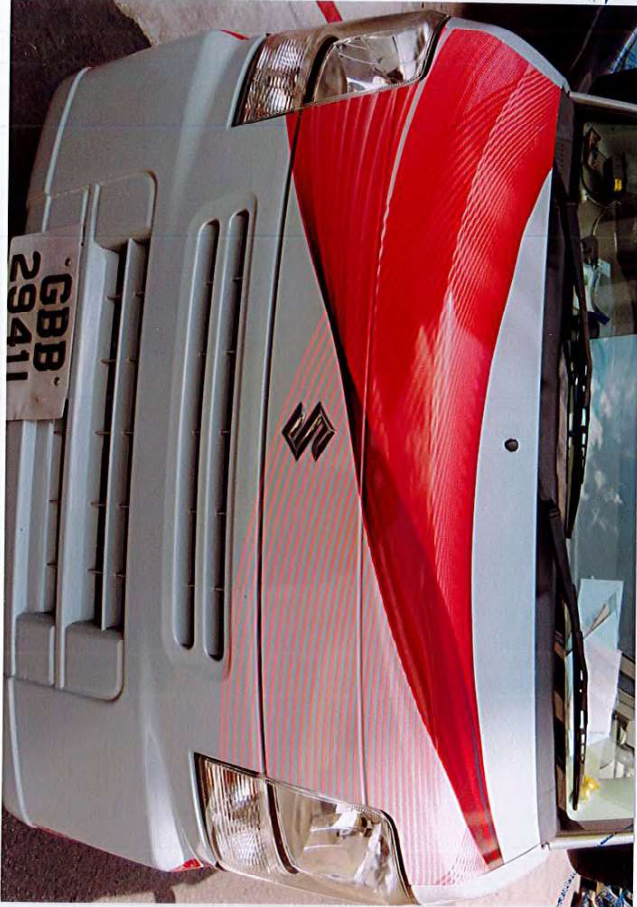
RE-INSPECTION AFTER REPAIR
