Your Ref: Porsche 911 Carrera T
(chassis number WP0ZZZ99ZKS100225)

18 September 2021

Our Ref : CI/TP21009650/D

**INSPECTION REPORT OF AN UNREGISTERD PORSCHE 911 CARRERA T
MOTOR CAR WITH CHASSIS NUMBER WP0ZZZ99ZKS100225**

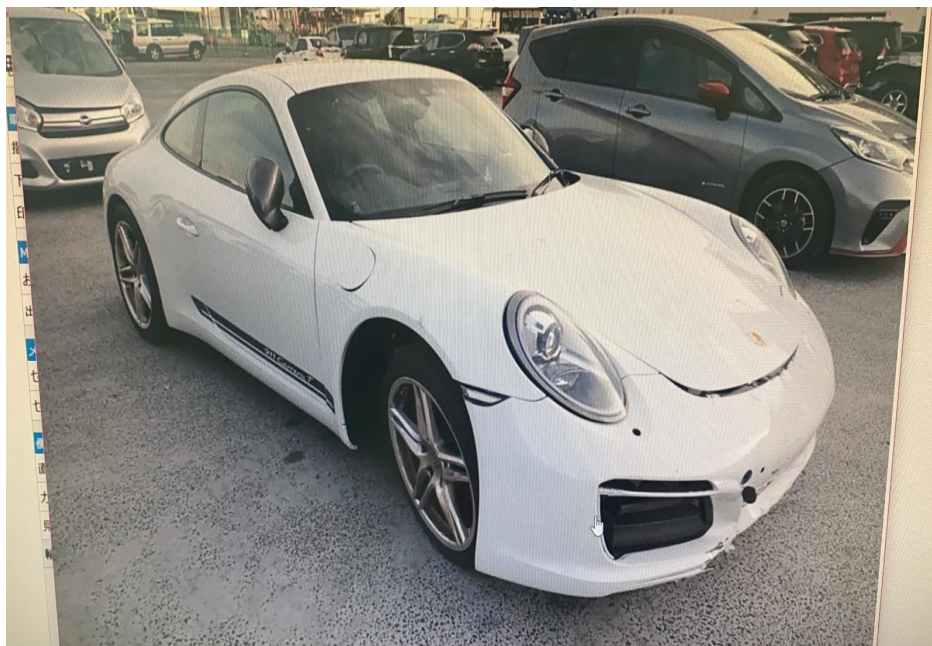
3. The photographs provided to me had showed damage to the frontal portion of the Motor Car. Body parts observed to be damaged include the front bumper, front bumper lower lip, front bumper left lower grille, front bumper right lower grille, front left day light, front right day light and front left signal lamp amongst others. The driver's airbag and front left passenger airbag were deployed.

4. The Motor Car's front right wheel was also observed to be tilted outwards from a vertical perspective. This would indicate damage to the front right undercarriage parts of the Motor Car. Parts that may possibly be damaged include the front right shock absorber, front right lower arm, front right upper arm, front right control arm, front right stabilizer link and front right steering tie rod end amongst others.

Photo 1 shows the front right body of the Motor Car (photograph provided to me). The Motor Car was observed to have sustained damage at its frontal portion. The front bumper, front bumper lower lip, front bumper right lower grille and front right day light were amongst the body parts that were observed to have been damaged. The front right wheel was seen to be tilted outwards, indicating damage to the front right undercarriage parts of the Motor Car.

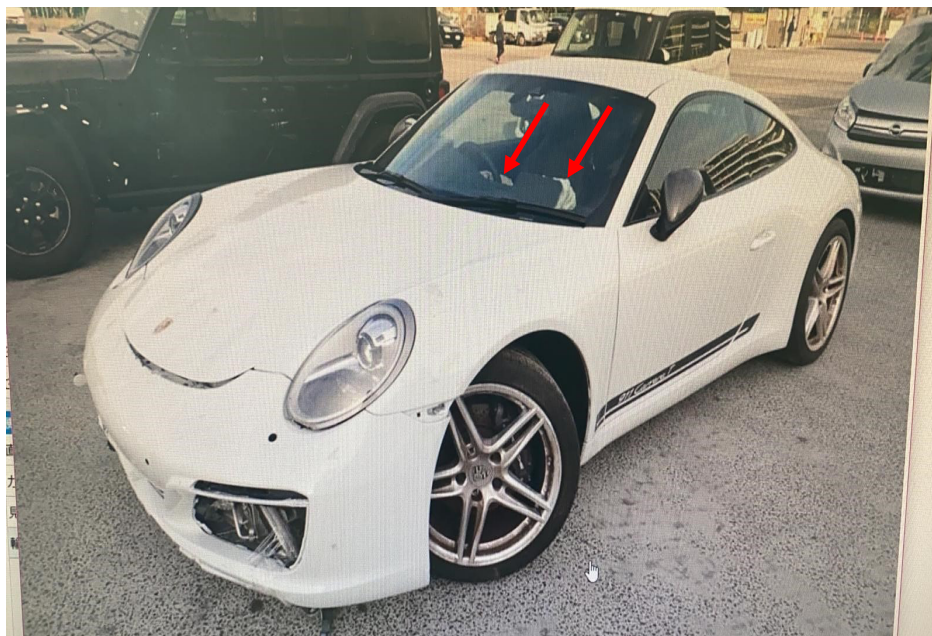
Photo 2 shows the front left body of the Motor Car (photograph provided to me). The Motor Car was observed to have sustained damage at its frontal portion. The front bumper, front bumper lower lip, front bumper left lower grille, front left day light and front left signal lamp were amongst the body parts that were observed to have been damaged. As seen from the photograph, the driver's airbag and front left passenger airbag were activated (arrowed).

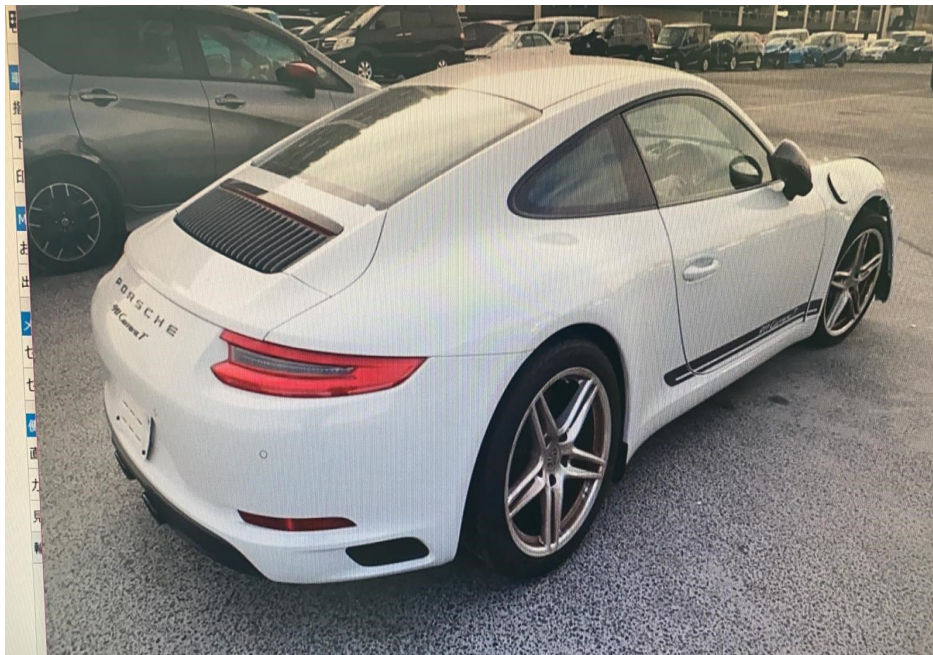
Photo 3 shows the rear right body of the Motor Car (photograph provided to me). Apart for the frontal portion, there was no physical damage seen to other areas of the Motor Car.

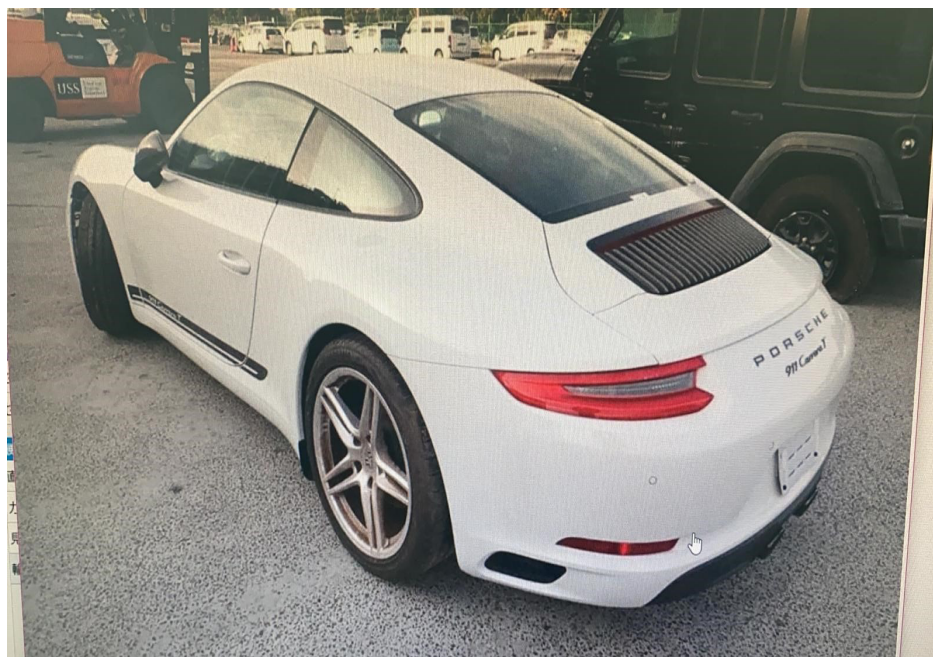
Photo 4 shows the rear left body of the Motor Car (photograph provided to me). Apart for the frontal portion, there was no physical damage seen to other areas of the Motor Car.

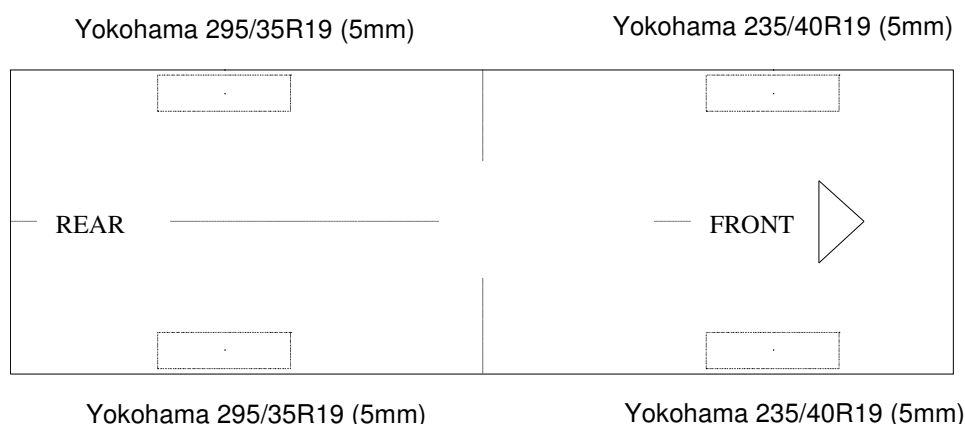
9. It was fitted with 19inch sport wheel rims that were wrapped with tyres that were observed to be of serviceable condition. The tyres were also sufficiently inflated for vehicular operation. The tyre brand, tyre size and approximate remaining tread depth of the 4 tyres of the Motor Car were recorded as follows: -

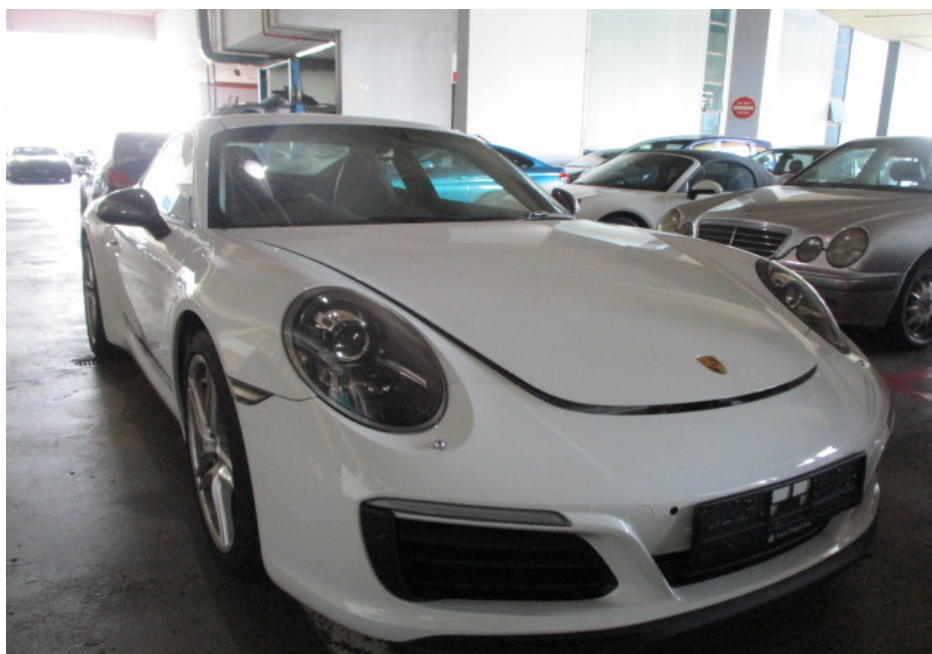
Photo 5 shows a general view of the front right body of the Motor Car at the time of my inspection. The Motor Car was observed to be in a relatively good general condition with no loose exterior fittings observed. The body parts at the frontal portion of the Motor Car were visually examined and it was observed that the repair/restoration works carried out to the damaged area of the Motor Car (refer to photograph 1 & 2 above) were reasonably adequate and in order.

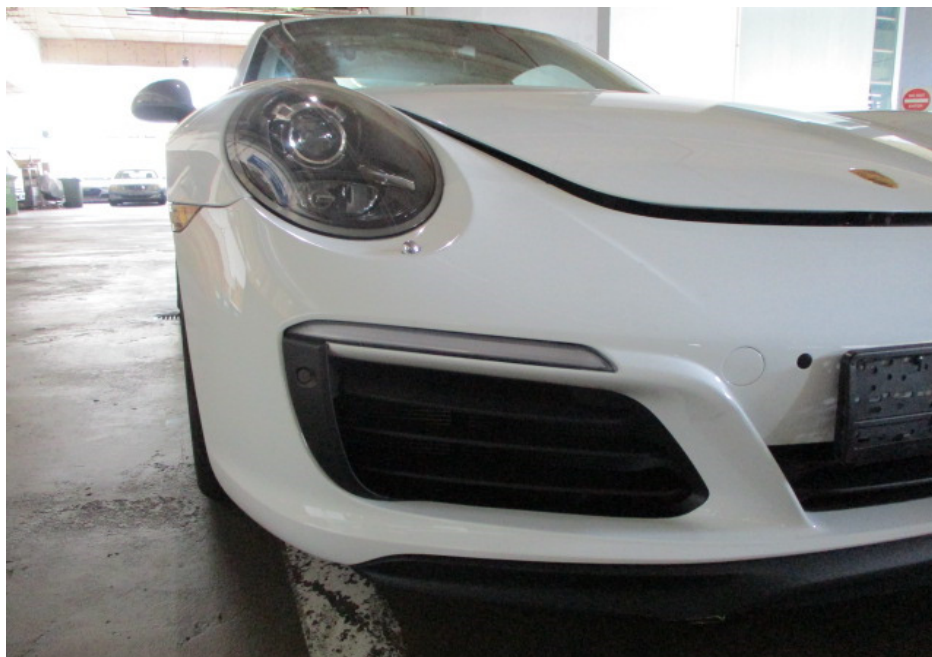
23. The body parts at the frontal portion and the undercarriage parts at the front right of the Motor Car were visually examined and it was noted that the repair/restoration works carried out to the damaged area of the Motor Car (refer to photograph 1 & 2 above) were reasonably adequate and in order.

Photo 6 shows a closer view of the Motor Car's front bumper, front bumper lower lip, front bumper right lower grille and front right day light. The body parts at the frontal portion of the Motor Car were visually examined and it was observed that the repair/restoration works carried out to the damaged area of the Motor Car (refer to photograph 1 above) were reasonably adequate and in order.

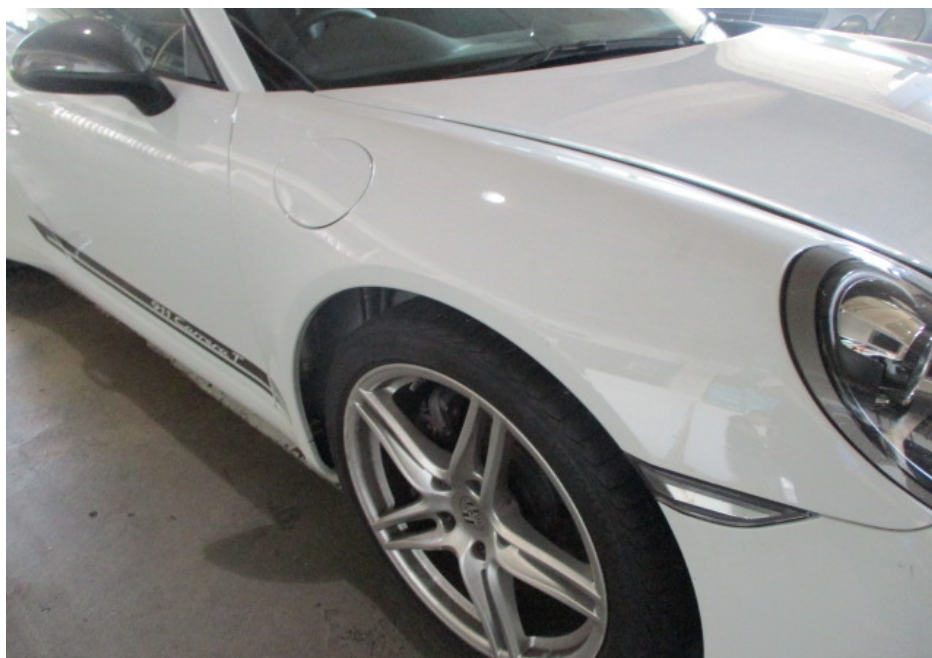
Photo 7 shows the front right wheel of the Motor Car. The undercarriage parts at the front right of the Motor Car were visually examined and it was observed that the repair/restoration works carried out to the damaged area of the Motor Car (refer to photograph 1 above) were reasonably adequate and in order. Refer to photograph 22 below showing the front right undercarriage parts of the Motor Car.

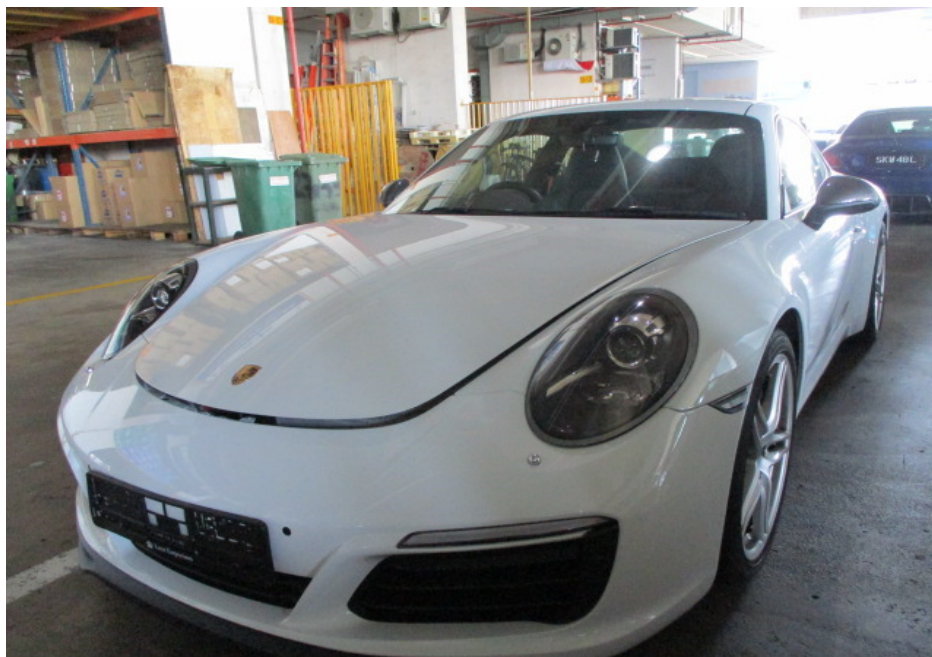
Photo 8 shows a general view of the front left body of the Motor Car at the time of my inspection. The Motor Car was observed to be in a relatively good general condition with no loose exterior fittings observed. The body parts at the frontal portion of the Motor Car were visually examined and it was observed that the repair/restoration works carried out to the damaged area of the Motor Car (refer to photograph 1 & 2 above) were reasonably adequate and in order.

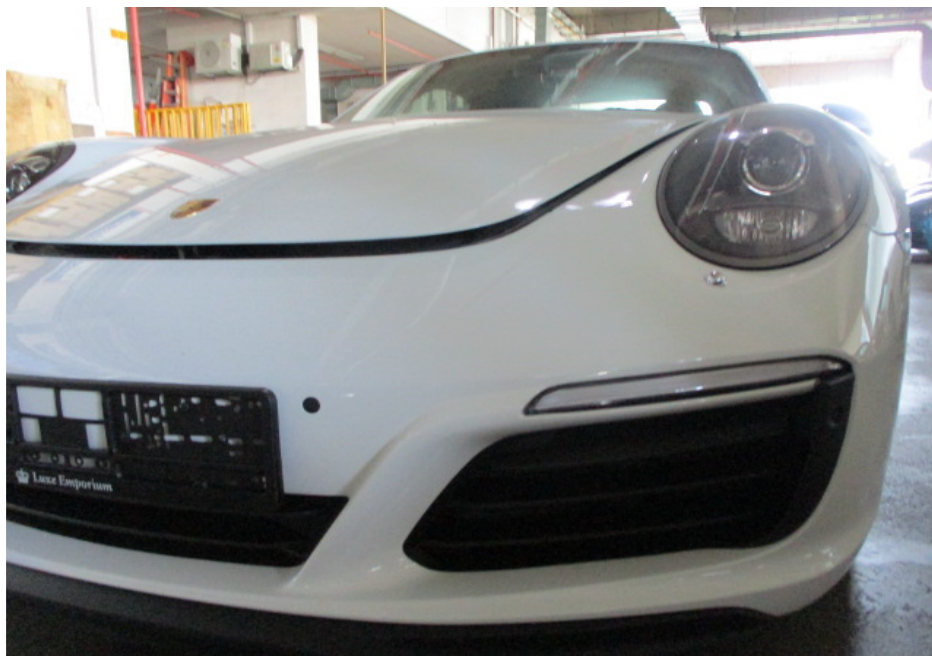
Photo 9 shows a closer view of the Motor Car's front bumper, front bumper left lower grille and front left day light. The body parts at the frontal portion of the Motor Car were visually examined and it was observed that the repair/restoration works carried out to the damaged area of the Motor Car (refer to photograph 2 above) were reasonably adequate and in order.

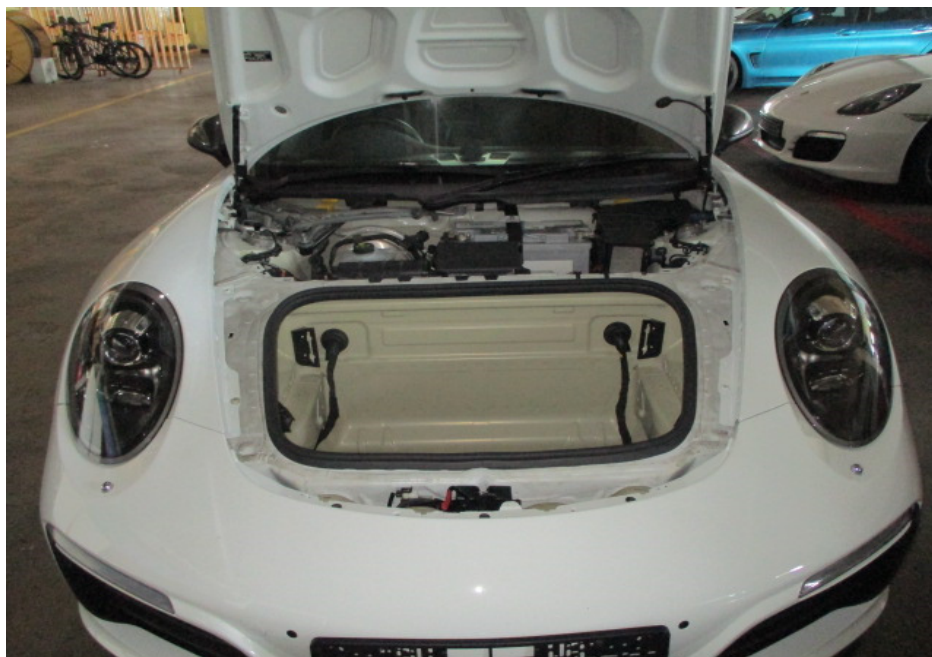
Photo 10 shows a general of the Motor Car's front bonnet compartment at the time of my inspection. Original spot weld marks and original factory sealant were found on the non-detachable body panels at the frontal portion of the Motor Car. The non-detachable body panels at the frontal portion of the Motor Car were originally fitted.

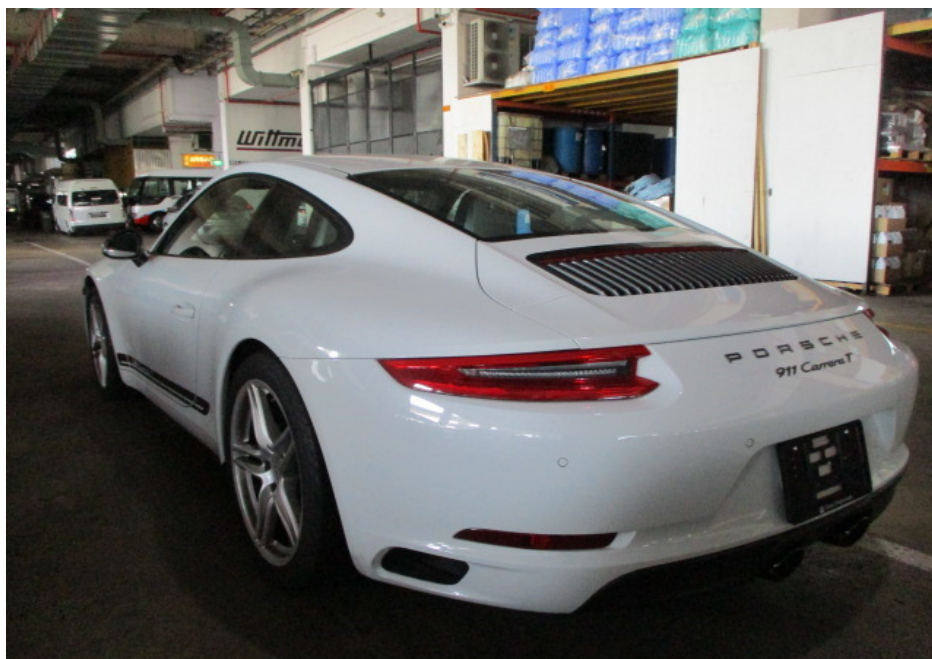
Photo 11 shows a general view of the rear left body of the Motor Car at the time of my inspection. The Motor Car was observed to be in a relatively good general condition with no loose exterior fittings observed. The mileage of the Motor Car recorded at the time of my inspection was 9,580km.

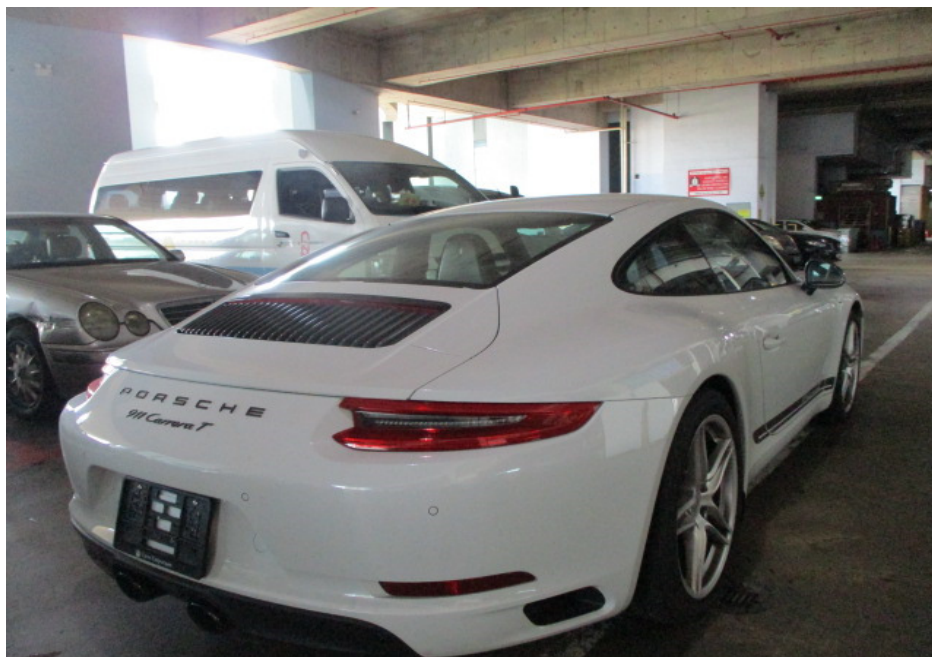
Photo 12 shows a general view of the rear right body of the Motor Car at the time of my inspection. The Motor Car was observed to be in a relatively good general condition with no loose exterior fittings observed. The mileage of the Motor Car recorded at the time of my inspection was 9,580km.

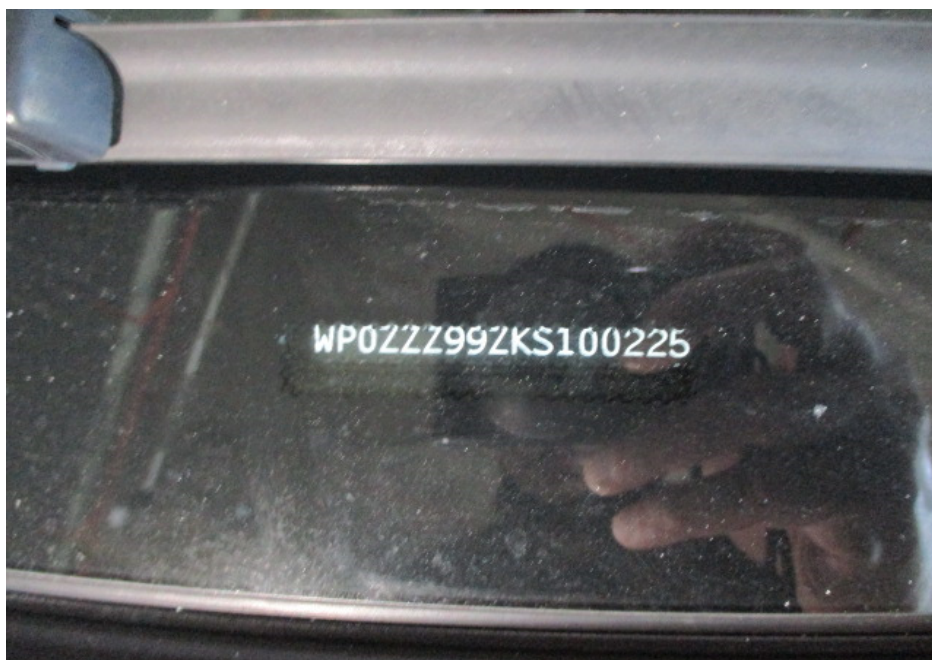
Photo 13 shows the chassis number of the Motor Car. The chassis number recorded WP0ZZZ99ZKS100225.

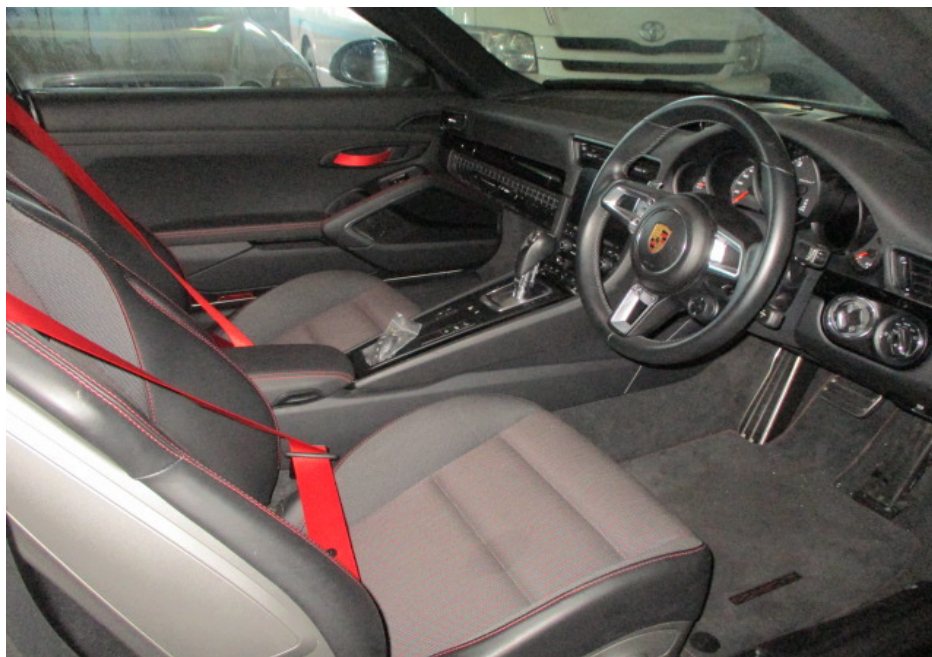
Photo 14 shows the interior compartment of the Motor Car at the time of my inspection. The various parts and components, trims, carpet and upholstery inside the interior compartment were all observed to be intact and properly fitted.

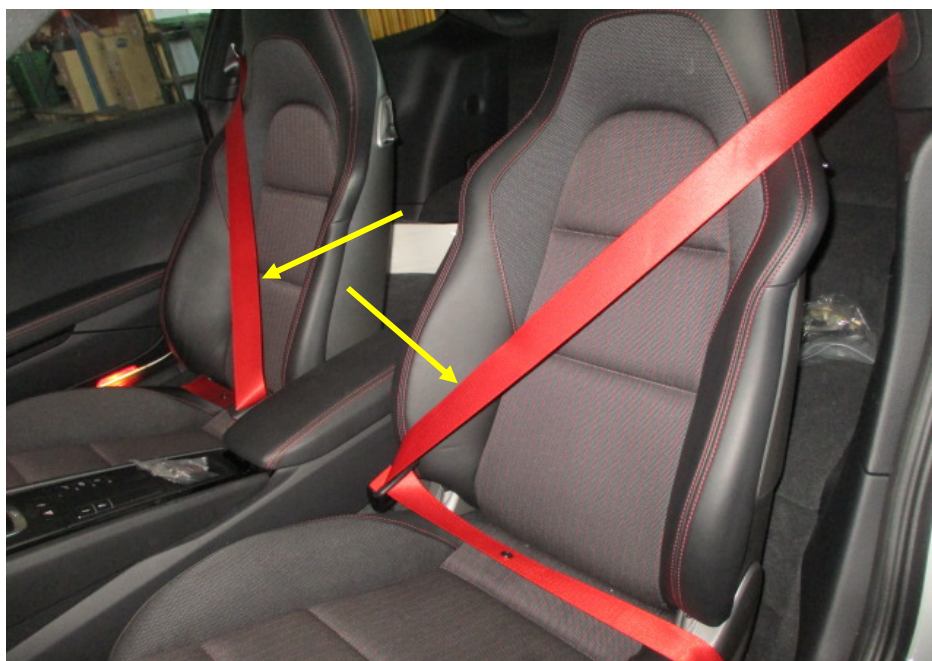
Photo 15 shows the seats of the Motor Car. All the seats of the Motor Car were secured via seat rails to the floorboard. They were also fitted with a retractable seat belt reel and a pre-tensioner. The seat belts (arrowed) were tested and were able to be fastened into the respective pre-tensions that were fitted on the side of each individual seat.

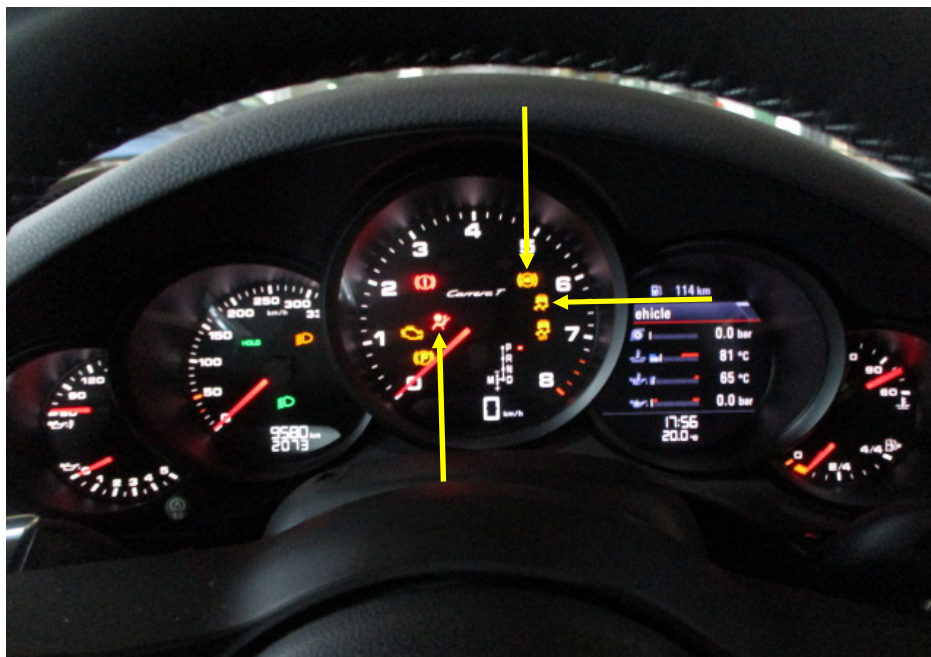
Photo 16 shows the warning lights for the various electronic safety features appearing on the instrument panel of the Motor Car during its self-test when the engine is cranked, in particular the ABS, SRS and TCS lights (arrowed).

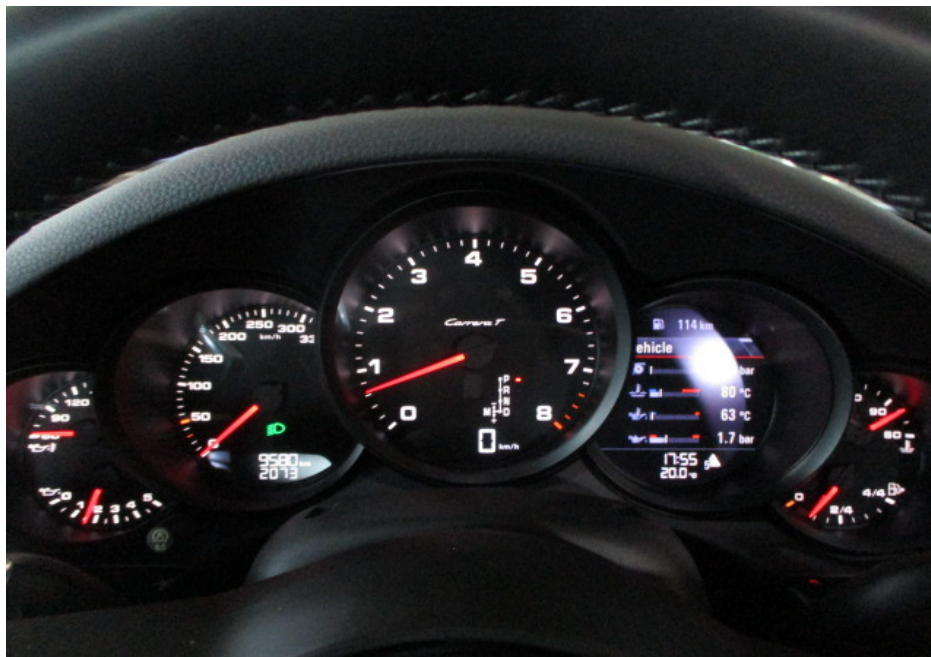
Photo 17 shows the respective warning lights no longer illuminated, indicating that there is no fault detected to the ABS, SRS and TCS systems of the Motor Car during the self-test. These electronic systems were hence in working condition at the time of my inspection.

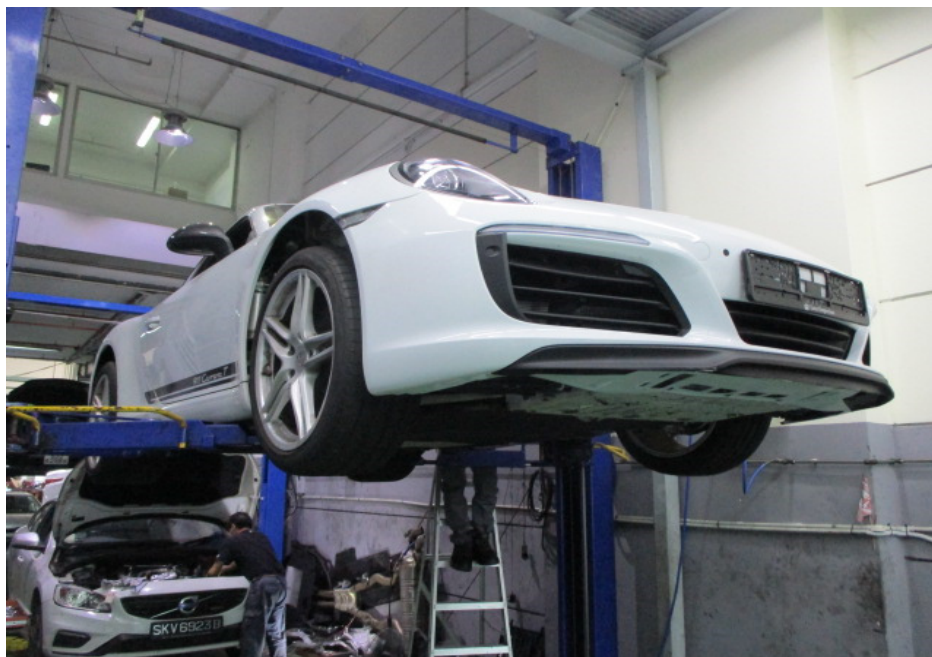
Photo 18 shows the Motor Car hoisted up for checks on its undercarriage. There was no sign(s) or indication(s) of fluid leakage and/or fluid stain(s) on the underside of the Motor Car. The undercarriage components of the Motor Car were also all observed to be intact and secured in an appropriate manner.

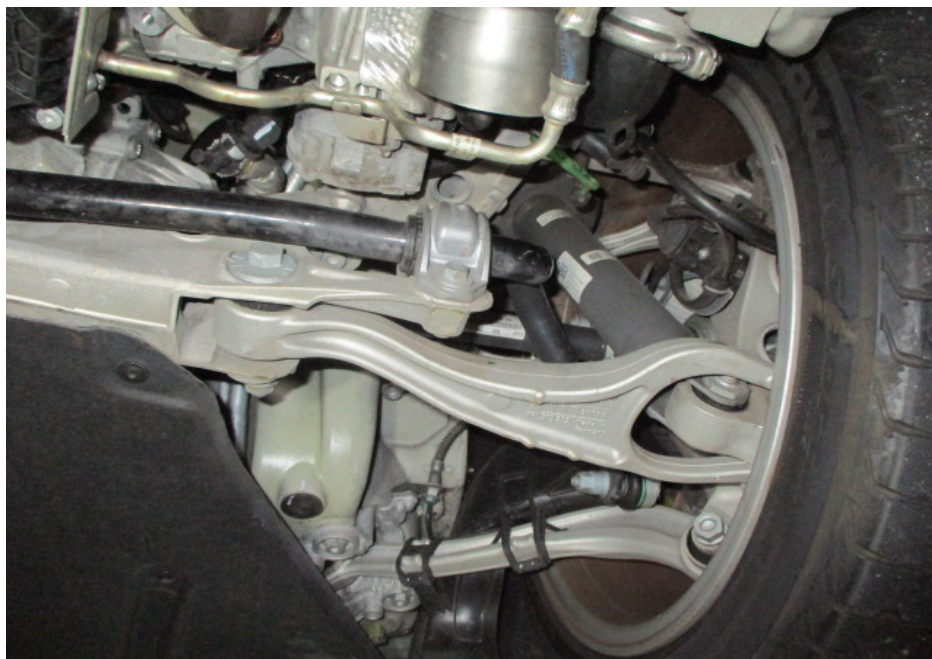
Photo 19 shows a general view of the control arms and linkages at the rear right wheel of the Motor Car. I did not observe any fluid leak and/or fluid stain on the underside of the Motor Car. All of the Motor Car's undercarriage components were observed to be intact and secured in an appropriate manner.

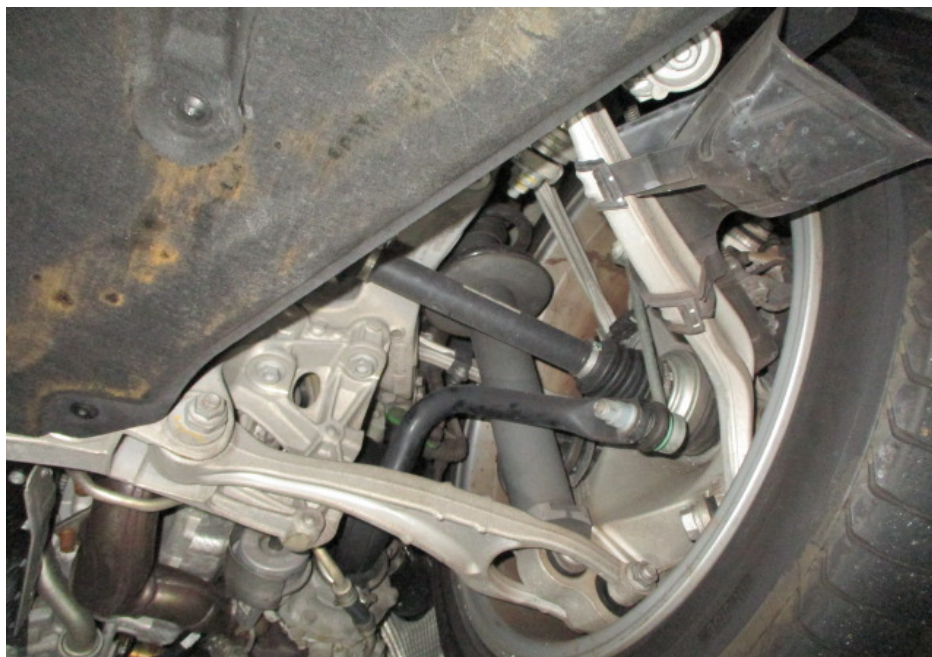
Photo 20 shows a general view of the control arms and linkages at the rear left wheel of the Motor Car. I did not observe any fluid leak and/or fluid stain on the underside of the Motor Car. All of the Motor Car's undercarriage components were observed to be intact and secured in an appropriate manner.

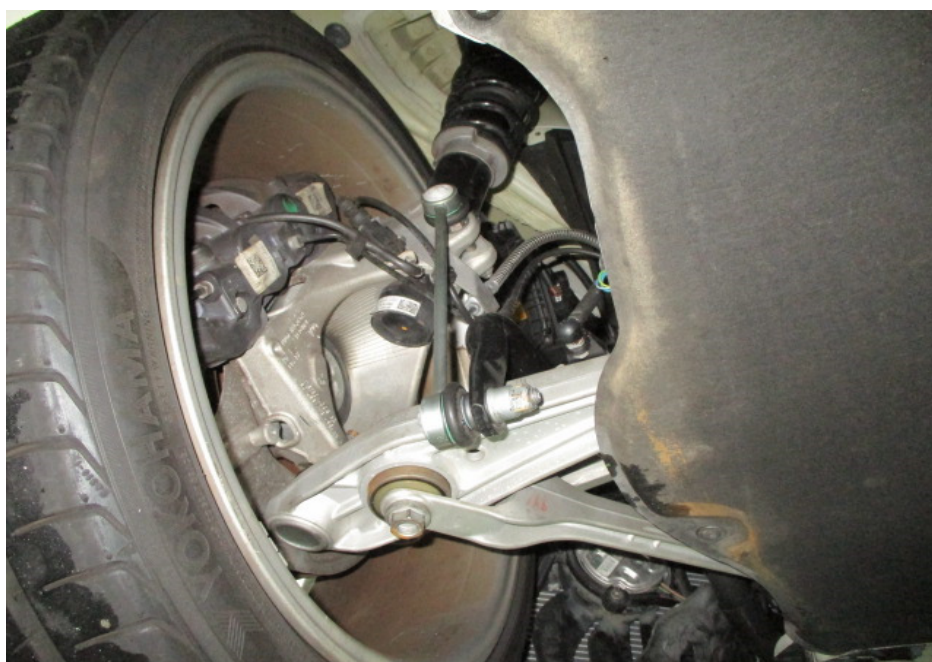
Photo 21 shows the various undercarriage components at the front left wheel of the Motor Car. The mechanical components, control arms and linkages were all found to be intact and secured in an appropriate manner.

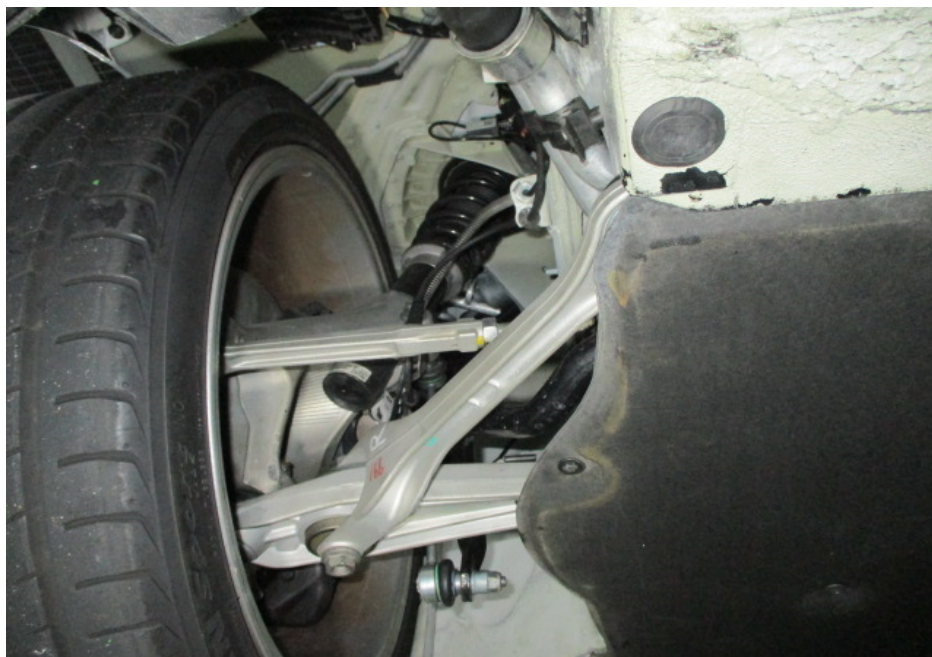
Photo 22 shows the various undercarriage components at the front right wheel of the Motor Car. The mechanical components, control arms and linkages were all found to be intact and secured in an appropriate manner. I also did not observe any fluid leak and/or fluid stain on the underside of the Motor Car.

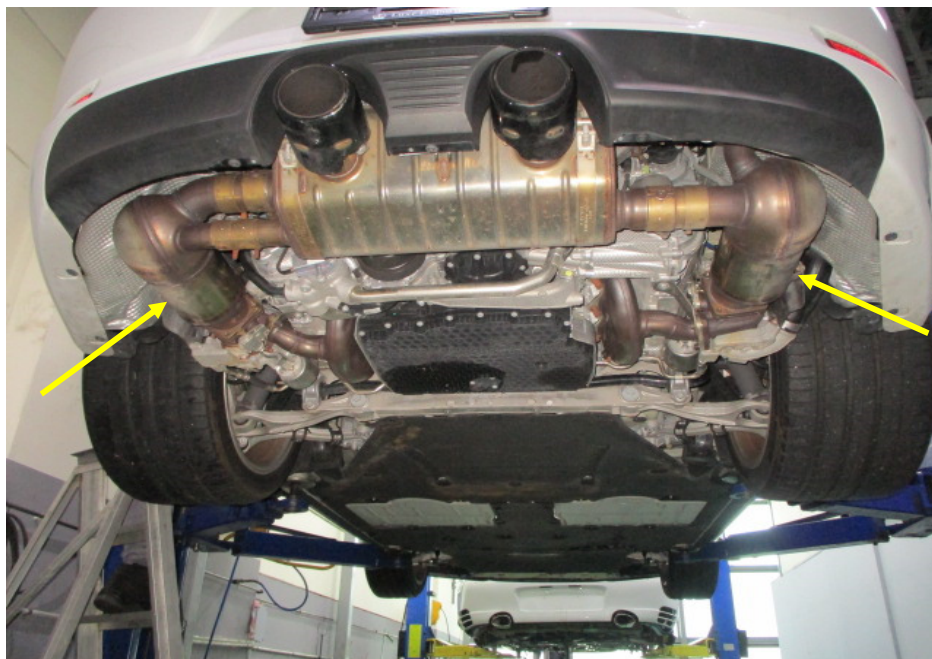
Photo 23 shows the Motor Car's exhaust system. My examination of the Motor Car's exhaust system revealed no sign(s) or indication(s) of any cut or weld marks along its exhaust pipes, on its exhaust manifolds, on its catalytic converters (arrowed) and on its rear muffler.

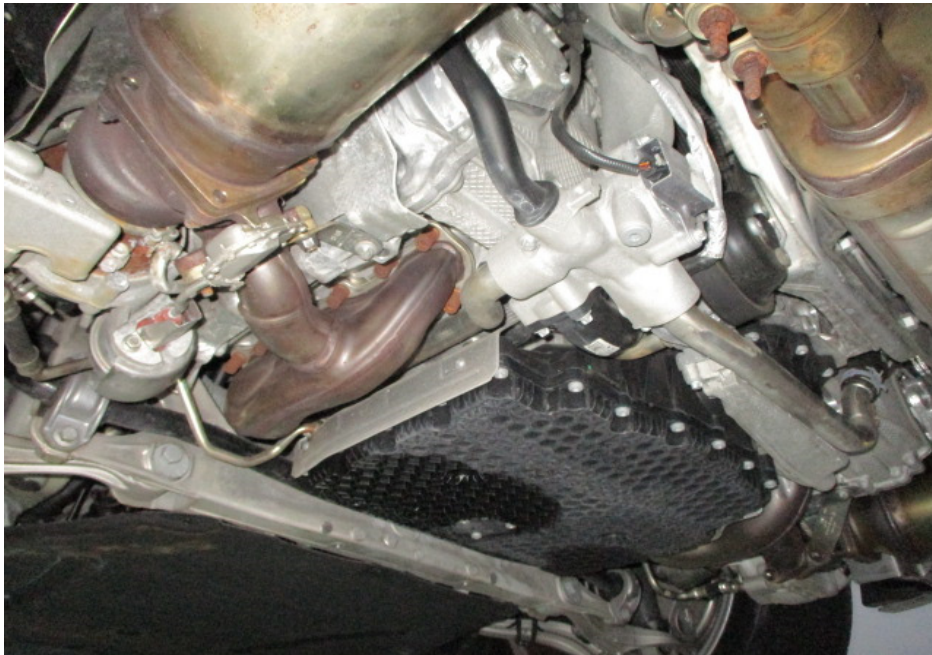
Photo 24 shows a general view of the Motor Car's engine compartment. The engine compartment was at the rear underside of the Motor Car. The various parts and components inside the engine compartment were all observed to be intact and properly fitted. There was also no sign(s) or indication(s) of fluid leak and/or fluid stain found inside the engine compartment.

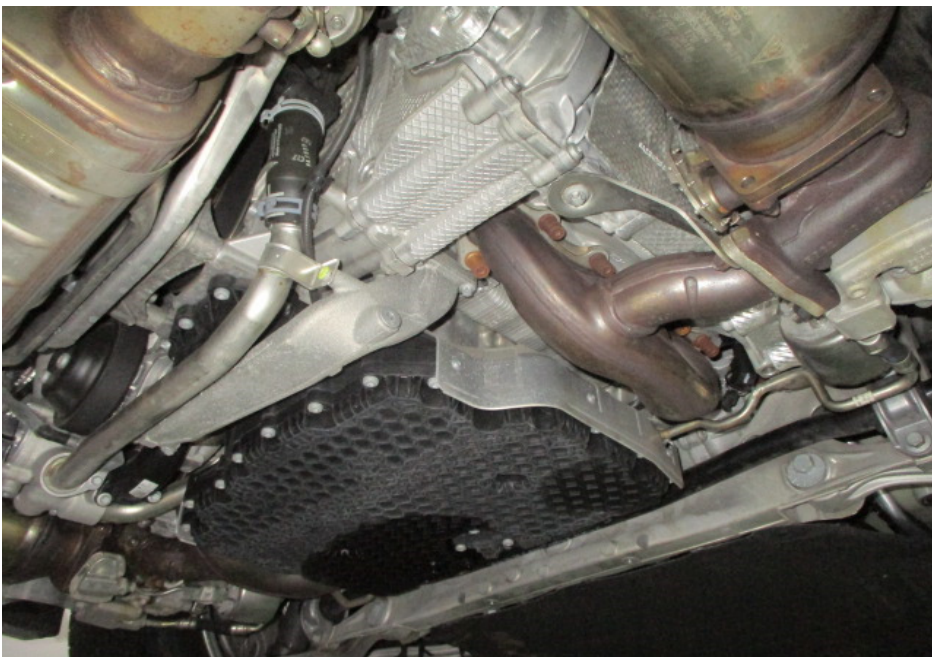
Photo 25 shows another view of the Motor Car's engine compartment. The engine compartment was at the rear underside of the Motor Car. The various parts and components inside the engine compartment were all observed to be intact and properly fitted. There was also no sign(s) or indication(s) of fluid leak and/or fluid stain found inside the engine compartment.

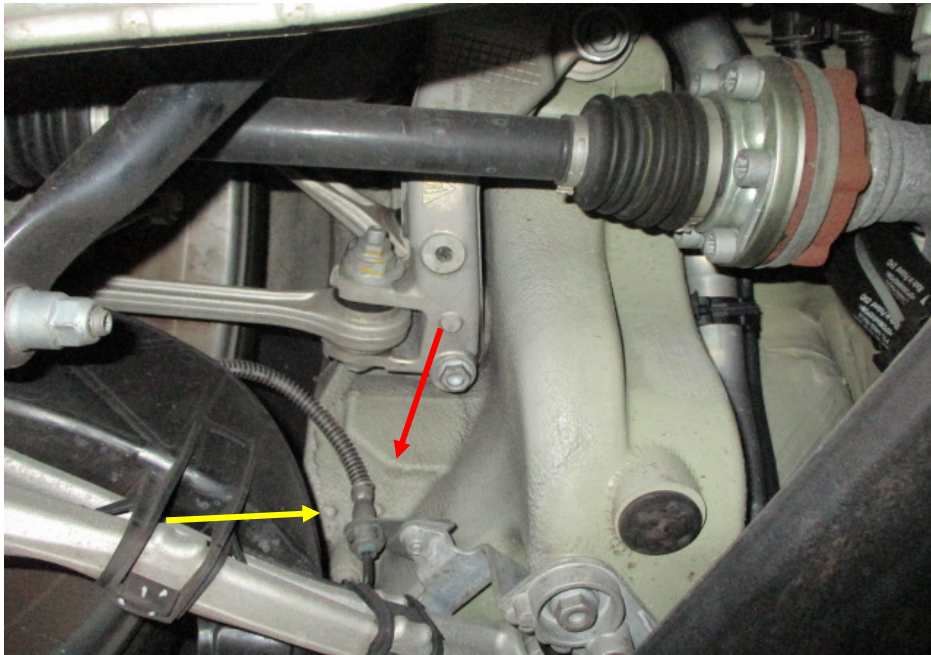
Photo 26 shows the chassis/structural body at the underside rear left of the Motor Car. I did not find any weld marks other than original spot weld marks (yellow arrow) on the chassis/structural body of the Motor Car. The original factory sealant (red arrow) at the joints along the chassis/structural body was untouched, indicating no work was done on the chassis/structural body of the Motor Car and that the chassis/structural body was originally fitted.

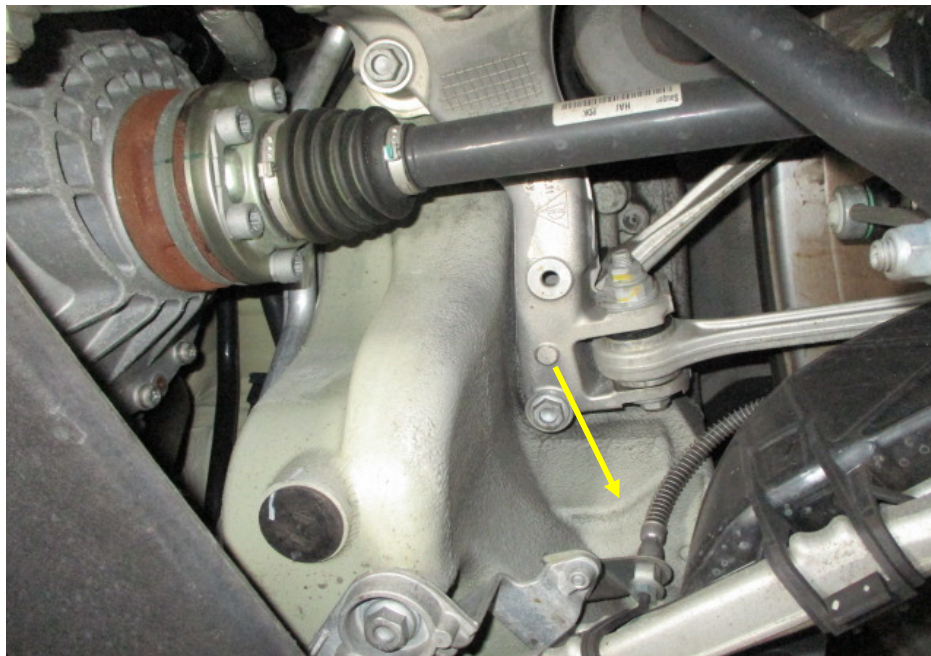
Photo 27 shows the chassis/structural body at the underside rear right of the Motor Car. The original factory sealant (arrowed) at the joints along the chassis/structural body was observed to be untouched. In general, I had found no work was carried out on the chassis/structural body of the Motor Car. The chassis/structural body of the Motor Car was originally fitted.

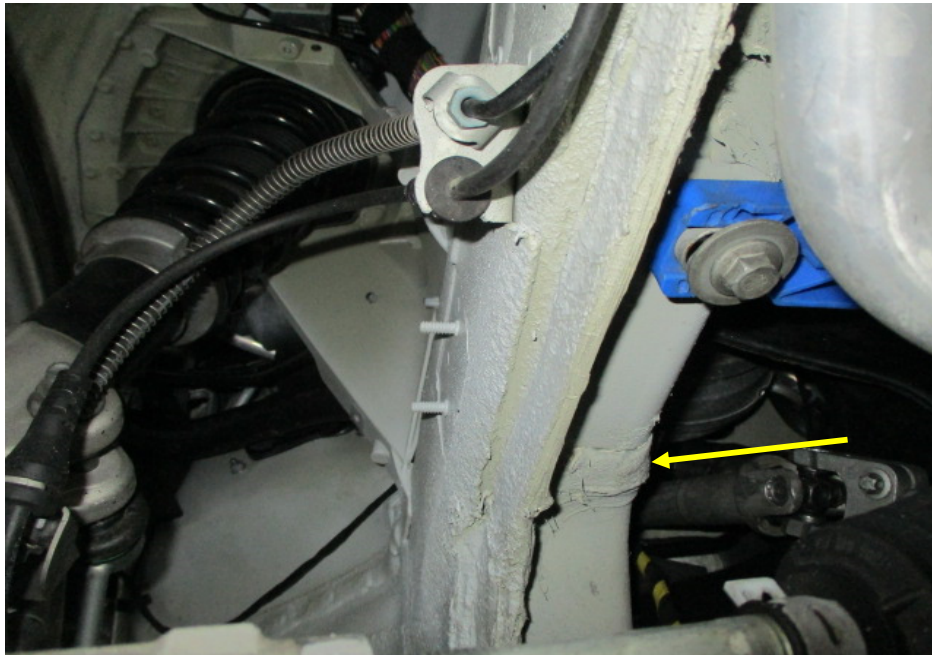
Photo 28 shows the chassis/structural body at the underside front right of the Motor Car. The original factory sealant (arrowed) at the joints along the chassis/structural body was observed to be untouched. In general, I had found no work was carried out on the chassis/structural body of the Motor Car. The chassis/structural body of the Motor Car was originally fitted.

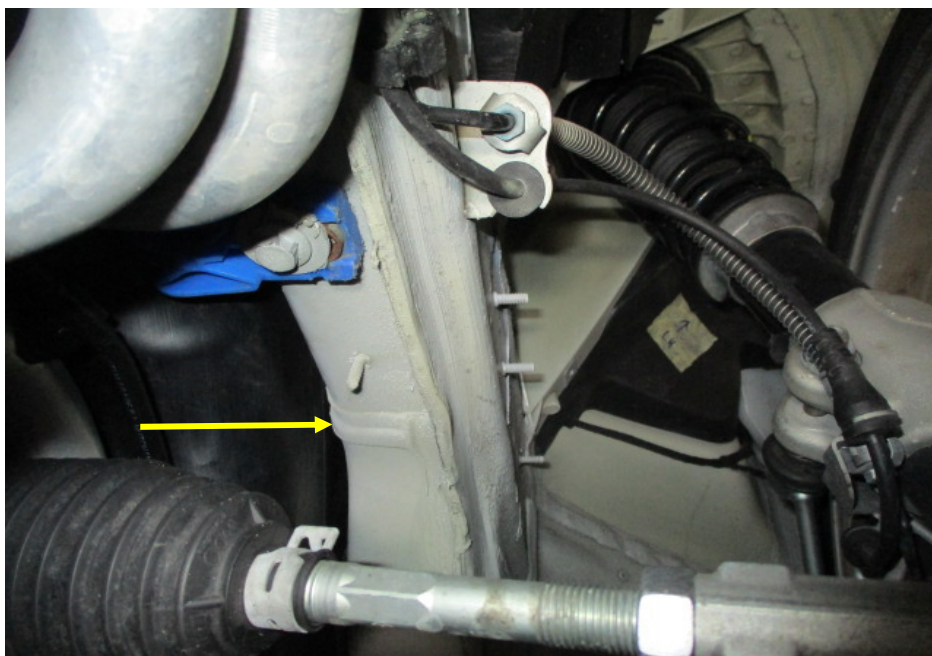
Photo 29 shows the chassis/structural body at the underside front left of the Motor Car. The original factory sealant (arrowed) at the joints along the chassis/structural body was observed to be untouched. In general, I had found no work was carried out on the chassis/structural body of the Motor Car. The chassis/structural body of the Motor Car was originally fitted.

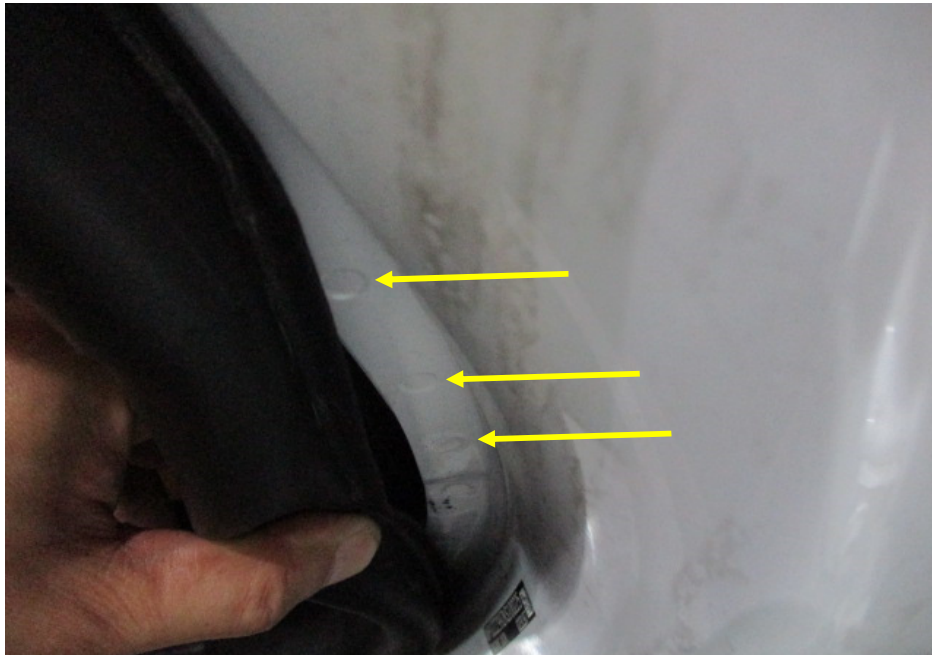
Photo 30 shows the front right "A" pillar of the Motor Car. I did not find any weld marks other than original spot weld marks (arrowed) on front right "A" pillar of the Motor Car, which indicates that there was no re-welding works carried out. In general, I had found all the non-detachable body panels of the Motor Car to be originally fitted at the time of my inspection.

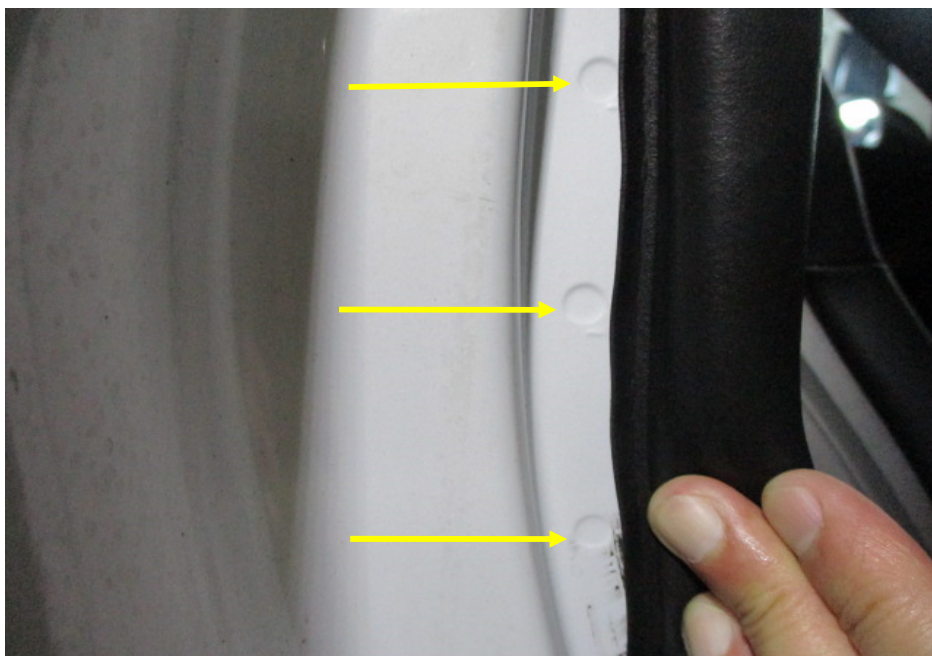
Photo 31 shows the rear right body panel of the Motor Car. I did not find any weld marks other than original spot weld marks (arrowed) on the rear right body panel of the Motor Car, which indicates that there was no re-welding works carried out. In general, I had found all the non-detachable body panels of the Motor Car to be originally fitted at the time of my inspection.
