Your Ref: Porsche 911 Carrera T
(chassis number WP0ZZZ99ZKS100225)

18 September 2021

Our Ref : CI/TP21009650/D

**INSPECTION REPORT OF AN UNREGISTERD PORSCHE 911 CARRERA T
MOTOR CAR WITH CHASSIS NUMBER WP0ZZZ99ZKS100225**

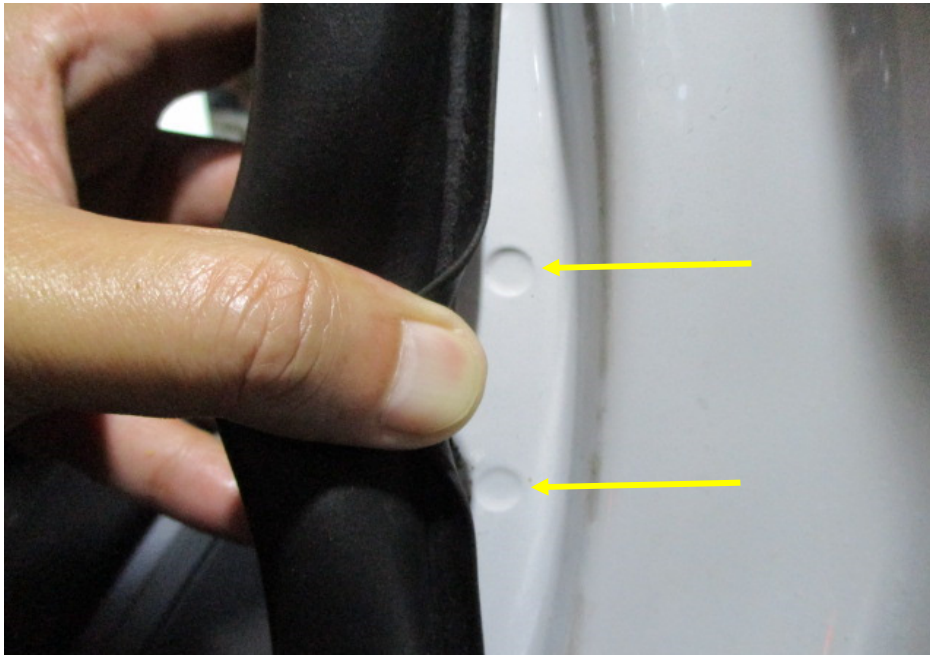
Photo 32 shows the rear left body panel of the Motor Car. I did not find any weld marks other than original spot weld marks (arrowed) on the rear left body panel of the Motor Car, which indicates that there was no re-welding works carried out. In general, I had found all the non-detachable body panels of the Motor Car to be originally fitted at the time of my inspection.
