Your Ref: BMW 840i  
(chassis number WBAGV22030BP82840)  
Our Ref : CI/TP21009651/D

18 September 2021

**INSPECTION REPORT OF AN UNREGISTERD BMW 840i MOTOR CAR WITH CHASSIS NUMBER WBAGV22030BP82840**

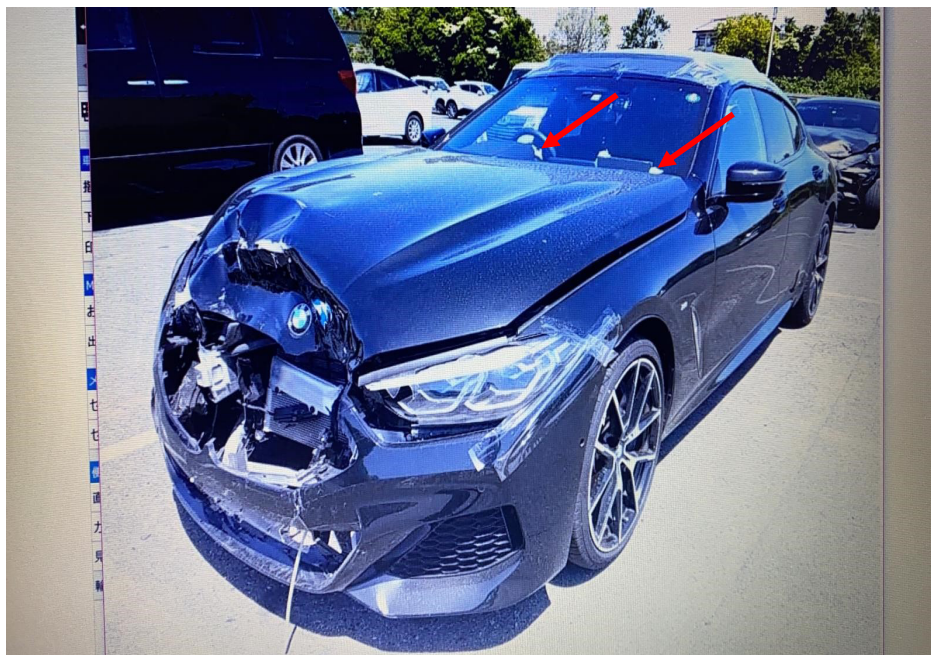
**Photo 1** shows the front left body of the Motor Car prior to any repairs being carried out (photograph provided to me). The Motor Car was observed to have sustained damage at its frontal portion. Body parts damaged include the front bumper, front bumper reinforcement, front left headlamp, radiator grilles, front bonnet and aircon condenser amongst others. The driver's airbag and front left passenger airbag were deployed (arrowed).

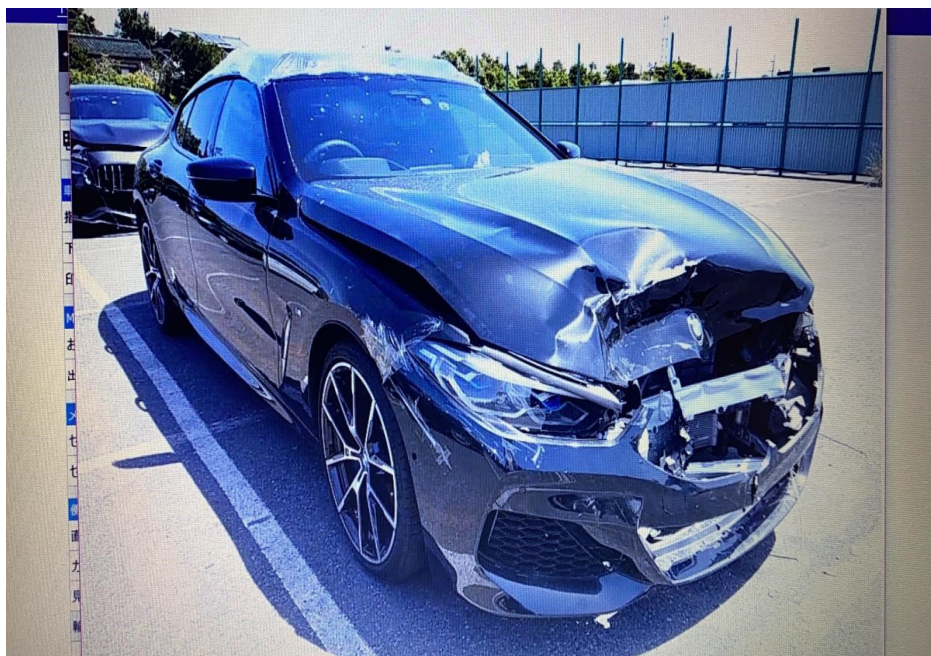
**Photo 2** shows the front right body of the Motor Car prior to any repairs being carried out (photograph provided to me). The Motor Car was observed to have sustained damage at its frontal portion. Body parts damaged include the front bumper, front bumper centre lower grille, front right headlamp, front right fender, front radar unit, front bonnet and front bonnet locks amongst others.

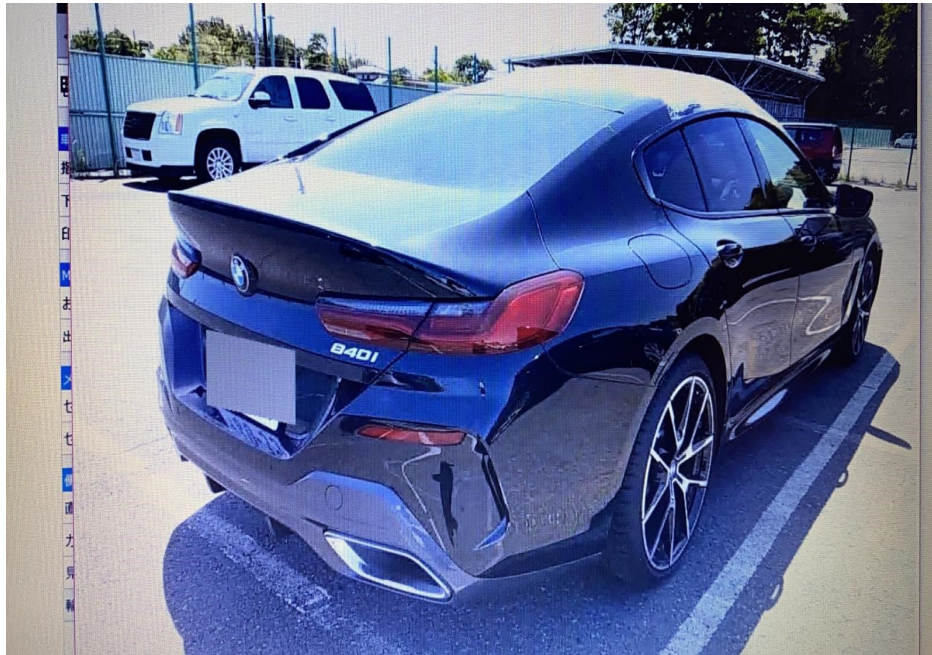
**Photo 3** shows the rear right body of the Motor Car prior to any repairs being carried out (photograph provided to me). Apart for the frontal portion, there was no physical damage observed to other areas of the Motor Car.

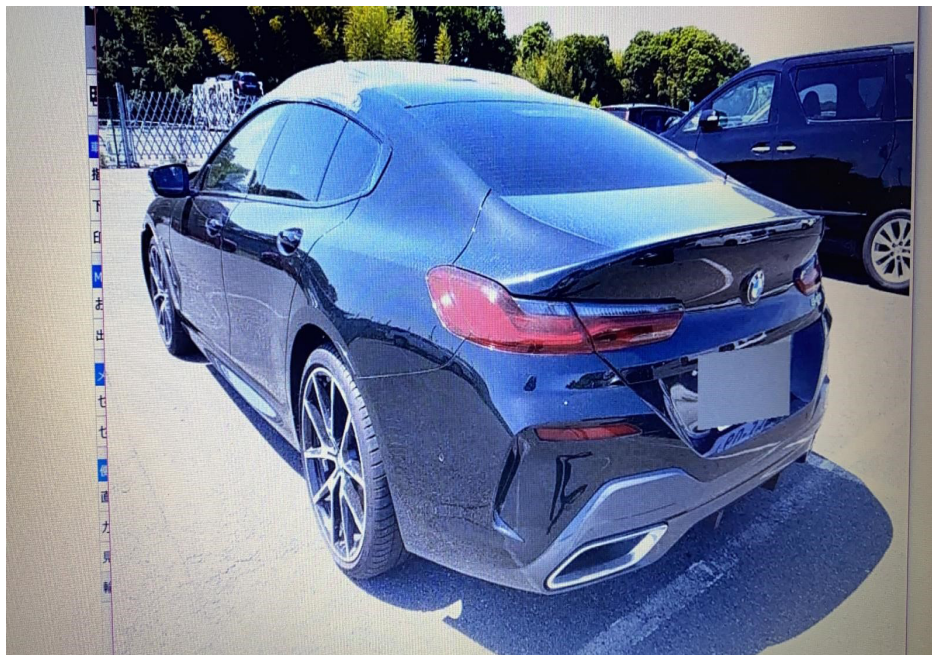
**Photo 4** shows the rear left body of the Motor Car prior to any repairs being carried out (photograph provided to me). Apart for the frontal portion, there was no physical damage observed to other areas of the Motor Car.

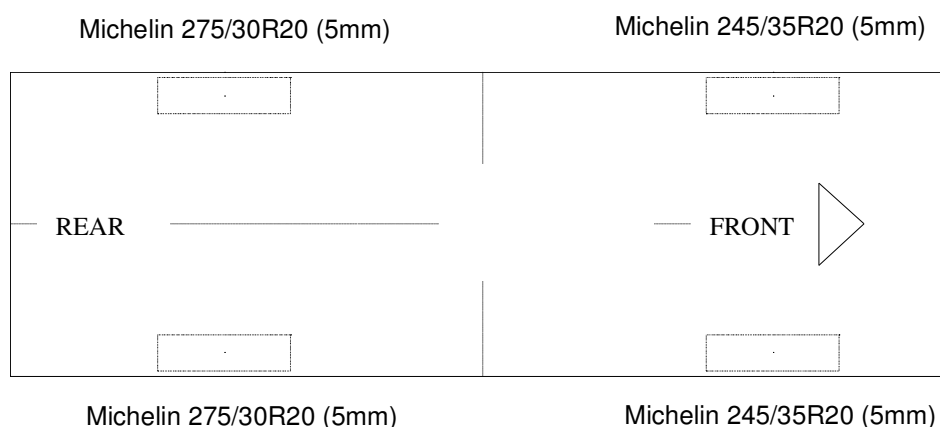
8. It was fitted with 20inch sport wheel rims that were wrapped with tyres that were observed to be of serviceable condition. The tyres were also sufficiently inflated for vehicular operation. The tyre brand, tyre size and approximate remaining tread depth of the 4 tyres of the Motor Car were recorded as follows: -

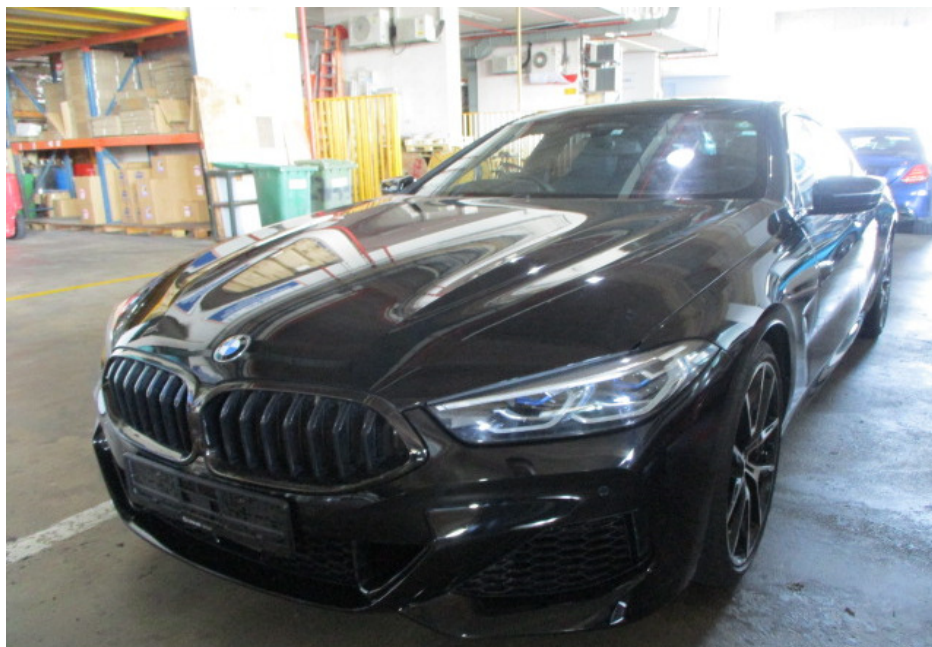
**Photo 5** shows a general view of the front left body of the Motor Car at the time of my inspection. The Motor Car was observed to be in a relatively good general condition with no loose exterior fittings observed. The body parts at the frontal portion of the Motor Car were visually examined and it was observed that the repair/restoration works carried out to the damaged area of the Motor Car (refer to photograph 1 & 2) were reasonably adequate and in order.

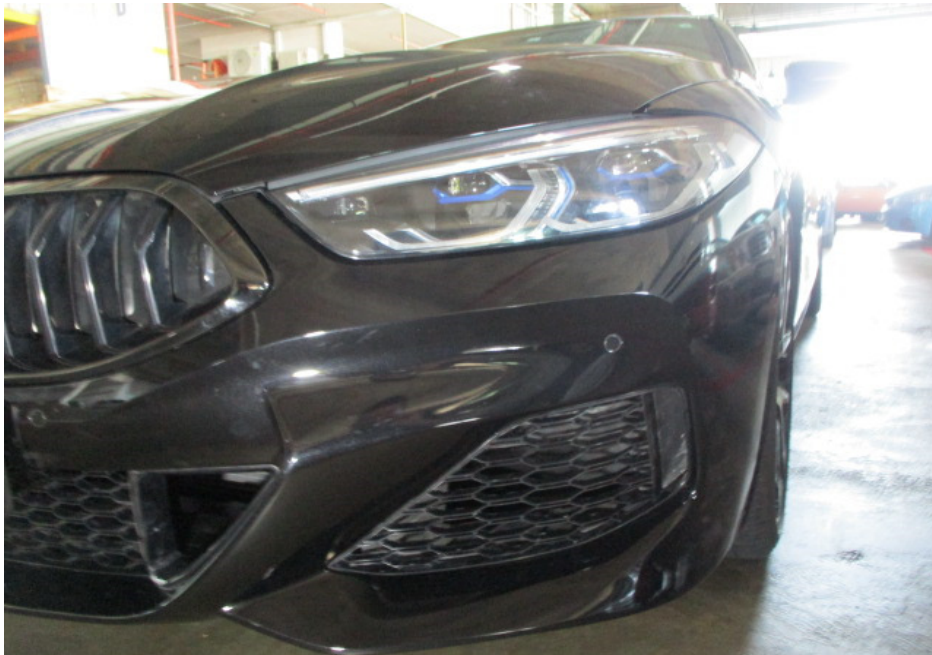
**Photo 6** shows a closer view of the Motor Car's front bumper, front bumper left lower grille, front sensors and front left headlamp. The body parts at the frontal portion of the Motor Car were visually examined and it was observed that the repair/restoration works carried out to the damaged area of the Motor Car (refer to photograph 1 & 2) were reasonably adequate and in order.

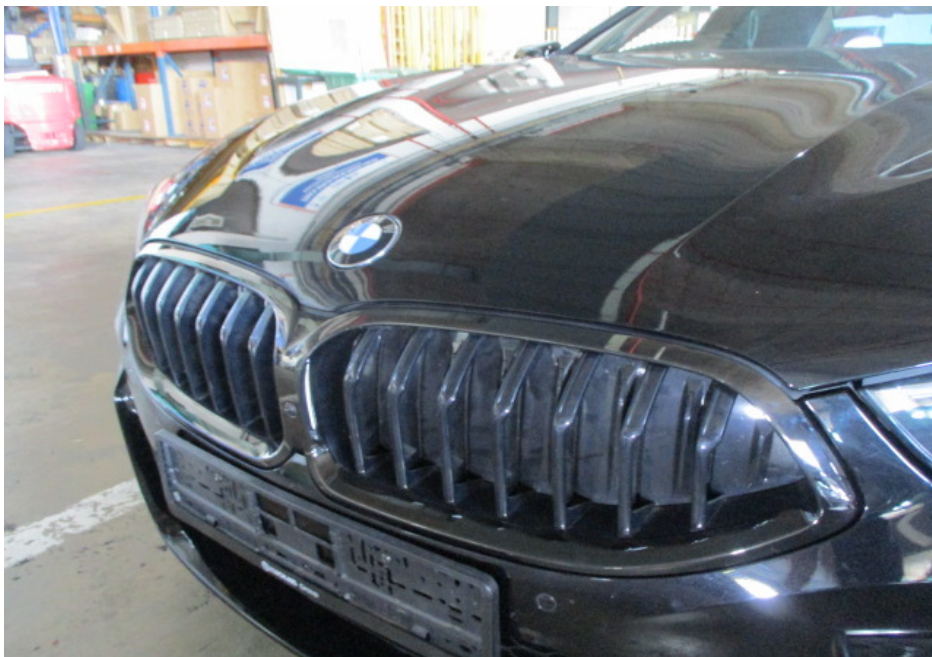
**Photo 7** shows a closer view of the Motor Car's radiator grilles, front bonnet, front emblem and front sensors. The body parts at the frontal portion of the Motor Car were visually examined and it was observed that the repair/restoration works carried out to the damaged area of the Motor Car (refer to photograph 1 & 2) were reasonably adequate and in order.

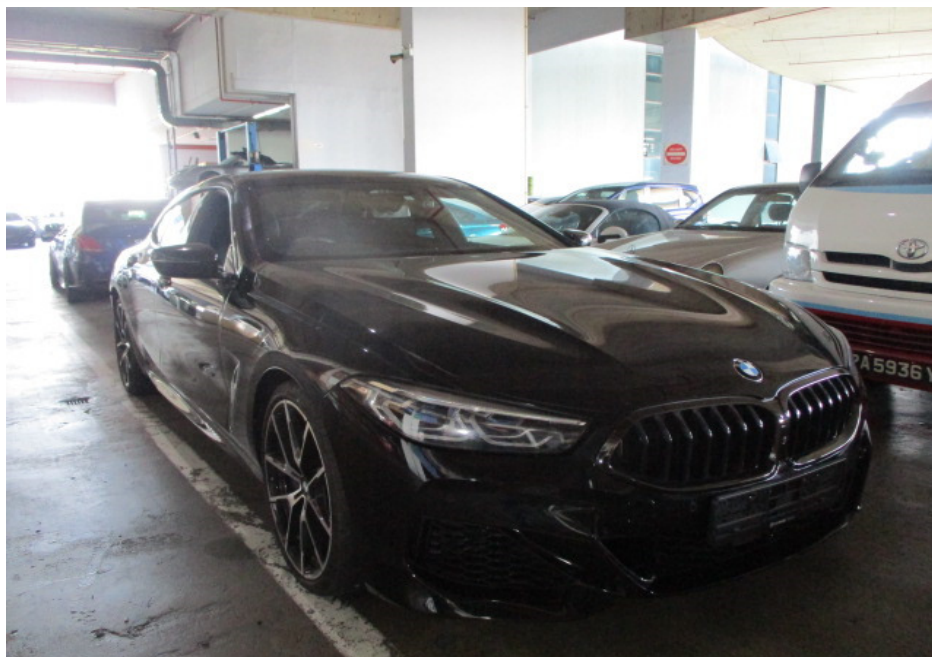
**Photo 8** shows a general view of the front right body of the Motor Car at the time of my inspection. The Motor Car was observed to be in a relatively good general condition with no loose exterior fittings observed. The body parts at the frontal portion of the Motor Car were visually examined and it was observed that the repair/restoration works carried out to the damaged area of the Motor Car (refer to photograph 1 & 2) were reasonably adequate and in order.

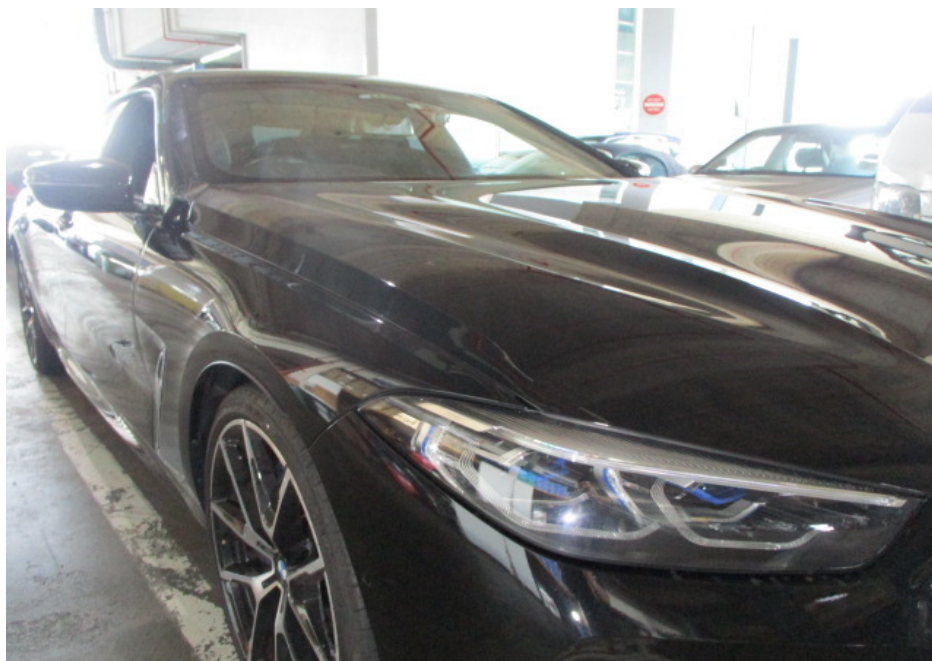
**Photo 9** shows a closer view of the Motor Car's front bonnet, front right headlamp and front right fender. The body parts at the frontal portion of the Motor Car were visually examined and it was observed that the repair/restoration works carried out to the damaged area of the Motor Car (refer to photograph 1 & 2) were reasonably adequate and in order.

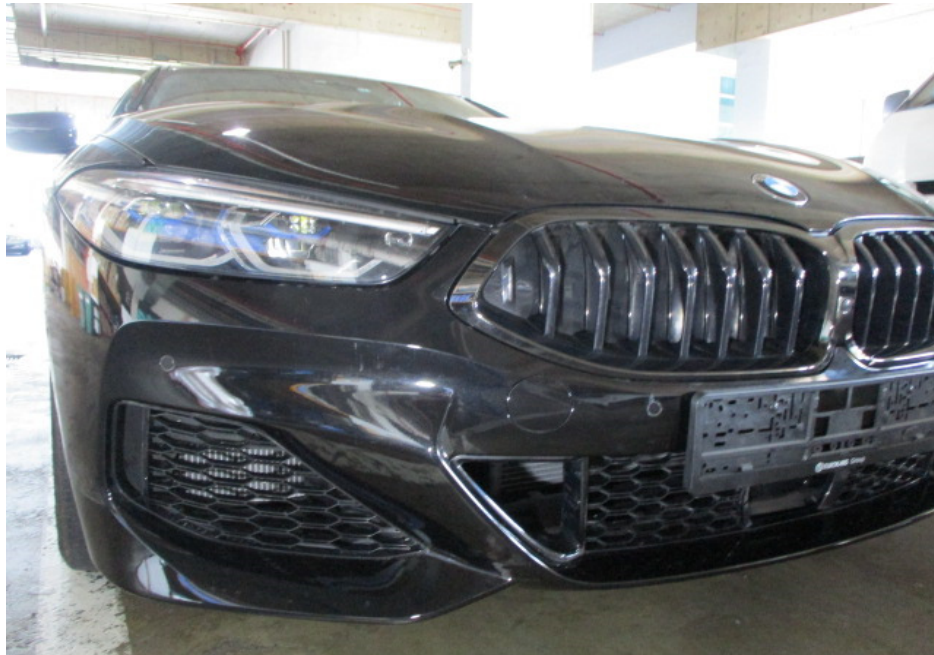
**Photo 10** shows a closer view of the Motor Car's front bumper, front bumper right lower grille, front bumper centre lower grille and front right headlamp. The body parts at the frontal portion of the Motor Car were visually examined and it was observed that the repair/restoration works carried out to the damaged area of the Motor Car (refer to photograph 1 & 2) were reasonably adequate and in order.

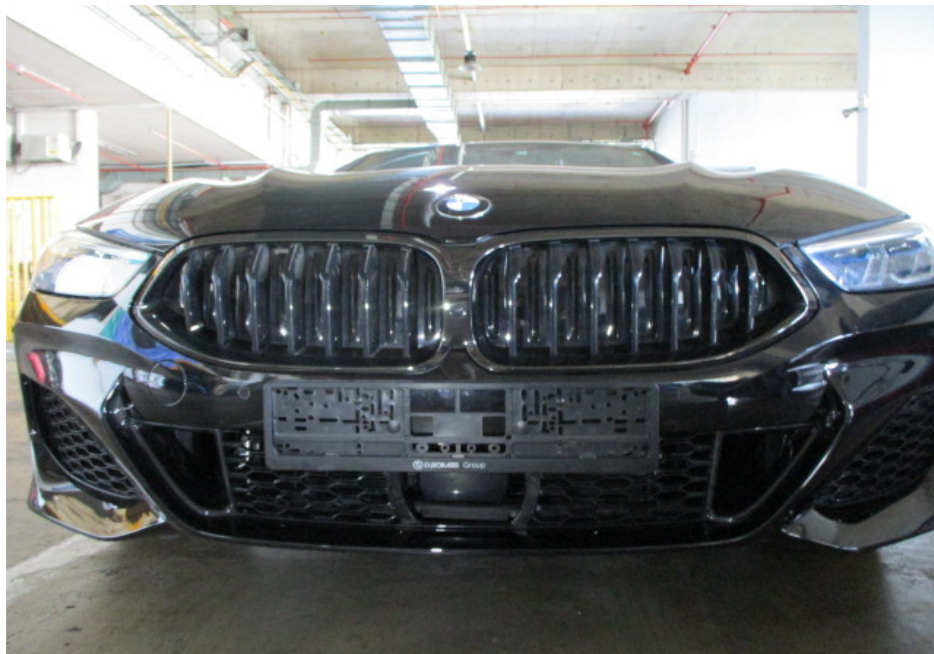
**Photo 11** shows a closer view of the Motor Car's front bumper, front bumper front bumper centre lower grille and front radar unit. The body parts at the frontal portion of the Motor Car were visually examined and it was observed that the repair/restoration works carried out to the damaged area of the Motor Car (refer to photograph 1 & 2) were reasonably adequate and in order.

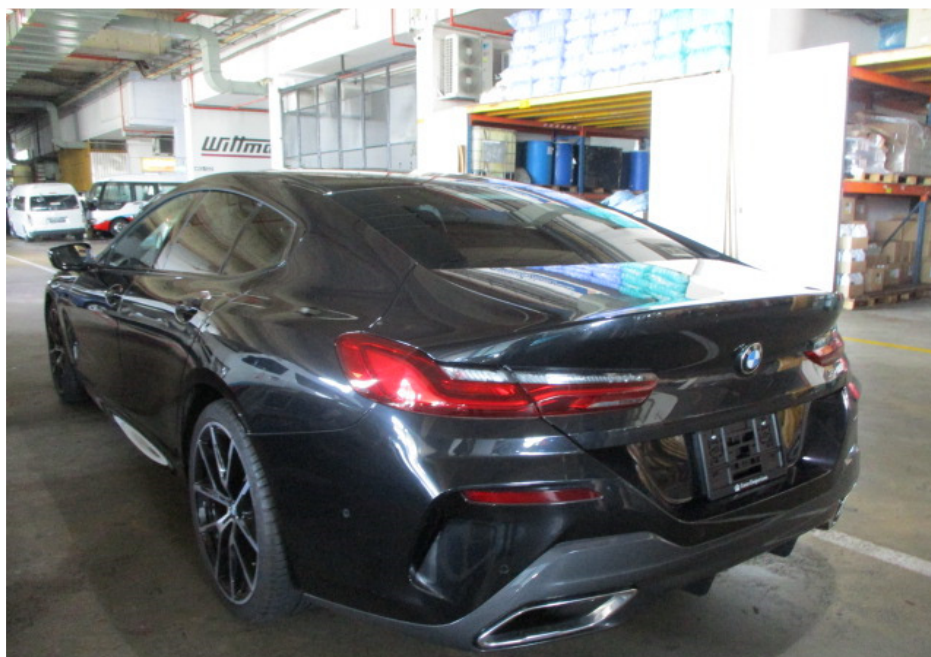
**Photo 12** shows a general view of the rear left body of the Motor Car at the time of my inspection. The Motor Car was observed to be in a relatively good general condition with no loose exterior fittings observed. The mileage of the Motor Car recorded at the time of my inspection was 8,687km.

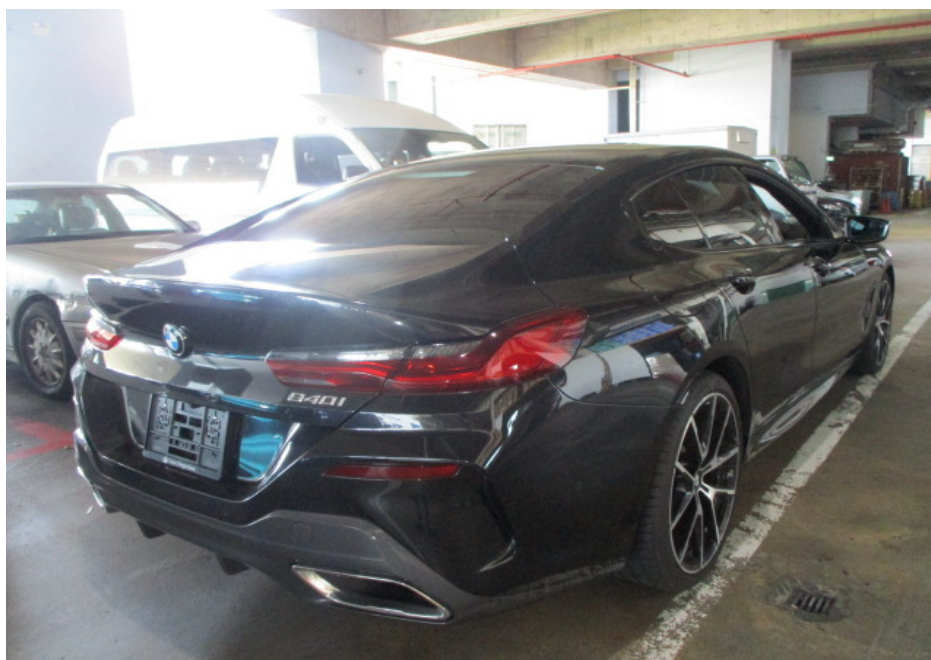
**Photo 13** shows a general view of the rear right body of the Motor Car at the time of my inspection. The Motor Car was observed to be in a relatively good general condition with no loose exterior fittings observed. The mileage of the Motor Car recorded at the time of my inspection was 8,687km.

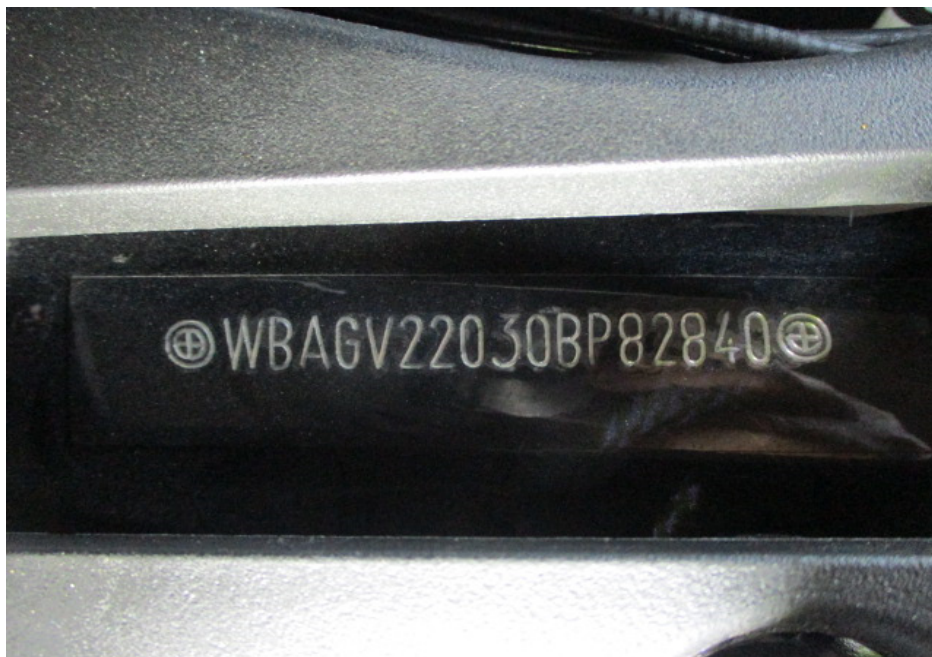
**Photo 14** shows the chassis number of the Motor Car. The chassis number recorded was WBAGV22030BP82840.

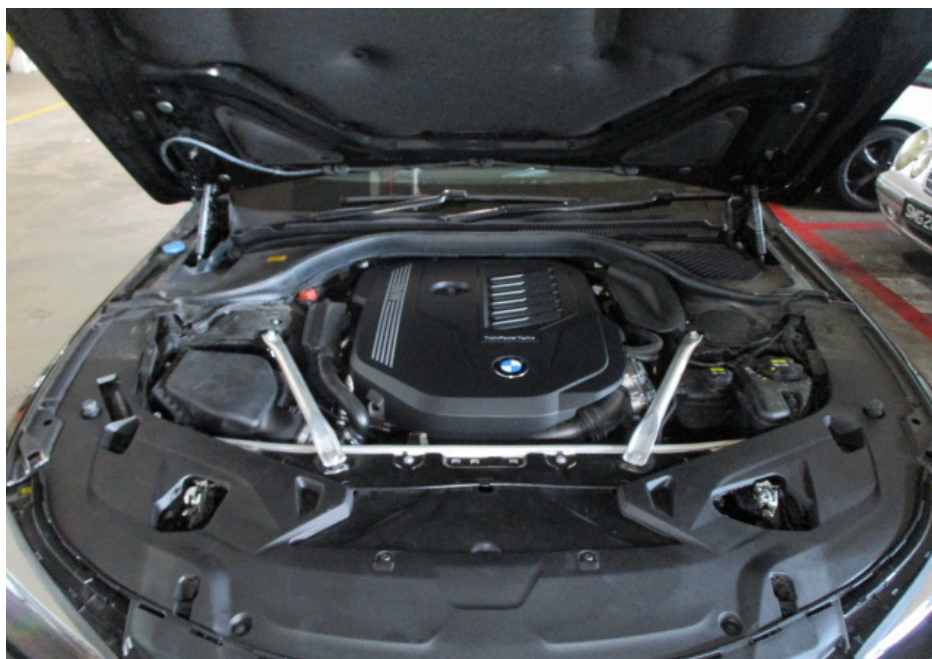
**Photo 15** shows a general view of the engine compartment of the Motor Car at the time of my inspection. The various parts and components inside the engine compartment were all observed to be intact and properly fitted. This includes the aircon condenser, radiator, cooling fan, front support panel, front support panel top garnish and front headlamp panels. There was also no sign(s) or indication(s) of fluid leak and/or fluid stain found inside the engine compartment.

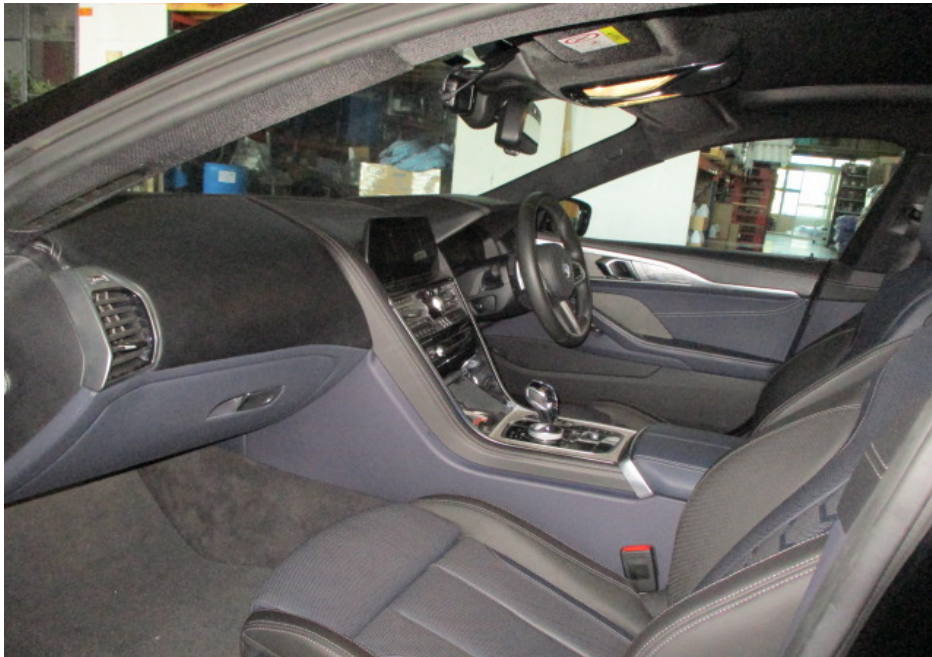
**Photo 16** shows a general view of the interior compartment of the Motor Car at the time of my inspection. The various parts and components, trims, carpet and upholstery inside the interior compartment were all observed to be intact and properly fitted.

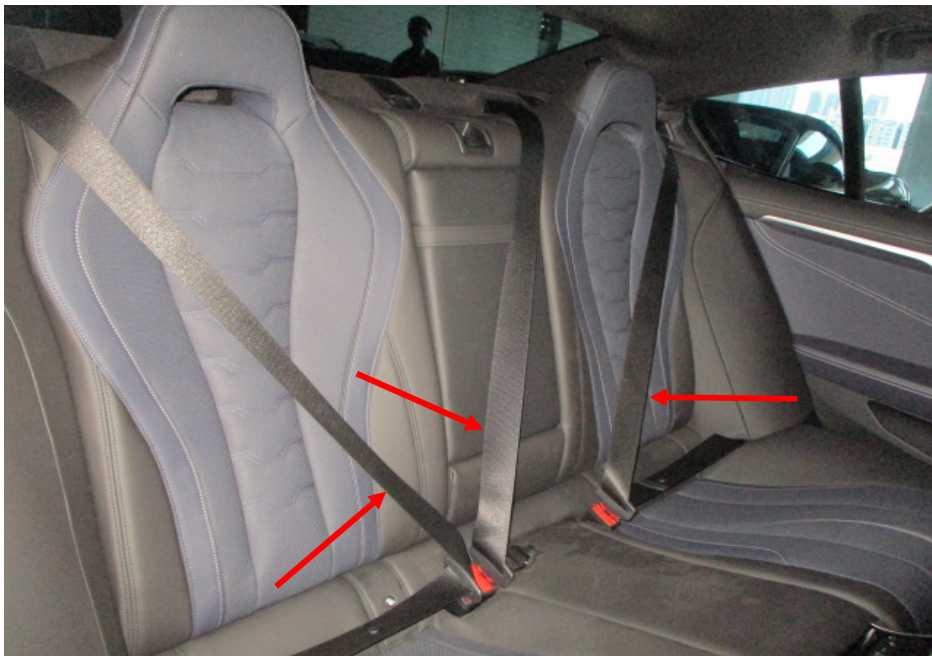
**Photo 17** shows the rear seats of the Motor Car. All the seats of the Motor Car were secured via seat rails to the floorboard. They were also fitted with a retractable seat belt reel and a pre-tensioner. The seat belts (arrowed) of the Motor Car were tested and were able to be fastened into the respective pre-tensions that were fitted on the side of each individual seat.

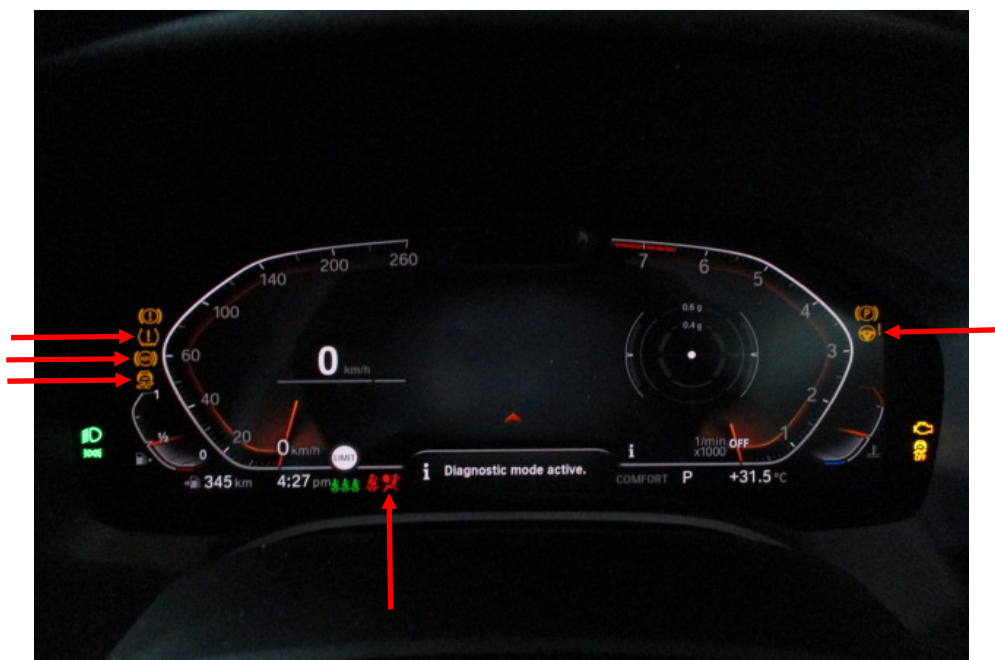
**Photo 18** shows the warning lights for the various electronic safety features appearing on the instrument panel of the Motor Car during its self-test when the engine is cranked, in particular the ABS, SRS, IAS, TPM and DSC lights (arrowed).

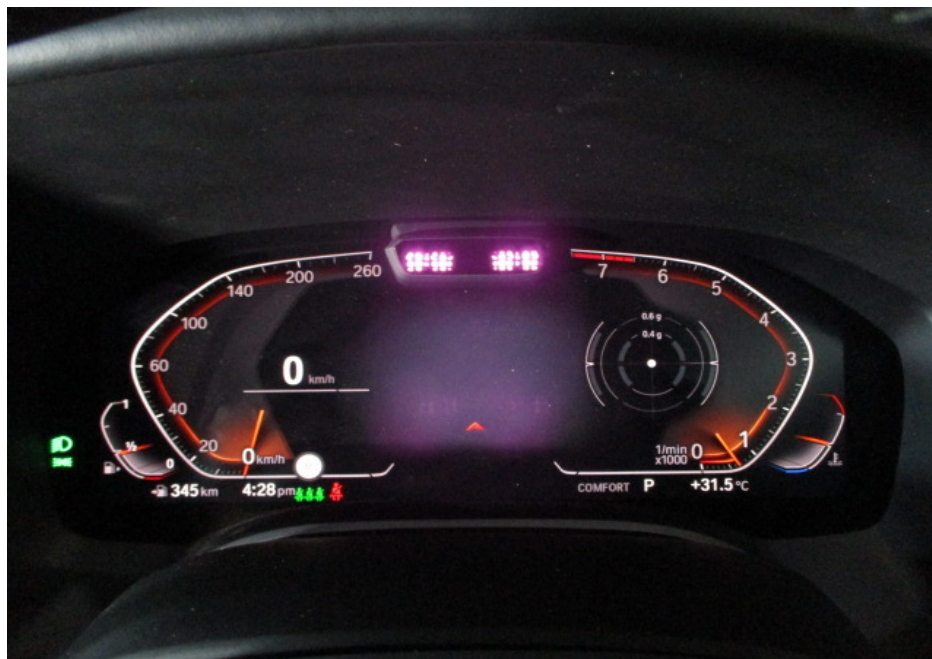
**Photo 19** shows the respective warning lights no longer illuminated, indicating that there is no fault detected to the ABS, SRS, IAS, TPM and DSC systems of the Motor Car during the self-test. These electronic systems were hence in working condition at the time of my inspection.

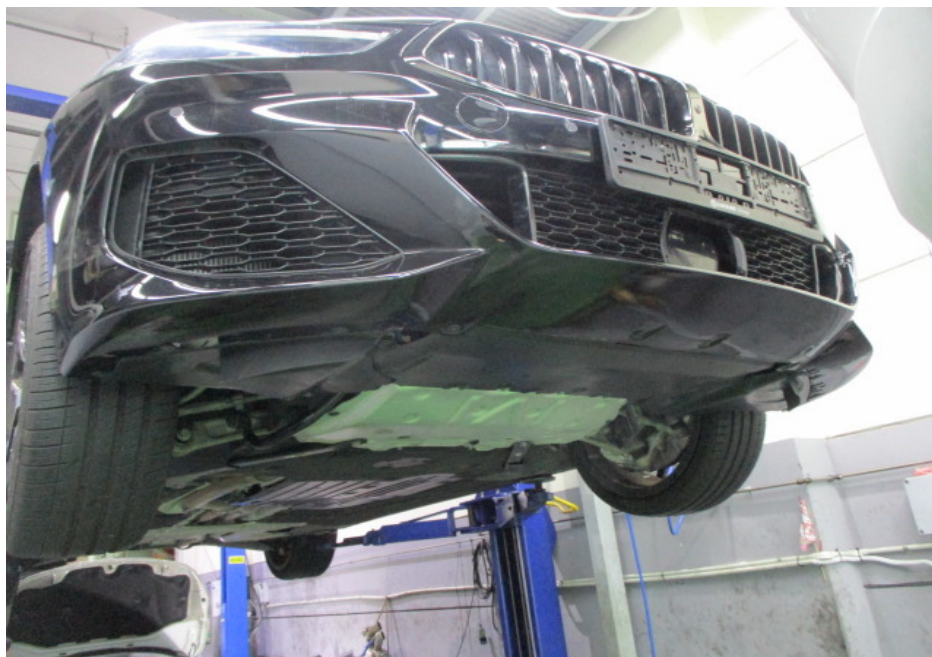
**Photo 20** shows the Motor Car hoisted up for checks on its undercarriage. There was no sign(s) or indication(s) of fluid leakage and/or fluid stain(s) on the underside of the Motor Car. The undercarriage components of the Motor Car were also all observed to be intact and secured in an appropriate manner.

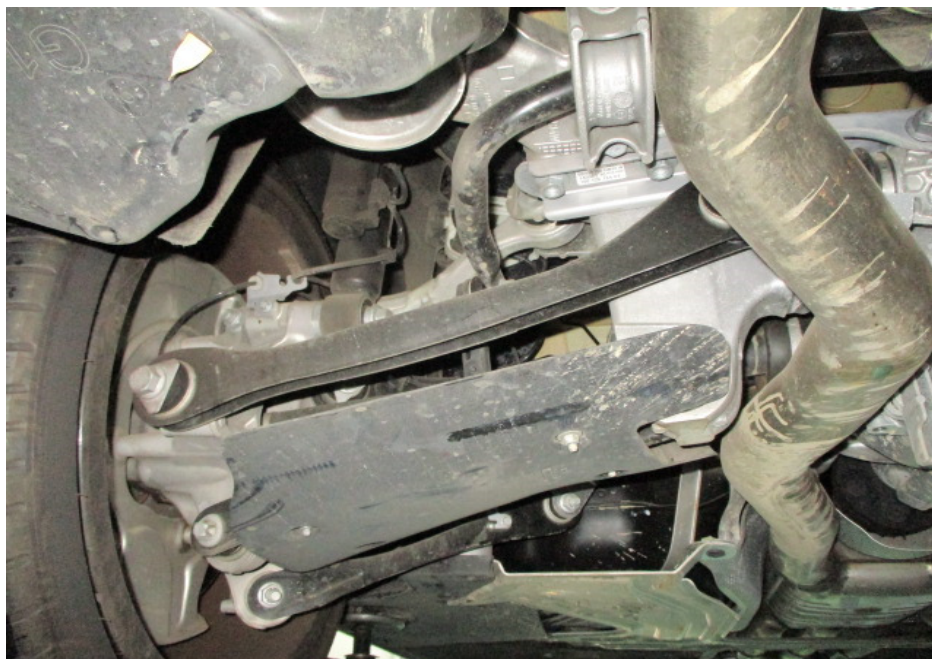
**Photo 21** shows a general view of the control arms and linkages at the rear left wheel of the Motor Car. I did not observe any fluid leak and/or fluid stain on the underside of the Motor Car. All the Motor Car's undercarriage components were observed to be intact and secured in an appropriate manner.

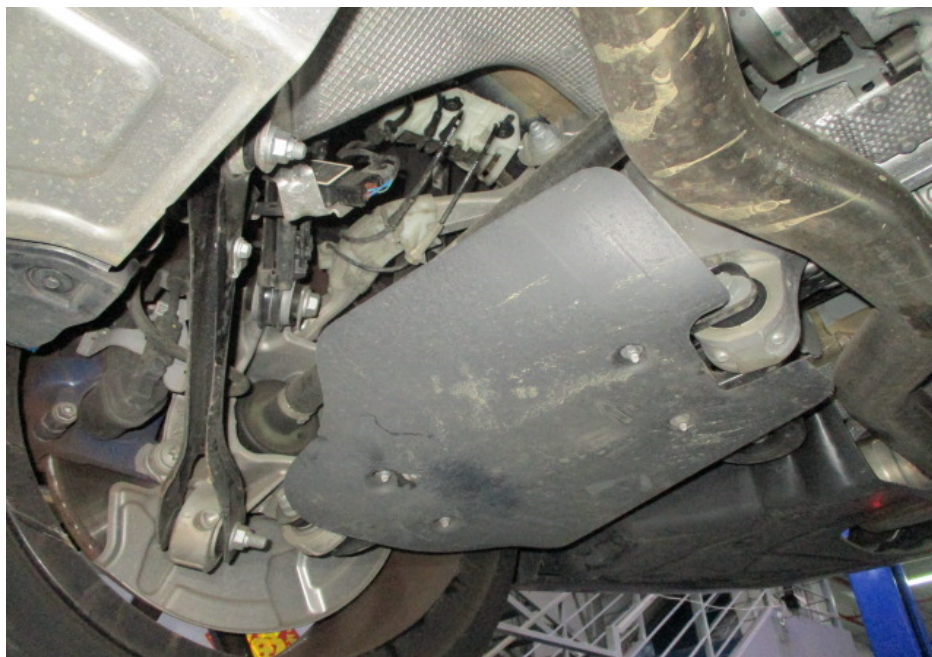
**Photo 22** shows the various undercarriage components at the rear right wheel of the Motor Car. The various mechanical components, control arms and linkages were all found to be intact and secured in an appropriate manner.

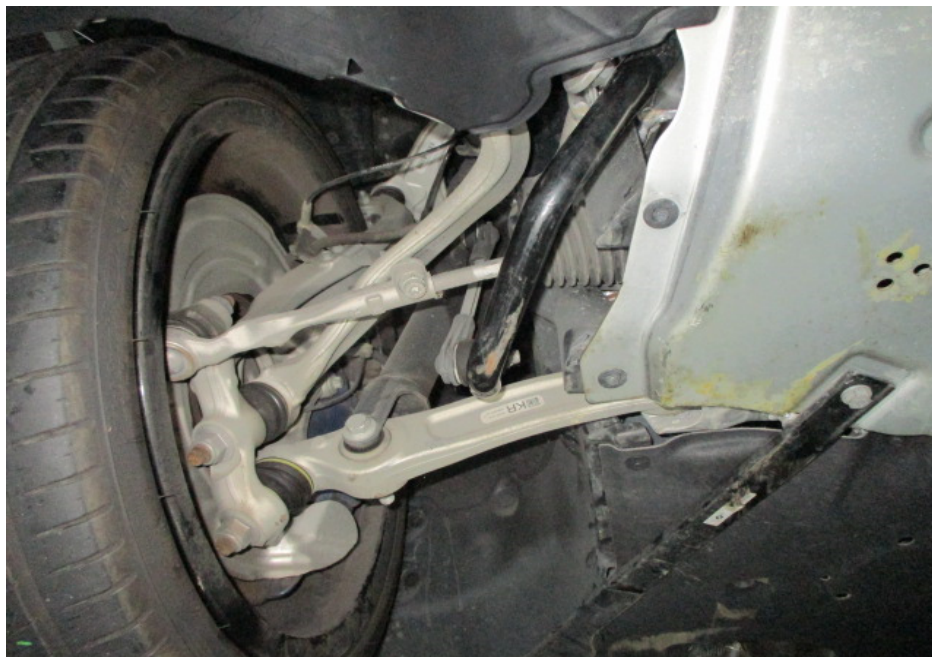
**Photo 23** shows the various undercarriage components at the front right wheel of the Motor Car. The mechanical components, control arms and linkages were all found to be intact and secured in an appropriate manner. I also did not observe any fluid leak and/or fluid stain on the underside of the Motor Car.

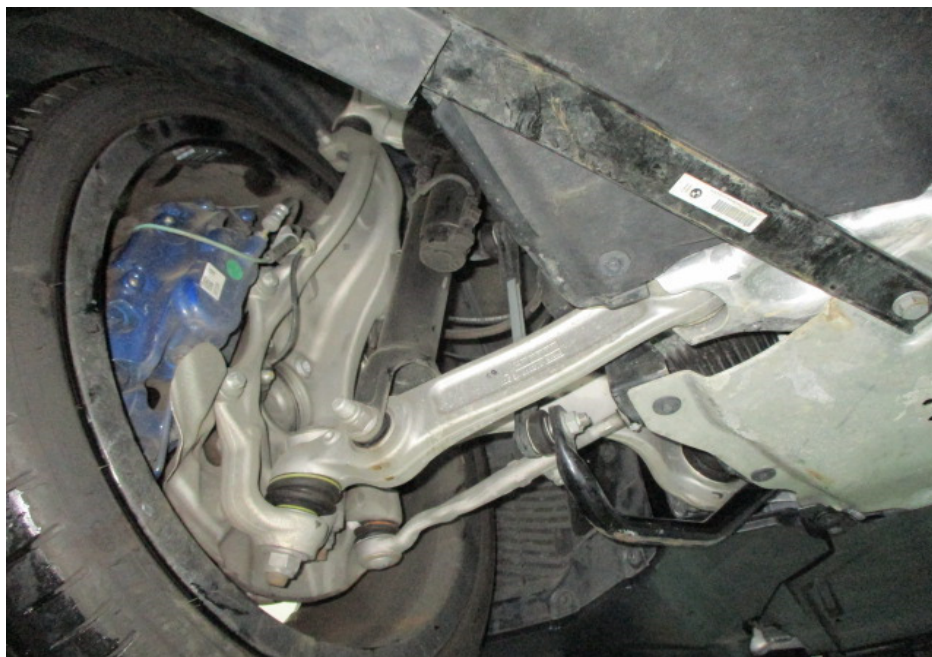
**Photo 24** shows the various undercarriage components at the front left wheel of the Motor Car. The mechanical components, control arms and linkages were all found to be intact and secured in an appropriate manner.

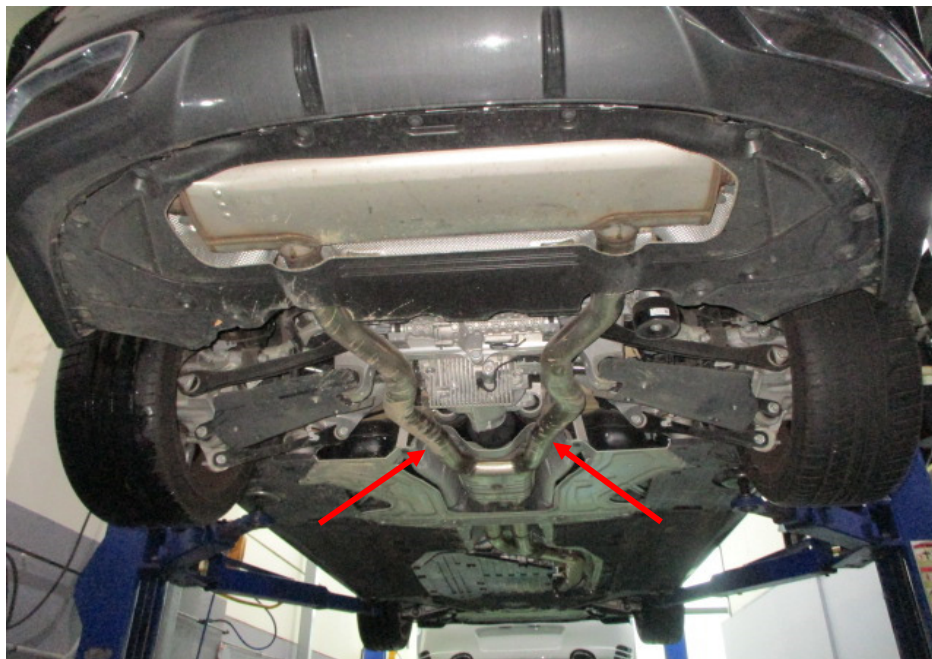
**Photo 25** shows a general view of the rear section of the Motor Car's exhaust system. My examination of the Motor Car's exhaust system revealed no sign(s) or indication(s) of any cut or weld marks along its exhaust pipes (arrowed), on its catalytic converter, on its centre resonator box and on its rear muffler.

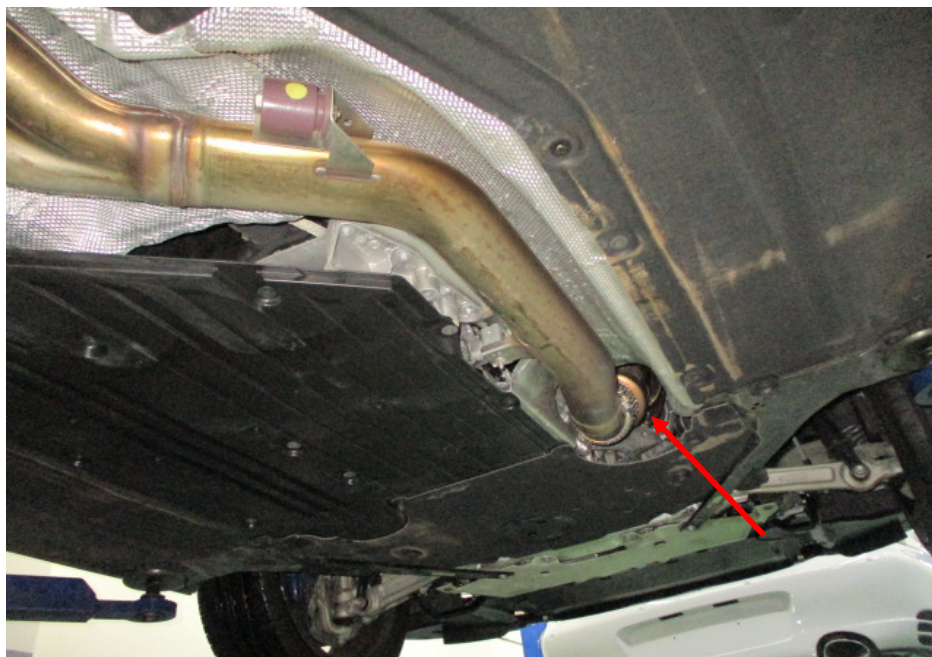
**Photo 26** shows a general view of the front section of the Motor Car's exhaust system. My examination of the Motor Car's exhaust system revealed no sign(s) or indication(s) of any cut or weld marks along its exhaust pipes, on its catalytic converter (arrowed), on its centre resonator box and on its rear muffler.

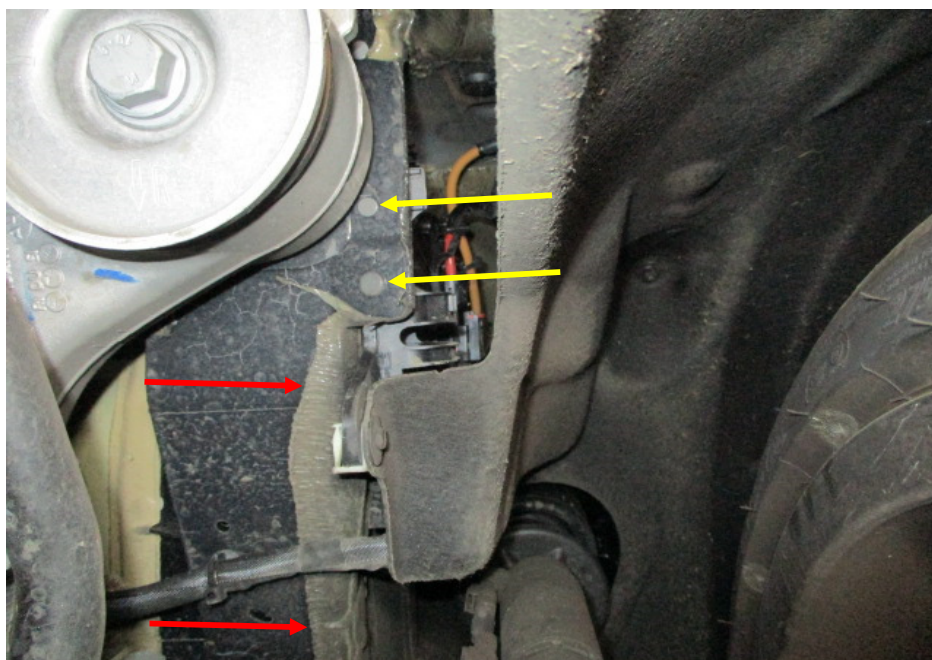
**Photo 27** shows the chassis/structural body at the underside rear right of the Motor Car. I did not find any weld marks other than original spot weld marks (yellow arrow) on the chassis/structural body of the Motor Car. The original factory sealant (red arrow) at the joints along the chassis/structural body was untouched, indicating no work was done on the chassis/structural body of the Motor Car and that the chassis/structural body was originally fitted.

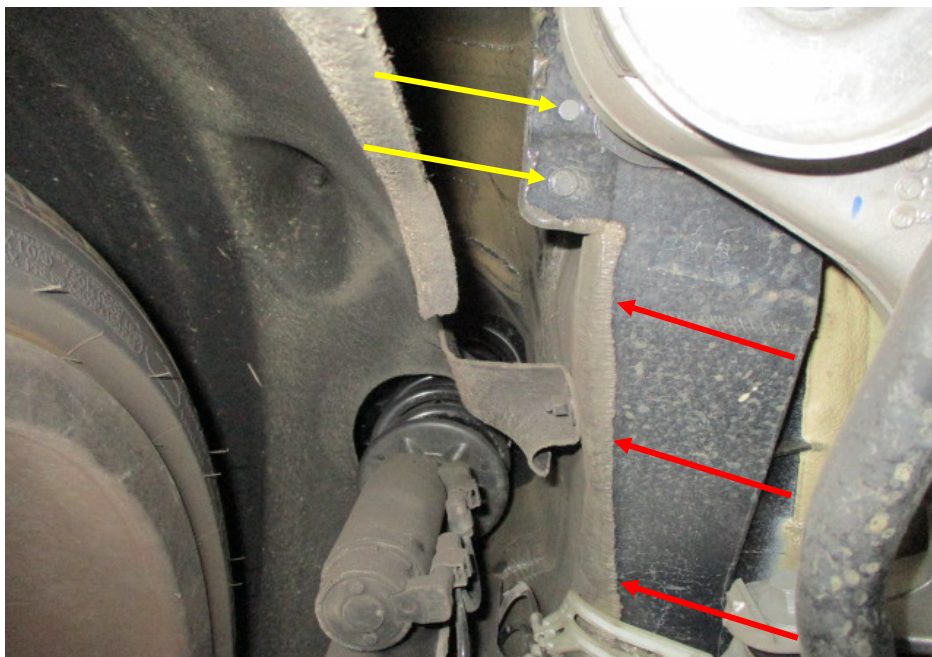
**Photo 28** shows the chassis/structural body at the underside rear left of the Motor Car. I did not find any weld marks other than original spot weld marks (yellow arrow) on the chassis/structural body of the Motor Car. The original factory sealant (red arrow) at the joints along the chassis/structural body was untouched, indicating no work was done on the chassis/structural body of the Motor Car and that the chassis/structural body was originally fitted.

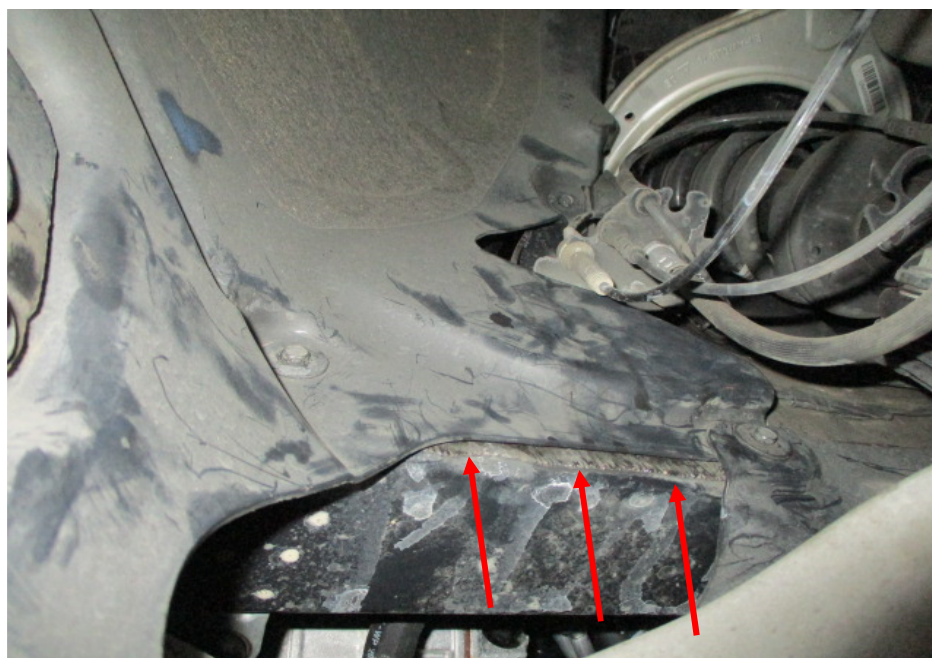
**Photo 29** shows the chassis/structural body at the underside front left of the Motor Car. The original factory sealant (arrowed) at the joints along the chassis/structural body was observed to be untouched. In general, I had found no work was carried out on the chassis/structural body of the Motor Car. The chassis/structural body of the Motor Car was originally fitted.

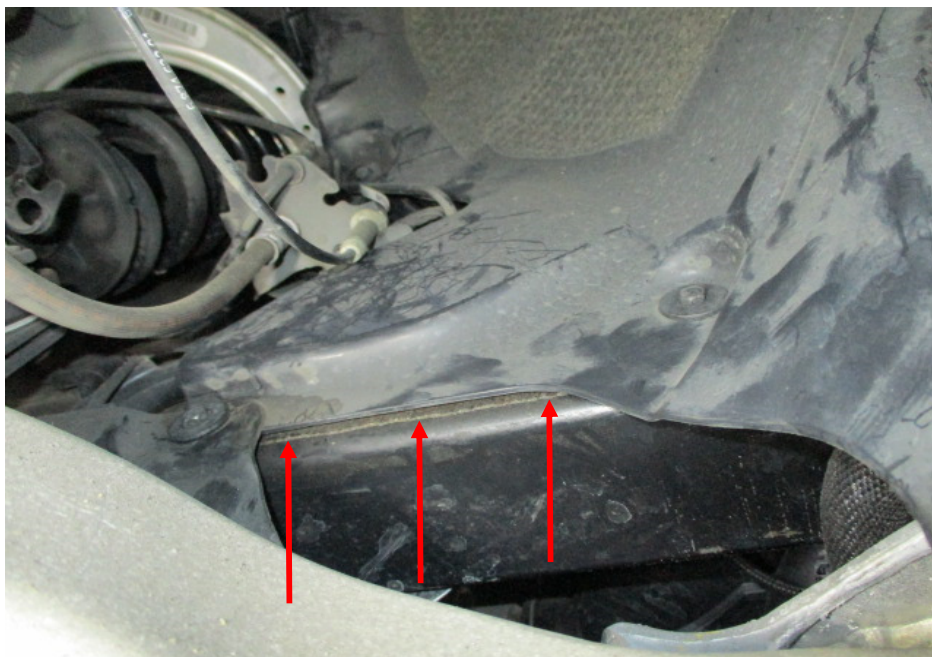
**Photo 30** shows the chassis/structural body at the underside front right of the Motor Car. The original factory sealant (arrowed) at the joints along the chassis/structural body was observed to be untouched. In general, I had found no work was carried out on the chassis/structural body of the Motor Car. The chassis/structural body of the Motor Car was originally fitted.

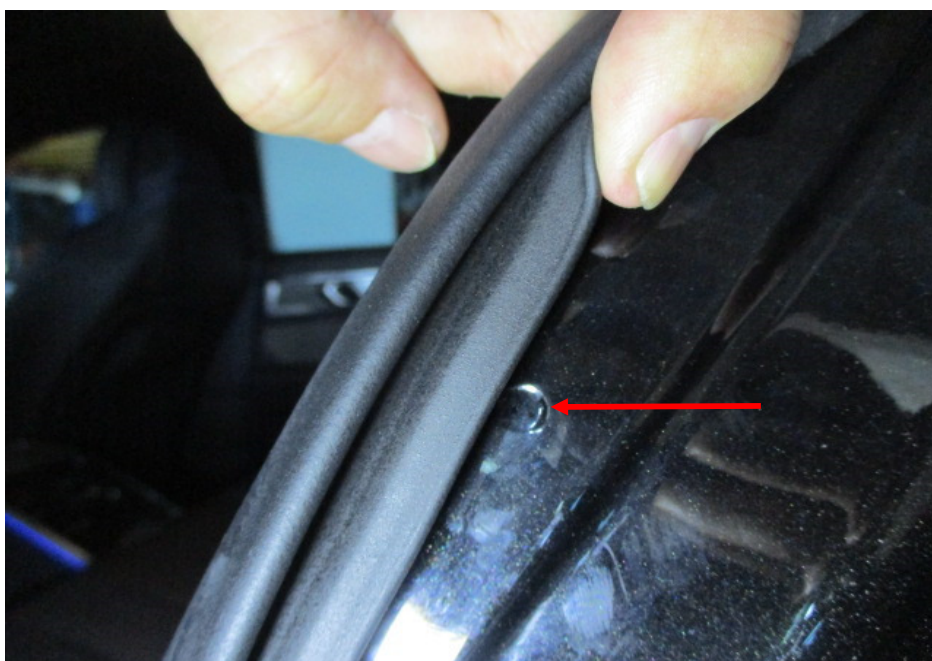
**Photo 31** shows the left side "C" pillar of the Motor Car. I did not find any weld marks other than original spot weld marks (arrowed) on the left side "C" pillar of the Motor Car which, indicates that there was no re-welding works carried out. In general, I had found all the non-detachable body panels of the Motor Car to be originally fitted at the time of my inspection.
