Your Ref: BMW 840i  
(chassis number WBAGV22030BP82840)  
Our Ref : CI/TP21009651/D

18 September 2021

**INSPECTION REPORT OF AN UNREGISTERD BMW 840i MOTOR CAR WITH CHASSIS NUMBER WBAGV22030BP82840**

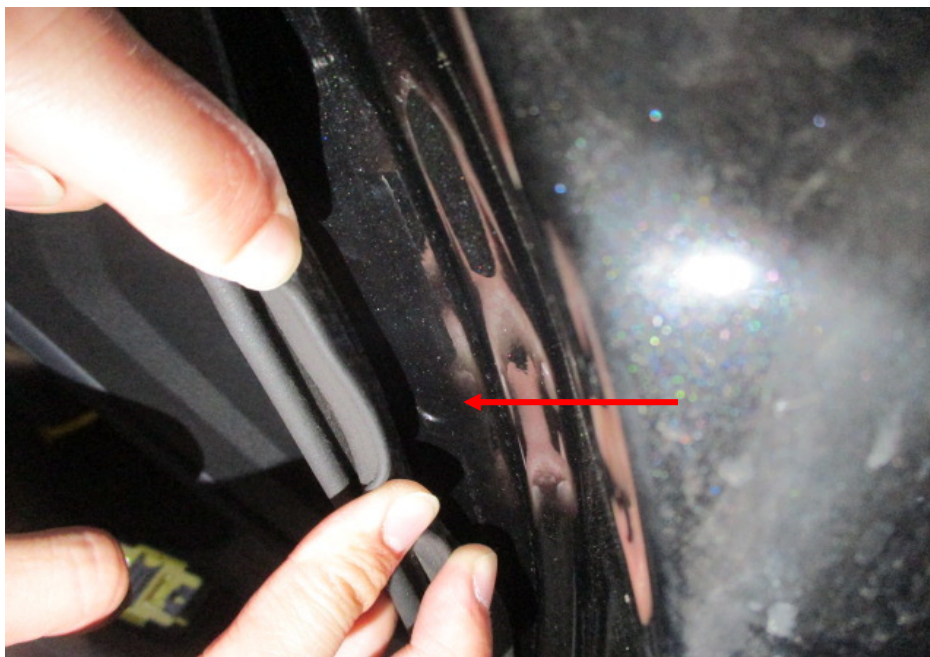
**Photo 32** shows the right side "A" pillar of the Motor Car. I did not find any weld marks other than original spot weld marks (arrowed) on the right side "A" pillar of the Motor Car which, indicates that there was no re-welding works carried out. In general, I had found all the non-detachable body panels of the Motor Car to be originally fitted at the time of my inspection.
