VEHICLE DAMAGE PRE REPAIR SURVEY REPORT

Our File No: **MS19-EQ-010016/TPFG**
Insurer Ref: **YP8938L**
Insured Name: -

Reg No:	YM6079U	Make:	ISUZU
Reg Year:	2007	Model:	NHR85EU3ES
Colour:	Green	Engine No:	4JJ1450635
Type:	-	Chassis No:	JAANHR85E77100047
Type of Claim:	Third Party's Claim	Odometer:	0
Market Value:	-	Engine Cap:	2999 cc

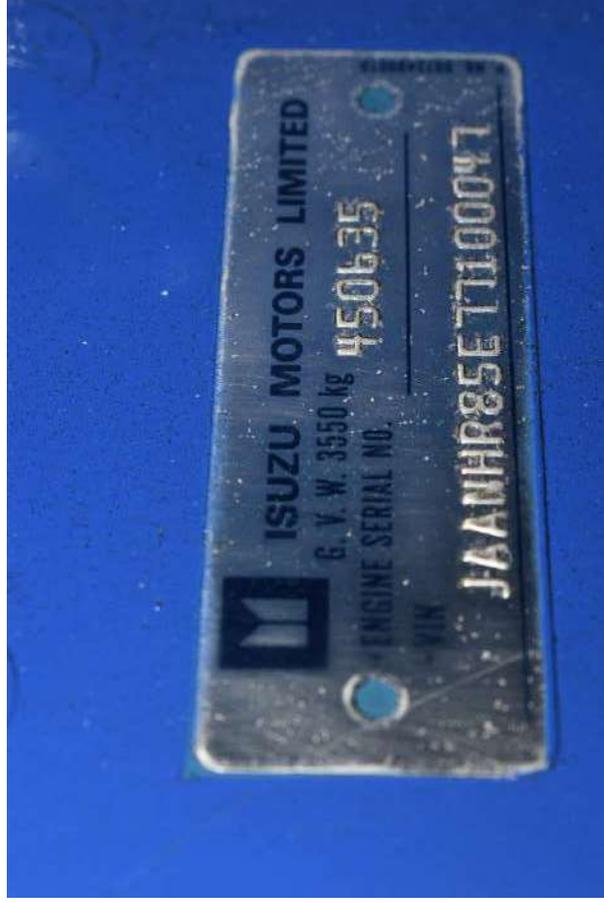
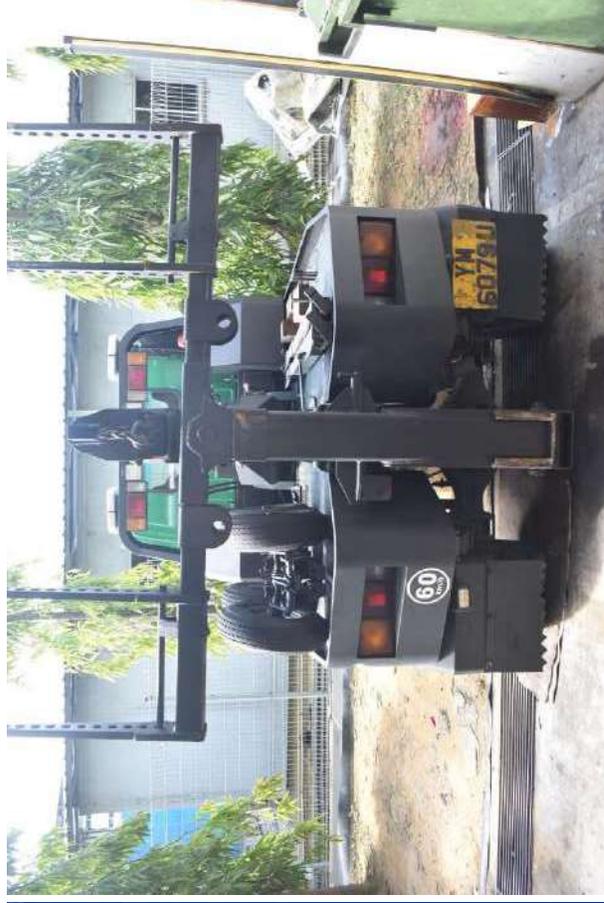
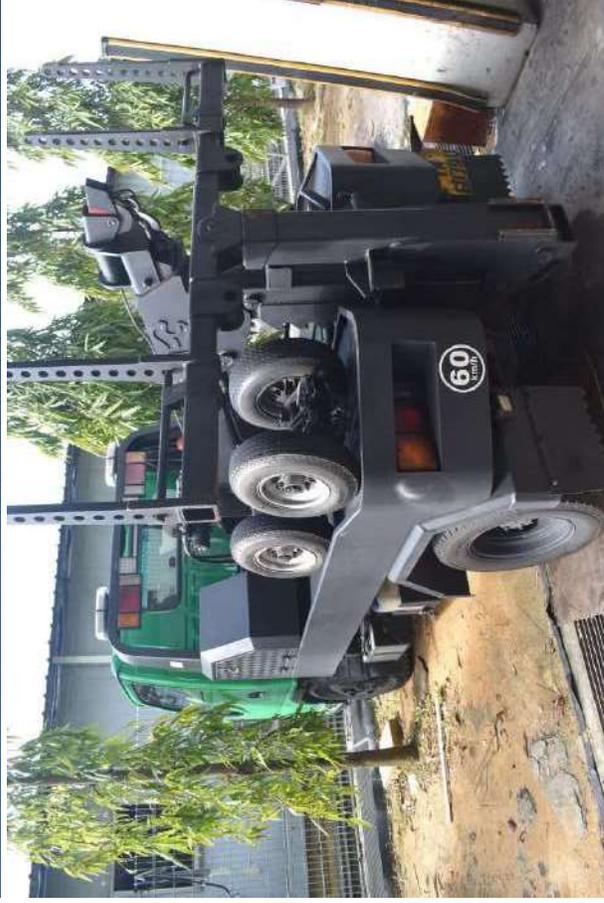
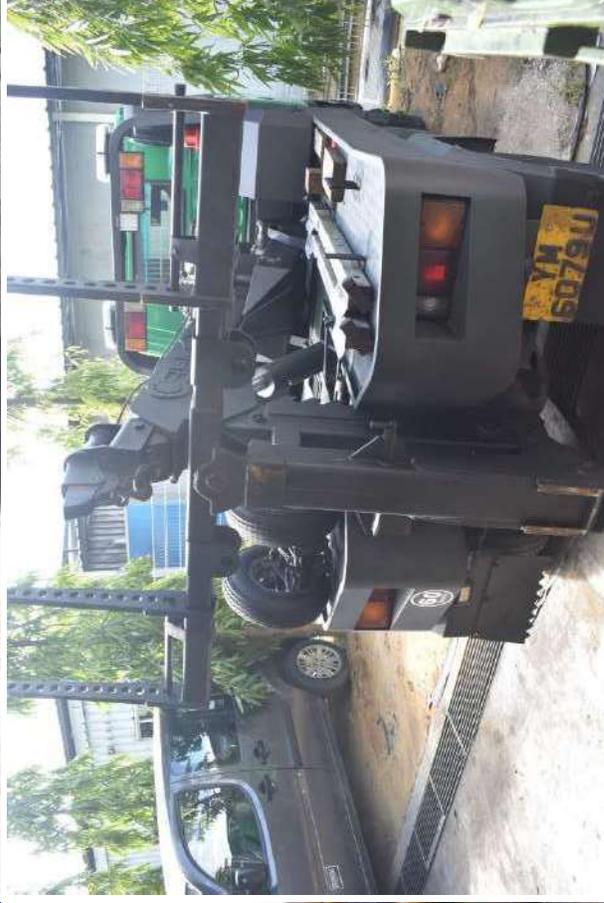
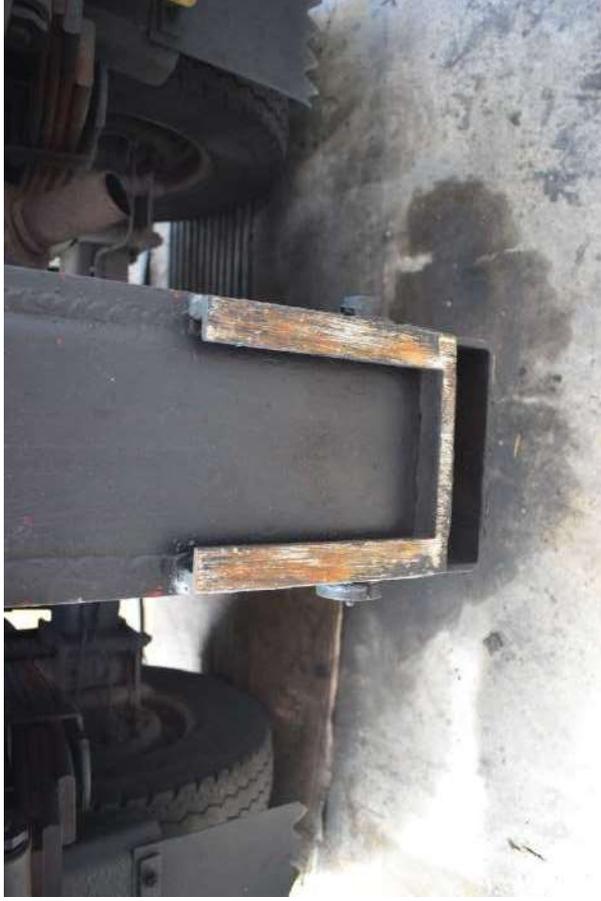
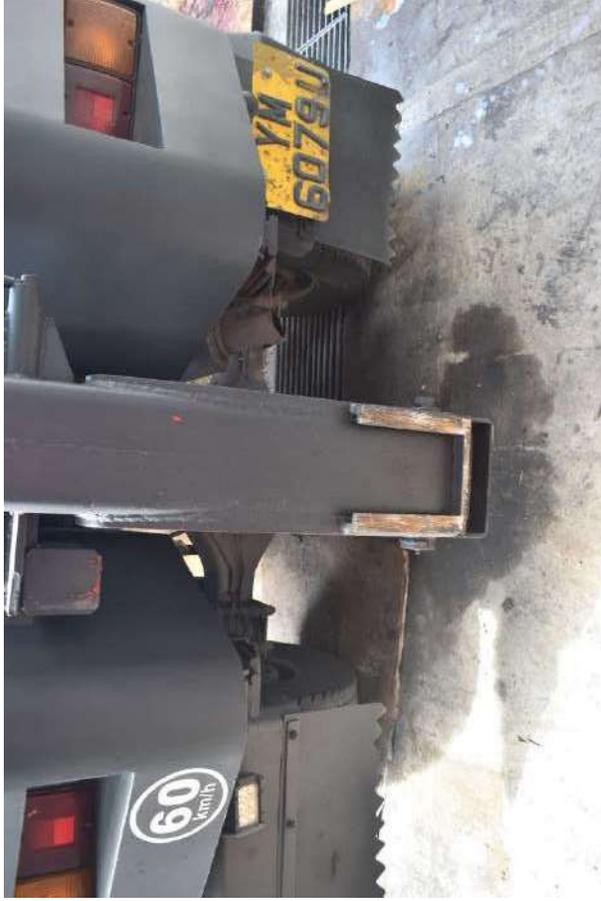
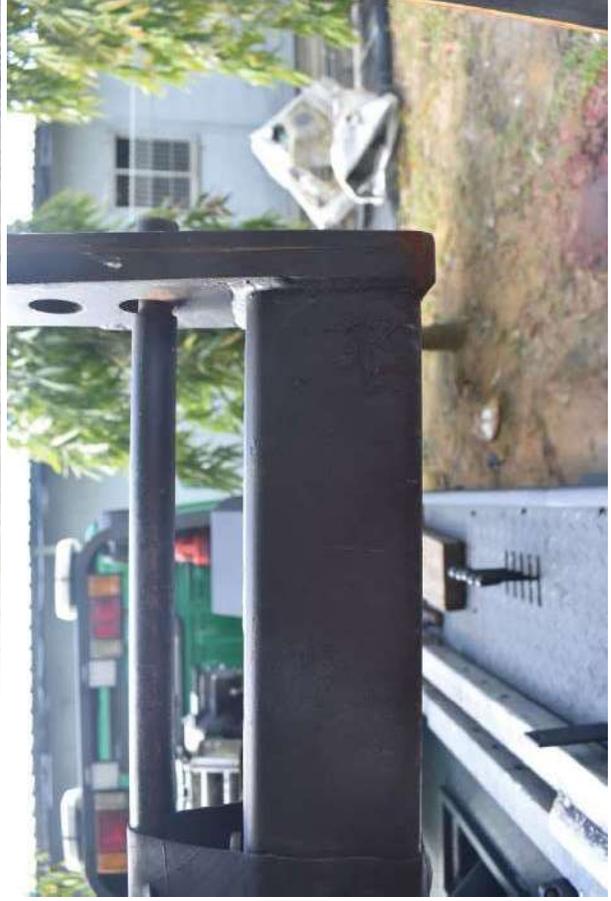
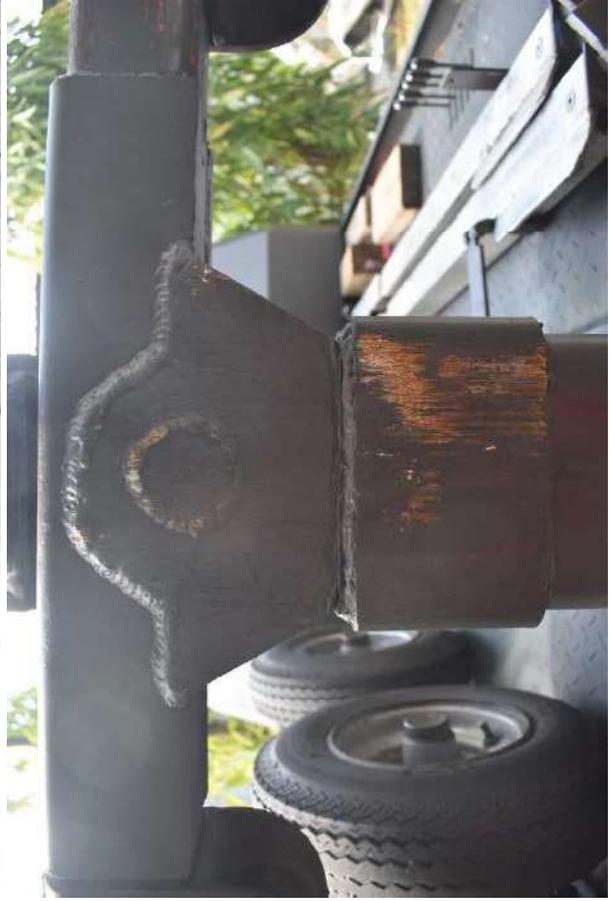
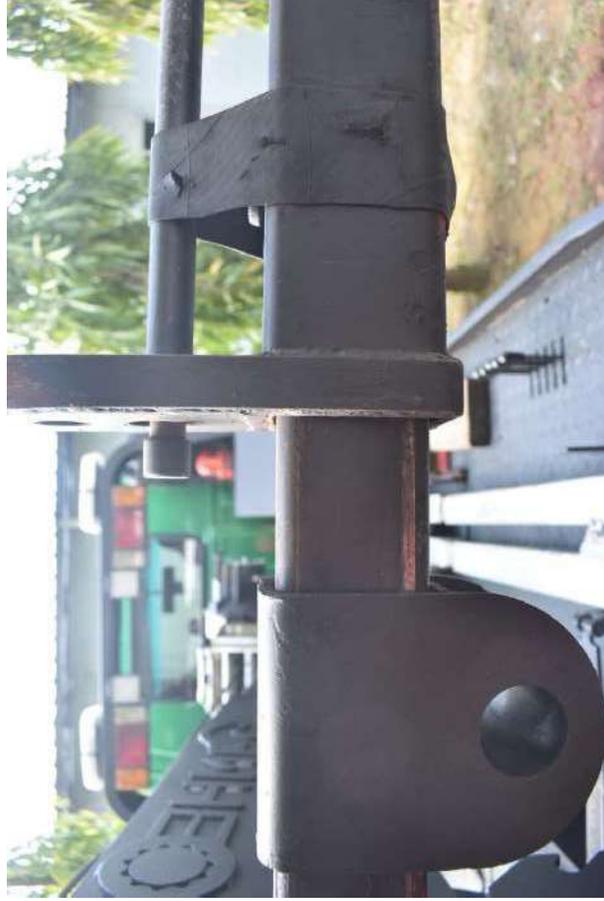
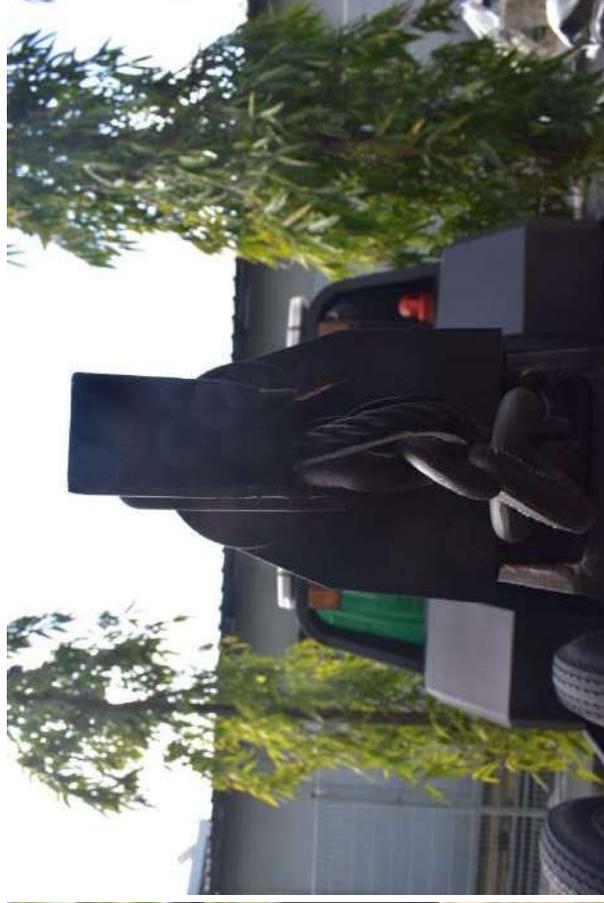
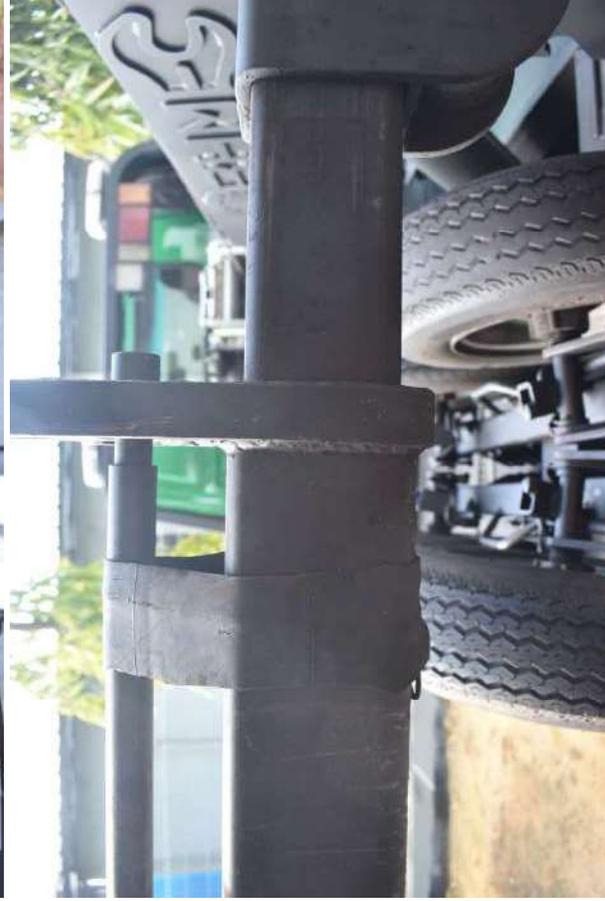
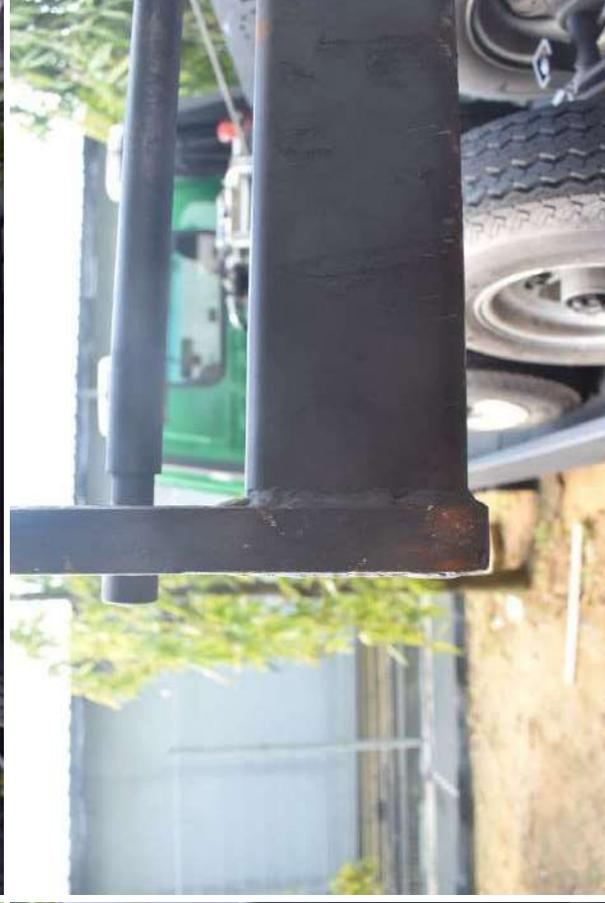
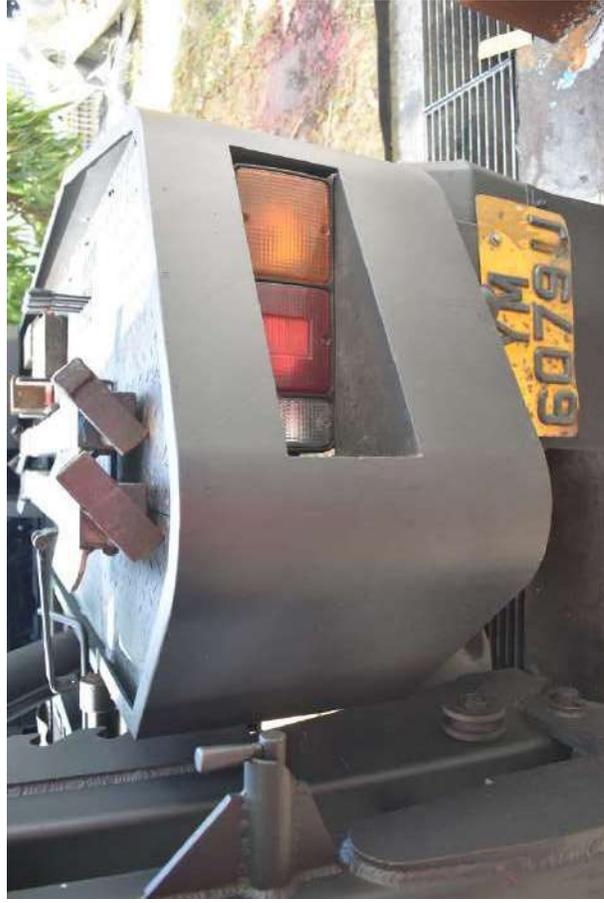
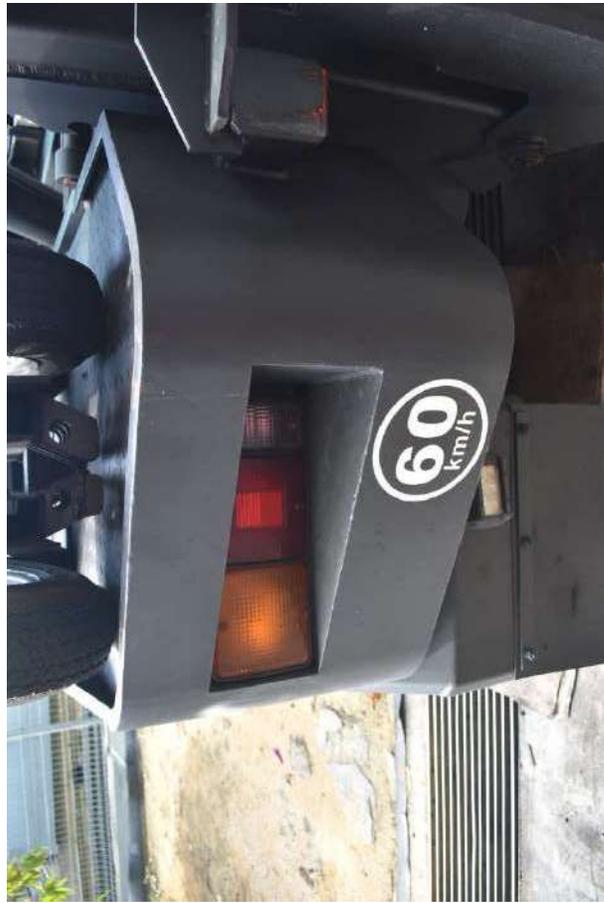
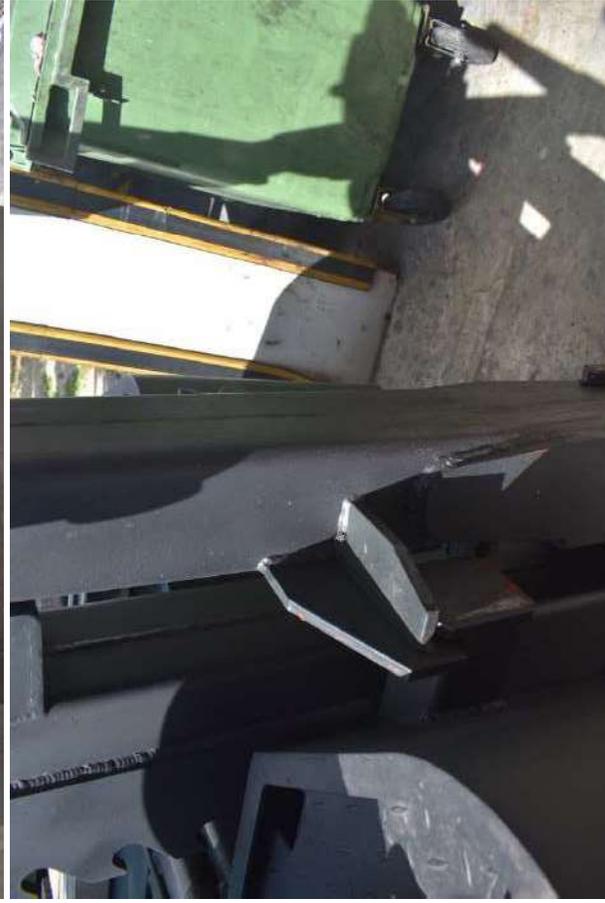
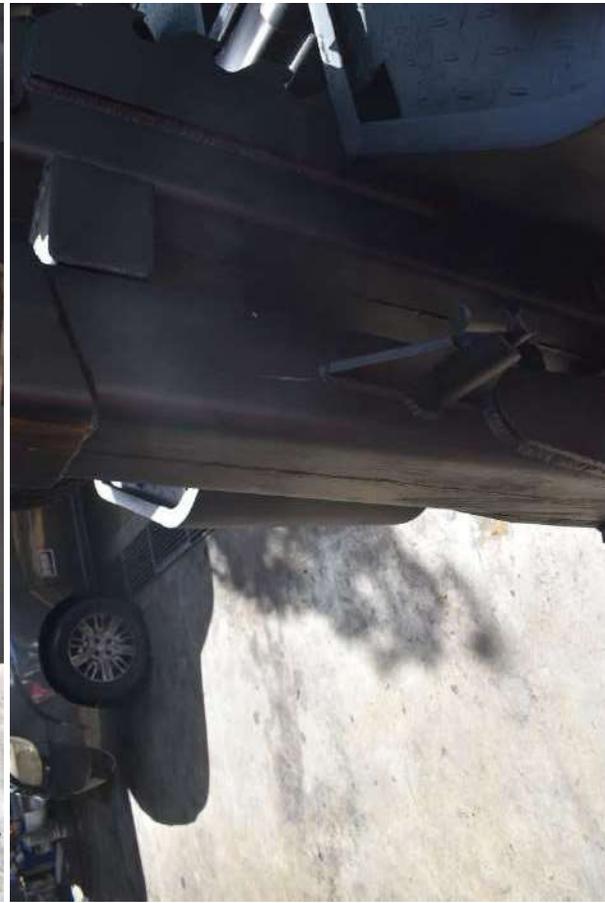
INSPECTION PHOTOS

<p>The vehicle sustained damages to the rear portion.</p>

Our visual inspection of the vehicle revealed that the damages noted are consistent with the accident as reported.

Recommended Estimate Repair Cost (S\$) : 3,000.00
