ACCIDENT VEHICLE INSPECTION / ASSESSMENT REPORT

Our Ref: CLM13040TP/T

: BJN 8800

VEHICLE DAMAGE ASSESSMENT REPORT

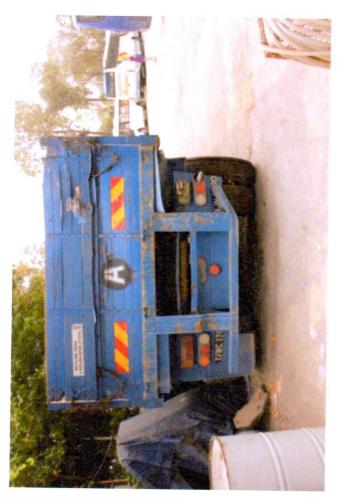
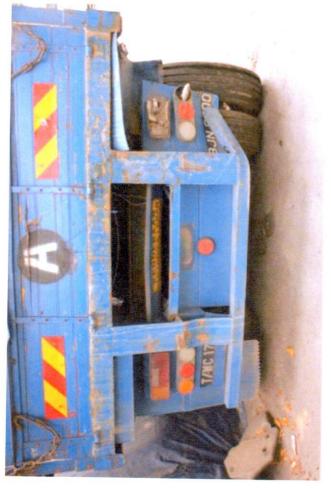
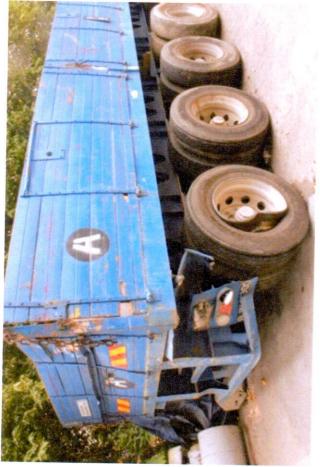
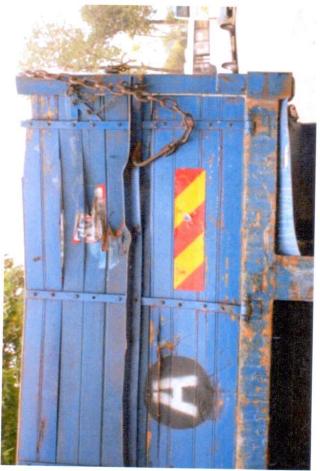
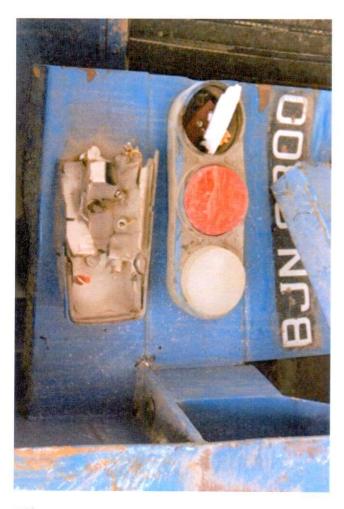
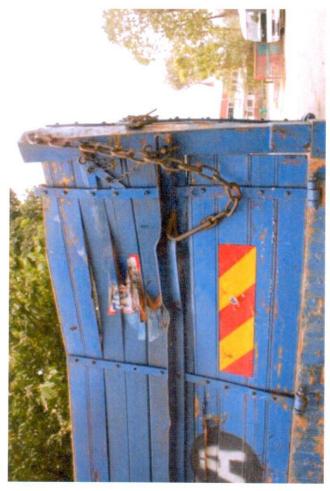
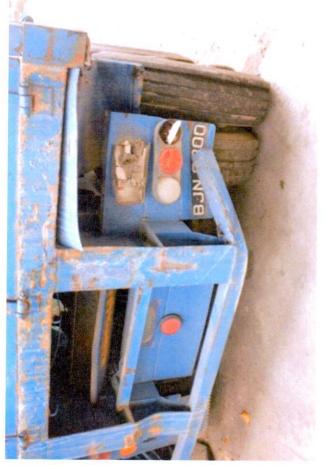
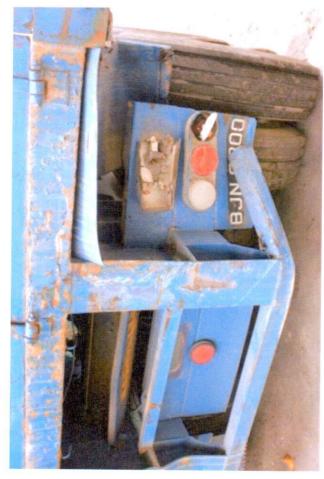
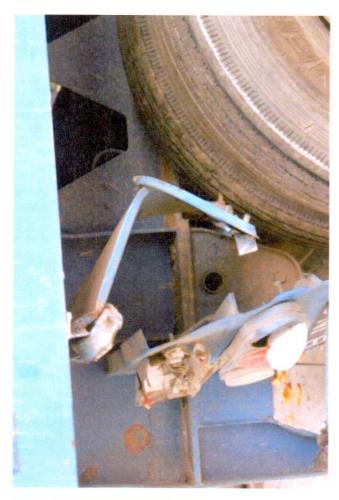
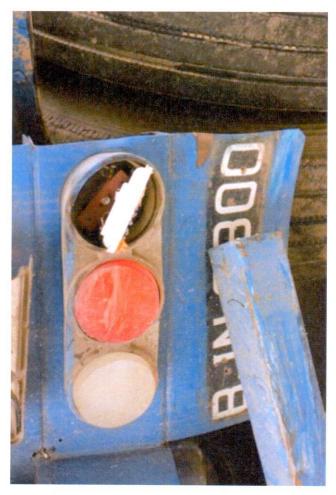
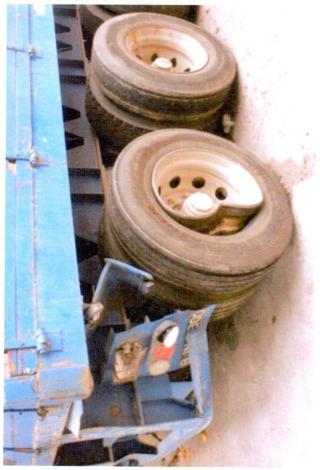
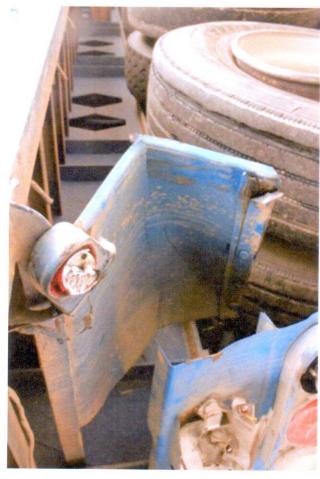
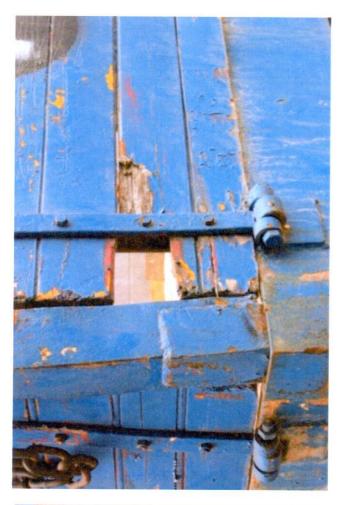
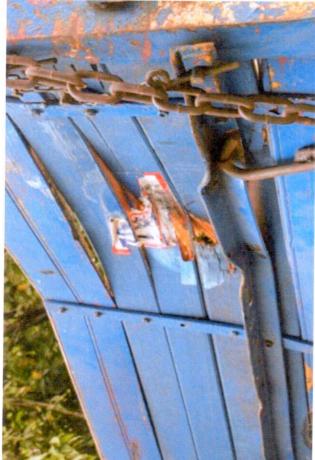
On site survey inspection revealed that the damage noted are consistent with the accident as reported.

Damage at the Rear panel, rear taillamp, rear signal lamp wooden tailgate, and etc.
